**SLOPE AND BANK
EROSIONAL STABILITY OF THE
CANONSBURG, PENNSYLVANIA,
UMTRA DISPOSAL SITE**

December 1994

Prepared for
U.S. Department of Energy
UMTRA Project Office
Albuquerque, New Mexico

Prepared by
Jacobs Engineering Group Inc.
Albuquerque, New Mexico

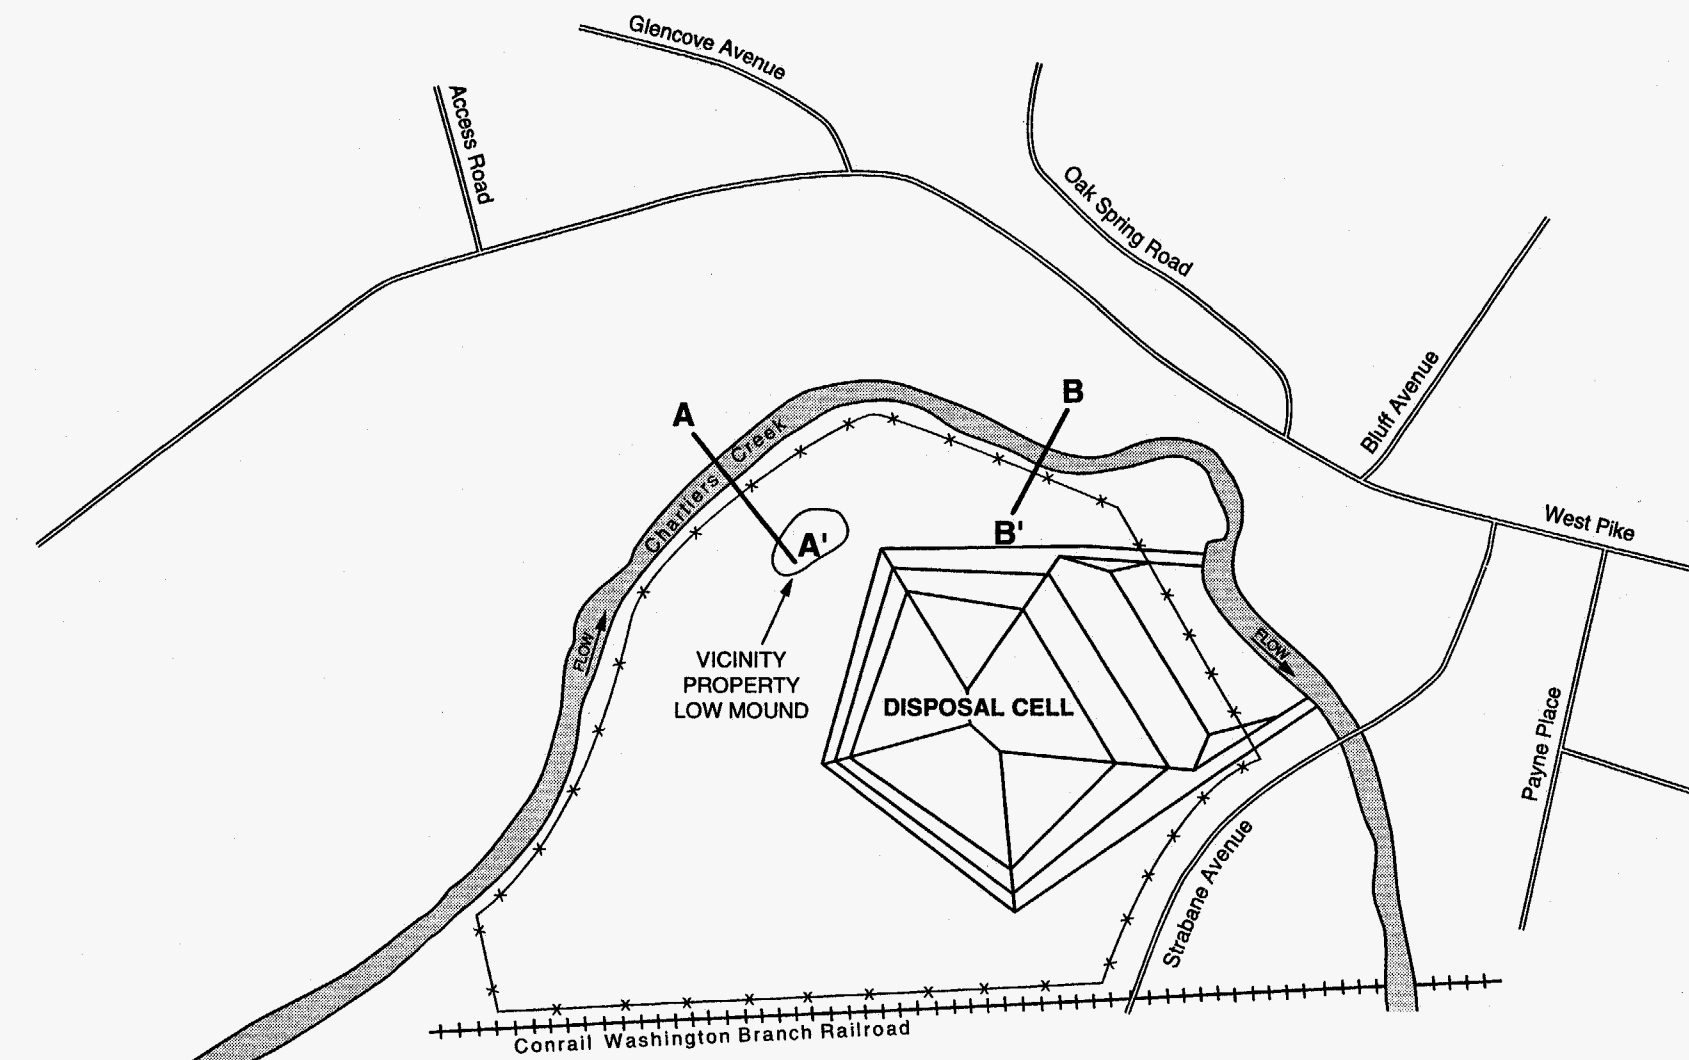
FIGURE 3.1
LOCATION PLAN WITH CROSS SECTIONS
CANONSBURG, PENNSYLVANIA, SITE

The location plan (Figure 3.1) shows the cross sections analyzed (Figures 3.2 and 3.3). Section A (Figure 3.2) was taken from the as-built site grading plan (MK-Ferguson Company, 1986b). The "critical section A" included on Figure 3.4 was generated by actual field survey data obtained along section A by Mounts Engineering Company, Washington, Pennsylvania. Section A was selected as the critical section because the current active erosion at Chartiers Creek is closer to the VP mound (which contains RRM) at this location (Figure 3.1) than to any other part of the site.

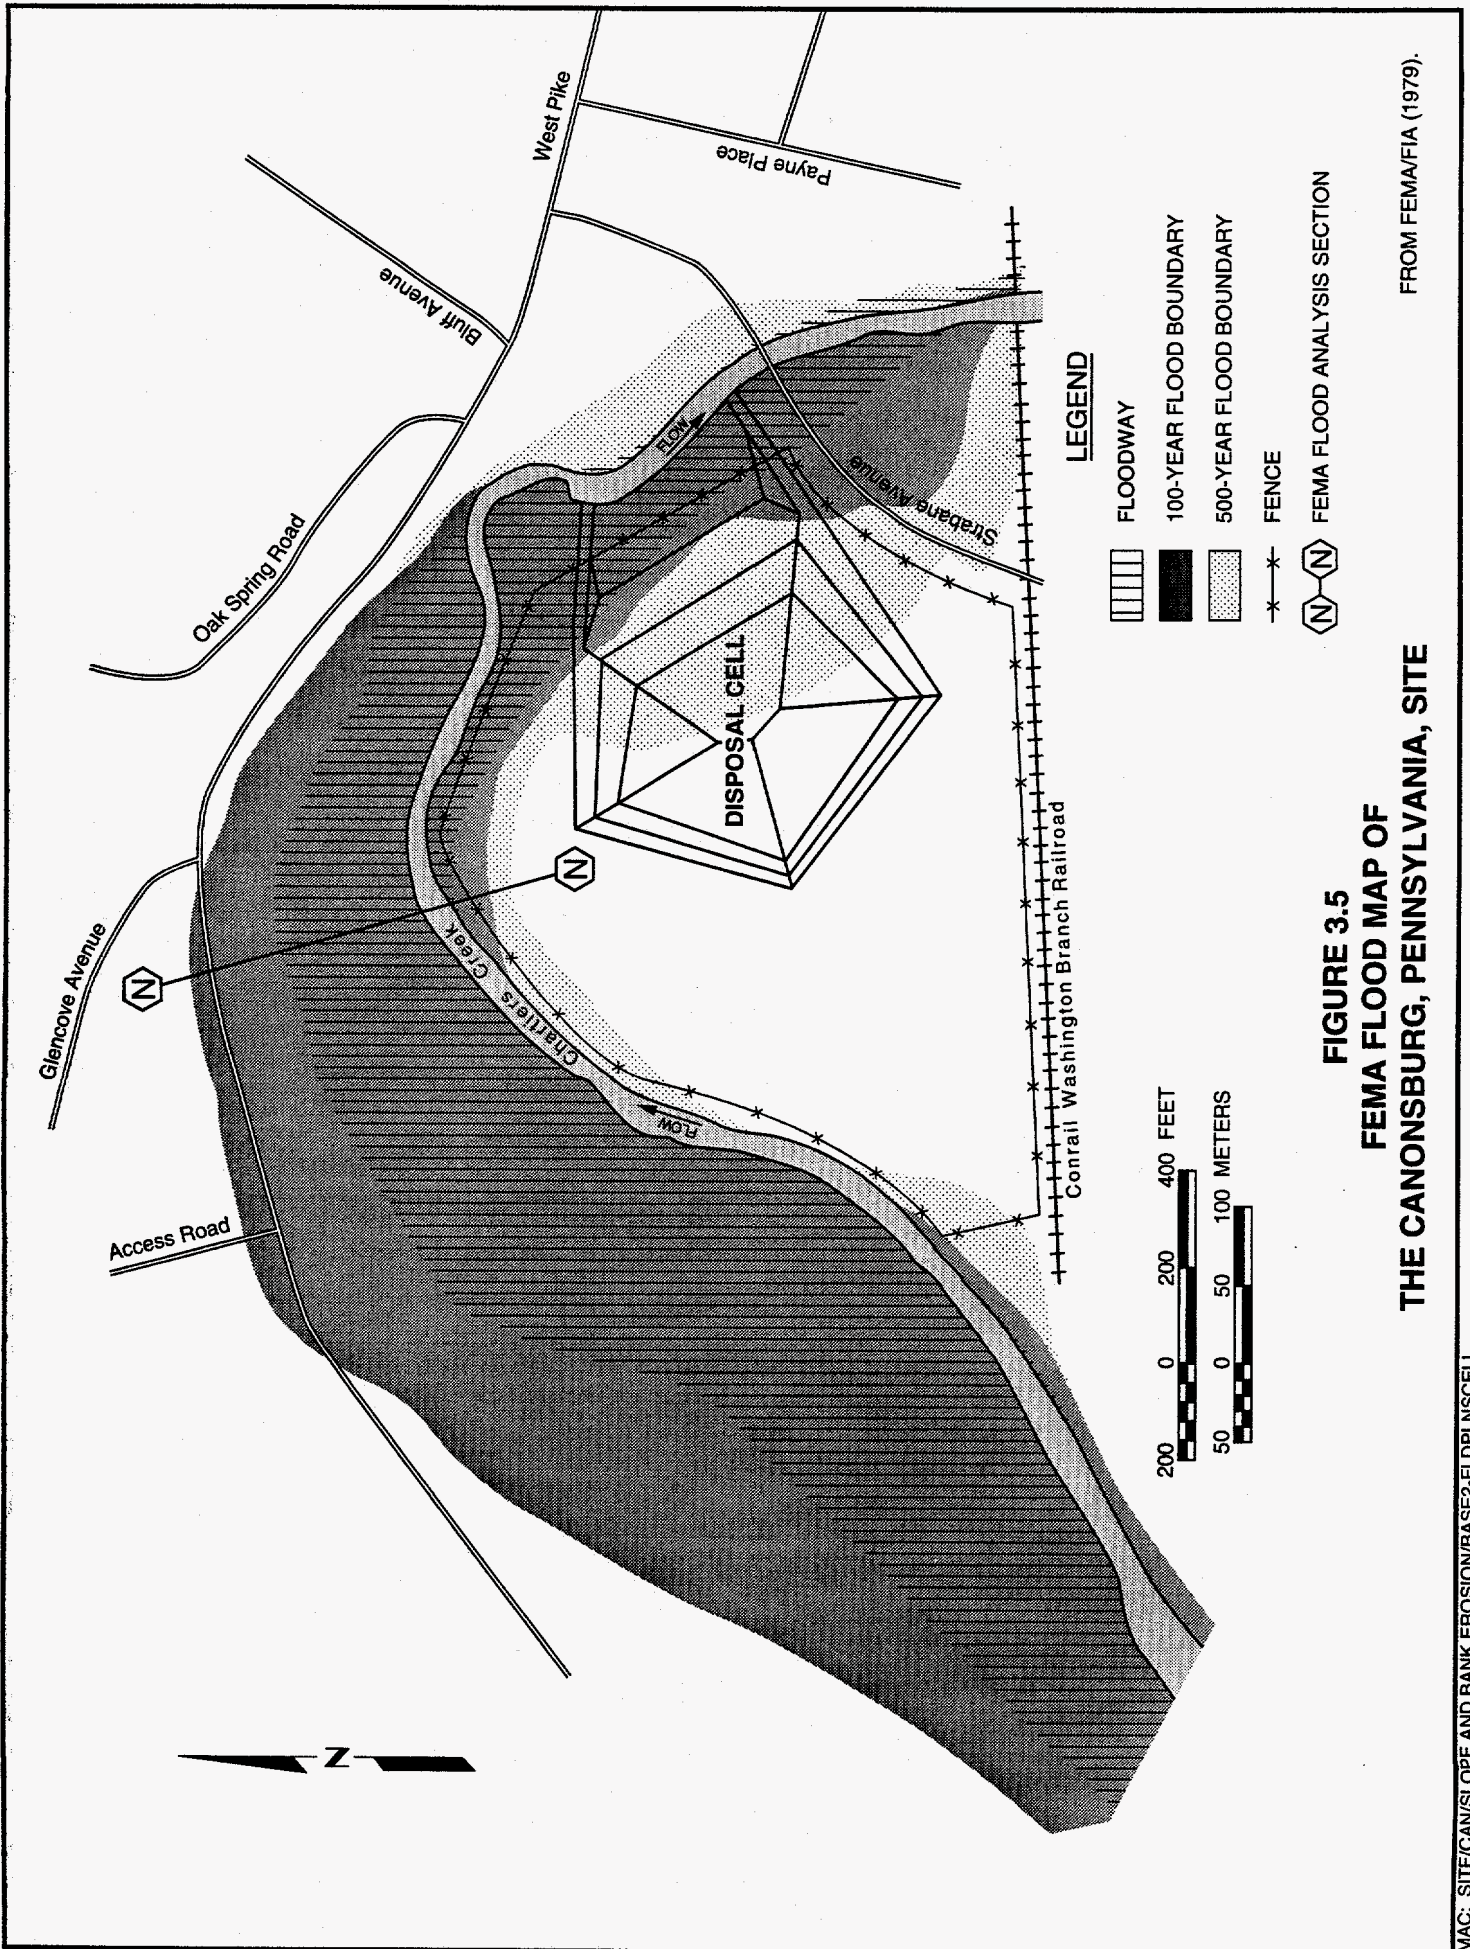
FIGURE 3.5
FEMA FLOOD MAP OF
THE CANONSBURG, PENNSYLVANIA, SITE

The Federal Emergency Management Agency (FEMA) and Federal Insurance Administration (FIA) flood insurance study for the Borough of Canonsburg, Pennsylvania, Washington County, Community number 420849 (FEMA/FIA, 1979) includes a cross section (cross section N) that approximates section A (Figure 3.5). The FEMA 100-year-flood level at section A is at elevation 949.6 ft, and the flood velocity is 4.6 feet per second (ft/s). FIA regulations do not allow construction in or modifications of river flood plain areas that will raise the floodway's 100-year-flood level by more than 1.0 ft (FEMA/FIA, 1979) (i.e., to elevation 950.6 ft at section A).

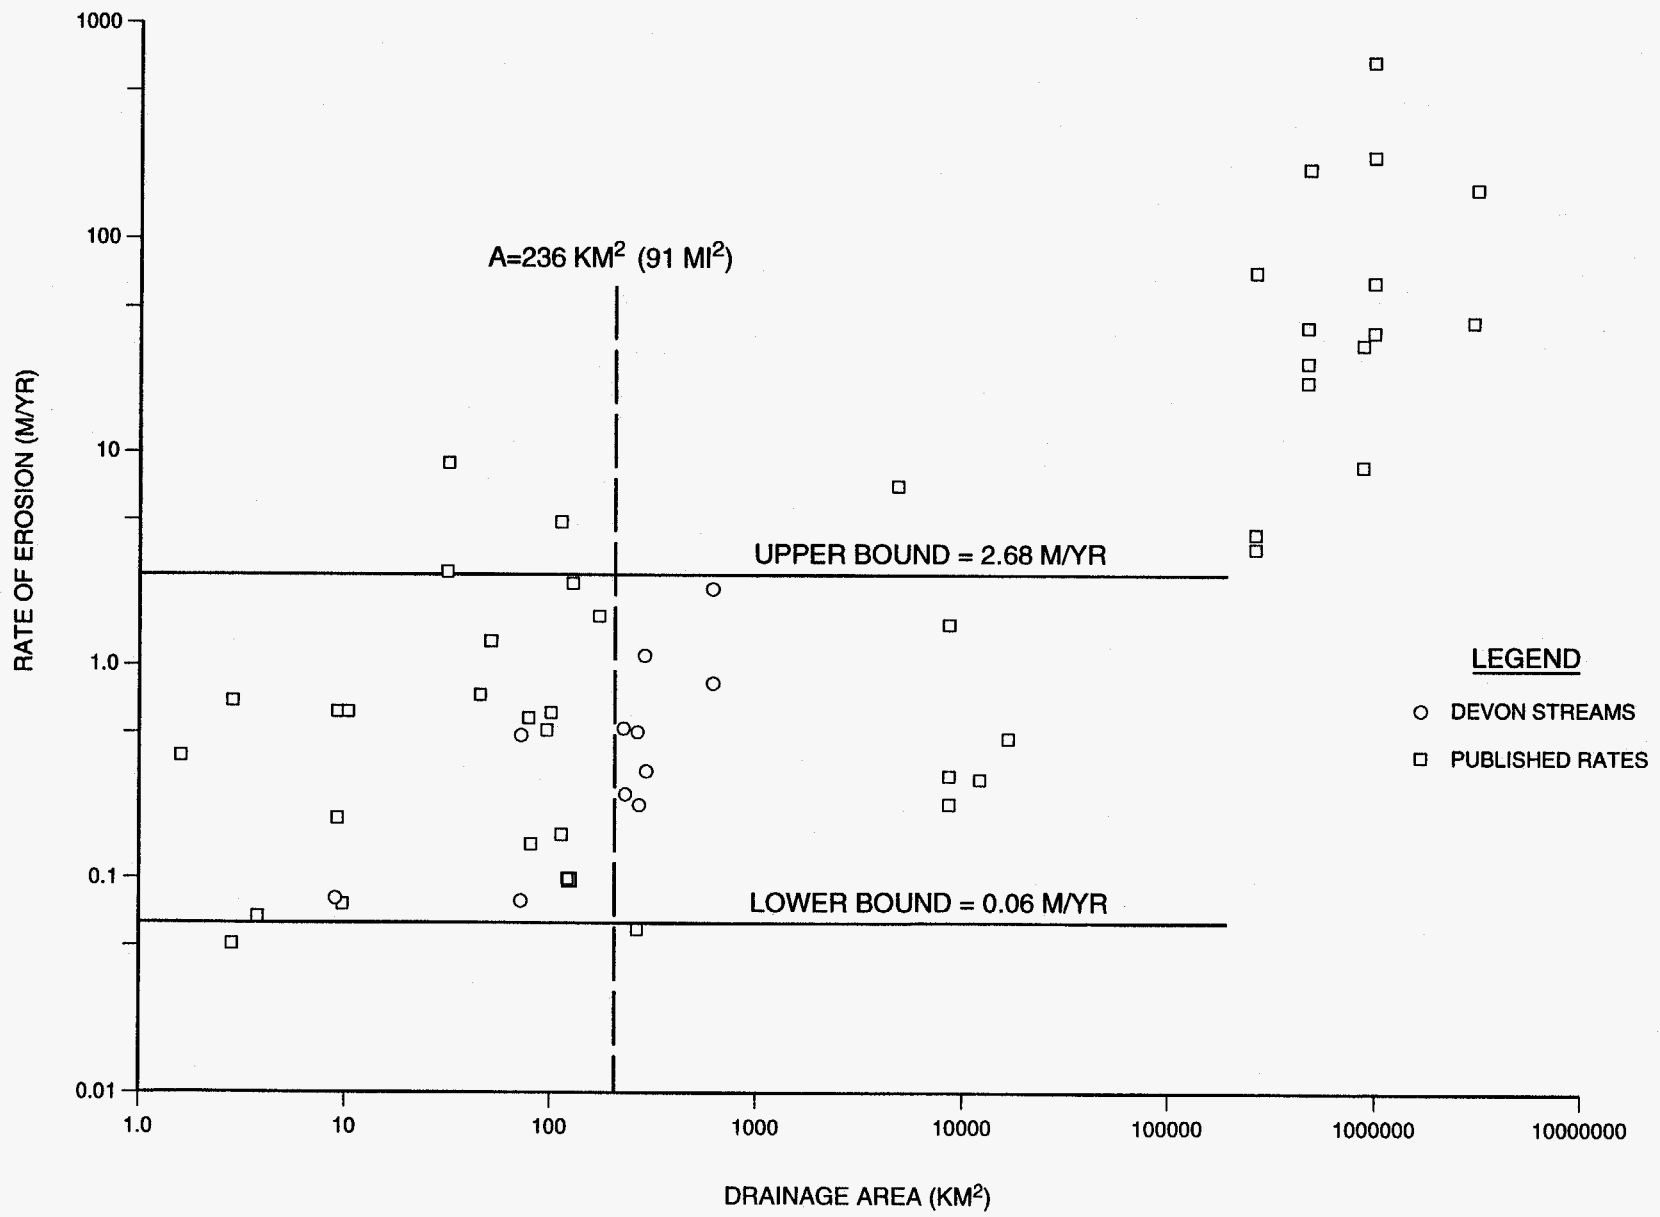
FIGURE 4.1
RELATIONSHIP BETWEEN EROSION RATES AND CATCHMENT AREA

Using data of stream-bank erosion from Hooke's paper (Hooke, 1980), upper and lower bounds on the expected annual stream-bank erosion on Chartiers Creek were estimated (Figure 4.1). Given that the Chartiers Creek drainage area is approximately 91 square miles (FEMA/FIA, 1979), the lower bound yearly bank erosion would be approximately 3 inches per year and the upper bound value would be approximately 9 ft per year. The 9 ft per year side-bank erosion rate was used in developing the "one bad year" scenario analysis requested by NRC (see Sections 5.0 and 6.0 below).

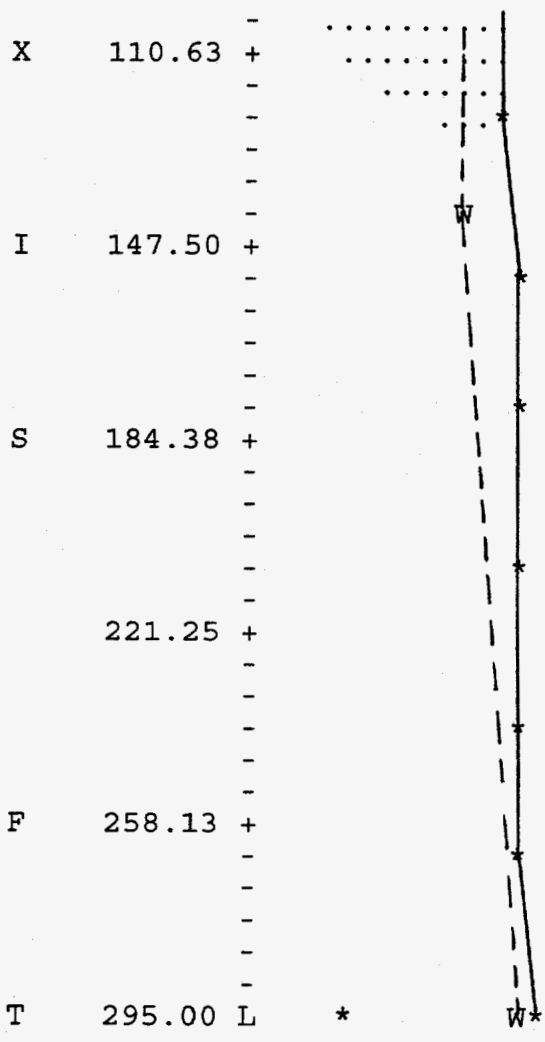
Canonsburg, Mounts, Section A w/erosion Soil 26.0 deg & 120 pcf, EQ = 0.0g
 Ten Most Critical. A:CANON.PLT By: John Lommler 12-09-94 8:37am

Using the actual field geometry along critical section A (surveyed by Mounts Engineering Company in July 1994) and assuming that a wedge of soil 9 ft wide at its base is eroded from the bank, the STABL5 program (Carpenter, 1986) was used to determine the location of likely failure surfaces that would be generated. The minimum factor of safety surface is plotted in Figure 3.4.
