ANL/ESD/TM-60

Initial Building Investigations at Aberdeen Proving Ground, Maryland: Building E5190

by K.L. Brubaker, J.M. Dougherty, and C. Tome

October 1993

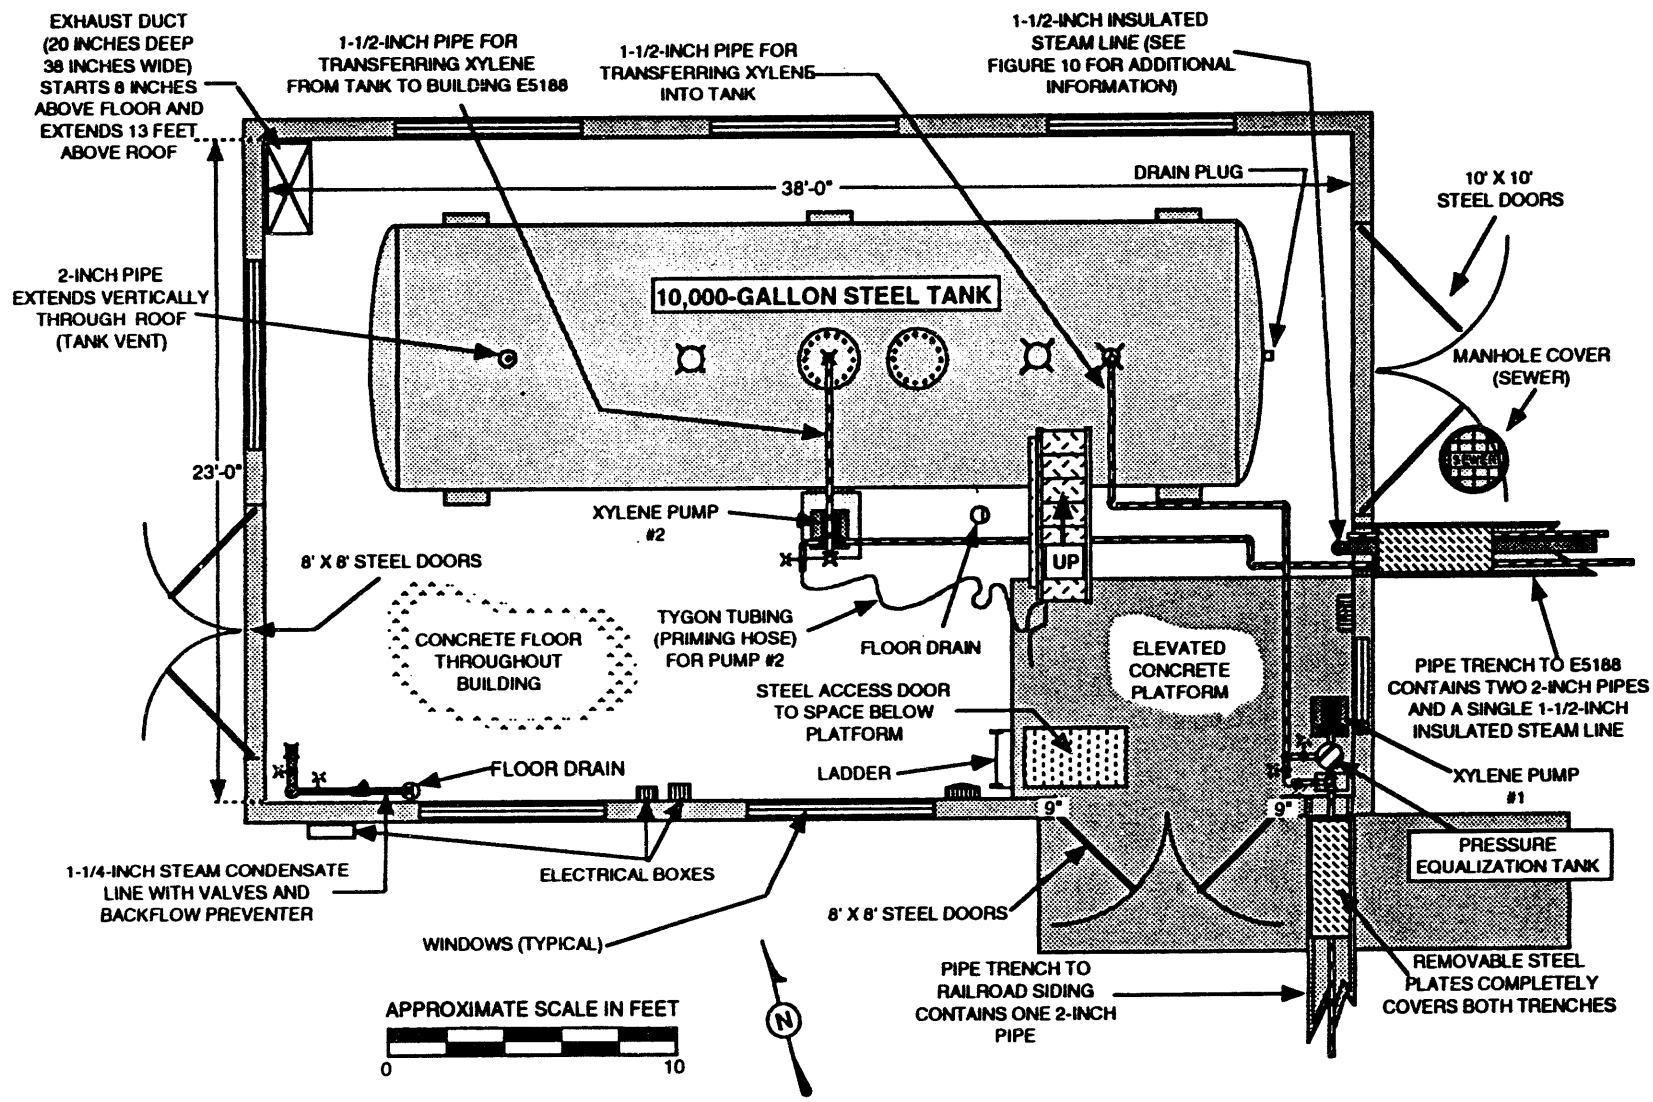
FIGURE 9 Building E5190 Floor Plan

Building E5190 has a 1-ft-thick, cast-in-place concrete floor installed 4 ft below the surrounding exterior grade of the building. The floor of E5190 is intact and in good condition for its age. There is no evidence to suggest that the floor of this building was modified in any way. No major cracks were identified.

The building contains two 2-1/2-in. floor drains (Figure 9). The outfall piping for these drain lines was not located during either the building inspection or the geophysical survey. The first of these drains, which is located approximately 5 ft northwest of the elevated platform, is equipped with a plug. This drain plug has a 4-ft-long metal rod extending vertically above the floor; this rod acts as a handle for the removal of the drain plug in the event that the building is flooded. The second floor drain is located along the south interior wall of the building, approximately 7 ft east of the southwest corner of the building, and is also equipped with a plug. This drain is dedicated to the removal of condensation water resulting from the steam heating system. A single 1-in. pipe is sealed in the drain plug (Figure 10) (Whitman, Requardt and Smith Engineers 1941a).

Building E5190 contains a single 10,000-gal storage tank, number 91695 in APG's liquid storage tank record system. The approximate dimensions and the location of this tank within the building are shown in Figure 9.

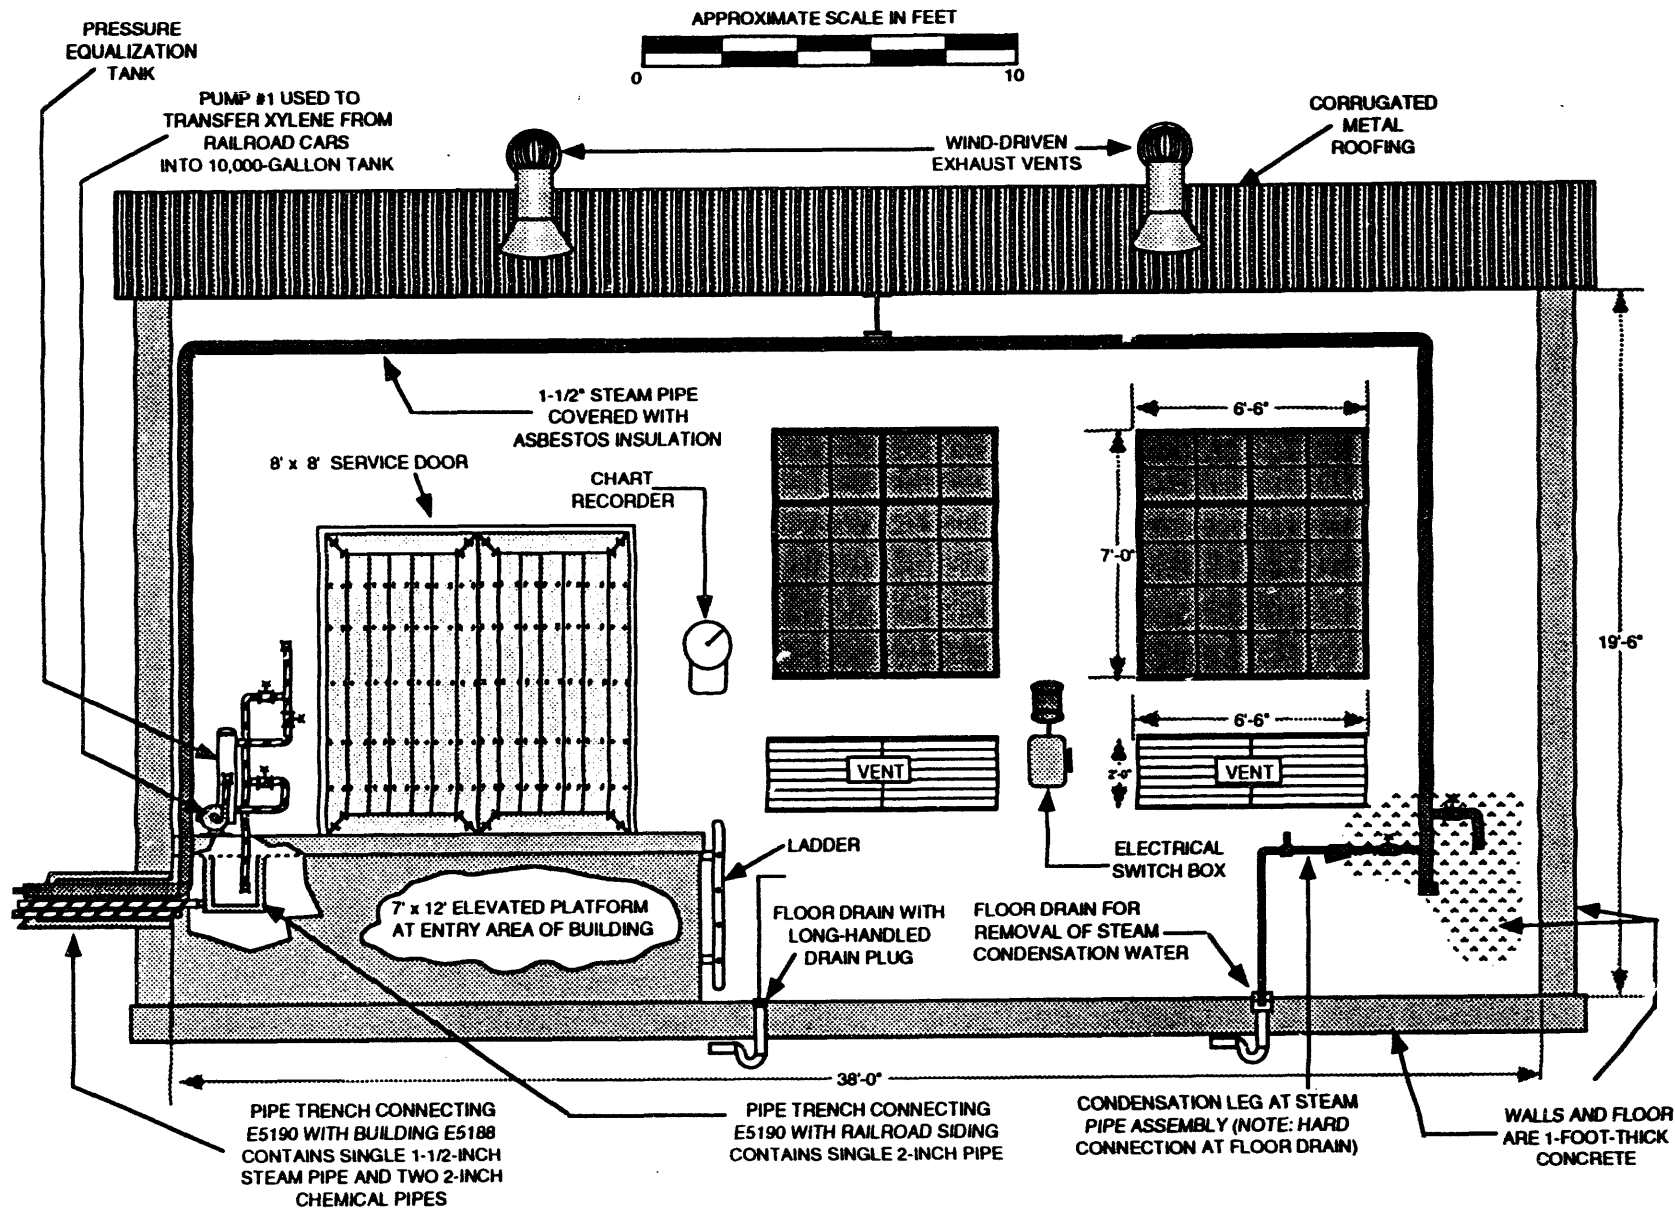
FIGURE 12 Building E5190 South Interior Wall

this platform. A ladder leads down to the floor level of the building (Figure 13). This platform seems to have been the main work area within the building. The area below the platform is empty unused space (Whitman, Requardt and Smith Engineers 1941a; see also Figure 12).

The south interior elevation of E5190 contains elements of two of the building's plumbing systems. The first of these systems is located in the southwest interior corner of the building. A 1-1/2-in. insulated steam line for the heating unit that has been removed from the building remains at this location (Figure 12). This steam system has an associated condensation leg that is hard-piped directly into a floor drain (Figure 12). The second piping system in this elevation is associated with the tank filling operation and is located at the elevated platform in the southeast corner of the building (see Section 4.7.8 this report and Figures 9, 11, and 12). The opening for the pipe trench that connects the building to the railroad siding to the south is located in the southeast corner of the building, directly beneath the elevated platform (Figure 12).

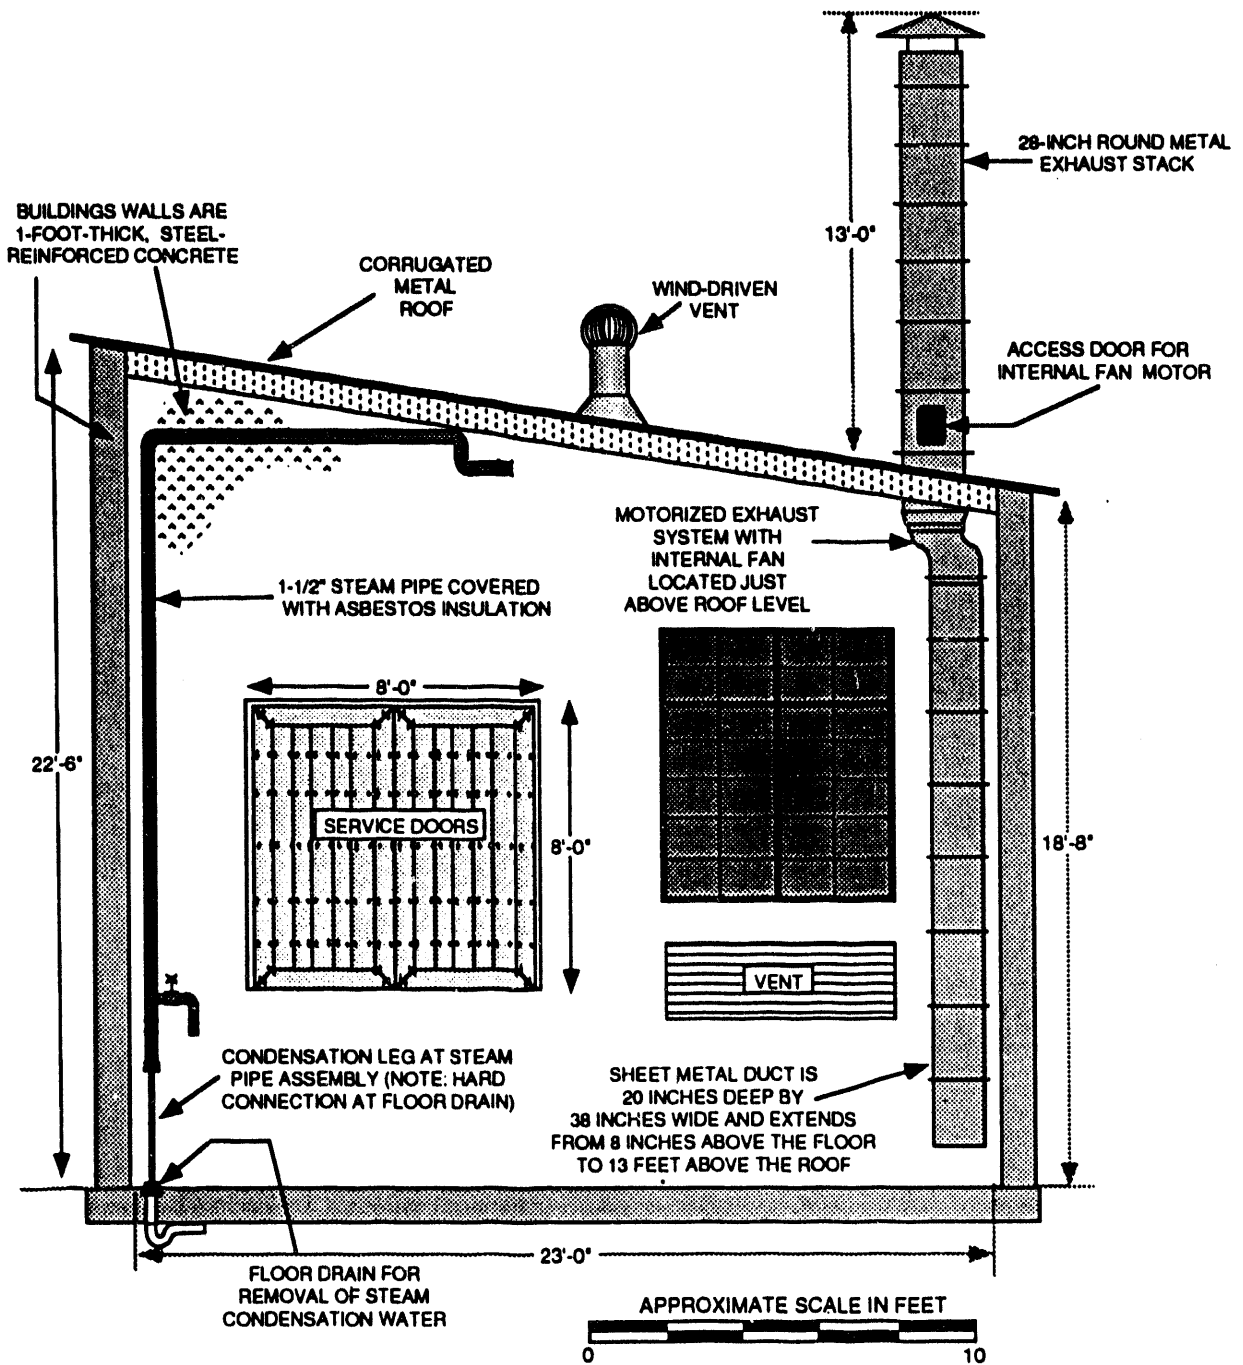
FIGURE 13 Building E5190 West Interior Wall

The interior walls of Building E5190 are raw or uncoated concrete (Figure 13).

The only piping associated with the west wall of the building is the 1-1/2-in. steam line; see Figure 13.

The only other equipment that is associated with west interior elevation is the sheet-metal exhaust duct that extends from the floor of the building through the roof of the building (Figures 9, 10, and 13).
