FINAL REPORT

ACCIDENTAL NUCLEAR EXCURSION

RECUPLEX OPERATION

234-5 FACILITY

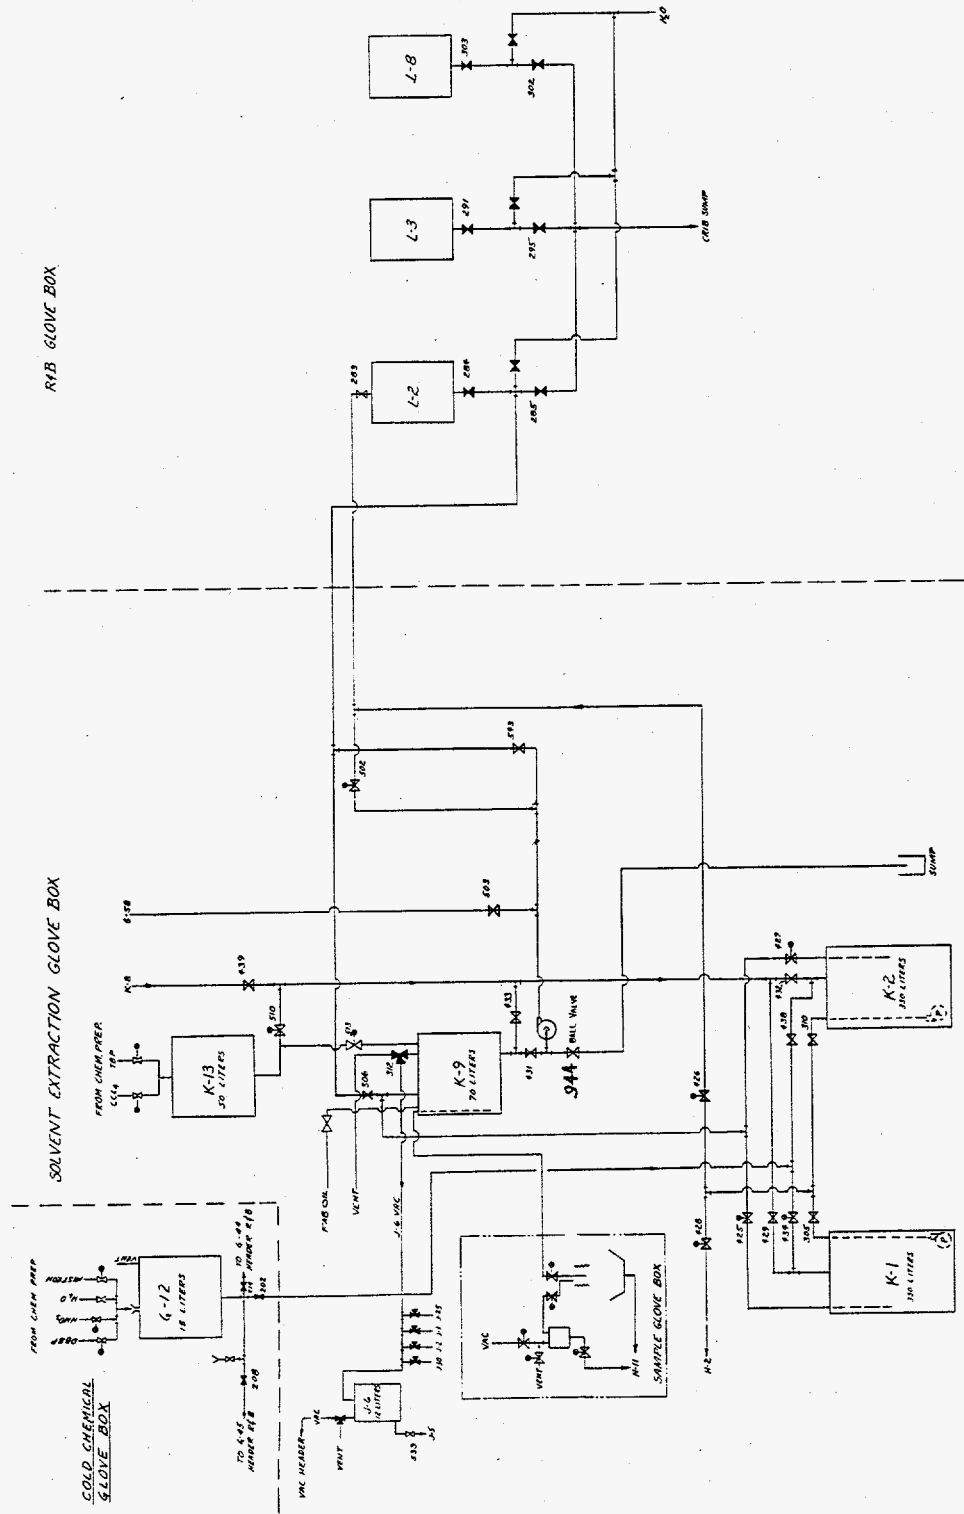
FIGURE VI-1
Solvent Extraction Partial Flow Diagram

Fig. IV-5 is a pictorial flow diagram of the SE process. This figure concerns itself mainly with the route by which product solution entered the K-9 tank, viz., from the J-1 tank via the J-1 overflow to the sump, and from the sump via the 1" temporary plastic line to the K-9 tank.

The 8-4 shift continued the transfer of contact organic from L-2 through K-9 to K-2 by opening valve 506, which is the normal route from L-2 to K-9. The operator who continued these transfers (Employee No. 1) does not remember closing the 543 and 431 valves (found open subsequently) which were used on the previous shift and were reportedly left open by the 12-8 shift operator, which allowed the material to be moved into K-9 from L-2 by two routes simultaneously. This transfer continued intermittently during the morning of April 7, 1962 until a total of 3 or 4 batches of approximately 50-55 liters each had been transferred into K-2 tank. (Operator recollection is hazy as to whether 3 or 4 batches were transferred.) The intermittent operation occurred due to interruptions caused by a flooding condition in the solvent extraction columns which required the operator's attention.

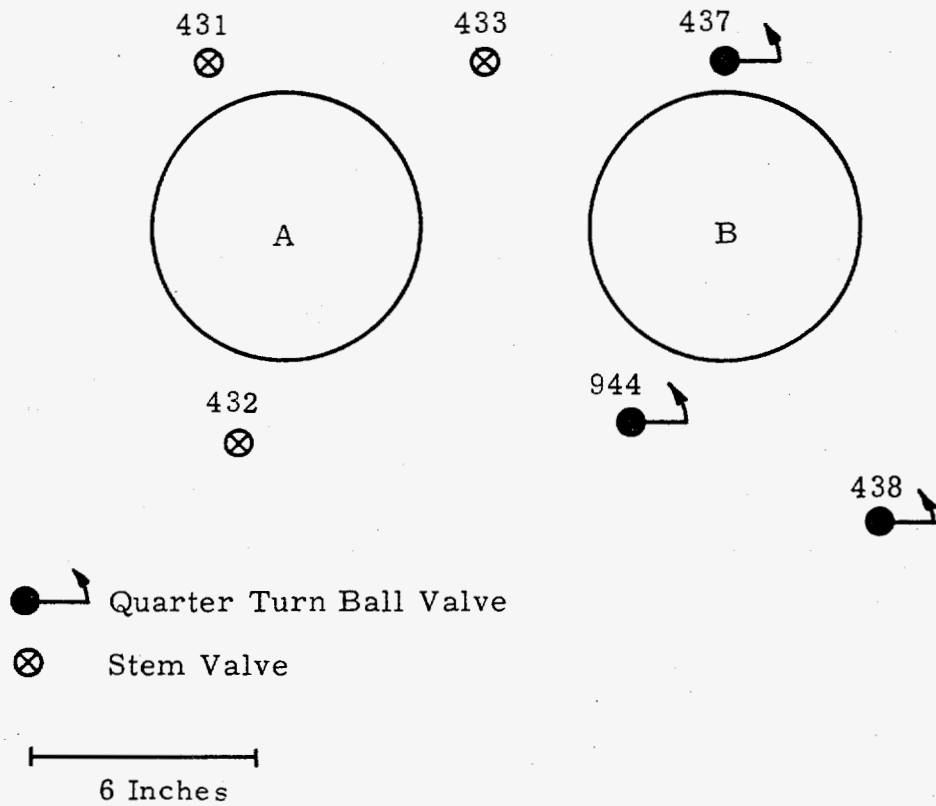
K-9 Piping and Post-Accident Valve Status

The product solution flowed across the floor of the solvent extraction (SE) hood, and was from there later partly sucked up into K-9 through a temporary line used in previous hood clean-up operations. In order for the solution to have entered K-9 via this temporary line, a valve (#944) in that line had to be opened and subsequently closed by human agency. The valve (#944) was found closed upon examination after the accident.

In adding these chemicals to K-2, standard practice had developed whereby the vacuum in K-9 was used to break the air lock in the interconnect line from the K-8 tank to the K-2 tank by cracking the valve (433) to K-9 momentarily to start the chemical flow. Following the incident the chemicals were not found in the K-8 tank and the valve from K-8 to the sewer was found partially open. The 433 valve to K-9 was found closed.

6. The valve (433) between K-9 and the chemical addition line from K-8 to K-2 was found closed.
7. The material which went critical in K-9 vessel was analyzed subsequent to the incident and found to have the following analysis:

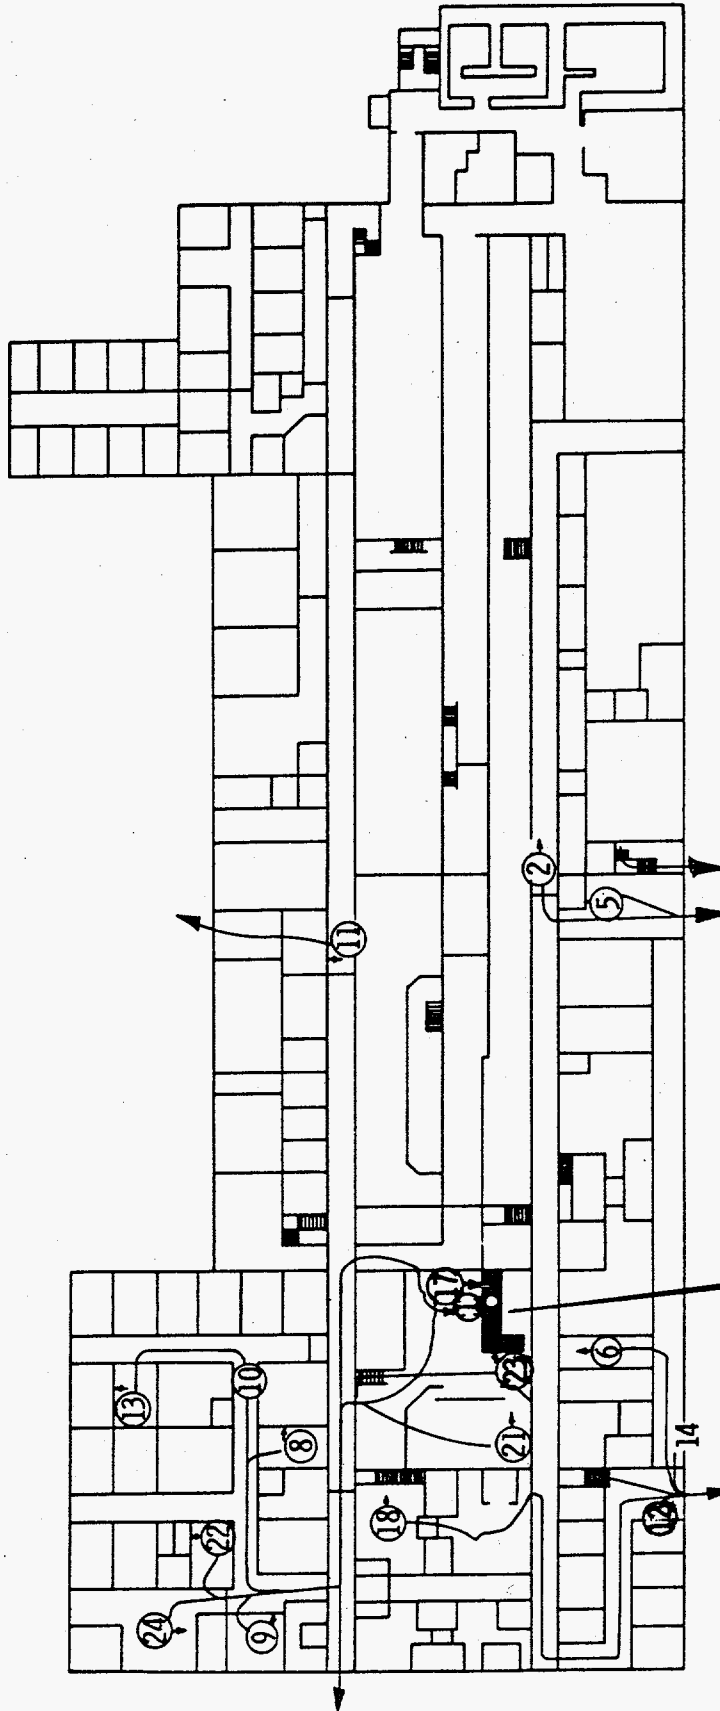
FIGURE 1

Information was obtained immediately from each employee to establish where he had been when the criticality alarm sounded and how he left the building. Detailed personal interviews were made during the following week. All but five people in the 234-5 Building evacuated immediately upon hearing the siren; all but one had left within about two minutes; the last man was out within four minutes. The routes each one followed in leaving the building are shown in Figures 1 and 2.

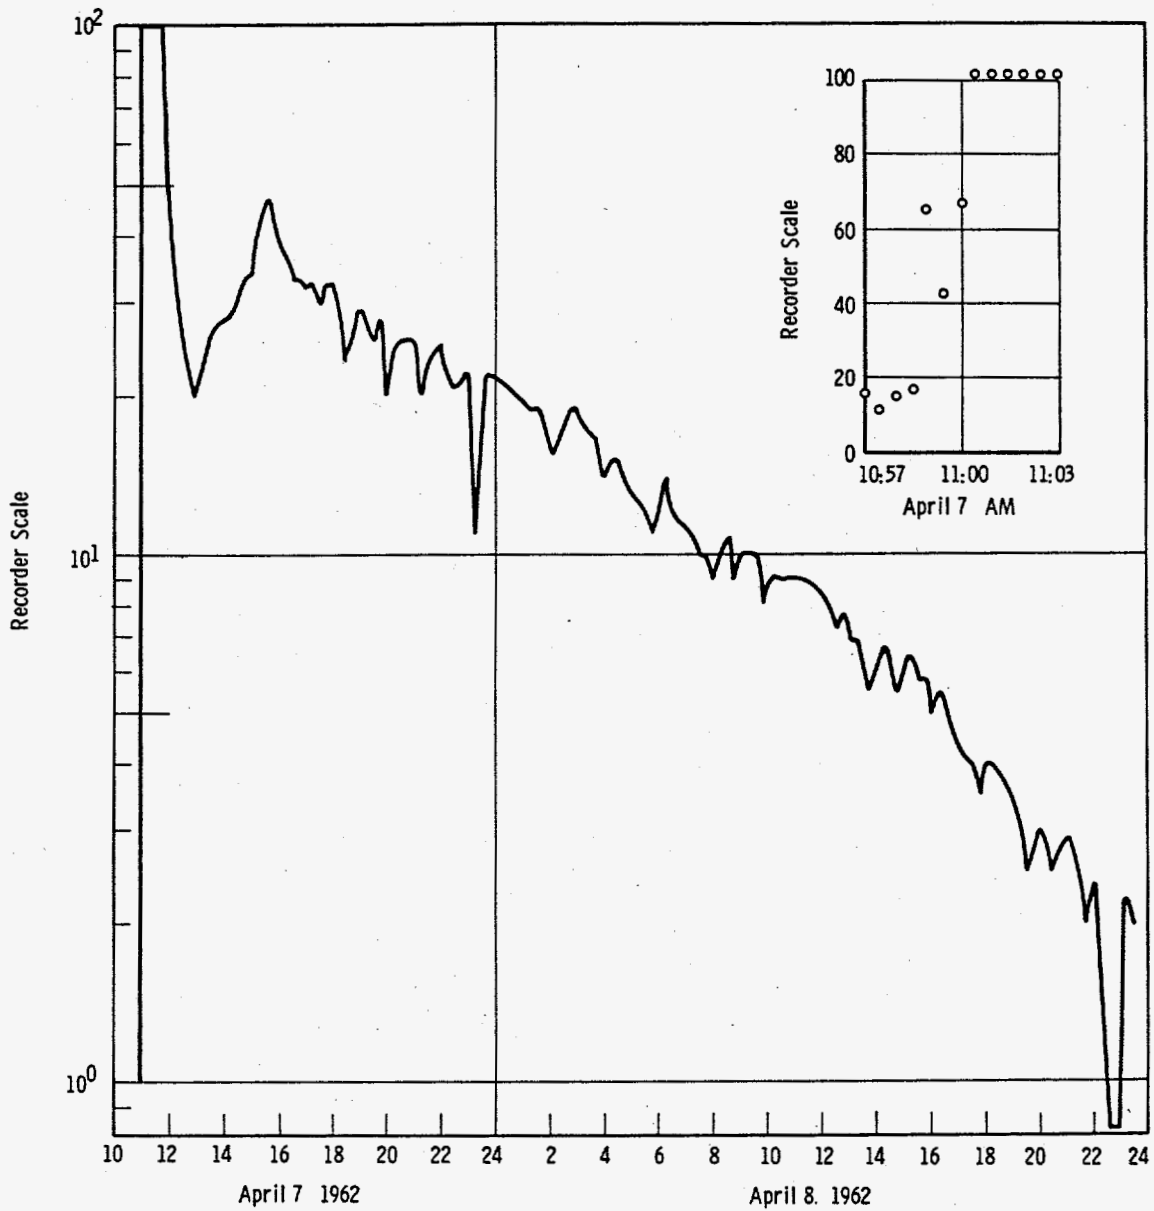
FIGURE 4

Before considering the measurements made for each individual, information of general interest can be obtained from instruments that were near the scene of the accident. Two recording BF_3 counters (one for high levels, one for low) were operating at the time of the accident in an incinerator room in the 234-5 Building. The data from the chart recorders are plotted in Figure 4. They indicate an initial excursion the exact magnitude of which cannot be determined because the flux level is recorded only every 30 seconds and it may be expected to vary by orders of magnitude within such a time period. Following this initial pulse which presumably activated the criticality alarm there was a continuing nuclear reaction of a magnitude sufficient to keep the recorder off-scale for a period of about 30 minutes. After the recorder returned to on-scale readings the fissioning continued at a generally reduced rate till 36 hours after the incident began. It appears that those in a position to be most seriously exposed to the critical vessel evacuated in time to limit their exposure to only a part of the initial excursion.

Data from a Recording BF₃ Counter Operating in the 234-5 Building at the Time of the Accident.
