SAND93-1380 • UC-261

## The Application of Non-Destructive Techniques to the Testing of a Wind Turbine Blade

Herbert Sutherland, Alan Beattie, Bruce Hansche, Walt Musial, Jack Allread,  
Jim Johnson, Mike Summers

NonDestructive Testing (NDT), also called NonDestructive Evaluation (NDE), is commonly used to monitor structures before, during, and after testing. This paper reports on the use of two NDT techniques to monitor the behavior of a typical wind turbine blade during a quasi-static test-to-failure. The two NDT techniques used were acoustic emission and coherent optical. The former monitors the acoustic energy produced by the blade as it is loaded. The latter uses electronic shearography to measure the differences in surface displacements between two load states. Typical results are presented to demonstrate the ability of these two techniques to locate and monitor both high damage regions and flaws in the blade structure. Furthermore, this experiment highlights the limitations in the techniques that must be addressed before one or both can be transferred, with a high probability of success, to the inspection and monitoring of turbine blades during the manufacturing process a

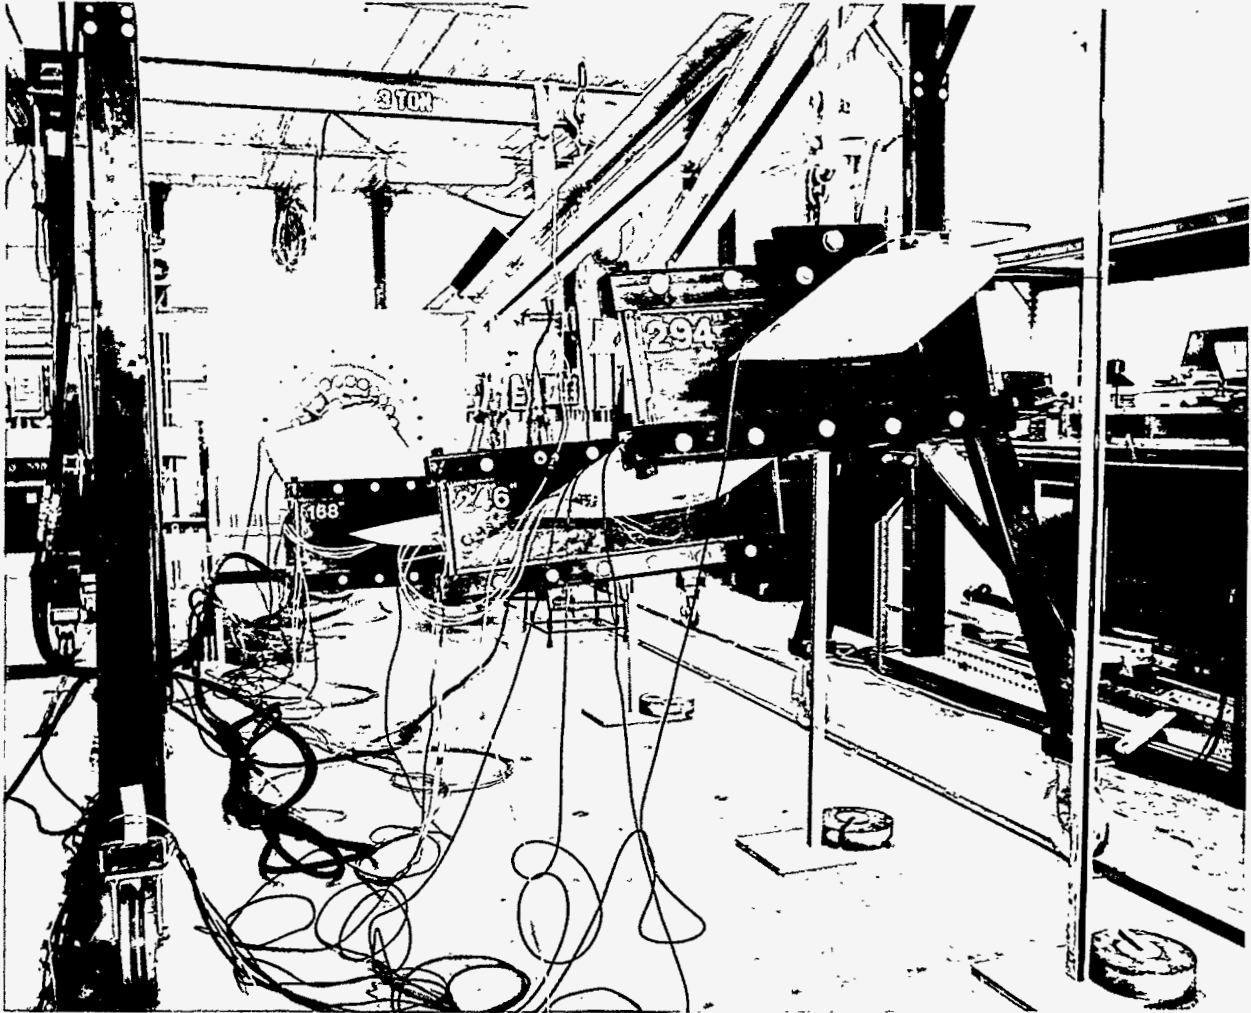
During phase 1 testing, the initial load on the blade was 1000 lb (4.5 kN). Strain gauge data were recorded continuously at a 20 Hz sampling rate. Deflection measurements were taken manually at each 1000 lb (4.5 kN) load interval. When 2000 lb (8.9 kN) was reached, the load intervals were reduced to 500 lb (2.2 kN) increments until failure occurred. Figure 6a shows the load vs time plot for this set of loads. After failure at 3925 lb (17.5 kN), the blade was unloaded and the failure locations were documented. A photograph of the blade under three-point loading is shown in Figure 7.

**Figure 7. Phase 1 blade test.**

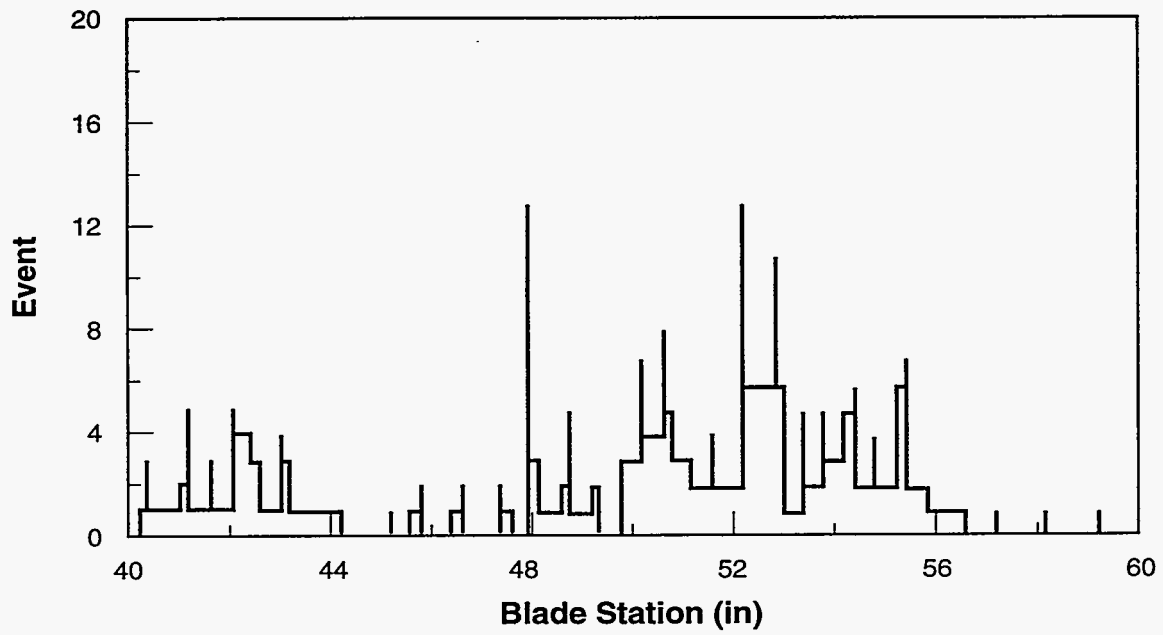
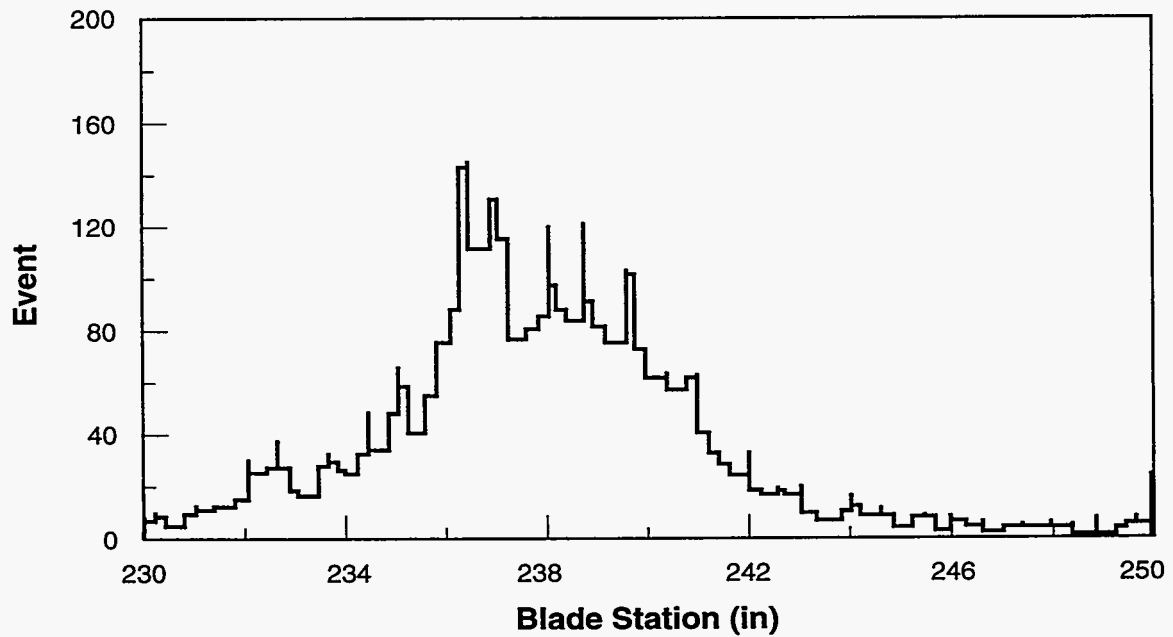
Phase 1 loading produced a failure in the blade near the tip. The location plot for blade during this load cycle (Figure 20b) shows two regions with a clustering of event locations. One is between stations 40 and 56 and the second is between stations 234 and 242. Expanded location plots for these two regions are shown in Figures 29a and 29b. The events shown in Figure 29a started very early in the loading and continued at a moderate level for all three loadings. Figure 30 shows the acoustic "energy" detected at sensor 14 (station 48) versus the load for the three different loadings. For Phase 1 loading, there is more "energy" emitted during the increasing load than during load holds. However on each load hold over 4800 lb (21.4 kN), there is more "energy" emitted during the hold than during the loading, although the amount of emitted "energy" decreases after the hold at 7100 lb (31.6 kN). The emitting structure between stations 40 and 56 appeared to be reaching a point where all the material which could break, had broken and the rest was still capable of bearing the load at 8996 lb (40.0 kN). Upon sectioning of the blade in this region, it was found that one side of the box spar, which started at about station 37 and then ran most of the rest of the length of the blade, was debonded from the top skin in the region from station 37 to about station 50. Also found was a section of the skin on the top of the blade, about 5 in. (127 cm) wide and running from about station 37 to station 54, which was only

Figure 29a. Station 40 to station 60.

Figure 29b. Station 230 to station 250.

Figure 29. AE locations for Phase 1 loading.

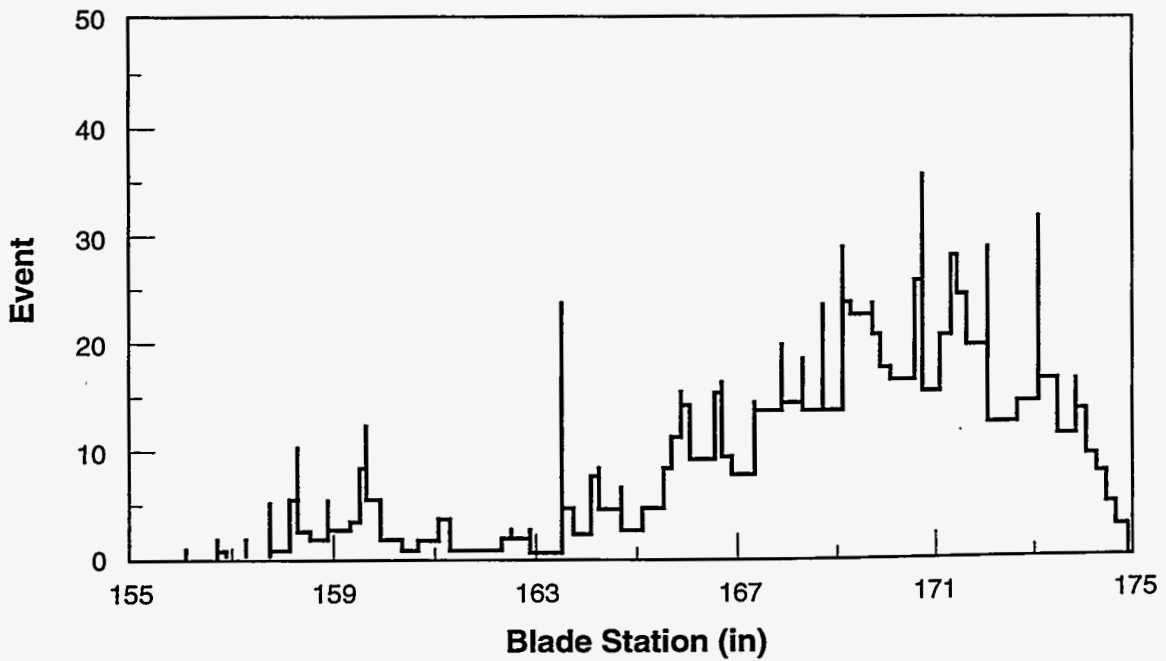
Figure 32. AE locations for Phase 1 loading between stations 155 and 175.

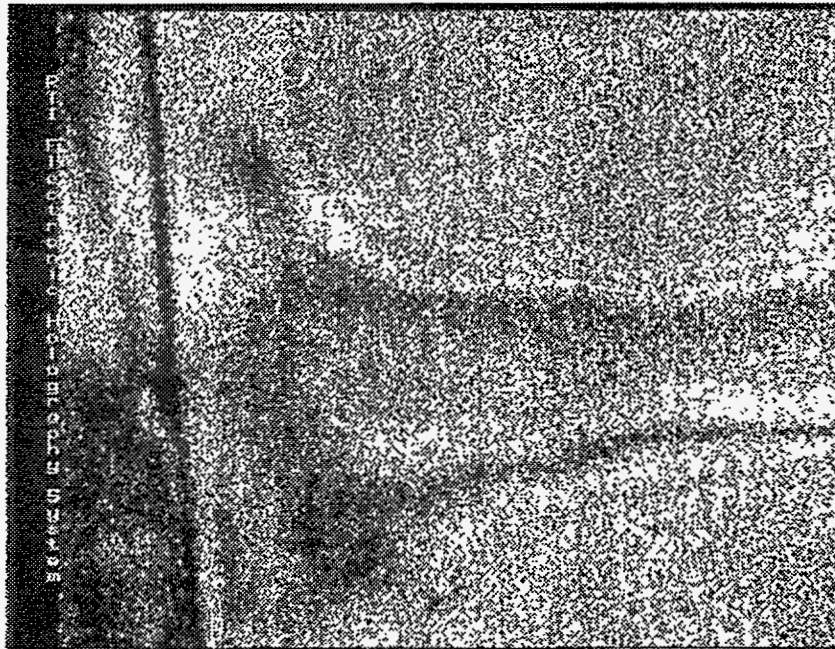
**Figure 36. Pre-test shearogram using thermal stress, station 240 to 252.**

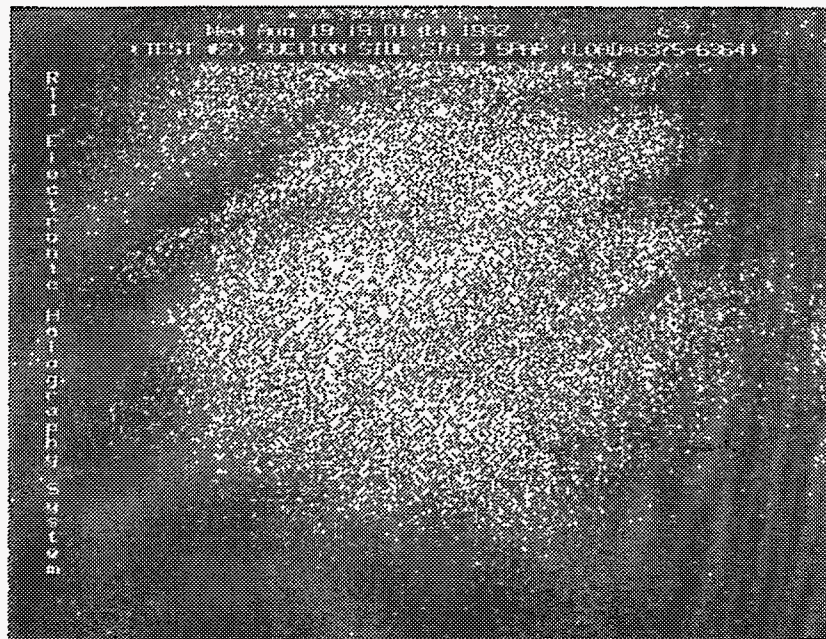
The 36 to 48 station view was also inspected while being stressed by tension and compression, to compare with thermal stressing. These stresses were applied by forcing the blade tip to the side by hanging weights (about ten pounds) on the tip rope visible in Figure 34. All three stress methods show the main blade spar (longitudinal) and some structure associated with the angled leading edge in that area. The thermal stress showed more detailed deformations, which could be either skin delaminations or thickness variations. None of these tests had strong flaw indications.

**Figure 37a. 0 to 10 pounds load.**

**Figure 37b. 6364 to 6375 pounds load.**

**Figure 37. Real-time shearograms using differential loads, station 36 to 48.**
