ANL-79-56

ARGONNE NATIONAL LABORATORY
9700 South Cass Avenue
Argonne, Illinois 60439

MATERIALS TECHNOLOGY FOR
COAL-CONVERSION PROCESSES
Seventeenth Quarterly Report
January—March 1979

W. A. Ellingson
Program Manager
Materials Science Division

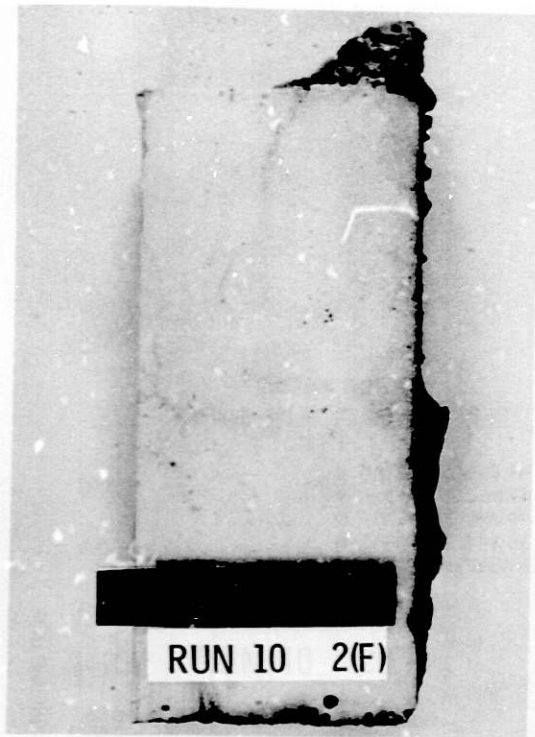
Full- and 1/2-size refractory samples were tested in the same test run. The temperatures at two locations (25.4 and 76.2 mm from the hot face) were recorded for each sample, as shown in Figs. 2-4. Generally, full-size bricks were 50- 100°C hotter than 1/2-size bricks. After the test, the samples were sectioned lengthwise to determine the extent of corrosion. The sectioned samples are shown in Figs. 5-7. Two slag-seed attack lines are visible on the fused-cast alumina sample (number 2) in Fig. 5a.

Fig. 5. Cut Sections (Entire Length of Brick is not Shown) from Fused-cast Refractories. (a) and (b), Full- and 1/2-length alumina (number 2), (c) and (d) full- and 1/2-length alumina-chromia (number 38), (e) and (f) full- and 1/2-length chrome-spinel (number 22). The right face of the bricks in (a) and (c)-(f) and the left face of the brick in (b) were exposed to the slag, which can be seen adhering to all the bricks. A chunk of material has spalled out of the sample pictured in (d) at the upper slag line. ANL Neg. Nos. 306-79-278, 279.

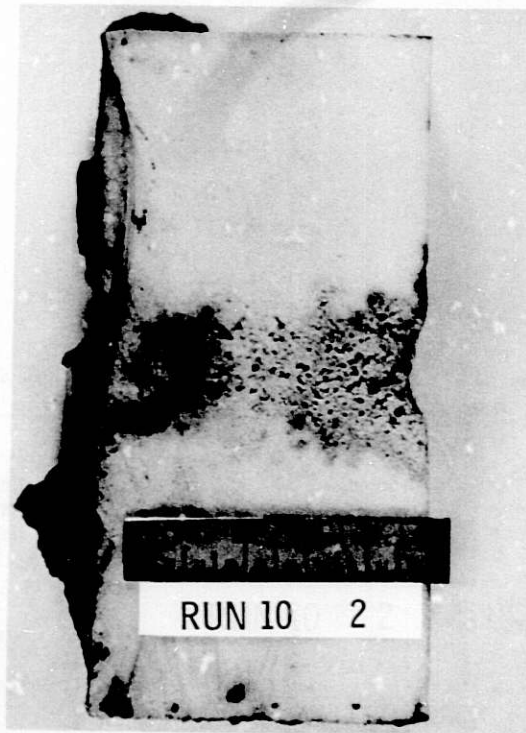
(b)

The relative resistance of the three fused-cast refractory compositions to seed-slag attack is summarized in Table III. It is apparent from the data on maximum depth of material removal and slag-seed penetration that among the fused-cast bricks tested, the chrome-spinel (number 22) exhibited the best performance. The fused-cast alumina-chrome bricks (number 38) had good corrosion resistance, but suffered from extensive cracking (Fig. 5a) owing to either thermal shock or the steep temperature gradient during the testing. The fused-cast alumina material (number 2) showed fair performance; however, extensive slag-seed penetration was observed in the central porous region (Fig. 5b) which was formed during casting of the brick.

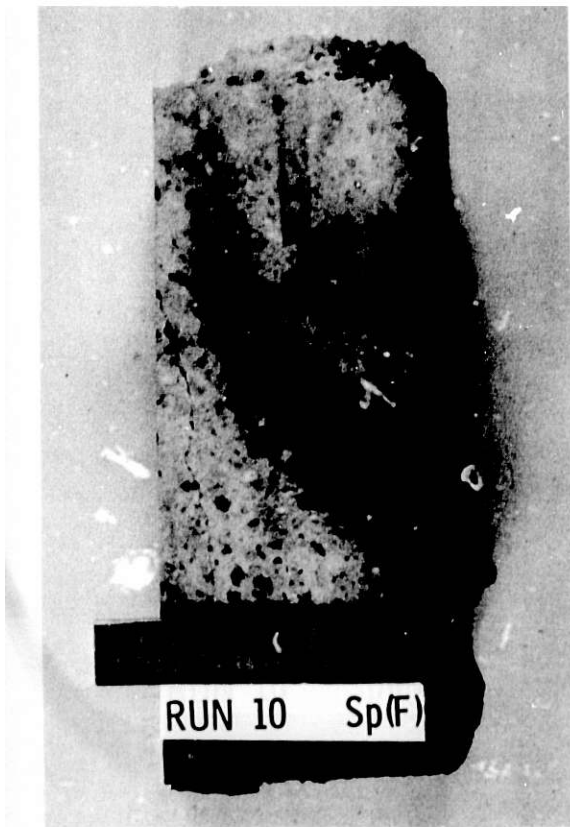
Fig. 6. Cut Sections (Entire Length of Brick is not Shown) from Sintered Refractories. (a) and (b) Full- and 1/2-length magnesia-spinel (number 98), (c) and (d) full- and 1/2-length alumina-chromia (number 23), (e) and (f) full- and 1/2-length magnesia-chrome (number 20), (g) and (h) full- and 1/2-length magnesia-chrome (number 29). The right face of each brick was exposed to the slag. ANL Neg. Nos. 306-79-280, 281, 282.

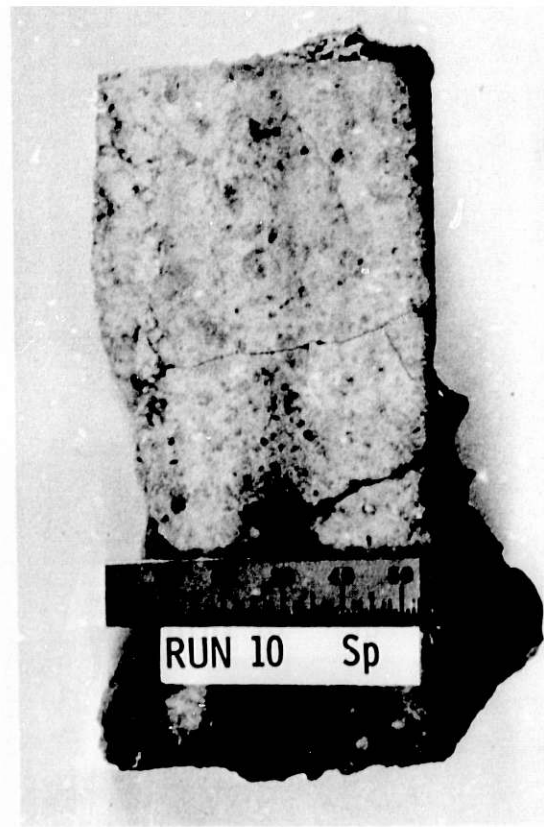
(b)

The relative resistance of the four sintered refractory compositions to slag-seed attack is summarized in Table IV. The sintered magnesia-spinel brick (number 98) had only average corrosion resistance, and also suffered from extensive cracking (Fig. 6b). This material also showed attack by the potassium-rich vapors produced during the test. A significant amount of seed-slag penetration was also observed for this material. The alumina-chromia material (number 23) showed intermediate corrosion resistance, but the full-length brick suffered from swelling (Fig. 6c) as a result of gas-phase attack. The two sintered magnesia-chrome refractories (numbers 20 and 29) showed the best corrosion resistance (minimum depth of removal) among the sintered materials; however, the 1/2-length bricks suffered from cracking (Figs. 6f and h), probably owing to the steep thermal gradient.

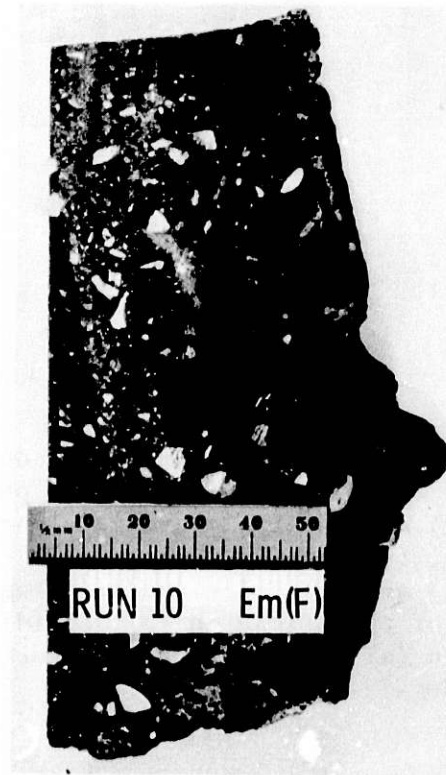
(e)

silicate-bonded chrome-ore (number 99) performed the worst. The alumina-chrome mix (number 96) showed intermediate performance, but the full-length brick exhibited substantial swelling (see Fig. 7e). The magnesia mix (number 97) suffered extensive cracking (see Figs. 7g and h), swelling, and more gas-phase than liquid-phase attack.

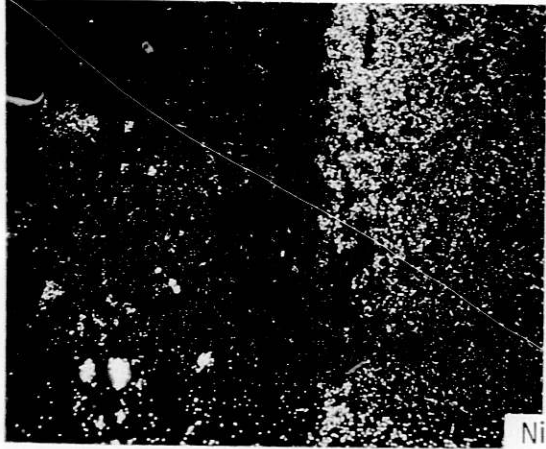
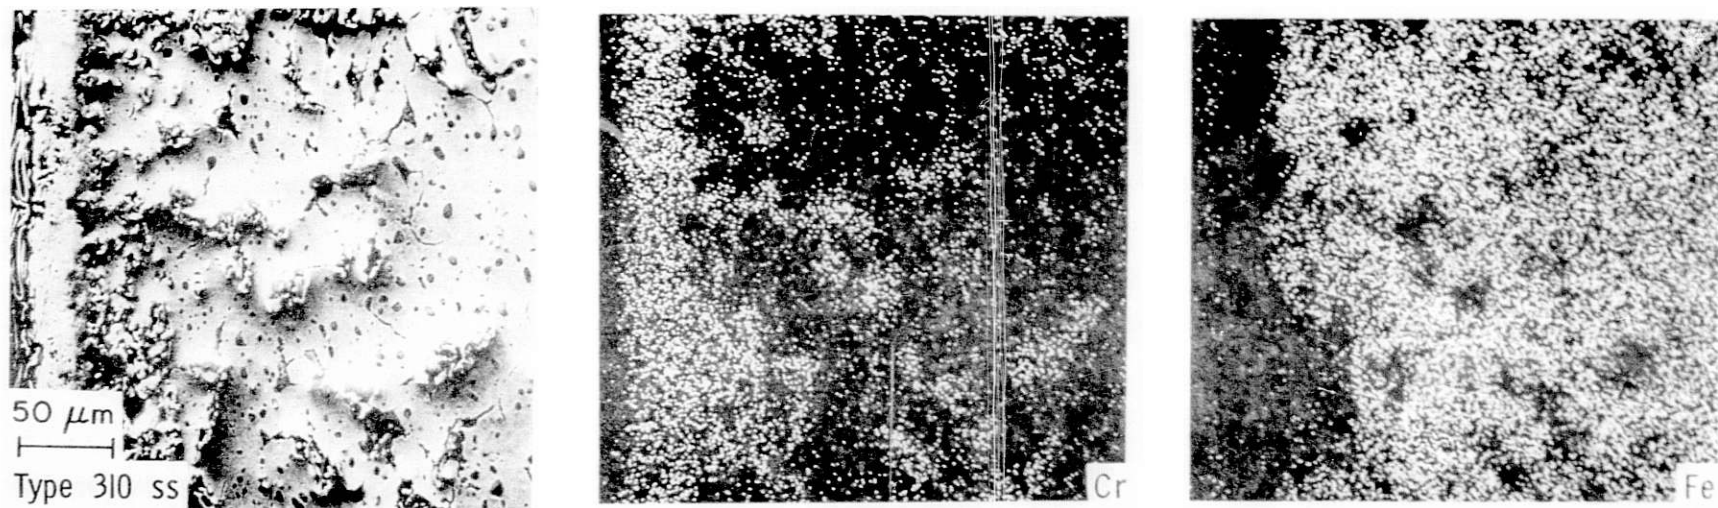
Fig. 35. X-ray Photograph and Cr, Fe, Ni, S, and O Distribution in Incoloy 800 Specimen After a 3.6-Ms Exposure to a Complex Gas Mixture at 982°C (Run B03A982). In the distribution pictures, light regions indicate a high concentration of the respective elements. ANL Neg. No. 306-79-327.

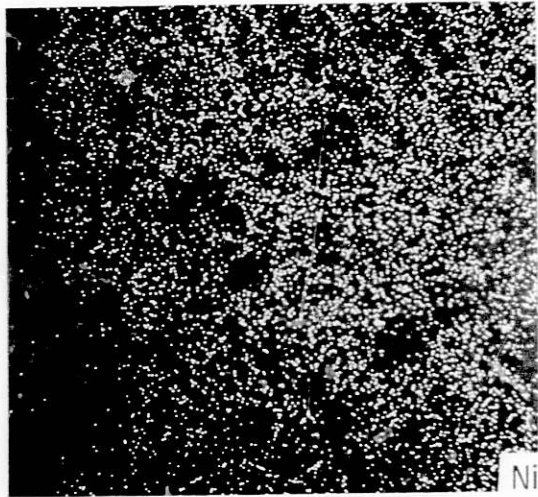
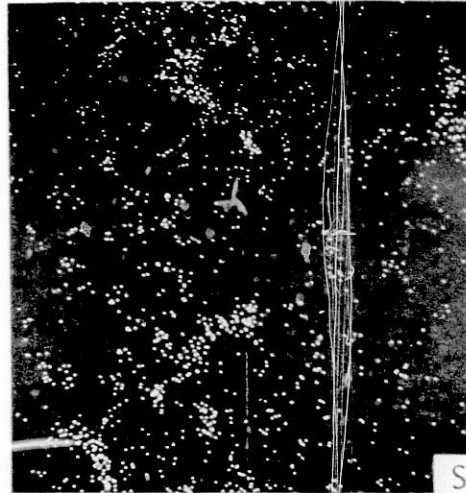
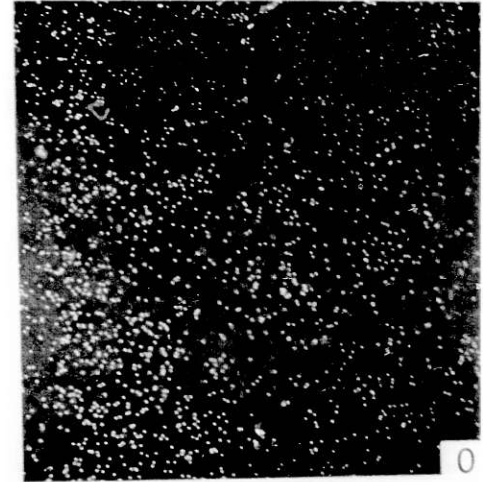
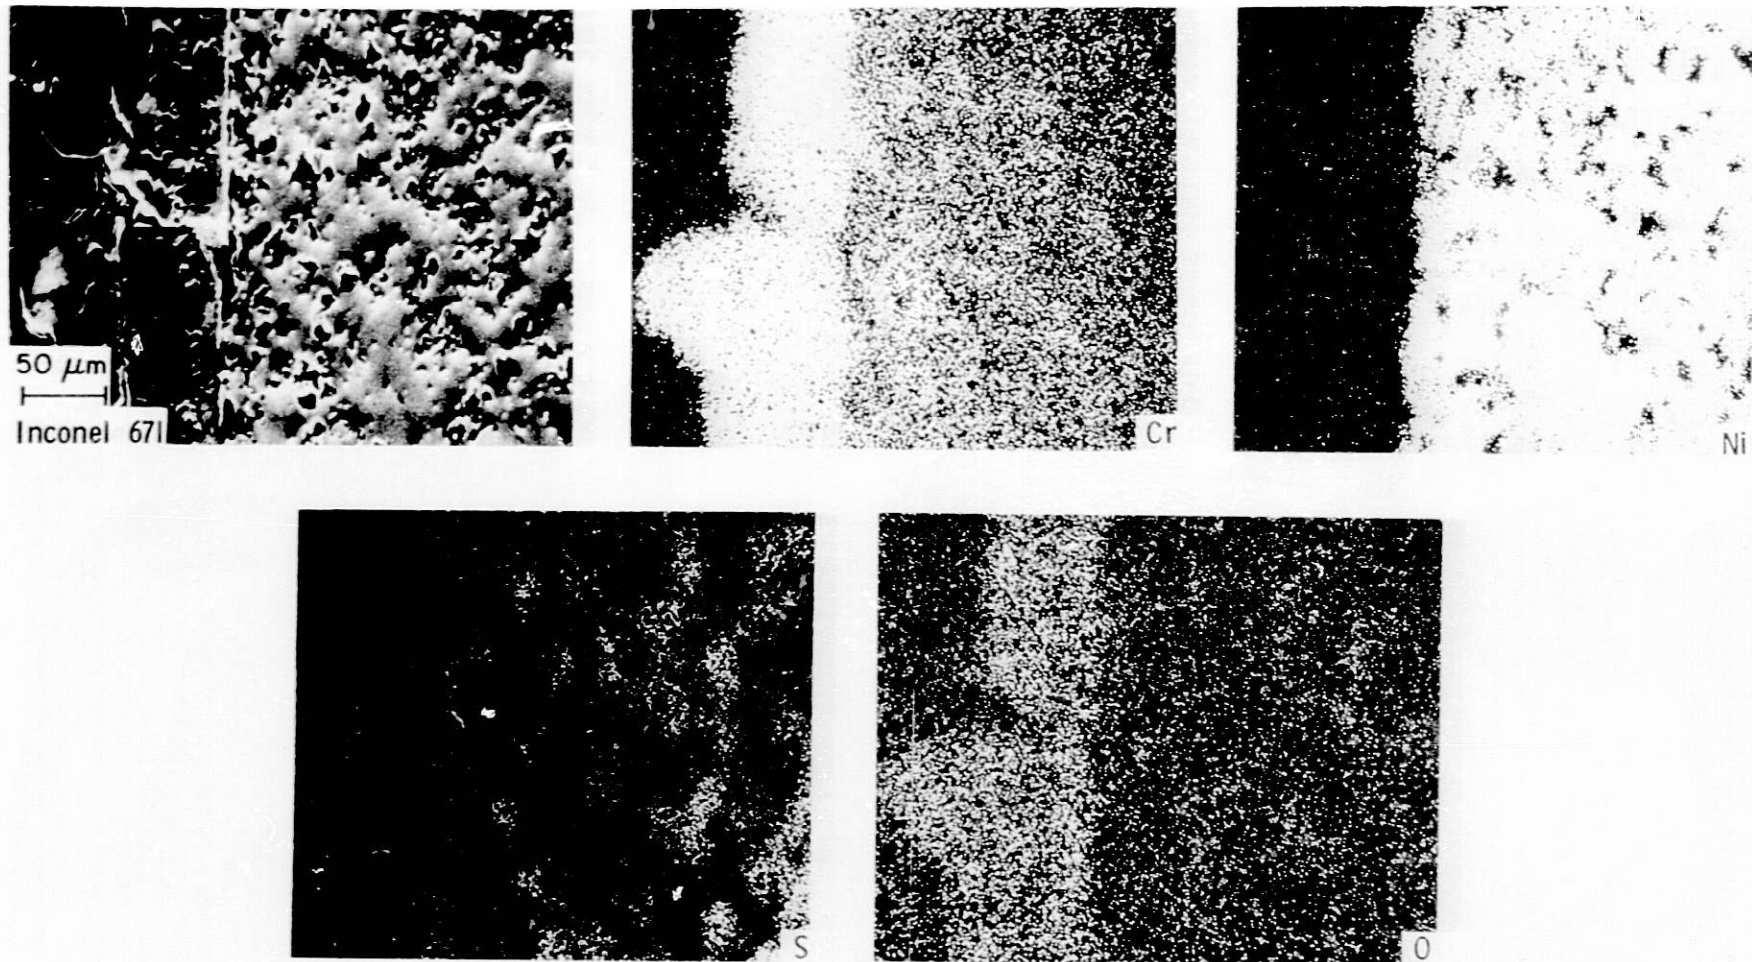
Fig. 36. X-ray Photograph and Cr, Fe, Ni, S, and O Distribution in Type 310 Stainless Steel Specimen After a 3.6-Ms Exposure to a Complex Gas Mixture at 982°C (Run B03A982). In the distribution pictures, light regions indicate a high concentration of the respective elements. ANL Neg. No. 306-79-326.

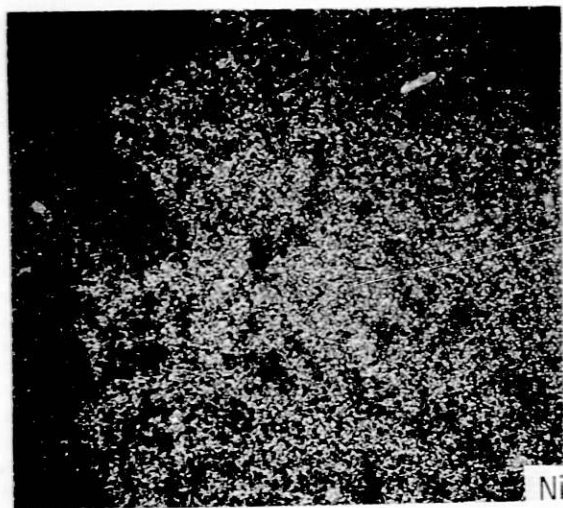
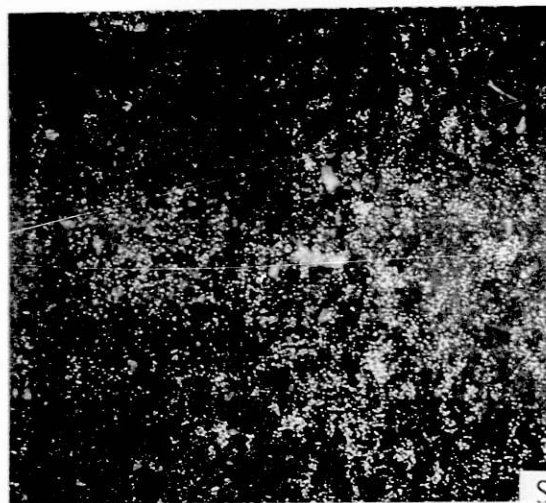
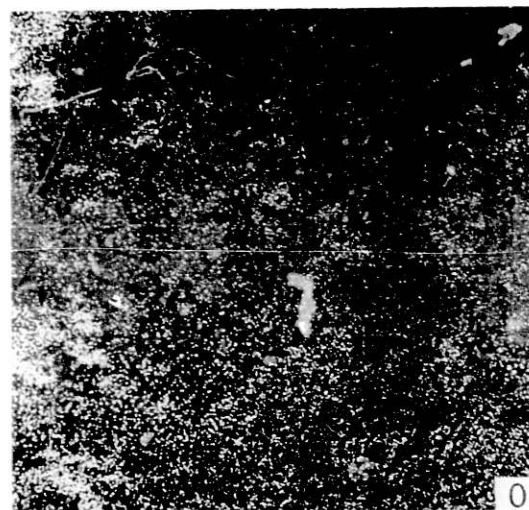
Fig. 38. X-ray Photograph and Cr, Fe, Ni, S, and O Distribution in U.S. Steel Alloy 18-18-2 Specimen After a 3.6-Ms Exposure to a Complex Gas Mixture at 982°C (Run B03A982). In the distribution pictures, light regions indicate a high concentration of the respective elements. ANL Neg. No.306-79-318.

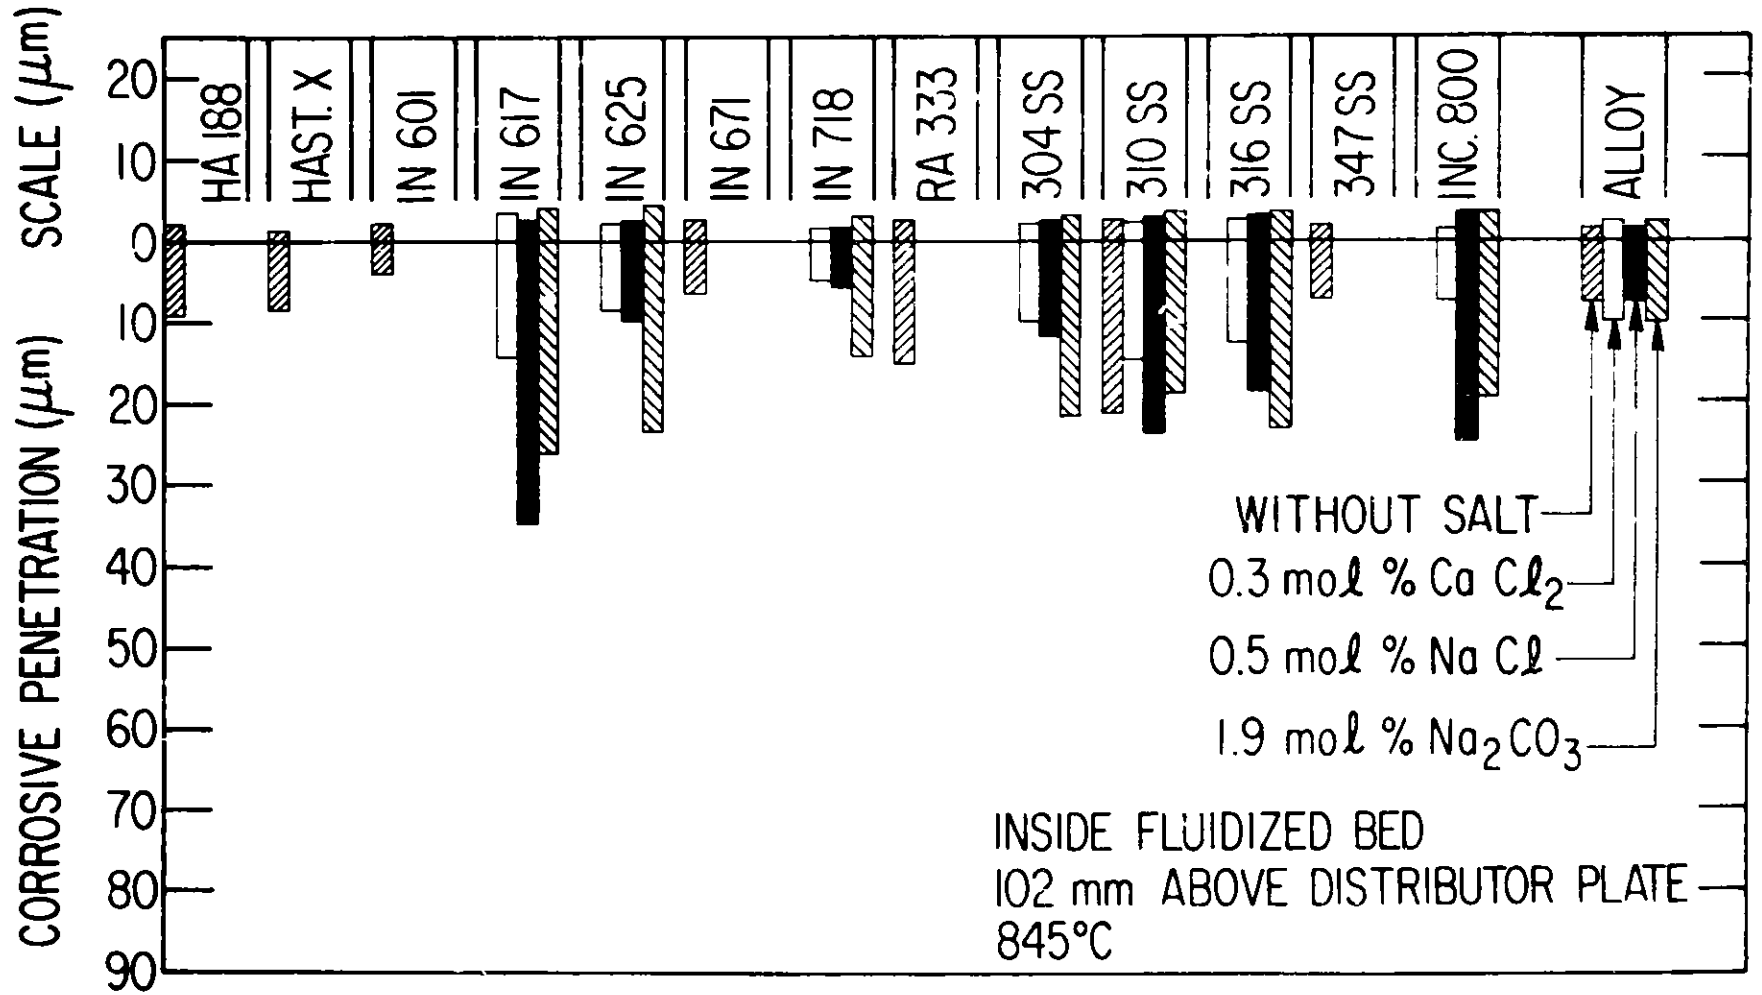
The corrosion specimens had an \sim 3- μ m-thick oxide scale on the surface. The internal corrosive penetration consisted primarily of internal oxidation along the grain boundaries and patches of sulfides ahead of the oxidation front. The average thickness of surface scale and depth of internal

corrosive penetration measured on the side surfaces of the specimens are shown in Figs 41 and 42 for specimens located inside the fluidized bed at distances of 102 and 610 mm, respectively, above the fluidizing gas distributor plate. The results show that the addition of 0.3 mol % CaCl_2 to the fluidized bed had no significant effect on the corrosion behavior of any of the materials. In general, the addition of 0.5 mol % NaCl or 1.9 mol % Na_2CO_3 increased the total corrosion, i.e., the combined value of the thickness of surface scale and depth of internal corrosive penetration, for most of the materials. The high-nickel alloys, namely Inconels 601, 617, and 671, RA333, and Incoloy 800, showed a significant increase in internal corrosive penetration. Micrographs of the cross section of Inconels 617 and 671 specimens from corrosion tests in which salt was present are shown in Fig. 43.

A comparison of the corrosion behavior of Type 310 stainless steel shown in Figs. 41 and 42 indicates that the total corrosion of the material was greater at the location 102 mm above the gas distributor plate than at the 610-mm position. For Haynes Alloy 188 and Types 310 and 347 stainless steel, the total corrosion with and without salt was essentially the same. Micrographs of Type 310 stainless steel specimens located inside the fluidized bed 102 and 610 mm above the gas distributor plate are shown in Figs. 44 and 45, respectively.

Fig. 41. Average Thickness of Surface Scale and Depth of Internal Corrosive Penetration for Corrosion Coupons Exposed Inside the Fluidized Bed for 360 ks at a Location 102 mm Above the Gas Distributor Plate. ANL Neg. No. 306-79-380.

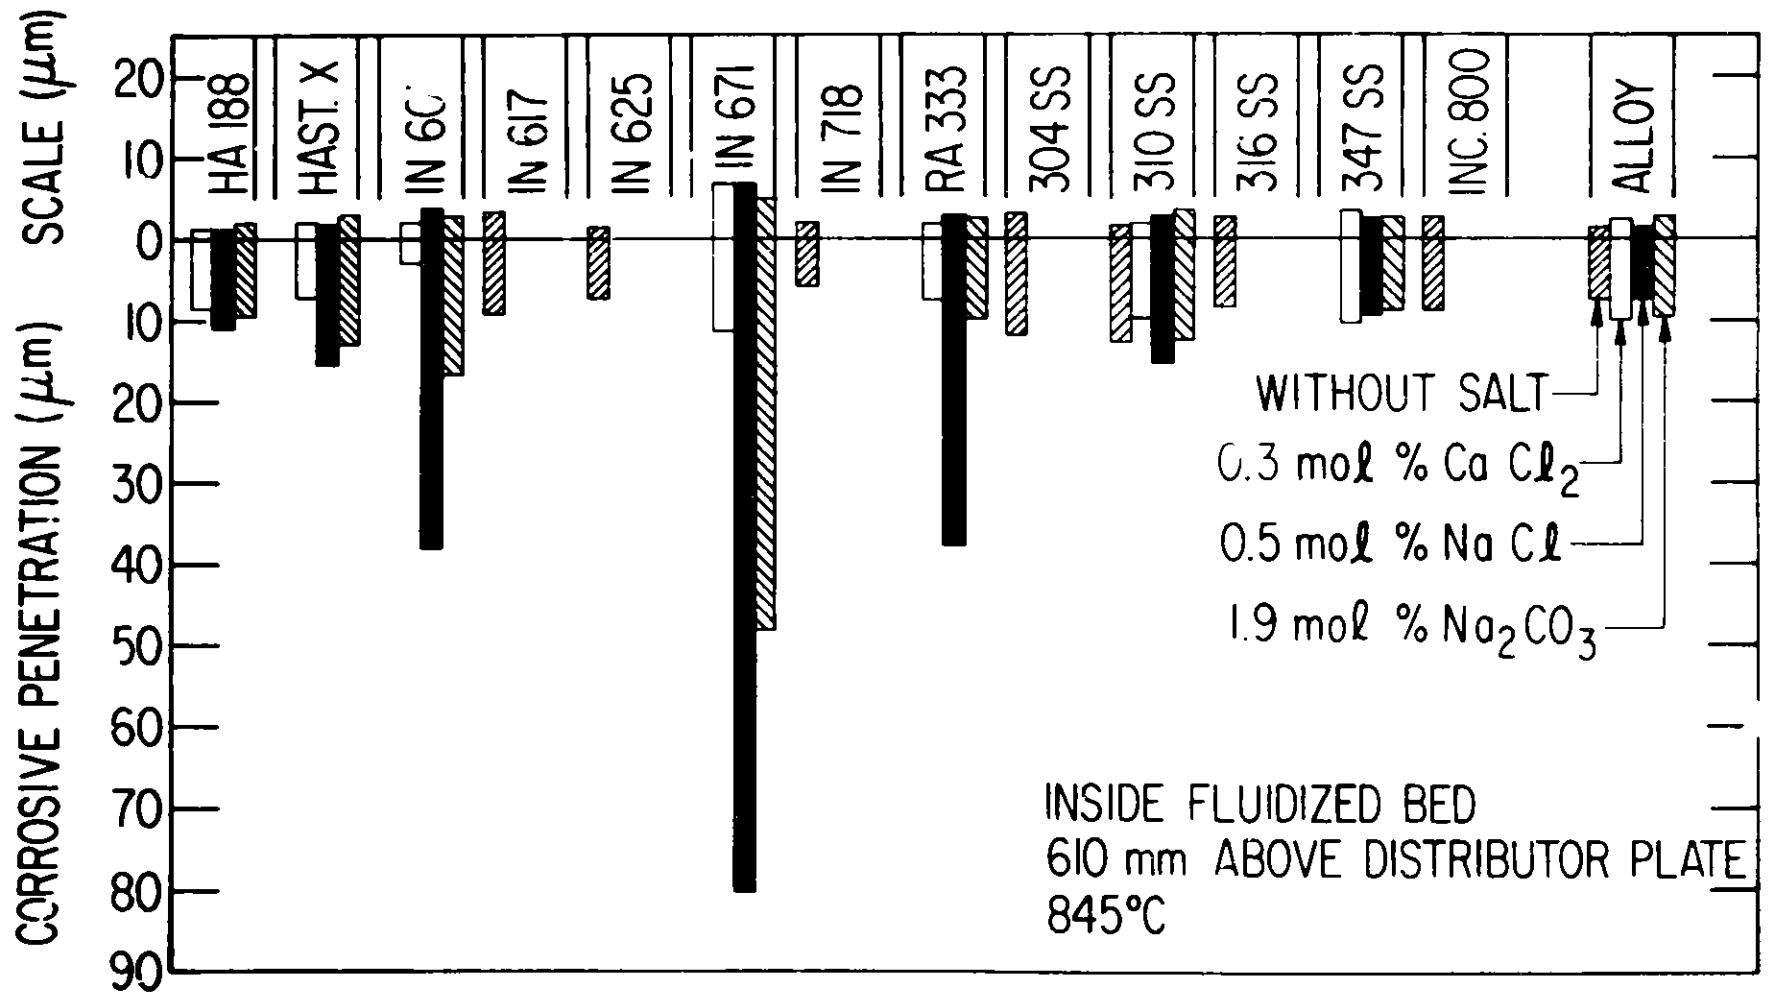
Fig. 42. Average Thickness of Surface Scale and Depth of Internal Corrosive Penetration for Corrosion Coupons Exposed Inside the Fluidized Bed for 360 ks at a Location 610 mm Above the Gas Distributor Plate. ANL Neg. No. 306-79-379.

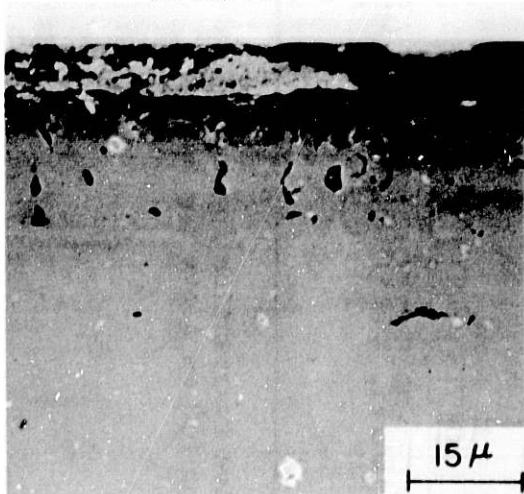
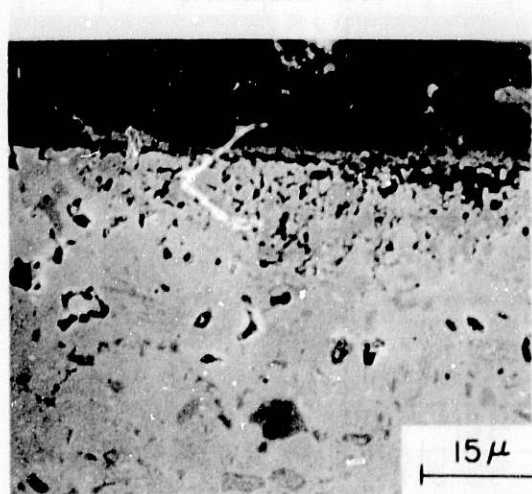
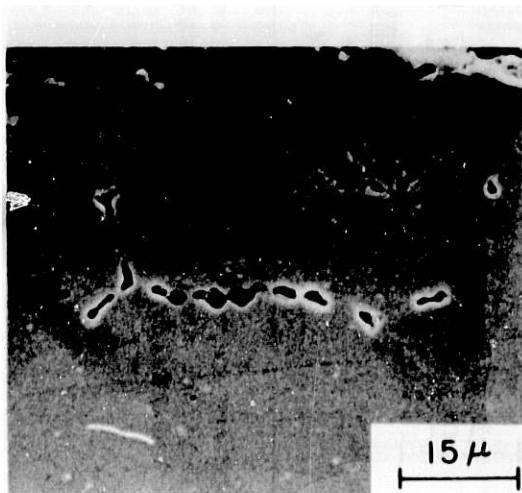
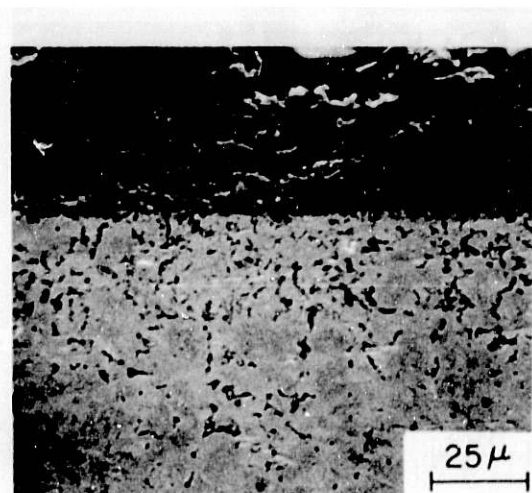
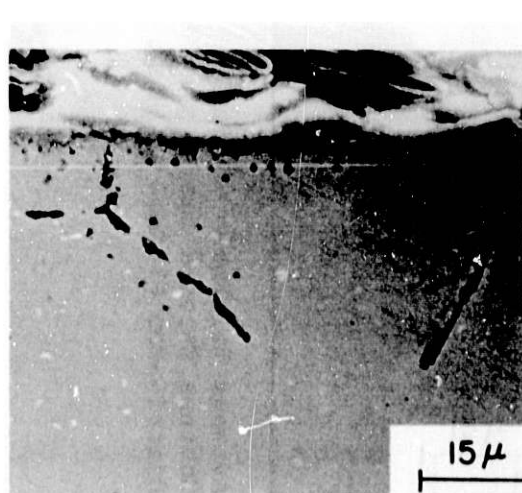
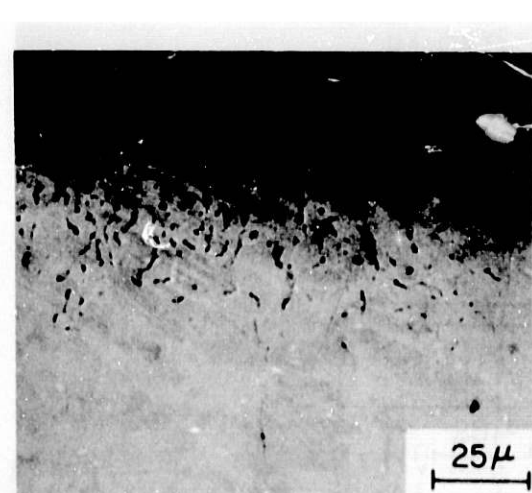
Fig. 43. SEM Photographs of Inconel 617 and 671 After a 360-ks Exposure at 1123 K Inside the Fluidized Bed. ANL Neg. No. 306-79-382.

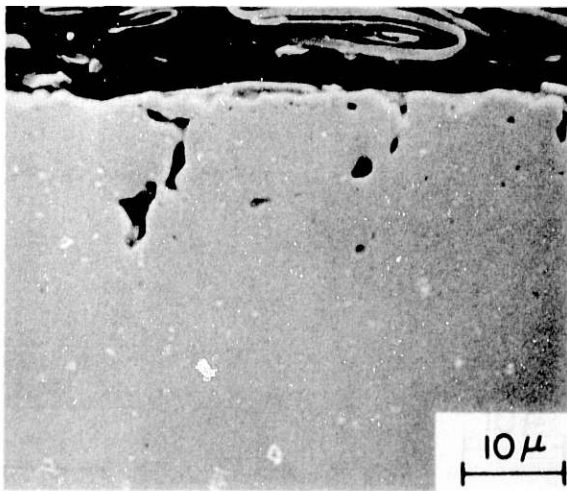
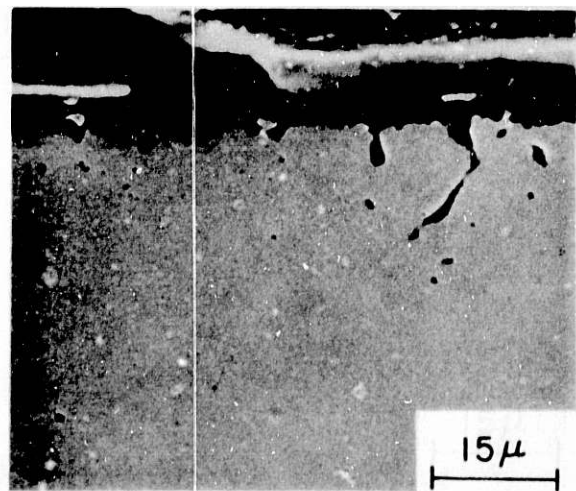
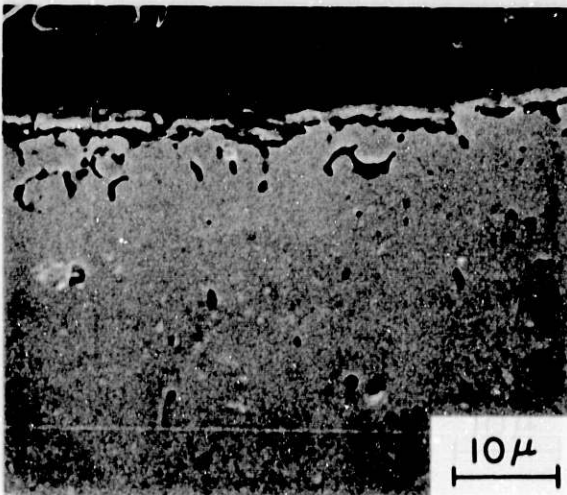
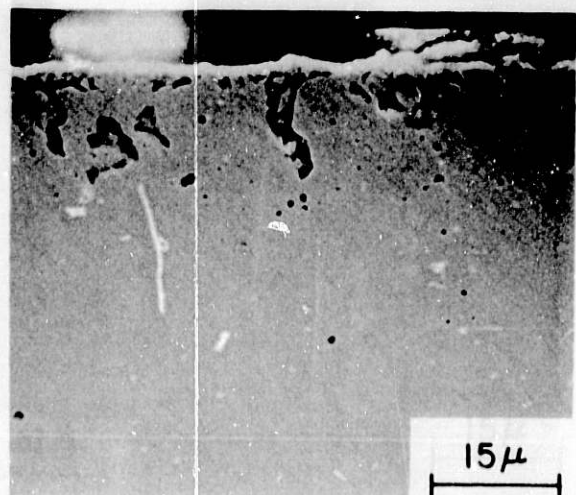
Fig. 44. SEM Photographs of Type 310 Stainless Steel After a 360-ks Exposure at 1123 K Inside the Fluidized Bed at a Location 102 mm Above the Gas Distributor Plate. ANL Neg. No. 306-79-381.

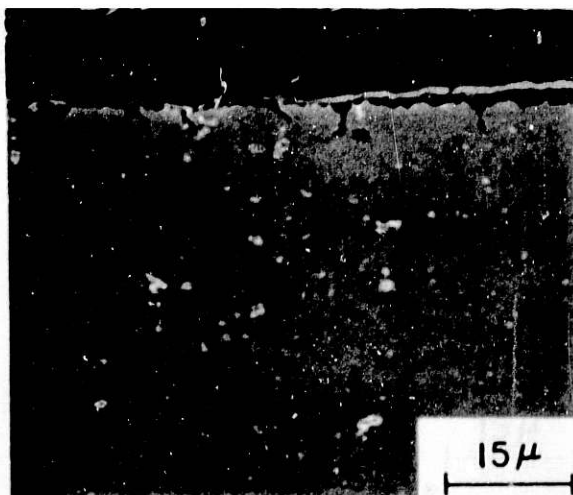
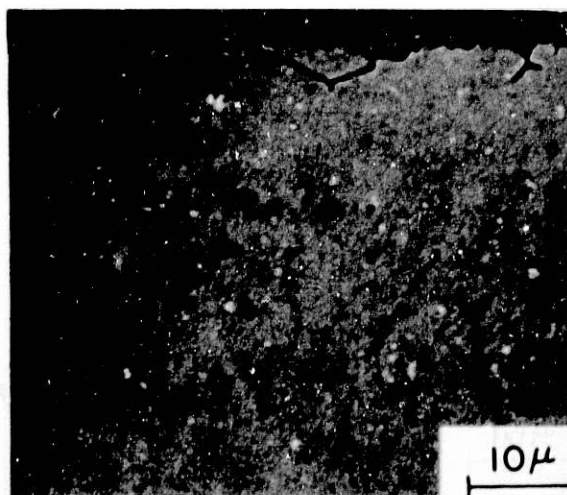
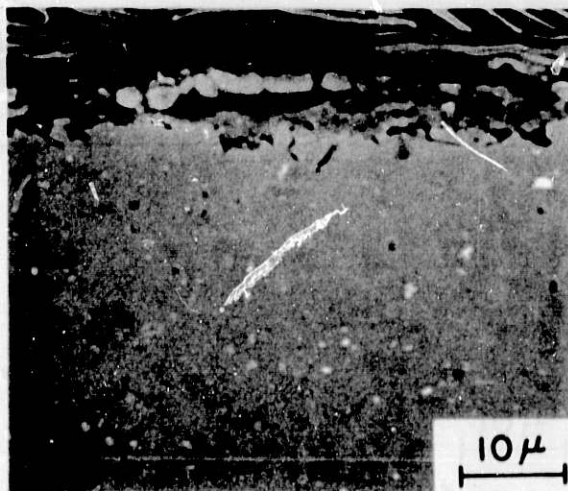
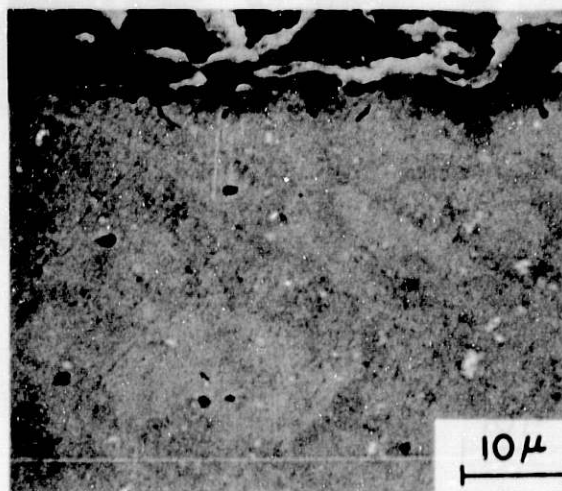
Fig. 45. SEM Photographs of Type 310 Stainless Steel After a 360-ks Exposure at 1123 K Inside the Fluidized Bed at a Location 610 mm Above the Gas Distributor Plate. ANL Neg. No. 306-79-383.

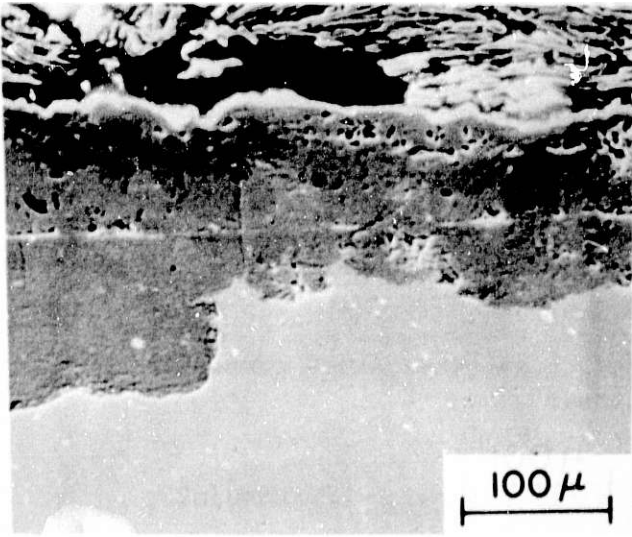
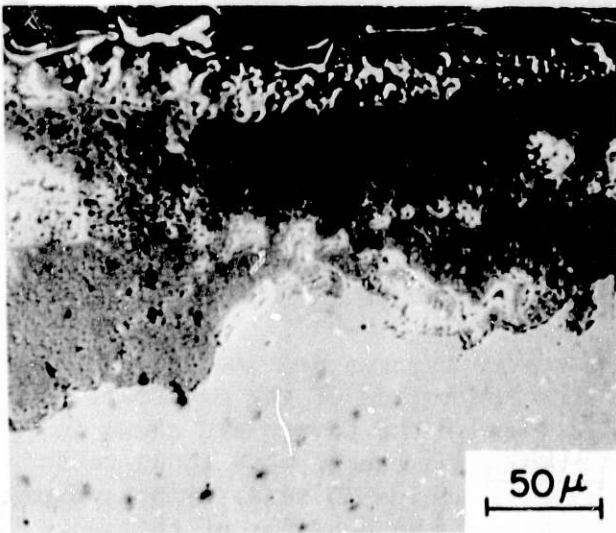
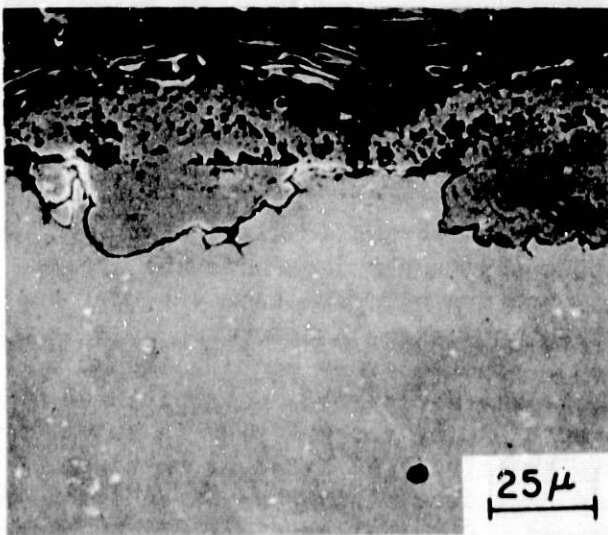
Scanning-electron micrographs of the surface region of alloy C-12 after corrosion tests with salt addition are shown in Fig. 46. The thickness of the surface oxide for tests CT-2 and -3 was between 100 and 140 μm , whereas in CT-4, the extent of oxidation was less because the temperature was ~ 50 K lower.

Fig. 46. SEM Photographs of Alloy C-12 After a 360-ks Exposure in the Freeboard Section of the Combustor. ANL Neg. No. 306-79-384.

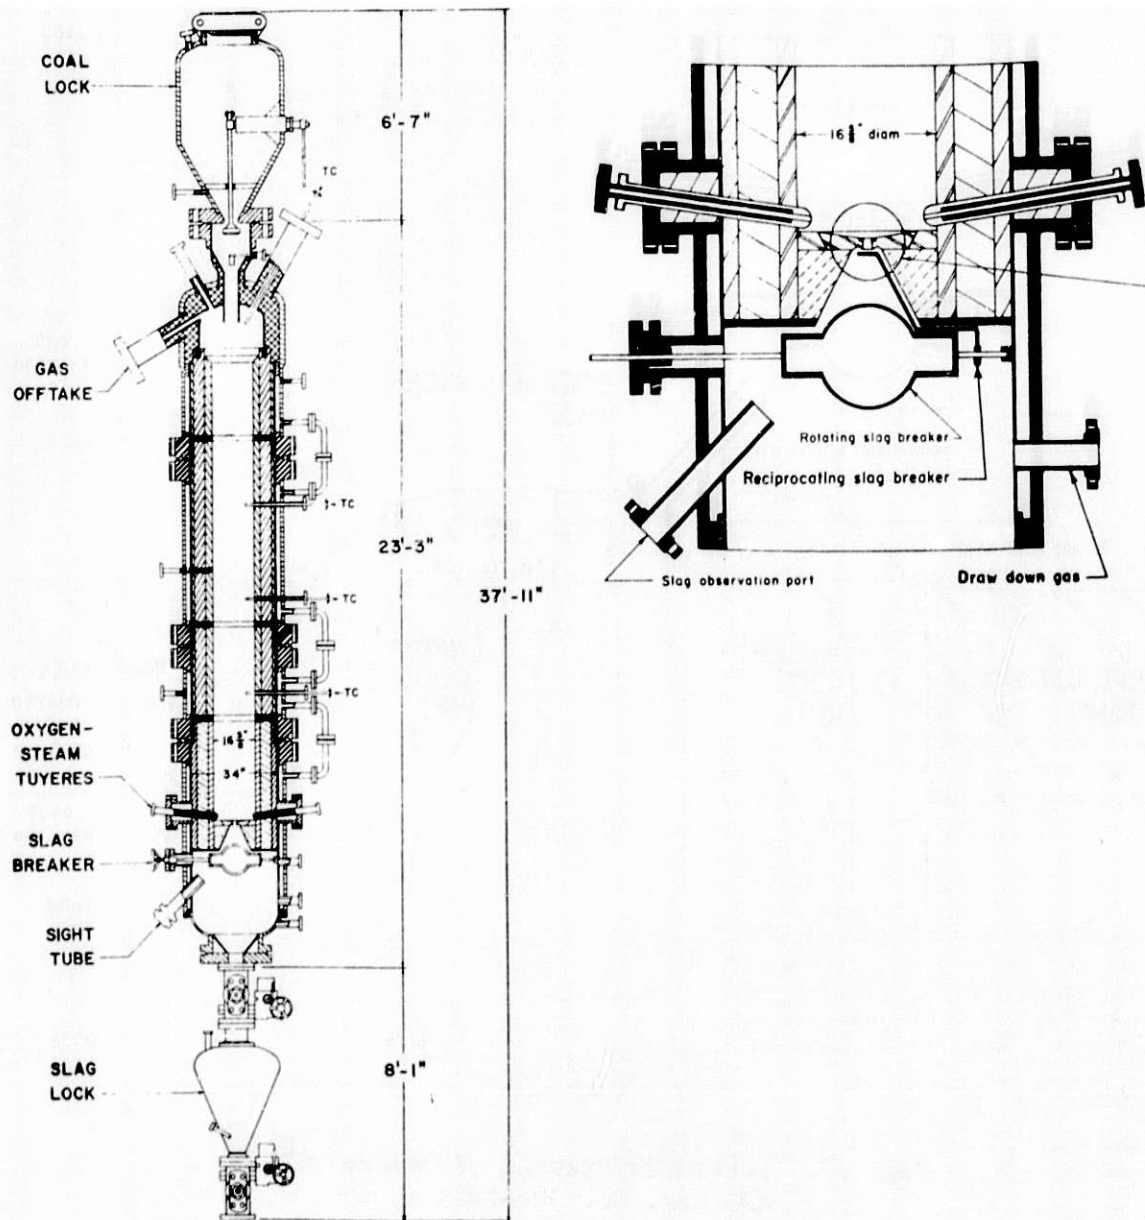
(1) *Tuyere Tips* - Four water-cooled tuyeres are used to continuously inject an oxygen-steam mixture into the bottom of the gasifier. A schematic of the gasifier and a detailed view of the tuyere are shown in Fig. 47. The tuyeres, made of Type 347 stainless steel, were found to be severely corroded, pitted and cracked after a series of runs. Since other tuyeres were subjected to similar environments, the behavior of this particular set was unexplained and an analysis was conducted to determine whether a materials problem was the cause of the failure. The exact operating temperature of the tuyeres is unknown but the maximum should be $\sim 1370^{\circ}\text{C}$, the temperature of the coal slag, and the minimum $\sim 30^{\circ}\text{C}$, the approximate temperature of the exit water from the taphole cooling coil. The composition of the atmosphere in the approximate vicinity of the tuyeres is unknown. The failure was noticed after ~ 300 h of operation at these conditions.

Fig. 47. Schematic of the Grand Forks Energy Technology Center Slagging Gasifier and a Detailed View of the Tuyere Region. ANL Neg. No. 306-78-567R.

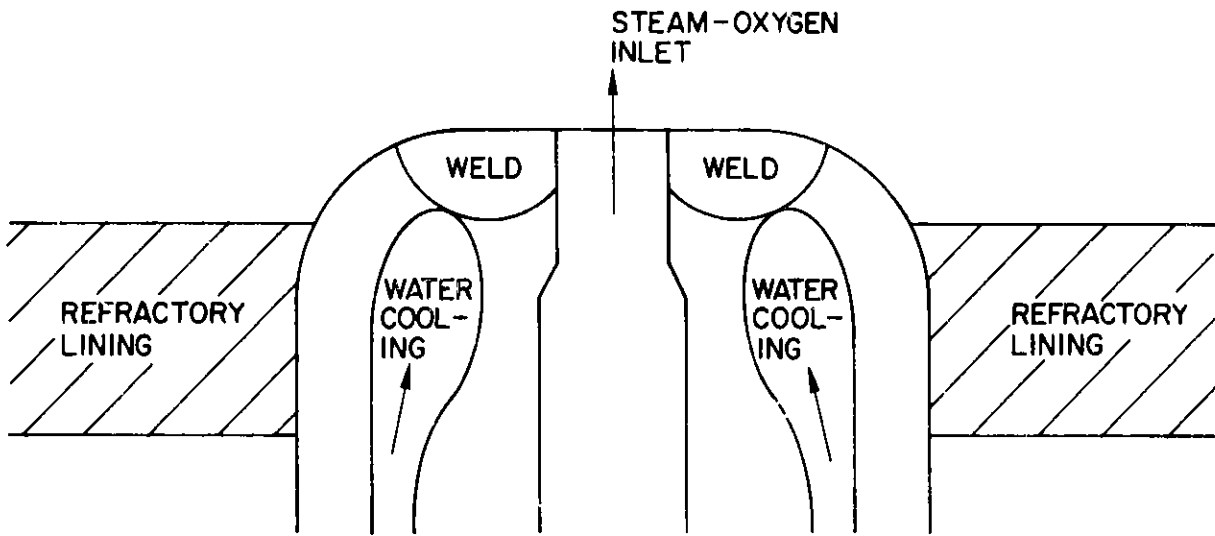
The tuyeres are constructed as shown schematically in Fig. 48. A weld joins the outer shell with the inner sleeve that conducts the steam-oxygen mixture. A photograph showing a sectioned tuyere from the west end of the gasifier is shown in Fig. 49a; the corrosion that occurred as a result of exposure to the atmosphere is evident. In the cross section shown in Fig. 49b, the weld and base metal are clearly delineated. A photograph of a quarter section of a tuyere from the south end of the gasifier is shown in Fig. 50a. Cracks at the weld-substrate interface can be seen; they appear more clearly as intergranular cracks in Fig. 50b. This type of behavior was observed in all three tuyere tips examined. Chemical analysis of the base

Fig. 48. Schematic Drawing of Tuyere Tip.
ANL Neg. No. 306-79-534.

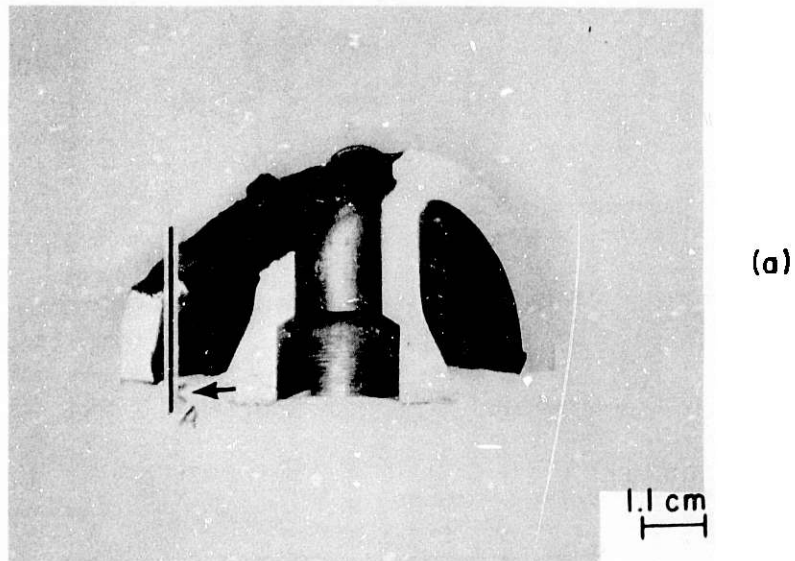
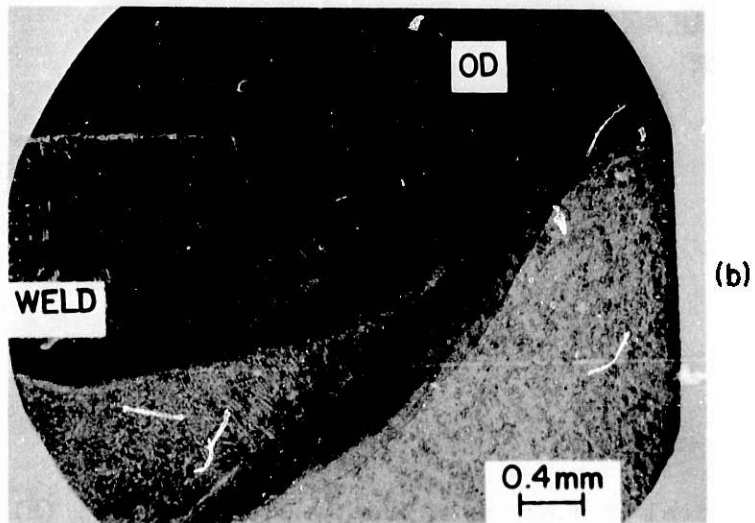
Fig. 49. (a) Optical Photograph of the West Tuiere Tip; (b) Micrograph of a Polished and Etched Cross Section through the Region Indicated in (a), Showing the Weld Metal and Base Metal. ANL Neg. No. 306-79-543.

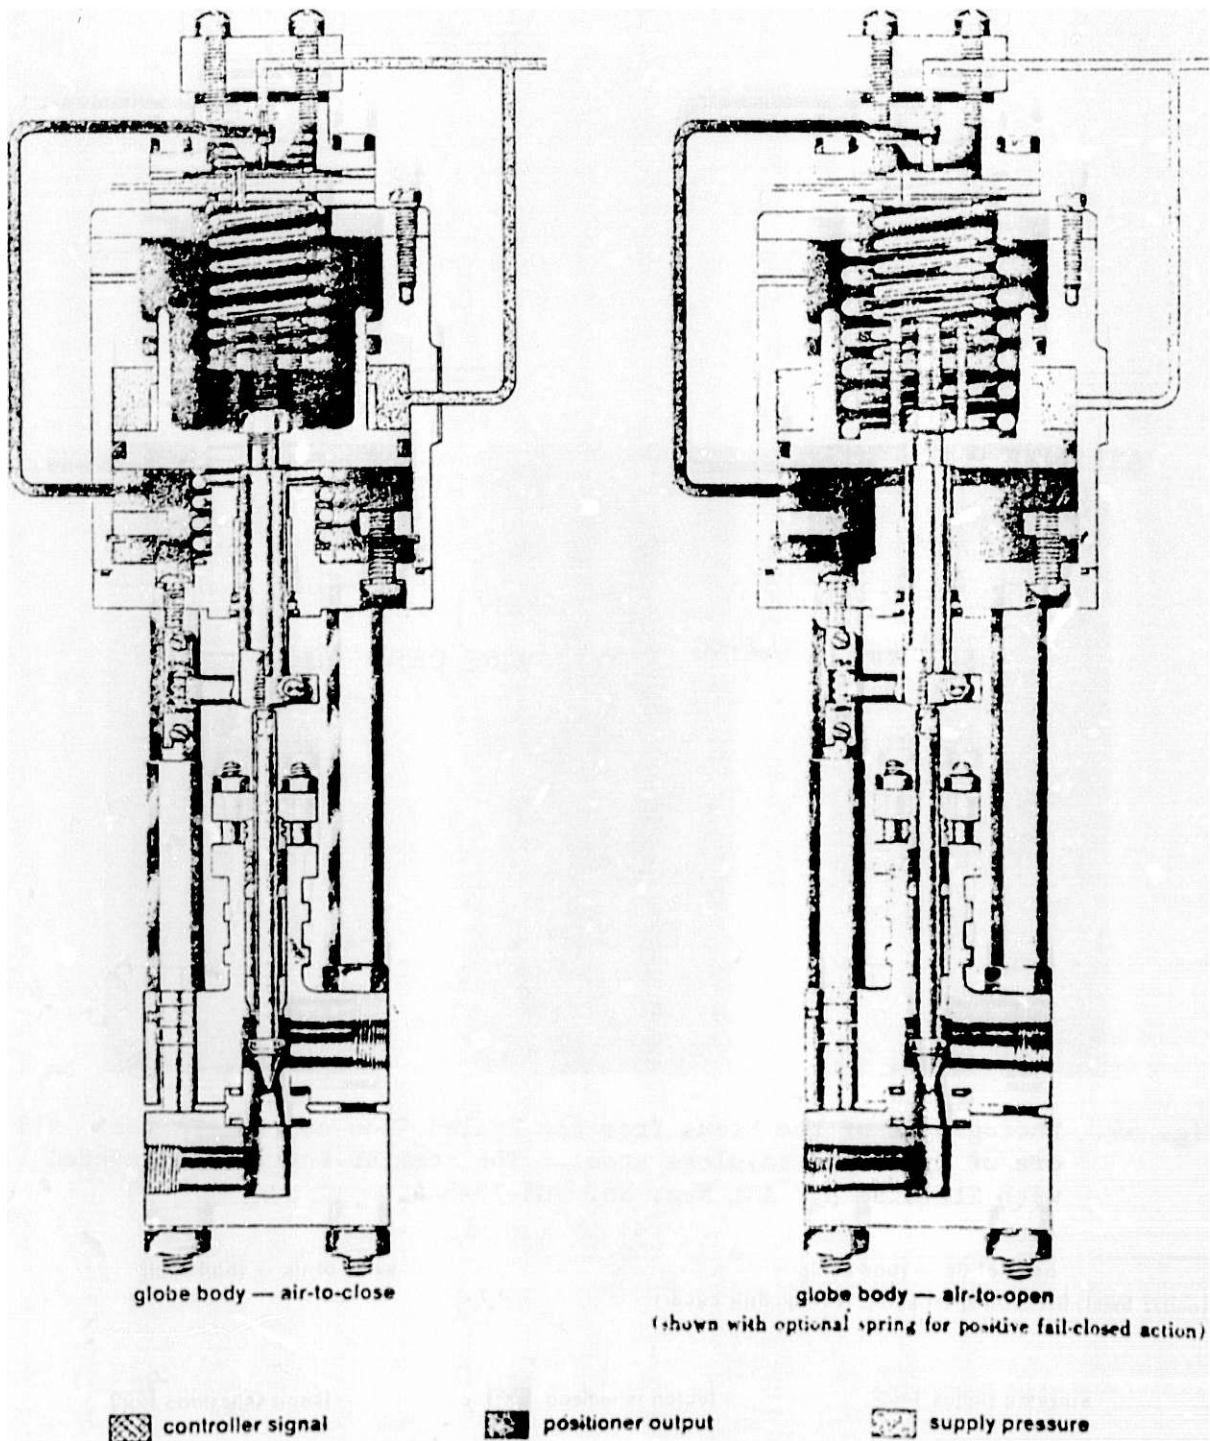
(3) *Flow-control Valves* - Three small flow-control valves from the slurry-letdown system of the liquefaction facility were found to be leaking. A visual inspection revealed "wire drawing" on the seating surfaces. The valves, manufactured by Masoneilan, operate at ~ 200°C and ~ 4000 psi. Two of the failed stems were of Type 316 stainless steel while the third was of the same base material with a Stellite B coating. A schematic of the valve cross section is shown in Fig. 53.

Fig. 53. A Schematic of the Flow-control Valves that Failed by Wire Drawing. ANL Neg. No. 306-79-540.
