**MATERIALS TECHNOLOGY FOR
COAL-CONVERSION PROCESSES**

**Thirteenth Quarterly Report,
January—March 1978**

ANL-78-54

W. A. Ellingson
Project Leader

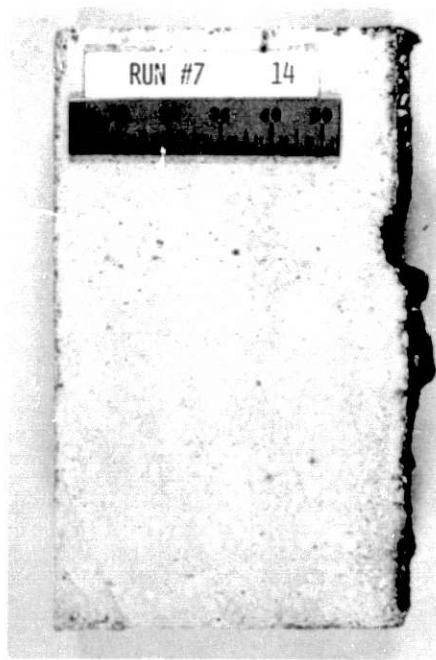
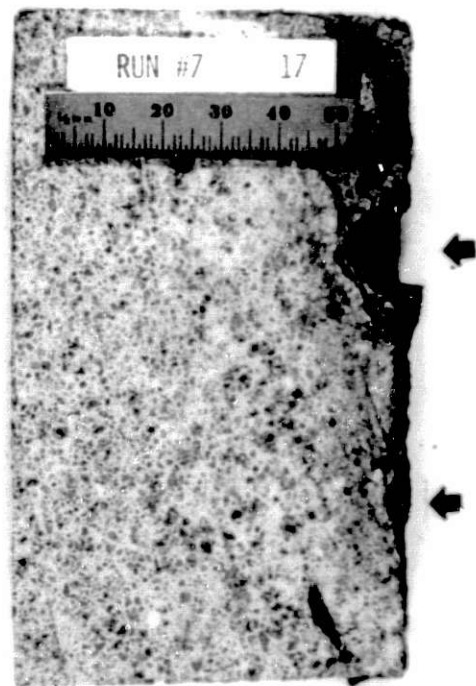
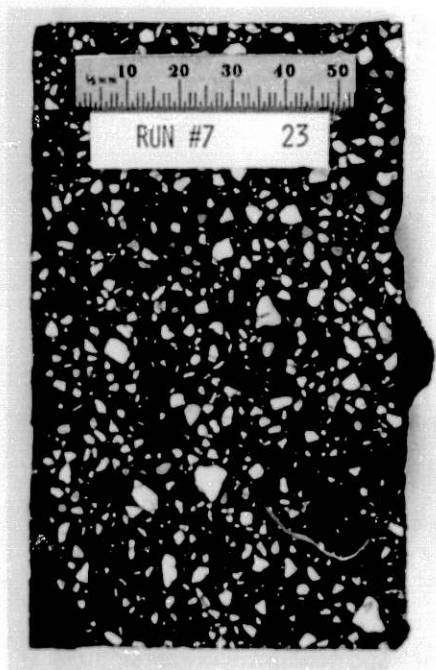
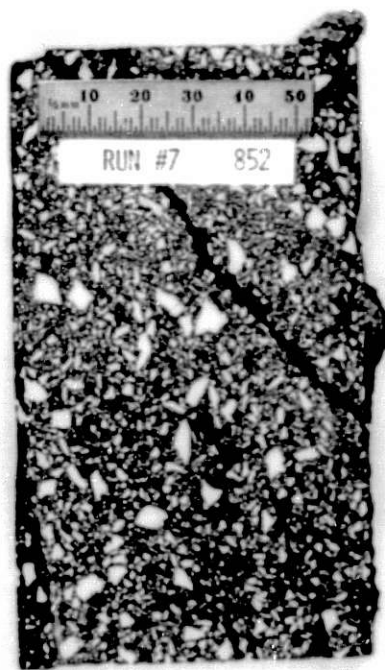
Fig. 3. Cut Sections of the 3/4-length Refractories Exposed to Slag Attack in Run 7. (a) Alumina-silica (Number 14), (b) alumina-silica (Number 17), (c) alumina-chromia (Number 23), and (d) alumina-chromia (Number 852). The vertical face on the right-hand side of each brick was exposed to the slag. Two lines of slag attack [see arrows in (b)] are visible on brick number 17.

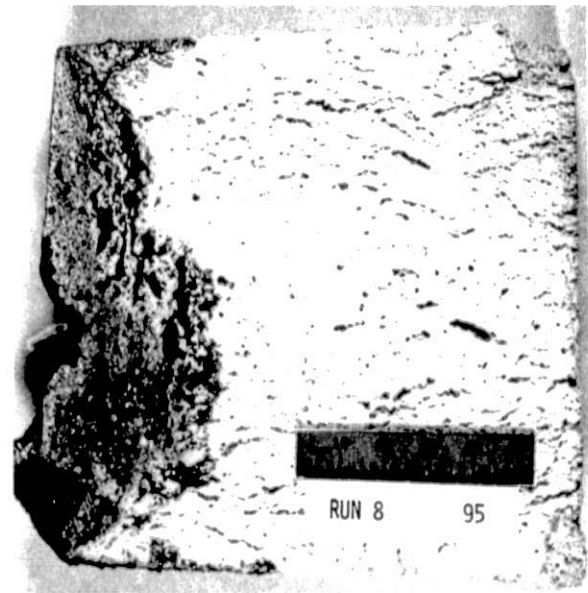
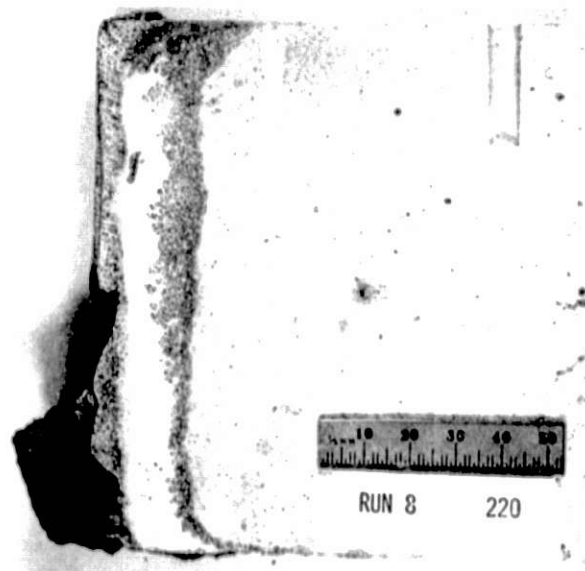
Fig. 8. Cut Sections of the Full-length Refractories Exposed to Slag Attack in Test Run 8. (a) Number 90 (bottom slag-attack zone is broken off), (b) Number 95, (c) Number 18 (bottom slag-attack zone is broken off), and (d) Number 220. The vertical faces toward the center of the page were exposed to two levels of slag.

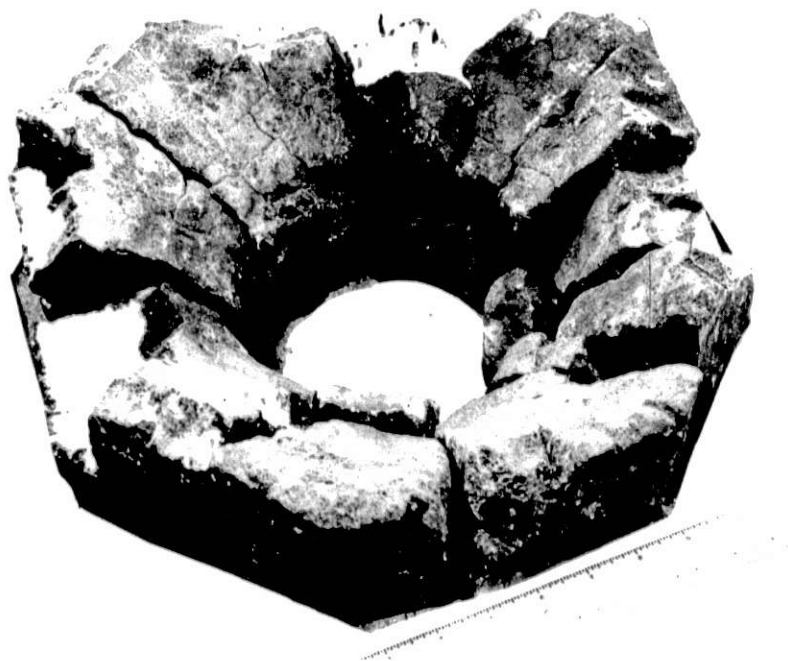
Fig. 11. Slag Outlet Block Obtained from Bi-Gas Pilot Plant, Homer City, PA.

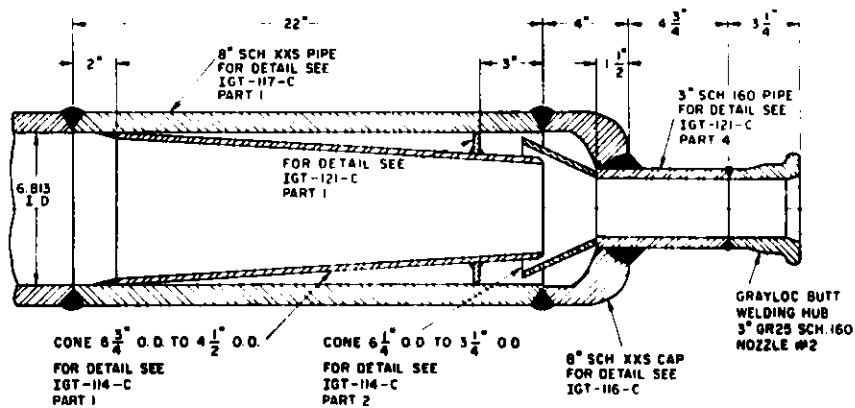
A substantial amount of erosion of the 0.51-m-long cone structure within the cyclone has occurred. The location of the Type 316 stainless steel cone in the assembly is shown in Fig. 13. The erosion process has produced a large-scale sawtooth ridge pattern on the inner surface of the long cone, with the ridges running generally in the axial direction and spaced 20-25° apart azimuthally. Ridge edges were irregular, as shown in an X-ray view exposed through the entire assembly and reproduced in Fig. 14. A schematic sketch of an end view of the sawtooth structure is shown in Fig. 15 together with thickness data based on a small number of determinations made ultrasonically with a 25-MHz Aerotech 1/4-in.-diameter alpha transducer fitted with a delay line, attached to a probe, and inserted to a depth of 0.5 m into the cyclone from the solids outlet flange. The limited data suggest that as much as 40% of the original 6.35-mm thickness of the cone has been eroded away.

Fig. 13. Section of HYGAS Cyclone Separator Showing Location of 0.51-m-long Cone. Solids outlet neck is at right. Drawing provided by Institute of Gas Technology. Neg. No. ANL-306-78-561

The foregoing results were reported to responsible personnel at the HYGAS plant. They have tentatively concluded that operation of the cyclone can be resumed but preparation of a replacement cyclone should be considered.

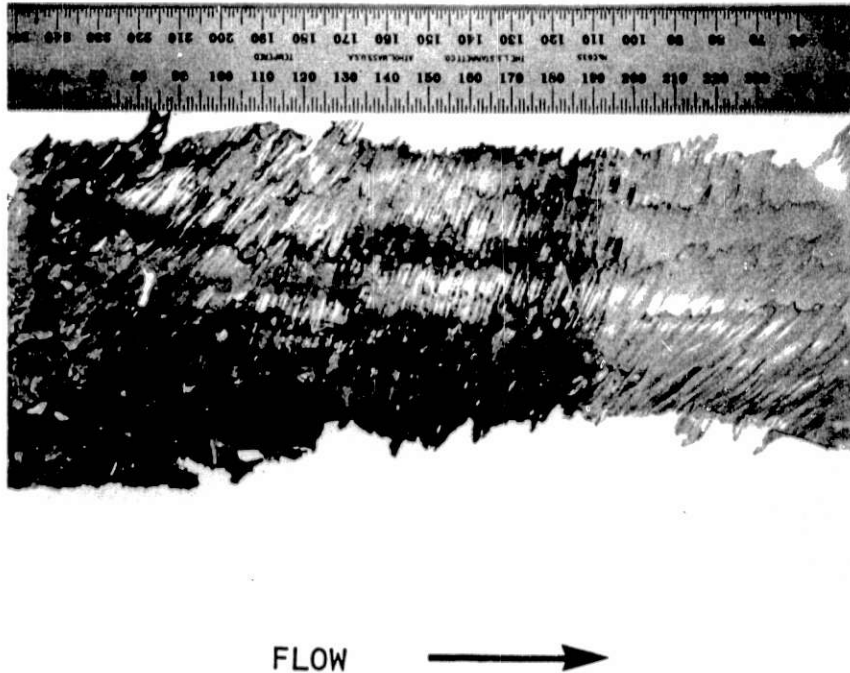
Considerable erosion of a stainless steel solids outlet liner that had been added to the cyclone since the last examination was evident, and a molded replica was made of the erosion pattern. A photo of the replica is given in Fig. 16. A longitudinal sawtooth pattern similar to that seen in the long cone section (Fig. 15) was present, superimposed on the helical grooves. The peak-to-valley distances on the replica were typically $\sim 1 \text{ mm}$, with some as large as 2.5 mm.

Fig. 16. Rubber Impression of Eroded Inner Surface of Liner in Solids Outlet Neck of HYGAS Cyclone Separator. Long dimension corresponds to axial direction and width includes a portion of the azimuthal surface, with outlet flange at right. Small divisions of ruler are millimeters. Neg. No. ANL-306-78-566

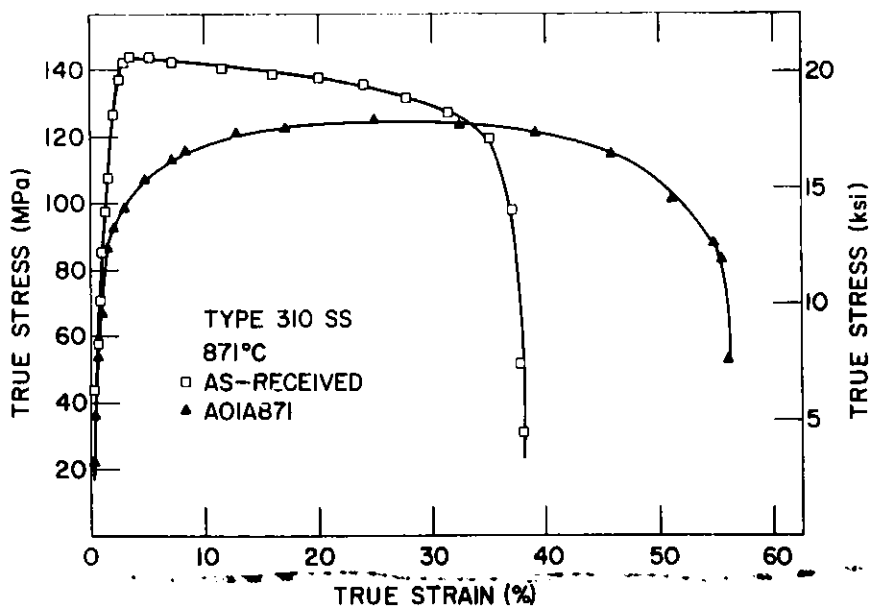
Figures 36 and 37 show the true stress-true strain curves for Type 310 stainless steel and Inconel 671, respectively, in the as-received condition and after a 1000-h exposure to a complex gas environment at 871°C (run A01A871). The results show that the preexposure leads to a decrease in flow stress and a substantial increase in axial strain. Incoloy 800 specimens that were exposed along with the other specimens in this run were fully embrittled, and specimens of U.S. Steel Alloy 18-18-2 were completely corroded.

Fig. 36. True Stress-True Strain Curves for Type 310 Stainless Steel in the As-received Condition and After a 1000-h Exposure to a Complex Gas Mixture at 871°C. Neg. No. ANL-306-78-306

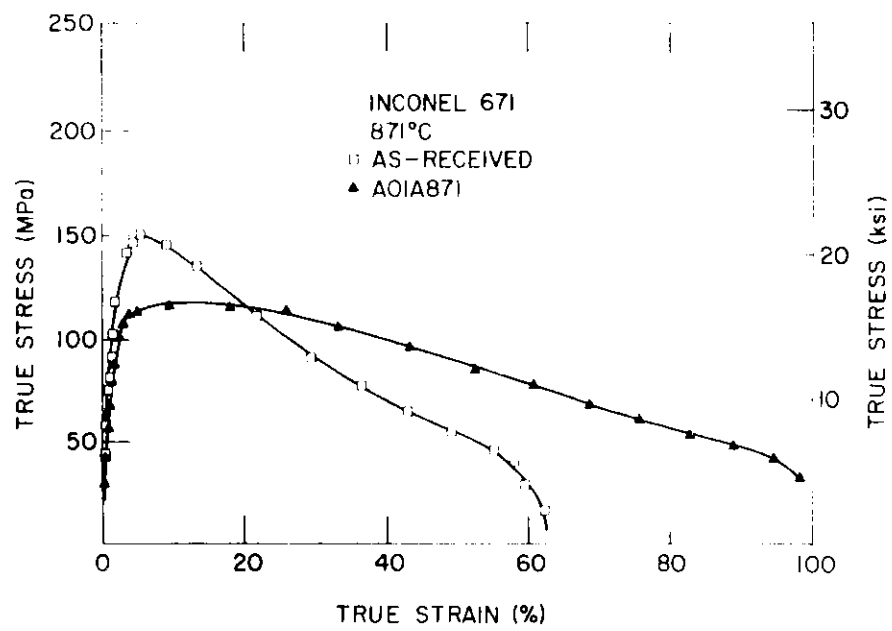
Fig. 37. True Stress-True Strain Curves for Inconel 671 in the As-received Condition and After a 1000-h Exposure to a Complex Gas Mixture at 871°C. Neg. No. ANL-306-78-332

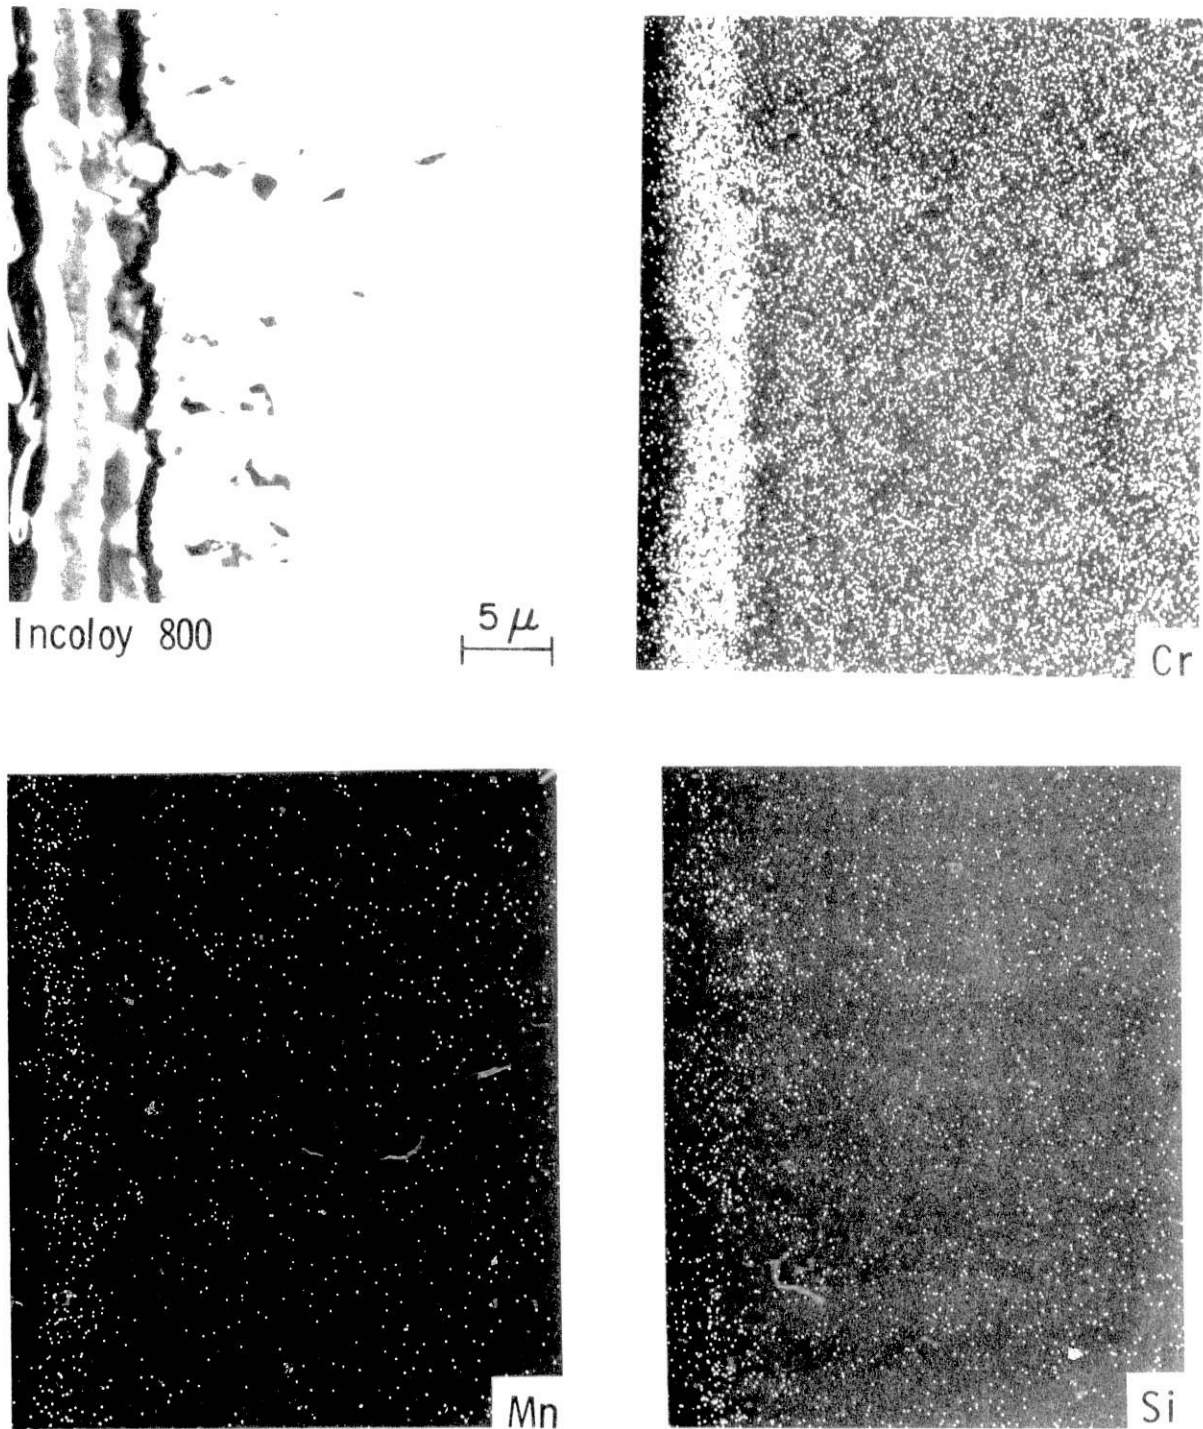
After the mechanical tests were completed, the cross sections and fracture surfaces of uniaxial tensile specimens were examined by SEM with an energy-dispersive x-ray analyzer. Figures 38-41 show SEM photographs of the cross sections of Incoloy 800, Type 310 stainless steel, Inconel 671, and U.S. Steel Alloy 18-18-2, respectively, after a 1000-h exposure to a complex gas mixture (run A01A750). Also shown in these figures are the metallic element (chromium, silicon, and manganese) and sulfur (if present) distributions in the scale/alloy interface regions of the samples. Figures 38-40 show that the scales developed on Incoloy 800, Type 310 stainless steel, and Inconel 671 in run A01A750 are predominantly Cr-rich oxide; virtually no sulfur was detected. The thickness of the oxide scale in these specimens ranged between 3 and 5 μm , and the depth of intergranular penetration in the alloy ranged between 3 and 10 μm . On the other hand, the U.S. Steel Alloy 18-18-2 developed a much thicker two-layered scale after exposure to the gas mixture in run A01A750. The outer scale layer consisted of Ni-rich sulfide and the interior layer was of Cr-rich oxide. The thickness of each layer was ~ 40 μm , and the depth of intergranular penetration was ~ 20 μm . The sulfidation mode of attack in this alloy is consistent with earlier corrosion data⁴ for this alloy in complex gas mixtures. The metallic-element-distribution photographs in Figs. 38-41 also show a predominant transport of Mn and Si toward the scale; the extent of Si migration is greatest in U.S. Steel Alloy 18-18-2, probably due to a larger initial concentration of Si in this material.

Fig. 38. X-ray Photograph and Cr, Mn, and Si Distribution in Incoloy 800 Specimen After a 1000-h Exposure to a Complex Gas Mixture at 750°C (Run A01A750). In the distribution pictures, light regions indicate high concentrations of the respective elements. Neg. No. ANL-306-78-339

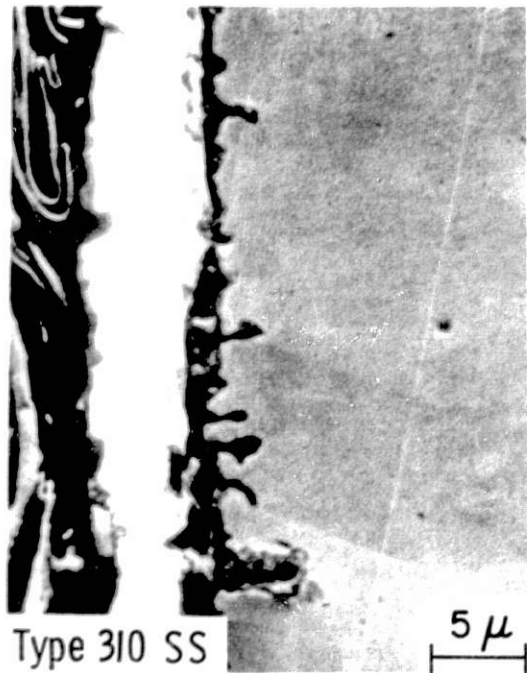
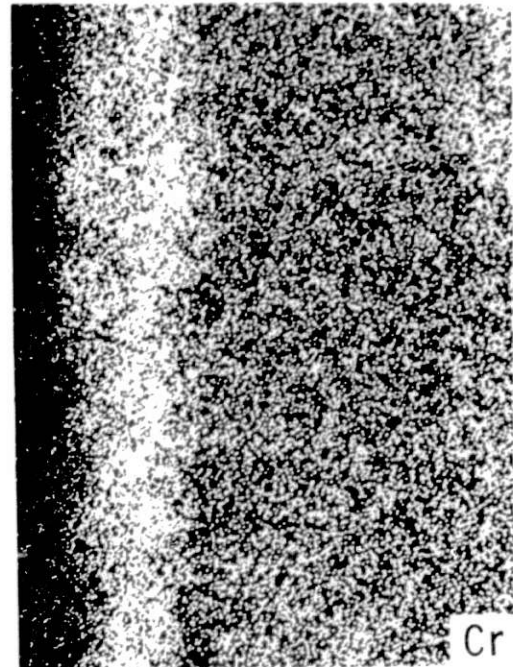
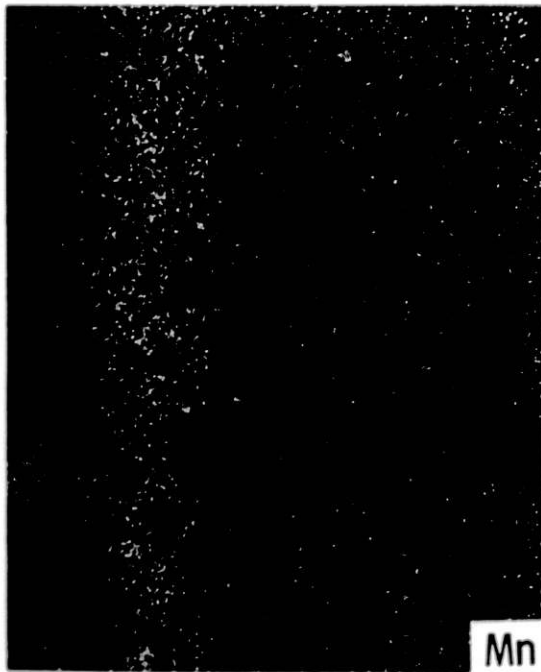
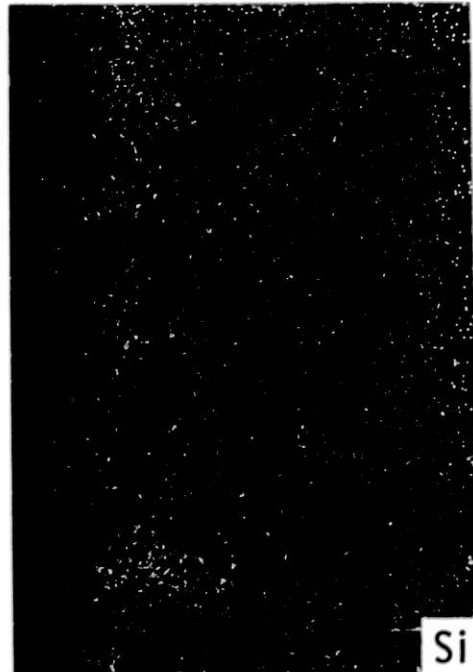
Fig. 39. X-ray Photograph and Cr, Mn, and Si Distribution in Type 310 Stainless Steel Specimen After a 1000-h Exposure to a Complex Gas Mixture at 750°C (Run A01A750). In the distribution pictures, light regions indicate high concentrations of the respective elements. Neg. No. ANL-306-78-343

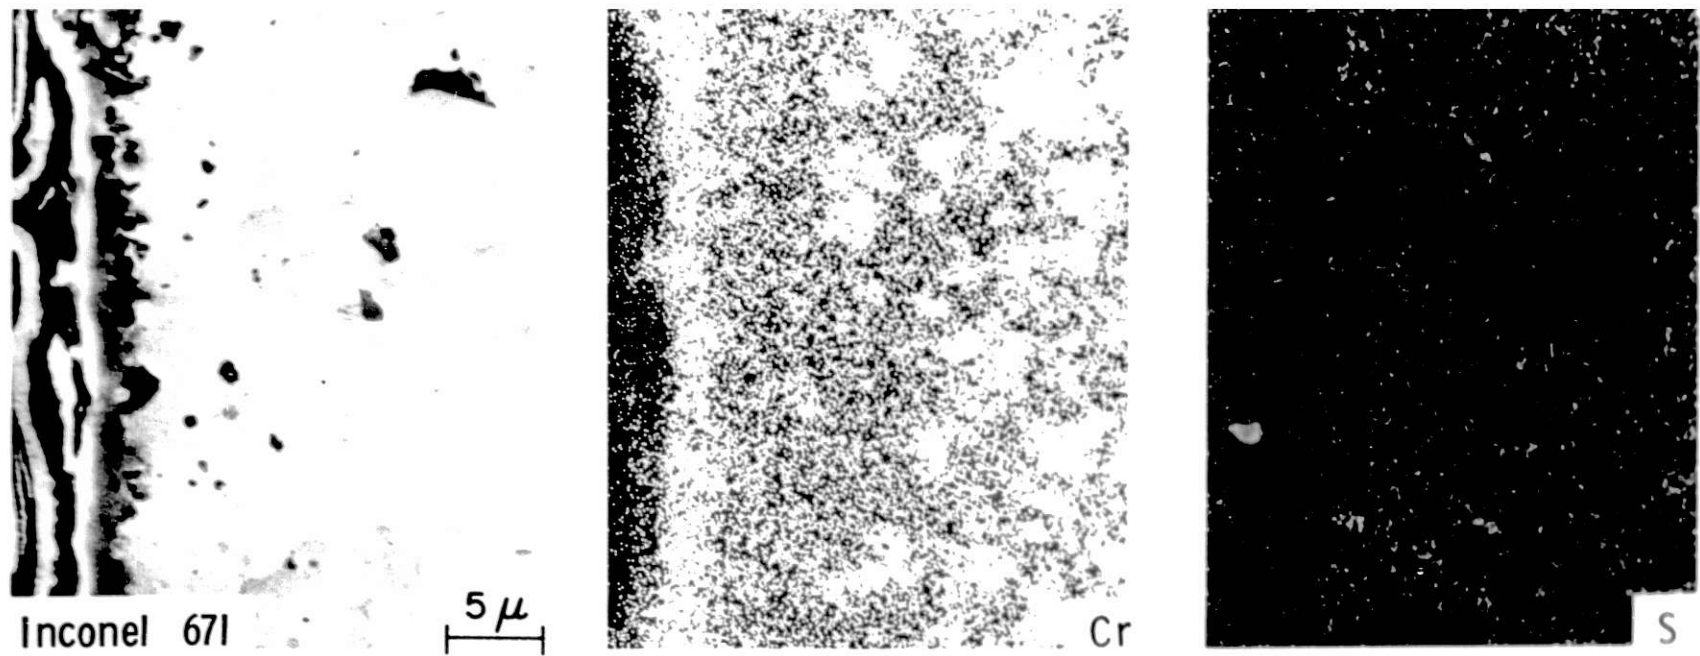
Fig. 40. X-ray Photograph and Cr and S Distribution in Inconel 671 Specimen After a 1000-h Exposure to a Complex Gas Mixture at 750°C (Run A01A700). In the distribution pictures, light regions indicate high concentrations of the respective elements. Neg. No. ANL-306-78-337

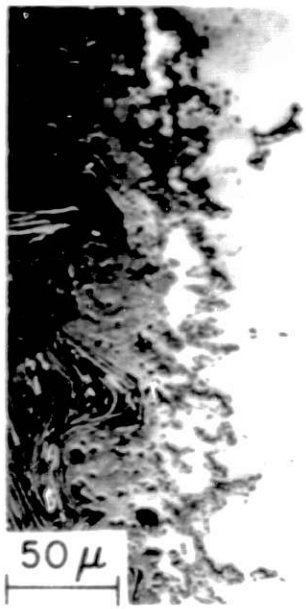
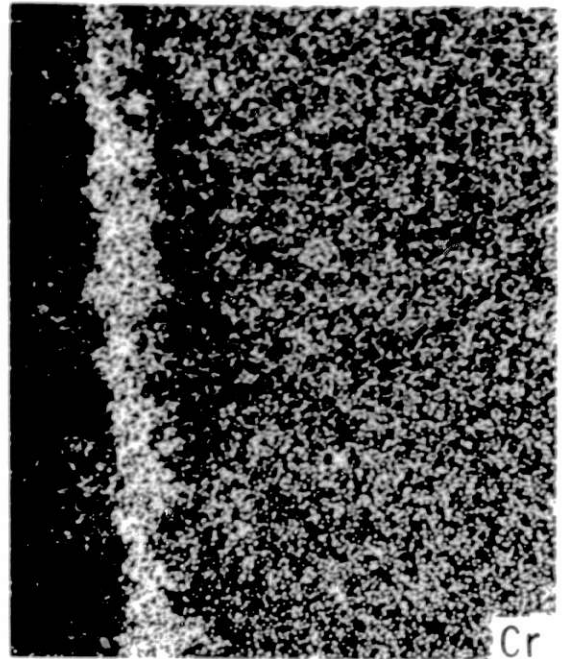
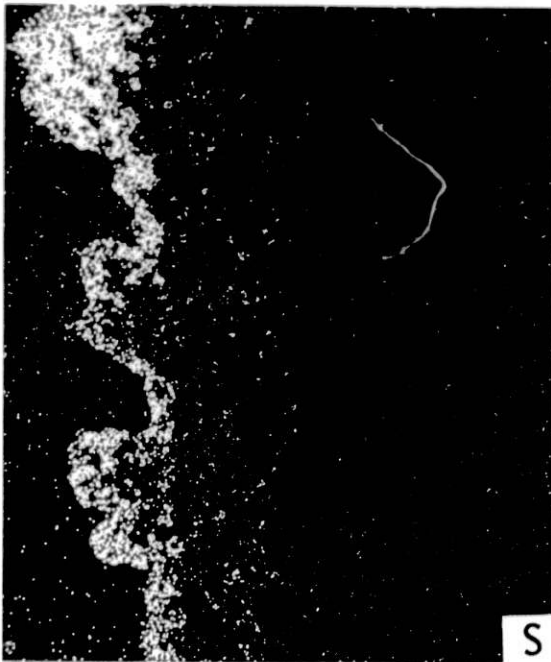
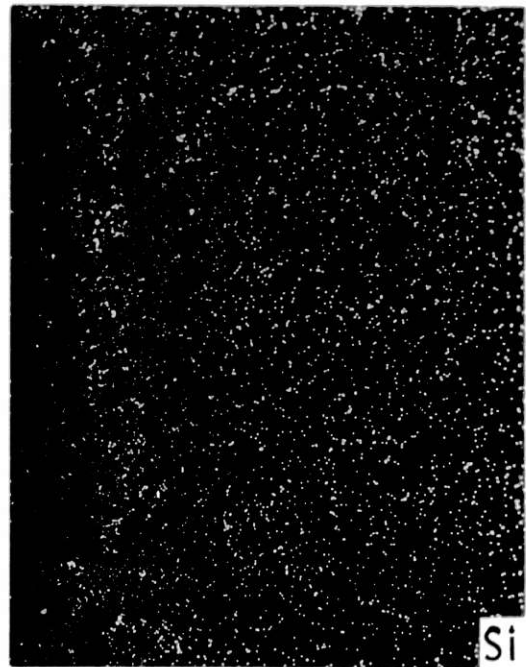
Fig. 41. X-ray Photograph and Cr, S, and Si Distribution in U.S. Steel Alloy 18-18-2 Specimen After a 1000-h Exposure to a Complex Gas Mixture at 750°C (Run A01A750). In the distribution pictures, light regions indicate high concentrations of the respective elements. Neg. No. ANL-306-78-338

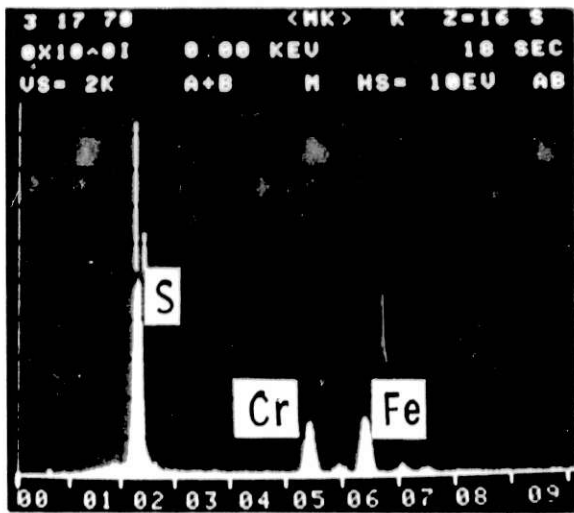
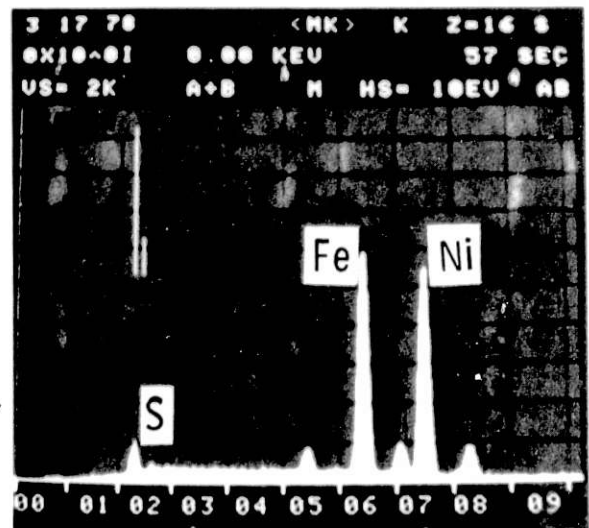
Figures 42 and 43 show the SEM photographs of the fracture surfaces of Incoloy 800 and Type 310 stainless steel tensile specimens after 1000-h exposure to the gas mixture in run A01A871 at 871°C. The X-ray analyses showed that two types of phases, i.e., (Fe,Cr) sulfide and (Fe,Ni) compound, were present in the fracture surface of Incoloy 800. In Type 310 stainless steel specimens, the X-ray analyses showed that the scale was predominantly Cr-rich oxide. There was evidence of an (Fe,Cr) intermetallic compound, probably the sigma phase, which is prevalent in iron-base alloys with high-Cr content. The sulfide phase was of the

type $(Cr,Mn)S_x$; distinct particles of this phase were observed on the fracture surface. Additional examinations of these specimens and analyses of the phases are presently being conducted.

Fig. 42. SEM Photograph of Fracture Surface and X-ray Identification of Phases in Incoloy 800 Specimen After a 1000-h Exposure to a Complex Gas Mixture at 871°C (Run A01A871). Neg. No. ANL-306-78-342

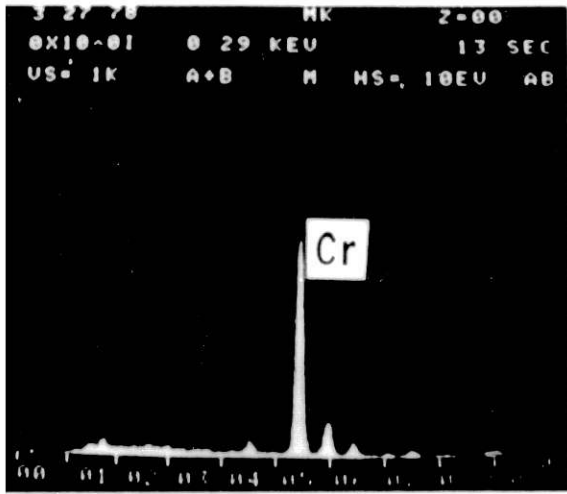
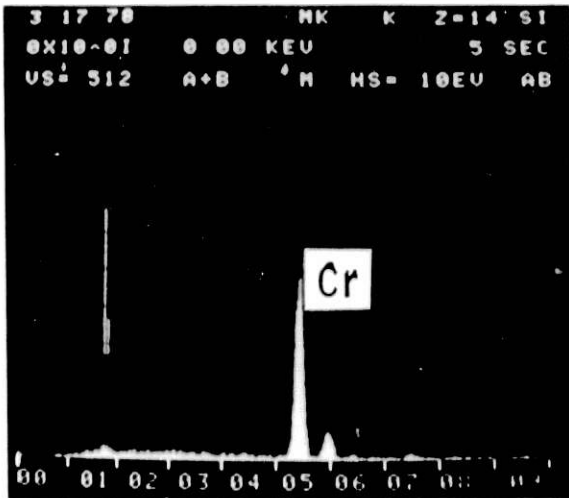
Figures 44 and 45 show the SEM photographs of the fracture surfaces of Incoloy 800, Inconel 671, Type 310 stainless steel, and U.S. Steel Alloy 18-18-2 tensile specimens after a 1000-h exposure to gas mixture 1A at 750°C (run A01A750). The results show the presence of Cr-rich oxide scales in all the alloys with the exception of U.S. Steel Alloy 18-18-2. Additional experiments are being conducted to evaluate the tensile behavior of these alloys after exposure to the gas mixtures listed in Table XIV.

Fig. 44. SEM Photograph of Fracture Surfaces and X-ray Identification of Scales in Incoloy 800 and Inconel 671 Specimens After a 1000-h Exposure to a Complex Gas Mixture at 750°C (Run A01A750). ANL Neg. No. 306-78-341

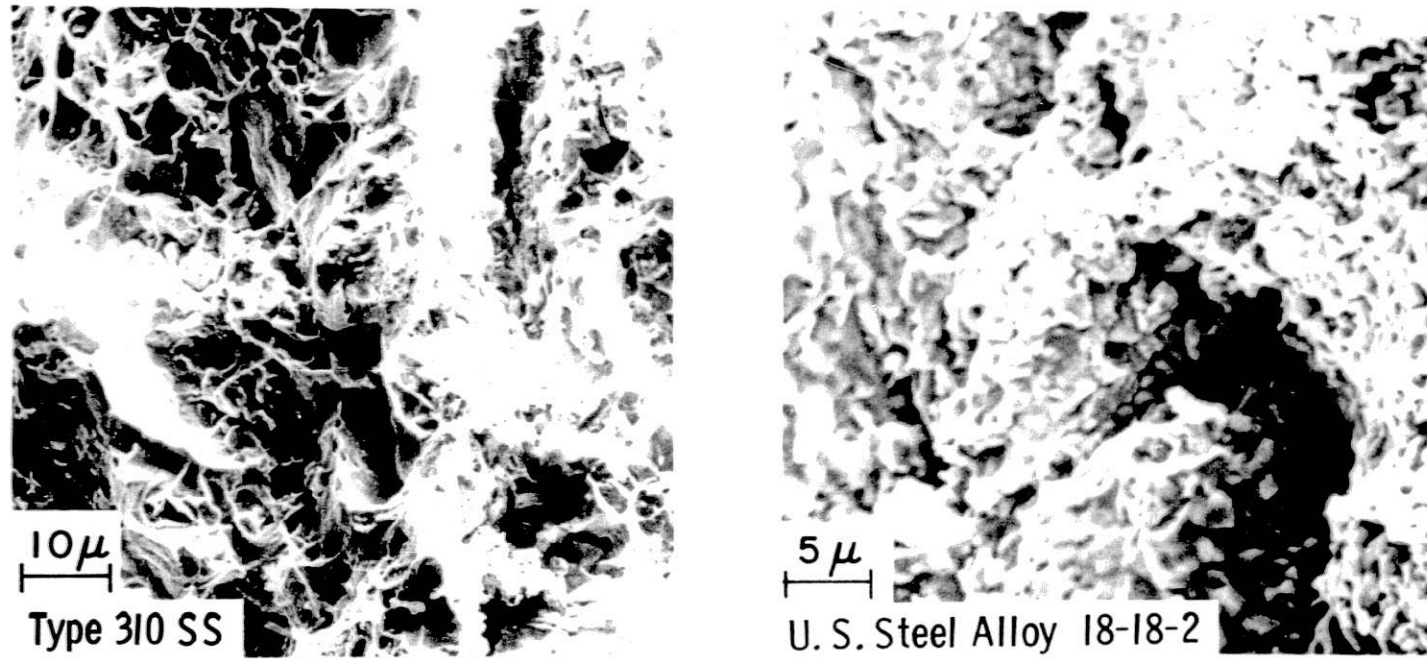
Fig. 45. SEM Photographs of Fracture Surfaces of Type 310 Stainless Steel and U.S. Steel Alloy 18-18-2 After a 1000-h Exposure to a Complex Gas Mixture at 750°C (Run A01A750). Neg. No. ANL-306-78-336

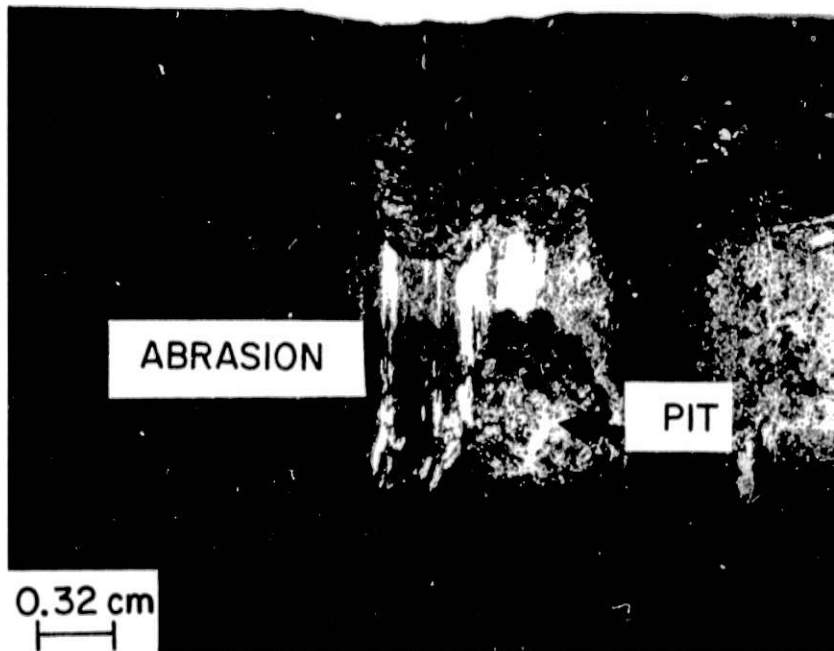
A photograph of the as-received pin is shown in Fig. 55. The diameter is out of round and the pin is bent. Additional photographs of surface pitting and galling are shown in Fig. 56. Considerable damage is evident at the hinge end. The pit depth and galling are also shown in Fig. 57. The galled regions were shiny; this indicates that the pits formed prior to the galling. Grain-boundary penetration (most probably by sulfides) and internal corrosion were also found; these results are shown in Fig. 58. A heavy corrosion scale is seen at the OD, and the grain boundaries and twins are outlined with corrosion product. Confirmation of the nature of the corrosion product is in progress.

Fig. 57. Photographs of a Pit and An Abraded Region of the HYGAS Hinge Pin. The pit depth is shown in (a); abrasion is visible in (b). The abraded region is shiny, indicating that abrasion occurred after the pits had formed. Neg. No. ANL-306-78-578

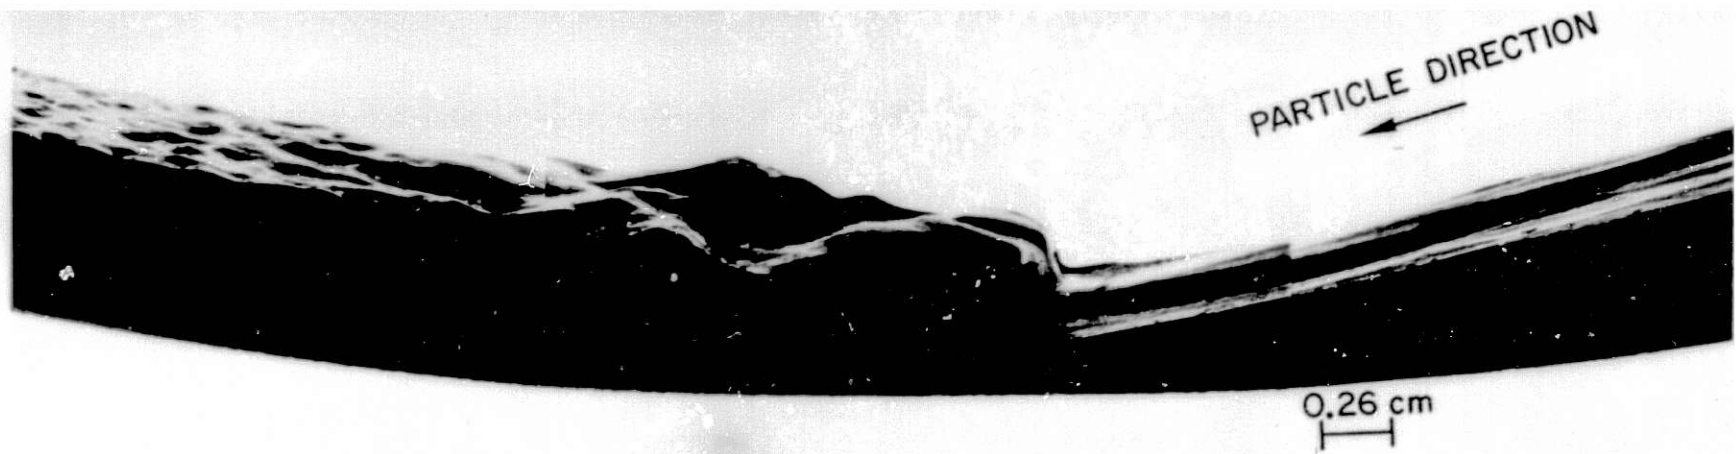
A photograph of the cyclone, showing the particle inlet and the eroded section, is shown in Fig. 59. The perforation occurred at an angle of 20-30° relative to the inlet axis of the cyclone; wall thinning is observed around the perforation. A photograph of the eroded region, as seen through the cyclone inlet, is shown in Fig. 60. The topography of the internal surface appears nonuniform. The eroded regions were sectioned for optical, scanning-electron, and transmission-electron microscopy. A photograph of a polished cross section from the region indicated in Fig. 59 is shown in Fig. 61. The direction of particle impingement is indicated; wall thinning is readily seen.

Fig. 61. Photograph of a Polished Cross Section from the Region Indicated in Fig. 59. Thinning of the wall is readily seen. ANL Neg. No. 306-78-579

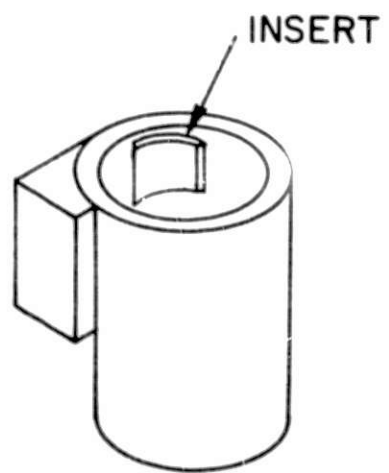
Optical micrographs of the internal surface of the insert, and a schematic of the patched cyclone, are shown in Fig. 64. Perforations and a rough, uneven surface are visible. A cross-sectional view of the weld and insert in the polished and etched condition is shown in Fig. 65. The heat-affected-zone (HAZ) adjacent to the weld can be seen. Particle impingement is from the direction indicated and is reflected in the topography of the internal surface. The weld and HAZ are not as severely eroded as the insert material, as shown in Fig. 66 where the HAZ is observed to be protruding beyond the severely eroded region of the insert material. The grain boundaries of the base material are decorated with precipitates, as shown in Fig. 67; however, the precipitation, which results from heat treatment or operation at high temperatures, did not contribute to the failure.

Fig. 64. Optical Micrographs of the Eroded Stainless Steel Insert and a Schematic of the HYGAS Low-Btu Internal Cyclone. Neg. No. ANL-306-78-573

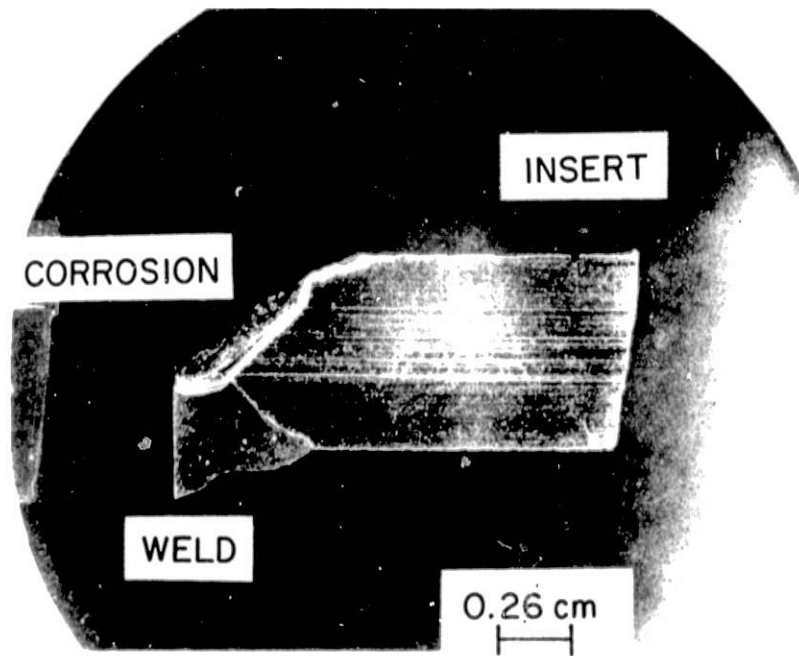
Fig. 70. Photograph of a Polished and Etched Cross Section of the Hard-faced Insert. The weld and insert material are shown. Neg. No. ANL-306-78-587

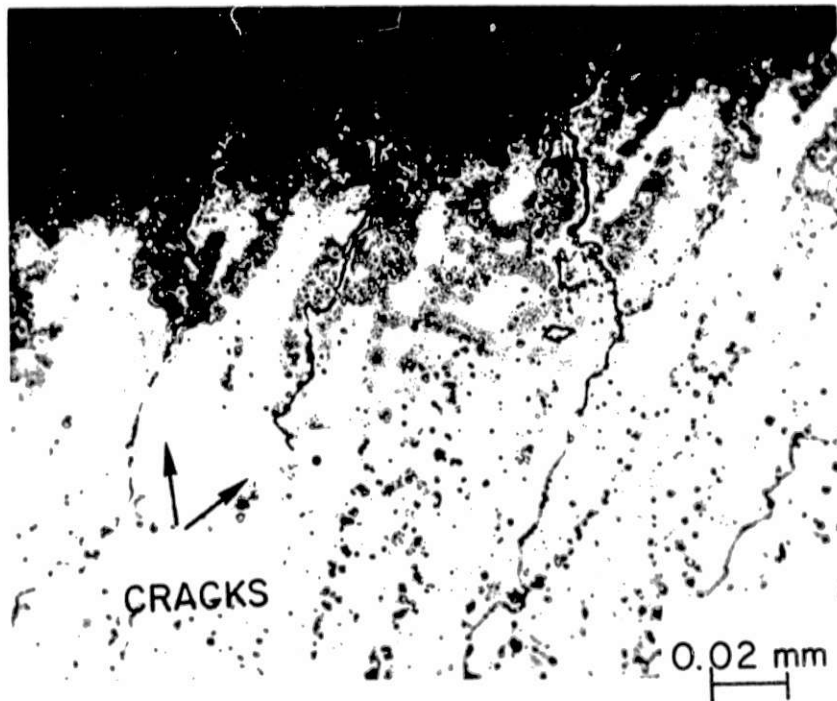
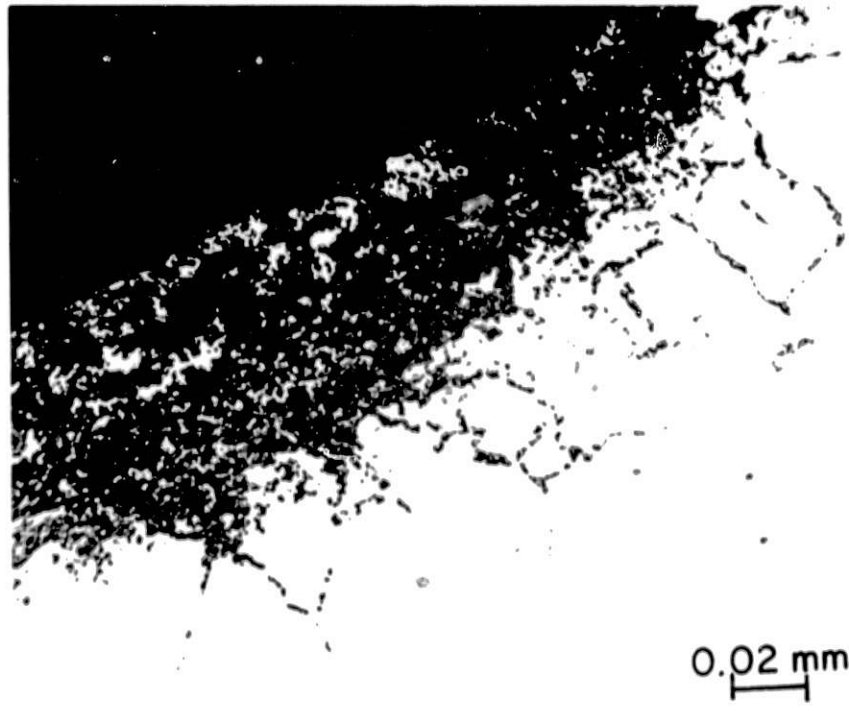
The two micrographs in Fig. 74 show cracking in the base metal near the coating-substrate interface (a) and corrosion and grain-boundary sulfide formation near the weld (b). Both these phenomena will contribute to the degradation of the insert.

Fig. 74. Micrographs of Cracks at the Interface Between the Coating and Substrate (a) and Corrosion and Sulfide Formation Near the Weld Region (b). ANL Neg. No. 306-78-585

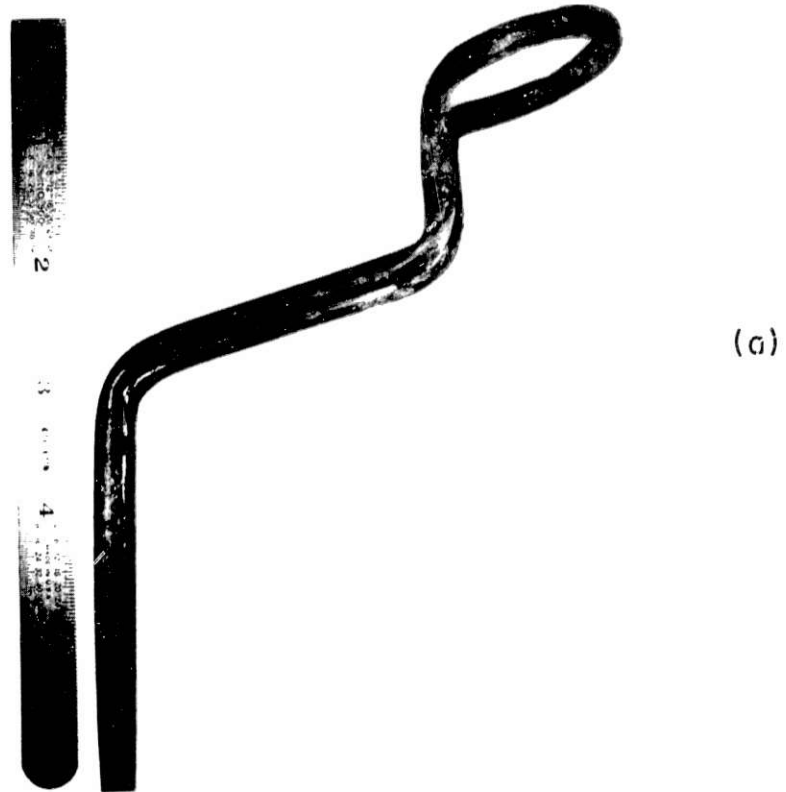
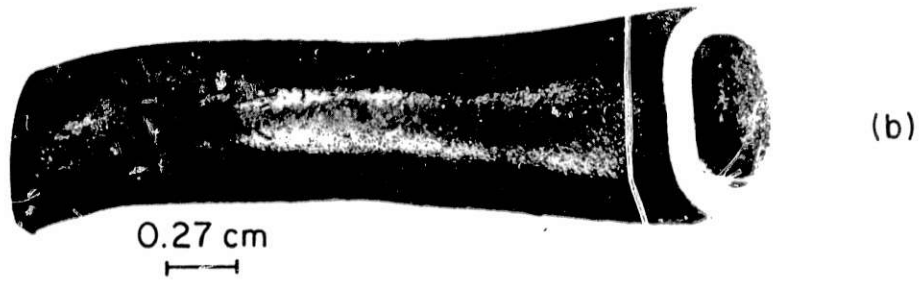
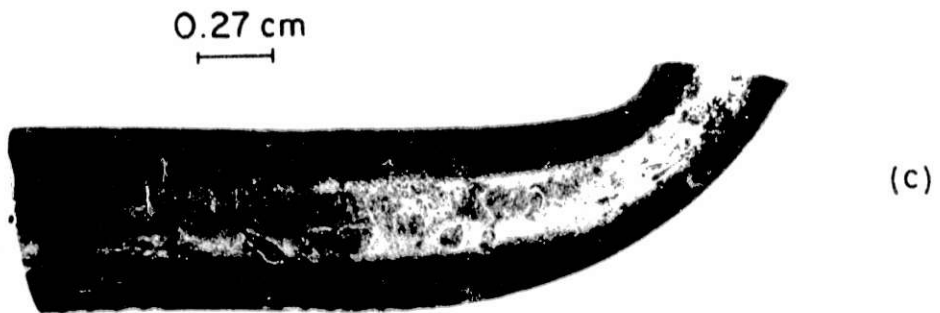
Fig. 76. Optical Photographs of the Taphole Cooling Coil: Overall view (a), Cross-sectional View (b), and Top View (c). The tube ID is out of round, and the outer surface contains many imperfections. ANL Neg. No. 306-78-572

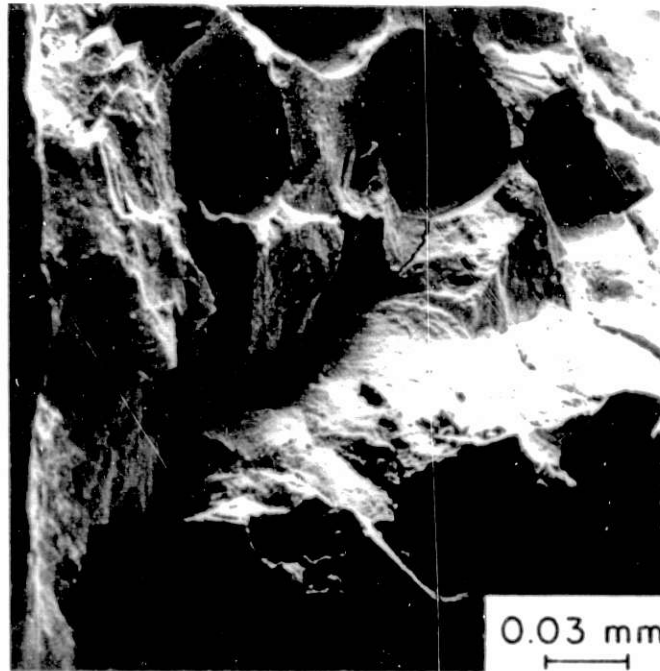
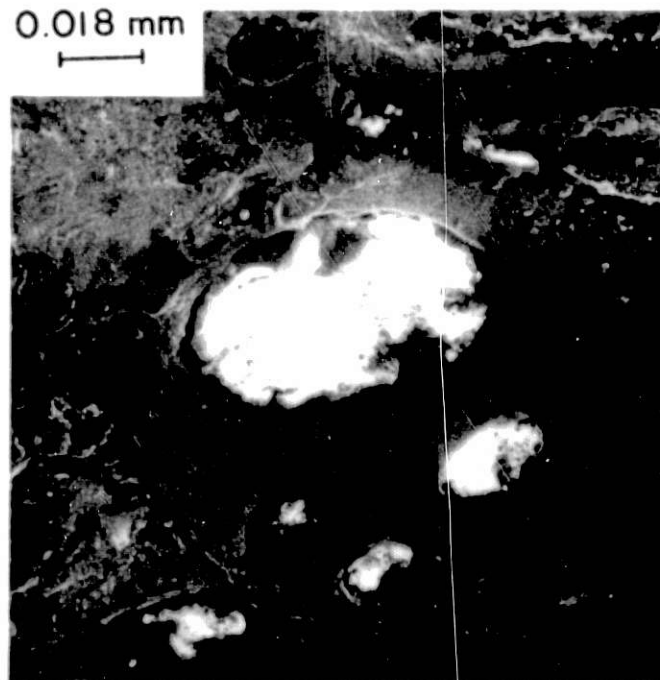
Scanning-electron micrographs of a fracture surface are shown in Fig. 80. The fracture surface in Fig. 80a contains circular depressions along which the crack propagated. These depressions were also visible at the outer surface; Fig. 80b shows several such depressions that contain a nonconducting phase. X-ray fluorescence spectroscopy showed that this phase contained the elements Mg, Si, Ca, S, and Cu.

Fig. 80. Scanning-electron Micrographs of the Fracture Surface (a) and the Outer Surface (b). Circular regions on the fracture surface in (a) contained non-conducting phases as shown in (b). ANL Neg. No. 306-78-571
