MISCELLANEOUS PAPER S-73-22

CONDITION SURVEY, MALMSTROM AIR FORCE BASE, MONTANA

R. D. Jackson

April 1973

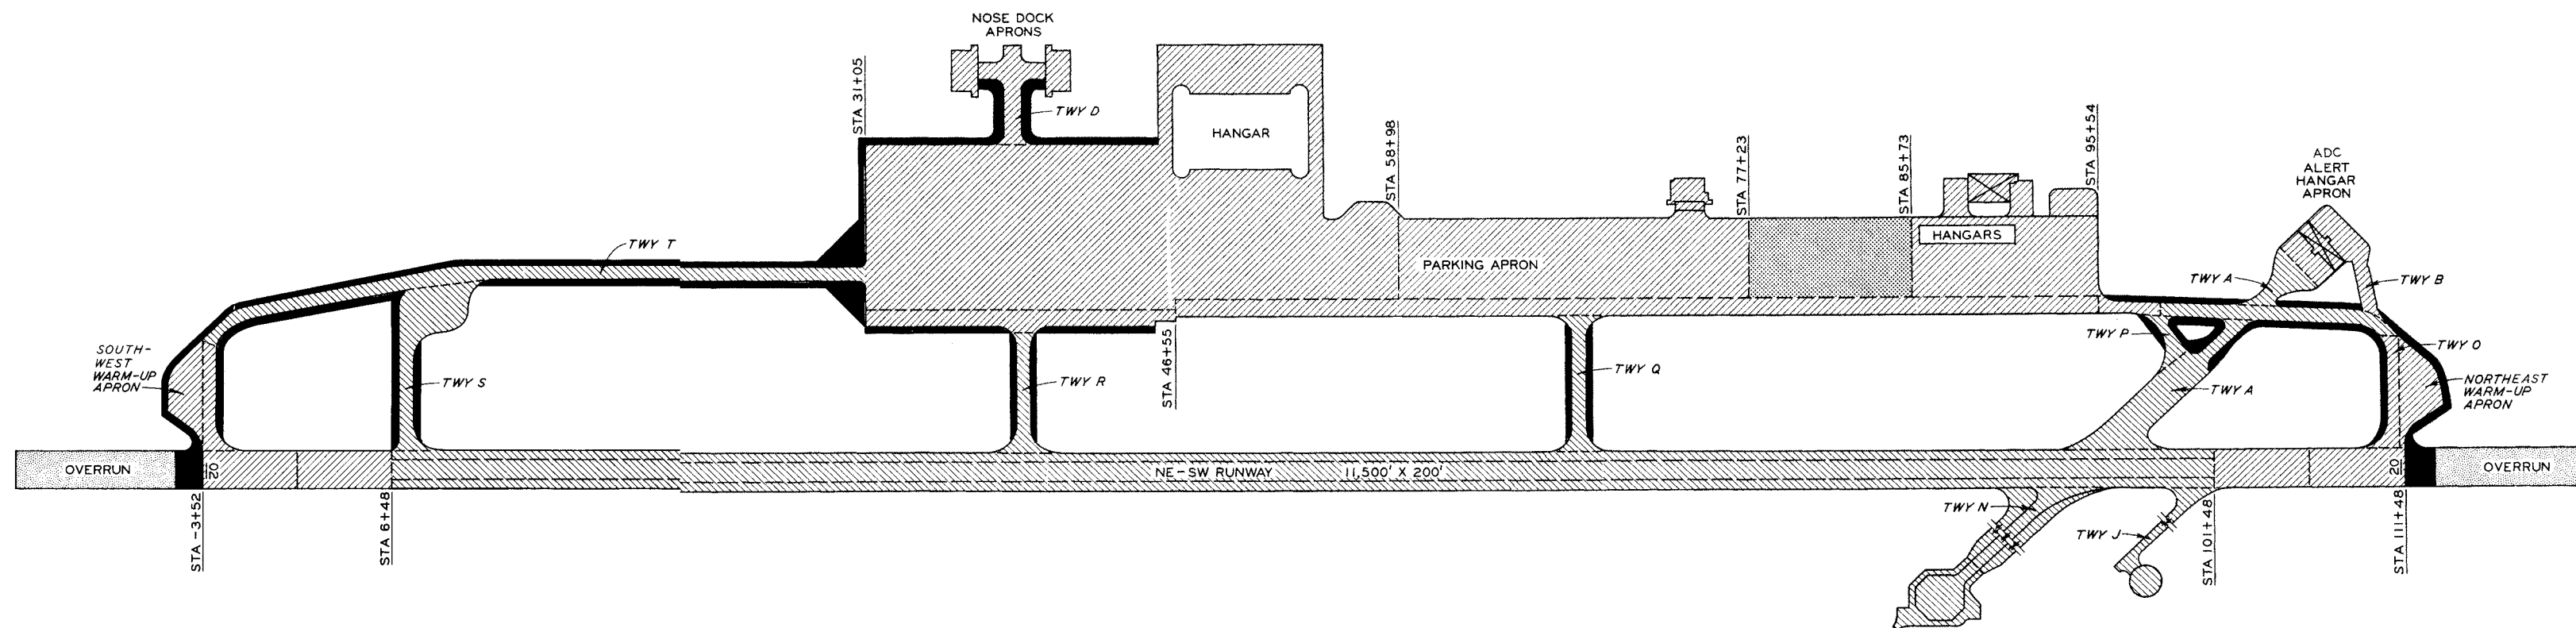
MALMSTROM AFB
PAVEMENT PLAN

13. The following procedure was used in conducting the inspection of the rigid pavements. Representative features were selected for detailed inspection. The features were then inspected slab* by slab, and the defects were recorded. The locations of the individual pavement features, the inspection starting points, and the directions in which the pavements were inspected (shown by arrows) are indicated in plate 1.
