MISCELLANEOUS PAPER S-73-33

# CONDITION SURVEY, GLASGOW AIR FORCE BASE, MONTANA

R. D. Jackson

May 1973

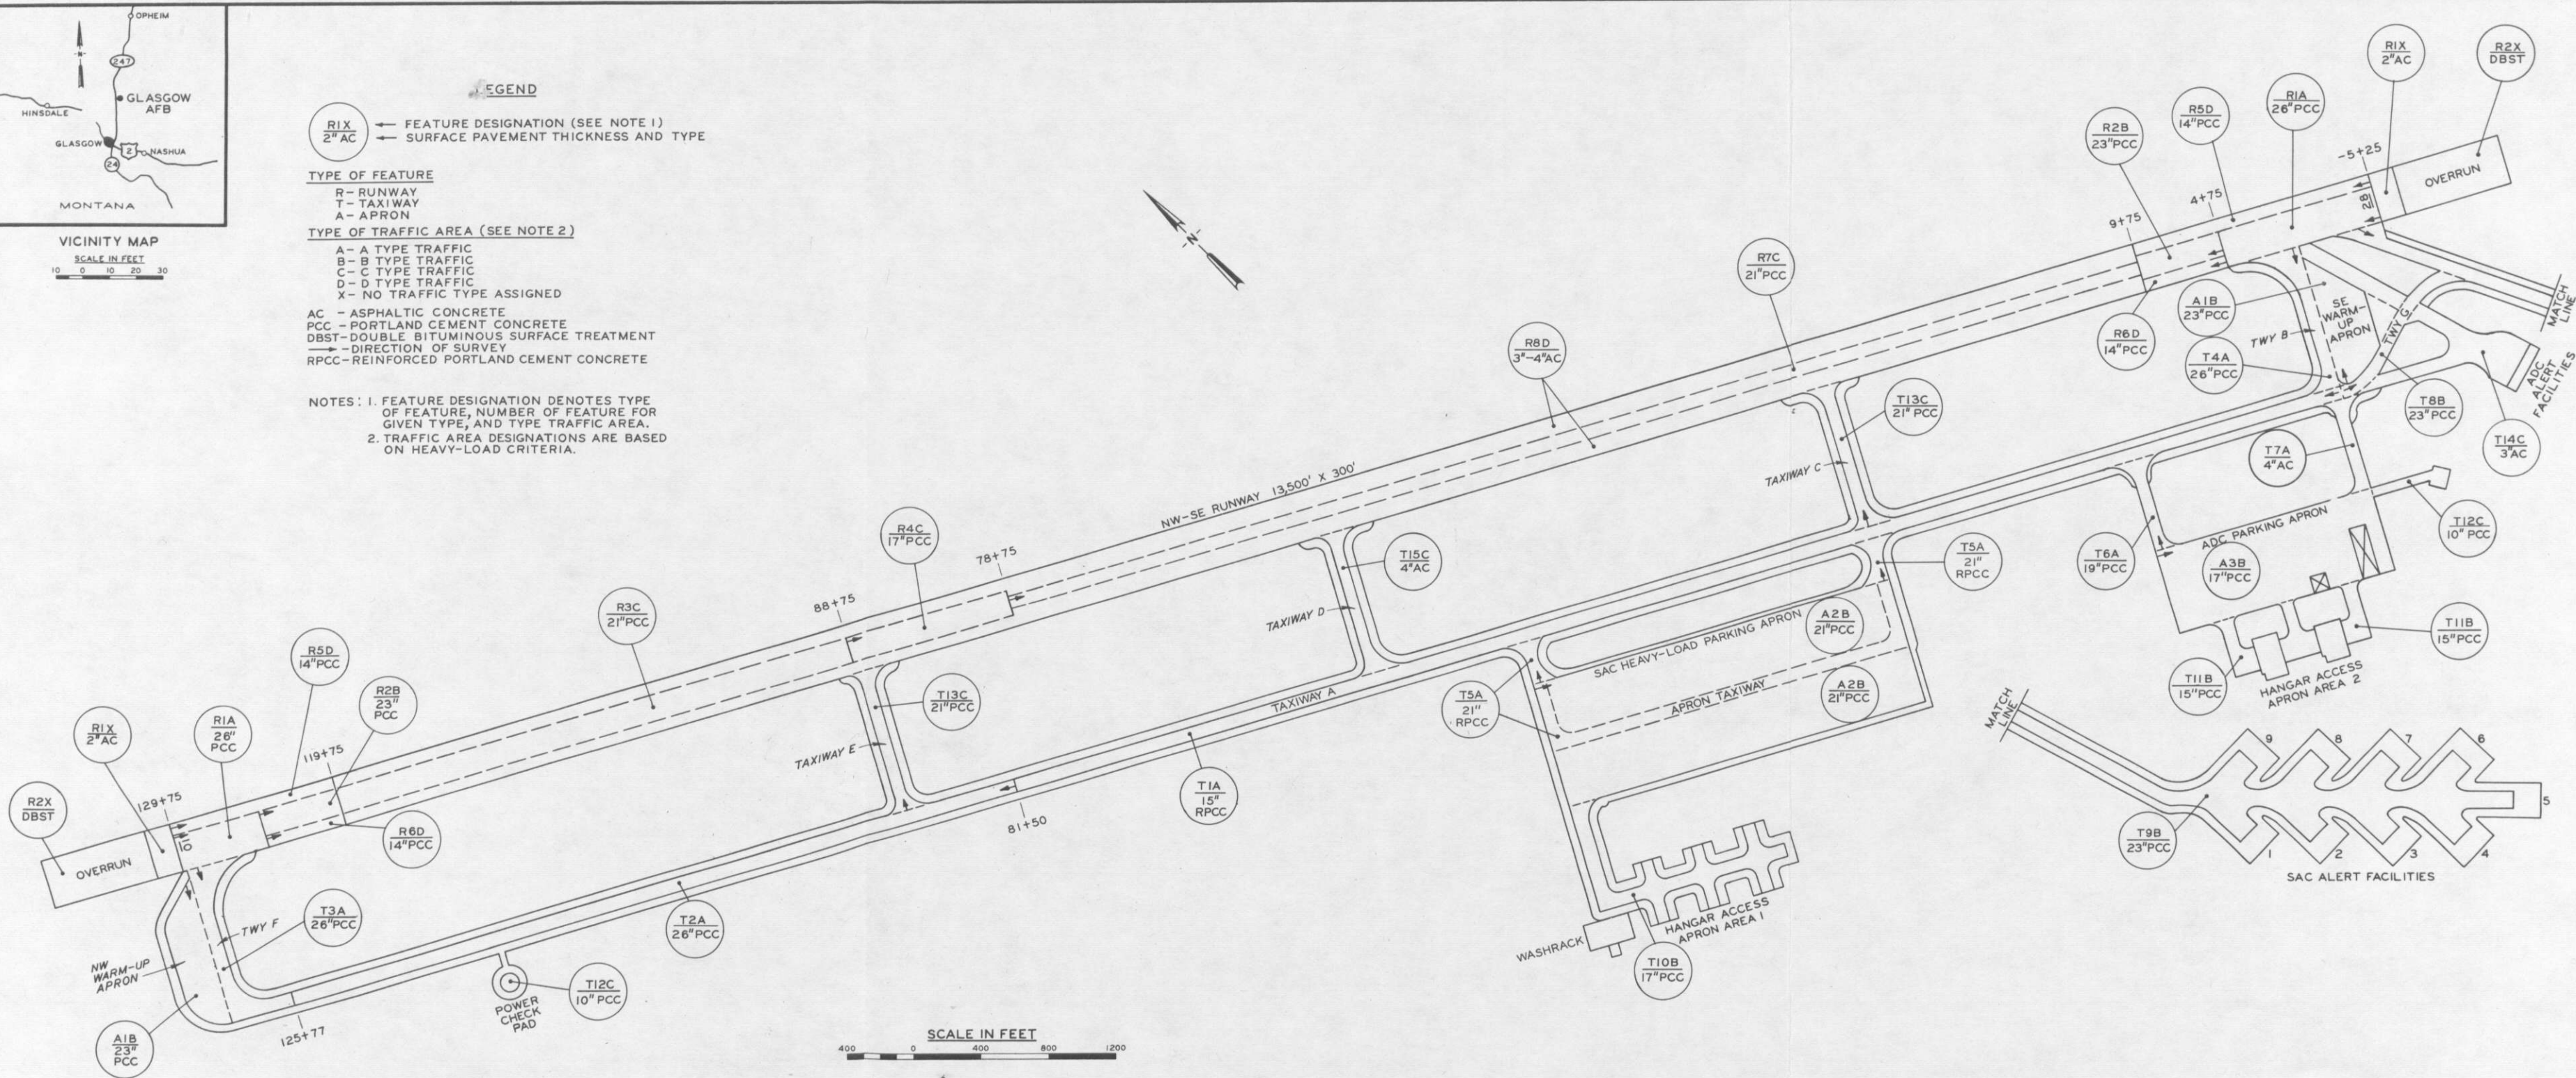
AIRFIELD LAYOUT

12. The following procedure was used in conducting the inspection of the rigid pavements. Representative features were selected for detailed inspection. The features were then inspected slab\*\* by slab, and the defects were recorded. The locations of the individual pavement features, the inspection starting points, and the directions in which the pavements were inspected (shown by arrows) are indicated in plate 1.
