NBS BUILDING SCIENCE SERIES 145

# Investigation of Construction Failure of Harbour Cay Condominium in Cocoa Beach, Florida

H. S. Lew  
N. J. Carino  
S. G. Fattal  
M. E. Batts

Sponsored by:  
Occupational Safety and Health Administration  
U.S. Department of Labor  
Washington, DC 20001

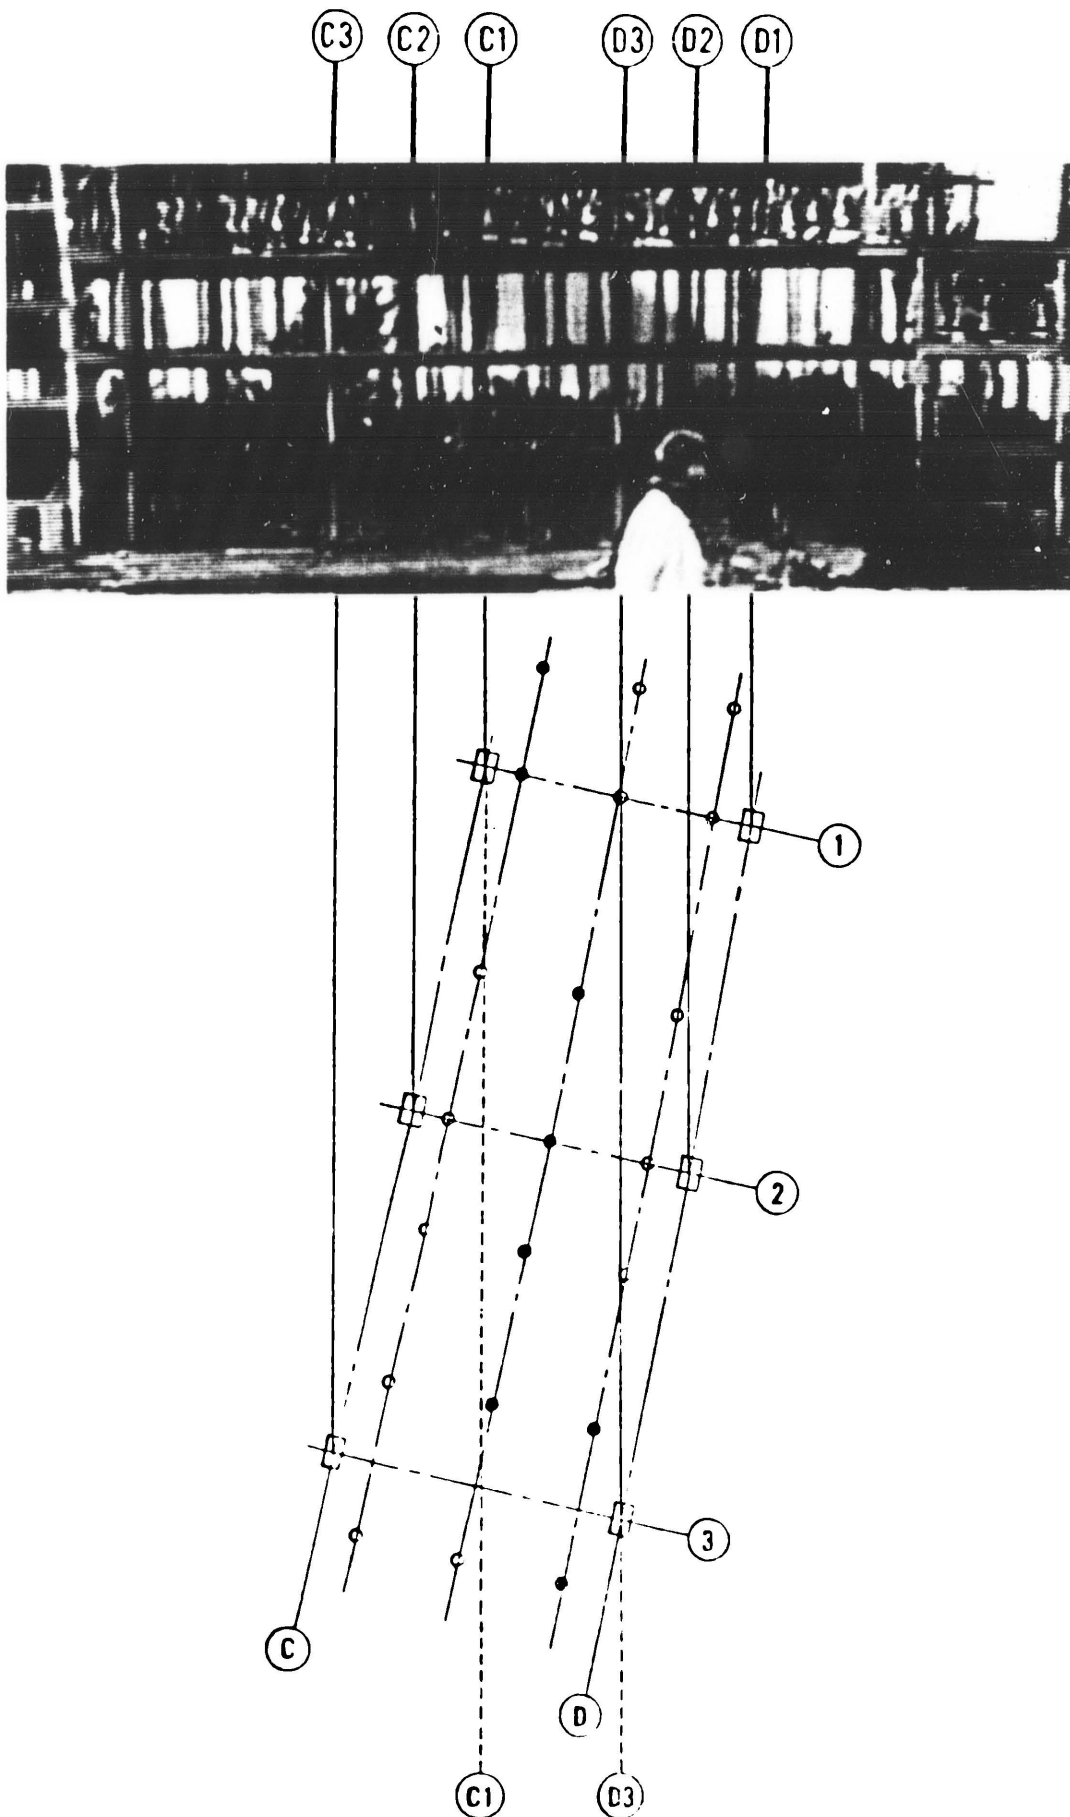
Figure 2.12 Schematics for determining amount of reshores using partial view of east side of building

The weight of the masonry walls on the periphery of the structure plus stacked masonry pallets on the north bay of the fourth floor (bay JK, fig. 2.1) and the south bay of the third floor (fig. 2.12 and bay AB, fig. 2.1) were included in the analysis of the structure. The walls were in place in the first, second and most of the third stories (see figure 2.1 for the location of masonry walls in a completed story). The wall loads for the second and third stories were estimated at 0.3 kips per lineal ft (4.4 kN/m) based on 35 lb (15.9 kg) unit weight for the masonry. The pallet loads were estimated at about 2 kips (9 kN) per end bay (south or north). Both wall loads and pallet loads were converted to equivalent concentrated loads and were placed at the appropriate nodes in the finite element model of the structure.

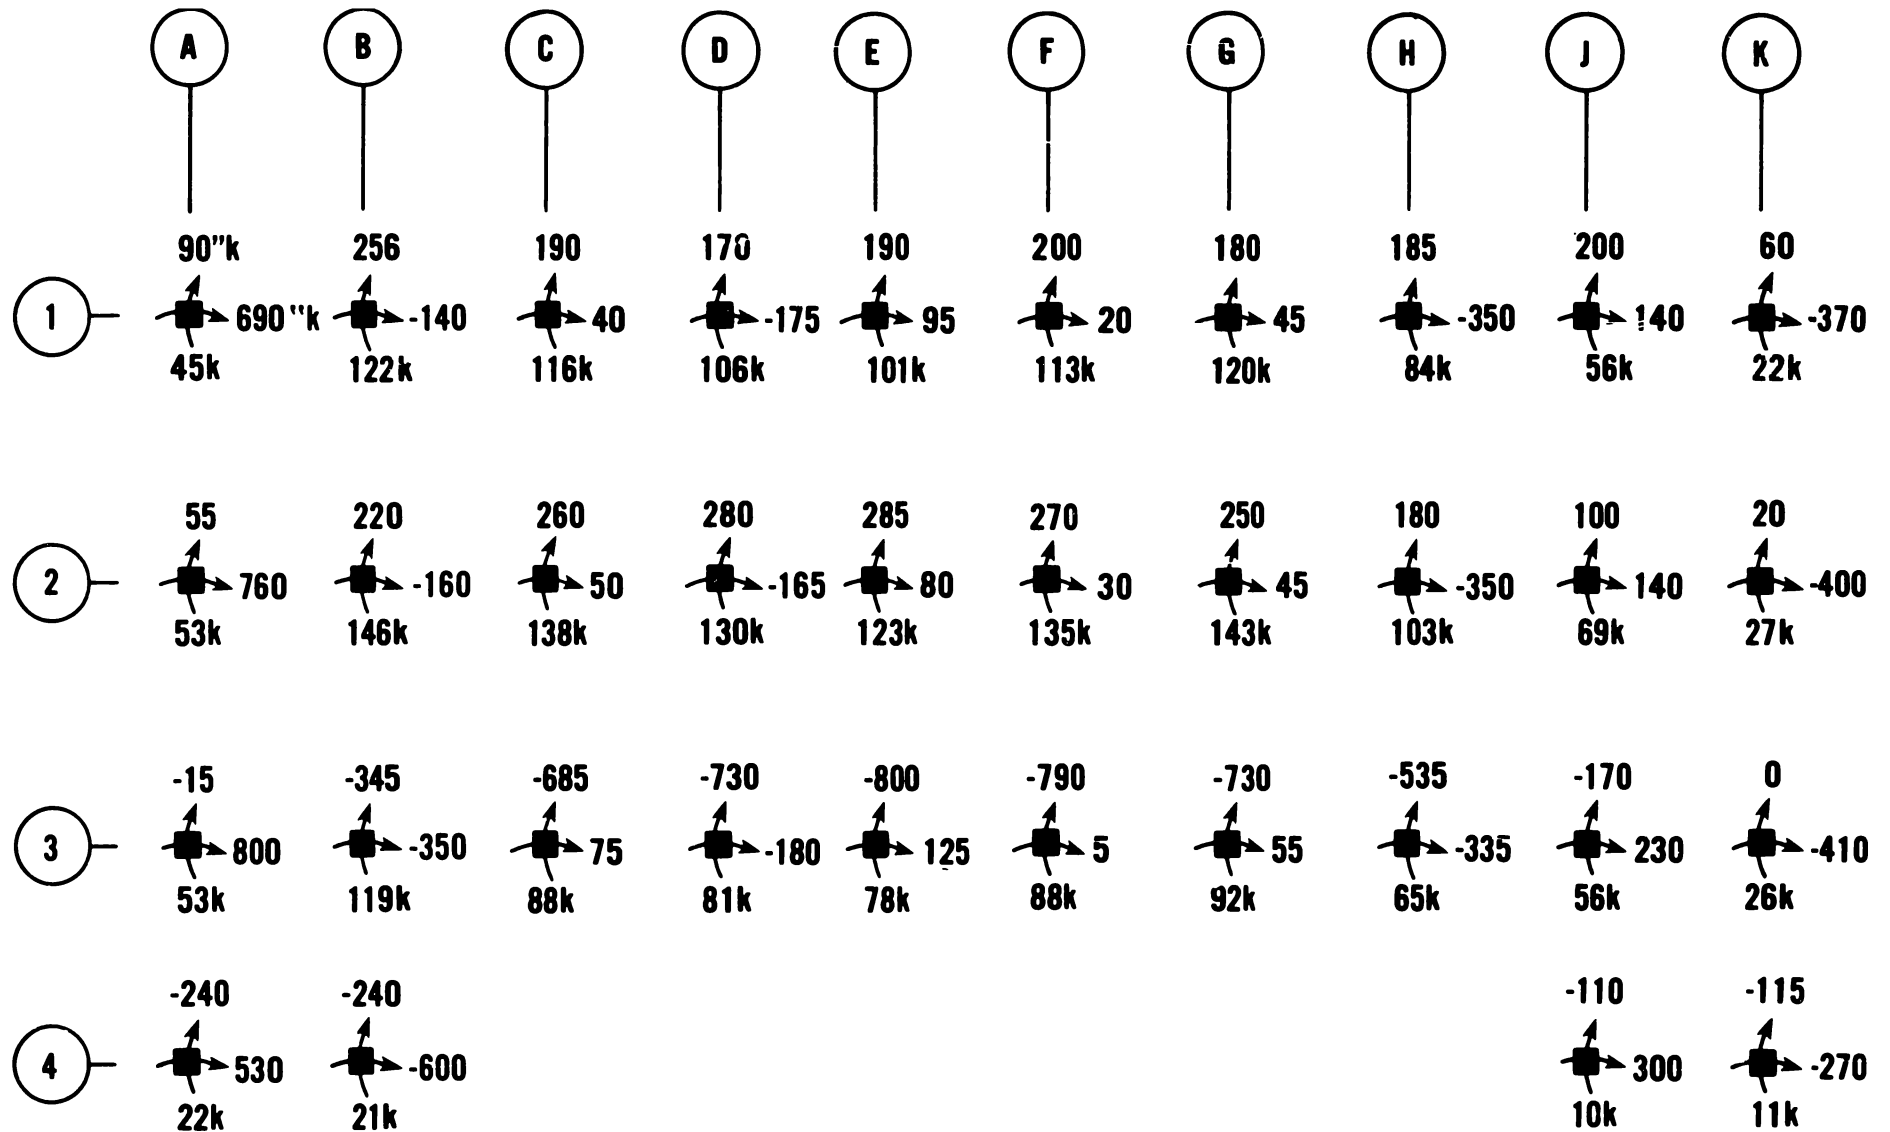
Figure 5.9 Axial loads and bending moments in column from FEM analysis of fifth floor only (without reshores)

The results for the column forces for the FEM model without the reshores are shown in figure 5.9. The largest column force is 146 kips (650 kN) occurring in column B-2. This value compares well with the value of 144 kips (641 kN) for the EFM results summarized in figure 5.5(b). The other column forces also agree reasonably well.

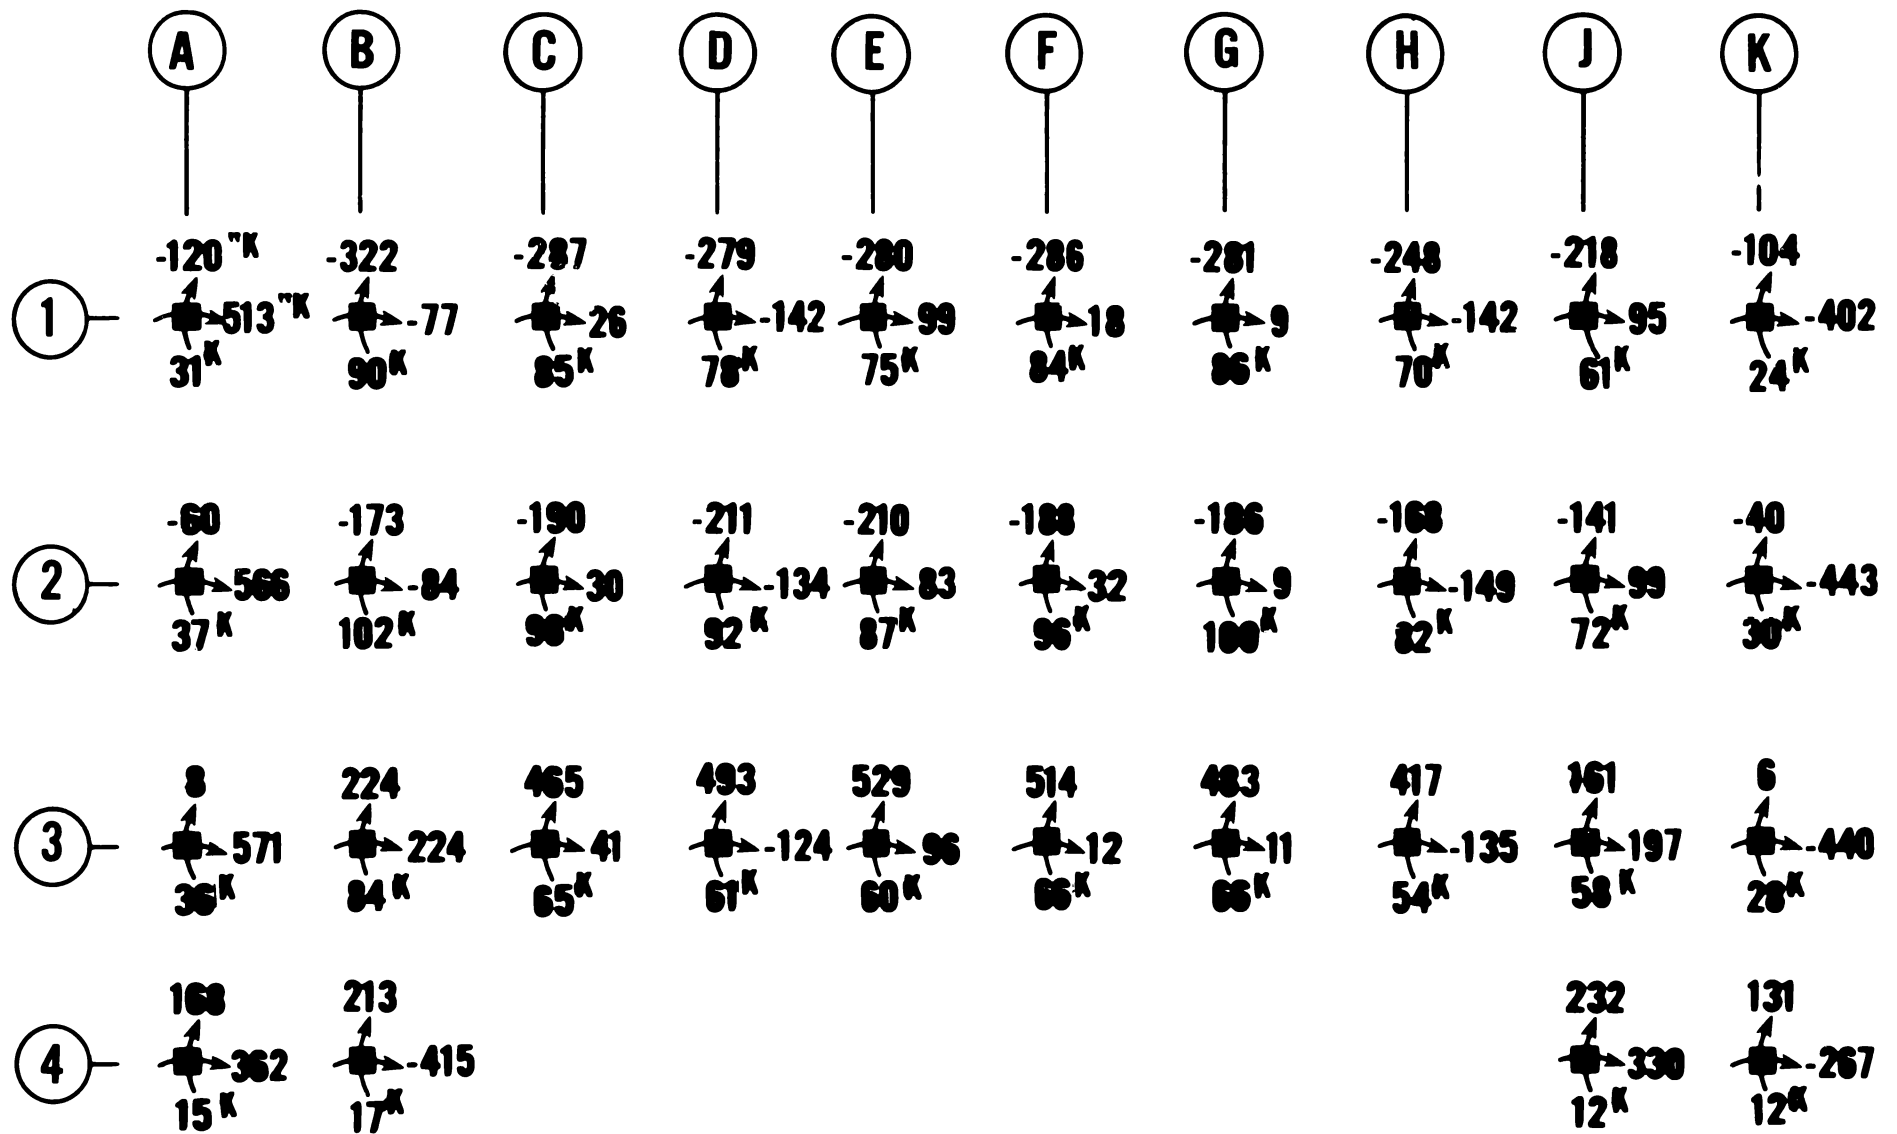
Figure 5.13 Fifth floor punching shear and column moments

- 4) In order to account for the three-dimensional response of the shored structure, the finite element method was used for the final analysis.
- 5) The results of the analysis indicate that the most heavily loaded slab-column connections are in the fifth floor at columns B-2 and G-2.
