NATIONAL ADVISORY COMMITTEE FOR AERONAUTICS

# WARTIME REPORT

FLUTTER TESTS OF B-34 FIN-RUDDER-TAB SYSTEM

By Theodore Theodorsen and N. H. Smith

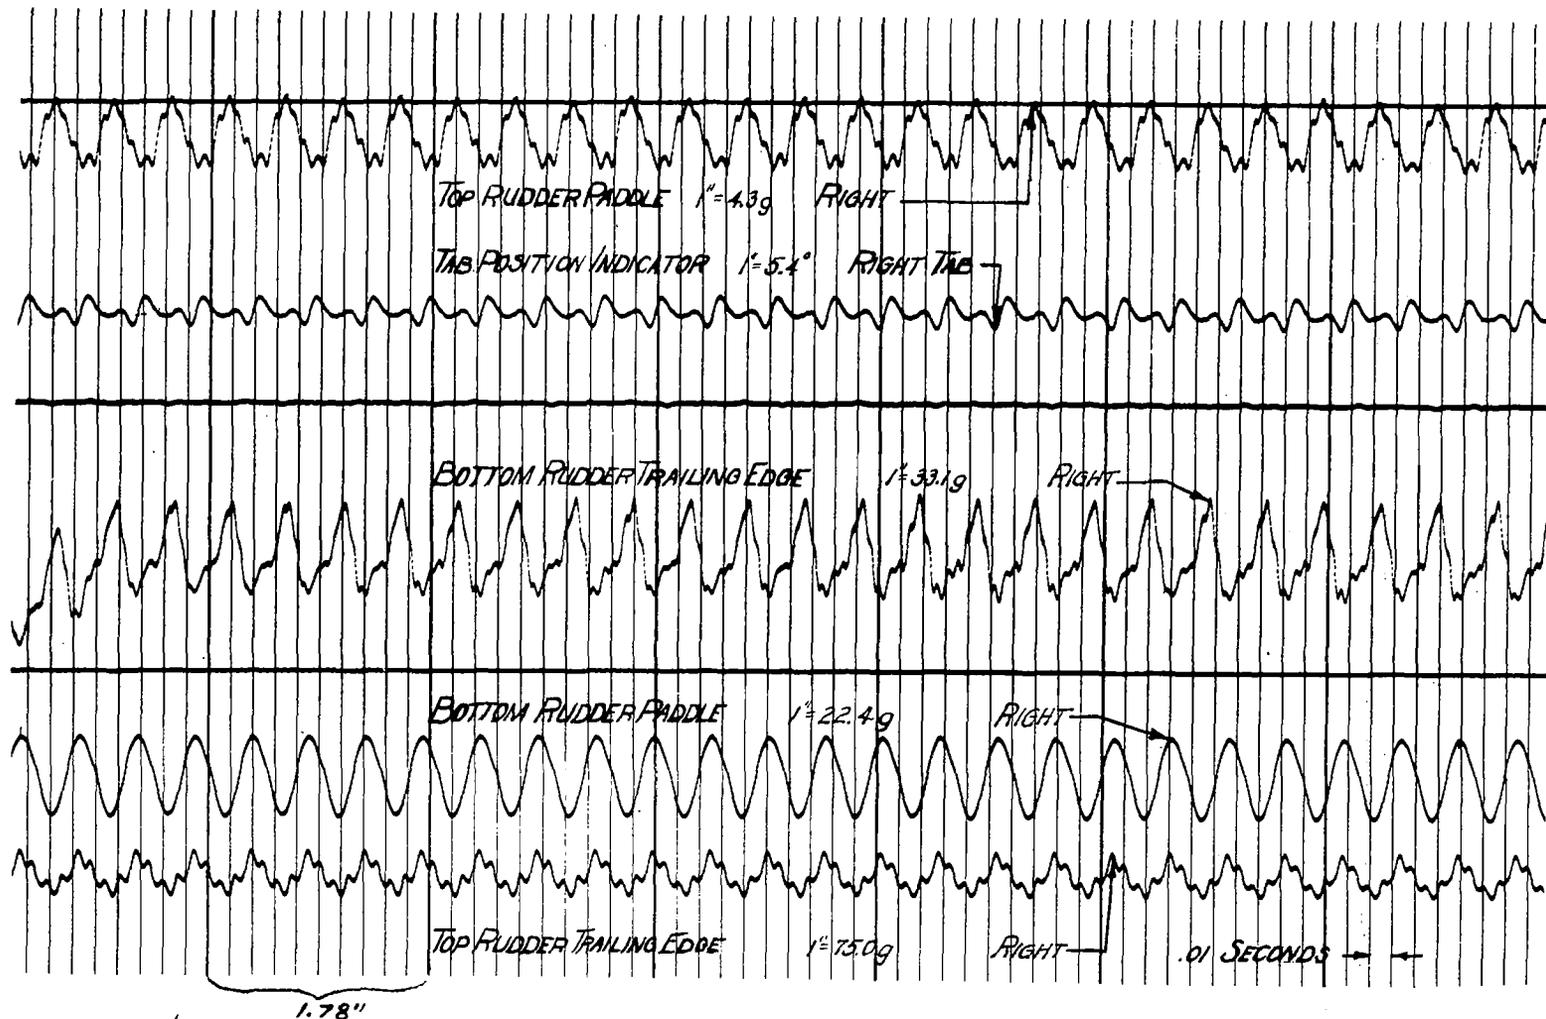
Figure 4.- Oscillograph record with rudder-torsion shaker on lower-rudder trailing edge.

Data from vibration tests at zero airspeed, which were made in the tunnel before each flutter test, are recorded in table I. A typical oscillograph record for rudder torsion is shown in figure 4. In all tests a heavy tab, having a moment of inertia of 0.102 inch-pound-second<sup>2</sup> about its own hinge line, was used.
