U.S. POSTAL SERVICE RADON ASSESSMENT AND MITIGATION PROGRAM PROGRESS REPORT FOR THE PERIOD SEPTEMBER 1993 TO NOVEMBER 1994

December 31, 1994

Prepared by
HAZARDOUS WASTE REMEDIAL ACTIONS PROGRAM
Environmental Restoration and Waste Management Programs
Oak Ridge, Tennessee 37831-7606
managed by
MARTIN MARIETTA ENERGY SYSTEMS, INC.
for the
U.S. DEPARTMENT OF ENERGY
under contract DE-AC05-84OR21400

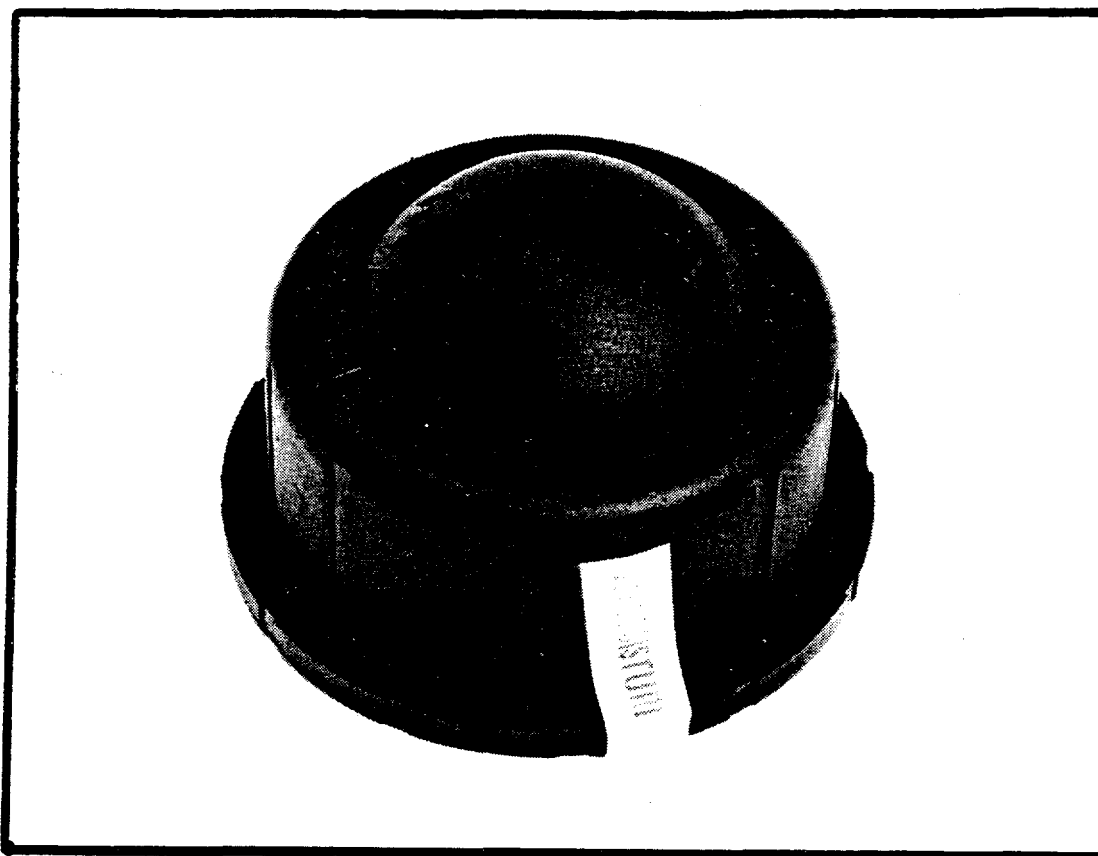
During the 1992-1993 USPS protocol evaluation study, USPS selected the model L-LT E-Perm manufactured by Radelec® (Fig. 1). Overall, the performance of the detector was good. However, the following problems were identified during the study that could have potentially complicated a nationwide radon survey.

Fig. 1. The model L-LT E-Perm detector was used during the 1992-1993 U.S. Postal Service protocol evaluation study.

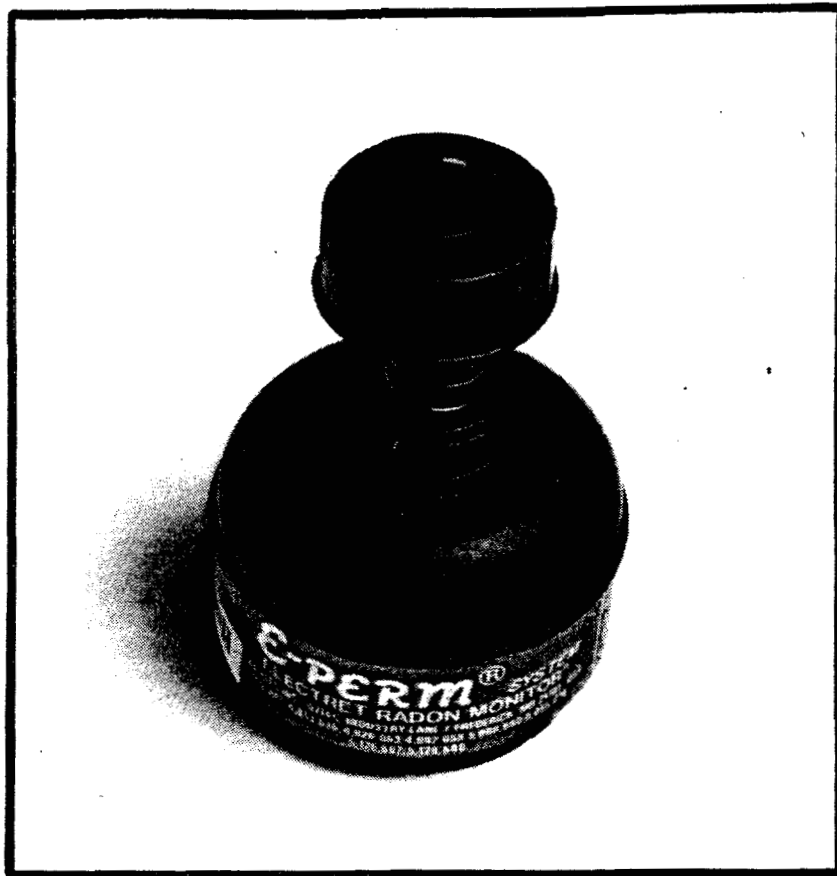
Based on the findings of the evaluation program, USPS requested that HAZWRAP evaluate the model S ion chamber (Fig. 2) for suitability during the pilot program. The advantages of using the S ion chamber are as follows:

Fig. 2. The Hazardous Waste Remedial Actions Program evaluated the model S ion chamber for suitability during the pilot program.

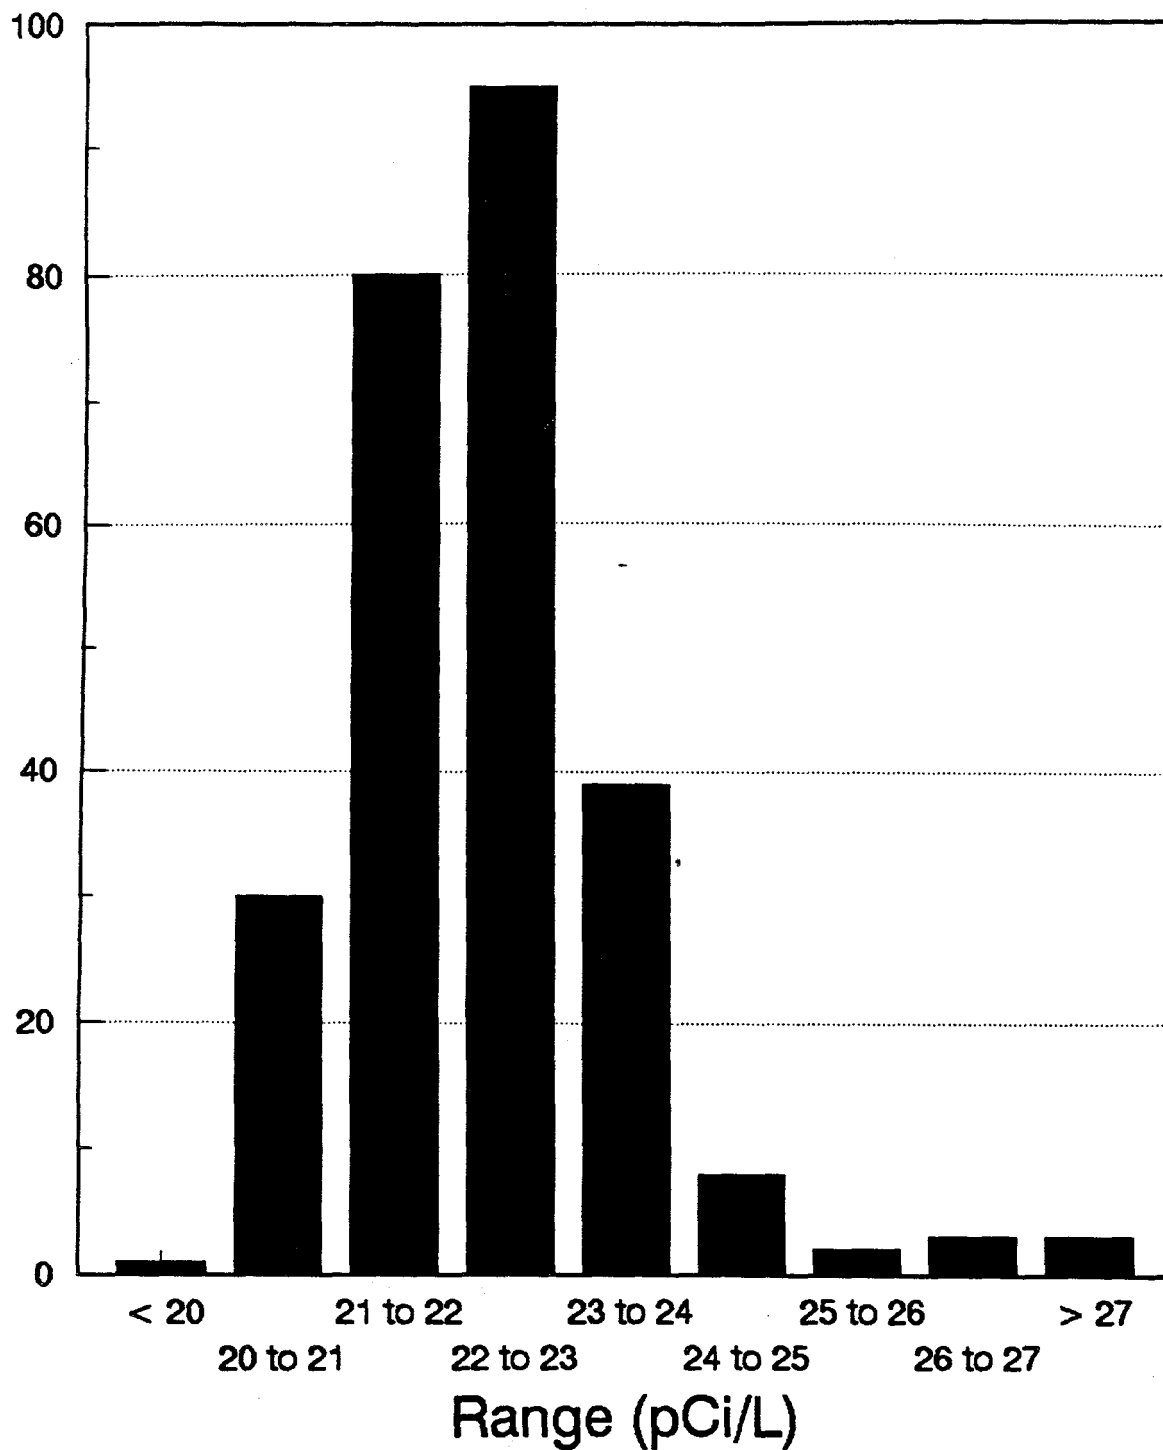
To verify detector calibration for the pilot program, 490 detector spikes (detectors exposed to a known concentration of radon) were performed at two concentrations within the ORNL Radon Calibration Facility. The first exposure was to verify the Radelec®-supplied voltage discharge curve. A total of 261 E-Perm detectors were exposed to a continuous concentration of radon (20.8 pCi/L) for 79 days. Temperature and humidity were maintained at 23°C and 50% RH for the duration of the study. The average concentration measured by the E-Perm detector was 22.3 pCi/L, with a range of 19.6 to 27.7 pCi/L and a standard deviation of 1.2 pCi/L. Figure 3 illustrates the range of the Round 1 results for the E-Perm chamber exposure.

Chamber mean concentration = 20.8 pCi/L
Detector mean concentration = 22.3 pCi/L

Fig. 3. E-Perm calibration distribution for Round 1.

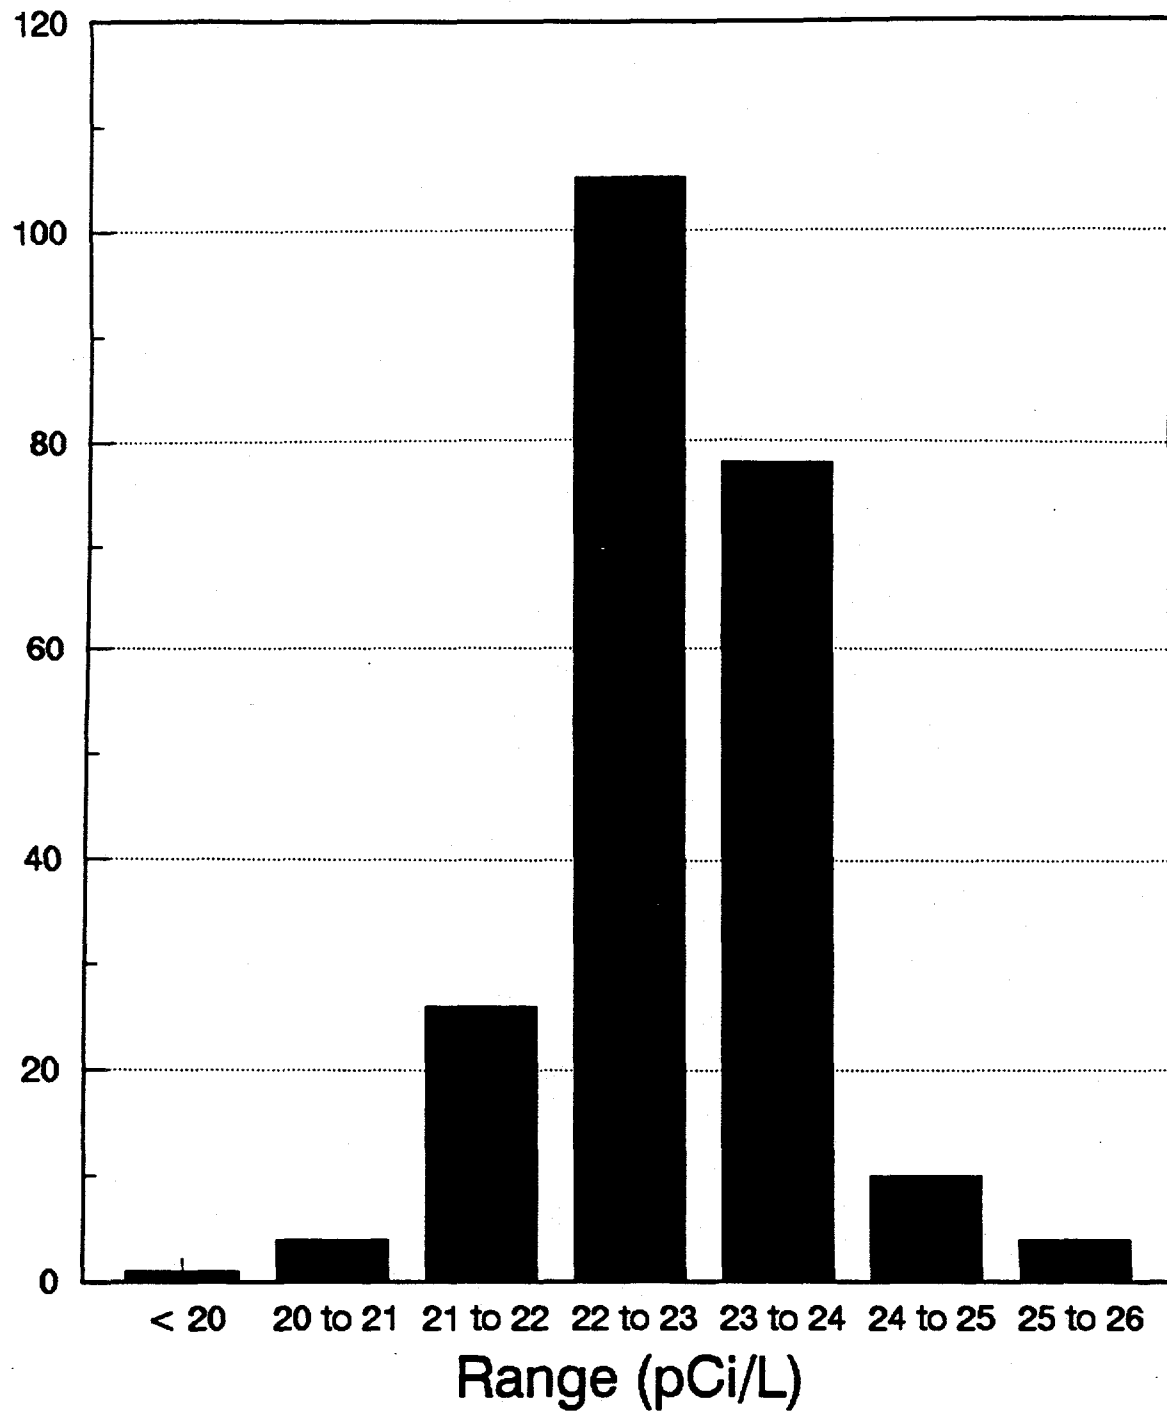
The purpose of the second exposure was to determine the accuracy of electrets below the recommended 200-V threshold. In a large survey, a significant number of the detectors will be returned from the field under low voltage conditions. Determining the exact voltage limitations of the detectors will enable USPS to set minimum voltage requirements for electret reuse. Past studies conducted by ORNL have shown that the electret has a high error rate for final voltages below 20 V. However, some marginal success was observed for electrets in the range of 40 to 60 V. To perform this experiment, a total of 229 E-Perm detectors with an average of 348 V were exposed to a continuous concentration of radon (20.8 pCi/L) for 91 days. As before, the temperature and humidity were maintained at 23°C and 50% RH for the duration of the study. The detectors were removed after the average charge of the detectors had dropped to 44 V. The average concentration measured by the E-Perm detectors was 22.8 pCi/L, with a range of 19.5 to 26.0 pCi/L and a standard deviation of 0.9. Figure 4 illustrates the range of E-Perm results for the chamber exposure.

Chamber mean concentration = 20.8 pCi/L
Detector mean concentration = 22.8 pCi/L

Fig. 4. Low-voltage E-Perm distribution for Round 2.

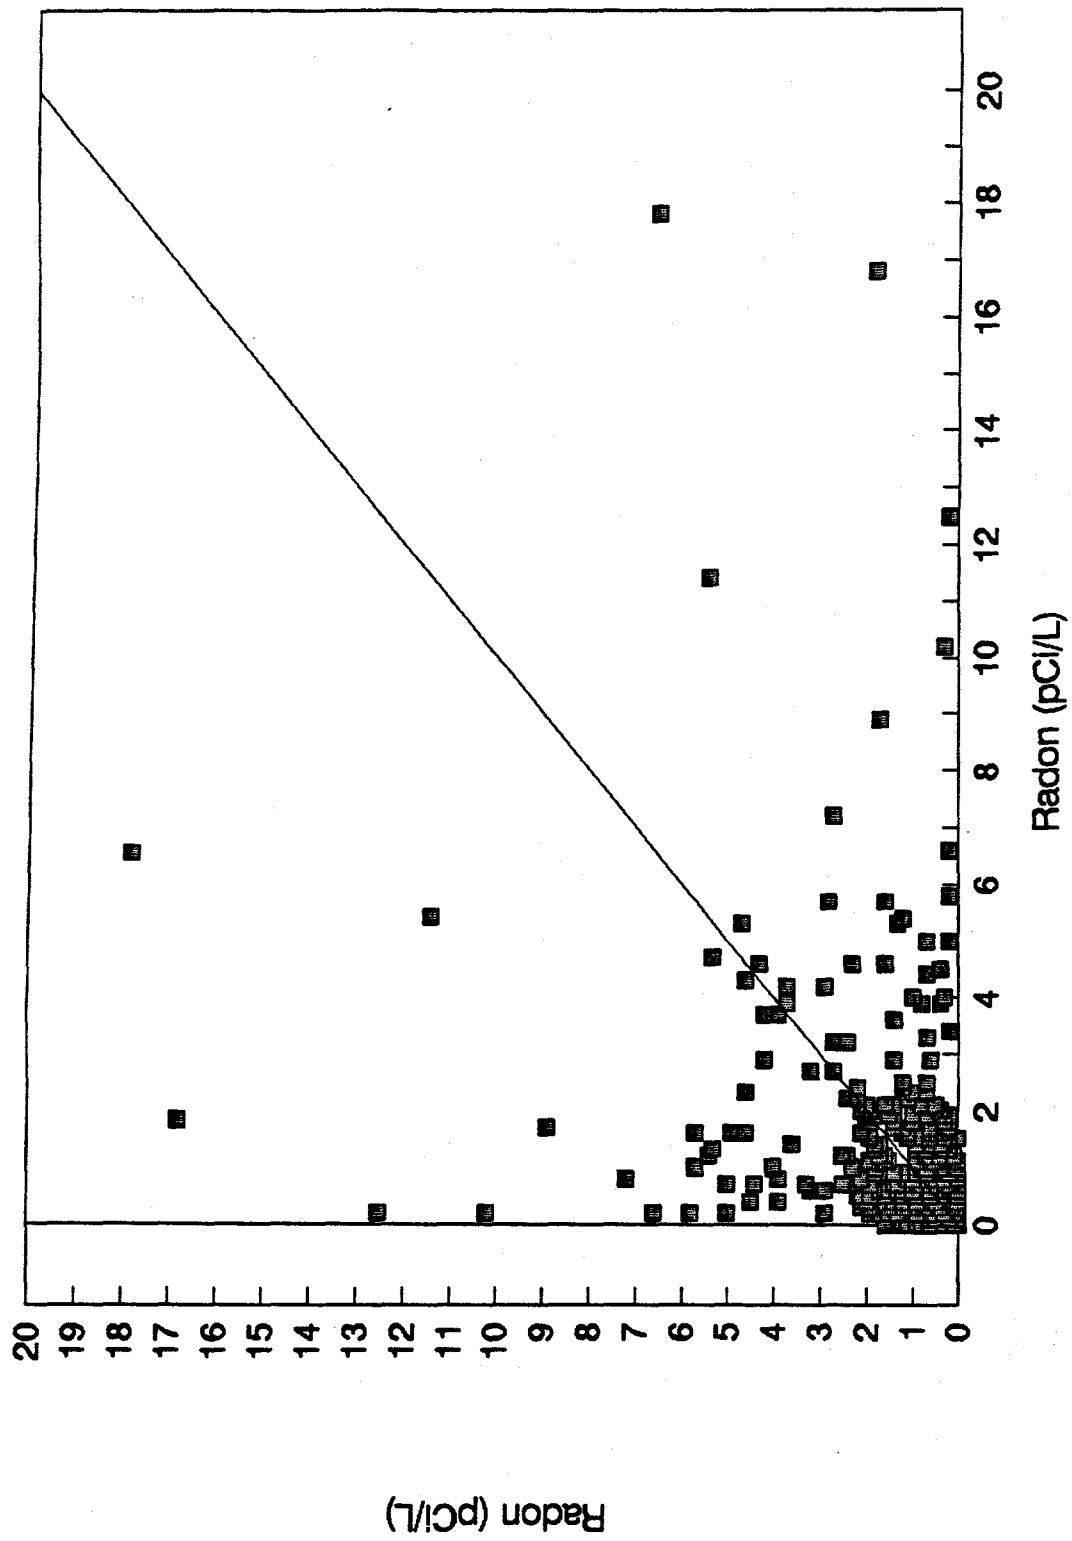
At each site, detectors were collocated to measure field precision. A key criterion for duplicate detectors was that they be located in an area or room where the likelihood of tampering would be slight. Unfortunately, well-meaning USPS personnel relocated or returned a total of 165 duplicate detectors, believing they were placed together in error or were forgotten. Therefore, the exact number of successful duplicate measurements per site varied. During the pilot program, 563 duplicate measurements were performed. The overall field variance was estimated to be 10%. Figure 5 illustrates the duplicate measurements.

Fig. 5. Duplicate radon measurements.

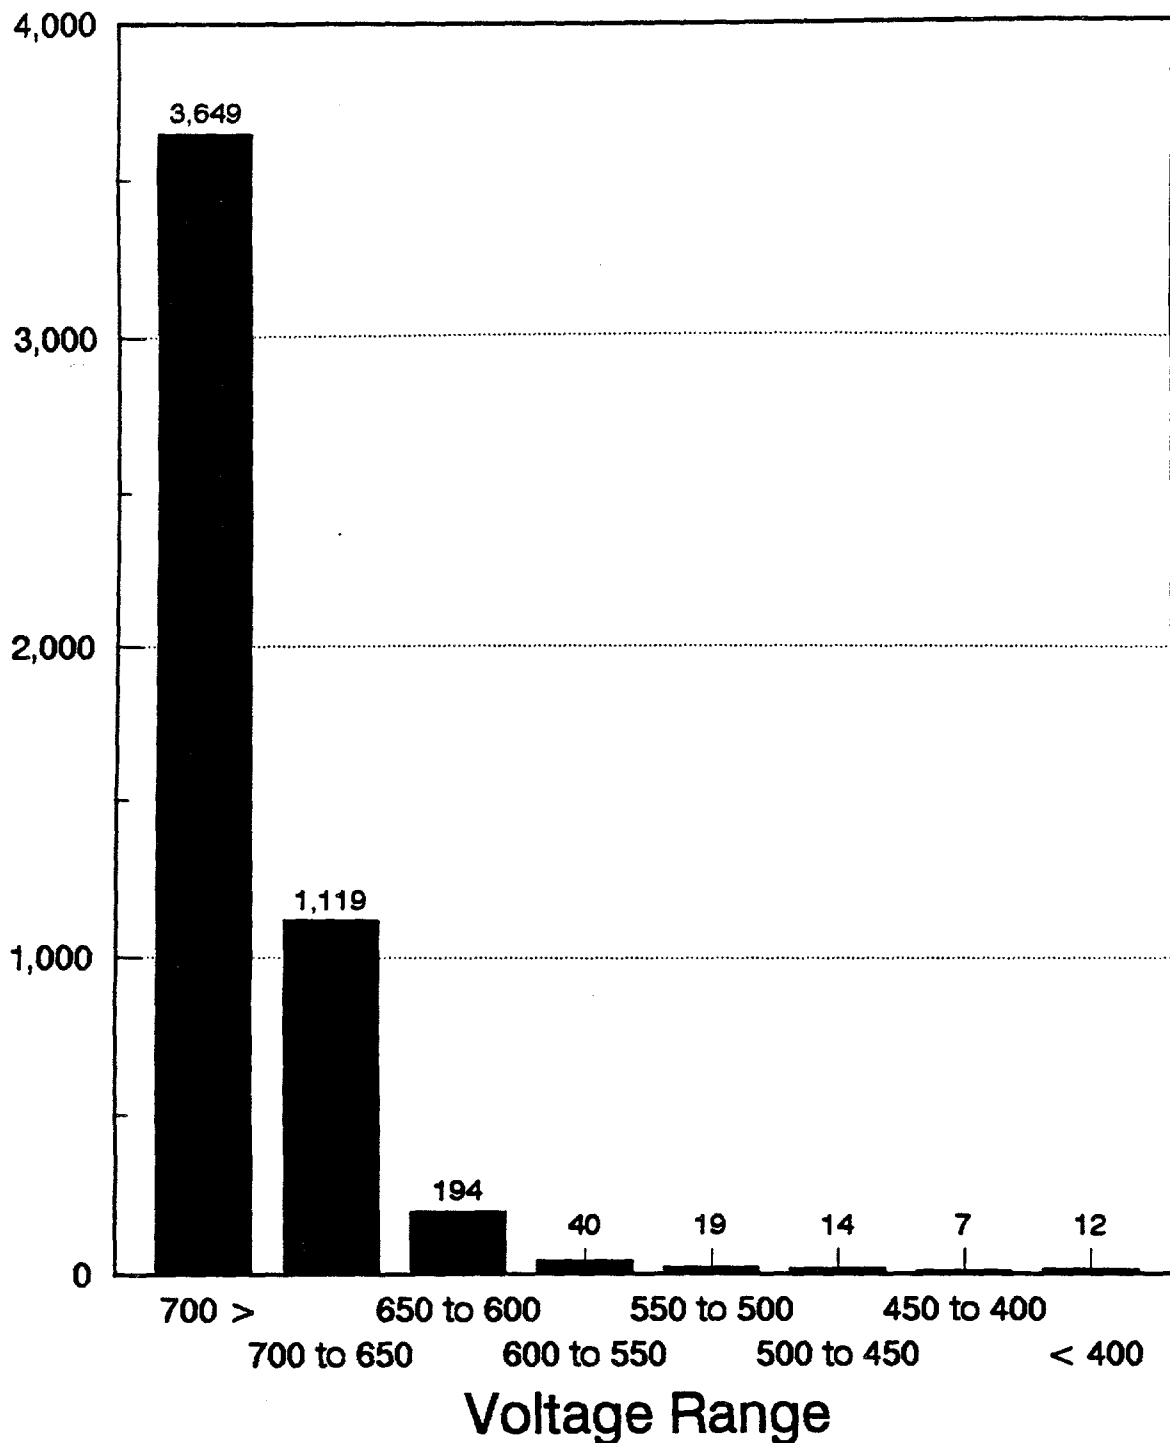
Based on 5,054 electrets

Fig. 6. Status of electret voltage.

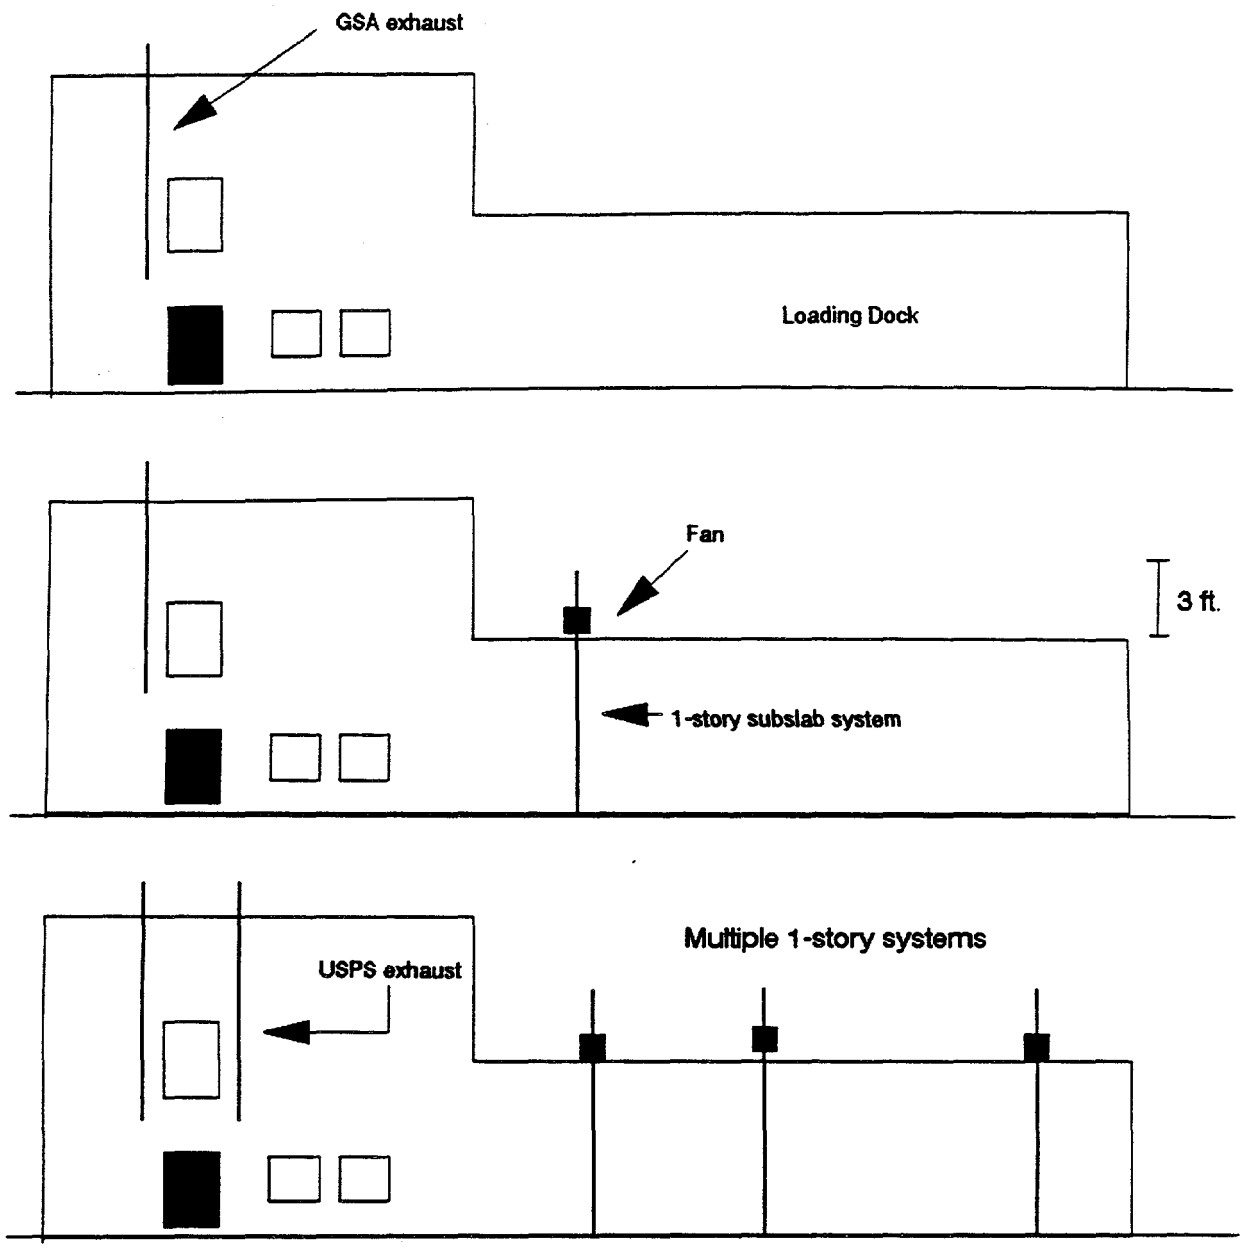
Fig. 13. Exterior of the U.S. Post Office in Talladega, Alabama.

Based on the data collected by the mitigation diagnostic team, the only practical mitigation option is SSD, specifically an LPHF system. To perform this mitigation, the existing GSA SSD system will first have to be removed and a new LPHF system installed in its place. For the new mitigation system, all pipe will need to be 4-in., SCH 40 PVC, and all fans will need to have at least 2.5-in. WC at 400 ft³/min. Each suction pit will need to be open style, excavated to bare soil (1 ft × 1 ft × 4.5 in.) For the office wing, a total of three SSD systems will be required. With respect to pipe runs, vertical penetration is not possible in the two-story office wing. However, two of the pipes can be run above the suspended ceiling in the hallway to exit the building above the back door. The other office wing pipe run could exit between the junction of the elevator lobby and the office wing (Fig. 12). For the postal part of the building, vertical penetration is possible and is highly recommended. The proposed system consists of nine vertical penetrations with a fan/pipe (Fig. 12). For all pit locations depicted, the option exists for movement within a 6-ft-diam circle to accommodate room functionality and existing obstructions. Networking pipes on the USPS side is not recommended because the cost of connecting the suction pits and the resulting larger fan would more than offset the expense of a single fan. Figure 13 illustrates the exterior view of the mitigation system. The cost for the proposed mitigation system is summarized in Table 113.
