NUREG/CR-6365
INEL-95/0383

Steam Generator Tube Failures

Prepared by
P. E. MacDonald, V. N. Shah, L. W. Ward, P. G. Ellison

A review and summary of the available information on steam generator tubing failures and the impact of these failures on plant safety is presented. The following topics are covered: pressurized water reactor (PWR), Canadian deuterium uranium (CANDU) reactor, and Russian water moderated, water cooled energy reactor (VVER) steam generator degradation, PWR steam generator tube ruptures, the thermal-hydraulic response of a PWR plant with a faulted steam generator, the risk significance of steam generator tube rupture accidents, tubing inspection requirements and fitness-for-service criteria in various countries, and defect detection reliability and sizing accuracy.

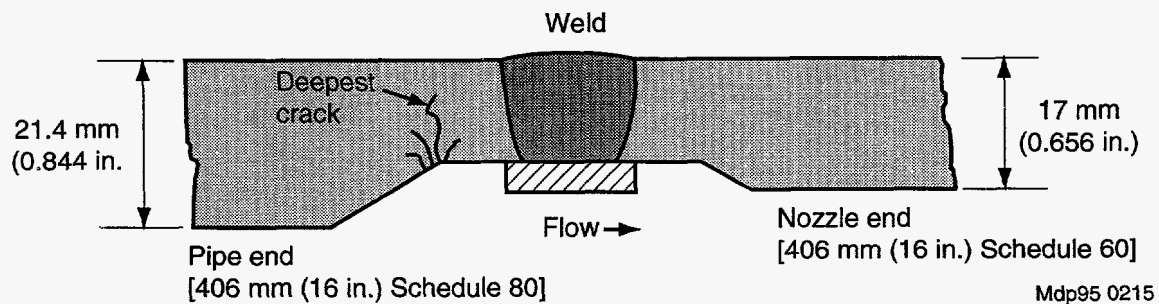
Figure 16b. Westinghouse feedwater piping-to-nozzle weld design at the D.C. Cook plant with crack locations identified (USNRC 1980)..

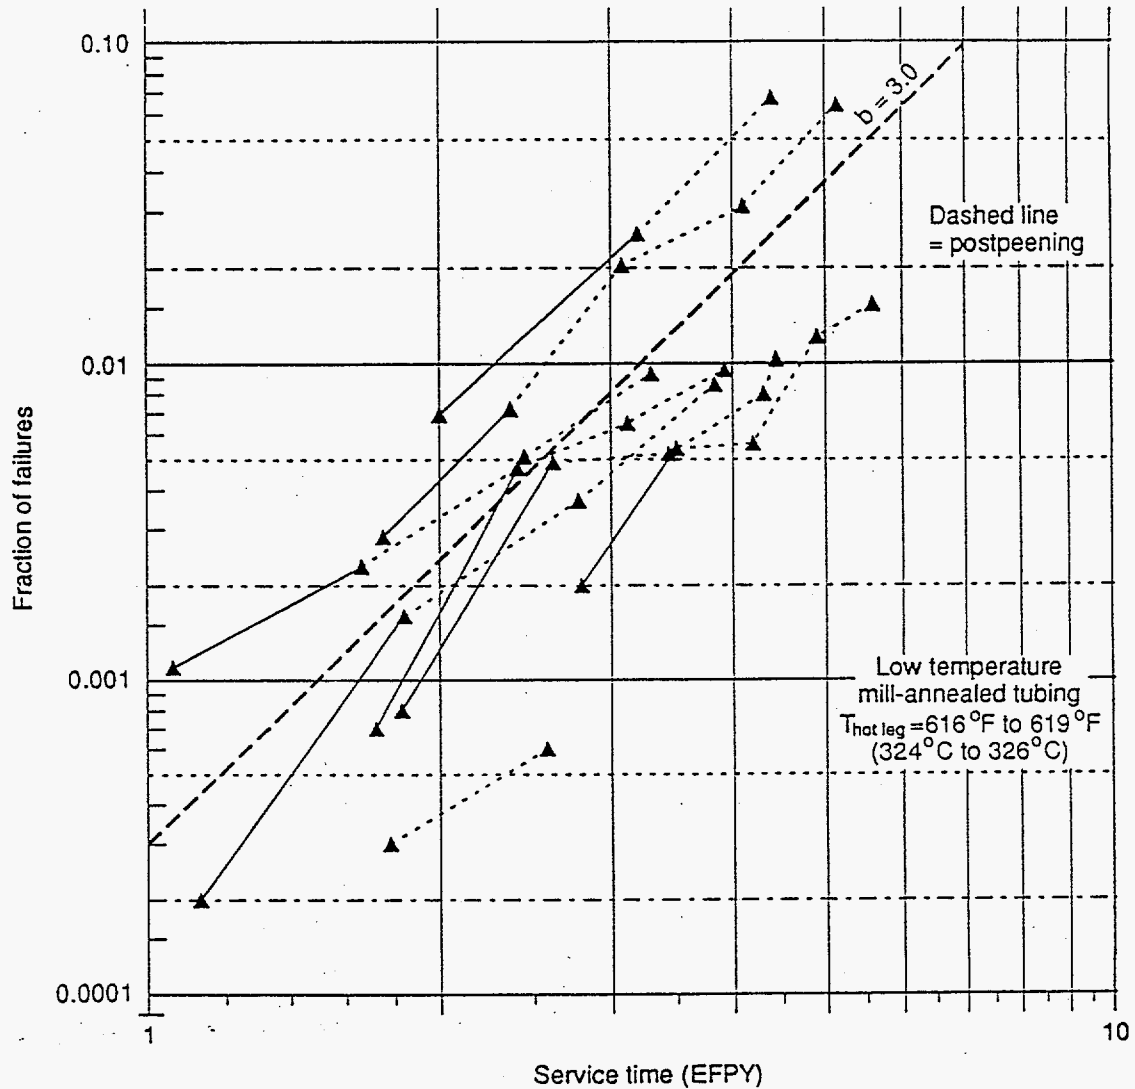
Figure 26 represents the application of the Weibull model for an assessment of PWSCC damage to the hot-leg transition region of recirculating steam generator tubes. Tube inspection data from several plants for PWSCC failure in the hot-leg transition and rolled portion of the tube near the top of the tubesheet have been compiled and plotted using a Weibull distribution. These plants use similar detection technologies and have similar low-temperature mill-annealed tubing material and primary water chemistry. Therefore all the tubes in all the plants are within the same PWSCC population. All the tubes are included in the analysis. The plots illustrate the scatter expected in plant inspection data for PWSCC degradation. The data for each plant lie approximately on a straight line, except where perturbed by application of peening as a remedial measure. Even though the intercepts and the slopes (Weibull exponents b) for each plot vary, the slopes scatter around the bold dashed line drawn for a Weibull exponent of 3.0. Therefore an exponent of 3.0 can be used to make short extrapolations to predict the future rate of degradation at a plant where insufficient data are available to establish a plant-specific slope. However, when looking at a Weibull plot of steam generator tubing failure data (or eddy-current indications of defects) over a longer period of time, the slope tends to taper off and the rate of cracking is over predicted when a slope of 3 is used. This has led some plant operators to use log-normal statistics for projections.

Figure 26. Weibull analysis of data for PWSCC at hot leg roll transitions and rolled area below the top of the tubesheet for plants with full depth rolls. Courtesy of A.P.L. Turner, Dominion Engineering.

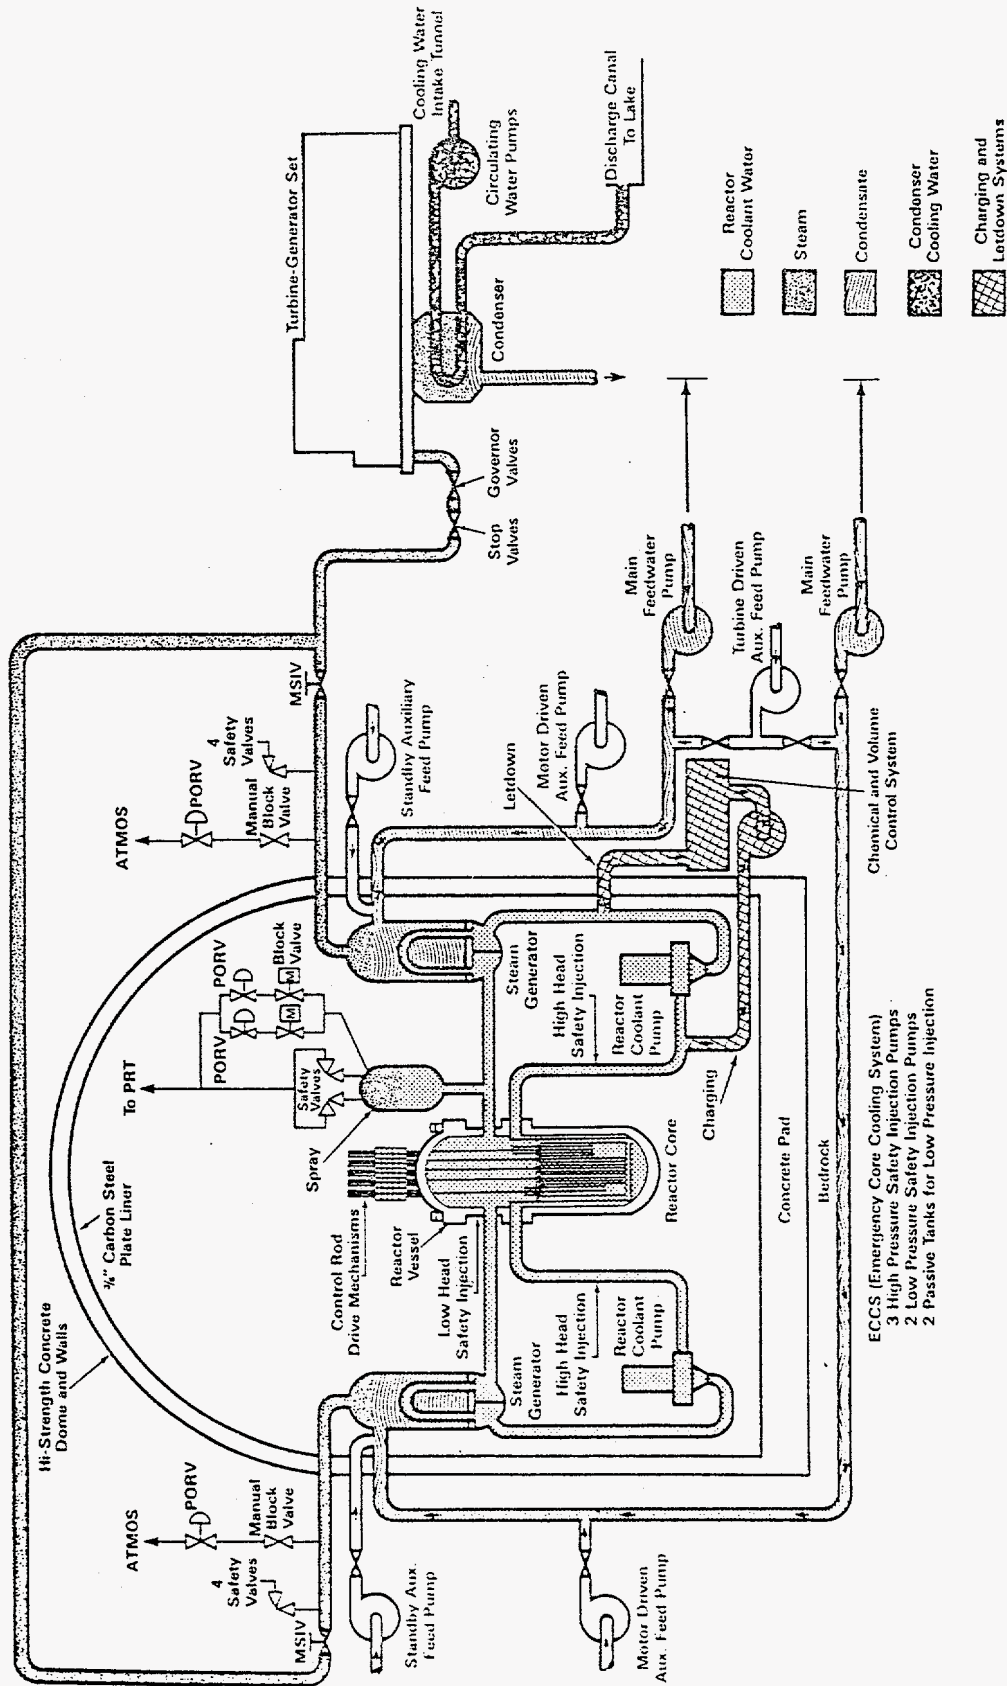
The Ginna rupture occurred while the plant was operating at full power. A schematic diagram of the Ginna plant is shown in Figure 30 (USNRC 1982c). The air ejector radiation monitor, the pressurizer level and pressure alarms, and the B steam generator level and steam/feed flow mismatch alarms indicated to the operators the existence of a large leak in the B steam generator (at 9:25 am). The operators began a power reduction at 1.5 minutes along with an increase in the number and speed of the operating charging pumps (the third charging pump was started at 2.5 minutes). Also at 2 minutes, the eight main steam dump valves opened automatically in response to a valid error signal from the reactor coolant system temperature and four valves closed automatically at 3 minutes. At 3 minutes there was an automatic reactor scram (at 12.91 MPa or 1,873 psig) and actuation of all three safety injection pumps (at 11.88 MPa or 1,723 psig) on low primary system pressure. This was followed by automatic containment isolation, main turbine trip (on reactor trip), automatic start of the auxiliary feed pumps, main feedwater isolation and trip of the charging pumps. At 4 minutes, both reactor coolant pumps were manually tripped as required, the pressurizer was almost empty, and the steam supply valves to the turbine-driven auxiliary feedwater pump opened automatically because of low water levels in the steam generators. At 5 minutes, the remaining four main steam dump valves closed automatically and the initial reactor coolant system depressurization stopped at about 8.27 MPa (1,200 psig), apparently due to the establishment of saturation conditions in the reactor vessel upper head along with the effects

Figure 30. Schematic diagram of Westinghouse-designed pressurized water reactor of Rochester Gas and Electric Corporation's Gimna Nuclear Power Plant (USNRC 1982c).

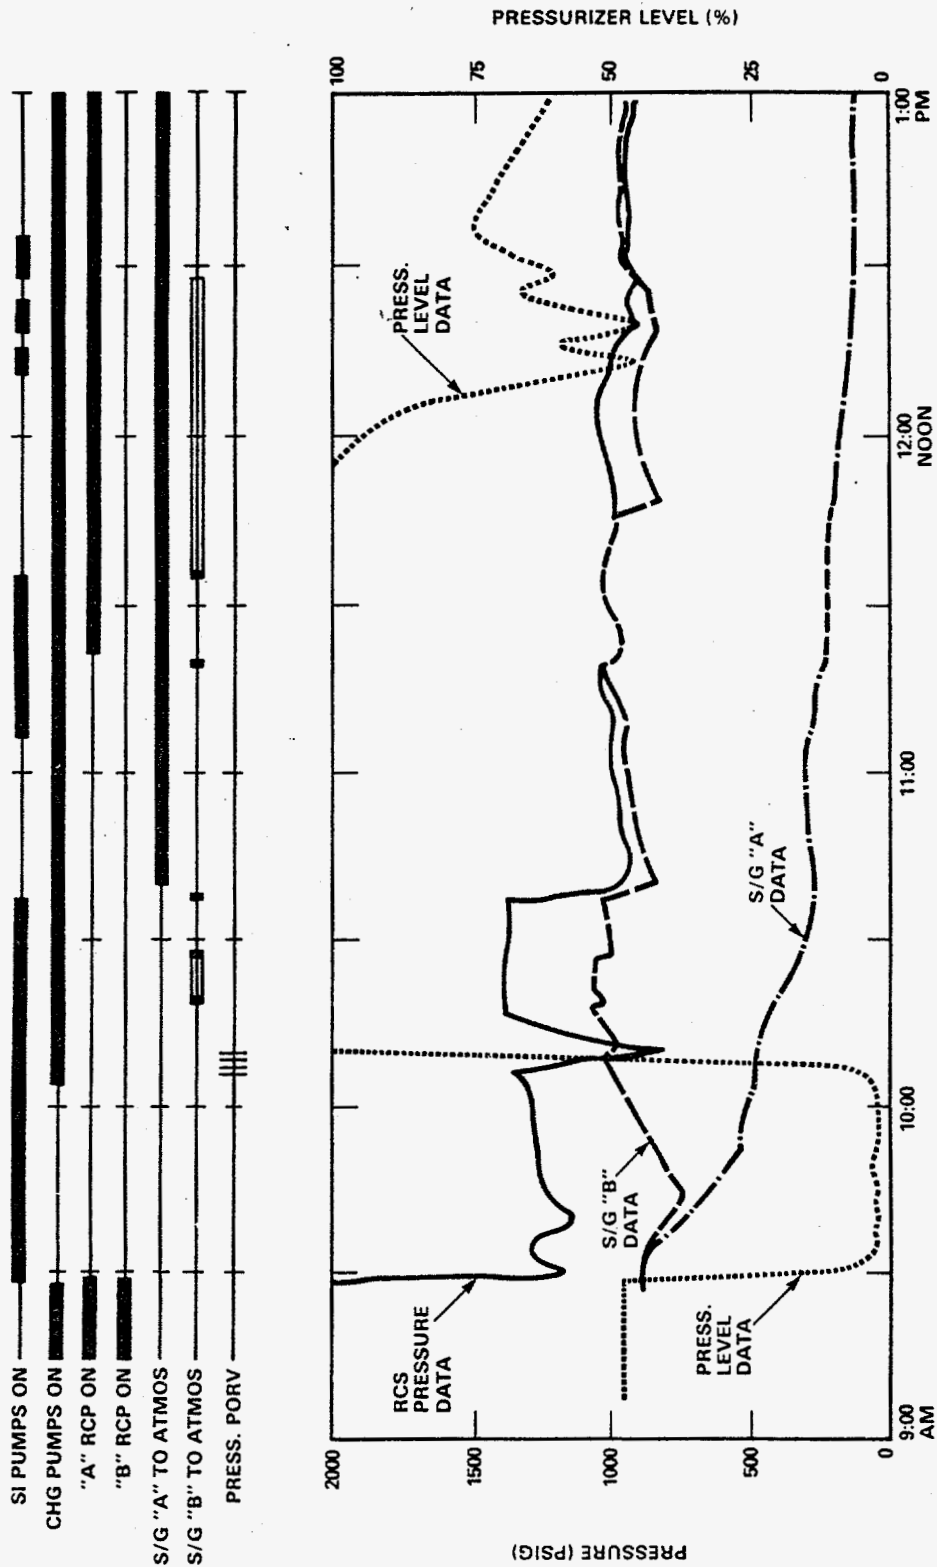
of the safety injection. A steam bubble probably formed in the upper head at this time. Plots of the reactor coolant system pressure, the pressurizer level, and the steam generator secondary side pressures are presented in Figure 31 along with the times when (a) the safety injection (SI), charging, and reactor coolant pumps (RCPs) were on; (b) the steam generators were dumping steam to atmosphere; and (c) the pressurizer power operated relief valve (PORV) was open.

Figure 31. Ginna reactor coolant and steam generator parameters as a function of time, January 25, 1982 (USNRC 1982c). The transient started at 9:25am.

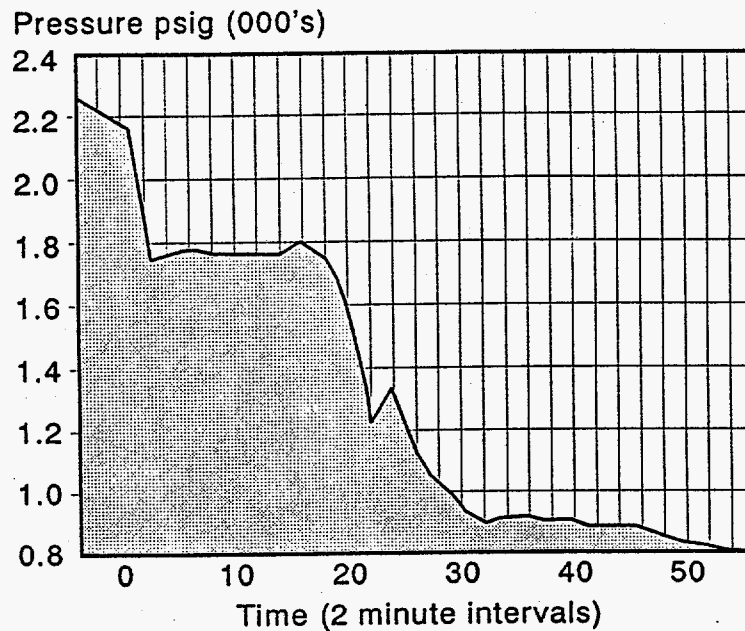
Figure 32. North Anna Unit 1 reactor coolant system pressure versus time during the first 58 minutes of the transient (Bowling 1987). The transient started at 6:30am.

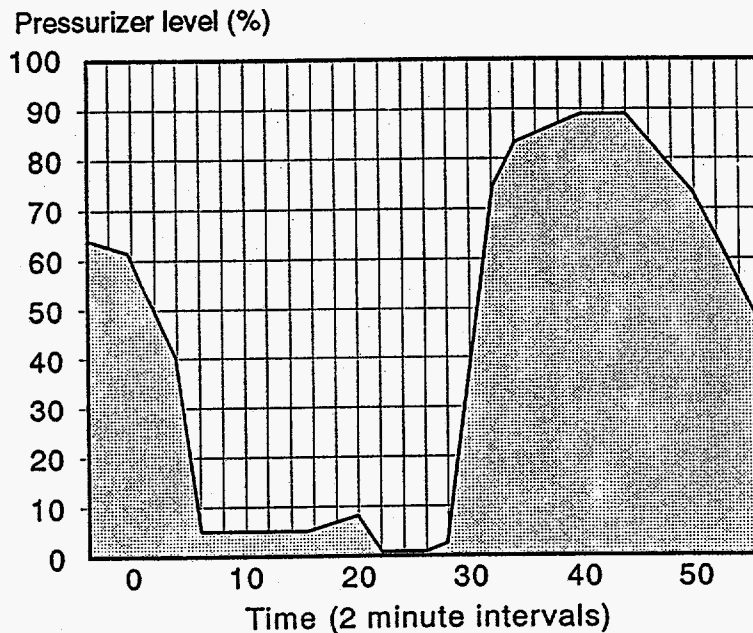
Figure 33. North Anna Unit 1 pressurizer level versus time during the first 58 minutes of the transient (Bowling 1987). The transient started at 6:30am.

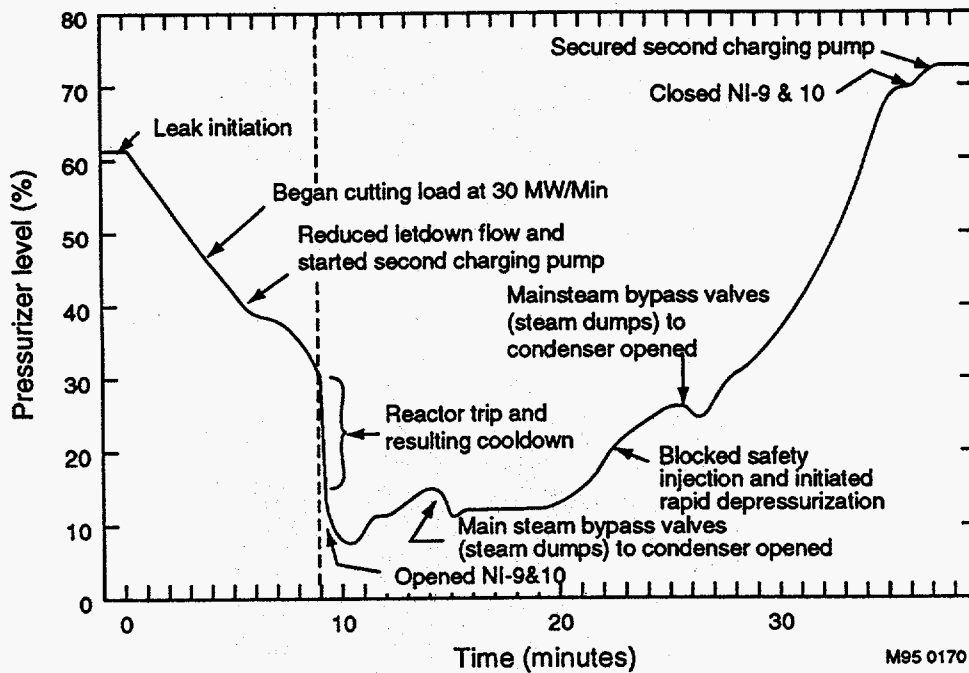
Figure 36. Pressurizer level during the first 39 minutes of the McGuire unit 1 steam generator tube rupture event of March 7 and 8, 1989 (Sipe 1989). The rupture occurred at 11:38pm.

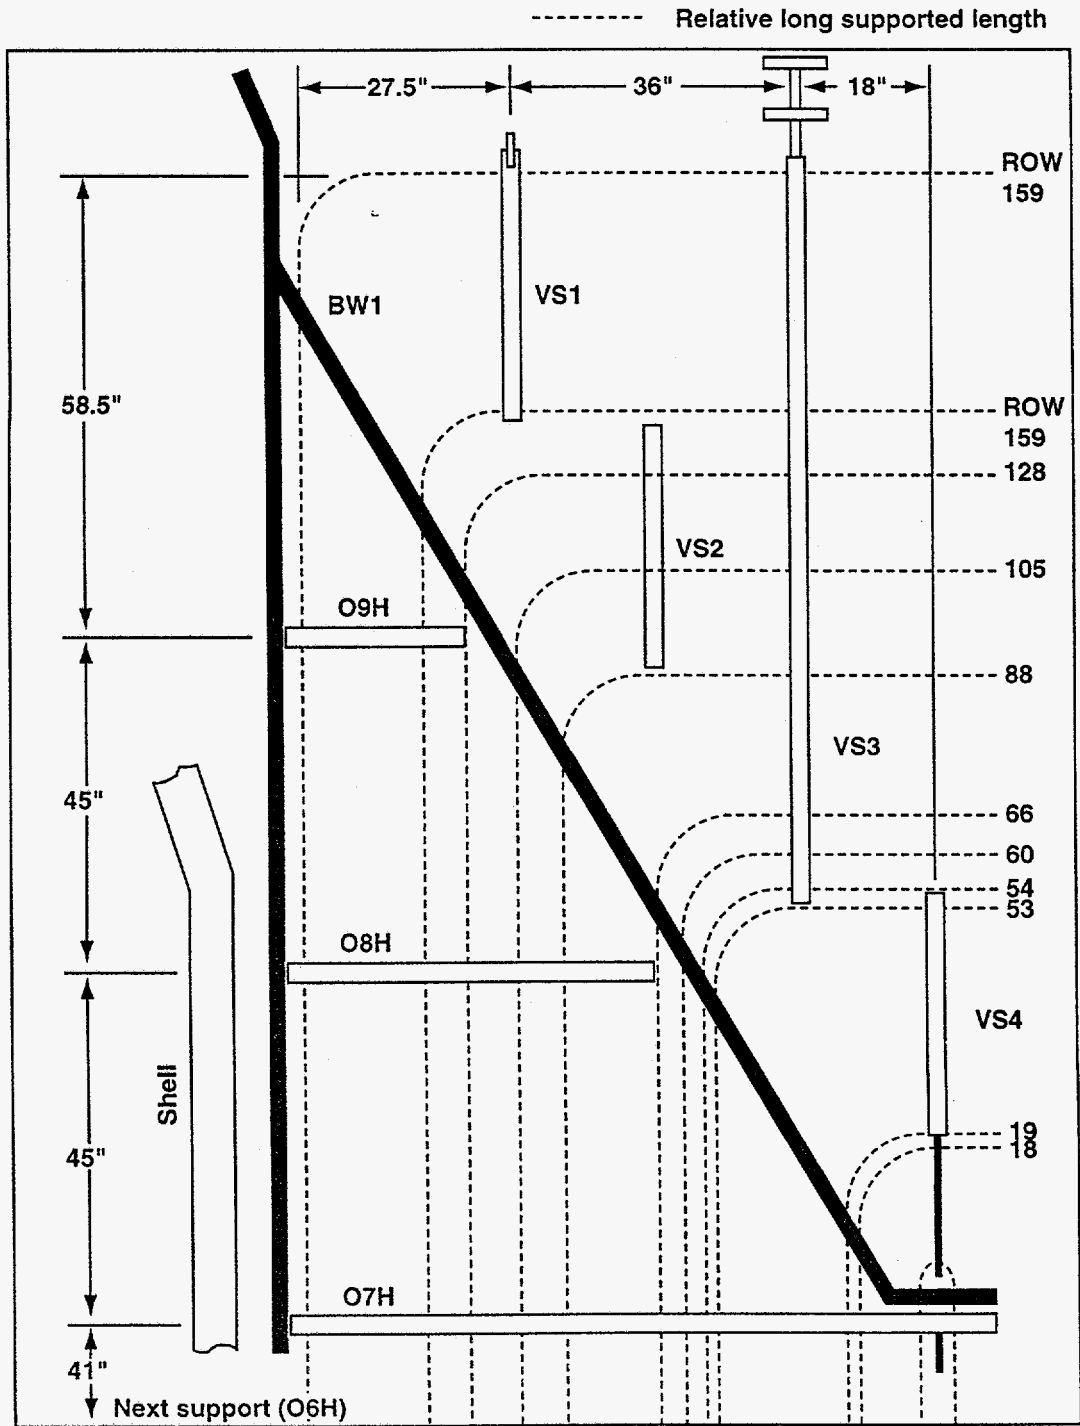
The Palo Verde rupture was caused by ODSCC which occurred, in part, as a result of tube-to-tube crevice formation in a free span region of a Combustion Engineering System 80 RSG. The rupture occurred on the hot leg side of the tube bundle between the 08H and 09H horizontal, partial eggcrate tube support structures. The rupture tube was located at Row 117, Column 144. A sketch of the Combustion Engineering System 80 upper tube bundle geometry on the hot leg side is shown in Figure 38. A cross section of the tube bundle in the region of the ruptured tube, with defects identified, is shown in Figure 39. The stress corrosion crack was oriented in the axial direction, about 250 mm (10 in.) long, and started about 760 mm (30 in.) above the center of the 08H eggcrate tube support structure (the top of the crack was about 130 mm (5 in.) below the 09H eggcrate). The rupture was about a 65 mm (2.5 in.) long "fishmouth" type opening.

Post-accident investigation of the Palo Verde rupture concluded that the key contributing factors were: free span crevice formation, a caustic-sulfate secondary side water chemistry, a

Figure 38. Palo Verde upper tube bundle geometry on the hot leg side (Conway 1993).

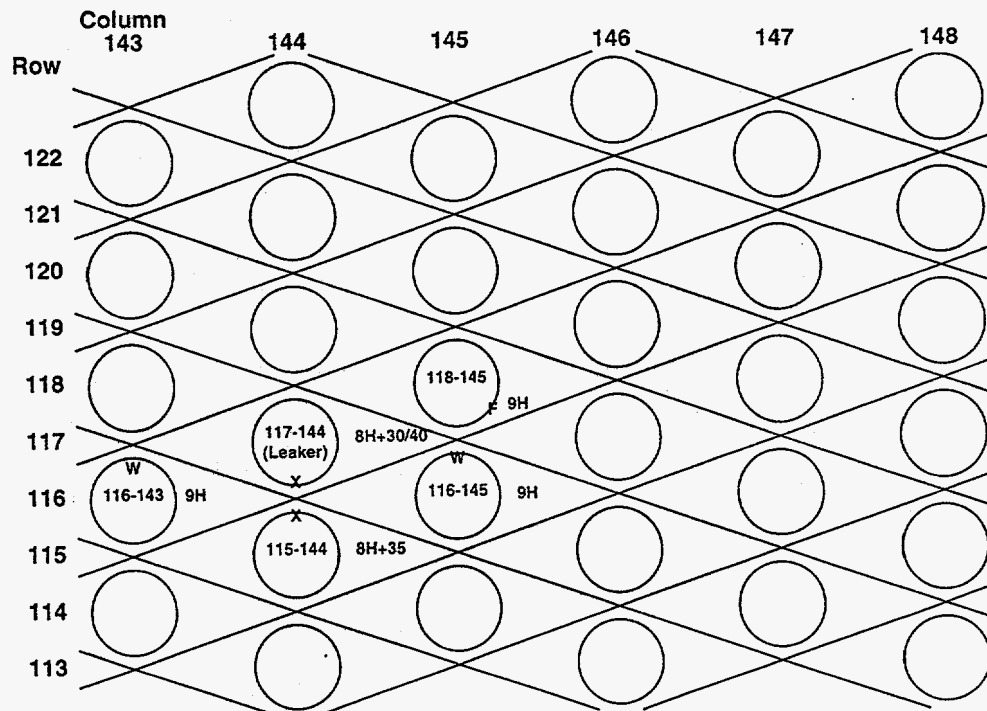
F = Axial flaw
 D = Deposit
 X = Axial flaw w/deposit
 W = Wear

Figure 39. Palo Verde steam generator cross section in the region of the tube bundle with the ruptured tube (Conway 1993).

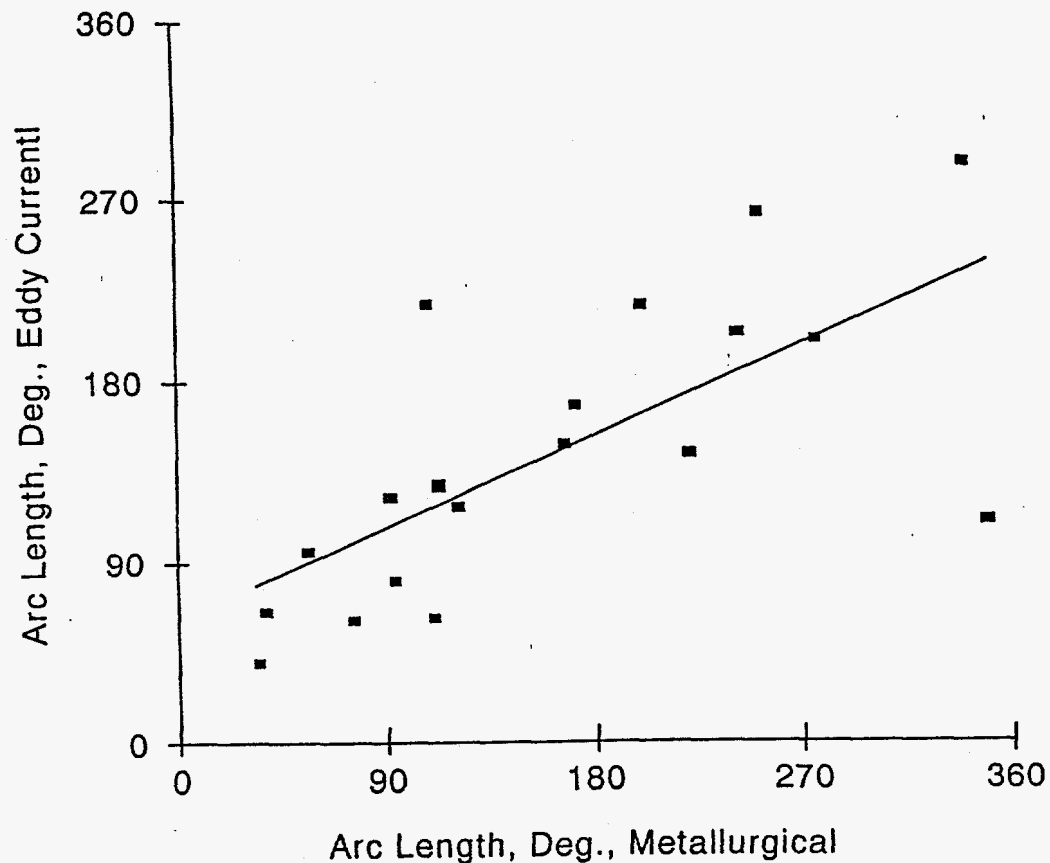
Figure 103. Comparison of actual arc length of circumferential cracks in pulled tubes with the ones estimated using eddy-current inspection (Malinowski 1995). The data represent worldwide experience as of 1992.

a Combustion Engineering design steam generator. World wide pulled tube metallographic data are also being used to develop the sizing techniques. The pulled tube data show that eddy-current inspections generally underestimate the actual arc length of a circumferential crack as shown in Figure 103 (Malinowski 1995). For example, an actual arc length of a circumferential crack was 360 degrees whereas the correspond-

ing eddy-current result was about 100 degrees. Enhanced analysis of the rotating pancake coil inspection results can reduce this deficiency (Malinowski 1995). Some industry efforts are also directed towards developing improved eddy-current techniques for sizing the maximum depths of circumferential cracks, which are needed for tube integrity assessments (Dembek 1995).

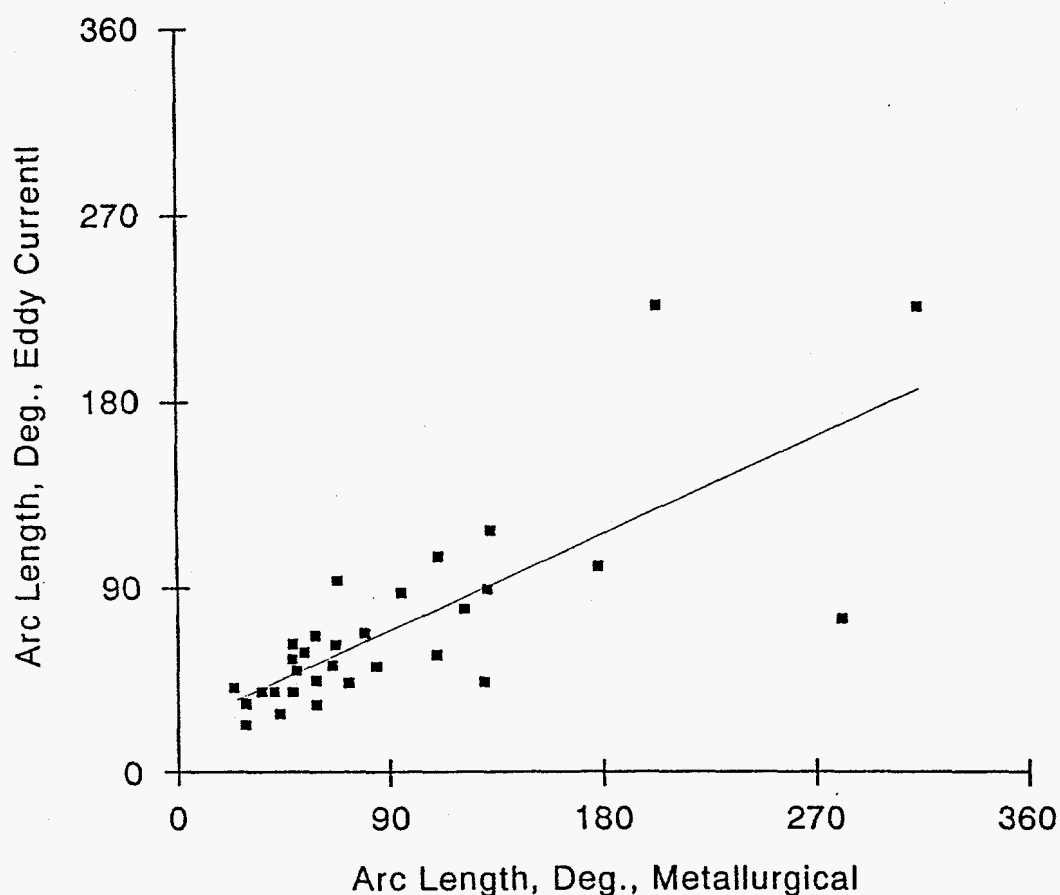
Figure 104. Comparison of actual arc length of circumferential ODSCC cracks in pulled tubes with the ones estimated using eddy-current inspection (Malinowski 1995).

The rotating pancake coil probes are qualified for detection of circumferential cracks. However, these probes underestimate the length of the circumferential cracks, including ODS/IGA cracks, and depth sizing of these cracks is difficult. The underestimation of crack length is illustrated in Figure 104, which presents a comparison of eddy-current measurements of the arc length of a variety of circumferential cracks with the corresponding metallographic examination results (Dembek 1995). For example, an actual arc length of a crack was about 270 degrees whereas the corresponding eddy-current measured arc length was 90 degrees. However, enhanced analysis of the rotating pancake coil inspection results can provide better agreement between the inspection and actual arc lengths (Malinowski 1995).
