NUREG/CR-4674
ORNL/NOAC-232
Vol. 22

Precursors to Potential Severe Core Damage Accidents: 1994 A Status Report

Appendix I

Appendix I:
License Event Reports and
Augmented Inspection Team Reports Cited in
Appendices C-G

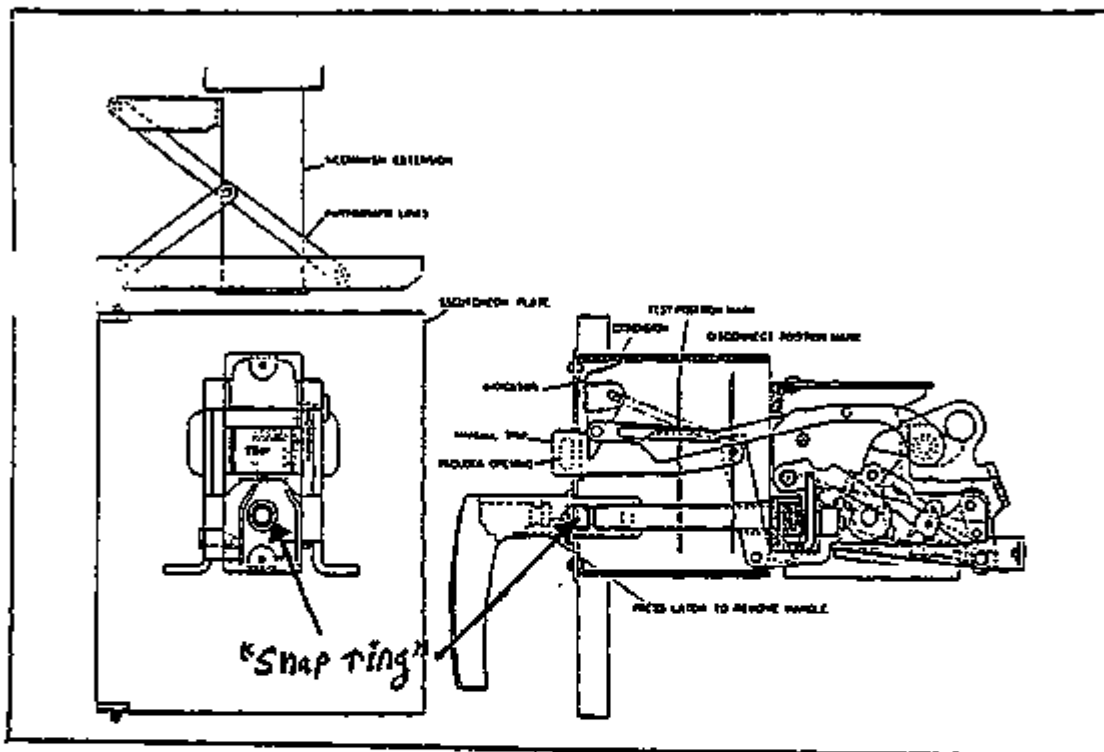
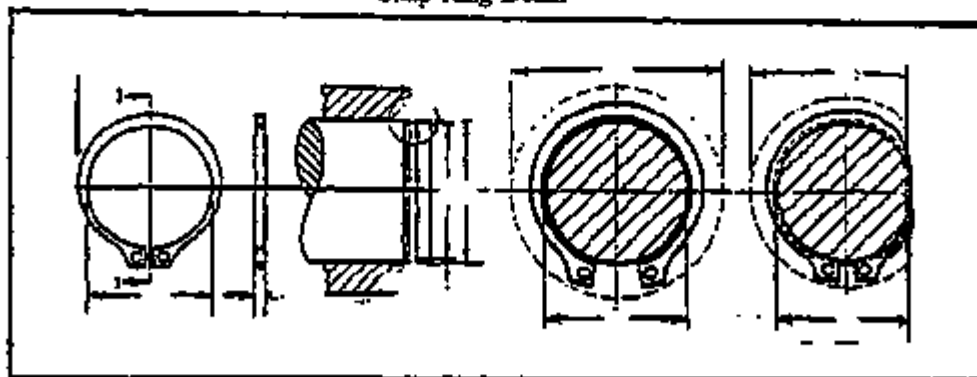
FIGURE 5
DB-25 BREAKER OPERATING MECHANISM

The cause of the bus 6 11C breaker to not close when position 2 was selected on the SS43 switch has been determined to be due to a mechanical problem within the breaker operating mechanism. A snap retaining ring was discovered approximately a half inch away from its mounting slot. This allowed the manual operating shaft to move further into the breaker than designed. It was able to travel far enough into the breaker that it interfered with the trip bar and actually maintained the breaker in the tripped position. When the breaker was called upon to close it would close and immediately trip. Performance of a root cause evaluation to determine all the circumstances that led to the MCC-5 ABT failure, including an assessment of the previous root cause evaluation was completed. The root cause of the ABT failures was confirmed to be an out-of-position retaining ring on the breaker closing handle operating shaft. Although it could not be determined how the retaining ring came out of position the most likely cause was that during breaker maintenance the retaining ring was moved out of position to lubricate the shaft and may not have been correctly re-installed. An assessment of the June 27, 1993 event found the previous root cause report to be comprehensive given the intermittent nature of the failure. The conclusive determination of the root cause of the recent failure was facilitated by the repeatability of the failure on demand.

Breakers 9C and 11C are Westinghouse Model DB-25 air circuit breakers. Figures 3 through 5 show the relevant features of the DB-25 design details. The licensee conducted visual inspections of the breaker 11C components on February 19. Covers to the auxiliary switches were removed and the auxiliary switch wiring and contacts were visually inspected. No abnormalities were identified during the visual examination of the auxiliary switches. The amptector (overcurrent device) and the cover to the closing/trip linkage was removed. During a visual inspection of the linkage, the licensee identified that the snap ring on the manual closing linkage was not properly located in the snap ring slot (see Figure 5). The snap ring was back away from the slot, toward the manual closing handle, approximately 1 to 1 1/2 inches. This allowed the manual breaker closing linkage to protrude into the closing/trip linkage.

1. Replacement of bus 6 breaker 11C manual operating mechanism.
2. Verification of position and condition of other breakers' manual operating shaft retaining devices.
3. Implementation of a modification to eliminate the preferred source selector switch SS43 and redesign the MCC-5 ABT scheme to block the trip of the normal feed bus 5 9C breaker on a total loss of AC power to minimize challenges to breaker operation.

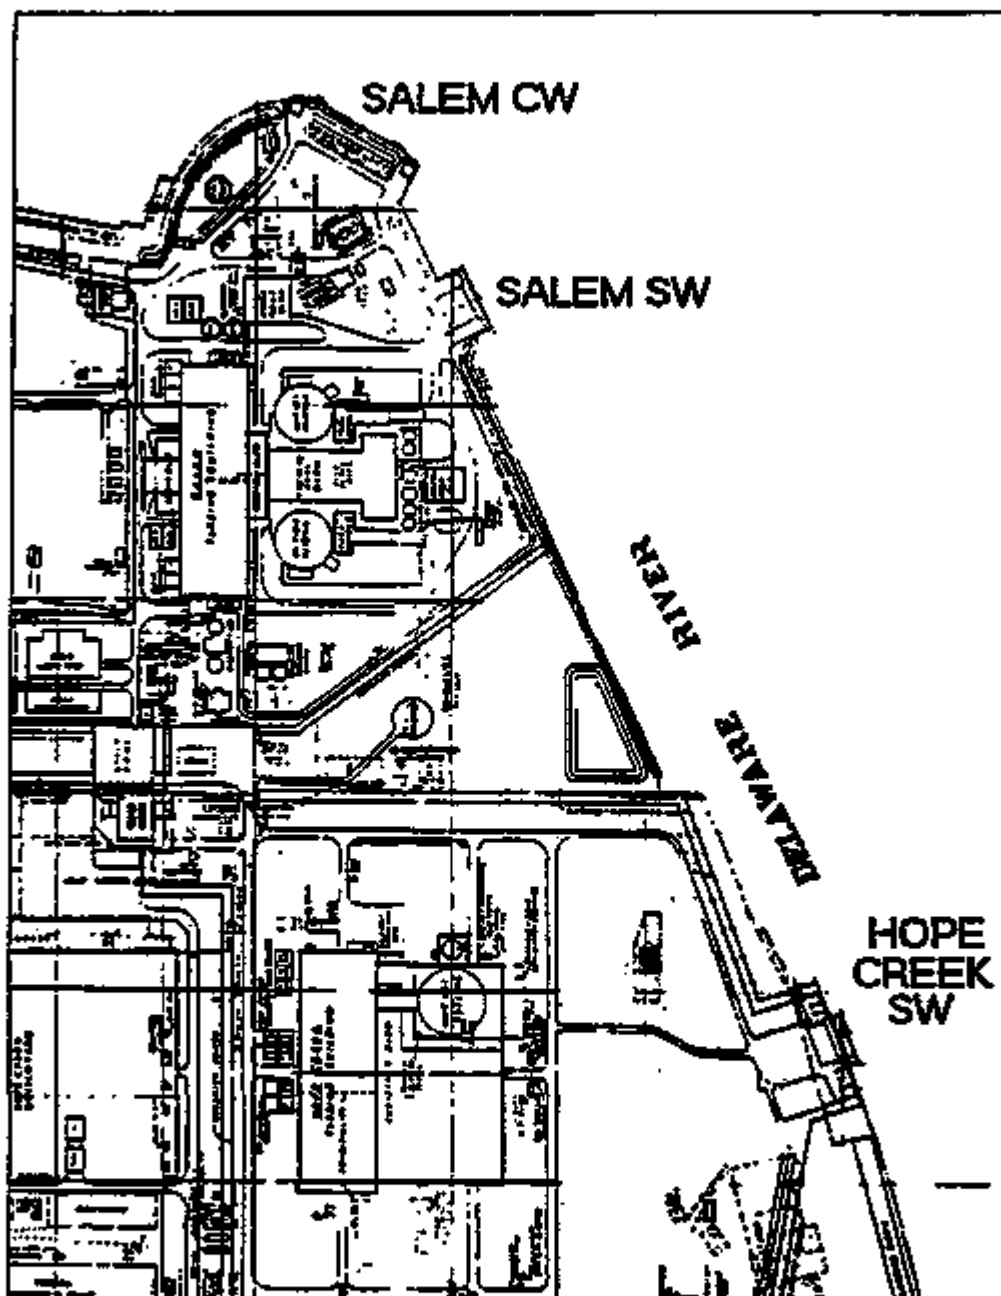
Figure 3. Relative Location of Water Intake Structures

Salem and Hope Creek have three water intake structures positioned as shown in Fig. 3 in Attachment 7.

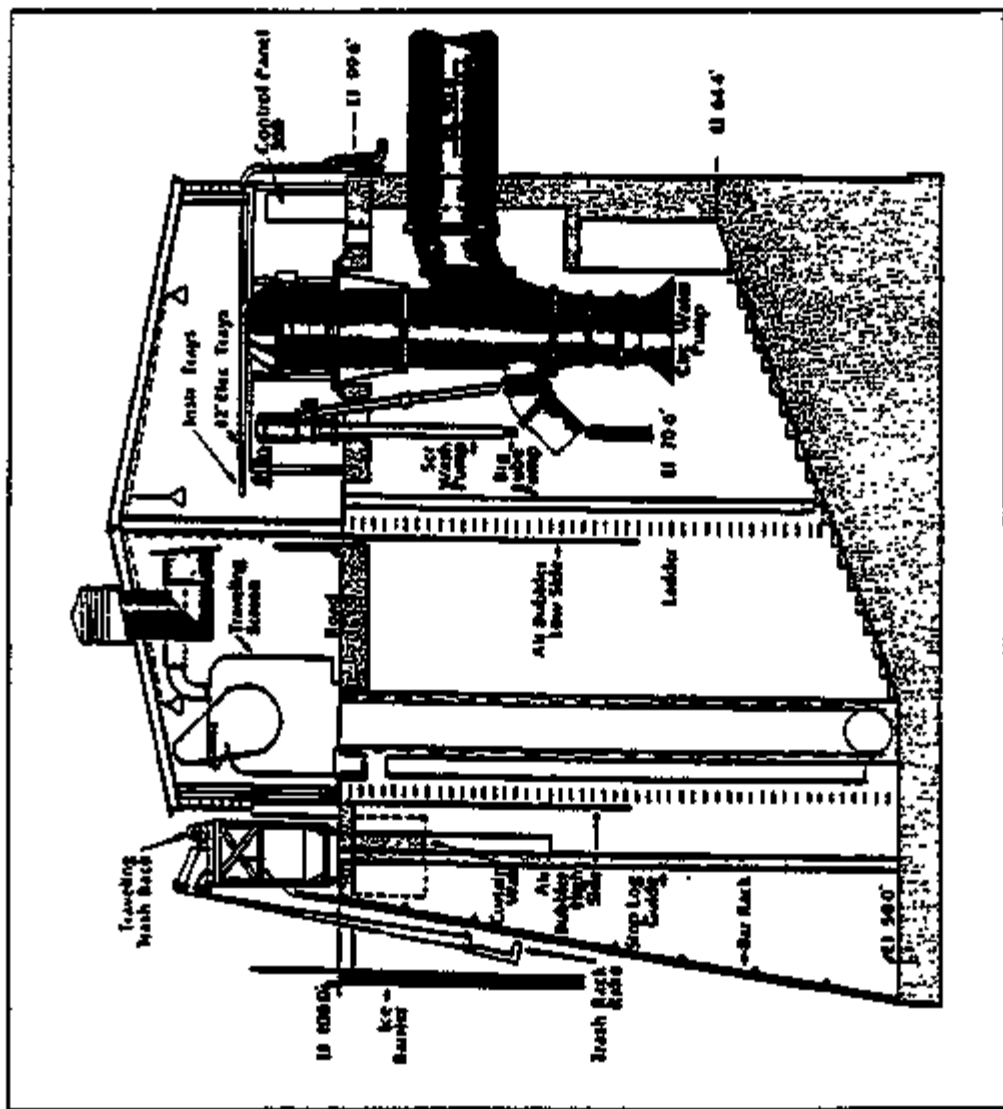
Figure 4. Salem CW Intake Structure and Equipment

Salem's SW intake is about 100 yds upstream (north) of the CW intake and Hope Creek's SW intake is about 3/8 mile upstream of the Salem SW intake. Water entering each intake structure passes through a trash rack, a moving screen, a pump, and, for SW, a filter. These are shown in Figs. 4 - 6 in Attachment 7. The bottom of both SW intakes is at about the river bottom, about 30 feet below surface grade. The CW intake bottom is 50 ft. below grade and the river bottom is dredged to that depth for the width of the intake structure and for a distance of 100 ft. from shore.

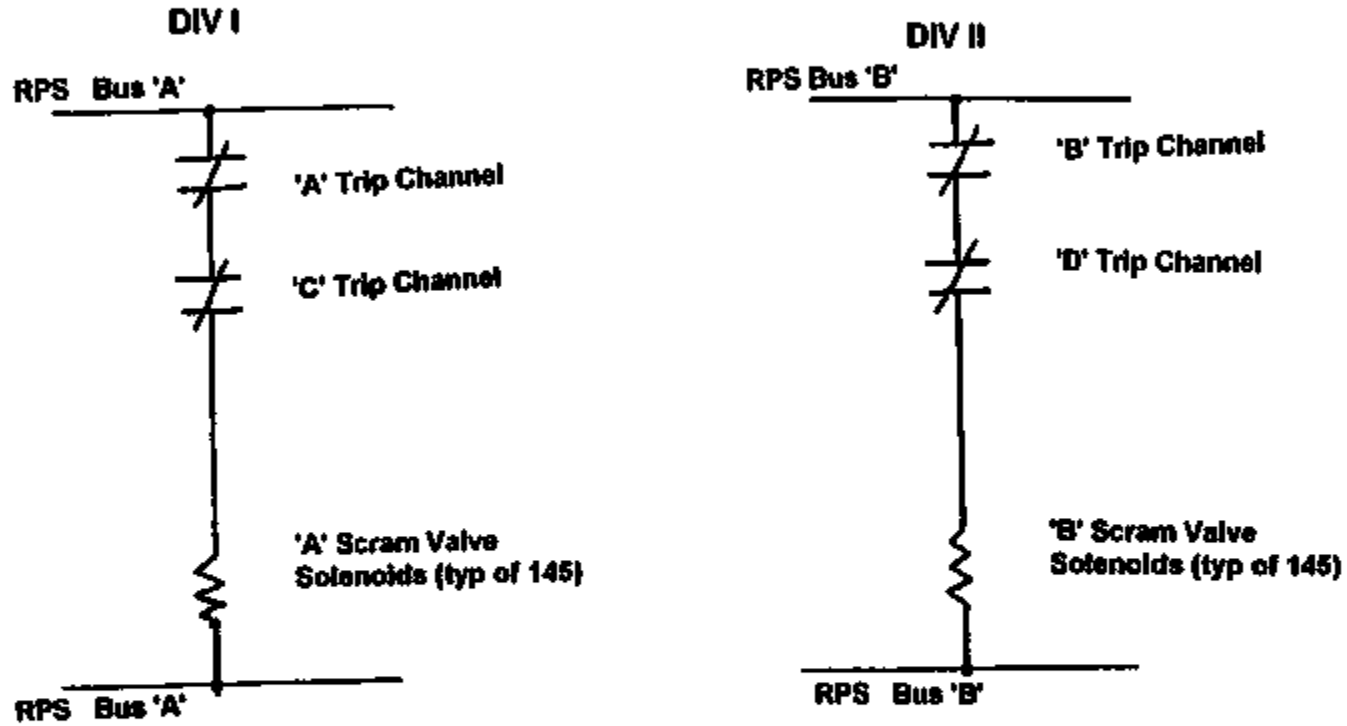
SIMPLIFIED RPS LOGIC CIRCUITRY

Both 'A' and 'B' Scram Valve Solenoids must deenergize to Scram a Control Rod.

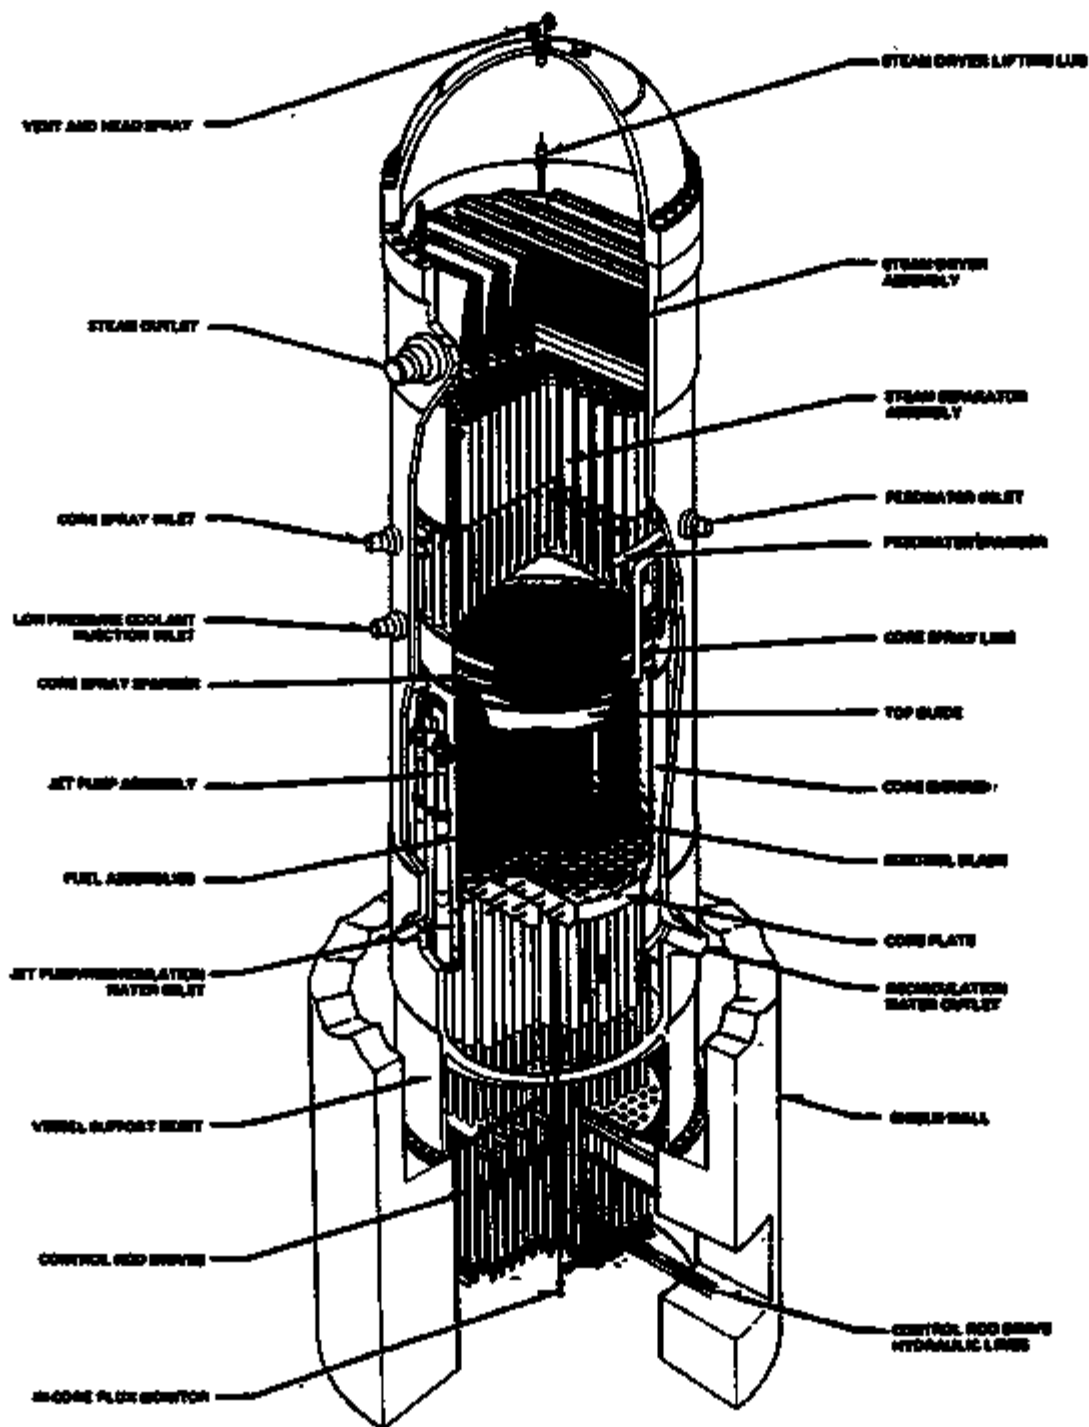
Figure 2-1. Reactor Assembly

- **CONCLUSION: (14 FAILURE MODES WERE ELIMINATED)**
 - **NO INTERNAL DAMAGE OR FEEDWATER BLOCKAGE CAUSED THE LEVEL 8 TRIP**
 - **NO MAJOR HYDRAULIC DISTURBANCE INTERNAL TO VESSEL**
