SAND94-1261
Unlimited Release
Printed June 1997

NET-1.2 Post-Irradiation Examination Report

The post-irradiation examination (PIE) of the NET-1.2 fuel element was completed in December, 1993. The goal of the PIE work was to gather data regarding the fracture of the hot frit during the experiment. Five cracks were observed in the hot frit at various locations although only two were believed to have initiated the overall component failure. These two cracks were complete circumferential failures and were located near the open and closed ends of the frit within the active flow region. The location and orientation of these fractures suggested that failure was the result of thermally-induced stresses that exceeded pre-test predictions. The cause of the failure was the temperature difference between the coolant flowing through the hot frit and the thermally massive end fittings. The resulting axial temperature gradients in the hot frit imposed thermal stresses that exceeded failure in the frit coating material. This coating fracture then propagated through the graphite substrate. Post-test analyses of the frit response based on measured data from the experiment verified that the frit co

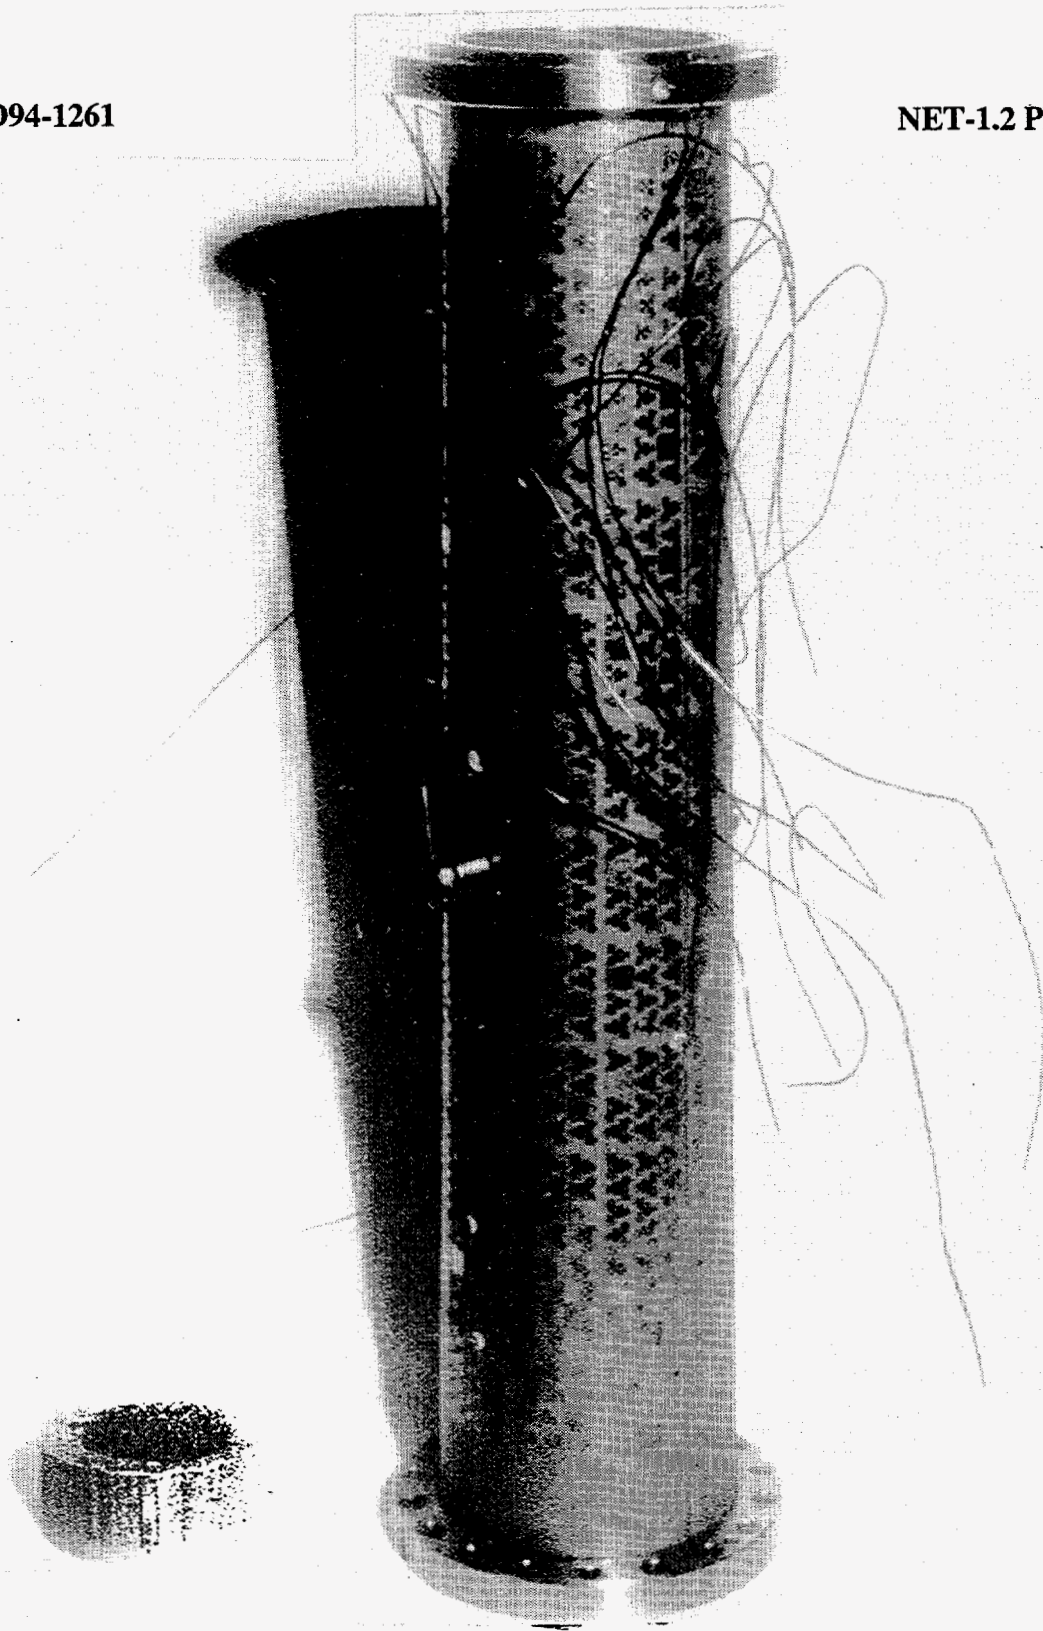
Figure 11. Cold Frit Exterior (with thermocouple lead wires visible)

An inspection of the cold frit exterior revealed nothing anomalous, again indicating no overheating problems or unexpected mechanical loads. A photograph of the cold frit exterior is presented in Figure 11 (the wires visible in the photograph are the lead wires for the internally mounted thermocouples). The amber to bluish color of the frit existed before the test and is the result of the heat treatment process used by the cold frit manufacturer in the construction of the component.

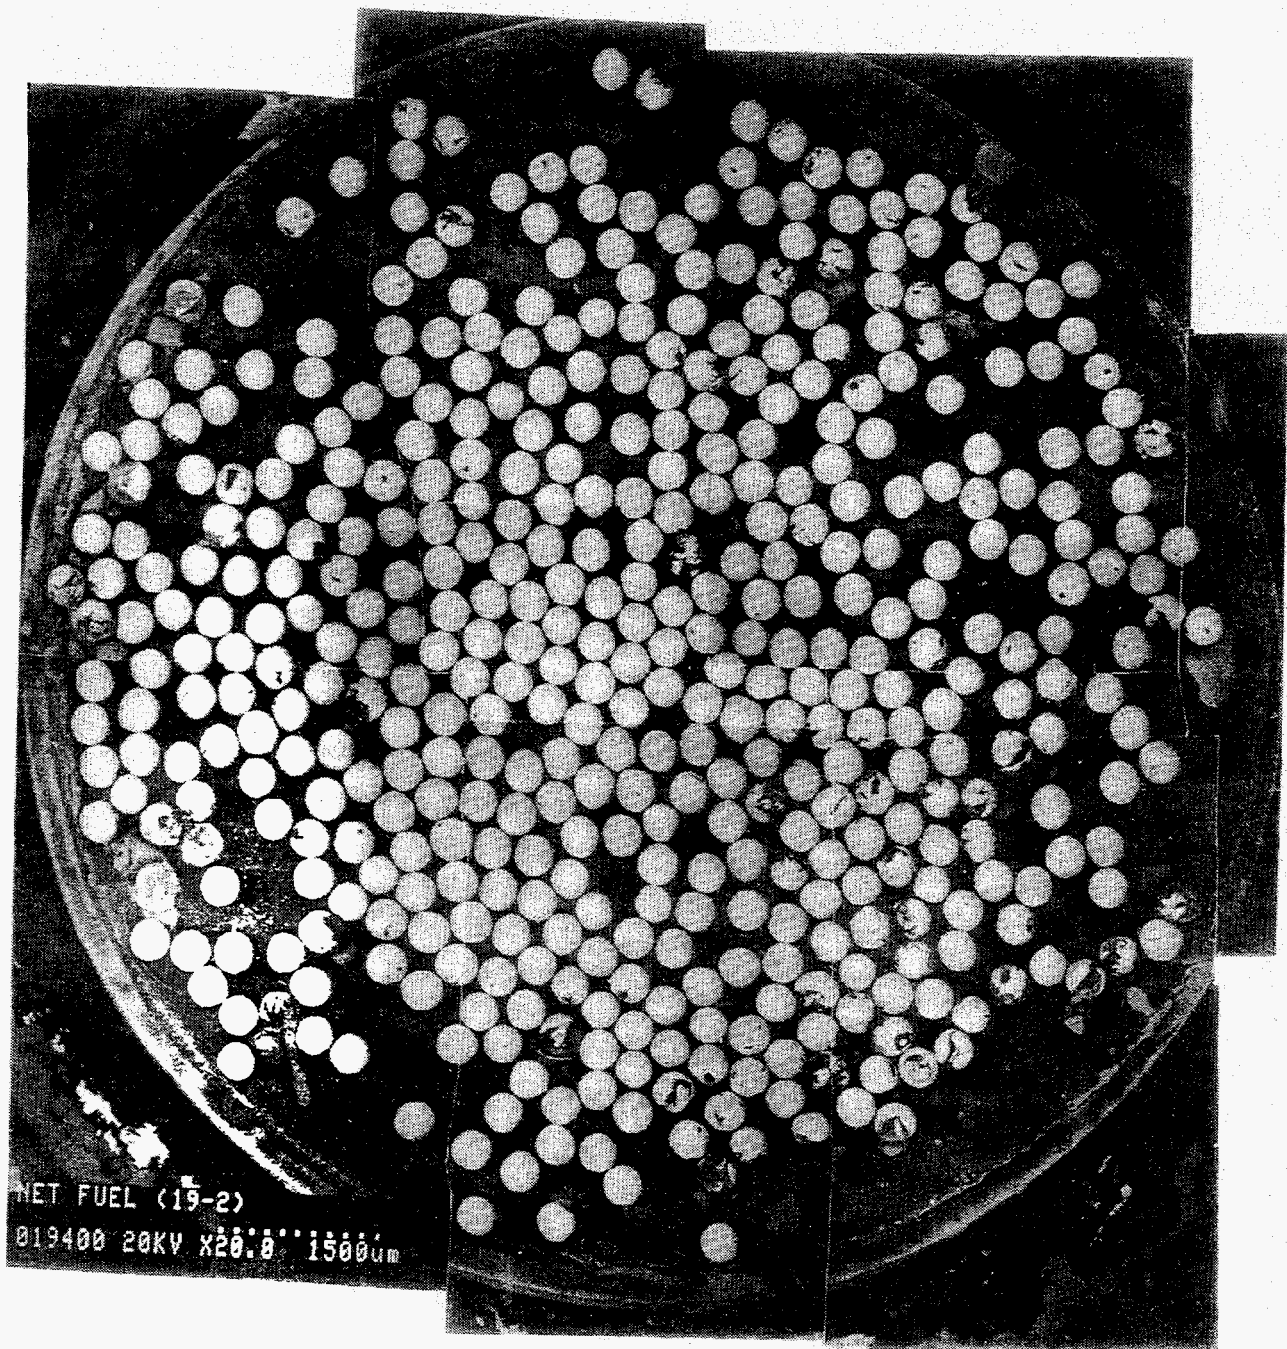
Figure 14. Scanning Electron Micrograph of Representative Whole Particle Fuel (original magnification 25X, as shown)

Figure 13 shows an optical macrograph of the unsectioned fuel particles. Variations in the apparent color of the particles indicates coating oxidation although it appears slight since no all black or all white particles can be seen (dark particles indicate slight to moderate oxidation). SEM inspection of these particles revealed no evidence of coating spallation (Figure 14), which has been linked in previous studies of these fuel particles to significant oxidation levels. This confirms the conclusion reached about the moderate thermal environment experienced by the fuels.
