SANDIA REPORT

SAND97-0497 • UC-704

Characterization of the Mechanical Properties of LTCC "Green Tape"TM for the MC4352 MET

Abstract

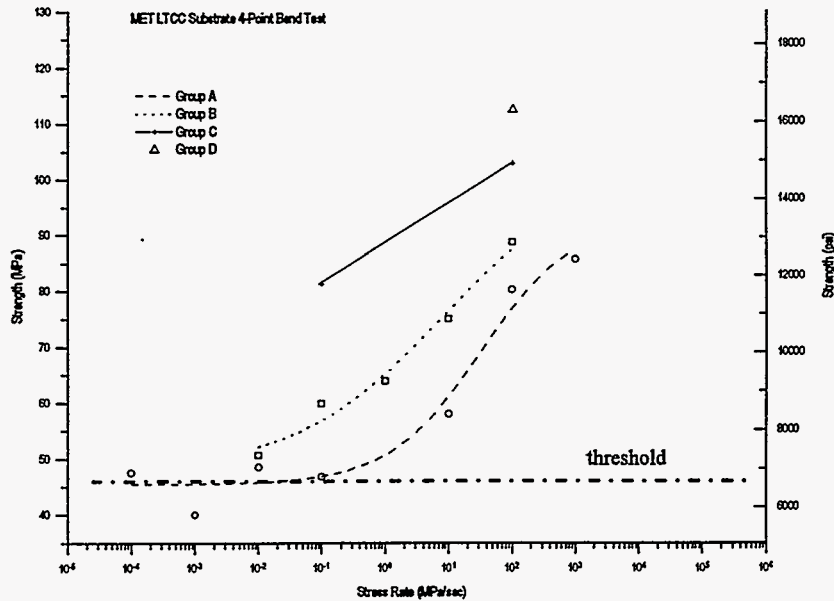
Results from testing are plotted in Figure 3. At high stressing rates, the measured strength of the .030-inch-thick substrates, Group A samples, was 12.5 Kpsi (85 MPa), and as the stressing rate decreased, the strength decreased to 6.5 Kpsi for all stressing rates below 1 MPa/sec. In test Groups B and C, the curves are shifted to a higher value of failure strength for a given stressing rate. The fast fracture strength of group D, the .050-inch-thick substrates, was 16 Kpsi (113 MPa). Fractographic analysis for each of the substrates, summarized in Table 1, revealed that failure origins were different from group to group.

Figure 3. Threshold stress measured on non-populated MET substrates.

The results of these tests confirm the anticipated SCCG behavior of the 951 LTCC substrate material. Slow stressing rates allow the environment, particularly moisture, sufficient time to reach the crack tip and initiate subcritical crack growth. Final failure occurs once the crack has reached a critical size. The shape of the Group A curve in Figure 3 is similar to that reported by DuPont. The strength decreases with decreasing stressing rate and a SCCG threshold plateau is defined. The threshold plateau, below which SCCG does not occur, is 2.2 Kpsi lower in the Group A than that reported by DuPont for unmetallized 951 material. Failure origins for the A and B group were generally at the 4596 conductor/resistor/glaze interface.

These results show that the presence of metallization slightly reduces the SCCG threshold plateau in 951 LTCC. The higher plateau strength reported for Group B suggests there is a small effect of fixturing on the test. Group C samples failed from intrinsic defects in the LTCC and from the LTCC/4596 metallization interface. These data indicate that Group C defects were smaller than the resistor flaw origin location in Groups A and B. Group D fast fracture strength was higher than the other groups. Nominally, groups C and D should have been the same because the processing was equivalent; however, the apparent difference could be within the error of the measurement. A larger number of samples would have to be tested to establish statistically relevant differences between groups C and D.

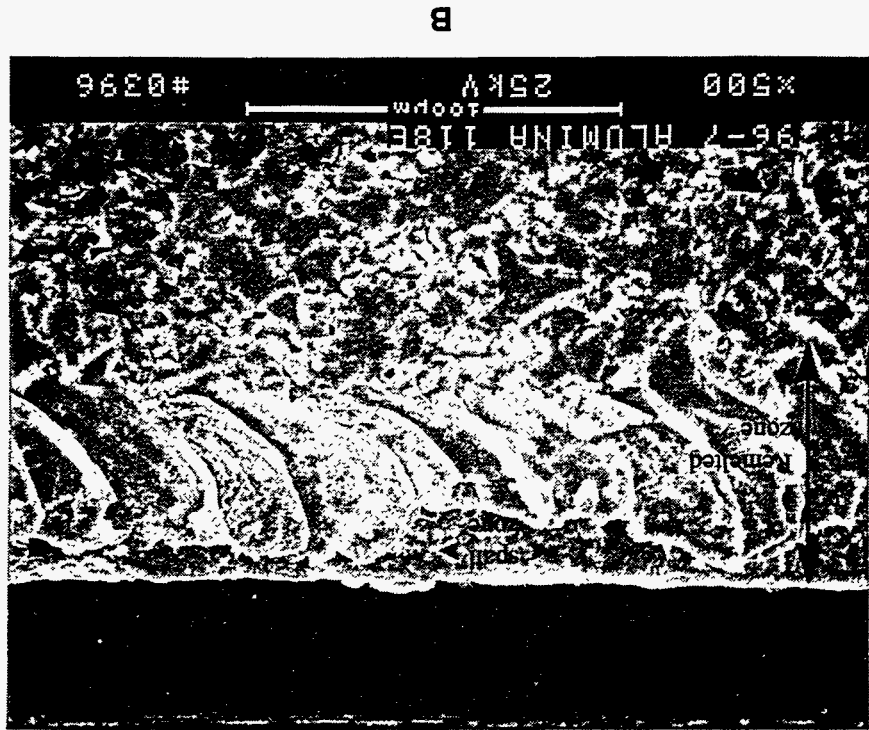
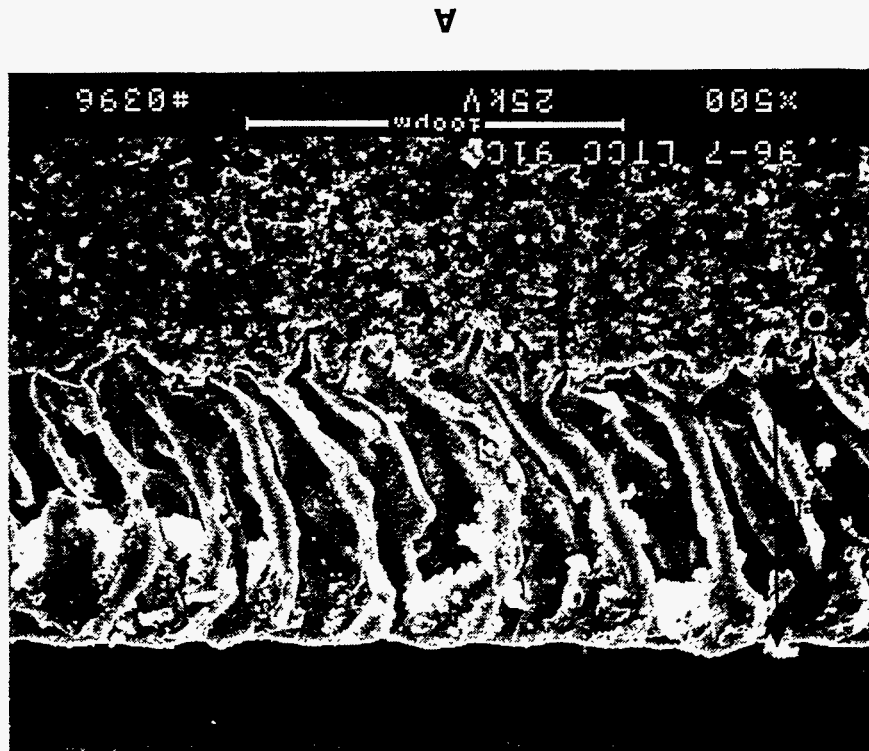
Figure 5. Laser entry side of bend bars shows remelt damage zone where failure originated.

Figure 6. Fracture surface shows failure origin and remelt zone at origin.

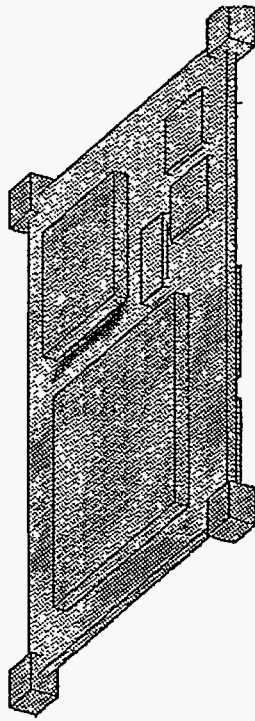
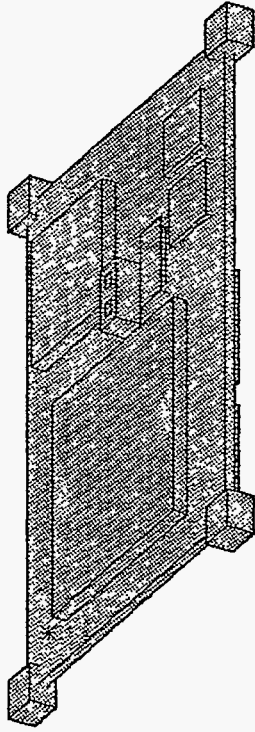
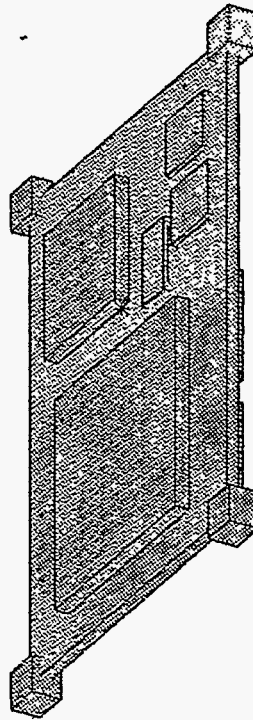
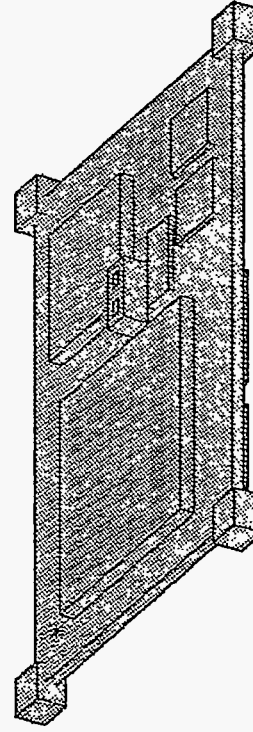
The stress in the MET substrate assembly for an applied constant acceleration load in both the +Z and -Z direction was computed using the general purpose finite element code ABAQUS. The shock load of most concern (142 G's @ 6.5 ms) is of sufficient duration that the acceleration can be considered to be applied statically. In Figure 8, contours of the computed maximum principal stress in the assembly for the applied acceleration load in the -Z direction (tending to bow the substrate up) are plotted. The peak stresses in the substrate are summarized in Table 6. These results indicate that the computed peak stresses are sufficiently below the slow crack growth threshold of 6500 psi even for the 0.040-inch-thick substrates.

Figure 8. Computed Maximum Principal Stress in Assembly Due to Acceleration Load

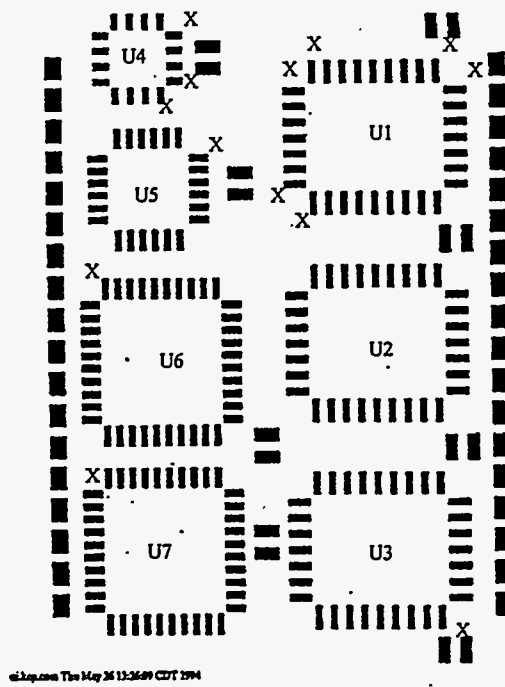
Figure 13. Schematic of locations where LCC packages are soldered to the LTCC substrate. "X" marks the location where the soldered and thermally cycled substrate was loaded in bending and fractured. The fracture surfaces at 13 locations were examined for evidence of small cracks that served as failure origins; none were found.

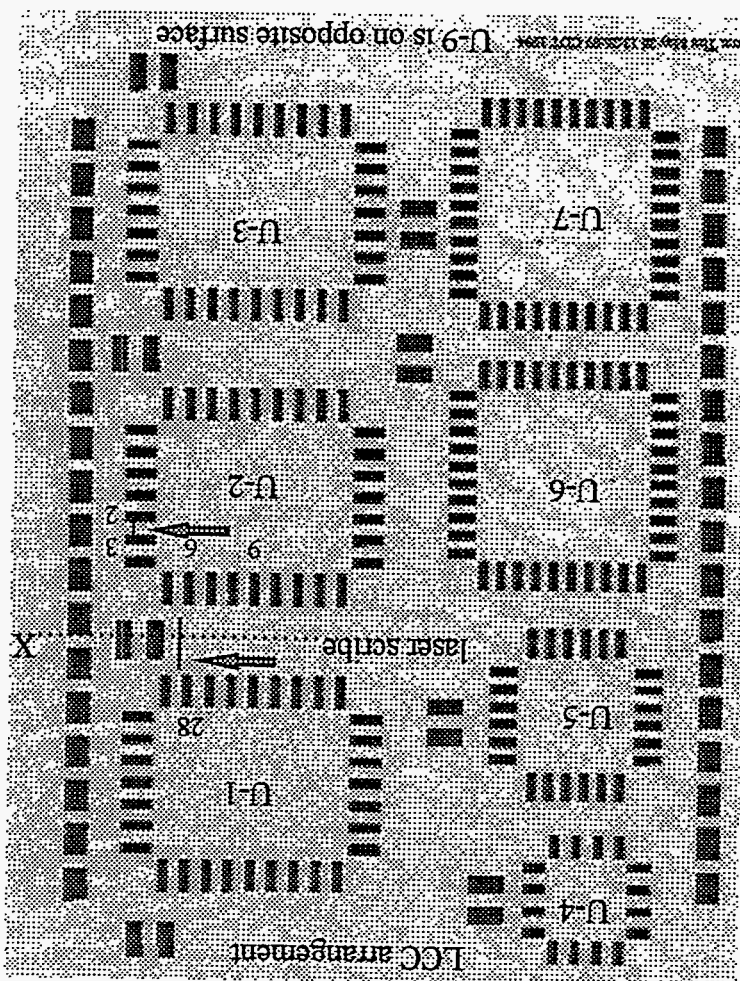
During random vibration (short term) testing at -65°C , TV #10 exhibited an electrical open at locations indicated in Figure 15. When the part returned to room temperature, the electrical open could not be detected. Subsequent exposure of TV #10 to cold temperature once again caused the electrical discontinuity and when the sample stabilized back to room temperature, the open was still present. Prior to failure, TV #10 had been aged at 125°C for 1000 hours, subjected to random vibration (long term) at ambient, cold (-54°C) and hot ($+85^{\circ}\text{C}$), and temperature cycled from -54°C to $+85^{\circ}\text{C}$.

Figure 15. Schematic of front, arrows show locations of open electrical paths in TV#10.

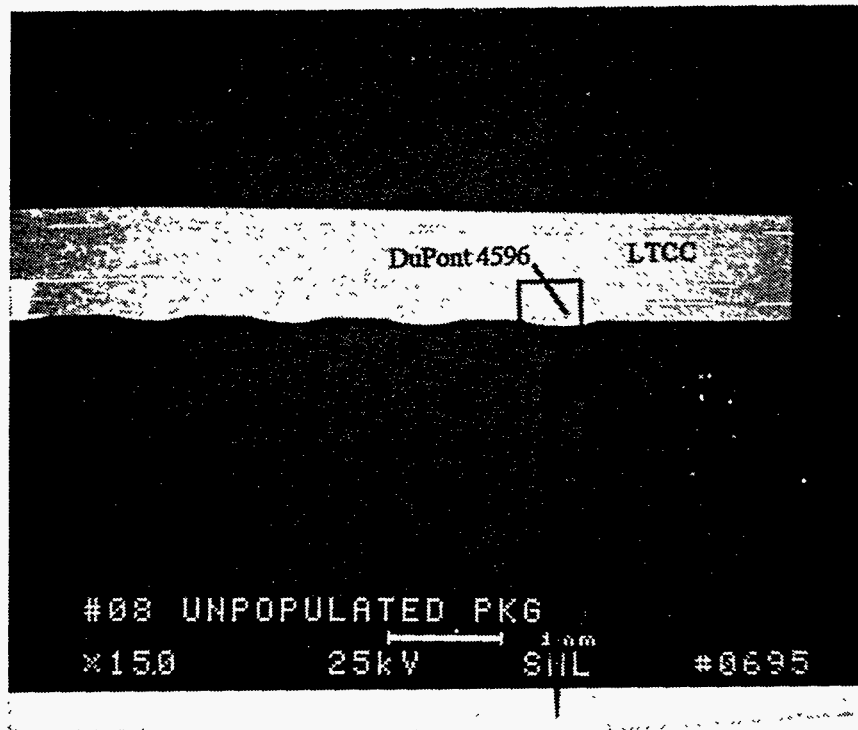
Unpopulated TV #8A is a substrate that had not been exposed to any solder assembly operation or environmental conditioning. This part provides baseline information about the characteristics of the DuPont 4596 Au-Pt metallization before any solder processing and allows examination of the opposing surfaces of the LTCC, which have a different number of metallization firings. SEM micrographs of the cross-section of TV #8A are shown in Figure 20A and 20B. The low magnification image in Figure 20A shows the LTCC substrate, vias, internal conductors, and Au-Pt surface conductors.

Figure 20A. Low magnification image of cross-sectioned #8A, the unsoldered, unaged MET Test Vehicle.

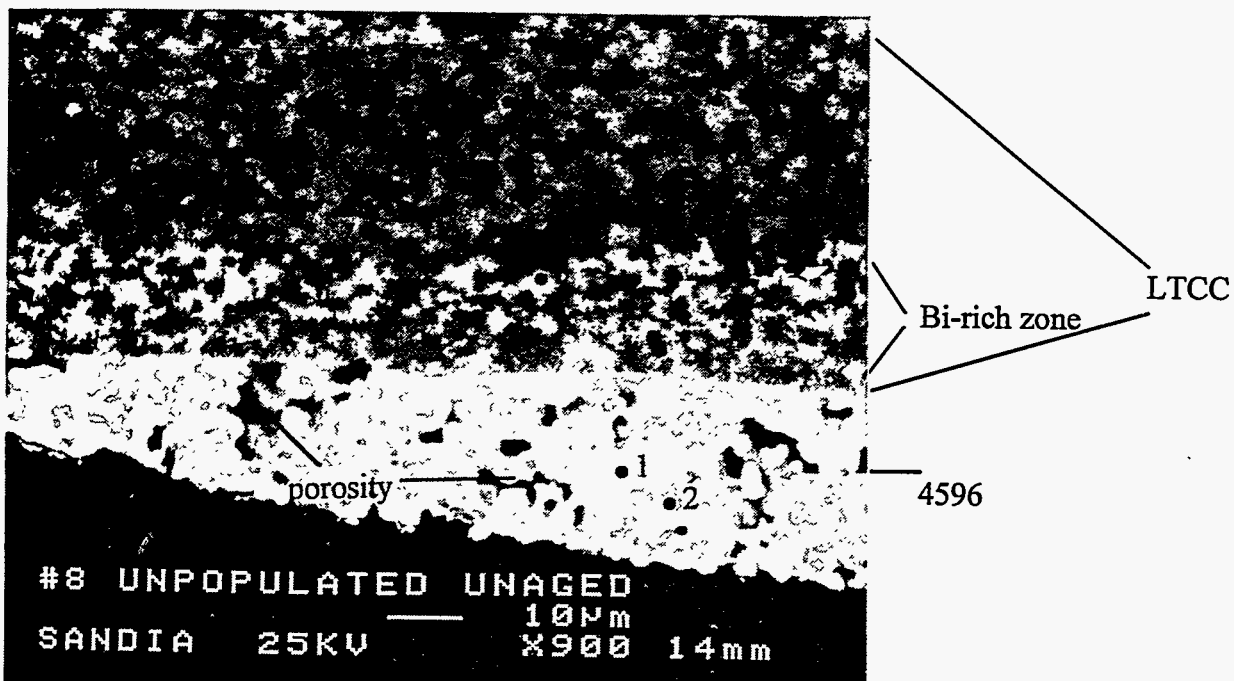
Cross-sections were made of the conductors over vias on both the front and back surfaces of the LTCC substrate. The higher magnification micrograph in Figure 20B is typical of the DuPont 4596 microstructure in both surfaces. The image in Figure 20B, taken using SEM backscatter mode, shows contiguous porosity in the Au-Pt conduction layer and little or no porosity in the LTCC. Five different areas, shown in Figure 20B, were analyzed using EDS.

Figure 20B. Higher magnification of boxed area in A shows five locations where EDS spectra were taken. EDS spectra are in Figure 21.

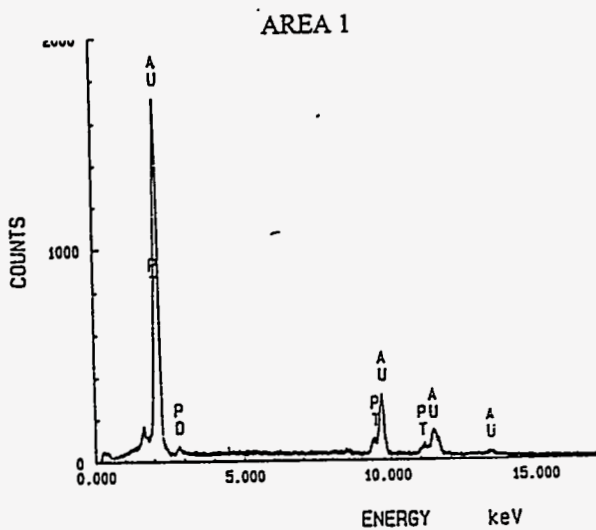
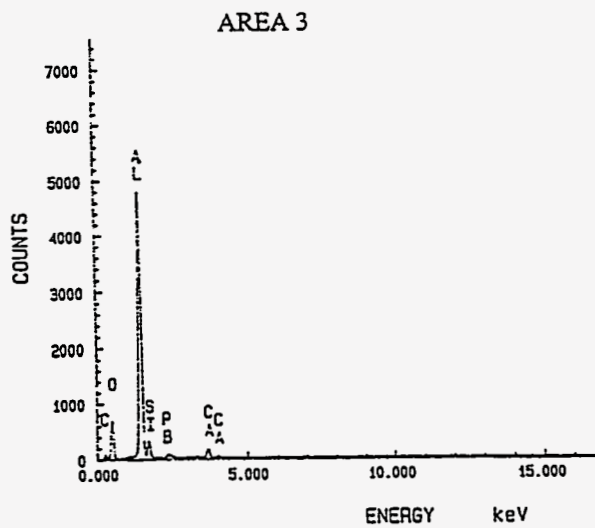
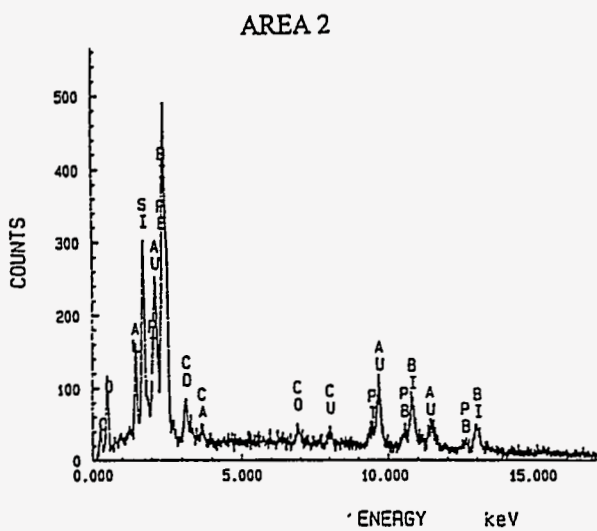
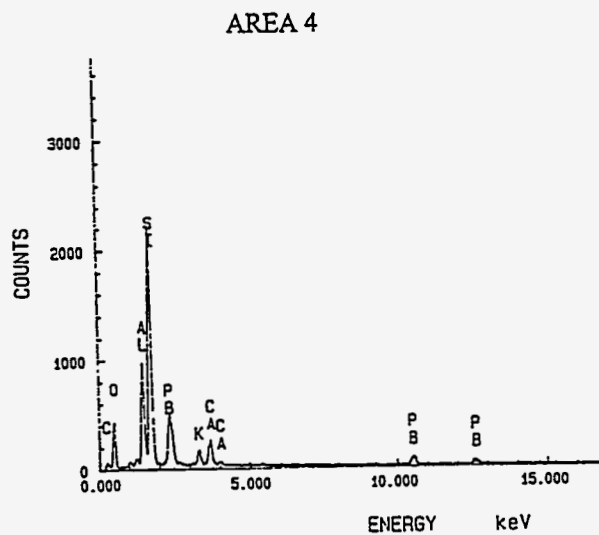
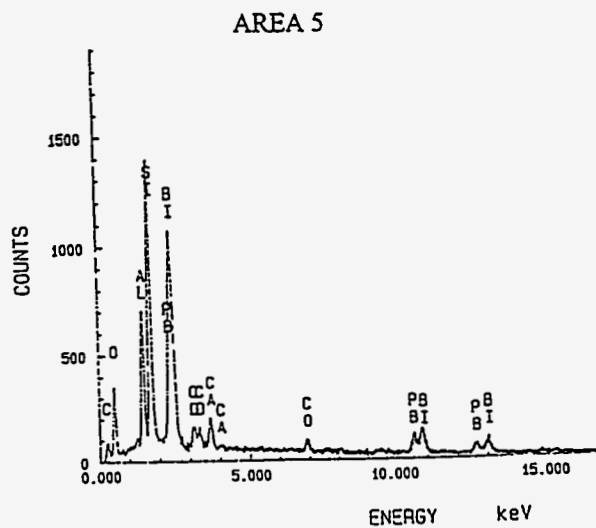
EDS spectra of areas 3, 4, and 5 show the bulk chemistry of LTCC and the LTCC chemistry near the LTCC/Au-Pt interface. Area 3 is the dark phase of the LTCC containing primarily Al with traces of Si, Ca, and Pb, and area 4 is the lighter phase containing primarily Si, with Al, Pb, Ca, and K. Both of these analyses were taken sufficiently far away from the Au-Pt interface to represent the composition of the monolithic LTCC. The bright band in the LTCC (Figure 20B) is limited to the area between the LTCC and Au-Pt. The brightest phase in that band, area 5, was analyzed and the spectra are shown in Figure 21, area 5. The spectra reveals that glassy constituents from both the LTCC and DuPont 4596 are present, in particular the presence of the large bismuth and lead peaks indicate interaction has occurred between the glass phases of the DuPont 4596 into the LTCC substrate. The thickness of the bismuth-rich layer, 16 to 20 microns, was measured on the front and backside surfaces of the LTCC and no substantial difference was observed. These micrographs and analyses, of the baseline part (TV #8A), show the interaction of some glassy constituents has occurred between the LTCC and DuPont 4596, and that multiple firings and processing to this stage have not caused any segregation of a phase or an isolated layer that would cause a weakened interface.

Figure 21. EDS spectra from areas identified in micrographs in Figure 20B from TV#8A.

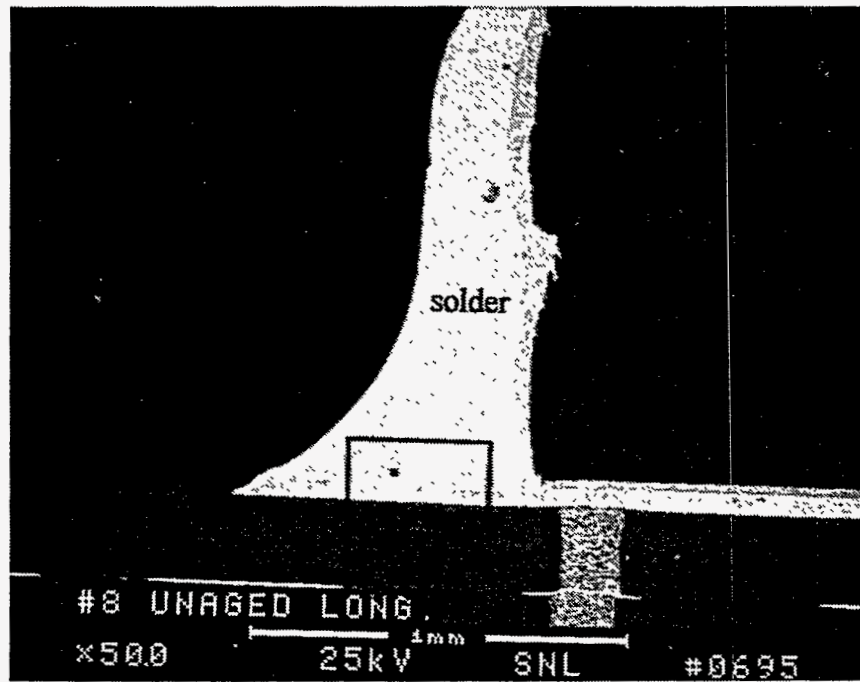
Test Vehicle #8, a substrate with soldered LCC packages, but unaged, shows the characteristics of the solder/Au-Pt/LTCC interfaces before exposure to the accelerated aging environment. The cross-section of TV #8 was examined and micrographs are shown in Figures 22A, 22B, and 22C. EDS spectra were taken from areas marked on Figure 22C. Again the bismuth-rich band in the LTCC, area 5, occurred only adjacent to the DuPont 4596 and the layer was about 20 microns thick.

Figure 22A. Low magnification of the solder fillet connecting LCC with LTCC substrate.

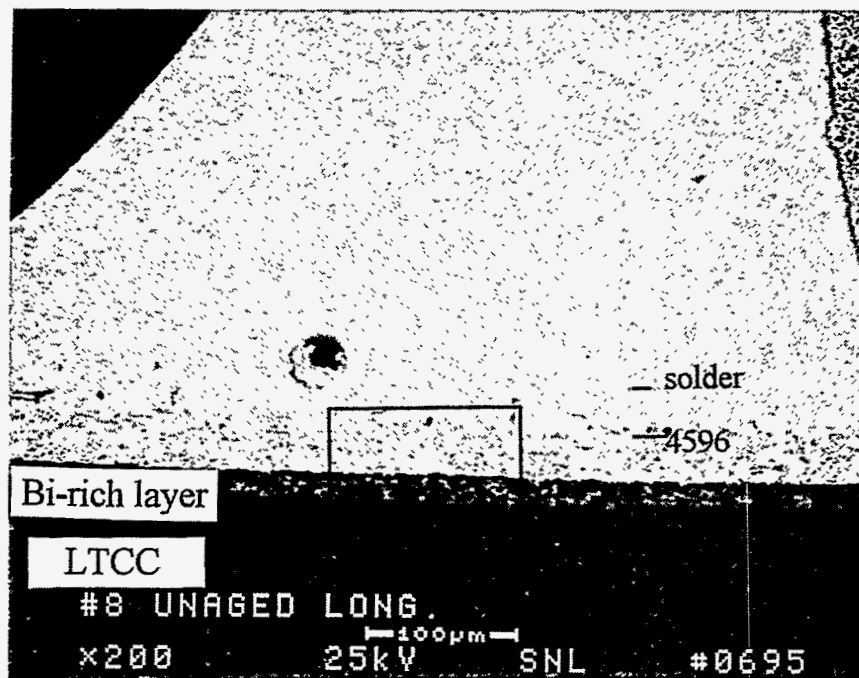
Figure 22B. SEM backscatter image of solder LTCC interface.

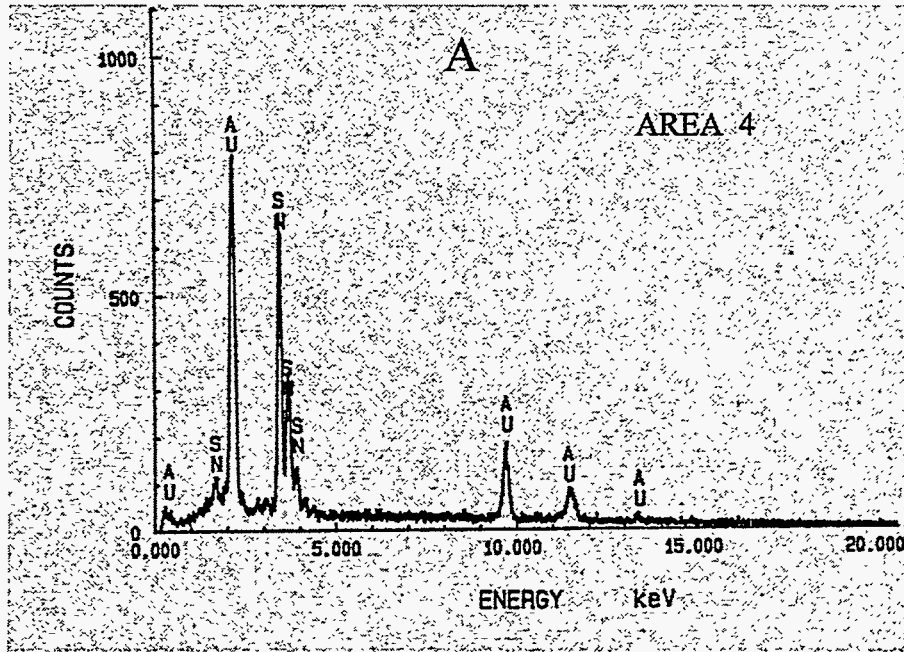
There were two additional distinct phases identified in the Au-Pt layer, areas 4 and 6 of Figure 22C. EDS spectra shown in Figure 23A of area 4, contains Au and Sn, indicating formation of the intermetallic compound. The extent of penetration of this compound, close to the interface, was surprising for a part that had not been aged. Other studies have shown that the Au-Sn intermetallic will form to some degree during the solder reflow process, but it is usually limited to a 1-2 micron thick layer between the solder and Au-Pt metallization.⁴

Figure 23A. EDS spectra of intermetallic compound found in the 4596 metallization.

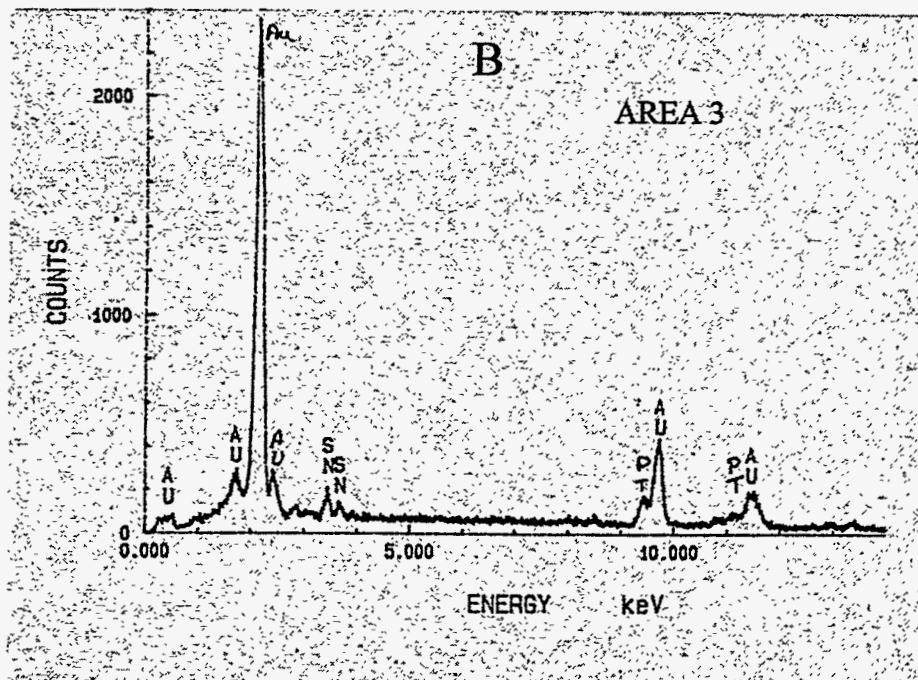
The micrograph in Figure 24D shows a very different interface microstructure than was observed in the "as-soldered" package (TV #8, Figure 22C). Almost no areas are left of the original Au-Pt metallization in TV #12. The entire layer has been consumed in the development of the 90-micron-thick Au-Sn intermetallic layer. In areas 1 and 3, Figure 24D, EDS analysis confirmed the intermetallic composition and isolated islands of the Au-Pt composition, respectively.

Figure 25B. EDS spectra of the islands of residual 4596 metallization.
