The January 17, 1994 Northridge Earthquake: Effects on Selected Industrial Facilities and Lifelines

**Mark W. Eli
Stanley C. Sommer
Thomas R. Roche
Kelly L. Merz**

February 1995

United States Department of Energy
United States Nuclear Regulatory Commission

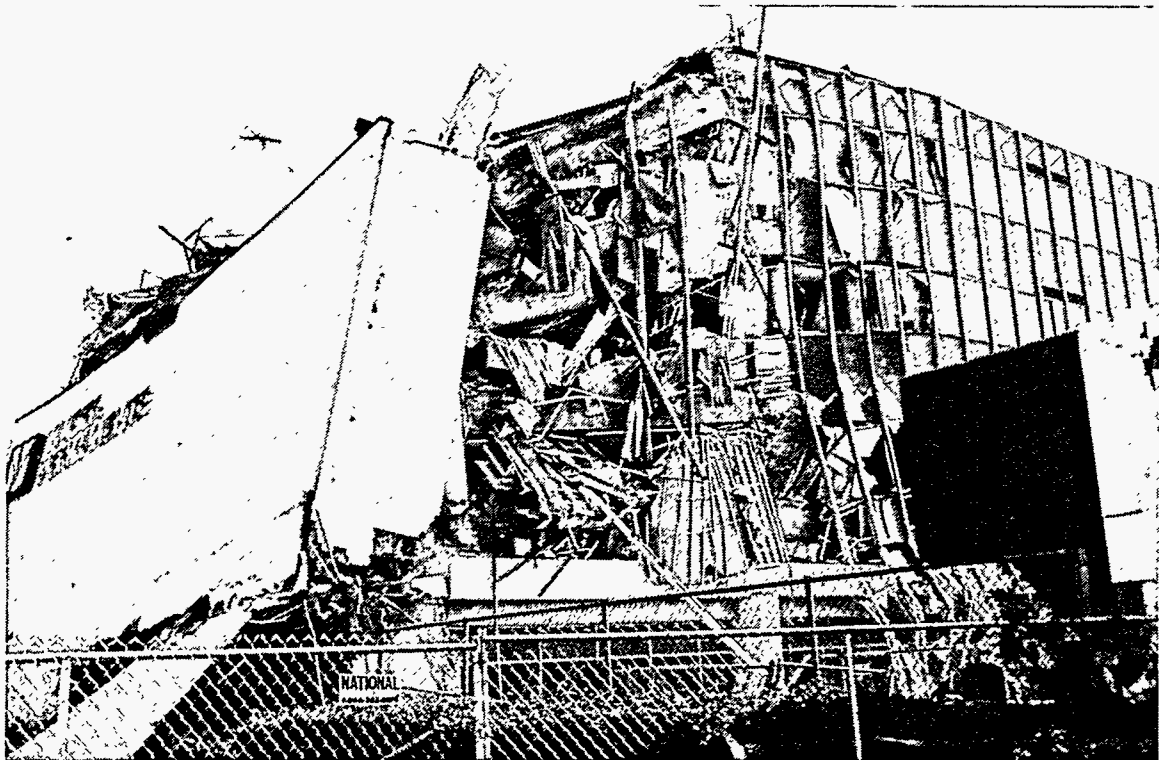
An example of a nonductile reinforced concrete frame building which collapsed is the Kaiser Permanente Medical Office Building. As shown in Figures 1.2-1 to 1.2-3, all of the columns failed just above the second floor. Located about 2 miles east of the epicenter, the Kaiser Permanente Building was a multistory frame with reinforced brick shear walls on its north and south faces. Poor beam-to-column details and lack of shear walls on the east and west faces contributed to the collapse. Since the north-south component of the earthquake appeared to dominate as discussed in Chapter 2 of this report, the massive east-west shear walls at each end of the building contributed little strength for resistance to the north-south component of the lateral load on the structure. Another nonductile reinforced concrete frame which collapsed was the Bullock's Department Store at the Northridge Fashion Center. It appeared that the concrete waffle slab on the second floor was not securely tied to the columns. This lack of connection allowed the floor to collapse as shown in Figures 1.2-4 and 1.2-5.

Figure 1.2-2: View from the NW corner of the collapsed Kaiser Permanente Medical Office Building.

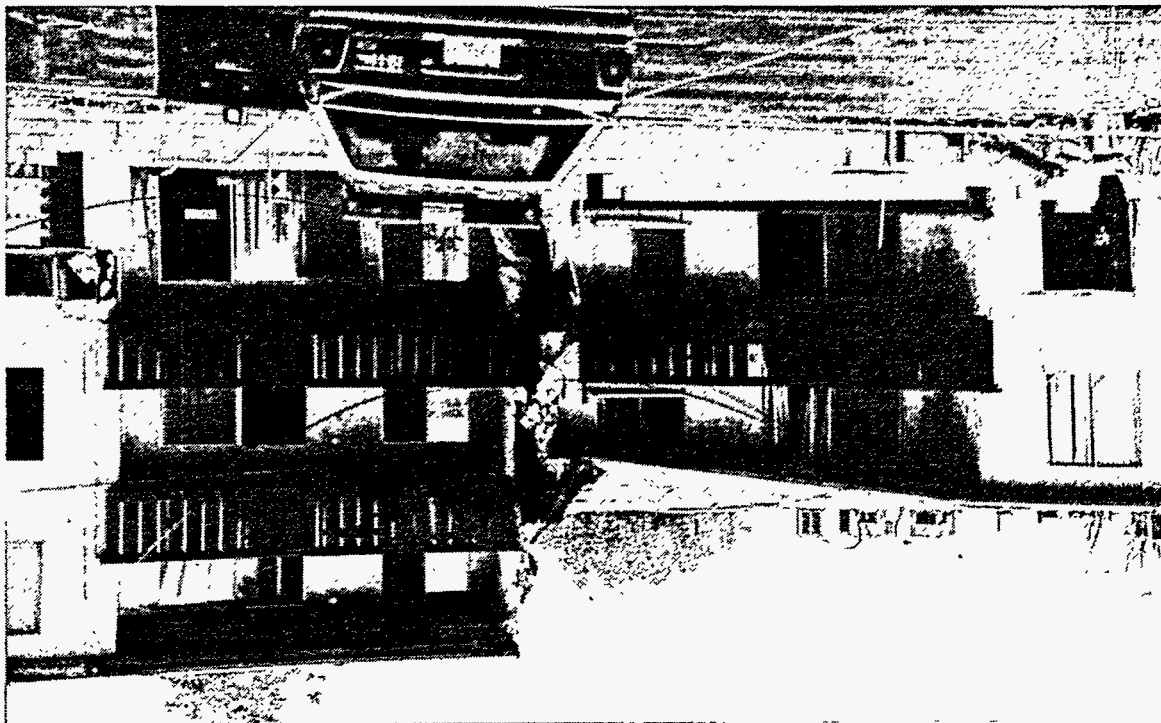
Figure 1.2-6: Northridge Meadows Apartments was an example of multi-story apartment buildings built with minimal seismic design details and poor construction practices. Due to collapse of the first story, 15 people were killed at this one apartment complex.

There were many severely damaged apartment buildings, especially those with parking garages on the first floor. These buildings were constructed as dwellings-over-garages. This building type typically does not perform well during earthquakes due to the inadequate horizontal shear capacity in the first floor and nonductile connections. Lack of good seismic design details and use of poor construction practices contributed to the collapse of the first story at the Northridge Meadows Apartments in Northridge as shown in Figure 1.2-6. Fifteen people were killed at this one apartment complex due to the earthquake.

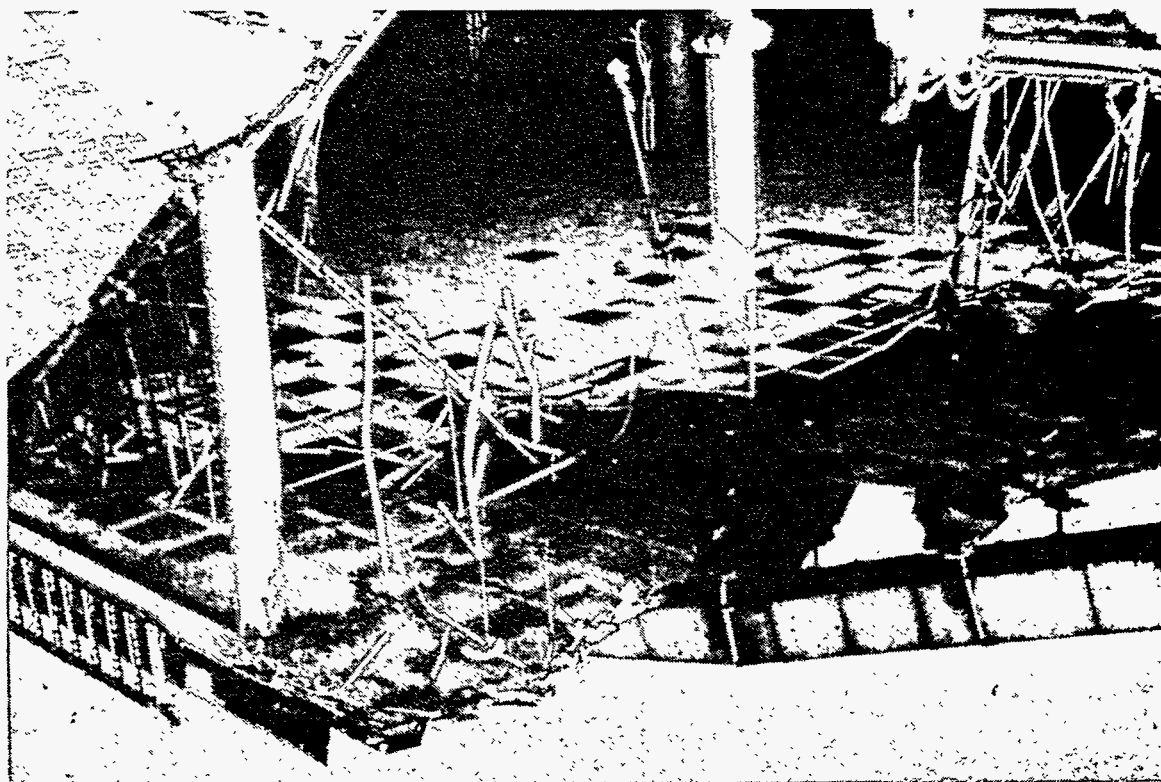
Figure 1.2-5: Close-up view of Bullock's Department Store at Northridge Fashion Center. The concrete slab on the second floor was apparently not securely tied to the columns, allowing the second floor to collapse.

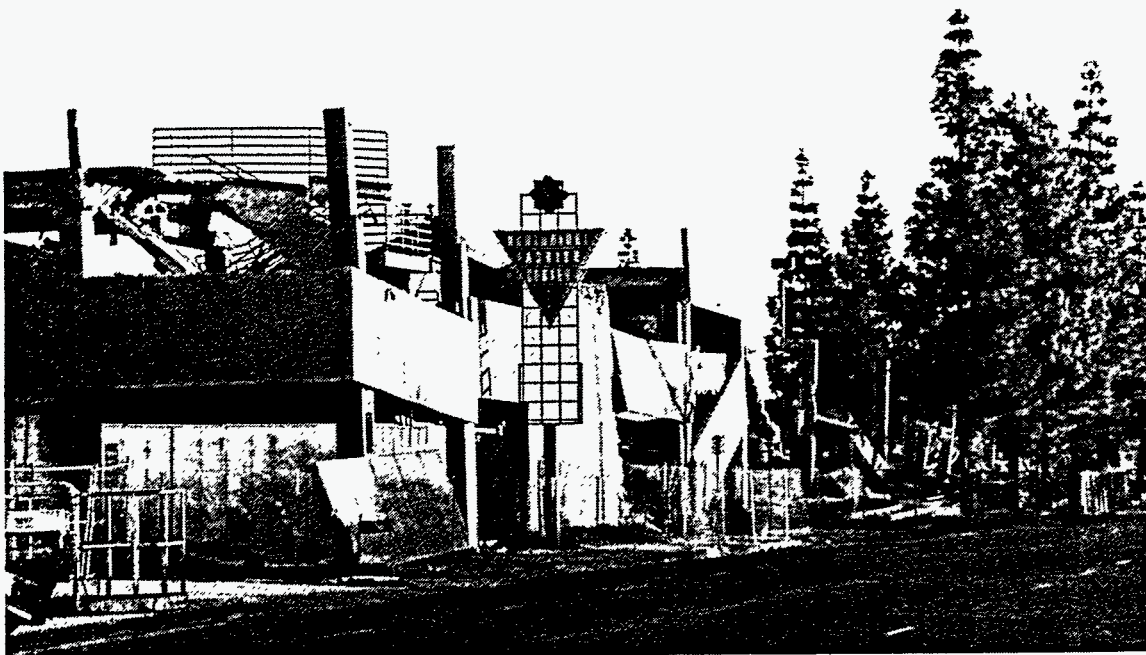
The Northridge Earthquake caused eight parking garages to partially or totally collapse and caused damage to numerous other parking garages. Most of these parking garages were precast concrete structures with poor construction details and inadequate lateral-load resisting systems. Figures 1.2-7 and 1.2-8 show the collapsed parking garage at the Northridge Fashion Center. Even though this structure was constructed in the early 1990s, it lacked adequate connection details to withstand the strong motion of the Northridge Earthquake. Another modern parking structure which collapsed during the earthquake was located at the California State University at Northridge (CSUN), shown in Figure 1.2-9. The CSUN structure had been designed as an exterior ductile frame with a nonductile interior structure. The short columns between the ramps and adjacent floors failed because they attracted loads which were higher than their intended capacities. In addition, the short development length of rebar between each column and the floor diaphragm did not provide sufficient resistance for the seismic strong motion. Both the Fashion Center and CSUN structures were located within 2 miles of the epicenter.

Figure 1.2-7: The concrete parking garage collapsed at the Northridge Fashion Center. A man working in a street sweeper was pinned underneath the collapsed structure for about nine hours until he was rescued.

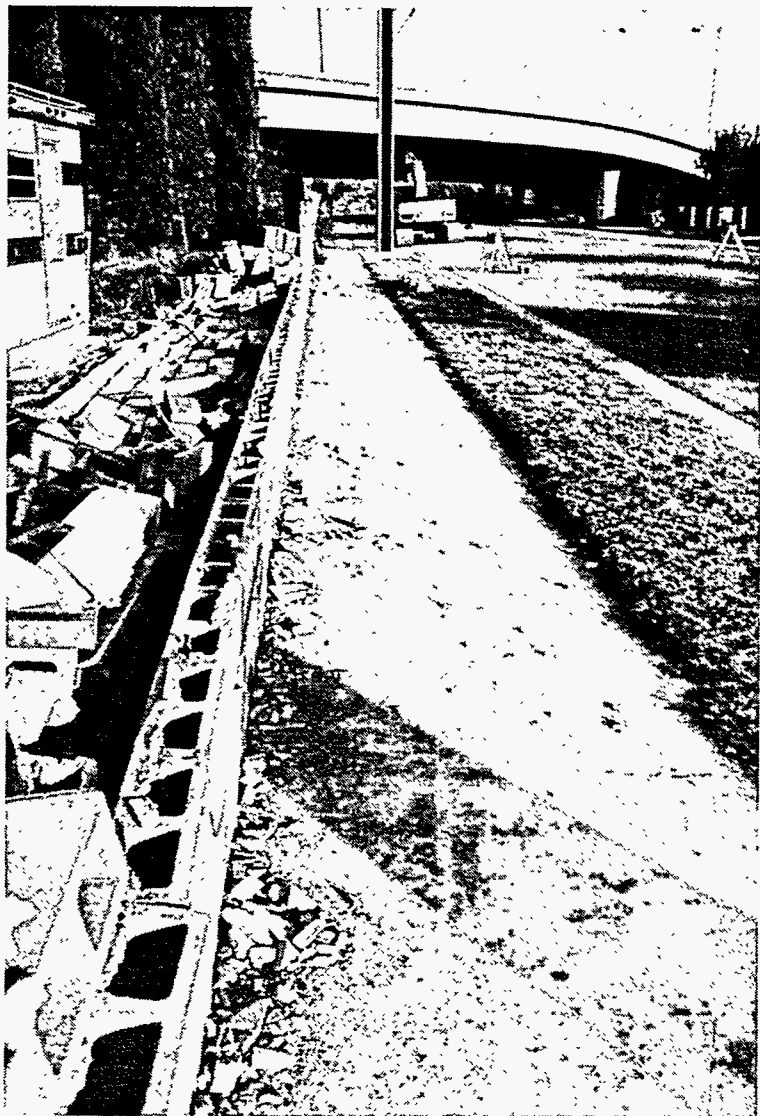
As has been typical in past earthquakes, unreinforced masonry (URM) buildings did not perform well. Figure 1.2-10 shows evidence of large diagonal cracks in the masonry wall of a URM building in Santa Monica. An out-of-plane-bending failure in a URM building is shown in Figure 1.2-11. Throughout the epicentral region, there were also widespread occurrences of typical earthquake damage including broken glass, fallen chimneys, and fallen poorly reinforced block walls as shown in Figure 1.2-12.

Figure 1.2-12: Typical poorly reinforced concrete block wall that collapsed in the San Fernando Valley area. Note that there was no grout in the cells that had rebar, and that any rebar used did not have adequate overlapping splices.

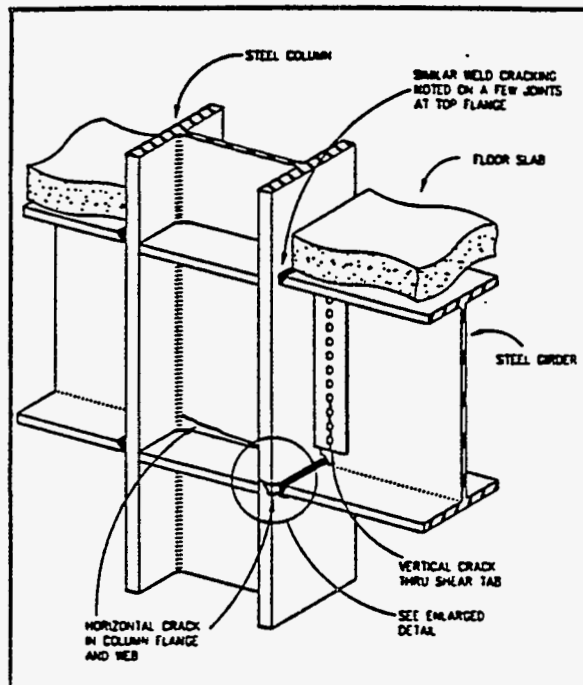
Figure 1.2-14: Typical damage to welded-flange, bolted-web connections of steel beams to steel columns in moment-frame buildings [ref 1.2-4].

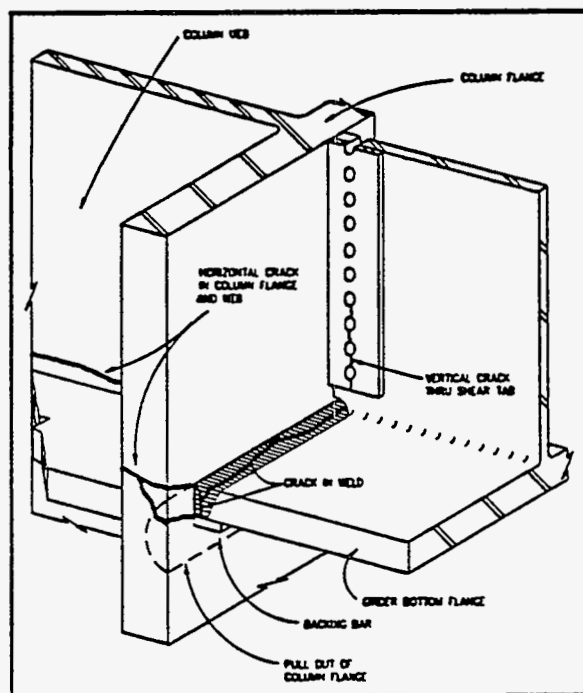
Figure 1.2-15: Enlarged detail of welded-flange, bolted-web connection damage [ref 1.2-4].

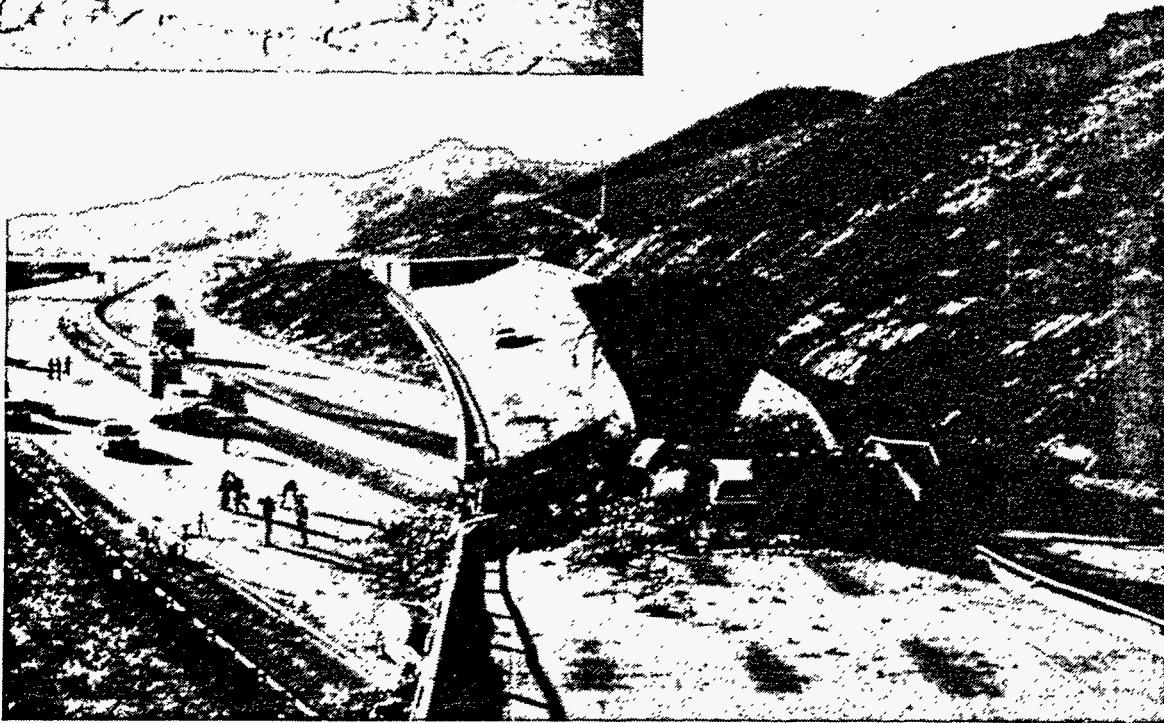
Figure 1.2-19: Collapse of I-5/SR-14 Separation and Overhead [ref 1.2-5].

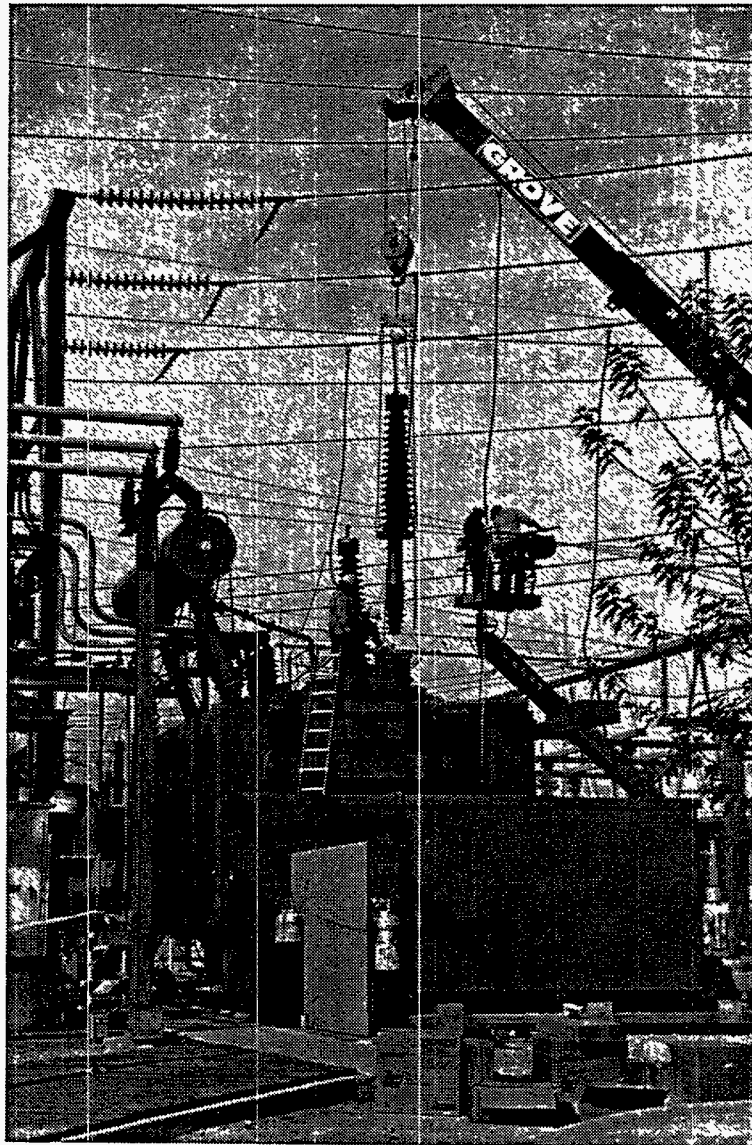
Figure 1.2-20a: Replacement of transformer bushing component at an electric power substation [ref 1.2-8].

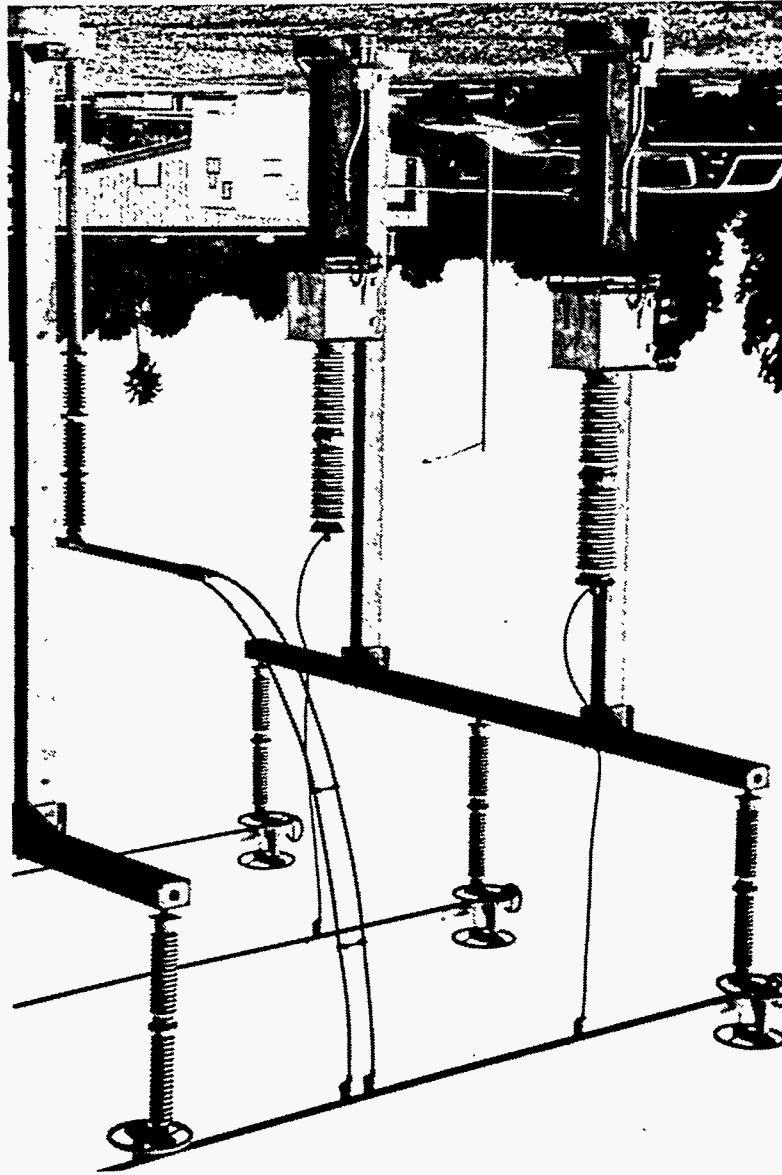
Figure 1.2-20b: At a substation in the epicentral region, buswork was suspended by chains which were attached to the top of the uppermost brittle ceramic insulators. During the earthquake, the buswork displacement exceeded the design drift limits of the ceramic / chain system with a resulting "unzipping effect" occurring as each successive chain broke. The repaired buswork is shown [ref 1.2-8].

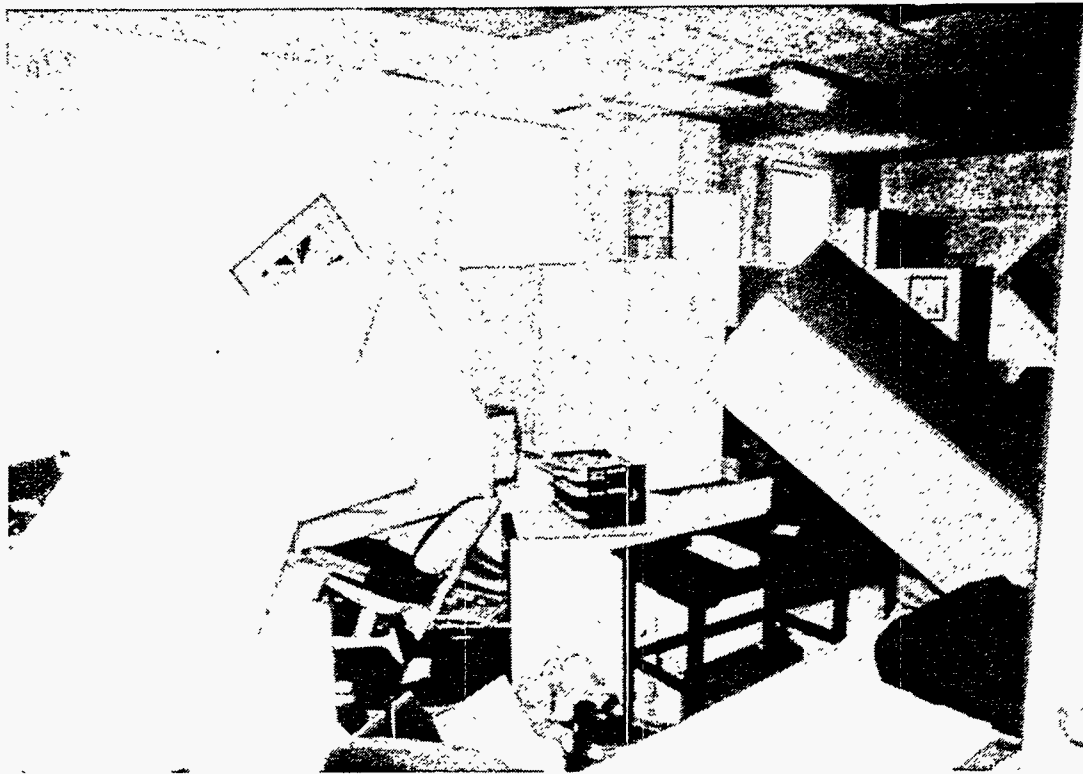
Figure 1.2-21: Typical nonstructural interior damage which caused a hospital to close [ref 1.2-5].

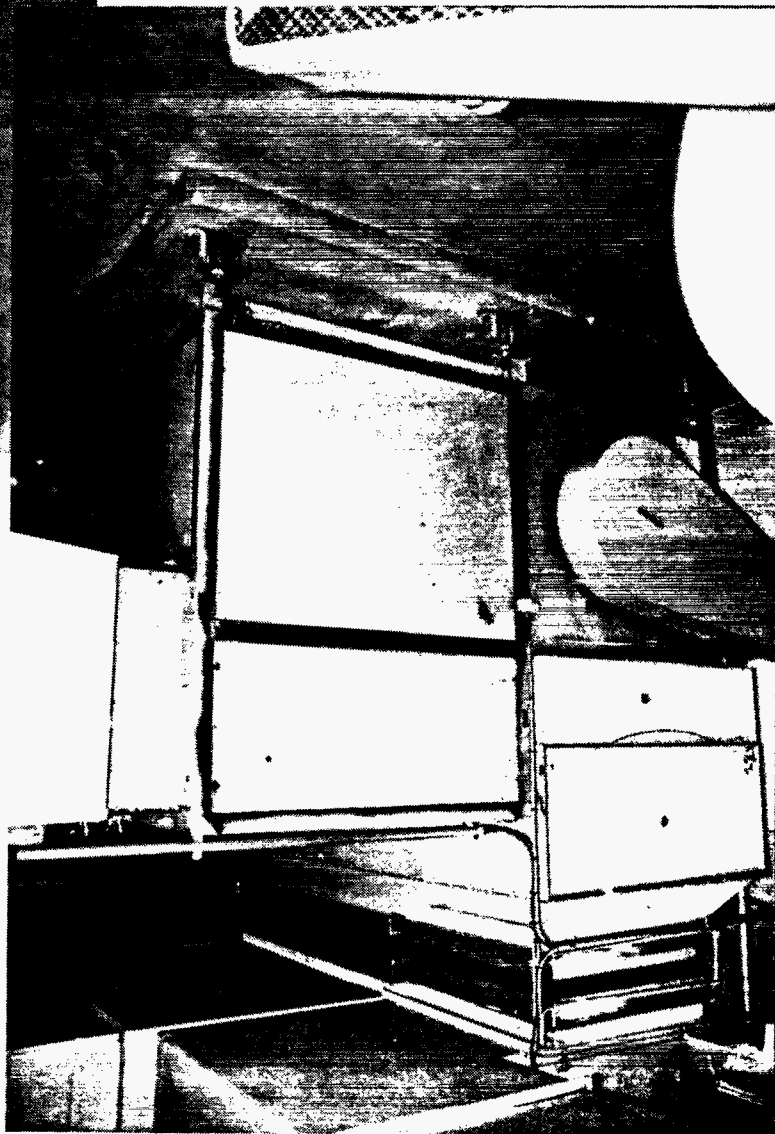
Figure 1.2-25: Close-up of air handler unit with failed vibration isolator detail that lack seismic bumpers.

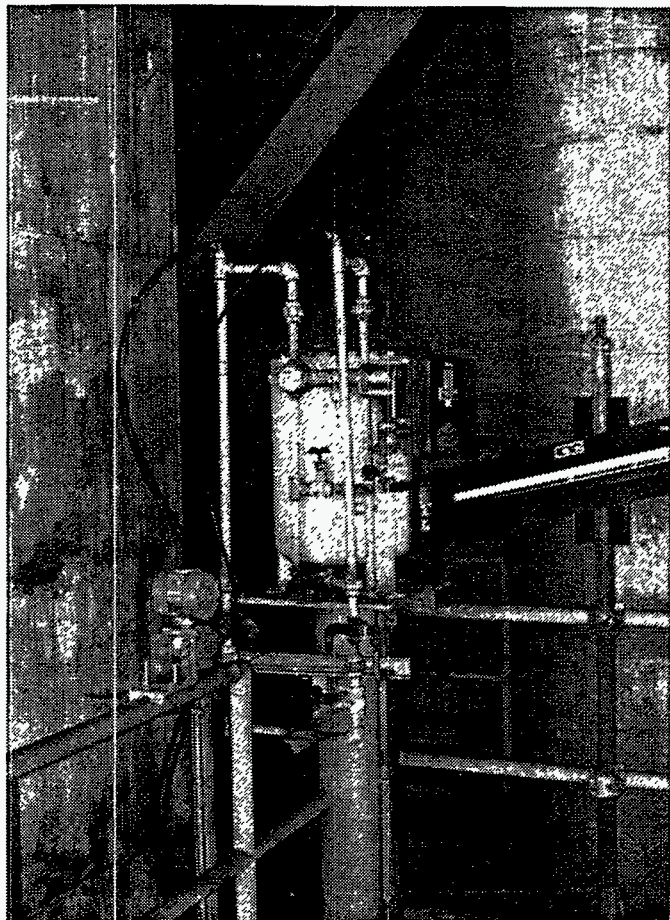
Figure 3.2.1-2: Mercury reservoir combustion air flow instruments (center) failed during the earthquake. Modern electronic transmitters (left) were installed to replace the much larger 1950's vintage hardware.

The facility sustained minor damage such as cracks in steel struts, a twisted wide flange support, distorted exhaust duct insulation panels, damaged piping insulation, inoperable combustion air instruments and superficial damage to building elements. Numerous relays had to be reset prior to restart. The damage did not prevent plant start-up.

The combustion air flow instrument failures are virtually identical to failures experienced at the plant during the 1971 San Fernando Earthquake and at the Pasadena Power Plant during the 1987 Whittier and 1991 Sierra Madre Earthquakes. The large mercury reservoir displacer dislodges from its slip-fit into a mechanical lever. Modern electronic differential pressure instruments were installed rather than repair the existing hardware (Figure 3.2.1-2). Parts were available since replacement of mercury reservoir instruments was planned for the near future.

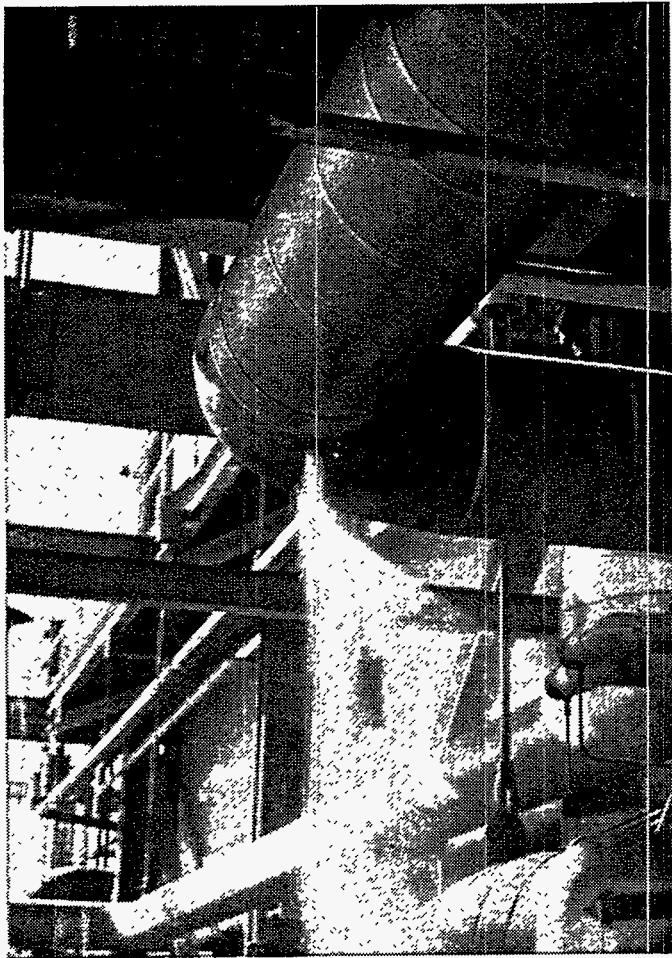
Upon restart, leakage in a 6 inch diameter welded steel condensate line was noticed (Figure 3.2.1-3). The leak occurred at the bottom of a butt-welded elbow in an area that is commonly prone to corrosion and erosion. The leak was small and did not prevent full operation of the plant.

Ultrasonic testing was performed several weeks later and wall thickness degradation due to erosion was determined to be the probable cause. A weld backing ring inside the pipe, used to align sections and facilitate full penetration welding, may have contributed to the erosion pattern. The shaking probably initiated a leak that would have developed in the near future regardless of the earthquake.

Figure 3.2.1-3: A leak developed in the elbow of a 6 inch diameter welded steel condensate line during post-earthquake restart. The leak was the result of long term erosion and would have developed regardless of the earthquake.

An 18 inch long temporary patch was welded to the line as a short term repair. The elbow and several feet of adjacent piping will be replaced when the plant is down for maintenance. Such repairs are common in fossil-fueled power plants.

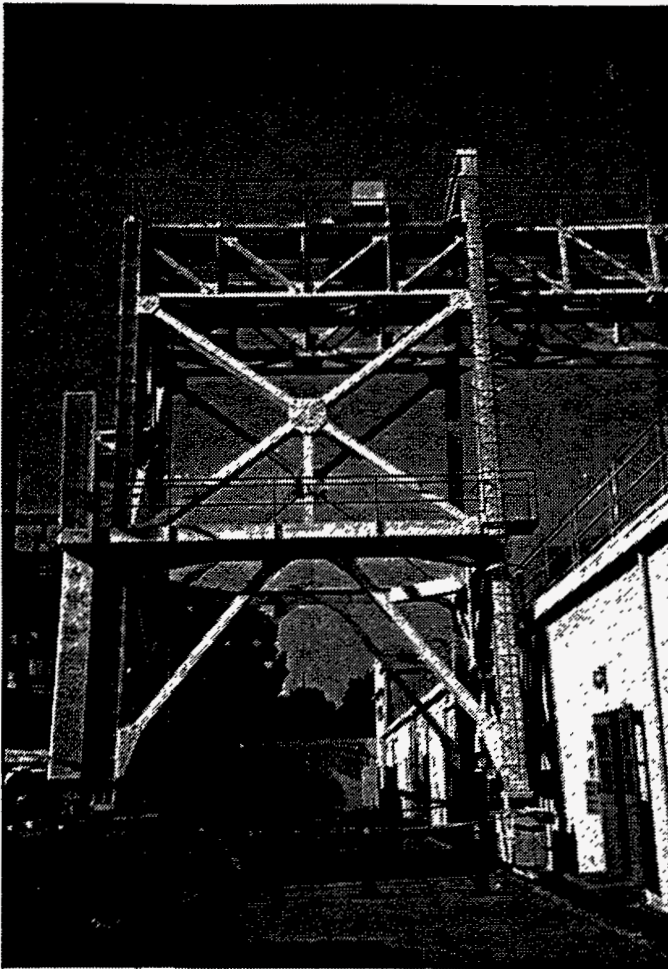
Several 1-1/4 inch bolts connecting the base of the Magnolia Unit gantry crane to the rail wheel assemblies failed (Figures 3.2.2-2 and 3.2.2-3). The crane hoist is cantilevered from the frame structure approximately 60 feet above the connection. The crane did not disengage from the rails but was inoperable. The same failure occurred during the 1971 San Fernando Earthquake [ref 3.2-5].

Figure 3.2.2-2: Several 1-1/4 inch bolts connecting the base of the Magnolia Unit gantry crane to the rail wheel assemblies failed.

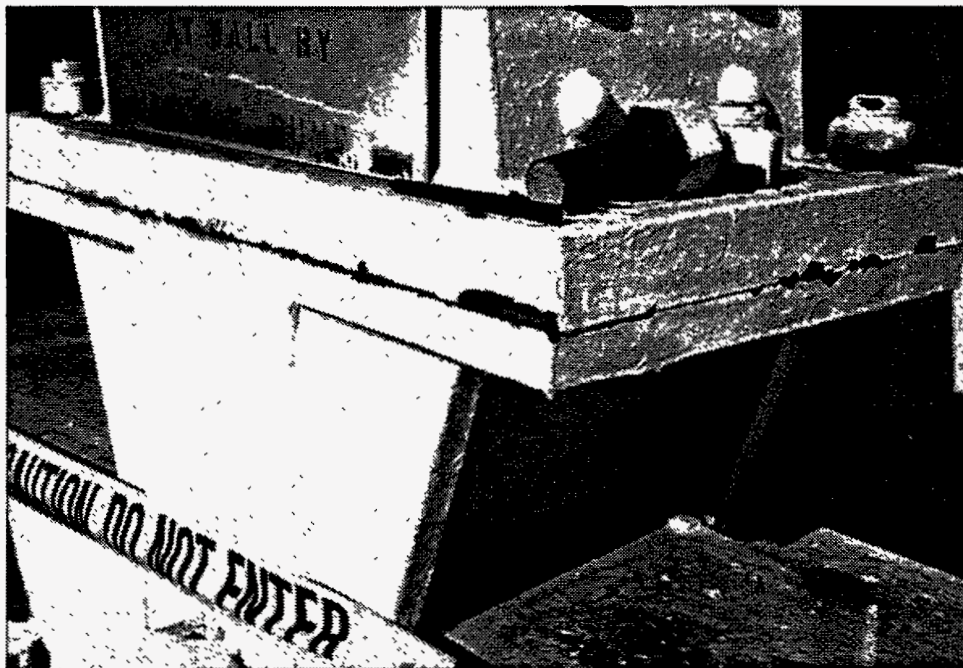
Figure 3.2.2-3: Close up of failed gantry crane bolts. Similar failures occurred during the 1971 San Fernando Earthquake.

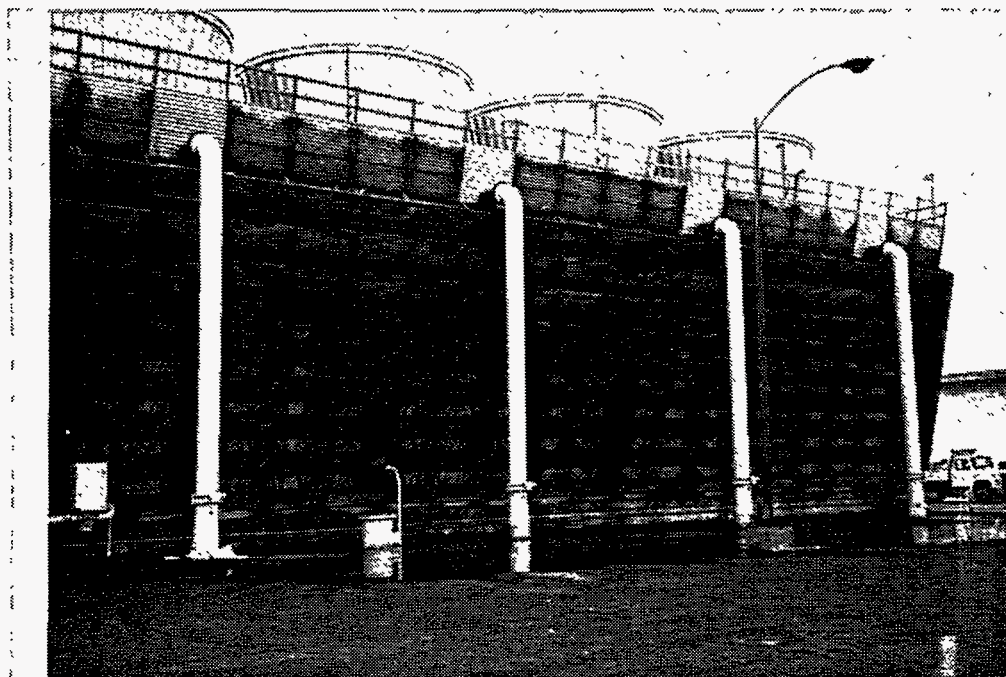
Two out of five 24 inch diameter cooling tower inlet risers ruptured at the point where they come out of the ground (Figures 3.2.3-2 and 3.2.3-3). The other lines showed significant corrosion at the same location. The cement lined inlet lines reduce from 24 inch at the ground to 20 inch before a valve. The spiral welded steel pipe continues up about 30' to flanged and supported connections at the top. Rupture was caused by displacement of the 50' by 150' by 40' high cooling tower. The cooling tower remained in operation. Prior to the earthquake, there were plans to add concrete anchors at the bottom of the lines but they were not yet in place.

Figure 3.2.3-2: 50' by 150' by 40' high cooling tower that displaced, resulting in the rupture of two of the 24 inch risers.

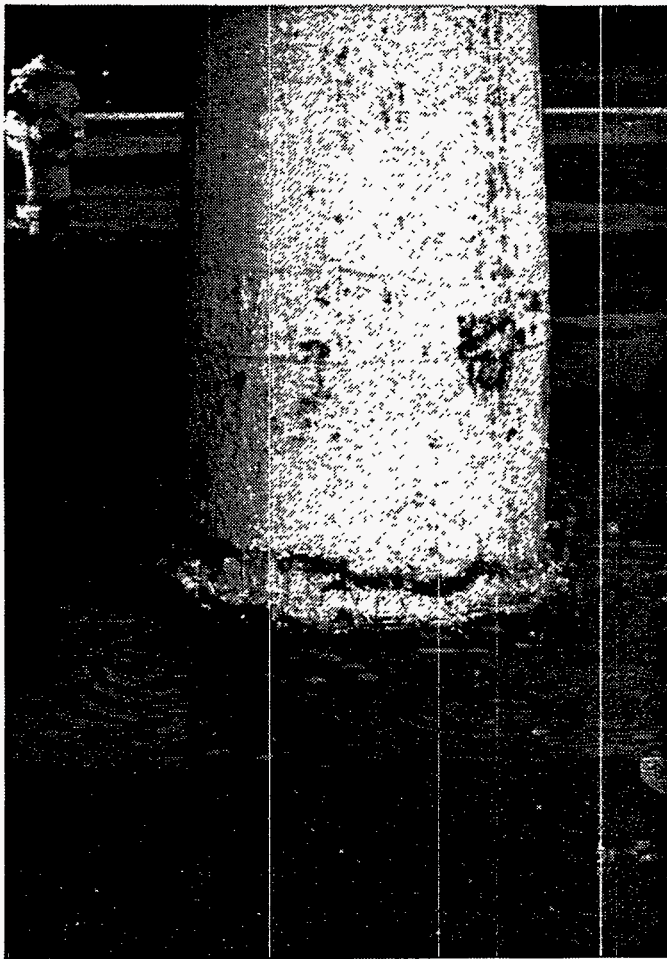
Figure 3.2.3-3: Failures occurred at grade level (before earthquake induced settlement) where corrosion from the standing water degraded the pipe.

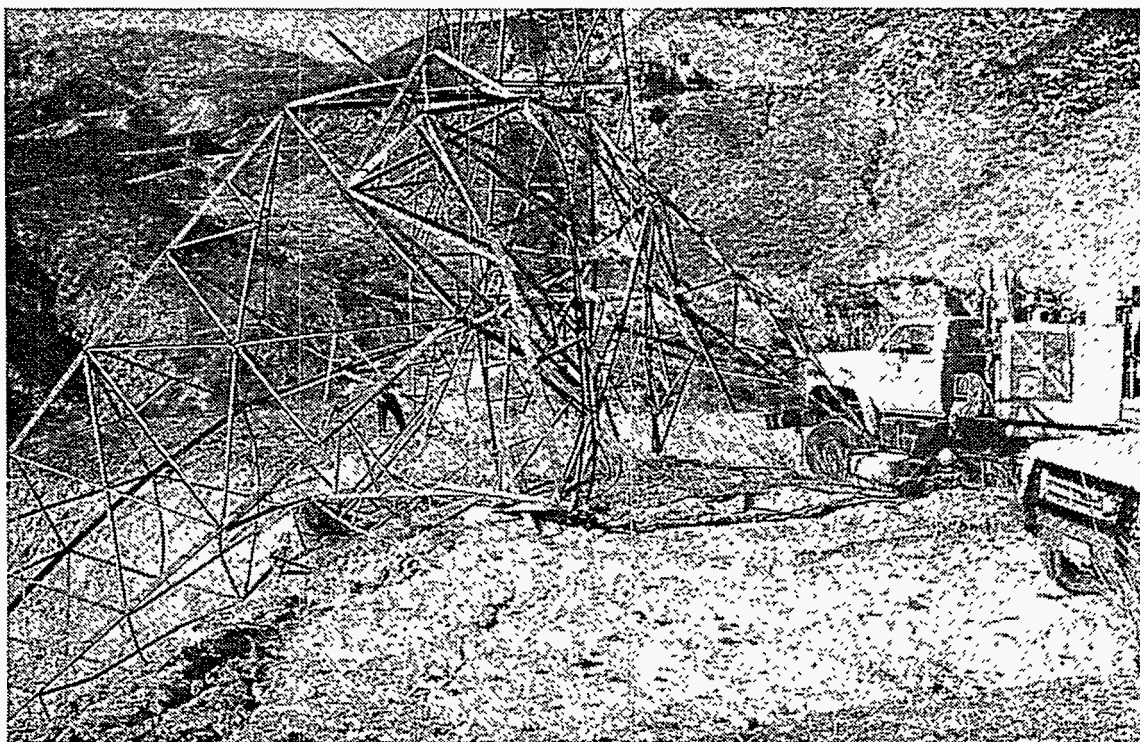
Figure 3.3-2: Several electrical transmission towers failed during the earthquake. Foundation distress was observed at most of the failed towers [ref 3.3-1].

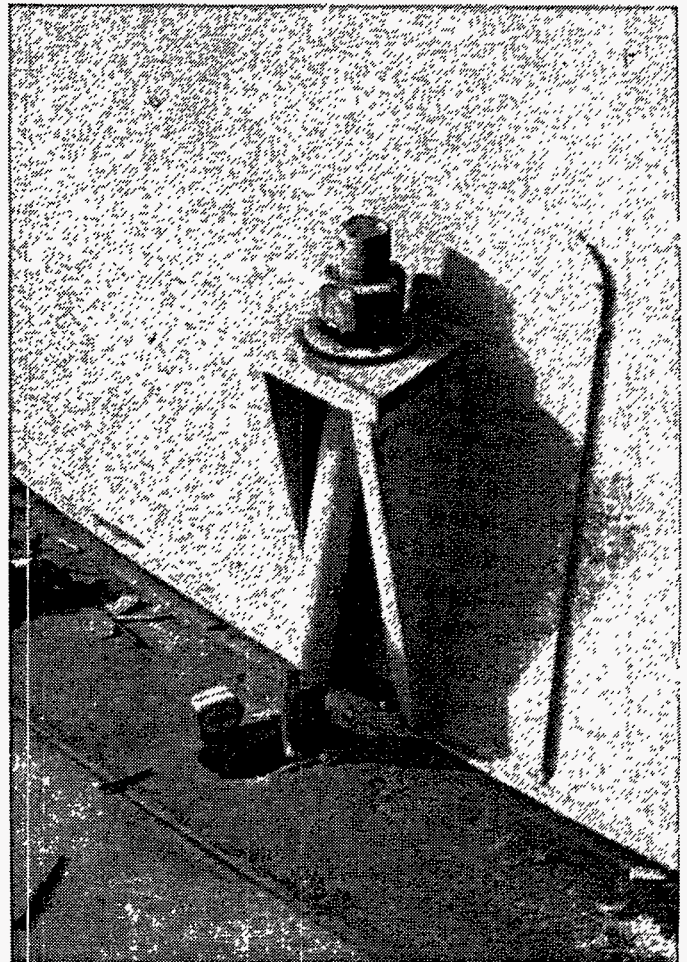
Figure 4.1.1-2: View of the fire water tank showing a deformed bolt sleeve.

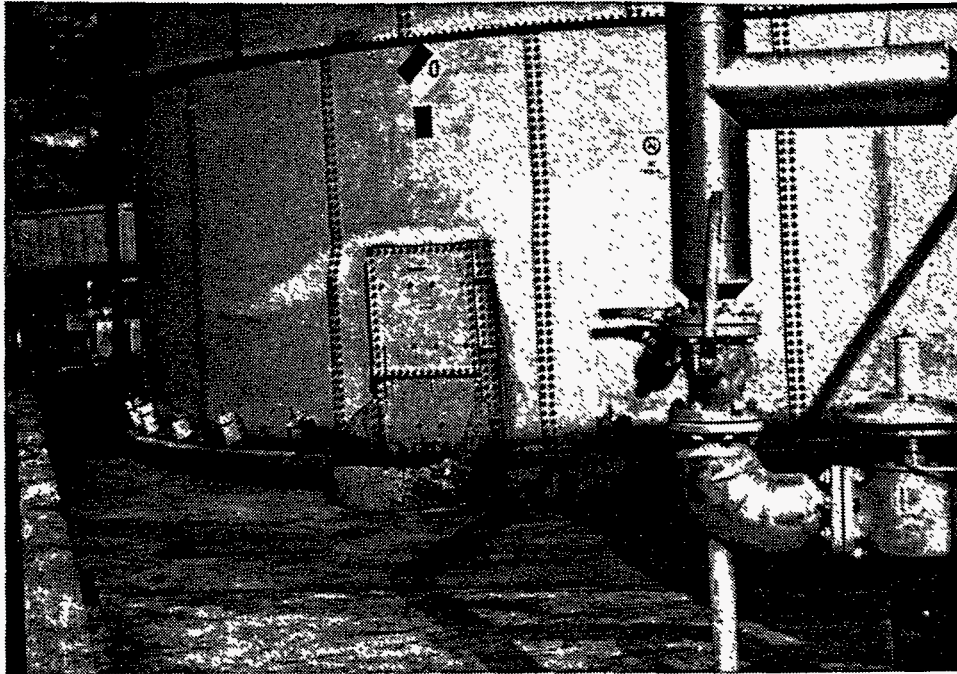
Figure 4.1.1-3: This oil field reclaimed water tank existed at the facility prior to developing the cogeneration plant. The 165,000 gal capacity bolted steel tank was anchored with numerous 3/4 inch anchor bolts. The anchor bolts pulled out and bent, the shell experienced elephant-foot buckling at the base, the foundation was damaged and small leaks developed at seams.

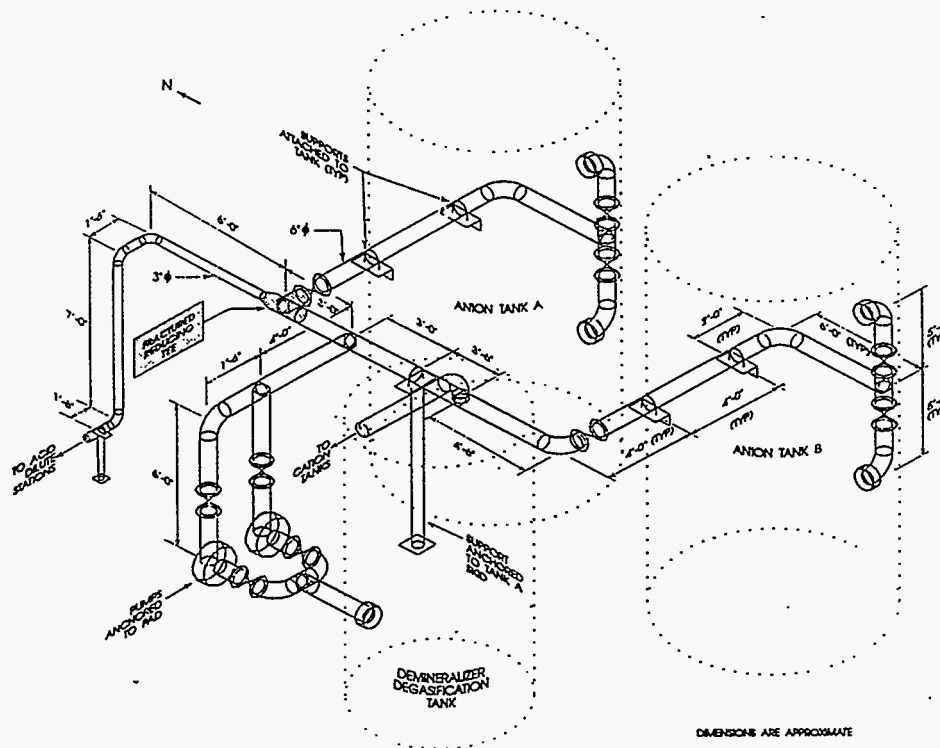
Figure 4.1.1-5: Sketch of the AES Placerita Canyon demineralizer piping and vessel arrangement. The shaded area shows the location of a fractured 6 inch diameter cast-iron fitting.

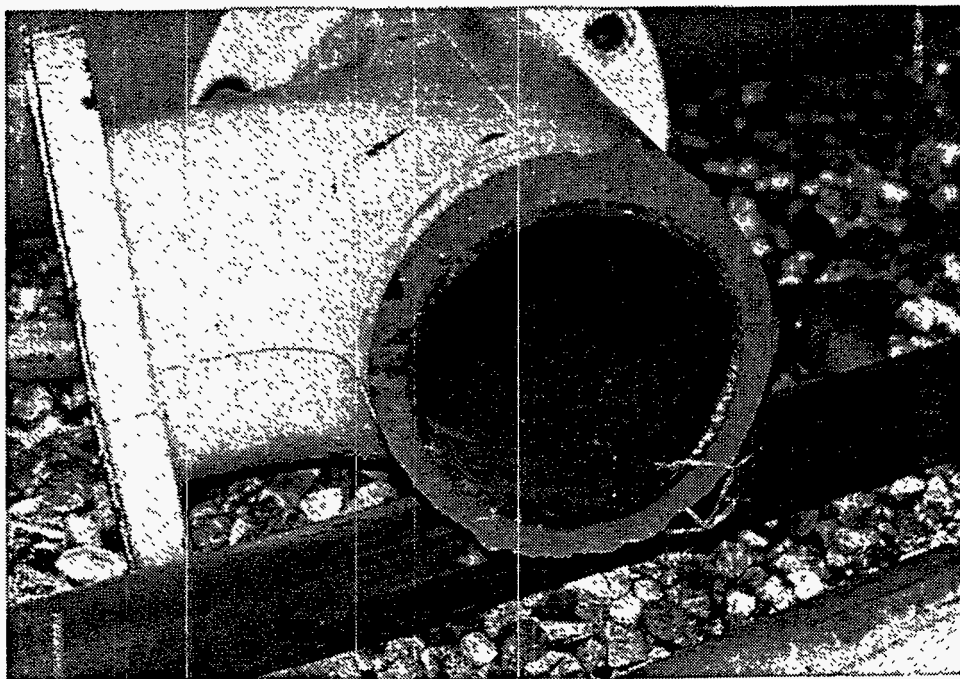
Figure 4.1.1-6: Anchorage failure and displacement of demineralizer skids resulted in failure of several cast iron water pipe fittings.

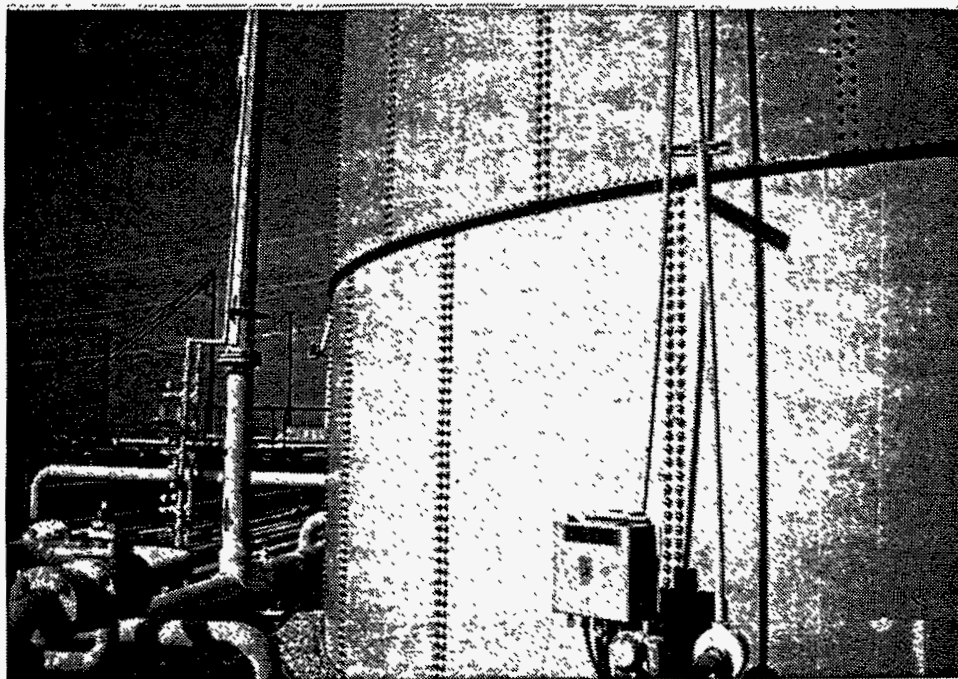
Figure 4.1.2-1: Unanchored bolted steel storage tank following replacement of the bottom course.

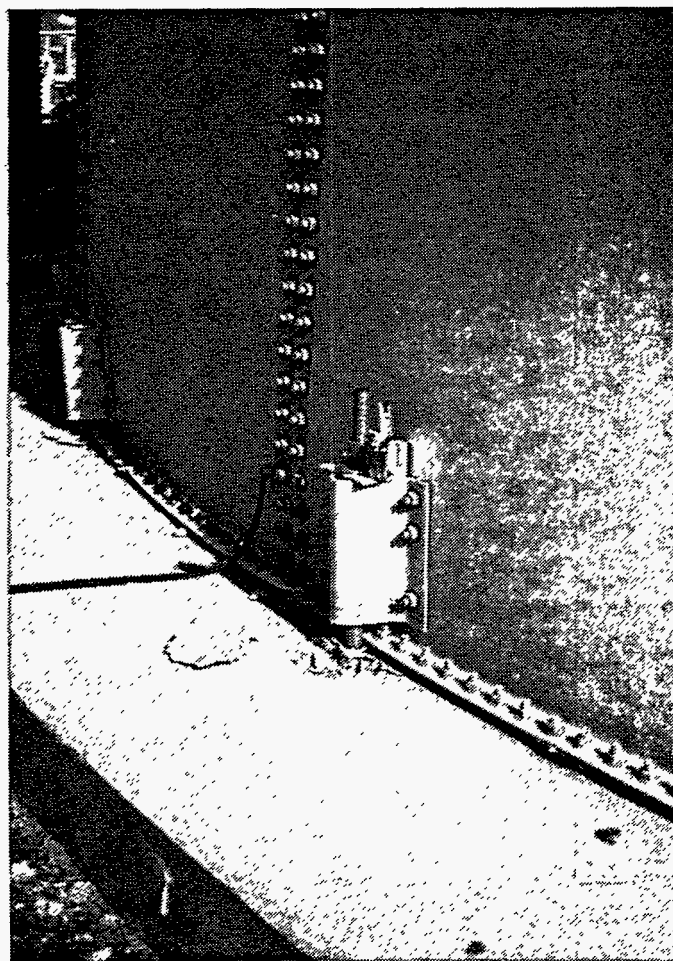
Newer tanks anchored to engineered foundations survived the earthquake without failure. Anchor bolts were, however, challenged as shown in Figure 4.1.2-3.

Figure 4.1.2-3: Anchor bolts on newer engineered tanks were challenged.

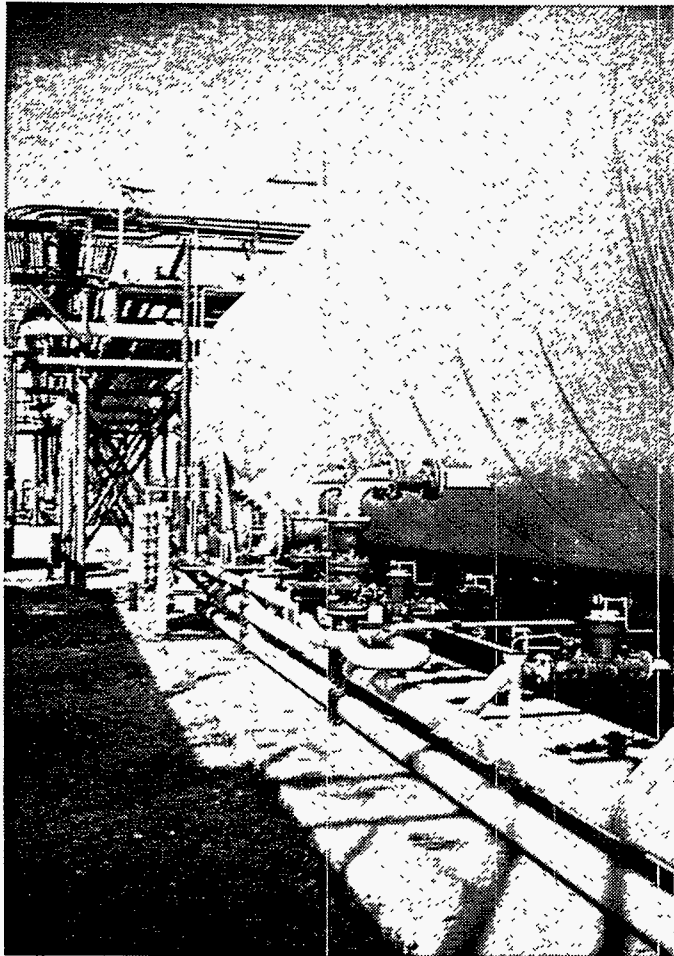
Figure 4.1.2-4: The 500,000 lbs vessel sheared anchor bolts and moved up to 6 inches. Flexibility of attached piping prevented system failure.

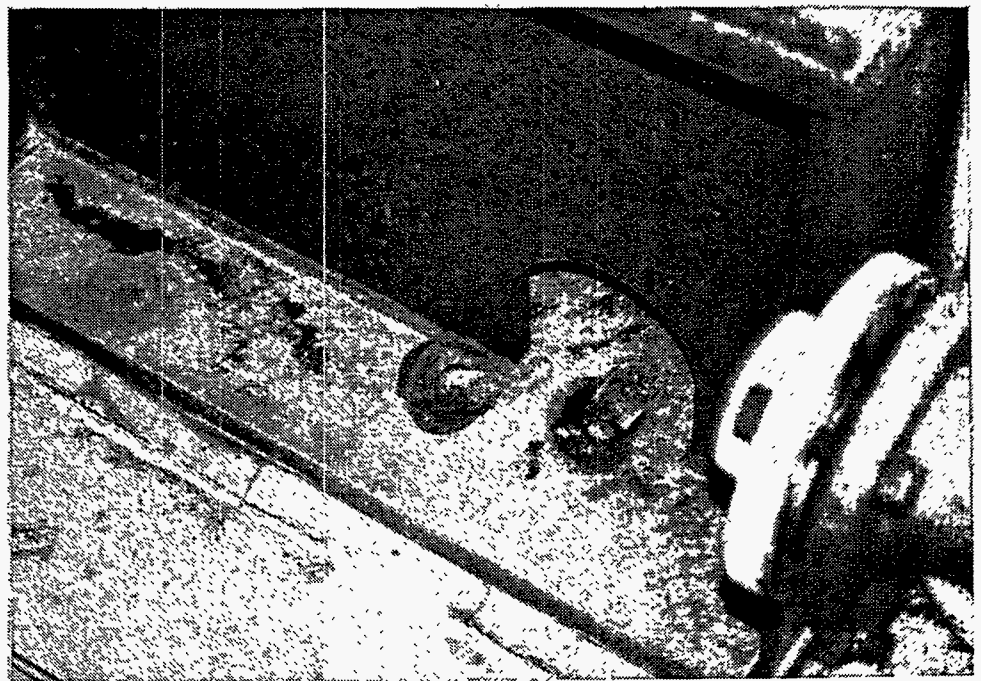
Figure 4.1.2-5: Close-up view of sheared bolt at vessel foundation.
