The January 17, 1994 Northridge Earthquake: Effects on Selected Industrial Facilities and Lifelines

**Mark W. Eli
Stanley C. Sommer
Thomas R. Roche
Kelly L. Merz**

February 1995

United States Department of Energy
United States Nuclear Regulatory Commission

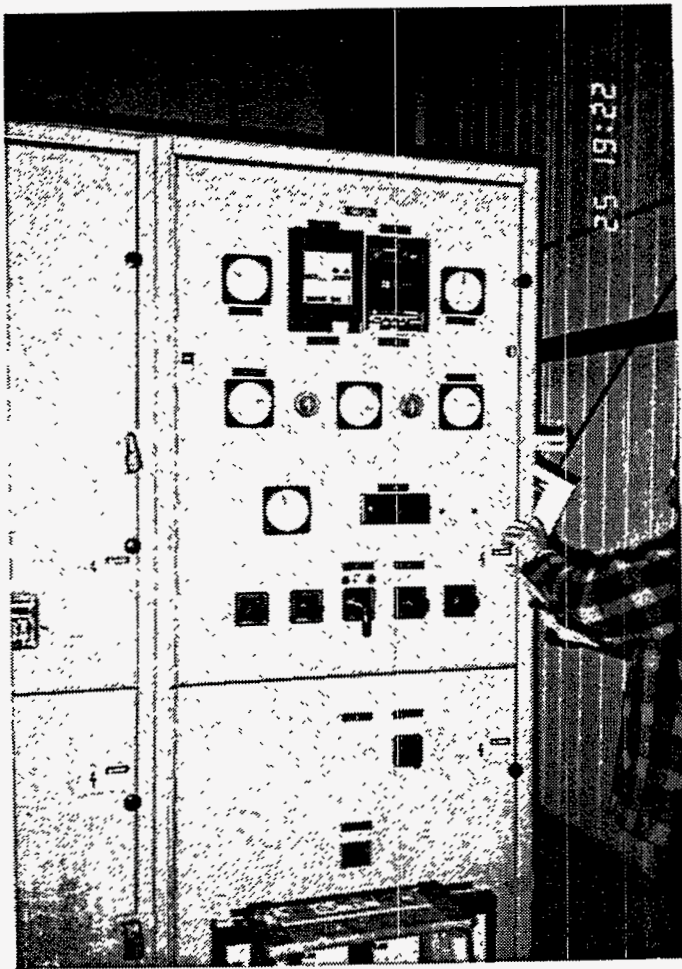
Figure 4.1.3-1: 12.5 kV circuit breaker that would not reset, preventing restart following the earthquake.

Figure 4.1.3-2: The breaker could not be racked due to misalignment of the rails. Springs dislodged from the sliding rails due to missing retaining clips.

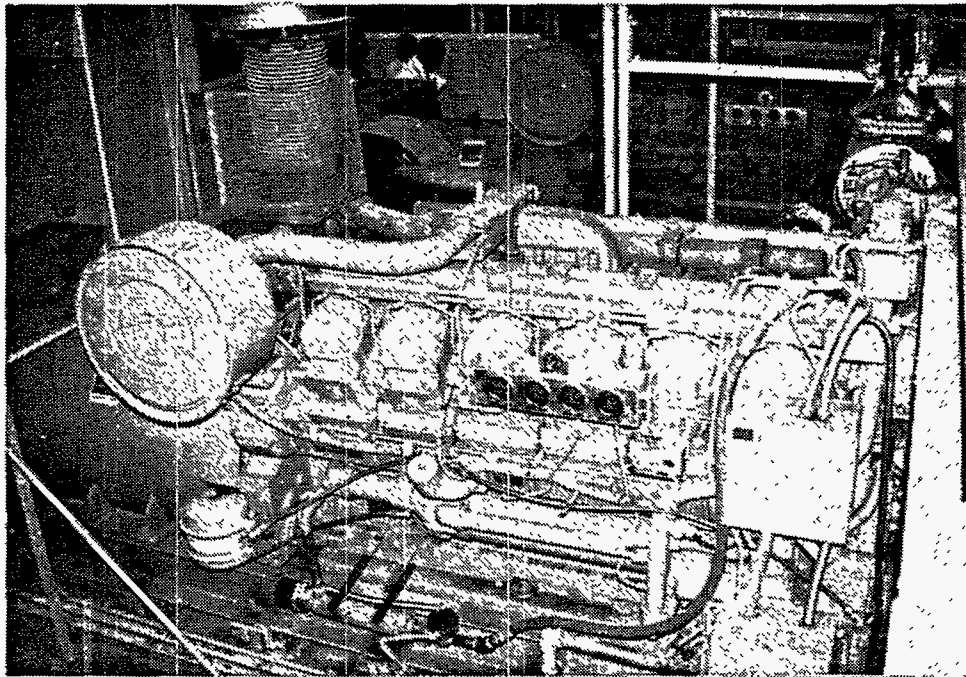
Figure 4.1.4-1: Olive View Medical Center and Power Plant Emergency Generators - the generators started and supplied power to the hospital until the day tank ran out of fuel.

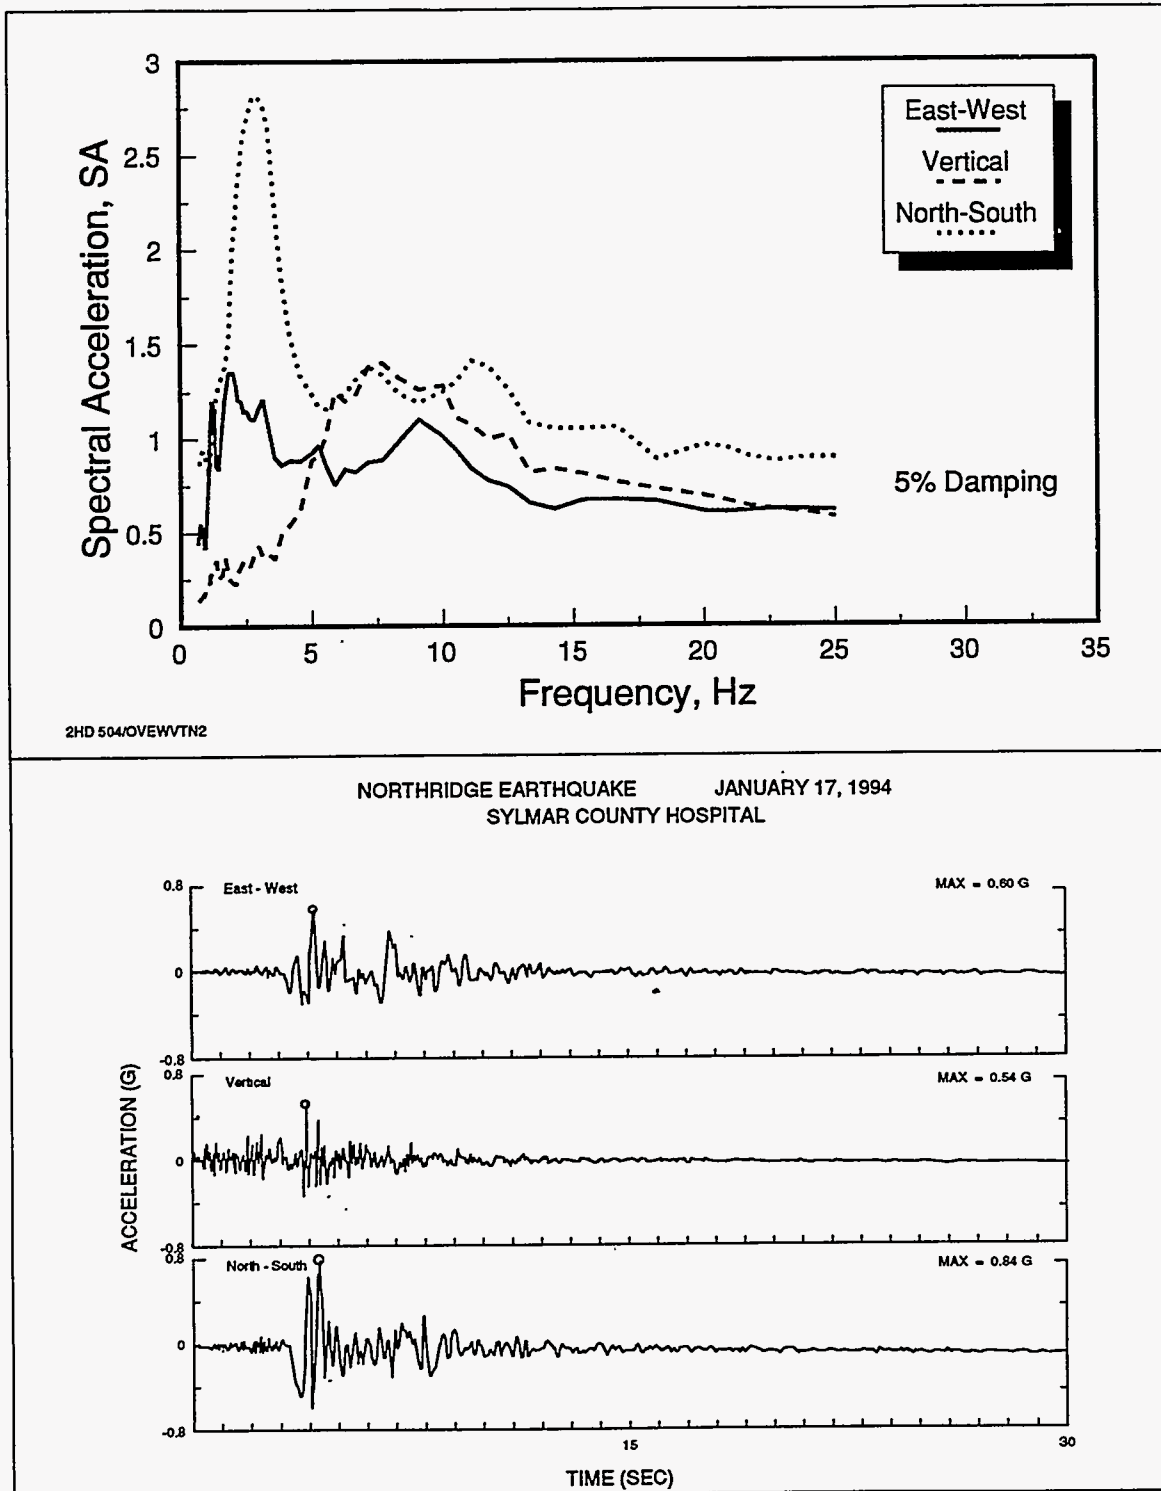
A CSMIP instrument, located less than 100 ft from the plant, recorded peak free-field ground acceleration of 0.91g horizontal and 0.6g vertical [ref 4.1-2]. Figure 4.1.4-2 presents the accelerograms and response spectra plotted at 5% damping for the Sylmar County Hospital record [ref 4.1-4]. The six-story hospital building is also instrumented under the CSMIP program. The roof instruments recorded over 2g peak horizontal acceleration. As discussed in Section 4.2.3 of this report, there was failure of anchorage, vibration isolation mounts (with seismic restraints), and two 3 inch diameter cast iron control valves resulting in cooling water discharge.

Figure 4.1.4-2: Accelerograms and response spectra plotted at 5% damping for the Sylmar County Hospital.

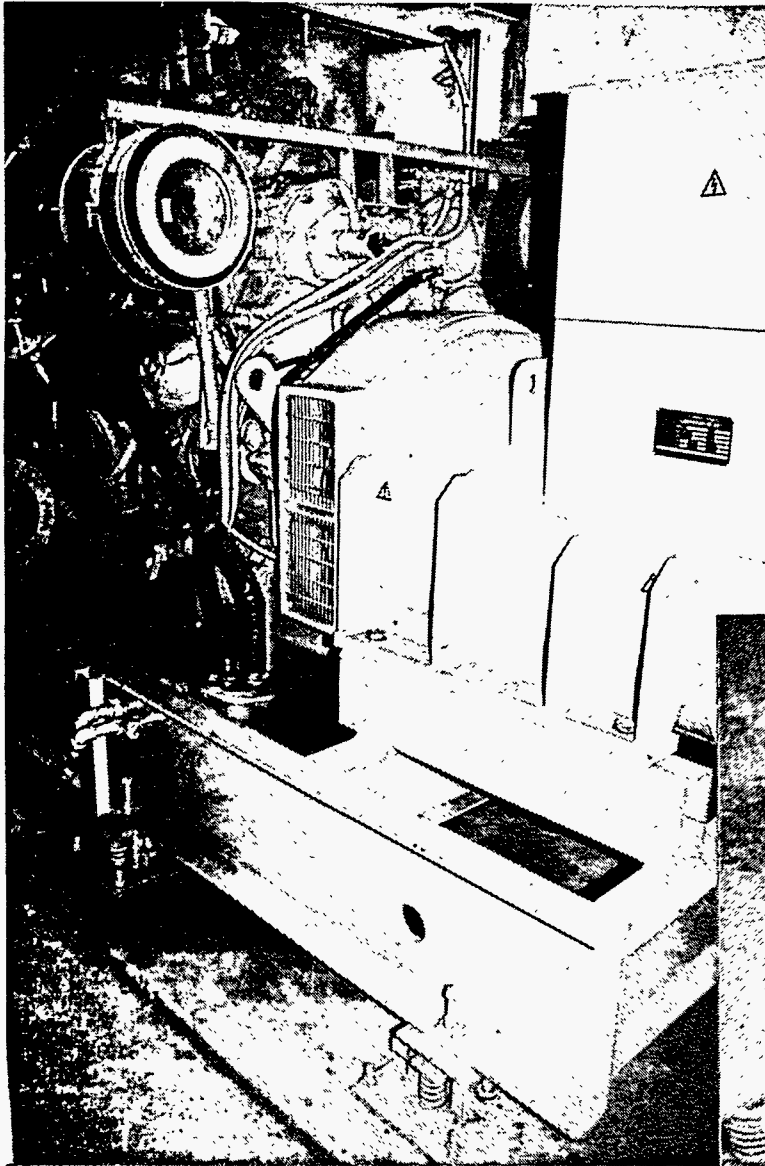
The emergency generator ran for about 20 minutes until the transfer switch was flooded. Even though the generator had no structural damage, it was inoperational because the electrical transfer switch had water damage and burned out. Figures 4.2-2a and 4.2-2b show the engine / generator set which had vibration isolators with seismic bumpers. These bumpers prevented excessive lateral motion of the engine / generator set.

Figure 4.2-2a: This engine / generator set is mounted on a common skid with vibration isolators that have seismic bumpers.

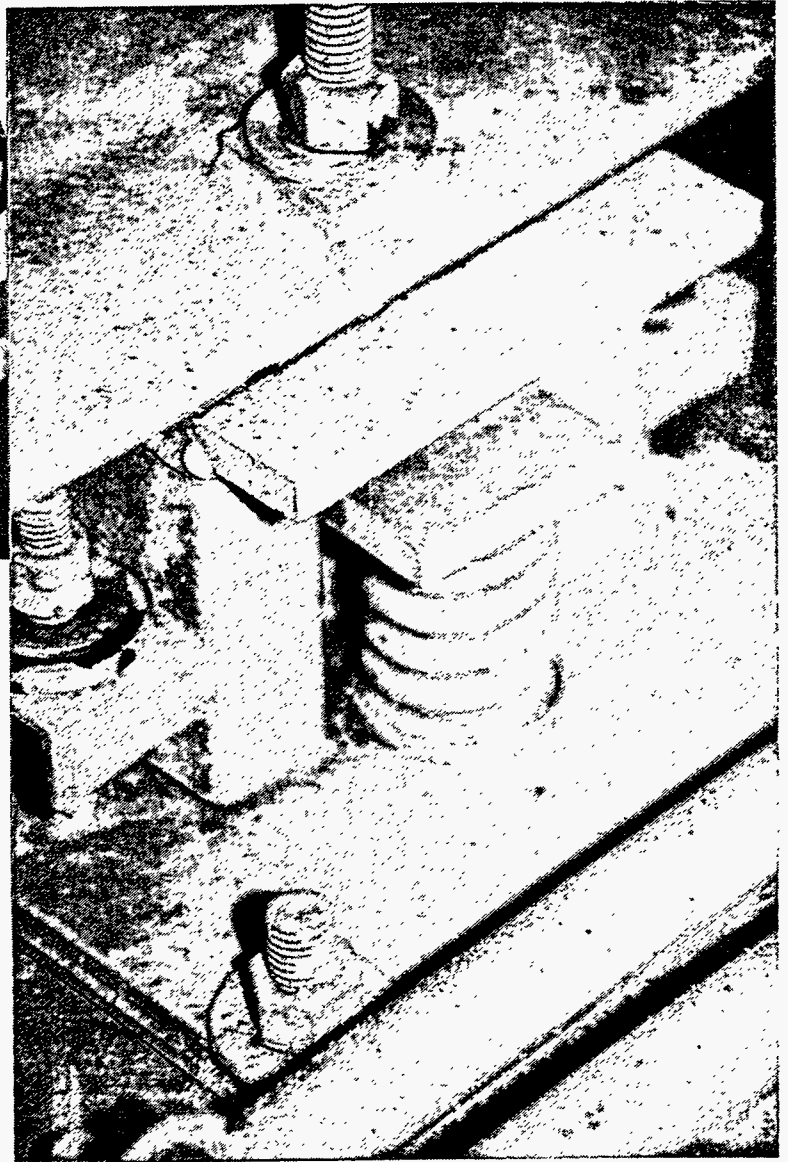
Figure 4.2-2b: Close-up view of vibration isolators with seismic bumpers.

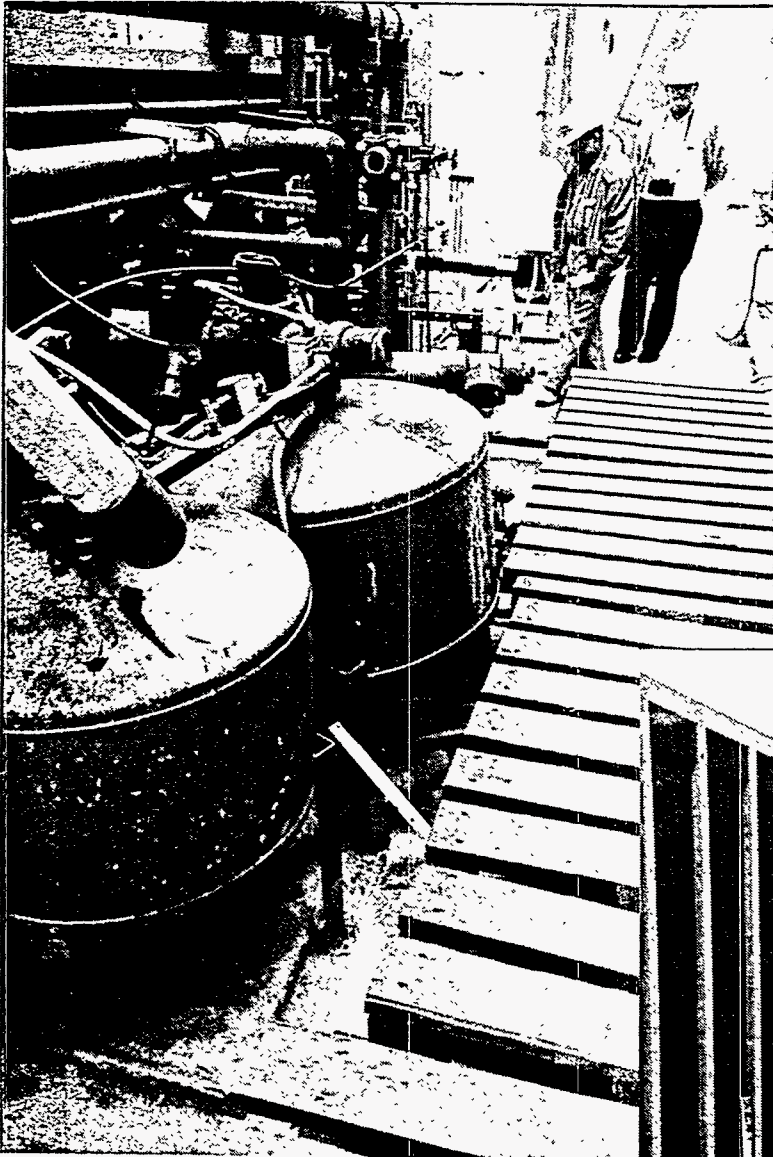
The 1.1 MWe cogeneration plant operated until the cooling tower lost its water contents. The ozone injection pipes (PVC) broke when the ozone tanks fell off their pedestals (see Figure 4.2-3a). It appears that the ozone tanks were unanchored. When the PVC pipes broke on the ozone injection lines, most of the water drained from the cooling tower on the roof down to the lower floors. The cooling tower was under repair for about 5 months.

Figure 4.2-3a: The ozone injection pipes (PVC) broke when the ozone tanks fell off their pedestals.

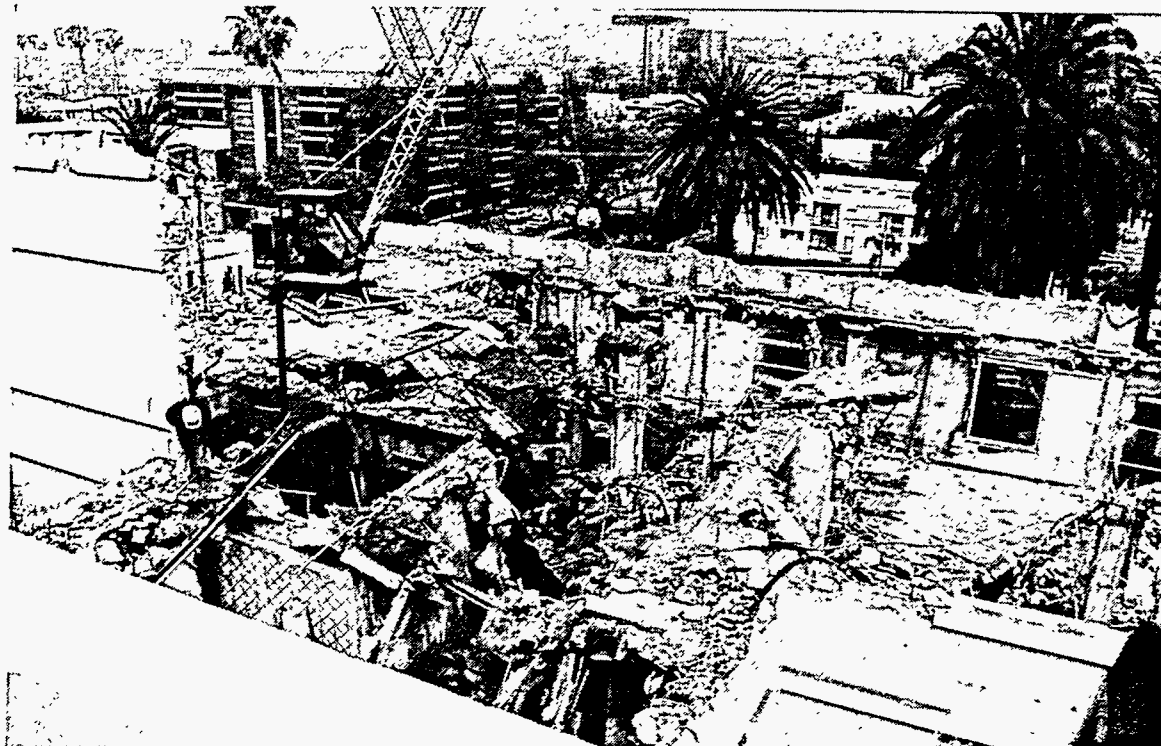
Much of St. John's Hospital is about fifty years old and has non-ductile reinforced concrete construction. The North wing at St. John's was already being demolished about 4 months after the Northridge Earthquake because of extensive diagonal cracking in the short piers between the windows on the second floor (see Figures 4.2-4a and 4.2-4b). The South wing at St. John's

Figure 4.2-4b: View of the roof of the North wing at St. John's Hospital as it is being torn down.

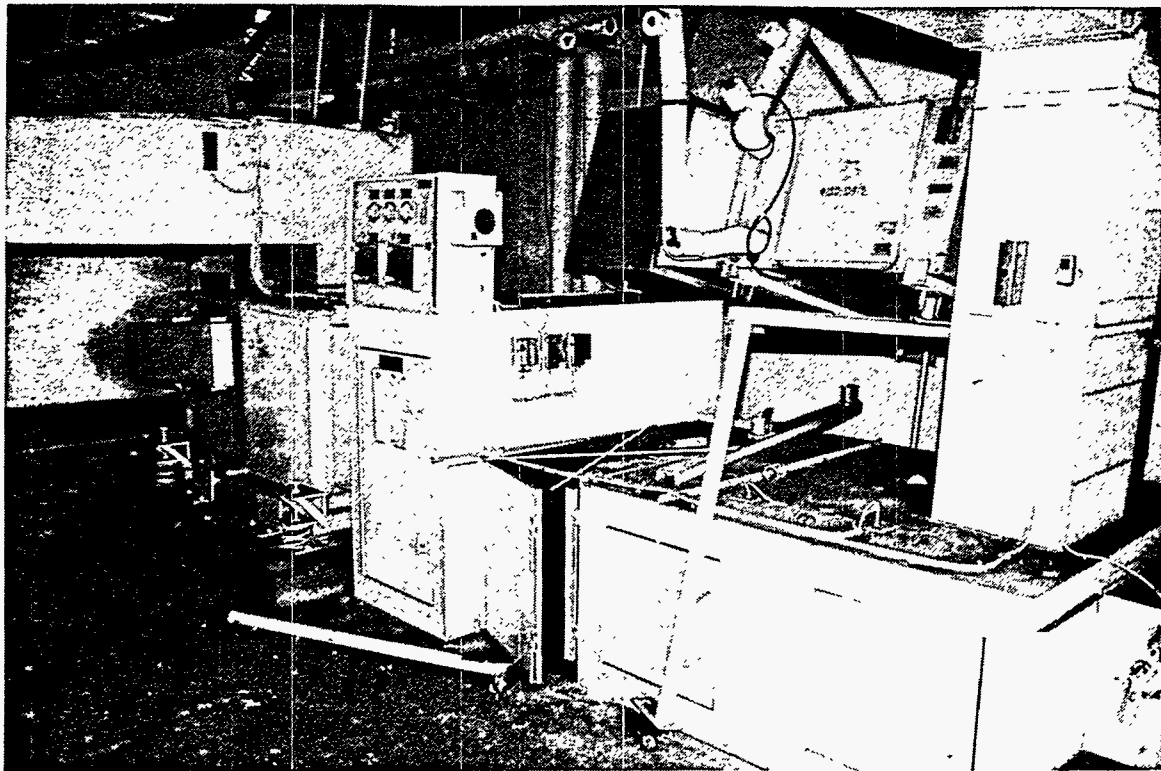
southwest wings moved out of phase with the central core of the hospital (Building 3) and resulted in pounding at the roof and penthouse level (see Figure 4.2-13). As a result, a fan came off of its support inside the penthouse (see Figure 4.2-14) and the north wing experienced diagonal cracking on the short piers between the windows at the 4th and 5th floors (see Figure 4.2-15).

Figure 4.2-14: As a result of the pounding between the wings of the building, a fan came off of its support inside the penthouse.

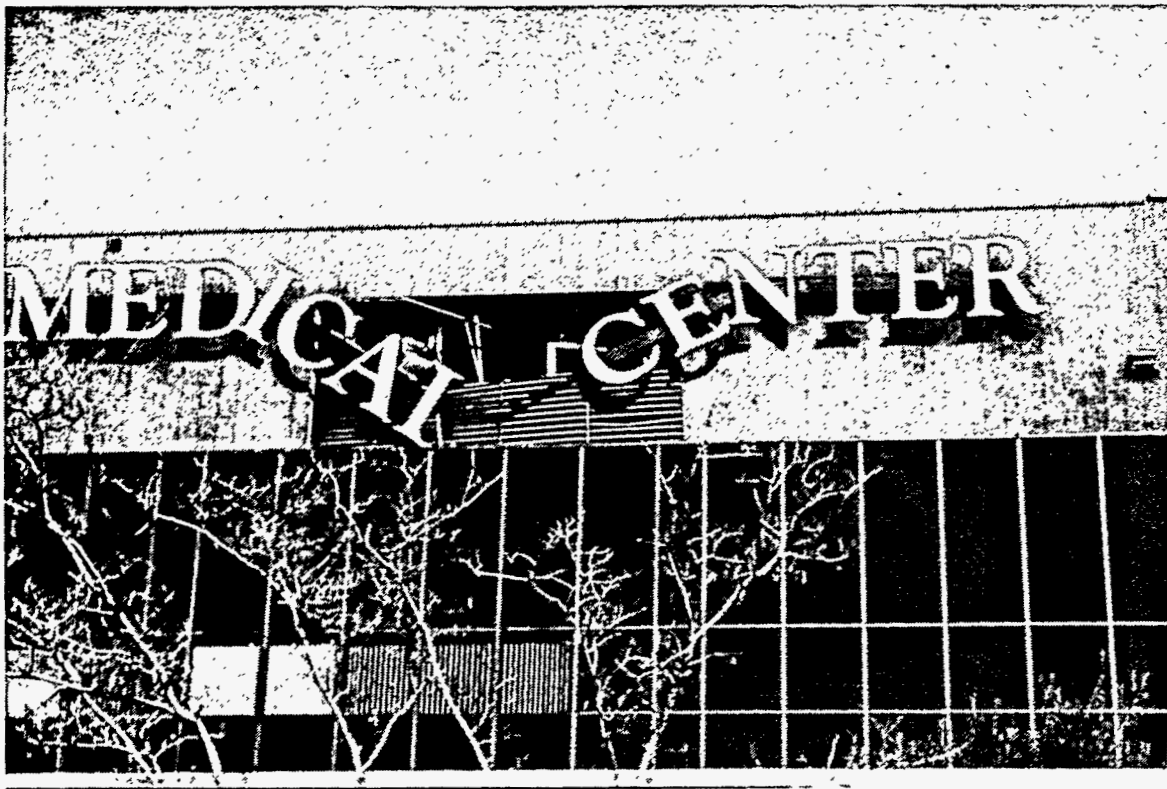
Holy Cross Medical Center is about 6 miles northeast of the epicenter. This facility was closed primarily due to HVAC systems that became inoperable as a result of the earthquake. At the penthouse level, suspended fans swung and impacted the exterior louver panels (see Figures 4.2-18 and 4.2-19). There was also extensive water damage from leaks in fire sprinklers and other HVAC piping [ref 4.2-5]. This site experienced about 0.5g horizontal ground acceleration.

Figure 4.2-18: At the Holy Cross Medical Center in Mission Hills, suspended fans at the penthouse level swung and impacted the exterior louver panels [ref 4.2-5].

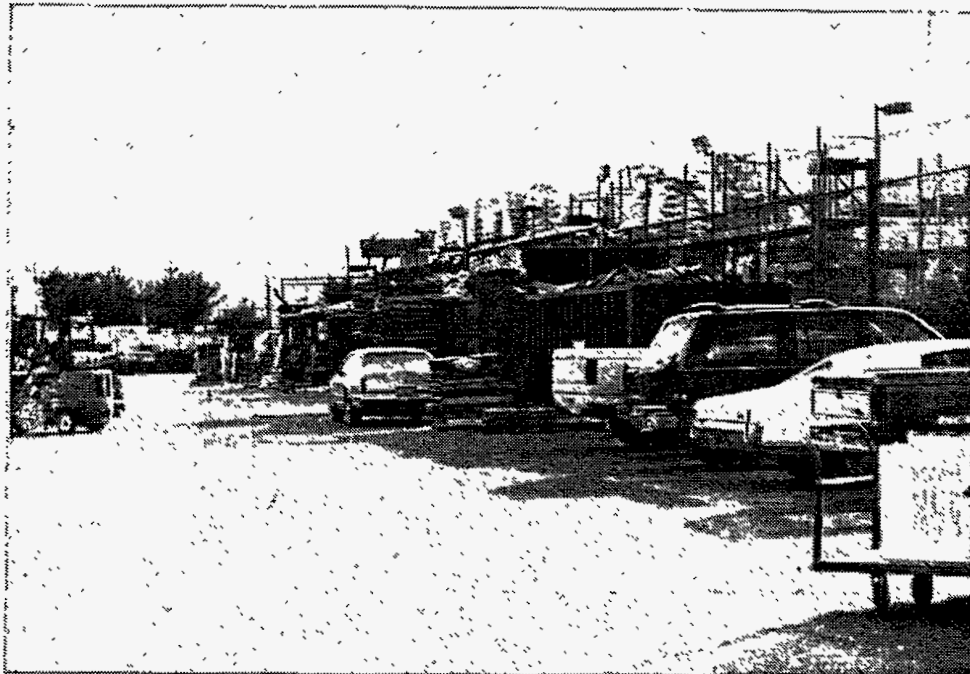
Racks located in warehouse style retail centers sustained similar failures. Figure 4.3-2 shows bins filled with damaged racks observed adjacent to a warehouse style home improvement center located within 5 km of the epicenter. The photo was taken after the center was cleaned up, new racks installed, restocked and opened to provide supplies for earthquake repairs. Some of the aisles were filled with heavy merchandise that toppled from racks on the morning of the earthquake. Serious injuries may have occurred had the earthquake struck during shopping hours.

Figure 4.3-2: Storage bins filled with damaged racks from a warehouse style home improvement center located within 5 km of the epicenter.

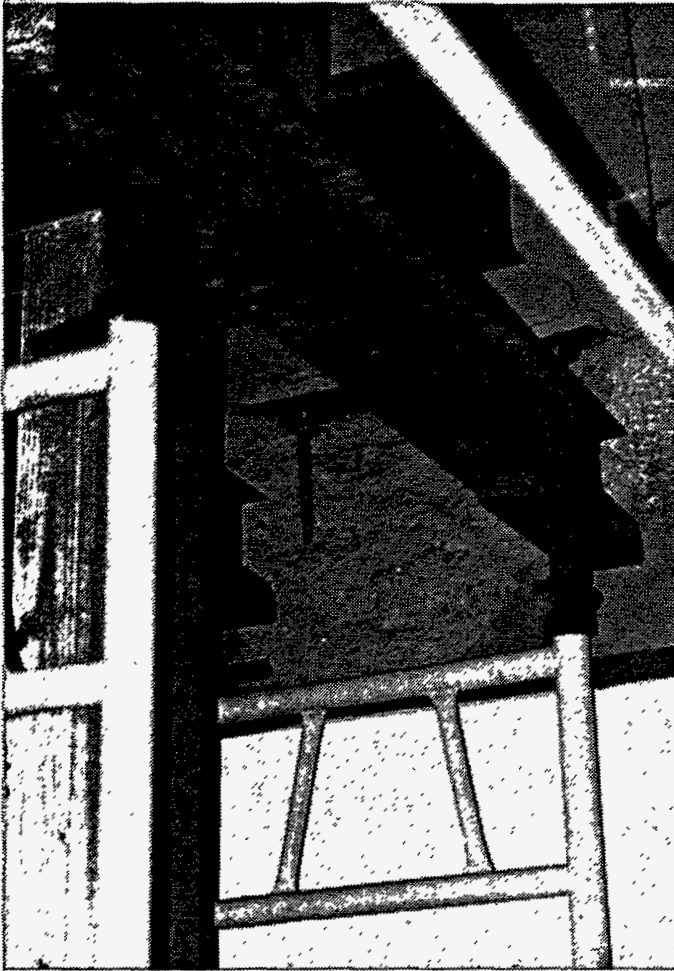
A large financial data processing center housed on a campus of modern tilt-up buildings sustained damage to connection details in several tilt-up buildings (Figure 4.3.1-1) and extensive damage to nonstructural elements. Items that were not restrained such as files, personnel computers and work stations fell to the floor.

Figure 4.3.1-1: Connections in several tilt-up buildings sustained damage, exposing rein-forcing steel and anchor bolts. Temporary supports were installed and operations moved to an alternate location.

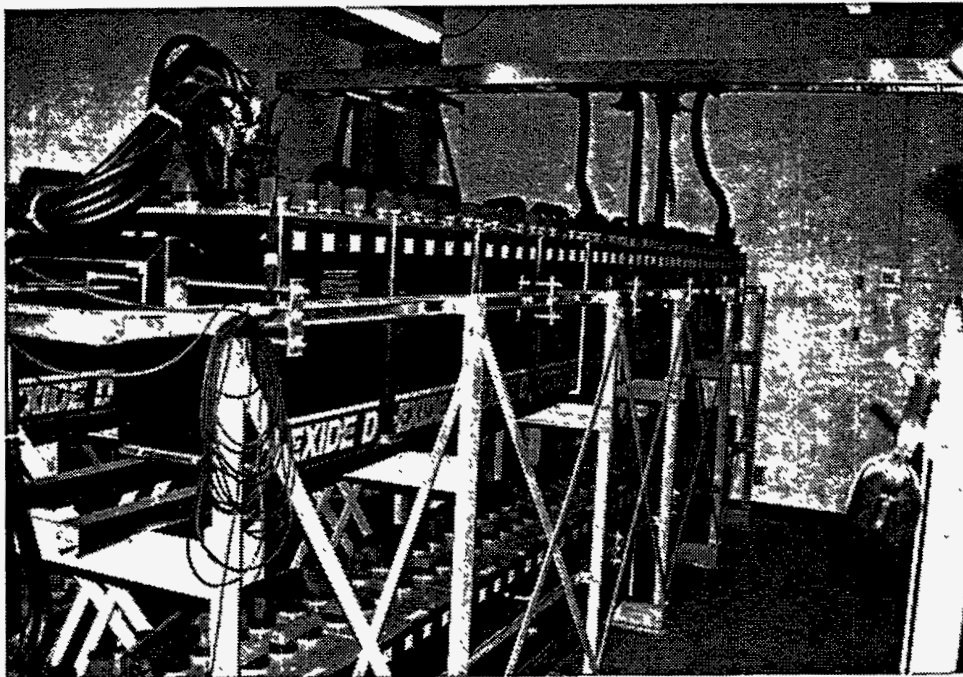
Figure 4.3.1-2: Engineered equipment such as these braced battery racks survived the earthquake. Minor pulling of battery rack anchor bolts was observed.

The uninterruptible power supplies (UPS) and associated equipment such as batteries (Figure 4.3.1-2), diesel generators and electrical gear performed almost without incident. HVAC systems sustained damage to roof-mounted equipment that was supported on vibration isolation mounts and to duct mounted units that were more flexible than their attached water lines. Figure 4.3.1-3 shows an HVAC unit that fell from its vibration mounts. Figure 4.3.1-4 shows a duct mounted cooling coil that displaced, pulling apart a copper cooling line from the coil. This was an additional source of water damage in many facilities.

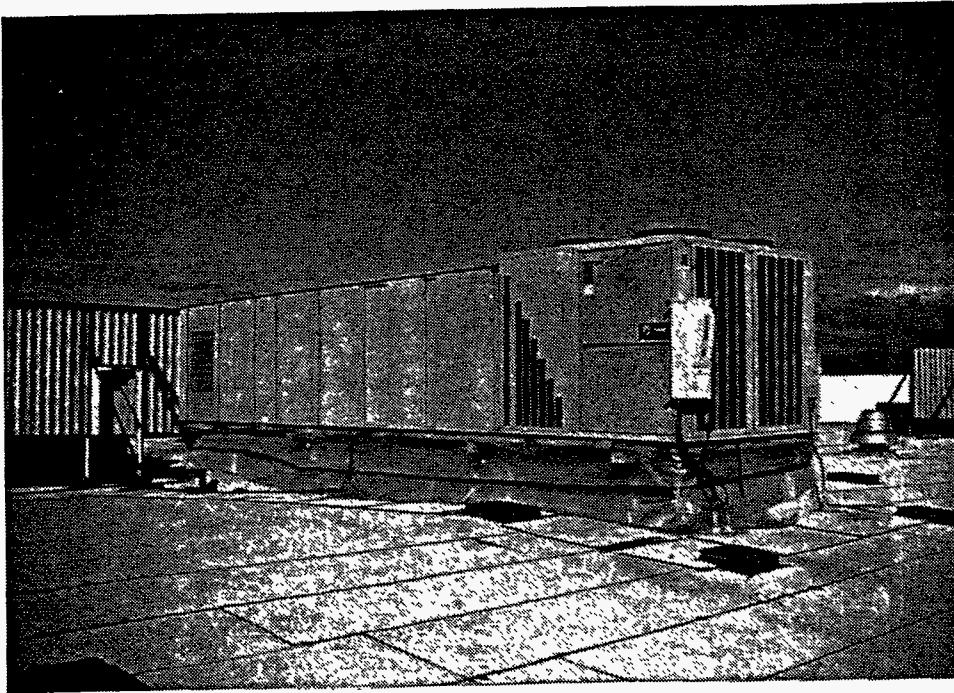
Figure 4.3.1-3: This HVAC unit fell off of its vibration isolation supports. The unit was operational after replacing the isolators with wood cribbing.

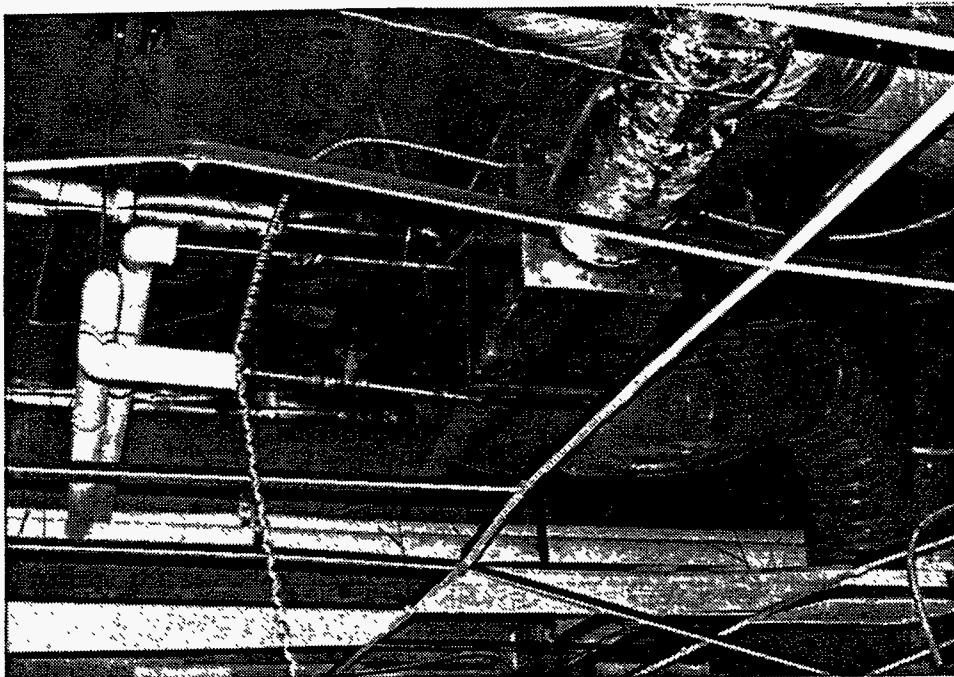
Figure 4.3.1-4: Several air handling units suspended above raised ceilings displaced and damaged copper cooling lines.

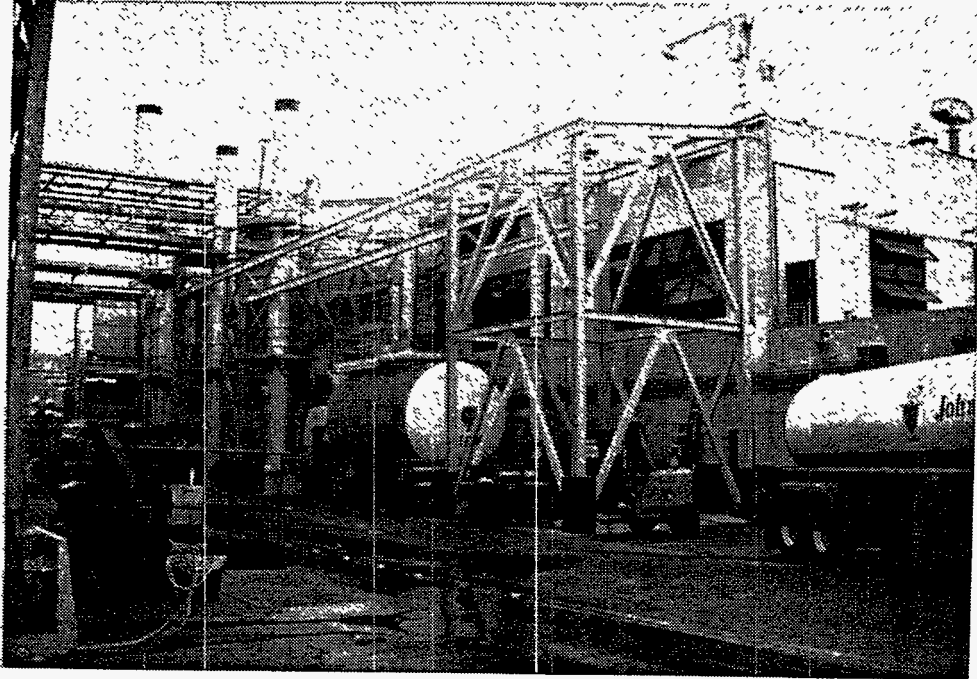
Production facilities contain a diversity of mechanical, electrical, instrumentation and process equipment that withstood the event with only minor damage. Figure 4.3.2-1 shows the central facilities building. The building was retrofitted prior to the earthquake by adding a steel buttress to the exterior due to space limitations and to minimize the impact on plant operations. The most serious central facilities damage was a small pipe break on a tank drain line. The horizontal tank displaced a few inches, causing the rigid drain pipe to fail at the threaded penetration.

Figure 4.3.2-1: The central facilities building was retrofitted prior to the earthquake by adding a steel buttress to the exterior.

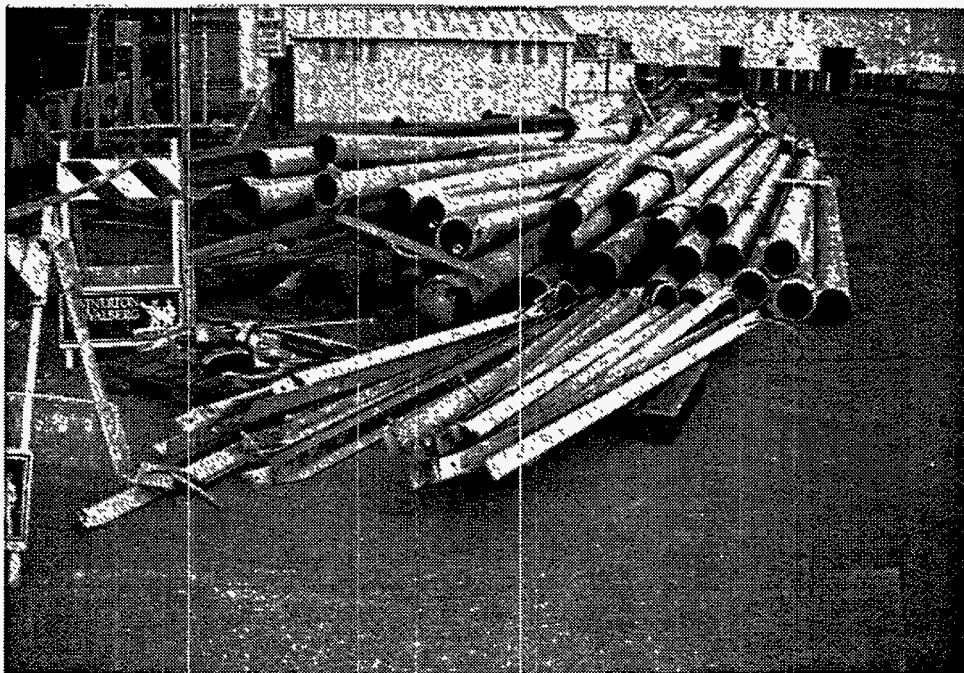
Several very large warehouse-type structures contain packaging materials and equipment as well as large inventories of finished product for shipping and distribution. Failure of over 2,000 linear feet of 8 inch diameter fire protection piping (Figure 4.3.2-2) affected a large portion of the warehouse. Supports failed and sections of pipe fell on pallets of finished product, resulting in the loss of inventory. Smaller diameter fire protection distribution lines also failed at several locations. Other significant earthquake effects observed in the warehouse structures were displacement of packaging equipment, a short circuit in a 13.8 kV transformer and minor architectural damage.

Figure 4.3.2-2: Over 2,000 feet of 8 inch diameter fire protection piping failed. The piping in the foreground was removed from the warehouse building.

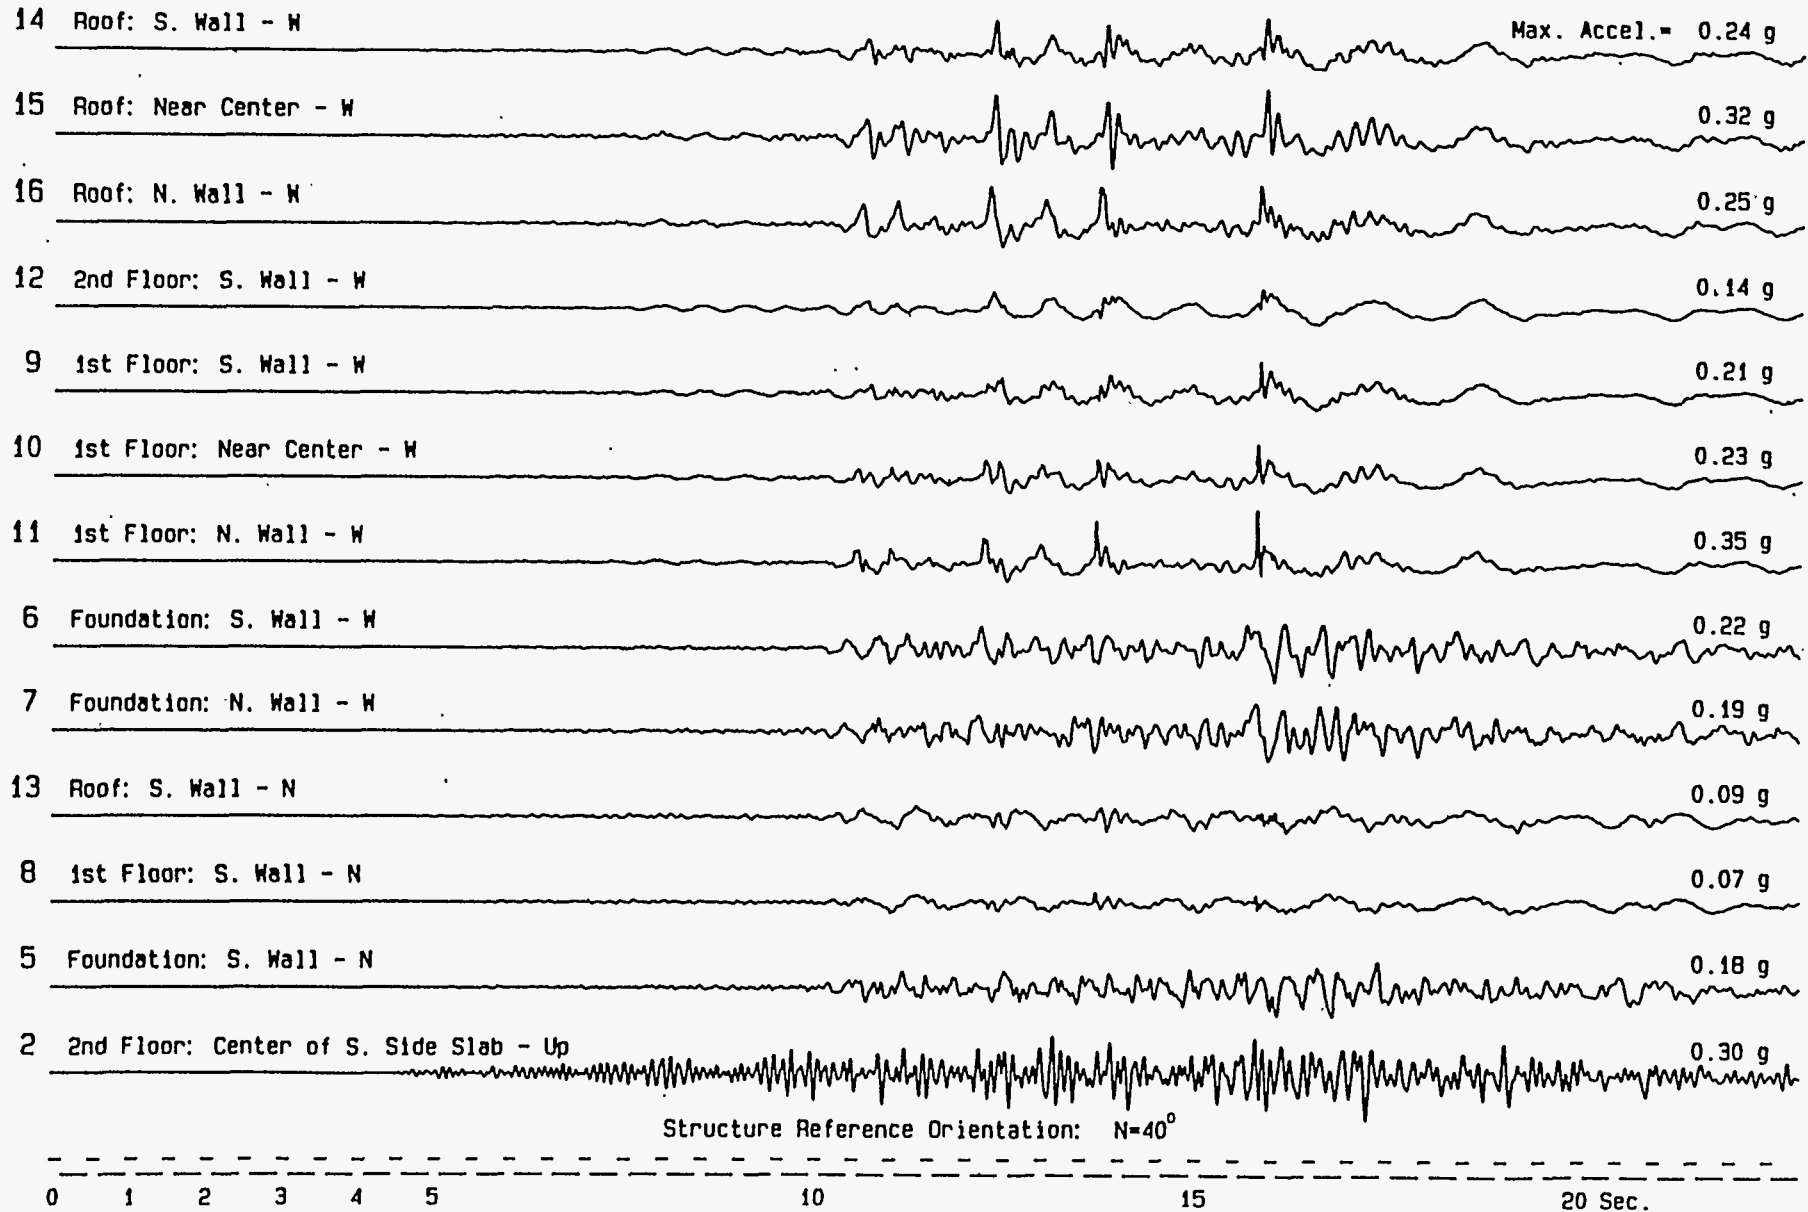
Using the records in Figure 4.4-2, several observations about the building response can be made. First, the building primarily responded in the east-west direction which is consistent with the location of the epicenter relative to the building. Second, the horizontal fundamental period corresponding to the maximum response displacement is about 1.3 seconds [ref 4.4-3]. This period is less than the design period of 2.17 seconds in the longitudinal and transverse directions

Figure 4.4-2: Strong motion records of the response of the Los Angeles County Fire Command and Control Facility during the Northridge Earthquake were obtained by the California Division of Mines and Geology [ref 4.4-4].

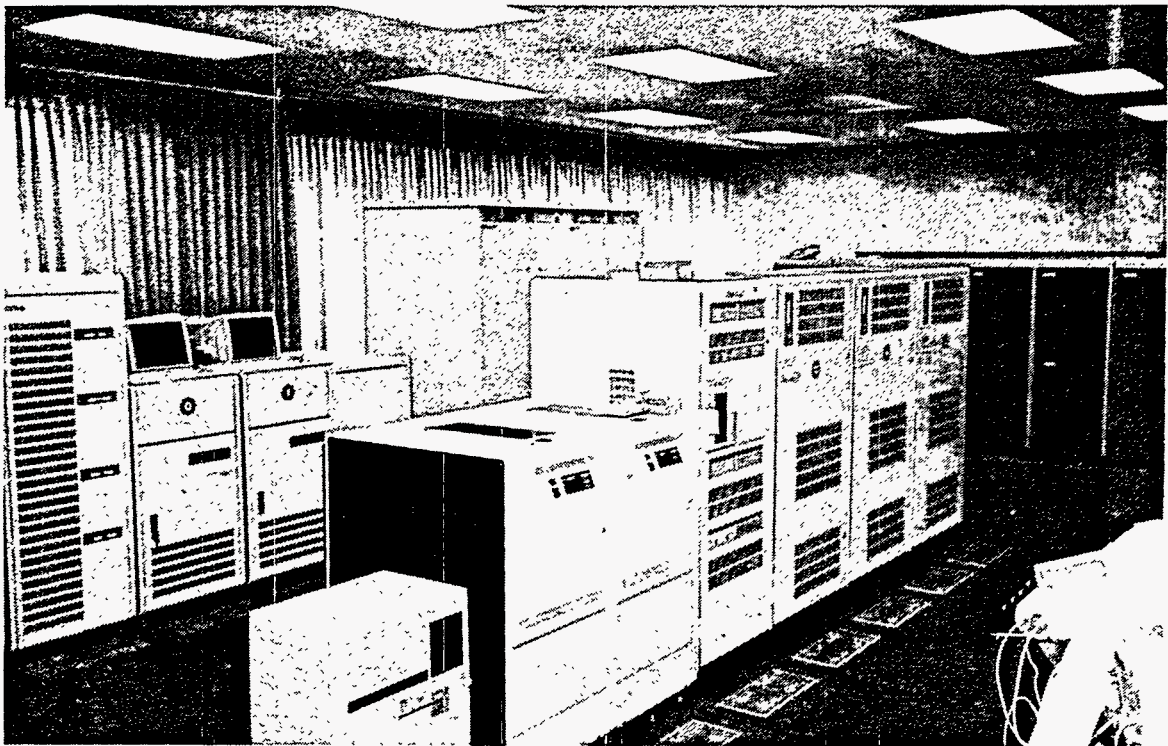
Figure 4.4-5: Unanchored computer equipment on the second floor of the Los Angeles County Fire Command and Control Facility remained fully operational.

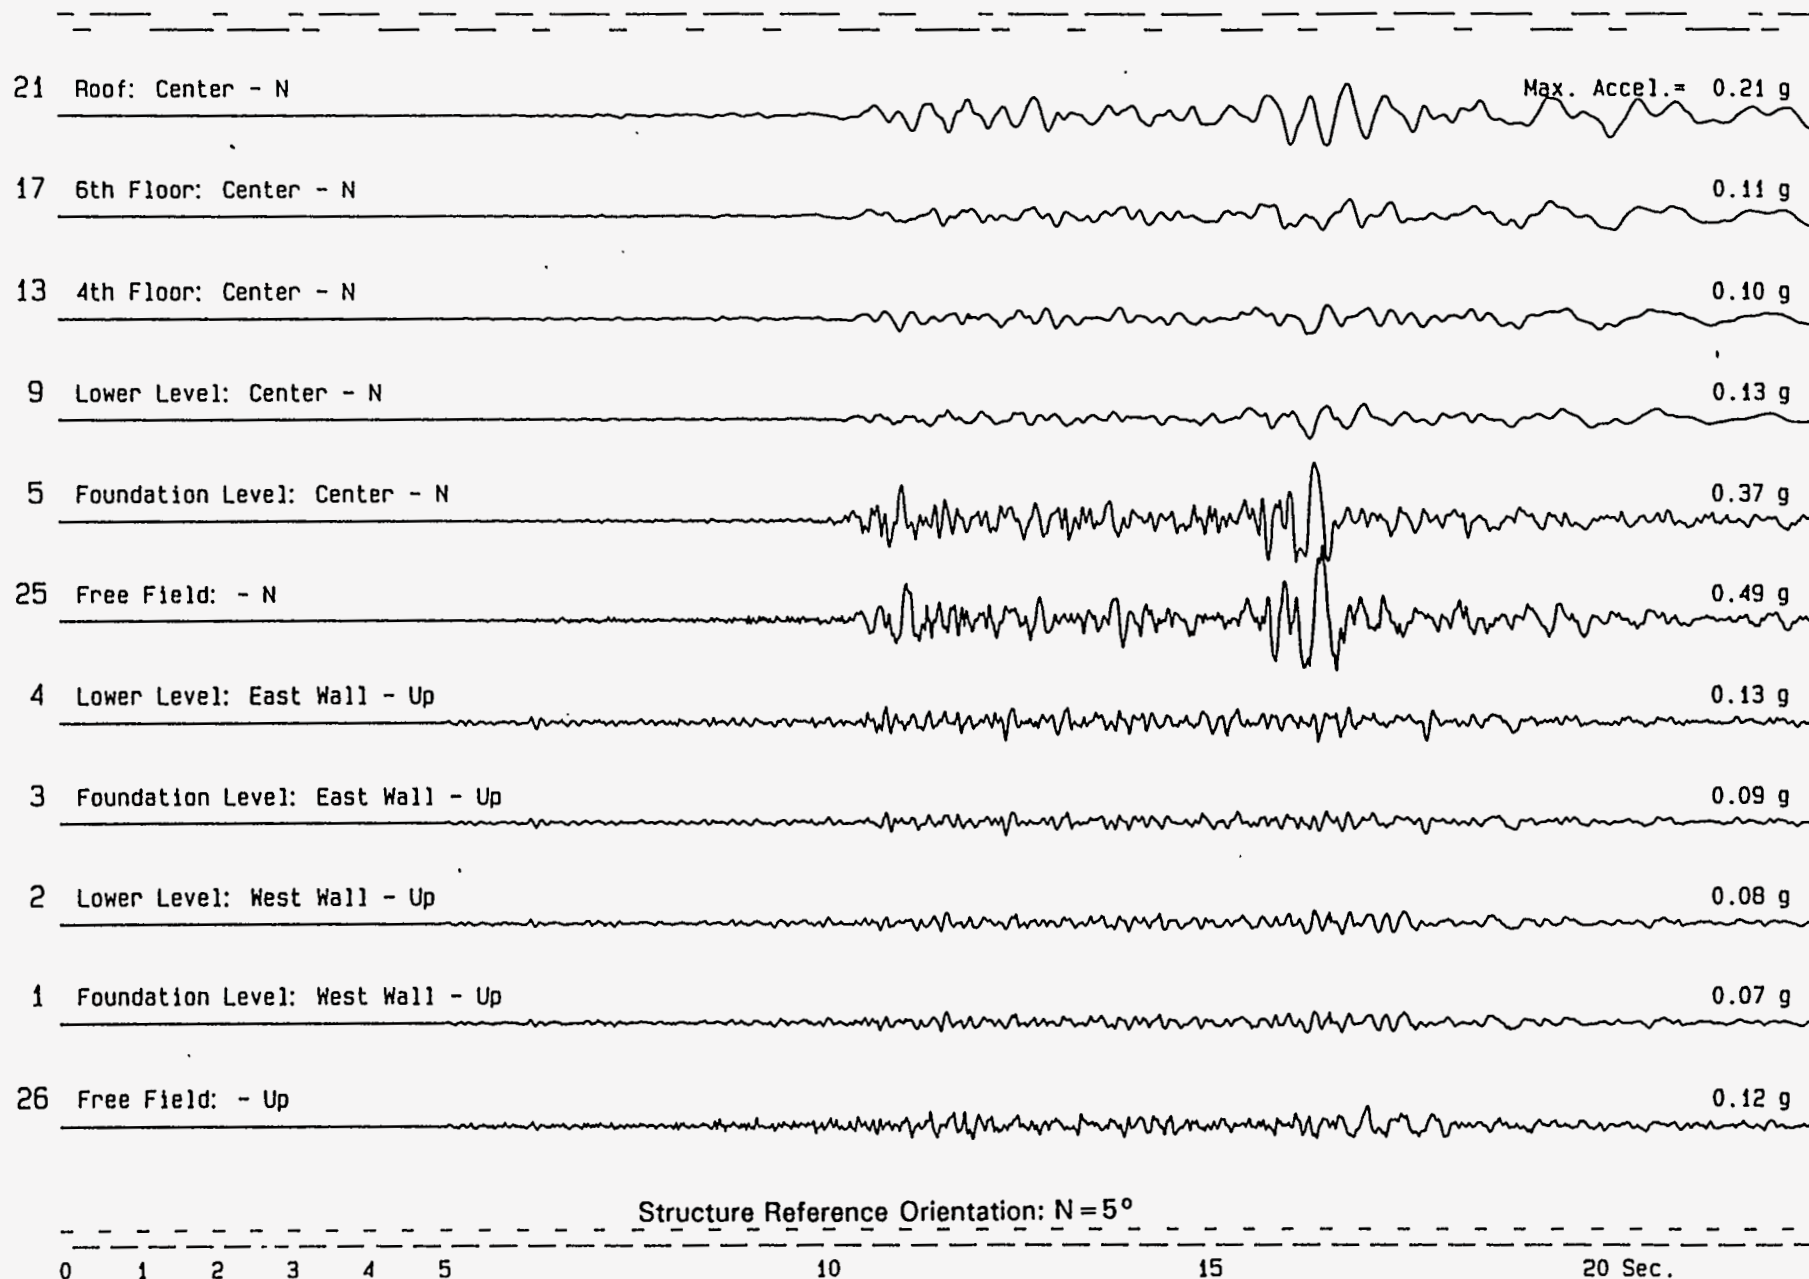
The records in Figure 4.4-7 indicate the benefits of isolation. The peak acceleration response was reduced from 0.37 g beneath the isolation system to 0.13 g above it. In addition, the earthquake-induced, short duration accelerations were transformed by the isolation system into long duration motion. Structural amplification through the height of the hospital was relatively minor as the peak acceleration at the roof was 0.21 g. It is reported that the structural amplification in a fixed-base structure of the same fundamental period as the hospital would have been a factor of about three based on elastic calculations [ref 4.4-1]. The motion in the hospital was sufficiently small to not activate the safety switches on the elevators.

Figure 4.4-7: Strong motion records from the USC University Hospital during the Northridge Earthquake were obtained by the California Division of Mines and Geology [ref 4.4-6].

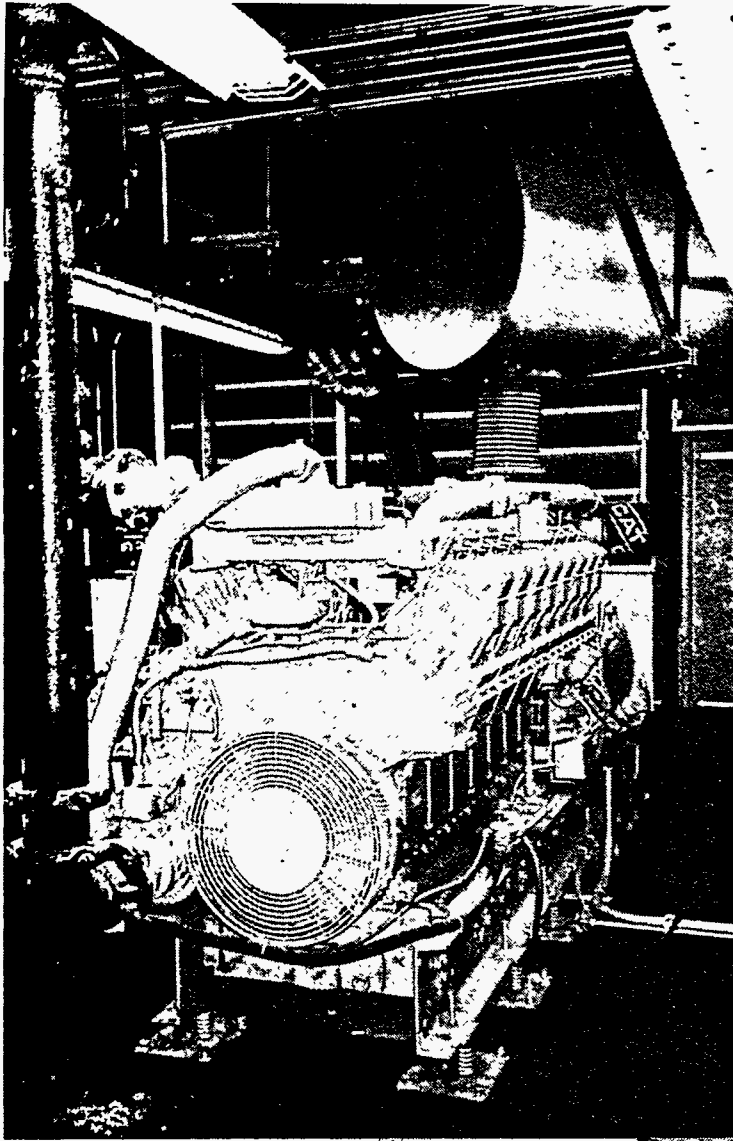
Figure 4.4-9: At the USC University Hospital, diesel generators mounted on vibration isolators without seismic bumpers performed as required.

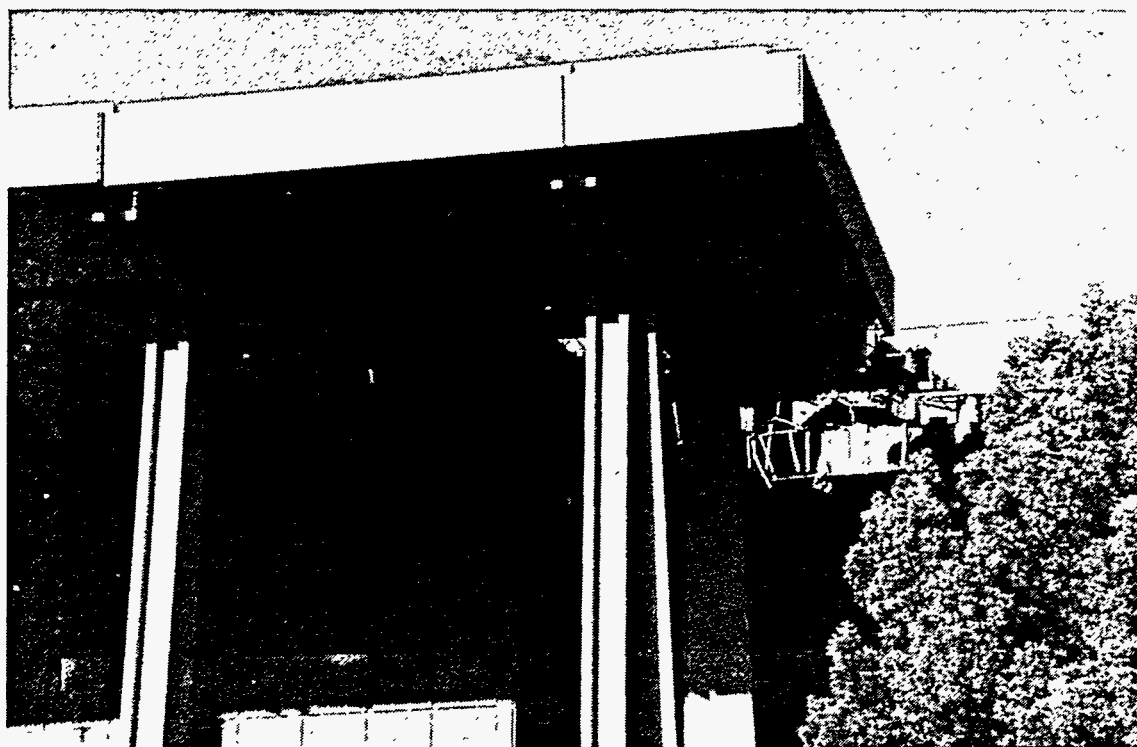
Oviatt Library at CSUN had damage to the architectural features near the roof line. Immediately after the earthquake, it appeared to be only cosmetic damage (see Figures 4.5-4 and 4.5-5). Upon further investigation by structural teams several weeks later, further significant damage was observed especially in the library additions. Close inspection of the steel braced frames in the additions revealed cracks which ran through the full thickness of the steel baseplate at the lower end of the X-bracing (see Figure 4.5-6) [ref 4.5-1]. This discovery focused attention on the brittle performance of connections in steel frame structures in the Northridge Earthquake.

Figure 4.5-5: Close-up of damage to architectural features near roof of Oviatt Library at CSUN.
