The January 17, 1994 Northridge Earthquake: Effects on Selected Industrial Facilities and Lifelines

**Mark W. Eli
Stanley C. Sommer
Thomas R. Roche
Kelly L. Merz**

February 1995

United States Department of Energy
United States Nuclear Regulatory Commission

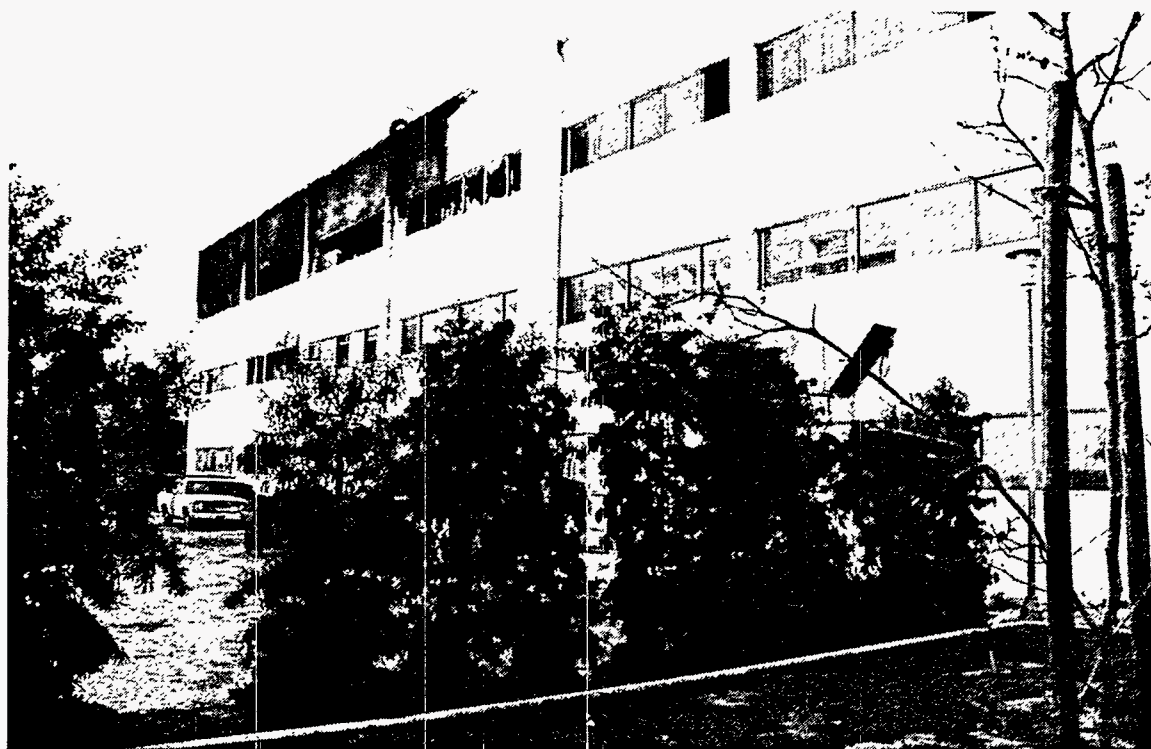
Figure 4.5-7: Fire in Science Building 3 at CSUN included toxic materials and required a Hazmat Team to perform clean-up operations.

As a result of the Northridge Earthquake, a fire occurred in Science Building 3 at CSUN that included toxic materials and required a Hazmat Team to perform clean-up operations (see Figure 4.5-7). Near the science building, a trailer fell off of its pedestals so that the doorway was blocked by the stairway (see Figure 4.5-8).

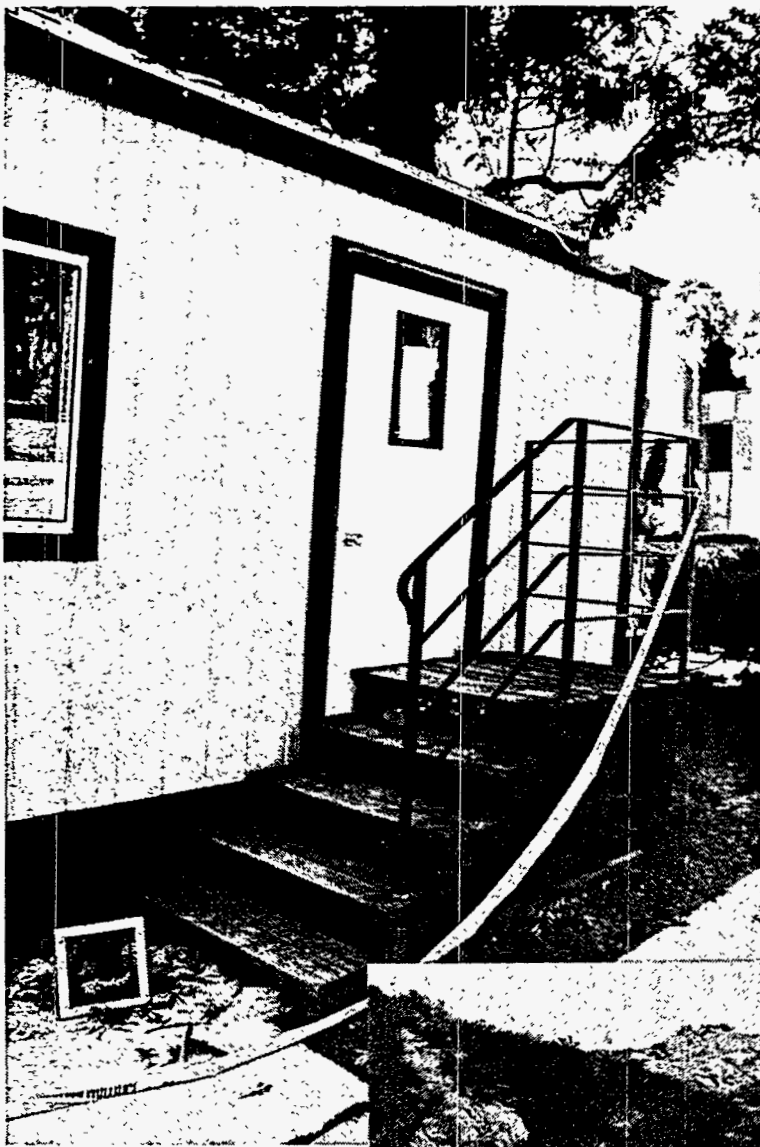
Figure 4.5-8: Near the science buildings, a trailer fell off of its pedestals so that the doorway was blocked by the stairway.

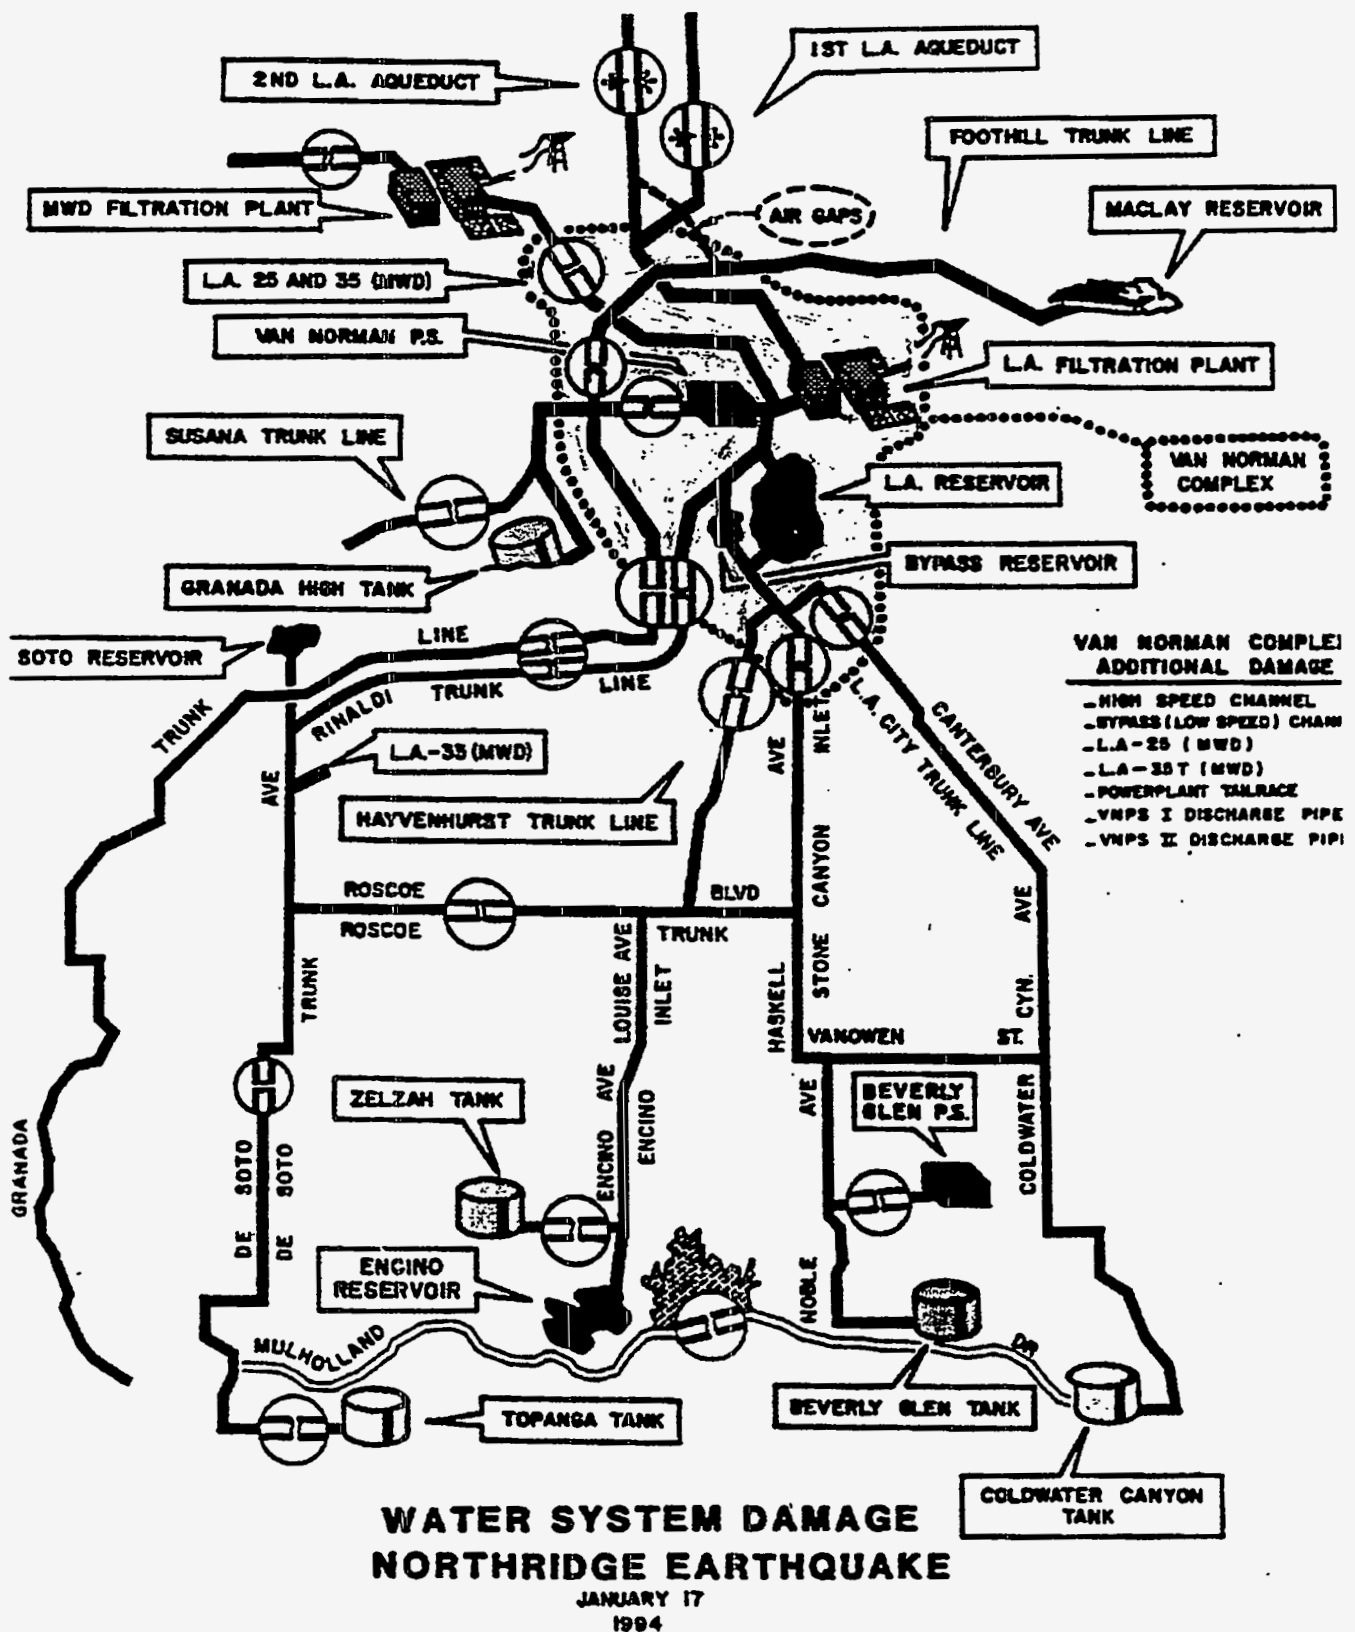
The earthquake did affect the performance of the LADWP system as shown in Figure 5.1-1. Earthquake-induced damage occurred in storage tanks, in the Los Angeles Aqueducts, and at the Los Angeles Aqueduct Filtration Plant. Additionally, many of the main trunk lines in the LADWP system either ruptured or sustained leaks. Numerous leaks in the smaller diameter pipes of the distribution system delayed the resumption of normal water service after the main components of the system such as the treatment plant were repaired. In the San Fernando Valley, over 1200 leaks were reported within the distribution network. There are several observations or lessons learned about the system performance during and following the earthquake. First, much of the damage in the LADWP system occurred in vulnerable pipelines. In addition, lack of flexible connections caused damage in storage tanks and their attached components. Next, there were interactions between the performance of the water system and other lifelines. Finally, redundancies in the system allowed service to be restored to most customers fairly quickly.

Figure 5.1-1: There was earthquake-induced damage to the water system operated by the Los Angeles Department of Water and Power [ref 5.1-9].

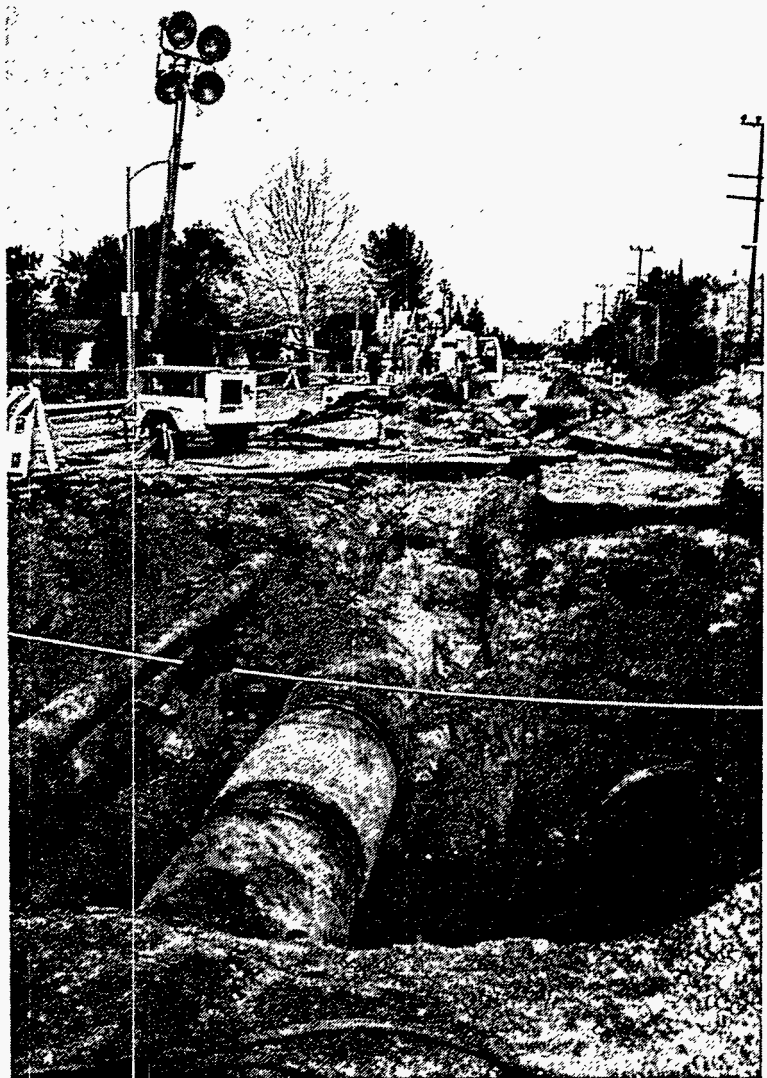
Before the earthquake, the Rinaldi Trunk Line had been identified as vulnerable in several locations where it was a relatively rigid concrete pipeline with no blow-off or shutoff valves. Without those valves, pressure changes induced by the ground motion of the earthquake had to be accommodated by the piping. Since the concrete pipeline was relatively rigid, several dresser couplings in the pipeline slipped causing leaks at those locations. Even though the dresser couplings were installed as expansion joints, they could not withstand the motion in the piping. A proposed retrofit is to use long-body dresser couplings which are more ductile since they allow for more elongation and less rotation. In addition, most modern pipelines are fabricated from welded steel pipe to allow for more ductile performance as compared to a concrete pipeline.

Figure 5.1-3a: Repairs to 68-inch diameter Rinaldi Trunk Line in the zone of ground compression.

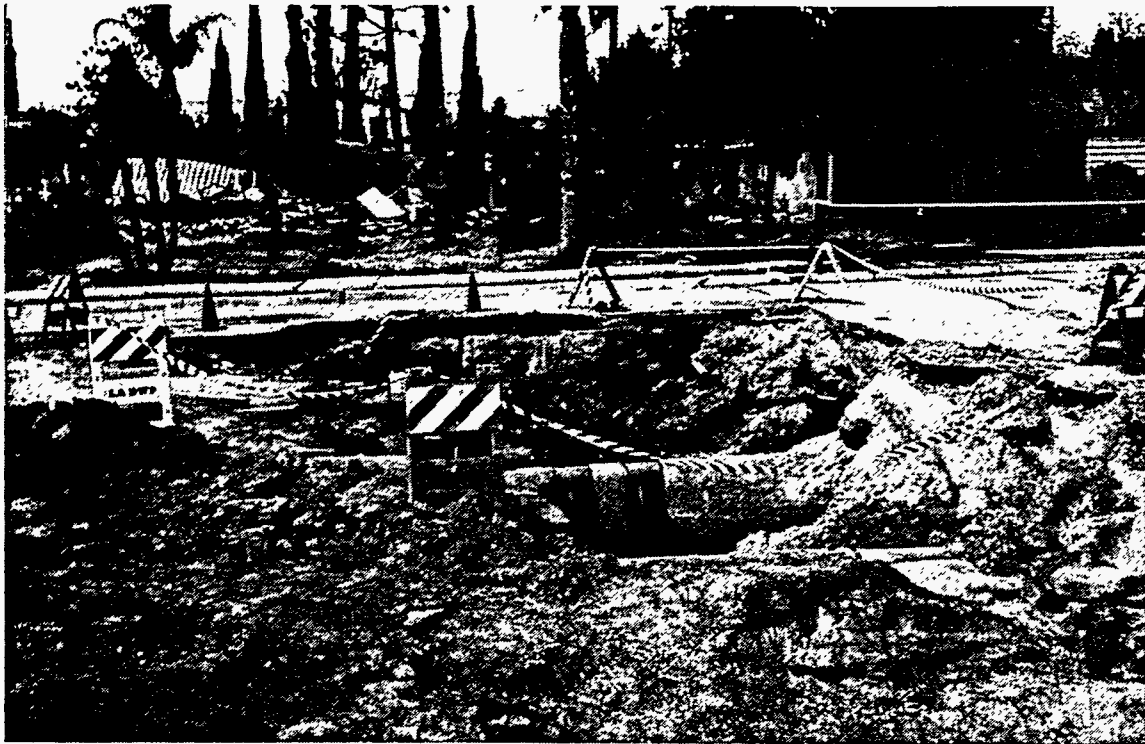
There were several locations where welded steel pipelines did not accommodate the earthquake-induced ground motion. A location of failed welded steel pipelines was along Balboa Boulevard between Lorillard and Rinaldi Streets. Balboa Boulevard is a utility corridor with several lifeline systems including water, natural gas, electric power, telecommunications, oil, and sewer. At this location, which is about 4 miles northeast of the epicenter, Balboa Boulevard runs north-south and slopes downward from Lorillard Street to Rinaldi Street at about 1/8 to 1/4 inch per foot. Ground displacement at this location created a tensile zone near Lorillard Street and a compression zone near Rinaldi Street. Figure 5.1-2 shows a 2-foot overlap in a sidewalk parallel to Balboa Boulevard which was caused by compressional buckling of the ground surface during the earthquake. Passing through both zones are the 49-inch diameter Granada Trunk Line and the 68-inch diameter Rinaldi Trunk Line which are both steel pipelines with welded slip joints. In the compression zone, the slip joints buckled and split near the top of the pipelines. Repairs to the slip joints are shown in Figure 5.1-3a. About 500 yards north of the compression zones, there were tensile failures near butt welded joints in the pipelines. Tensile cracks in the soil were evidenced near these failures as shown in Figure 5.1-3b. Extensive flooding occurred in the area due to the compressive and tensile failures in the water pipes. A combination of permanent ground motion and insufficient flexibility in the pipelines contributed to the failures at Balboa Boulevard.

Figure 5.1-3b: Near tensile failures in water and natural gas pipelines, a tensile crack in the ground is evidenced as it crosses perpendicular to Balboa Boulevard.

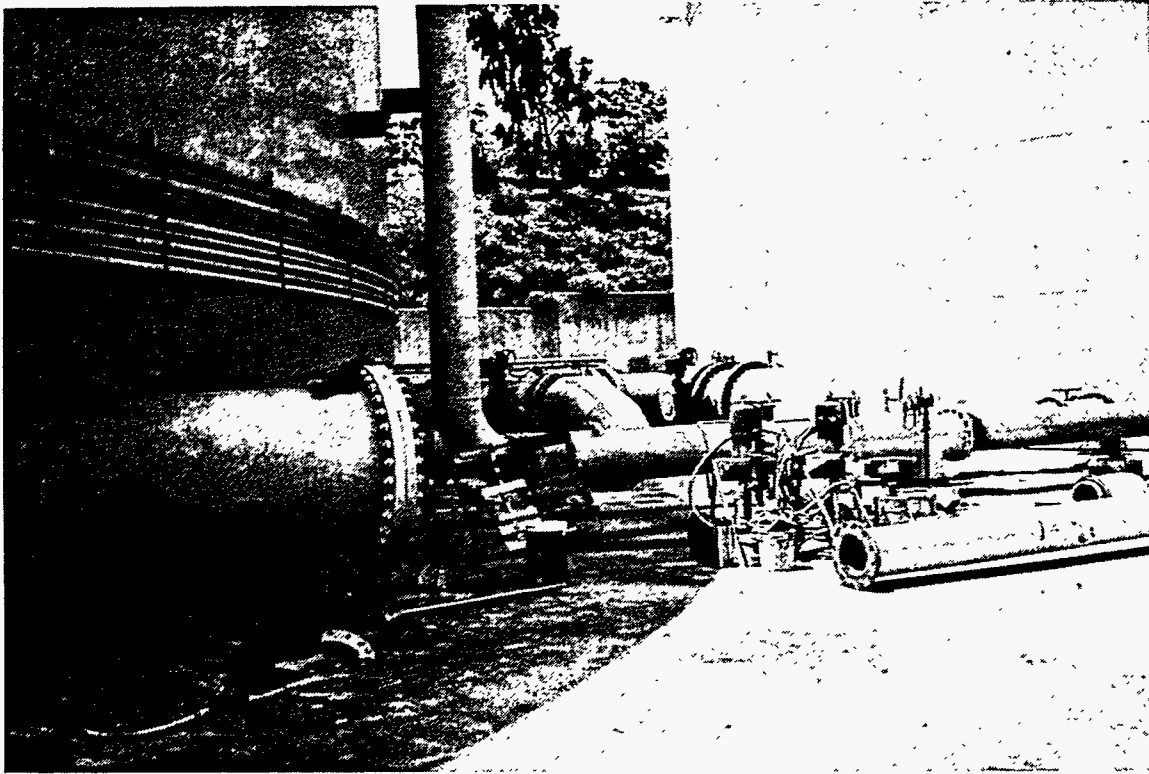
Figure 5.1-9: Attached lines between two unanchored tanks at the Jensen Plant accommodated the relative motion of the tanks.

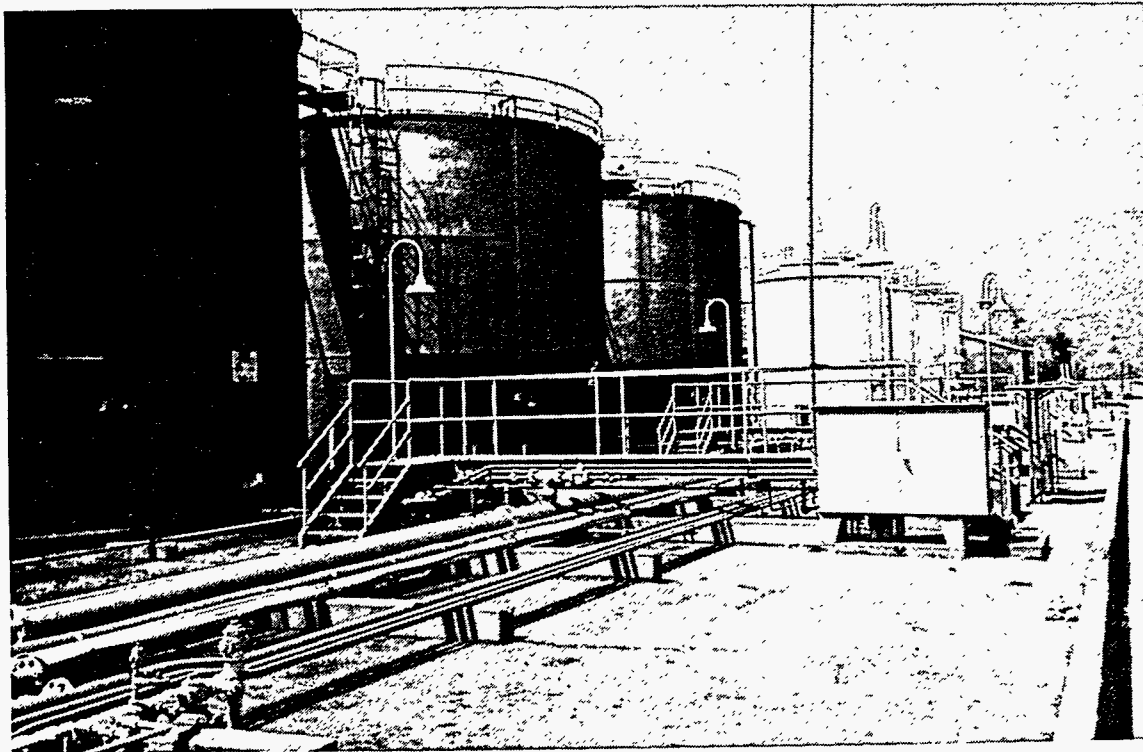
Figure 5.1-10: There was minor evidence of relative tank motion in the chlorine tank farm at the Jensen Plant.

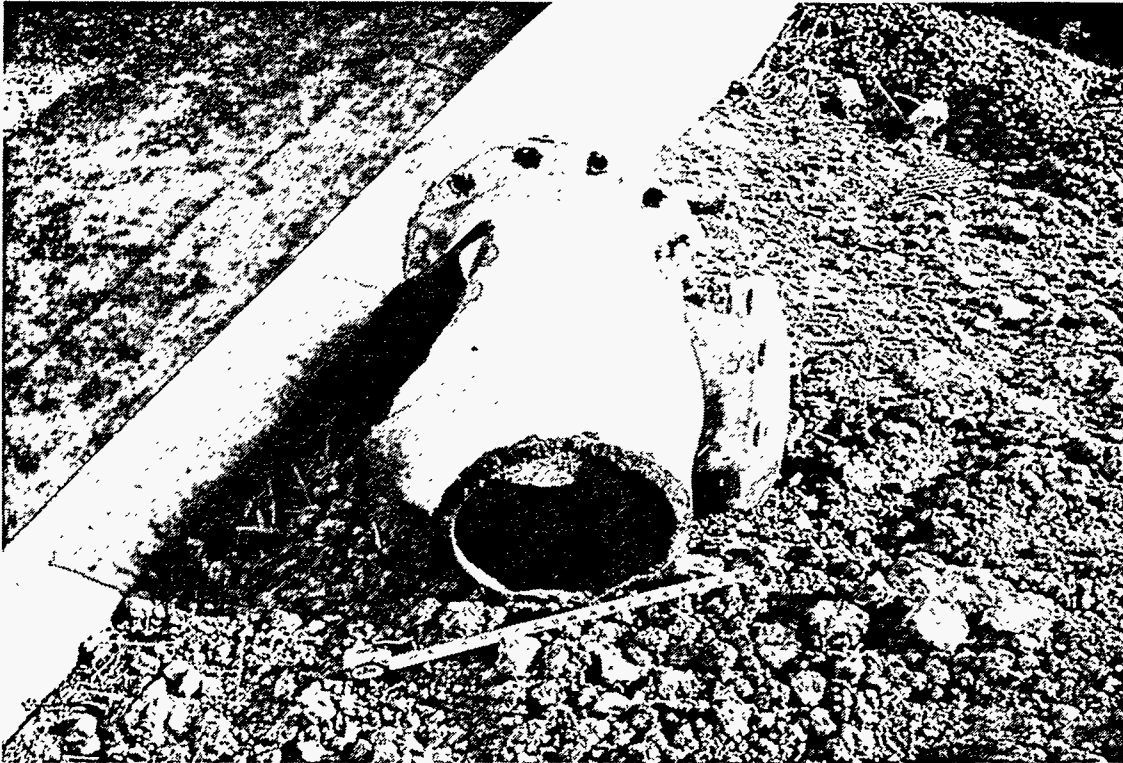
was severely cracked due to differential motion between the adjacent tanks during the earthquake. In addition, a 12-inch diameter, cast iron, valve body ruptured when there was differential movement at the rigid connection between the attached piping and the tank during the earthquake. Cast-iron components, such as the valve body shown in Figure 5.1-11, typically do not have sufficient ductility to accommodate large displacements. Fortunately, there was adequate ventilation at the top of the tanks which allowed the evacuated tanks to appear salvageable. As shown in Figure 5.1-12, the tanks did not suffer roof collapse or elephant's foot buckling. The tanks were each holding about one million gallons of water and this water flooded several homes in a nearby neighborhood as shown in Figure 5.1-13. In contrast to the performance of those two tanks, several other tanks closer to the epicenter appeared fully functional. Located about 5 miles northwest of the epicenter, a 300,000-gallon and a one million-gallon welded-seam steel tank showed no evidence of structural damage. As shown in Figure 5.1-14, the tanks had flexible, elastomeric couplings between the tank valves and their inlet and outlet pipes entering the ground. The flexible couplings permitted relative motion between the tanks and the rigid piping.

Figure 5.1-11: A cast-iron valve body ruptured on a 12-inch diameter line due to relative motion between the tank and the attached piping.

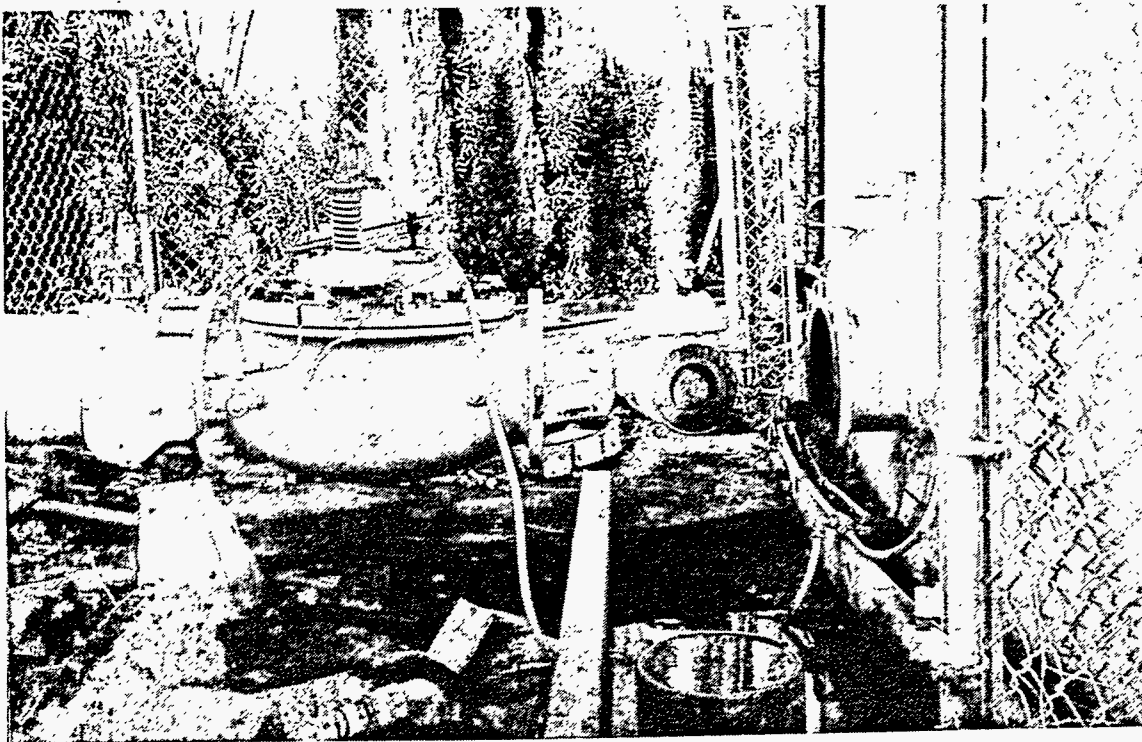
Figure 5.1-12: Adequate ventilation at the top of the tank prevented roof and wall damage when a valve body on an attached line ruptured.

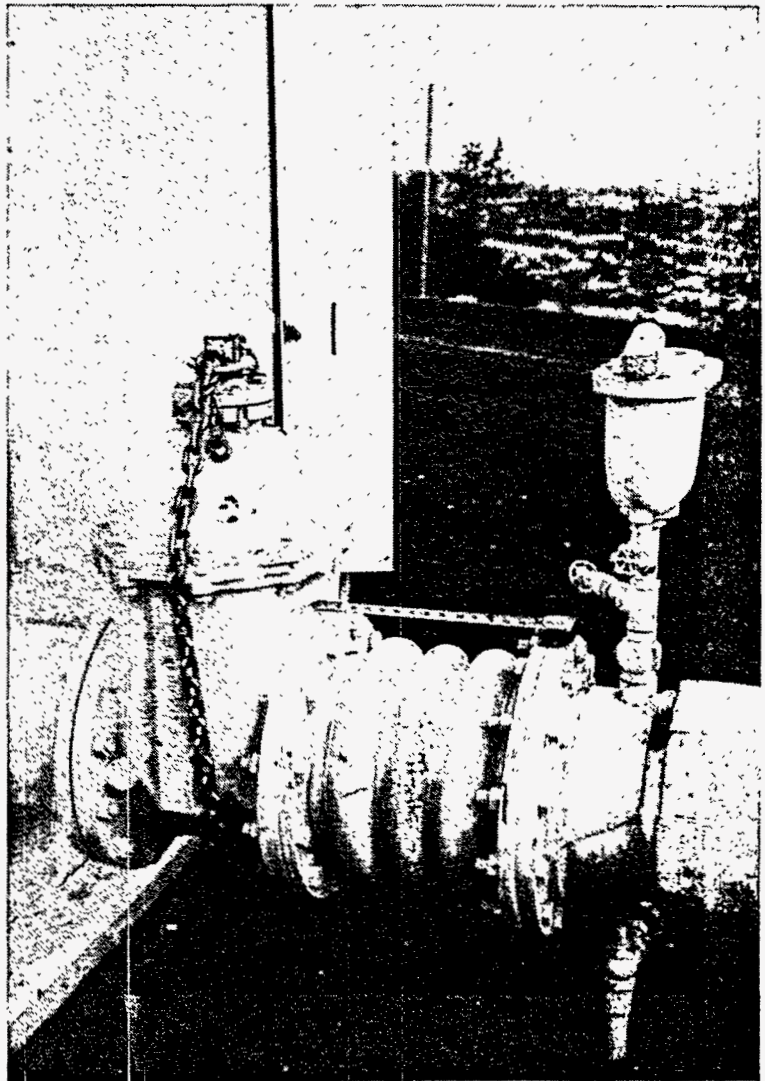
Figure 5.1-14: The flexible connection on the attached piping accommodated the relative motion of the tank and piping.

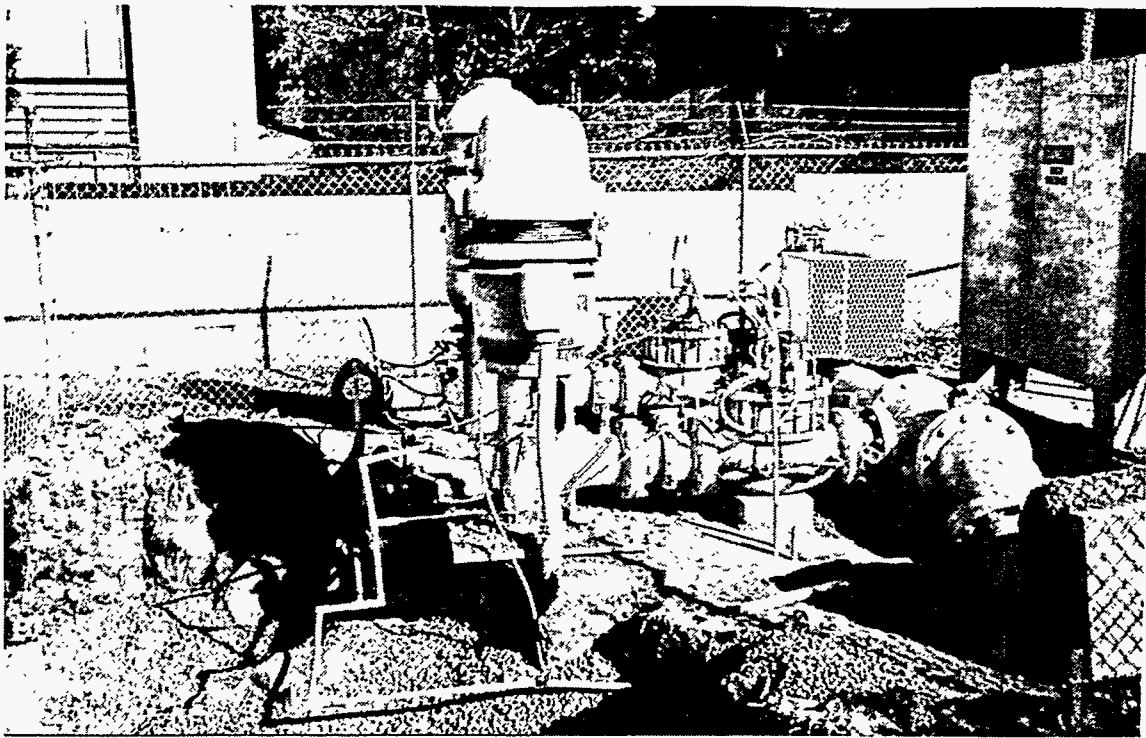
Figure 5.1-15: Ground settlement at the lift station caused underground attached piping to crack and leak.

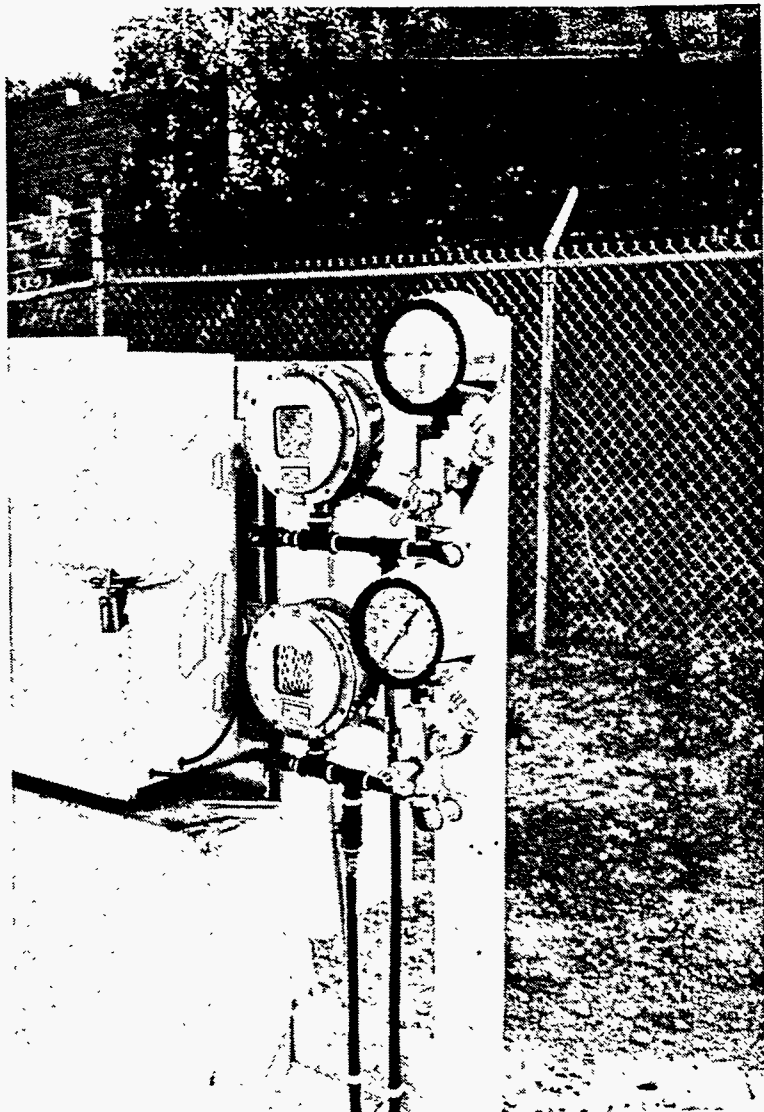
Figure 5.1-16: A Mercoid Switch connected to the pressure transmitters at a lift station may have had an inadvertent change of state.

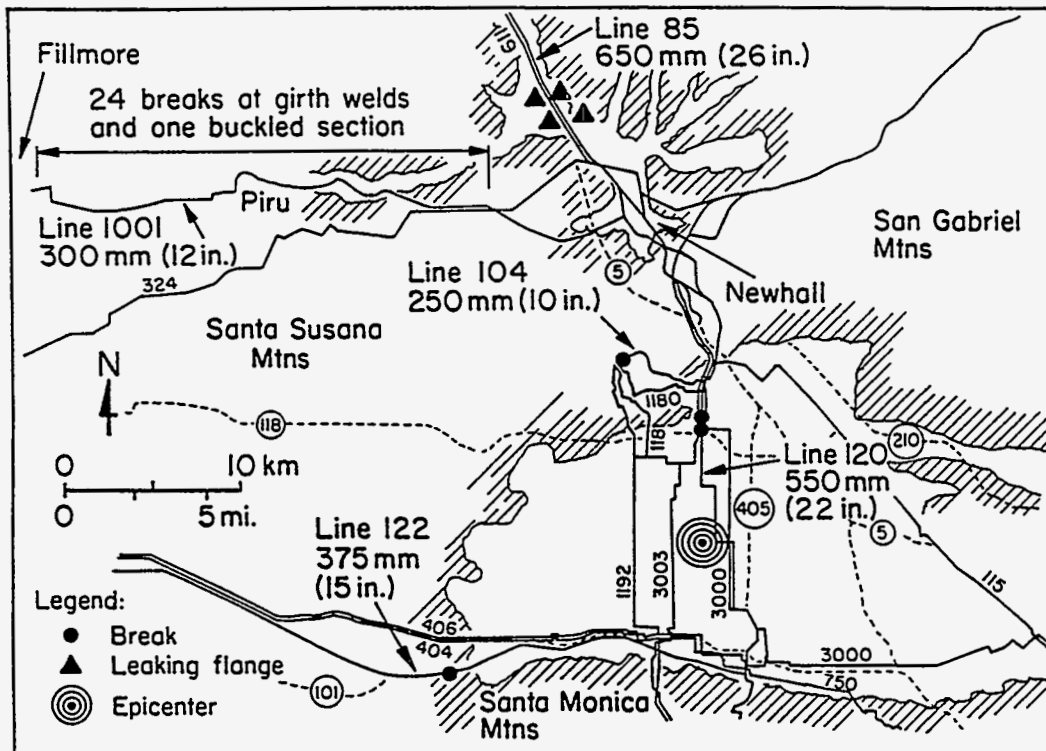
As shown in Figure 5.3-1, there were several locations of breaks and leaking flanges in the transmission system. In some cases, there were lifeline interactions between the damaged gas pipelines and adjacent lifeline systems such as electric power and water mains. It is reported that there were 35 repairs to transmission pipelines at locations of non-corrosion related damage. About 75% of those repairs occurred at cracked or ruptured oxyacetylene girth welds. These type of welds were used in SoCalGas pipelines prior to World War II and they are currently characterized as poor quality due to a lack of appropriate procedures for their fabrication. Oxyacetylene welds often have defects such as lack of proper fusion, overlapping and undercutting at the weld toe, and inadequate root penetration. Due to the inferior weld quality of oxyacetylene girth welded lines, SoCalGas has identified those lines as the most vulnerable to earthquake effects. According to SoCalGas statistics, 83% of all earthquake-related repairs due to ground vibrations have occurred in oxyacetylene girth welded lines. During the Northridge Earthquake, Figure 5.3-1 shows that the highest amount of damage due to ground vibrations occurred on Line 1001 which had oxyacetylene girth welds. In addition, there was damage to Lines 85 and 122 which had oxyacetylene girth welds.

As indicated in Figure 5.3-1, Line 1001 conveys natural gas between Newhall and Fillmore through Pico and Potrero Canyons. The 12-inch diameter pipeline was constructed in 1925 and was operating at an internal pressure of 245 psi during the earthquake. The line had 24 breaks at oxyacetylene girth welds and one section of buckled pipe. One of the ruptured welds was under California State Highway 126 near the town of Fillmore. There was interaction between the gas and electric power systems at this location as gas escaping from the damaged welds was ignited by a downed power line.

Figure 5.3-1: There are several natural gas transmission pipelines in the epicentral region which sustained damage during the earthquake [ref 5.3-1].

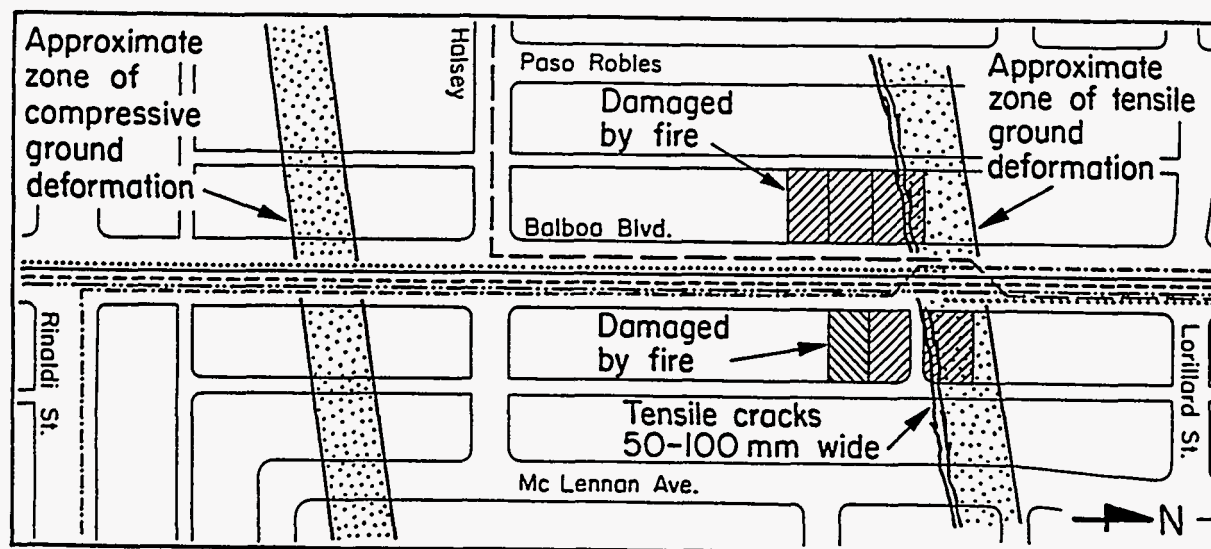
Figure 5.3-2: Tensile and compressive ground deformations contributed to the damage along Balboa Boulevard between Lorillard and Rinaldi Streets [ref 5.3-1].

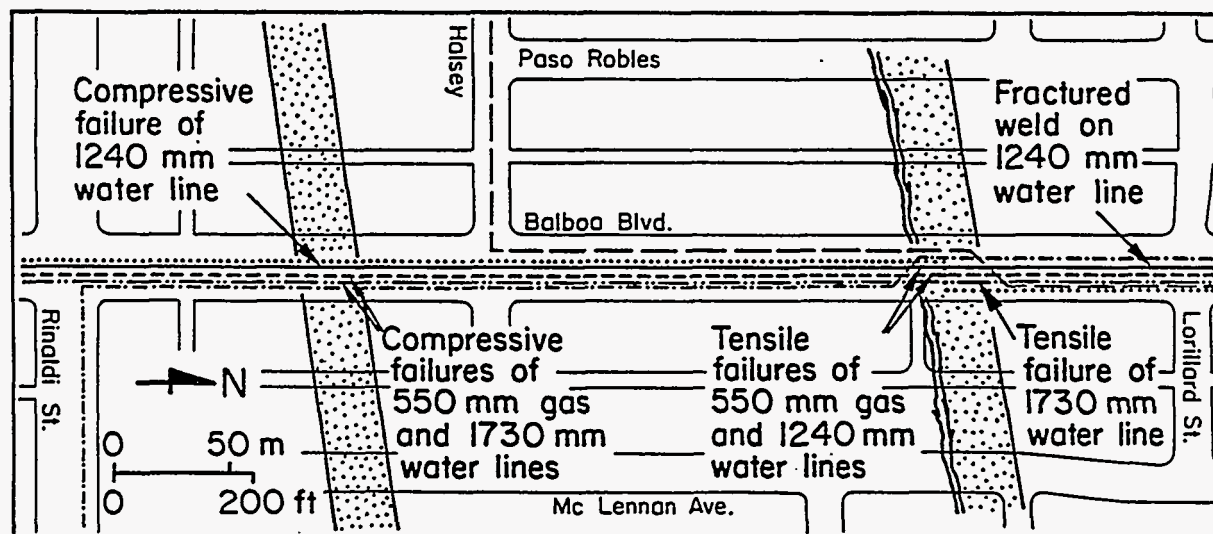
Figure 5.3-3: Underneath Balboa Boulevard and between Lorillard and Rinaldi Streets, both gas and water pipelines had failures [ref 5.3-1].

There was interaction of the damaged Line 120 with both adjacent water and electric power systems. Failures of the water mains caused extensive flooding in the area which affected repair efforts with Line 120. In addition, natural gas which leaked from the tensile failure in Line 120 was ignited by a vehicle which was stopped by the flooding. The ensuing fire destroyed five homes and partially destroyed another one as shown in Figures 5.3-2 and 5.3-6. Failures of both the water and natural gas pipelines produced an unusual image of flames rising from flooding water.

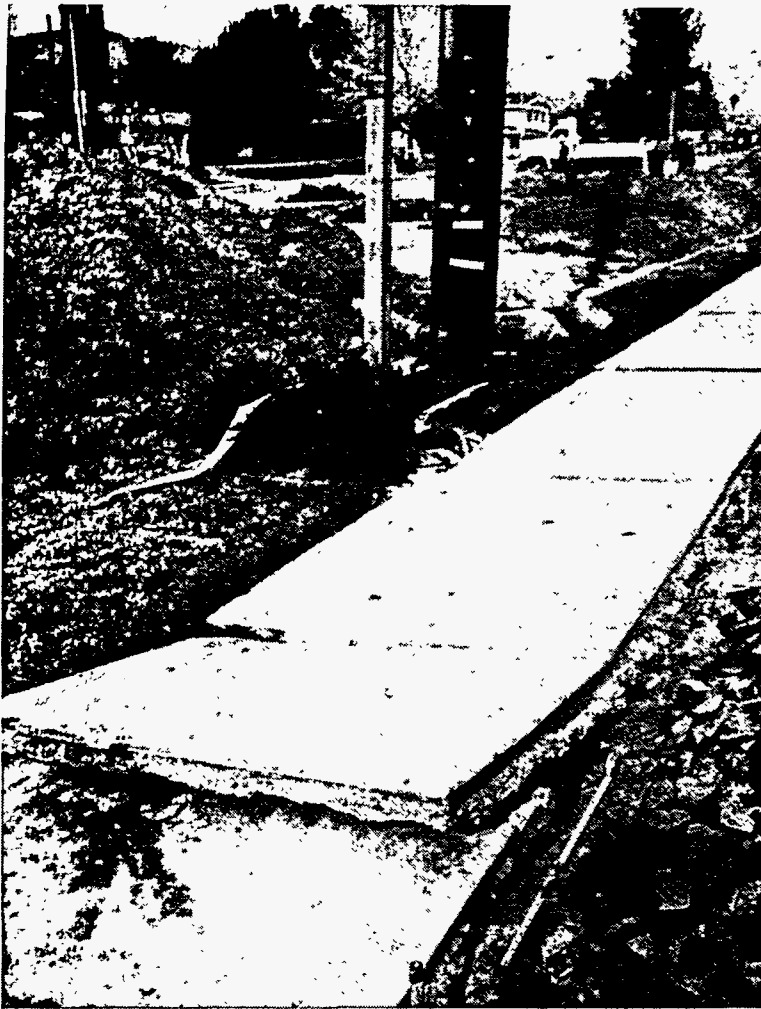
In the compression zone, compressional buckling of the ground surface caused a 2-foot overlap in a sidewalk parallel to the east side of Balboa Boulevard as shown in Figures 5.1-2 and 5.3-4. Examinations of Line 120 and the Granada Trunk Line disclosed a compressive buckling of about 10 inches. Repairs of the buckled sections of Line 120 and the Granada Trunk Line are shown in Figure 5.3-5. About 500 yards north of the compression zone, there were tensile failures in Line 120 and the water trunk lines. Tensile cracks about 2 to 3 inches wide in the soil were evidenced near these failures as shown in Figures 5.1-3b and 5.3-6. The ground deformation indicates that lateral spreading occurred in the local alluvial fan sediments. The orientation of the pipelines relative to gravity also contributed to the ground deformation. At the location of pipeline damage, Balboa Boulevard runs north-south as it slopes downward from Lorillard Street to Rinaldi Street at about 1/8 to 1/4 inch per foot.

Figure 5.3-4: In the zone of compressive ground deformation, the north portion of the sidewalk parallel to Balboa Boulevard moved over the south portion with a relative displacement of about two feet.

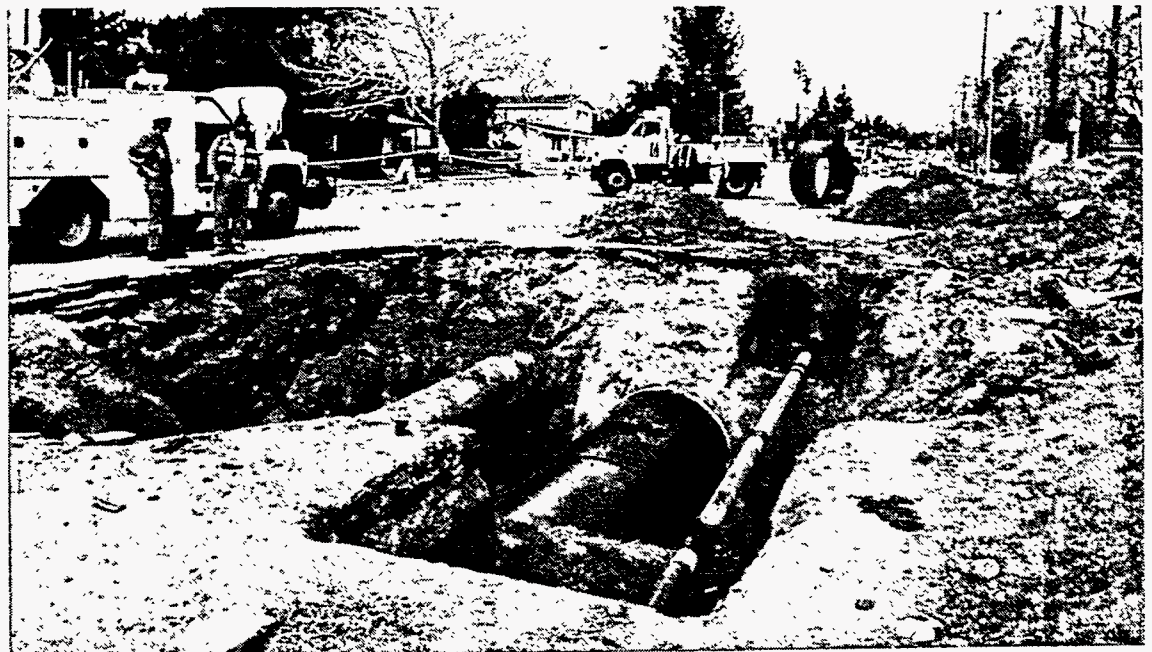
Figure 5.3-5: A natural gas distribution pipeline, Line 120, was buckled in the zone of compressive ground deformation. A larger diameter water pipeline next to the gas pipeline was also buckled.

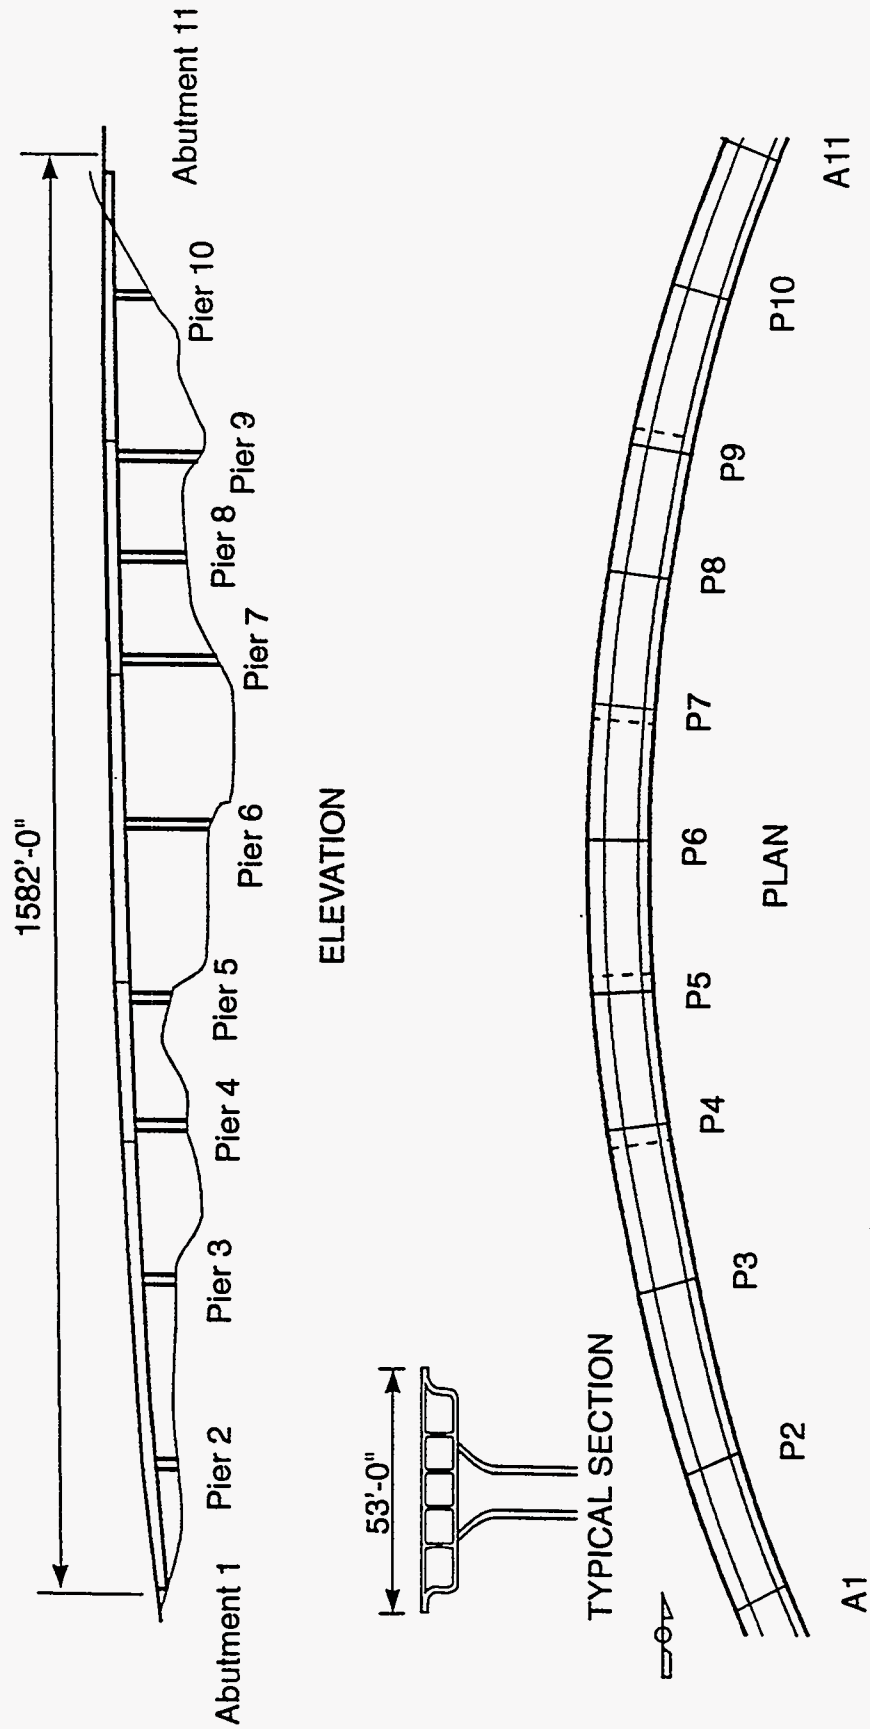
Figure 5.4-1b: SR-14/I-5 Separation & Overhead (Southbound) - General Plan and Elevation [ref 5.4-3].

The first frame of the structure collapsed. At the abutment, the diaphragm was found unseated and lying on the ground approximately 5 feet from the face of the abutment seat. The right exterior shear key failed completely, and the left exterior shear key appeared undamaged. The abutment seat had no internal shear keys. There was no evidence of any significant longitudinal movement in the backwall. The backwall remained intact, with no signs of cracking [ref 5.4-1].

At pier 2, the column failed completely. The main reinforcing steel in the column remained attached to the bent cap. The top of the column at pier 2 had translated several feet ahead of the base of the column (along the centerline of the bridge) toward pier 3. The exterior girders on both sides of the bent cap had large vertical cracks at the face of the bent cap (looking in elevation) [ref 5.4-1].

Pier 3 remained standing. Pier 3 did not have cracking on the transverse face, while some vertical cracking (~3/8" wide) was evident on the longitudinal face (looking in elevation). The superstructure on both sides of the pier was on the ground. The #18 bars appeared undamaged, and all the concrete was cleaned from the bars. The #5 stirrups in the bent cap had been ripped from the bent cap. Furthermore, there was no longitudinal, mild steel through the bent cap. When the prestressing was over-stressed and failed, the superstructure had almost no negative moment capacity [ref 5.4-1].

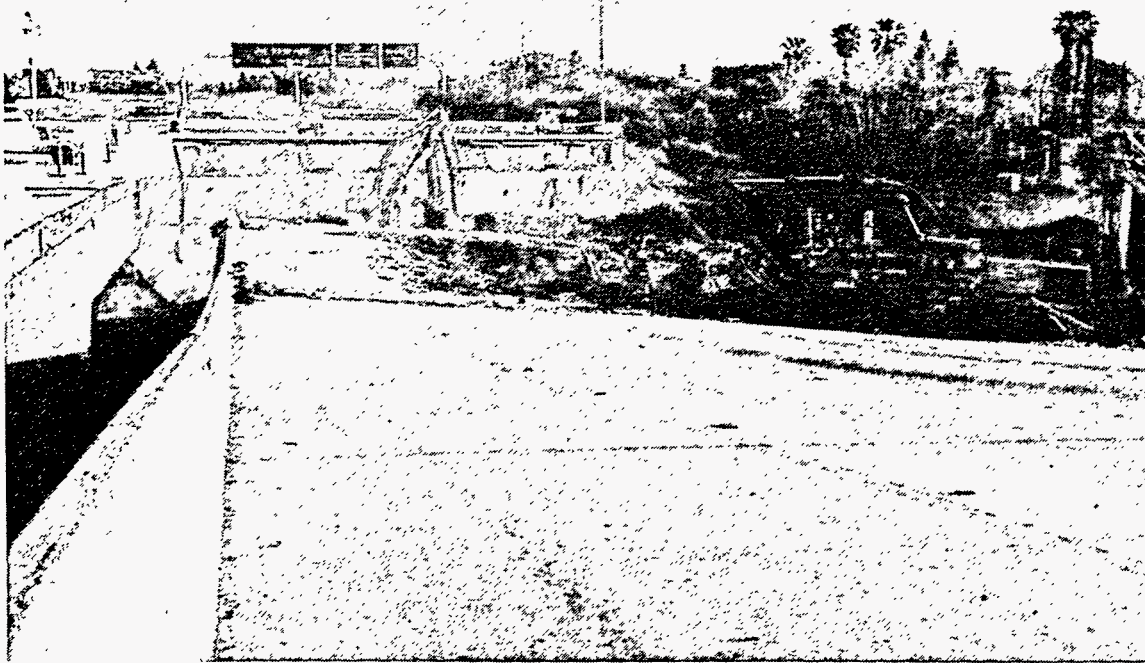
Figure 5.4-4: SR-118 at Mission-Gothic Undercrossing (looking southerly at the eastbound structure. The eastbound structure partially collapsed and was torn completely down several weeks after the main earthquake.

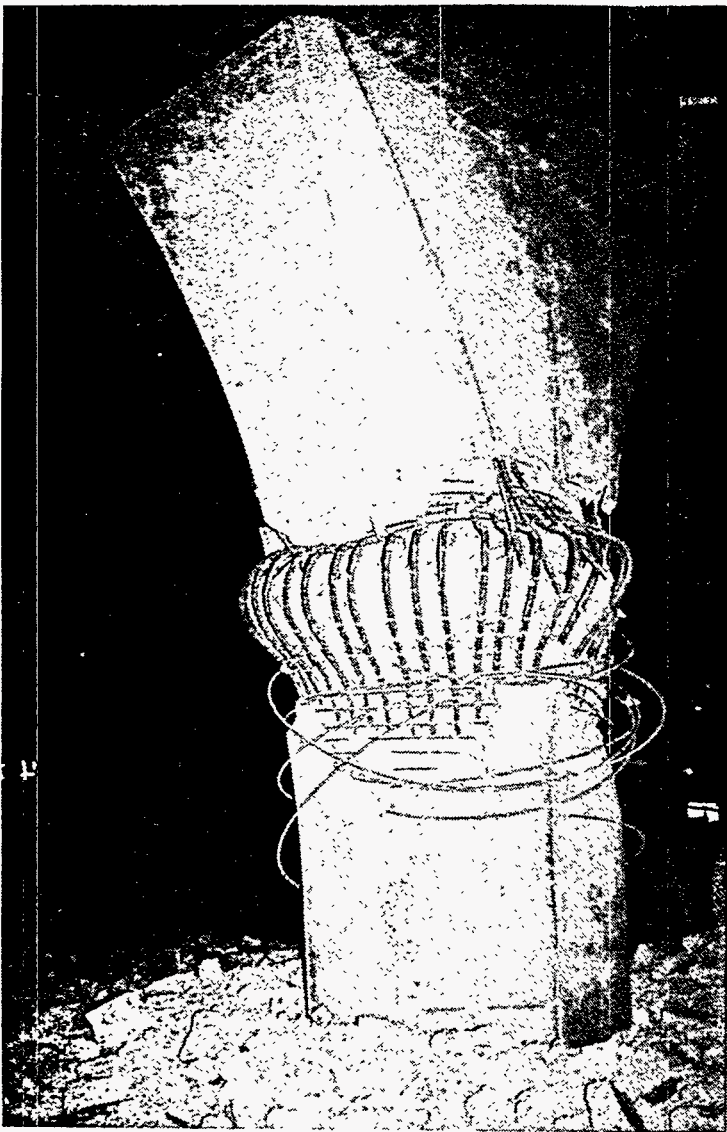
Figure 5.4-6: Close-up of column (failed in shear) on westbound structure of SR-118 at the Mission-Gothic Undercrossing. As core confinement of the column degraded, the vertical bars had very little axial compression load capacity.

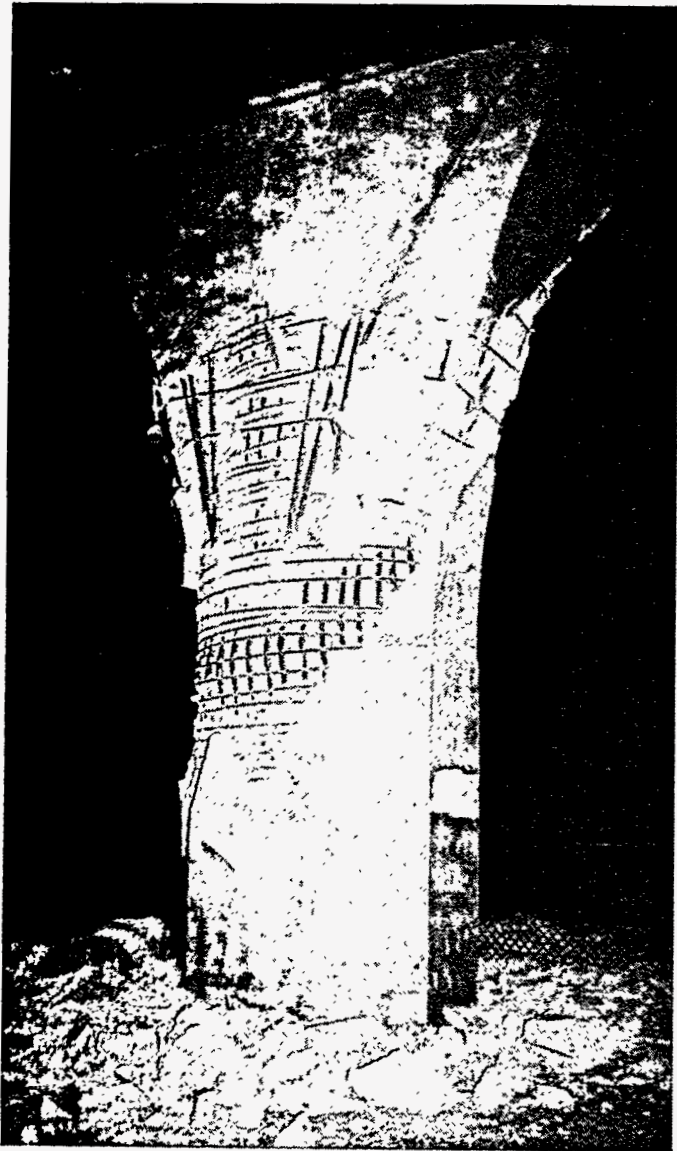
Figure 5.4-8: Close-up of column (on westbound structure of SR-118 at Mission-Gothic Undercrossing) with incipient structural damage.
