The January 17, 1994 Northridge Earthquake: Effects on Selected Industrial Facilities and Lifelines

**Mark W. Eli
Stanley C. Sommer
Thomas R. Roche
Kelly L. Merz**

February 1995

United States Department of Energy
United States Nuclear Regulatory Commission

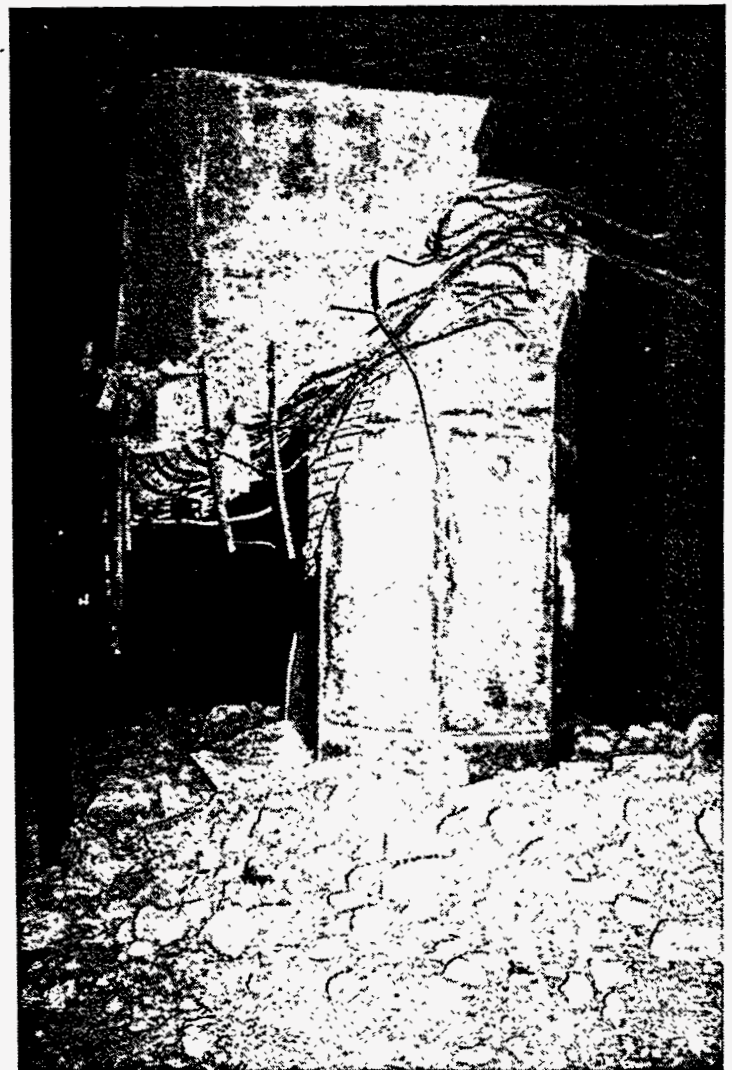
Figure 5.4-9a: Close-up of column (on eastbound structure of SR-118 at Mission-Gothic Undercrossing) with shear failure at mid-height.

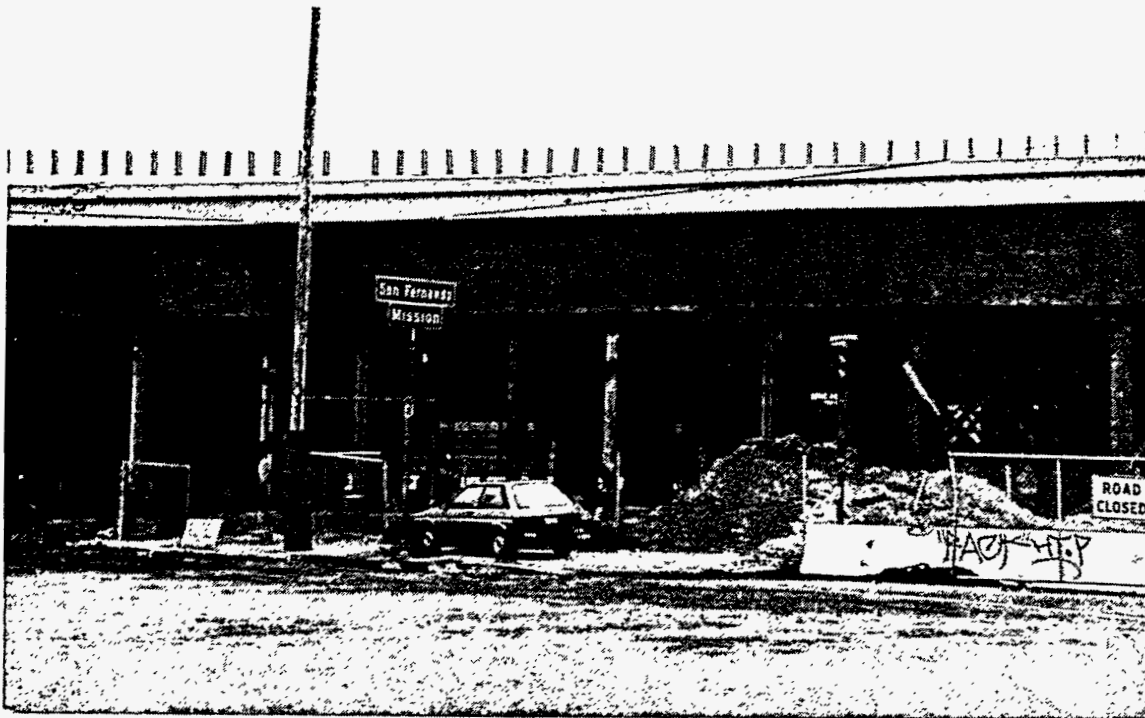
Figure 5.4-10: SR-118 westbound structure at Mission-Gothic Undercrossing received wood timber and steel falsework that was erected to shore up the damaged structure. This was executed so that the eastbound bridge next to it could be replaced while traffic in both directions was routed onto the westbound structure.

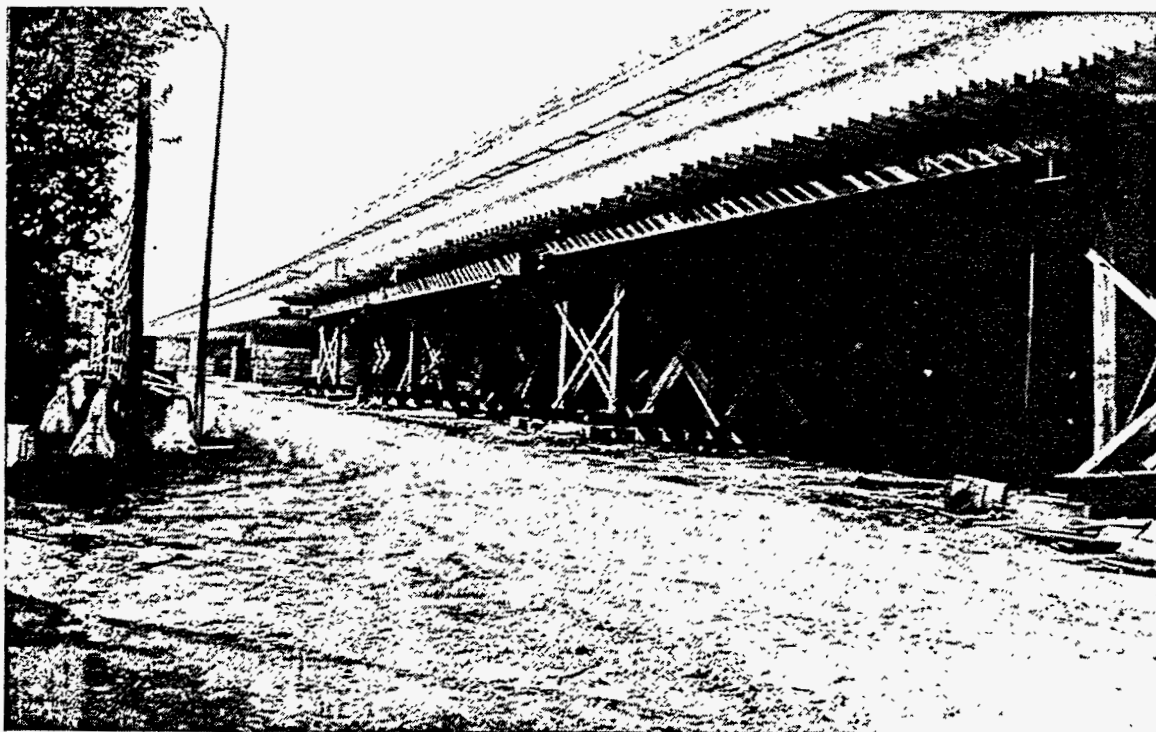
Figure 5.4-11: View looking north at replacement of SR-118 eastbound structure at Mission-Gothic U/C. In early May 1994, the forms and falsework were beginning to be removed from the new eastbound structure (SR-118 at Mission-Gothic).

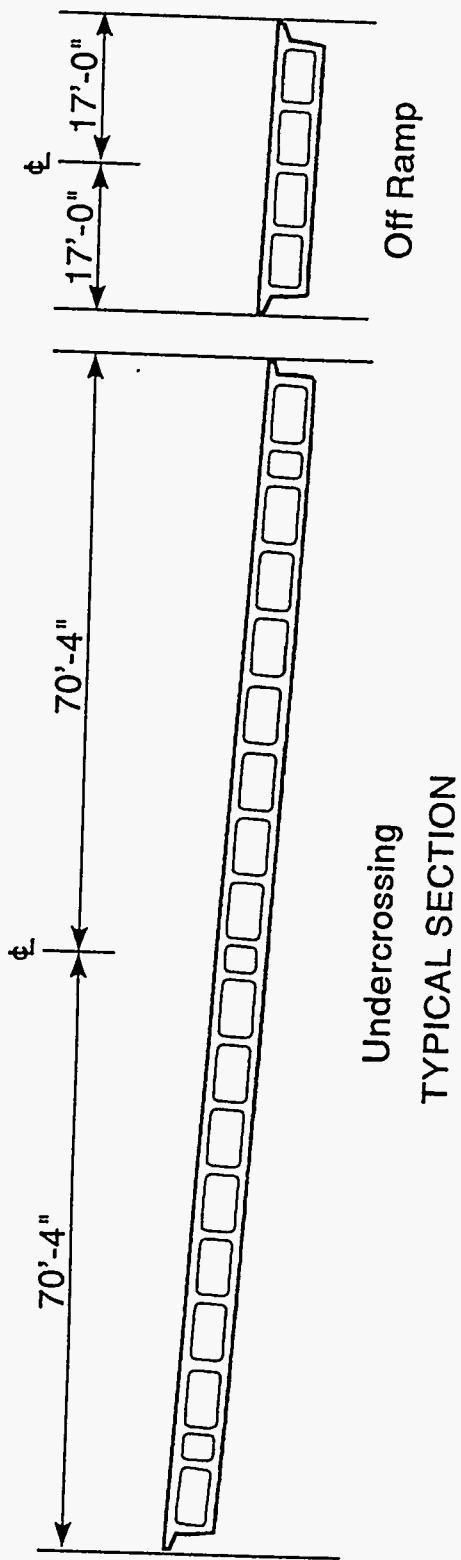
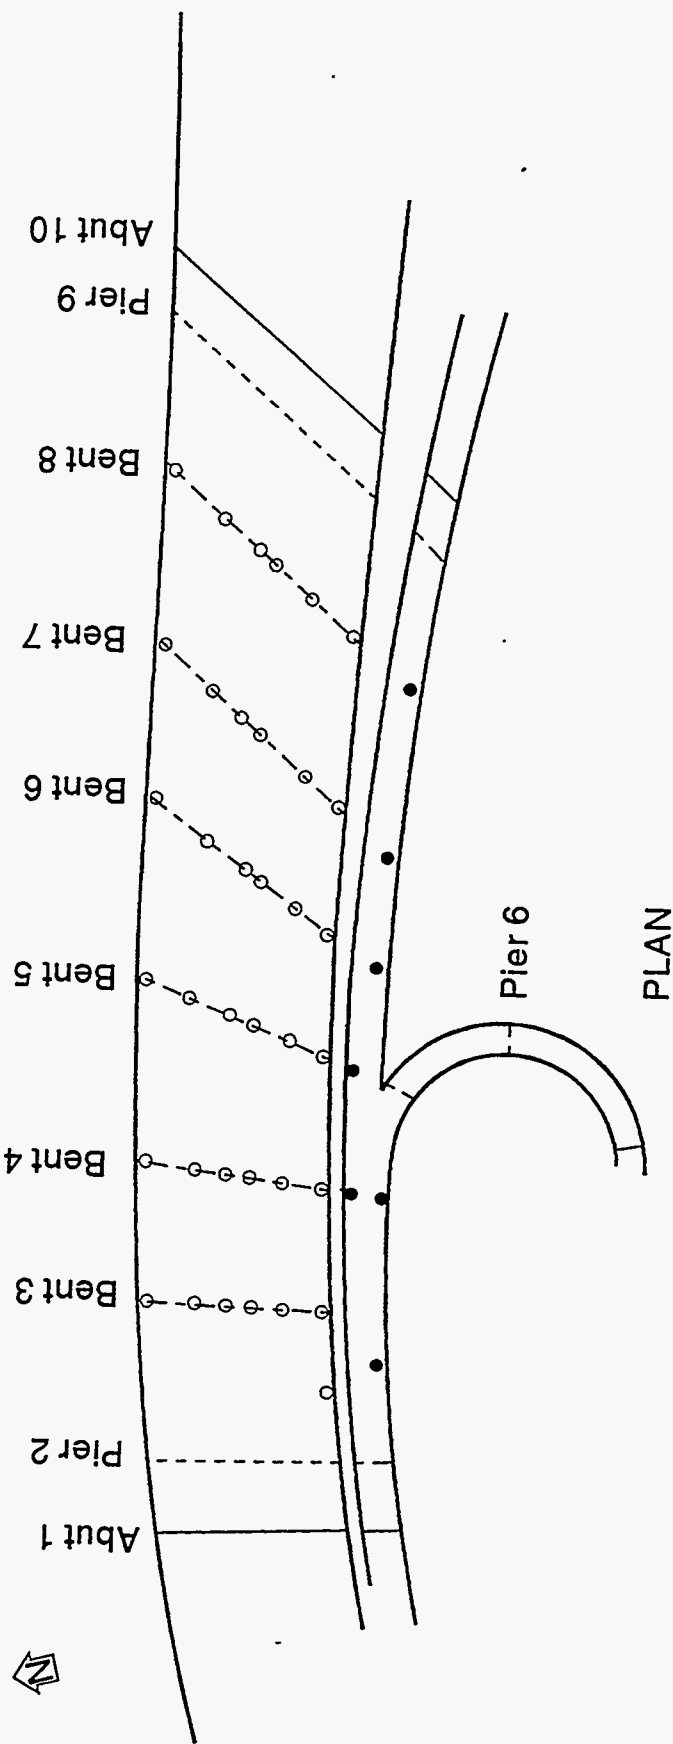
Figure 5.4-13: I-10 at La Cienega-Venice Undercrossing - General Plan and Elevation [ref 5.4-3].

This bridge was constructed in 1964, and was retrofitted with cable restrainers in 1978. The bridge superstructure consists of cast-in-place, reinforced concrete box girders supported by multi-column bents (see Figure 5.4-13). These columns lost core confinement of concrete due to shear failure. The typical shear reinforcement in the columns was #4 bars @ 12 inches or #4 spiral @ 12-inch pitch. The columns are each about 4 feet in diameter.
