WSRC-TR-94-0554, Rev. 1

Zink Rotary Kiln Seal-Cam Followers (U)

D. L. Fisher

Westinghouse Savannah River Company

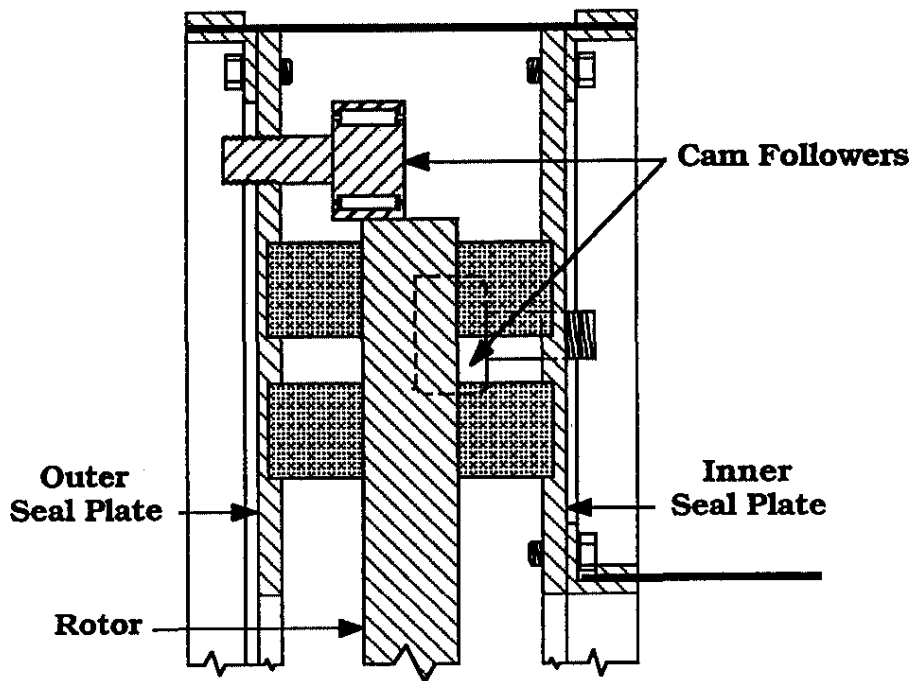
Figure 2. Double Faced Seal - Upper Cross Section

A 45" i.d. replica of the Zink double faced rotary kiln seal was installed on a test stand at TNX (figure 1). During initial run-in, seal plate motion was evident and was accompanied by low frequency noise similar to rail cars rolling over track joints. A cross section of part of the seal (figure 2) shows how the seal plates are carried by rollers (cam followers) riding on the rim of a rotor. The seal plates are fixed, but the rotor turns with the kiln barrel. Followers are evenly spaced at 60° intervals around the seal plates. When the seal plates are installed, opposing followers are staggered 30° to avoid interference.
