SAND98-1086

H1616 Supplemental Compliance Test Report

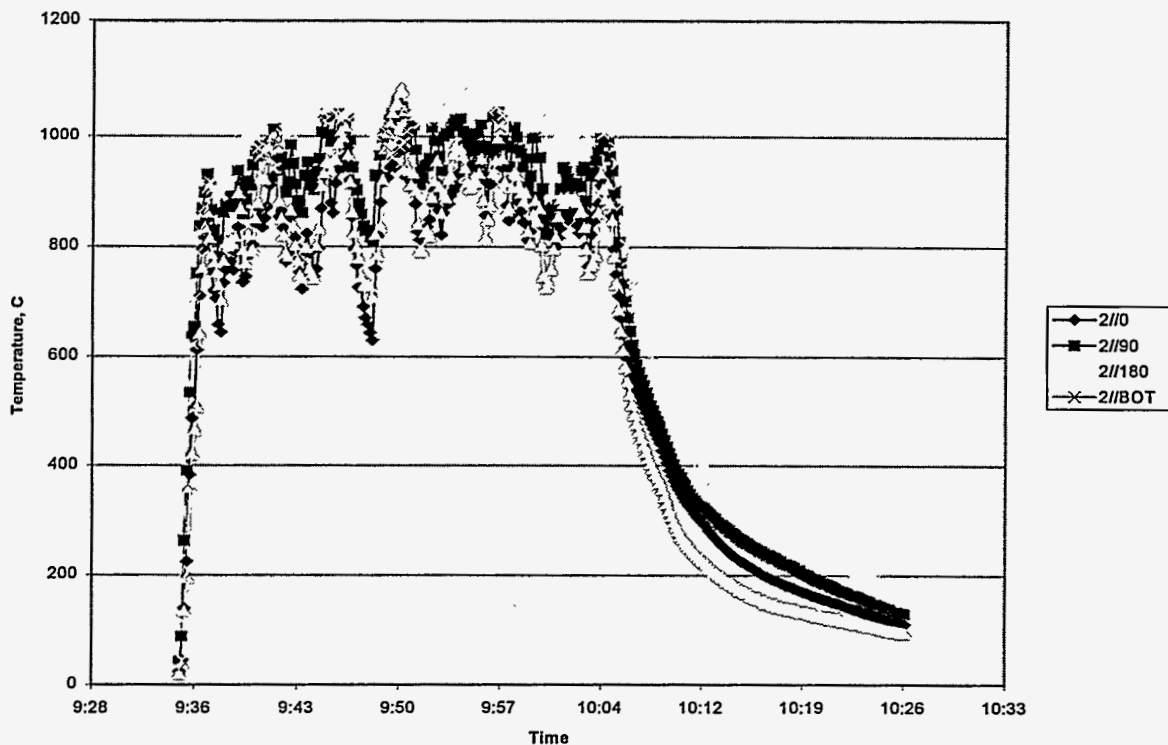
Figure 18: SCTU-2 Pool Fire Test Data

Figures 18, 19 and 20 show the temperature histories for each of the containers. These plots show the range of temperature variation within a given pool fire. These range from the tight variation and high temperatures in SCTU-4 to the relatively highly variable, cooler results seen for SCTU-3. In all events, the heat input to each container complied with the regulatory requirements.

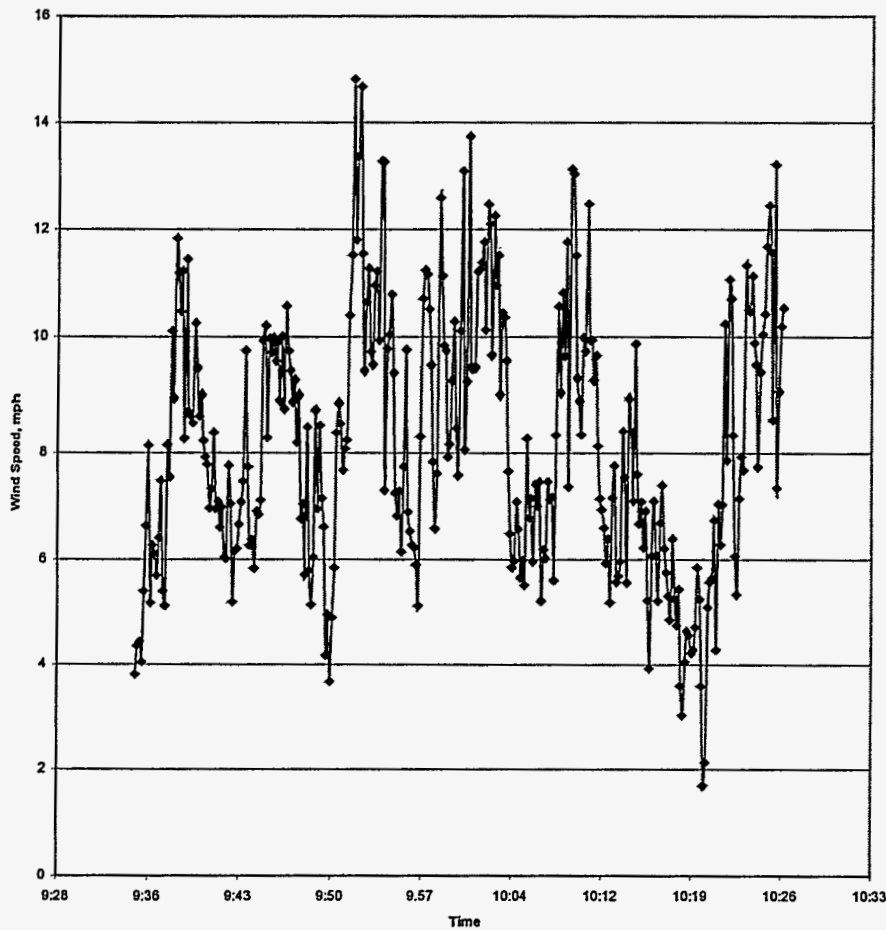
Figure 21: Wind Speed

The wind speeds for the pool fire test are shown in Figure 21. These wind speeds are measured outside of the windscreen that protects the fire. As is apparent from the previous temperature histories, these wind speeds did not adversely affect the pool fire.
