WAPD-260  
AEC RESEARCH AND  
DEVELOPMENT REPORT

# THE SECOND REFUELING OF CORE 1 OF THE SHIPPINGPORT ATOMIC POWER STATION

C. E. Center, H. Feinroth, and J. E. Yingling

August 1962

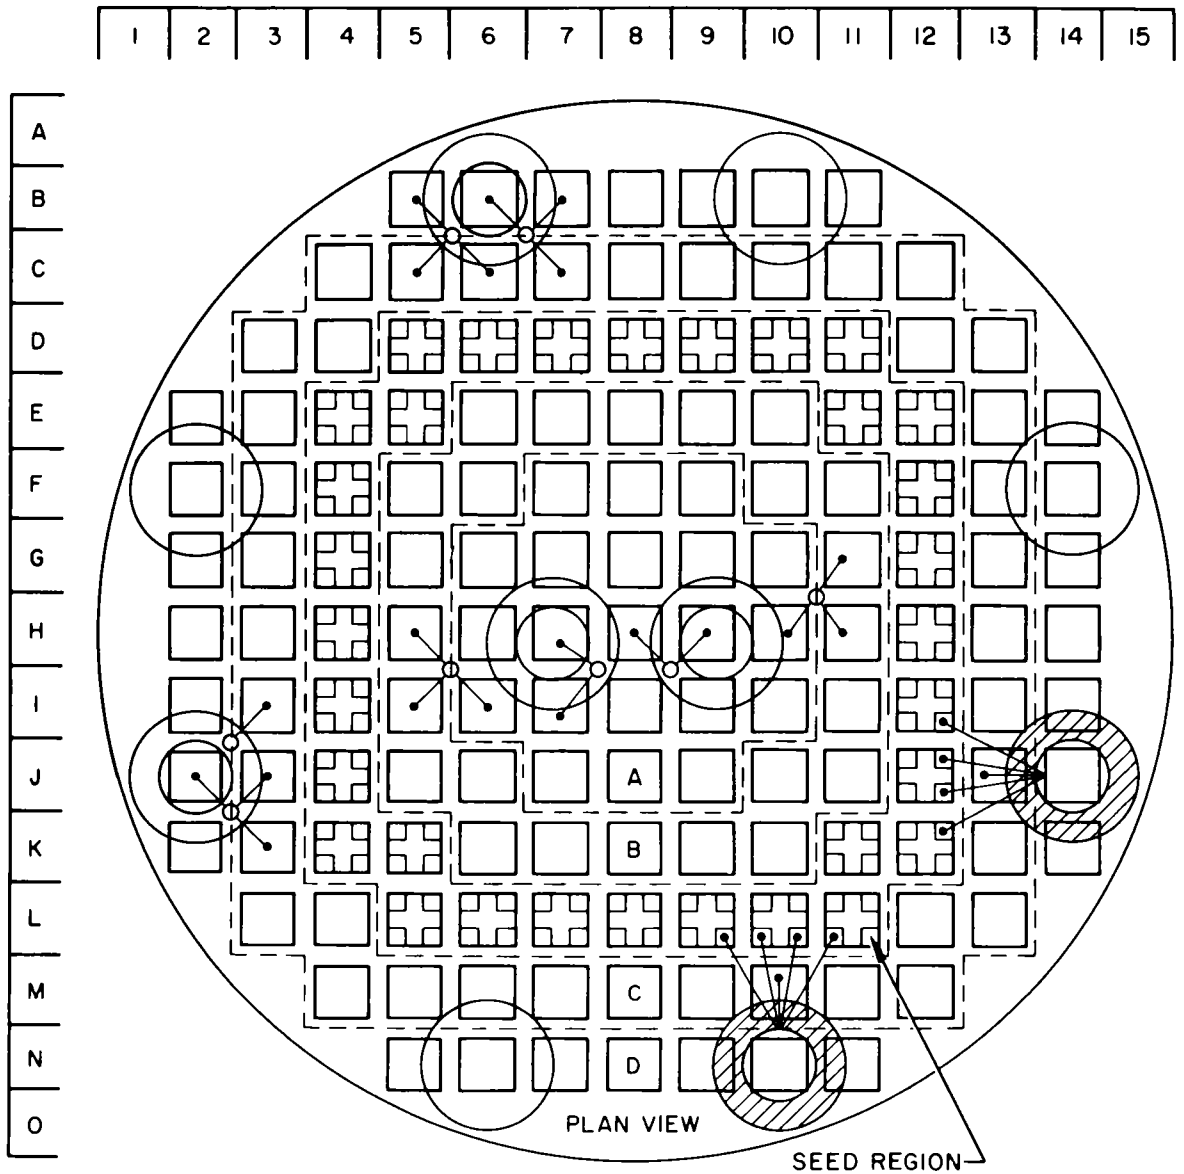
Figure 13. BEWI and ASEWI Location Diagram - Seed 3.

shutdown showed at least one thermocouple in each assembly was operable. A majority of thermocouples in the assemblies at B-10, F-14, and N-6 were known to have failed and could not be replaced. A new BEWI assembly with replaceable thermocouples was to be installed at fuel port location B-6 which previously had been a noninstrumented port. This new BEWI monitors the exit water temperatures of blanket assemblies in the northwest quadrant of the core locations B-5, B-6, B-7, C-5, and C-7. The arrangement of the BEWI and ASEWI for Seed 3 operations is shown in Figure 13.

1. AT H-7 NO THERMOCOUPLES ARE OPERABLE
2. AT J-2 ONLY THE THERMOCOUPLES IN J-3 AND K-3 ARE OPERABLE

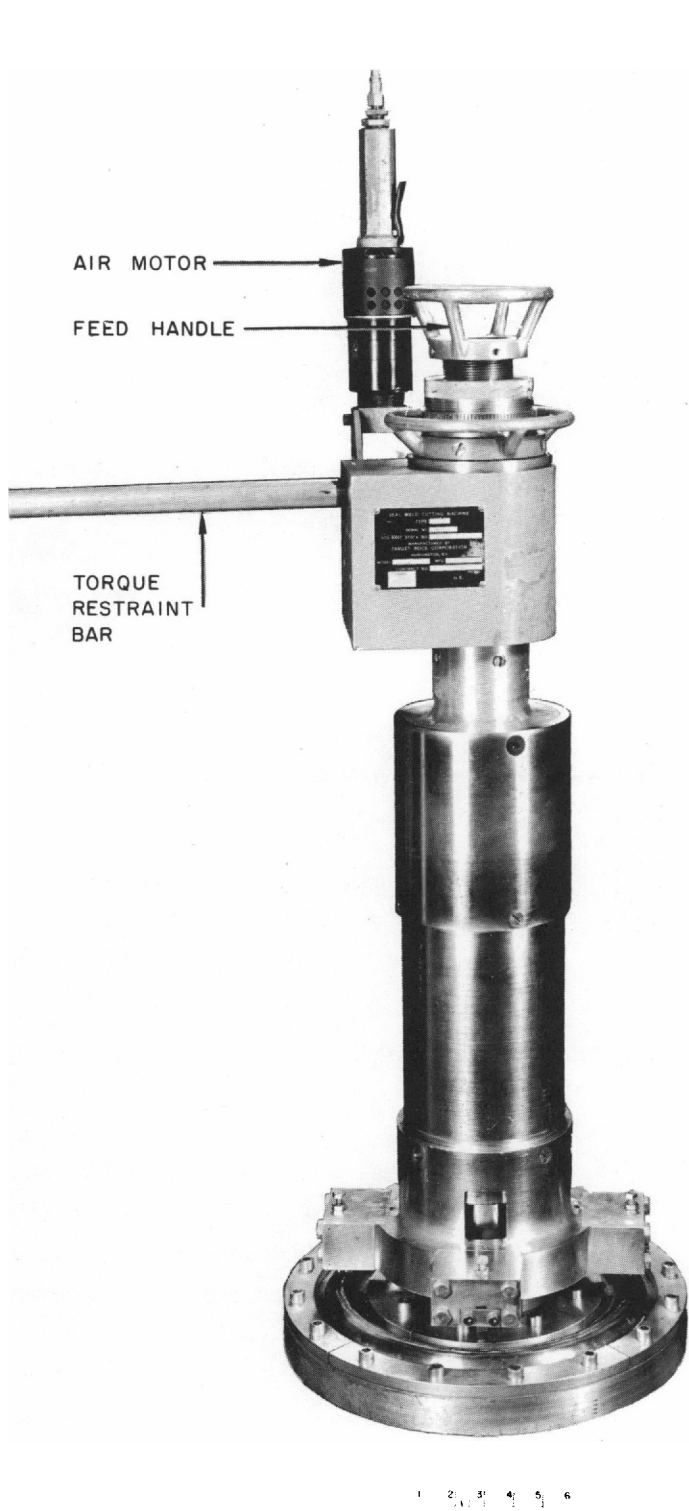
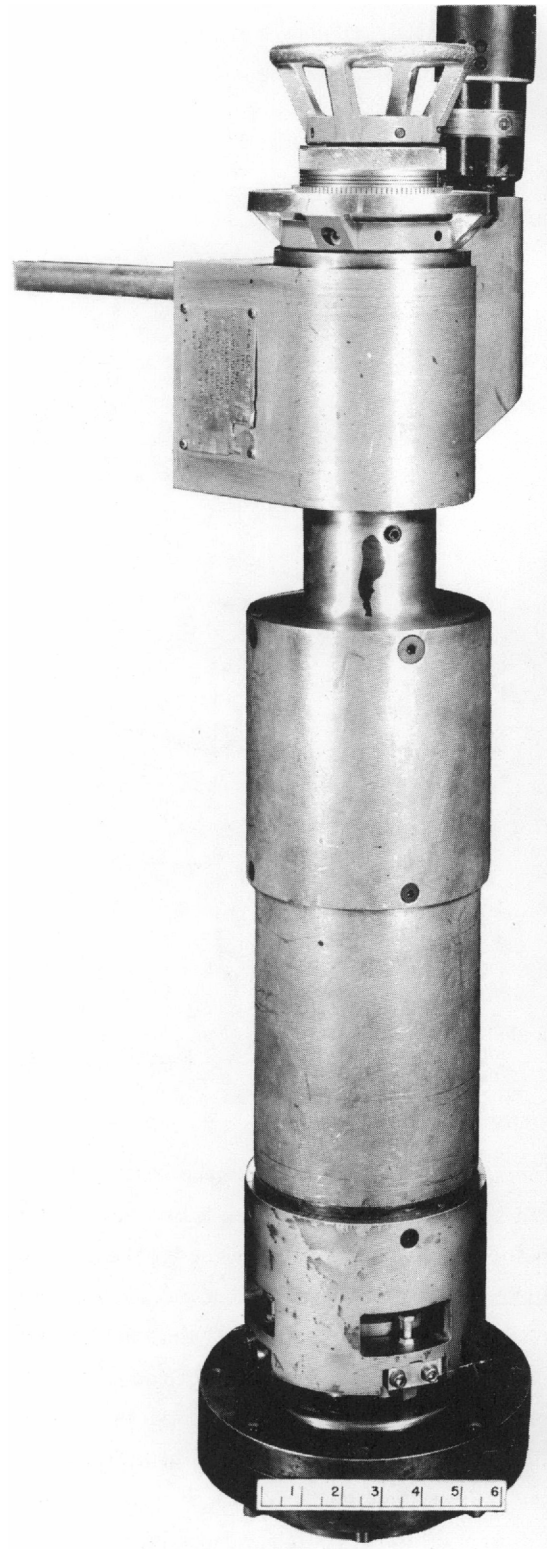
Figure 15. Omega-Seal Weld Cutting Machine.

The original tool modification had provided a positive torque restraint and antichatter system of torque bars and an adjustable framework which bridged the trellis structure. However, when initially used for the Seed 2 - Seed 3 refueling, it proved to be too cumbersome and time consuming to set up. A long bar arrangement was substituted. Torque restraint to prevent the machine body from rotating was provided by a long bar extending horizontally from the body (Figure 15). The bar was long enough to extend through the row of motor

tubes in the array opposite the cutting location, but did not use these tubes as a bearing surface. The outer end of the bar was lashed to the trellis structure with nylon rope to minimize backlash and chatter and was so tied off that the bar would not distort the vertical position of the cutting machine as it travels downward during the cut. When cutting the fuel ports located outside the mechanism array, the same long bar projected radially away from the array, and its outer end was lashed to the trellis structure. This arrangement was very successful.

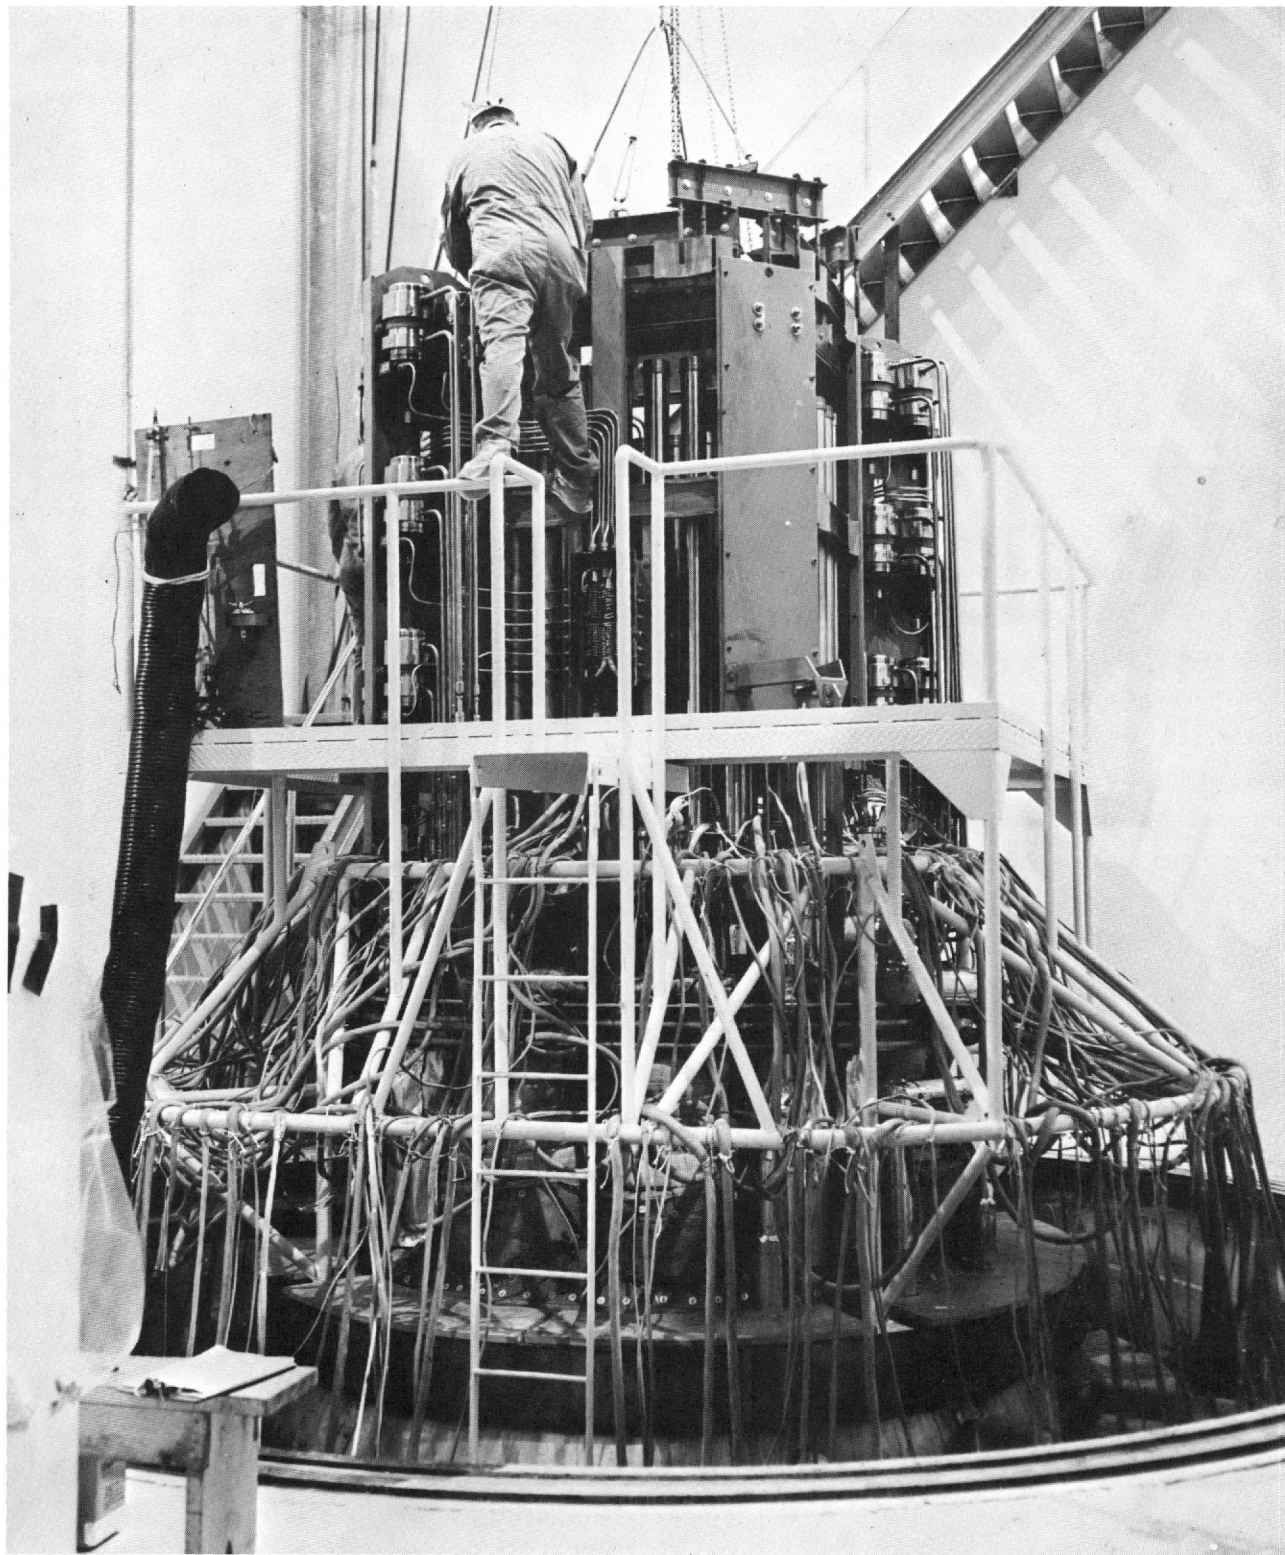
Figure 24. Reactor Vessel Head after Chamber Dome Removal.

The pit was drained and, after the residual water was cleaned from the pit floor, the reactor container dome was removed with no difficulty. Figure 24 shows the head and cover after the dome was removed. Electrical cables (a total of 138) leading from the mechanism motors and position indicator coils and instrumentation terminal boxes to the ring bus were removed, tagged, and stored in polyethylene bags for later electrical testing. Lead shot shielding was placed on the reactor vessel head. The procedure specification that temperature of the head be below 100 F to guard against possible melting of the polyethylene cover over the bags containing the lead shot was revised to about 200 F, because the slow cooling rate of the vessel metal and water would have delayed operations and the bags could withstand the higher temperature. The revised specification value was acceptable and proved to be adequate.

Cooling water headers and lines to the control rod drive mechanisms and multiport valve were drained and blown out without incident. When removing the 66 cooling water lines, difficulty was encountered in three instances where the fittings were very tight. Threads on the outlet header connector from mechanism location D-9 were damaged and a thread die was used later to dress the threads. The outlet connection adapter and nut threads at the stator, location E-12, were galled sufficiently to prevent removal with a wrench. The connector was heated, the stator water jacket was protected by asbestos cloth, and removal was accomplished. The stator connection threads were damaged and required subsequent repair. Eight

pairs of the cooling water inlet and outlet lines did not have identification numbers etched on them; this was corrected before reinstallation. At one location (H-4) the mechanism position-indicator-water jacket assembly was seated loosely on the housing. None of these conditions delayed progress.

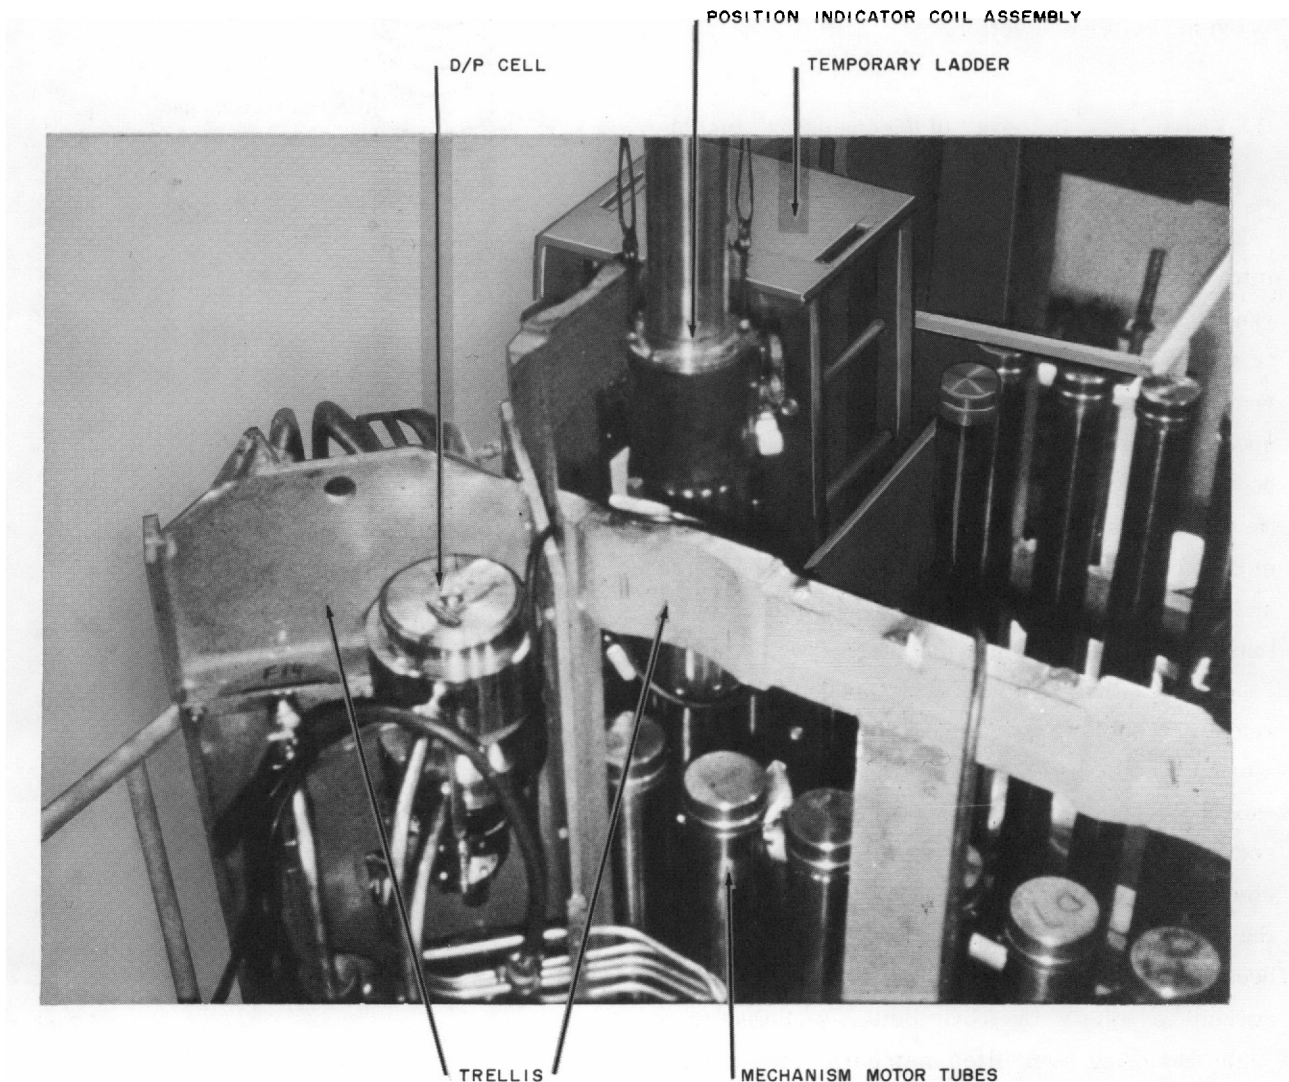
Figure 25. Control Rod Drive Mechanism Stator-Position Indicator Coil Assembly Removal.

The position-indicator coil and mechanism stator assemblies were removed (Figure 25) and stored in the modified head-bolt storage racks. The filled racks were hoisted to a balcony floor where, concurrently with other work, the electrical testing and mechanical inspection of the assemblies was performed. Removal of mechanism position-indicator coil covers and housing spacers revealed slight deposits of greenish corrosion product on some of the housing spacers, indicating galvanic corrosion between the brass covers and the stainless steel spacers and tubes. Also, slight corrosion products, asserted to be chromate, were found on three of the mechanism water jackets.

Neither of these was considered significant; they were attributed to the accumulation of moisture during shutdown periods.

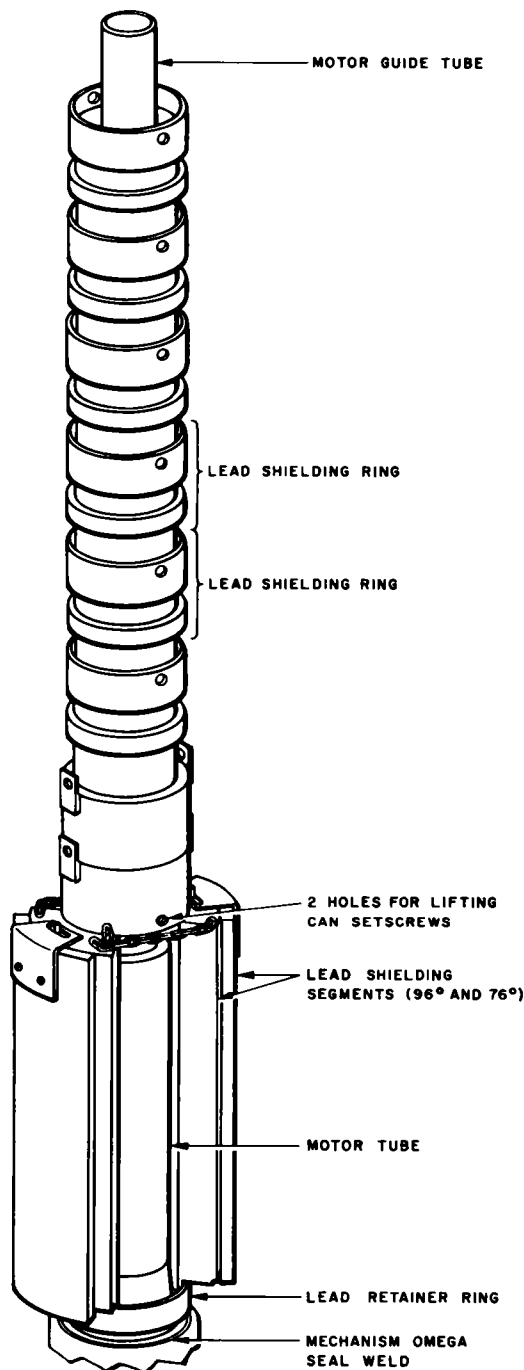
Figure 26. Mechanism Guide Tube Lead Shielding.

The new motor tube lead shielding rings and segments (Figure 26) were installed.

To take the place of lead sheet shielding of the mechanism motor tubes, several types of cast lead cylindrical segments, spacers, full cylinders, and covers were designed and manufactured (Figure 26). The large segments, weighing about 50 pounds each, were provided with short chains with snap locks for connecting pairs of segments together around the lower sections of each motor tube. These chains became twisted or jammed and some snap locks broke. An improved mechanical support is being devised for future refuelings. For the upper areas of the motor tubes, 20 pound cylindrical rings (donuts) were slipped down over the tops of the guide tubes. Up to seven such pieces could be stacked and nested on each motor tube. These were small enough to be handled manually, but a cylindrical handling container, which could hold a complete stack of rings, was also used to facilitate covering the motor tubes. To make room for installing the weld cutting machine on one motor

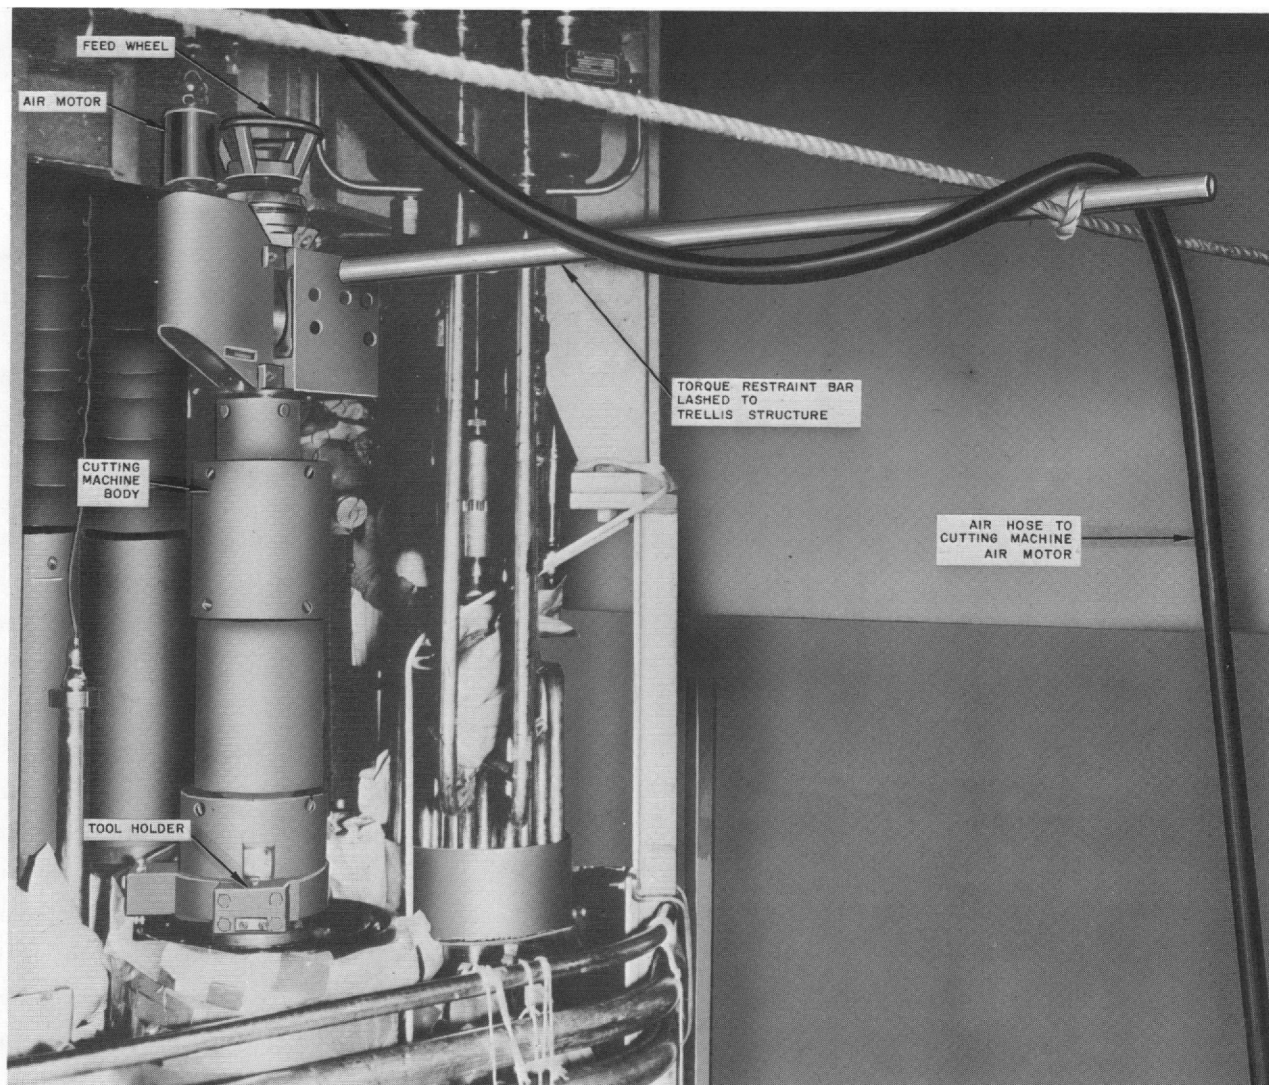
Figure 27. Seal Weld Cutting Machine on Fuel Port B-6.

The double seal welds at the eight remaining fuel ports were cut after the mechanism welds were cut (Figure 27). Each of these ports contained thermocouple leads extending through welded plugs in a central closure piece. Between the closure piece and fuel port housing is an annular nut, threaded on the outside diameter. The seal welds join the nut to the outside housing, and the central closure piece to the annular nut. The closure nuts and pieces were removed, the housing threads inspected, and the housing weld lips dressed. Little difficulty was encountered in the cutting operation on any of these welds, except for thick welds and some which had irregular configuration, requiring the use of a planer tool on one and of hacksaw

blades to part three welds. The nuts and closure pieces were removed satisfactorily, except the BEWI closure nut and closure piece from fuel port location J-2 (Step 48). The omega seal weld cutting machine had cut and parted the outer (11 inches nominal diameter) and inner (7 inches nominal diameter) fuel port seal welds without apparent incident. However, when the closure nut was turned for removal, the nut interfered with both the housing in the vessel head and the closure piece. When the nut was turned, the closure piece also rotated, tending to twist the thermocouple wires which project through it into the BEWI terminal box. The nut was turned down again, thereby carrying chips into the pilot between the nut and housing and into the fit between the nut and closure piece, thus, further preventing removal. Investigation disclosed an error in setting up the seal weld cutting machine. When attaching the tool post to the closure, dowel pins were not installed in the two locating holes. Without these pins there was enough clearance between the tool post holddown bolts and their holes to allow this tool post to be tightened down 0.020 inch off center. Thus, when cutting the welds, both omega seals were cut concentric with each other, but 0.020 inch eccentric with respect to the true centerline, or 0.040 TIR, causing the nut to bind between the central closure piece and the stationary housing.

The mechanism and fuel port seal weld cutting difficulties were caused mainly by excessive underbead reinforcement and tungsten inclusions in the welds which had been made during the first refueling. These made the final parting cuts troublesome.

The solution was to recenter the tool post and recut the outer omega seal to a diameter larger than normal by 0.040 inch. The inner weld was cut to a 1/2 inch wide V-gap so that the interference occurring between the nut and closure piece could be cleaned of chips. The nut could then be unscrewed. This cutting made both the closure piece and nut unusable, and also enlarged the diameter of the stationary housing seal lip. This cutting back of the housing lip decreased its height by about 0.010 inch, and the gap to be welded later, using a new nut, would be larger than nominal. Therefore, in preparation for later reinstallation,

a spare closure nut was prepared having an over-size lip diameter made to match the housing lip so that the root gap of the weld preparation would be within the range of the automatic welding machine. A replacement closure piece was also obtained from stock spares.

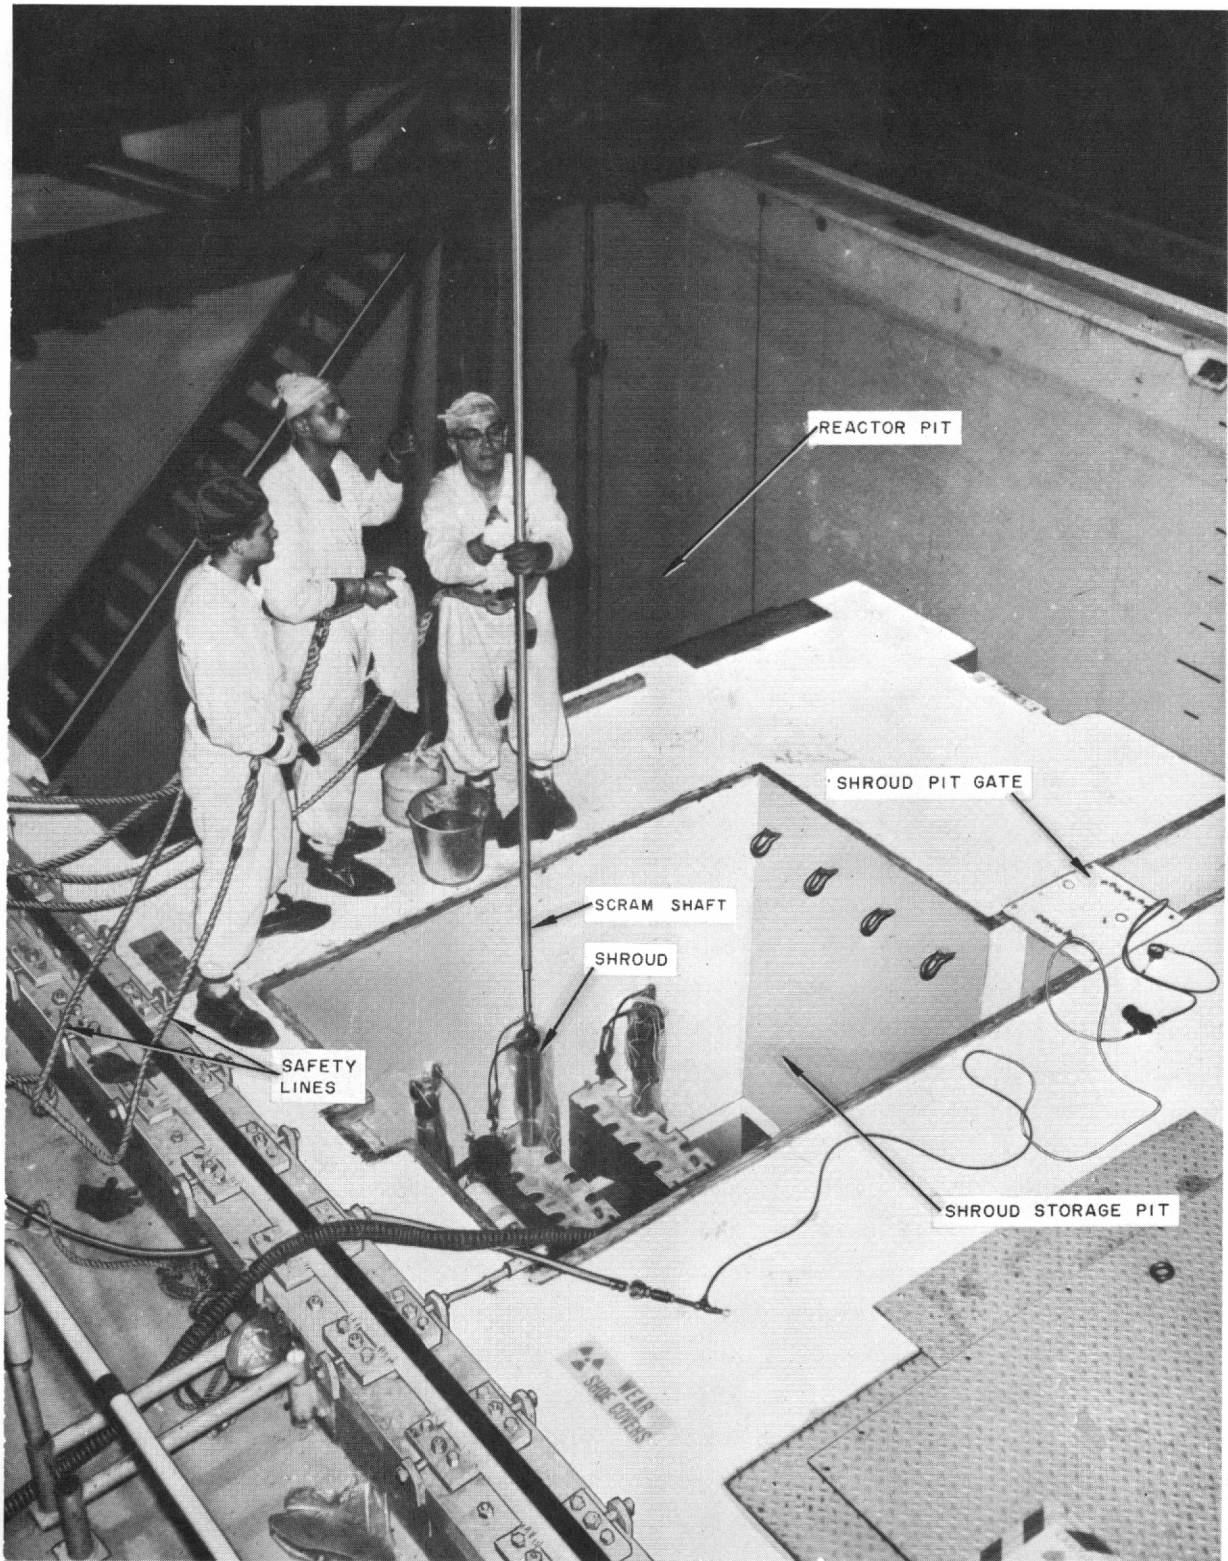
Figure 28. Installing a New Scram Shaft in Shroud Removed from Location L-8.

All lead screws from these shroud-scram shaft assemblies were visually inspected in the fuel storage pit where they were lifted up past the viewing device of the microscopic lead screw inspection stand. Selected assemblies from locations E-12, H-4, H-12, J-4, J-12, L-8, and K-5 were chosen for disassembly and for internal and external inspection of the shroud or the scram shaft or both. K-5 was to receive a new scram shaft for Seed 3 operation. Shrouds to be inspected were from locations E-12, H-4, H-12, and J-4. The scram shaft assemblies from locations E-12, H-4, H-12, J-12, and L-8 were inspected. External visual inspection was made of the control rod shrouds from locations H-4, E-12, H-12, and I-12. The shrouds from H-4, E-12, H-12, J-4, and K-5 were disassembled for internal inspection. The K-5 and J-4 scram shafts were removed by placing each shroud in its storage rack and pulling the shaft out and up into the air, instead of using the scram shaft disassembly stand for underwater removal as originally specified. Operators were working in a radiation field of about 20 mr/hr during this removal in air. The Seed 1 shroud removed during the first refueling from location L-8 was fitted with a new lead screw and scram shaft (Figure 28) and reinserted into location J-4 for

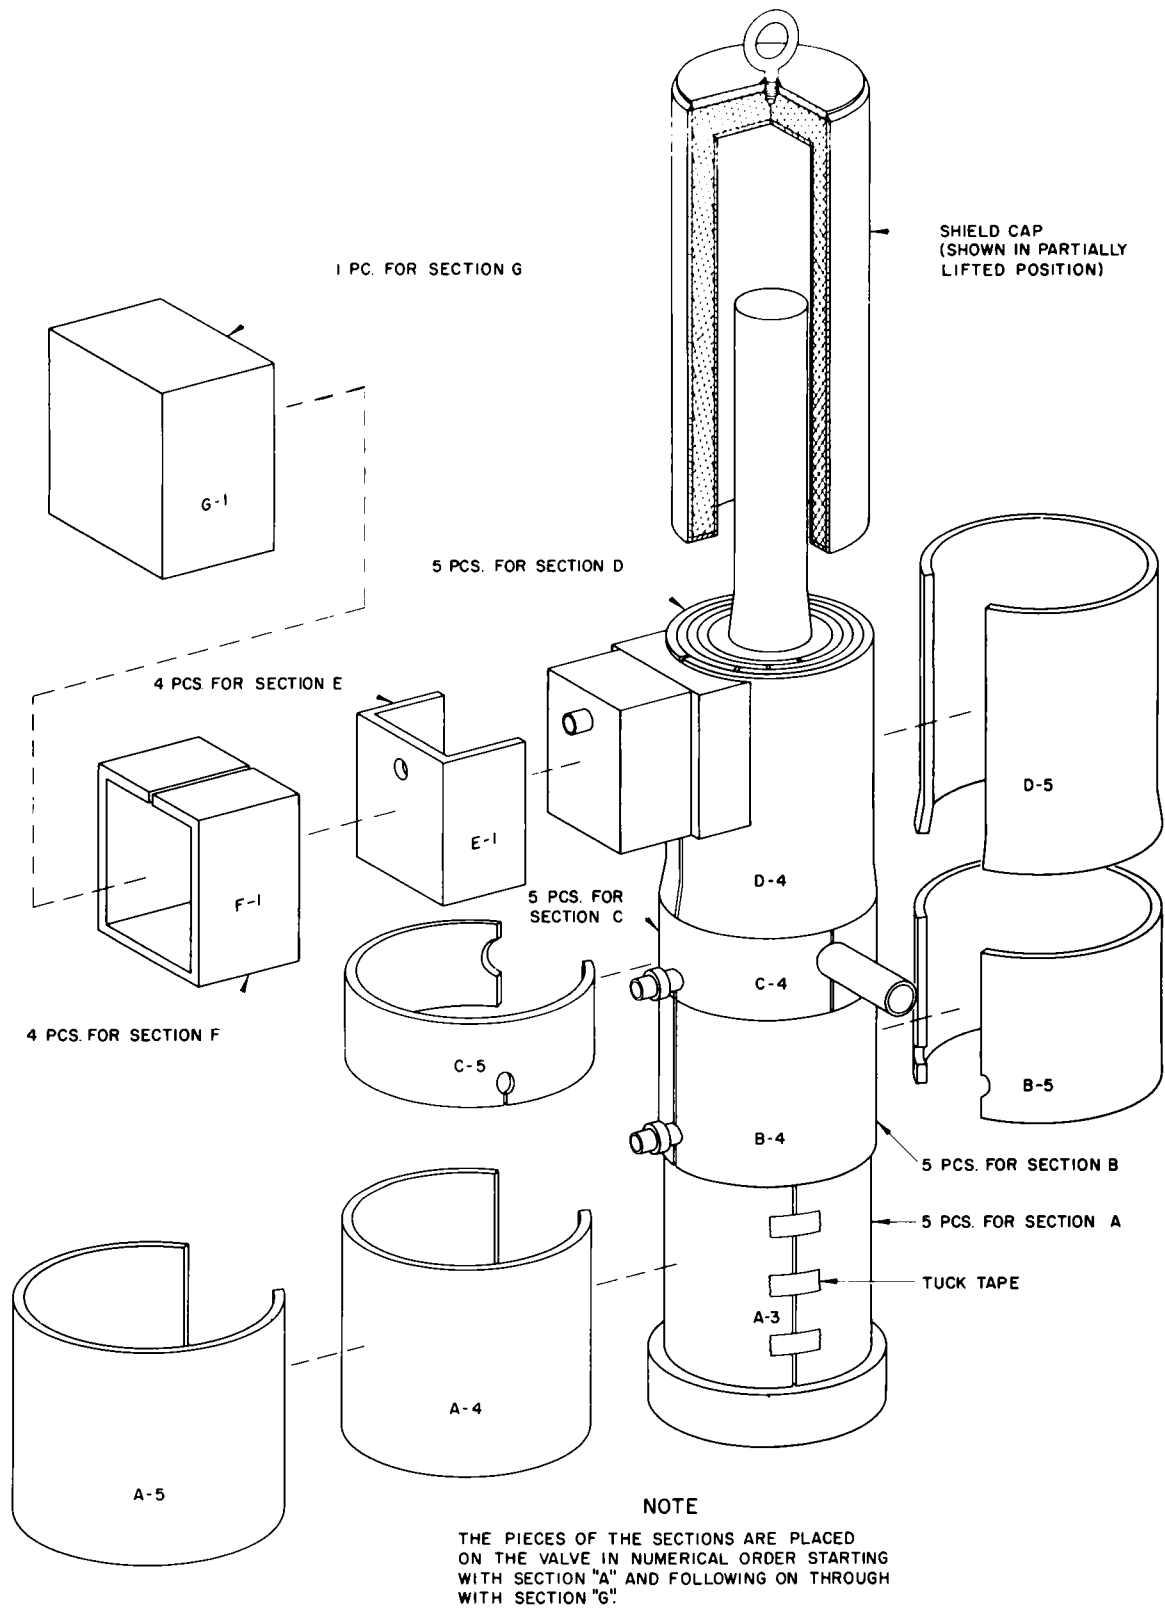
Figure 32. Multiport Valve Shielding.

The multiport valve is a crud trap and, therefore, a source of high radiation. Special lead segments were formed from sheet lead and cut to fit snugly in multiple layers, using a spare multiport valve as a form. The largest of the shielding segments weigh about 50 pounds each, and all were installed by hand. Following the removal of the multiport valve thermal insulation and stator water jacket assembly, the "cap-type" shield was installed over the motor tube as shown in Figure 32. The multiport valve bypass pipe and the two sample lines were shielded by wrapping them with 3/16 inch lead sheet until sufficient thickness was reached to attenuate radiation to a minimum practicable level. This shielding was effective and reduced the radiation levels at the multiport valve by a factor of about 4.

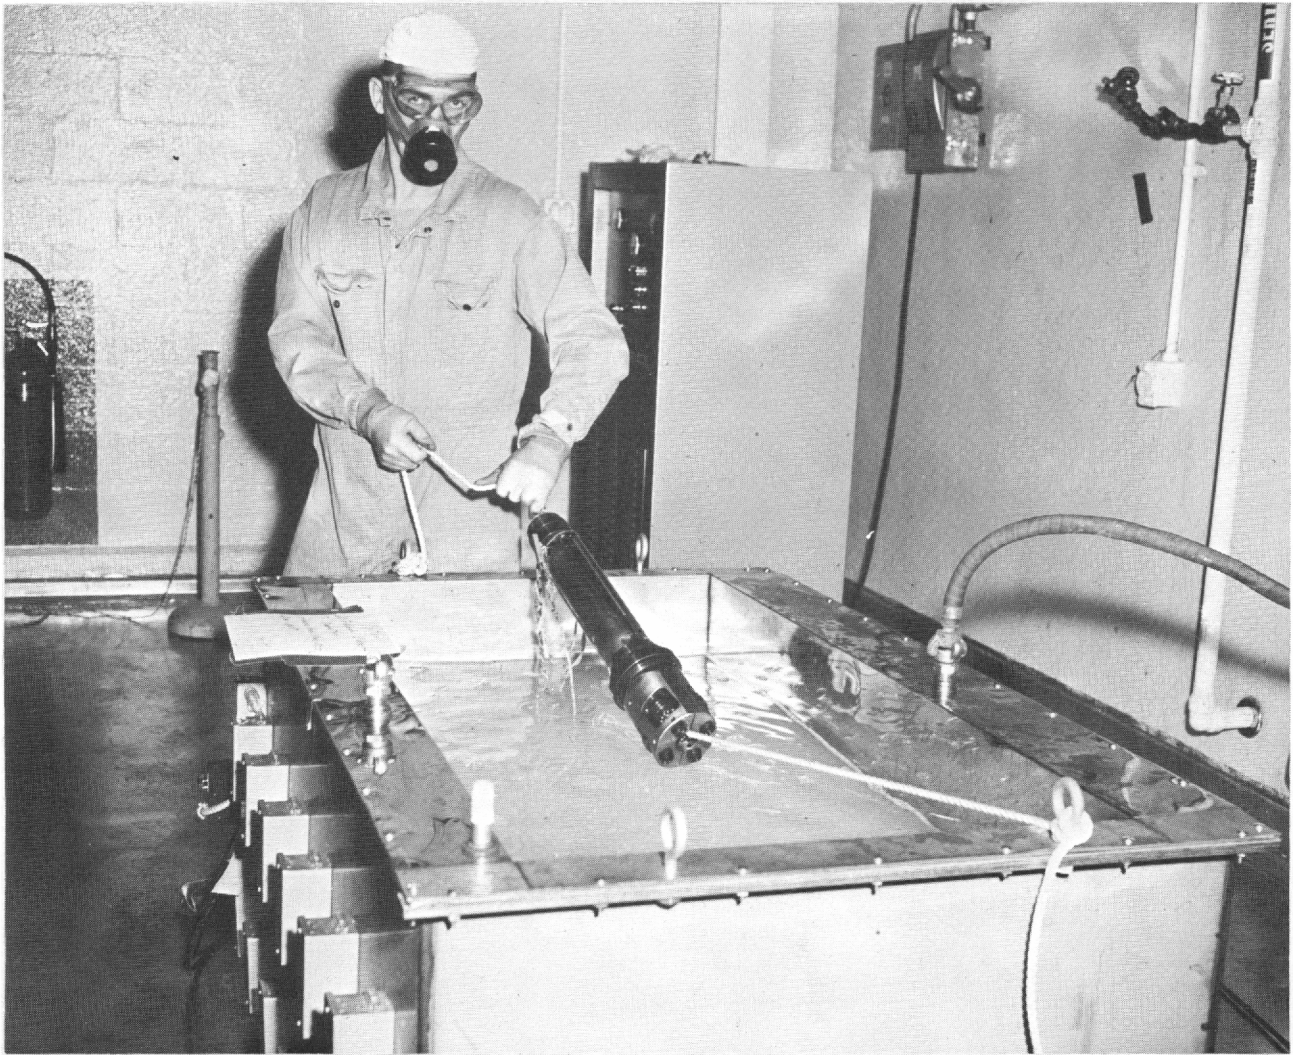
Figure 33. Ultrasonic Decontamination of Mechanism Rotor from Location D-10.

head), respirators were also required. Decontamination of areas and equipment by vacuum cleaning, mopping, and wipedown controlled air activity to prevent an ingestion hazard. Decontamination of components by ultrasonic baths (Figure 33) and scrubbing reduced the radiation levels during their reinstallation. Other personnel protection measures included maintenance of clean areas, normally required control areas, and highly radioactive restricted areas, in addition to continuous area monitoring including the mounting of film badges at various locations in the reactor pit. The contaminated change room and showers provided a buffer area which effectively prevented the spreading of contamination to the clean locker rooms or

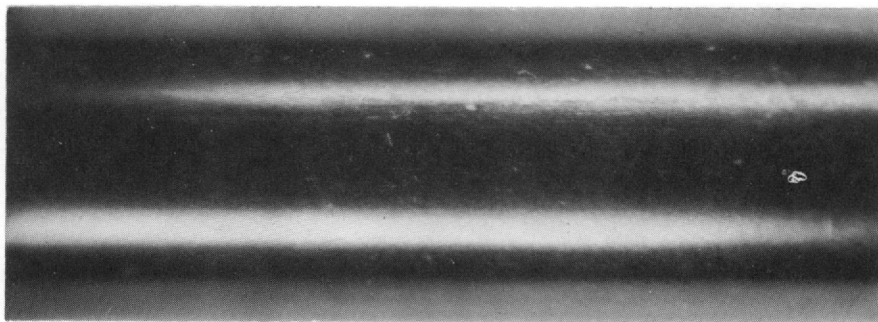
Figure 40. General View of Rod Surface; X4.3.

The rod was examined for evidence of corrosion using a stereo viewer and low-magnification (4 to 6.6X) photographs. No accelerated corrosion attack has taken place, and the rod retained its unirradiated black lustrous film over the entire surface (Figure 40). Some minor surface scratches were evident, but these were apparently due to the post-irradiation handling process.

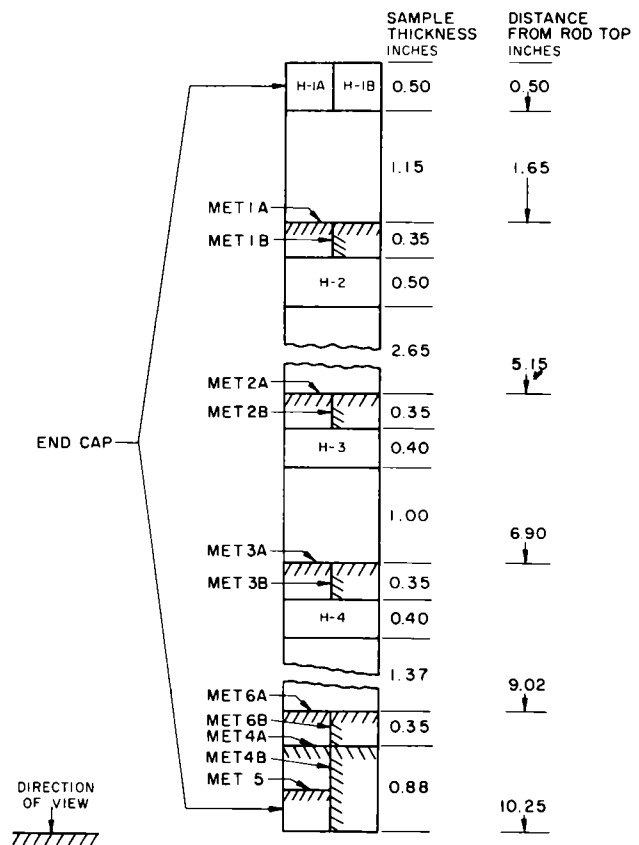
Figure 41. Sectioning of PWR Core 1 Blanket Fuel Rod for Hydrogen Analysis and Metallographic Examination.

Metallography samples were prepared by sectioning the fuel rod at the locations shown in Figure 41. This operation was accomplished by using a tubing cutter to section the cladding at pellet interfaces, thus keeping disturbance of the fuel to a minimum. A total of four fuel pellets were then pressure mounted using Hysol epoxy resin to penetrate each crack. The pellets were sectioned on a transverse cut and polished and etched to bring out the grain structure of the cladding or fuel. Longitudinal samples were prepared in a similar manner as shown in Figure 41. The Zircaloy cladding and end cap, designated as Met 4 and Met 5 in Figure 41, were examined in the longitudinal and transverse directions to examine the weld metal structure. The oxide film on the outside of the rod was examined under higher magnification, and average thickness values were obtained by

The cut faces of the sectioned fuel pellets displayed a radial crack pattern of the type shown in Figure 42. There was no fragmentation of fuel in the metallographic samples located in the body of the rod; however, the pellet located next to the end cap, Met 4A of Figure 41, fractured fairly extensively into large coherent pieces which became dislodged from the cladding. This fracture is attributed to the thermal stresses set up during the welding operation of the end cap. Microexamination of the transverse and longitudinal sections revealed fine uniform grains with no indication of grain growth or centerline melting. Typical grain size of the fuel at the pellet center is shown in Figure 43; that of  $UO_2$  fuel from the most highly depleted rod at the end of the first seed life ( $1.77 \times 10^{20}$

Cladding sections designated by "H" in Figure 41 were completely separated from fuel and carefully etched in boiling  $HNO_3$  acid to remove any residual  $UO_2$  fuel, then analyzed for hydrogen content by the hot vacuum extraction method. This method allowed a correlation between microstructurally observed zirconium hydride needles and the hydrogen content of the cladding.

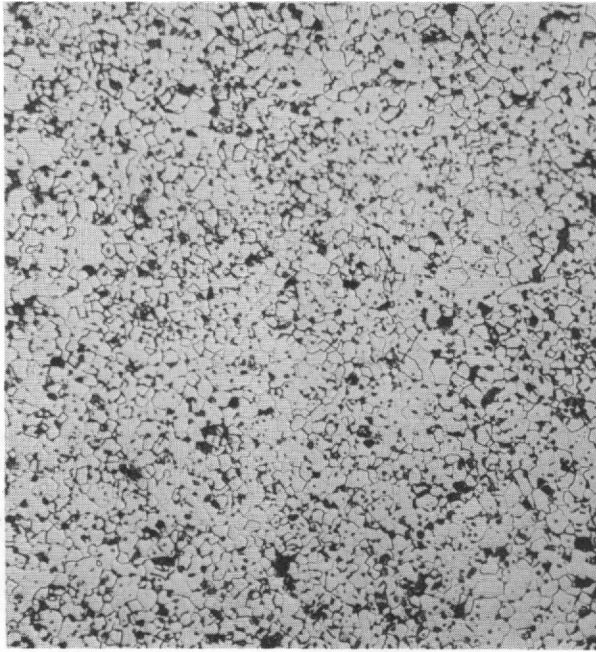
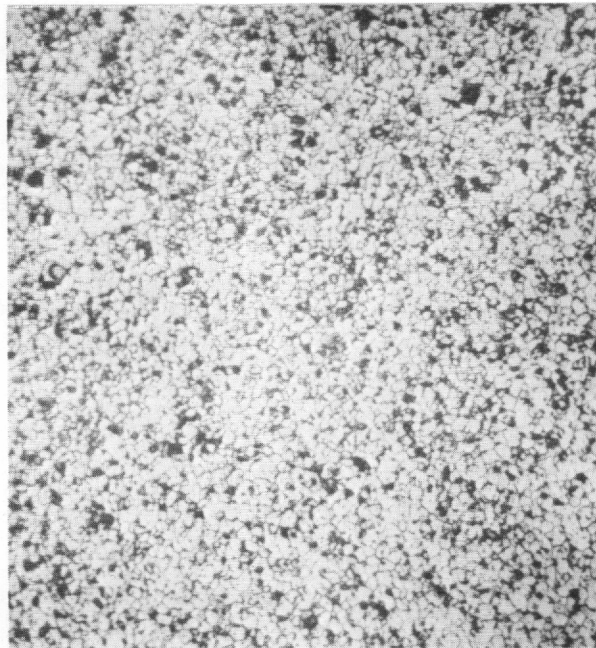
fissions/cc) is shown in Figure 44. Grain size at the clad surface is shown in Figure 45, and a typical microstructure of nonirradiated  $UO_2$  is shown in Figure 46. These comparisons indicate that no significant structural changes occurred. The lack of structural or dimensional changes in the fuel after exposure is also shown in Figure 47 where the diametral clearances between fuel and cladding may be seen. The as-fabricated clearance was specified as 0.002 inch, which compares with the measured annulus of 0.0018 inch in Figure 47.

Figure 43. Typical of the Fine Grain Microstructure at Center of Pellet 2A at the End of the Second Seed Life; X250.

Figure 44. Fine Grain Microstructure of UO<sub>2</sub> at End of One Seed Life; X250. (No change in grain size in comparison with figure 43; micrographs are of same general rod area.)

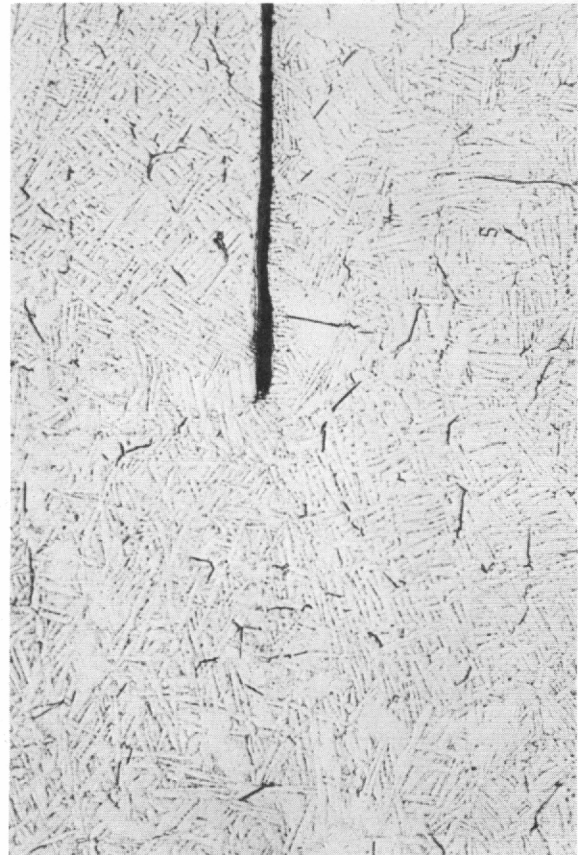
Figure 48. End Cap Weld; X150. (Note good weld penetration of longitudinal section.)

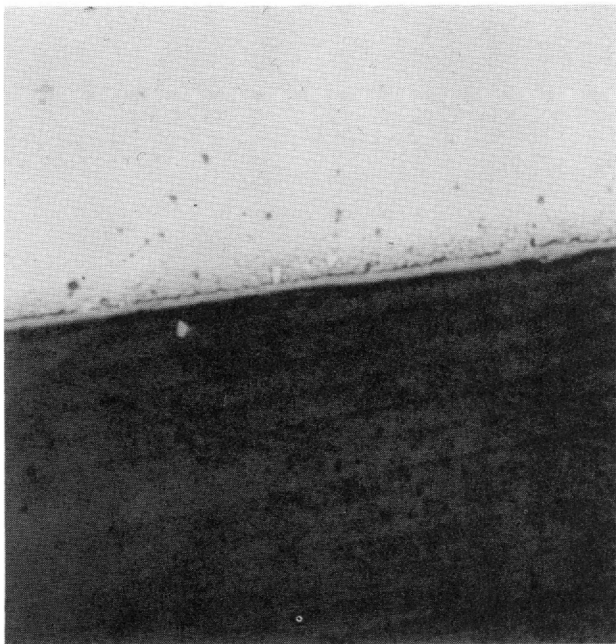
Measurements of the oxide film thickness made on the cladding are presented in Table XIII, and a representative photomicrograph is shown in Figure 50. These results showed an average oxide film thickness of 0.000056 inch. The theoretical oxide film buildup can be summarized as follows:

Figure 50. Representative ZrO<sub>2</sub> Film; X1600. (Note high conformity and continuity.)
