# **Final Report Summary of DM1200 Operation at VSL**

**VSL-06R6710-2, Rev. 0, 9/7/06**

K. S. Matlack  
Vitreous State Laboratory,  
The Catholic University of America

**Summary of DM1200 Operation at VSL**

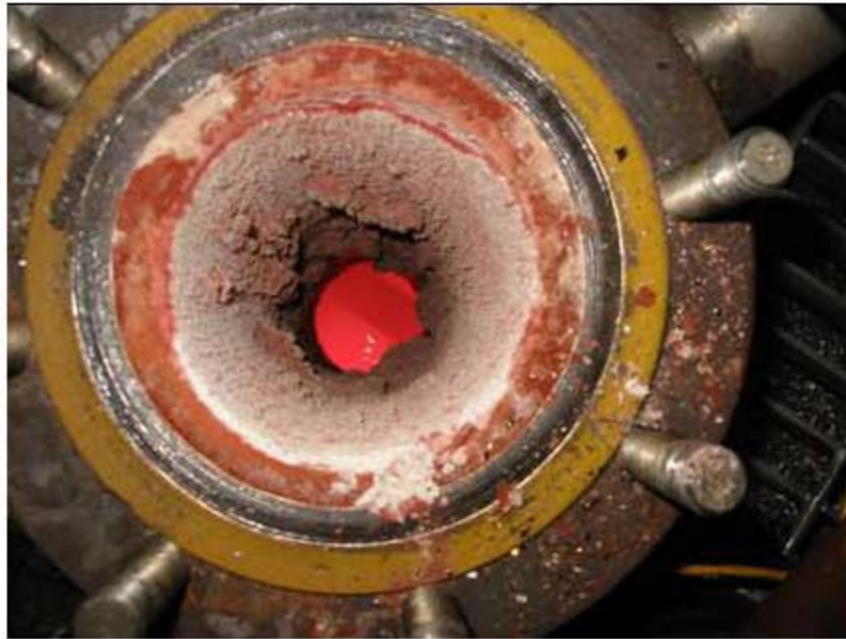
Film Cooler: At the end of the LAW Sub-Envelope A1 test series, the film cooler was removed and inspected in detail. Photographs of the solids deposits in various parts of the film cooler are provided in Figures 4.8 - 4.11. Although the mass of the deposits was not recorded, significant solids deposition can be observed in the photographs. In addition to the solids deposition, significant corrosion damage at the bottom of the film cooler was observed, as shown in Figures 4.12 - 4.19. DCP analysis of a sample of solids removed from the film cooler after washing indicated that the deposits consist mainly of sodium and silicon, with lesser amounts of aluminum, boron, chromium, iron, nickel, selenium, and zinc. Cleaning of the film cooler was only marginally successful, as shown in Figures 4.20 - 4.23.

**Figure 4.8.** View of top of the installed film cooler after tests (pre-cleaning) with LAW Sub-Envelope Al simulants [14].

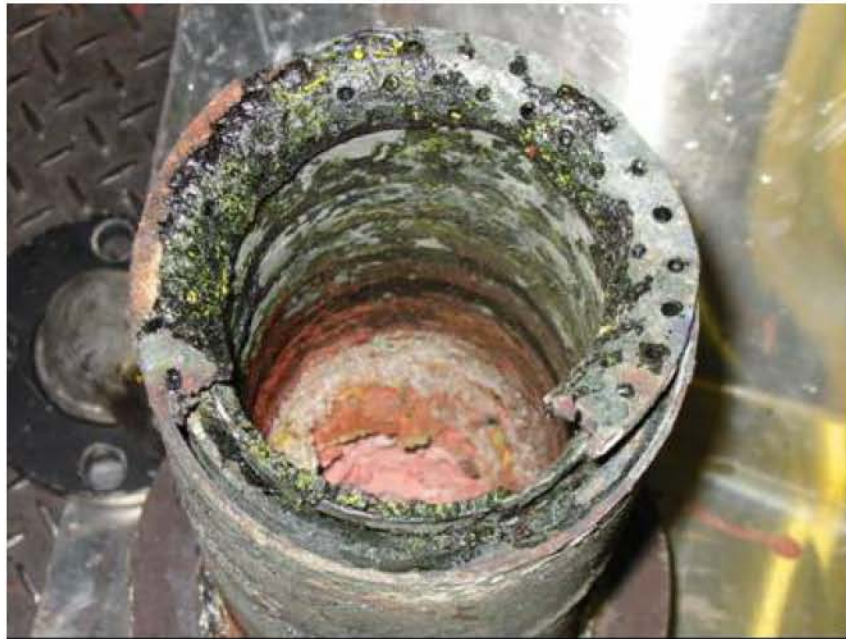
**Figure 4.14. Another bottom view of the film cooler (pre-cleaning) after tests with LAW Sub-Envelope A1 simulants [14].**

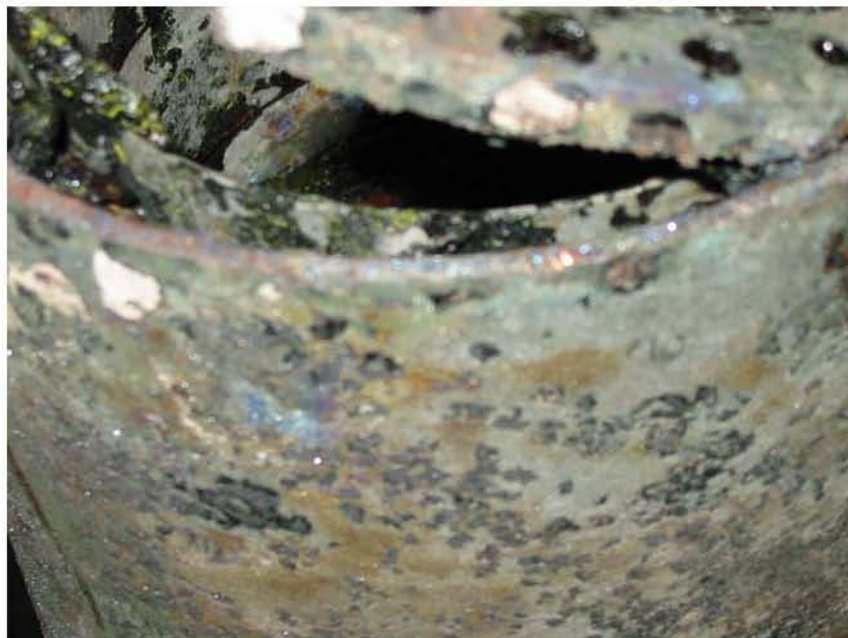
**Figure 4.15. View of detachment of the film cooler bottom ring (pre-cleaning) after tests with LAW Sub-Envelope A1 simulants [14].**

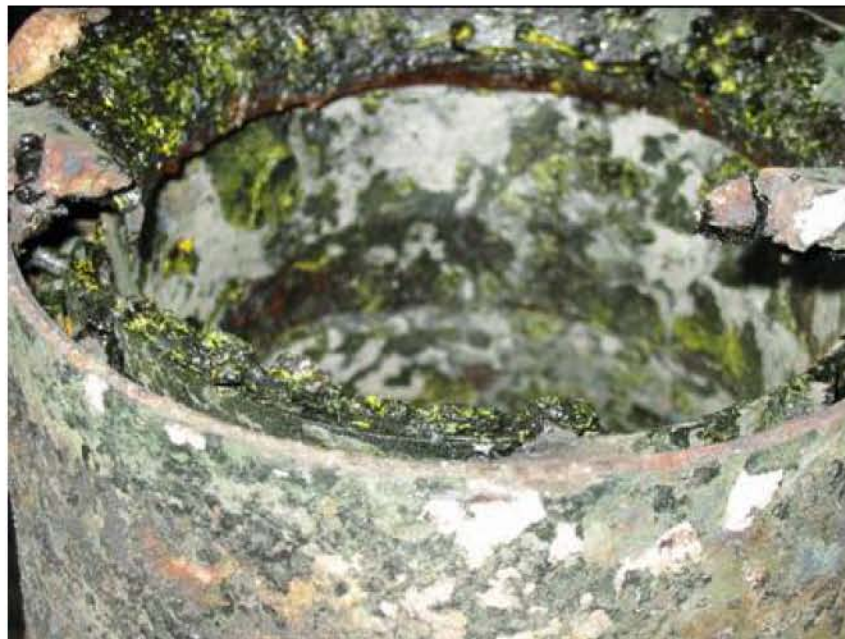
**Figure 4.17. View of louvers of the film cooler (pre-cleaning) after tests with LAW Sub-Envelope A1 simulants [14].**

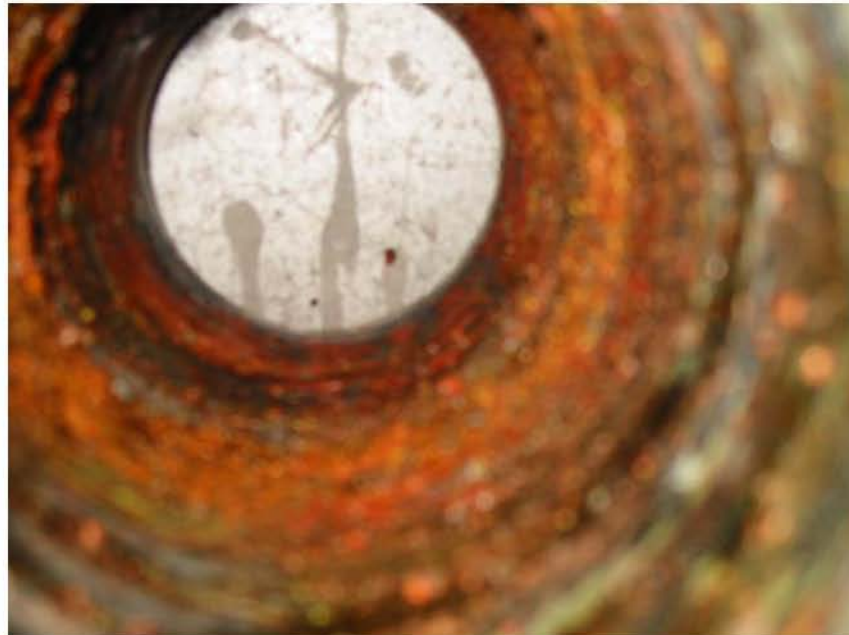
**Figure 4.22. View of exit end of the film cooler (post cleaning) after tests with LAW Sub-Envelope A1 simulants.**

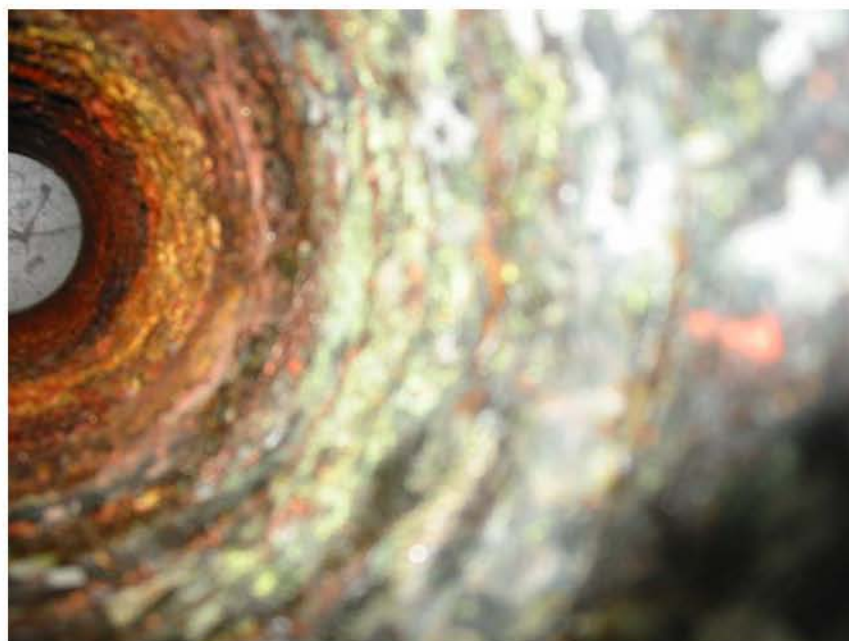
**Figure 4.23. Close-up view of exit end of the film cooler (post cleaning) after tests with LAW Sub-Envelope A1 simulants.**

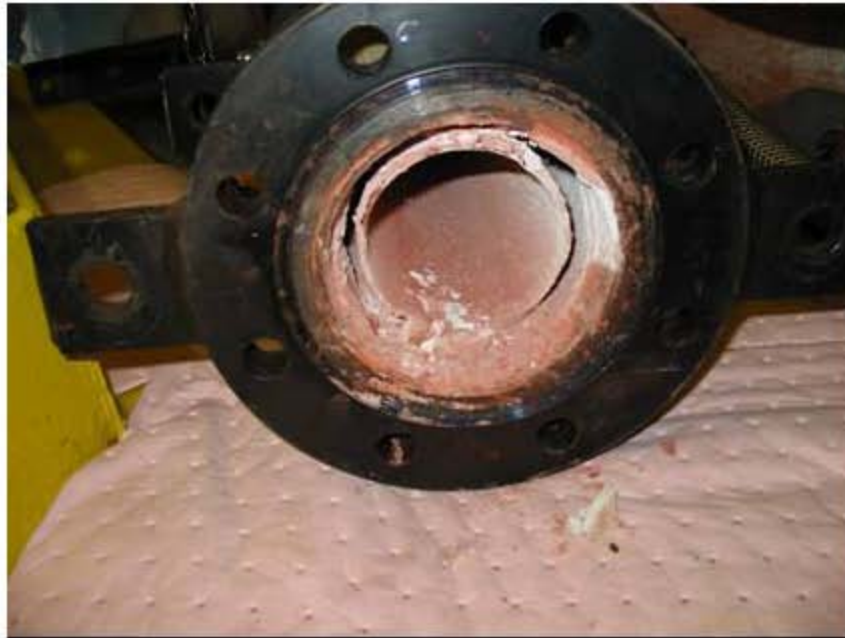
Transition Line: After 121.6 hours operation (in between the second and third test segments) and at the end of the test series, parts of the transition line were removed for inspection. The inside of the flexible bellows between the film cooler and the transition pipe and the inside of the transition pipe (SBS side) contained solids deposits after 121.6 hours operation, as shown in Figures 4.25 and 4.26. Similar, but not as extensive deposits were also observed at the end of the test series.

**Figure 4.25.** View of flexible bellows (pre-cleaning) during tests with LAW Sub-Envelope A1 simulants [14].

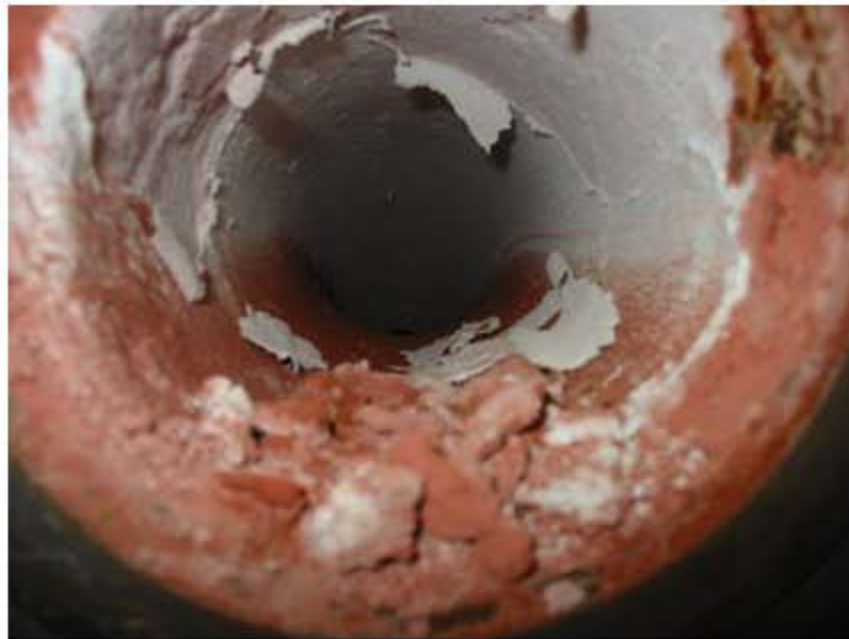
**Figure 4.26.** Inside view of the SBS-side of the flexible bellows (pre-cleaning) after 121.6 hours of operations during tests with LAW Sub-Envelope A1 simulants [14].

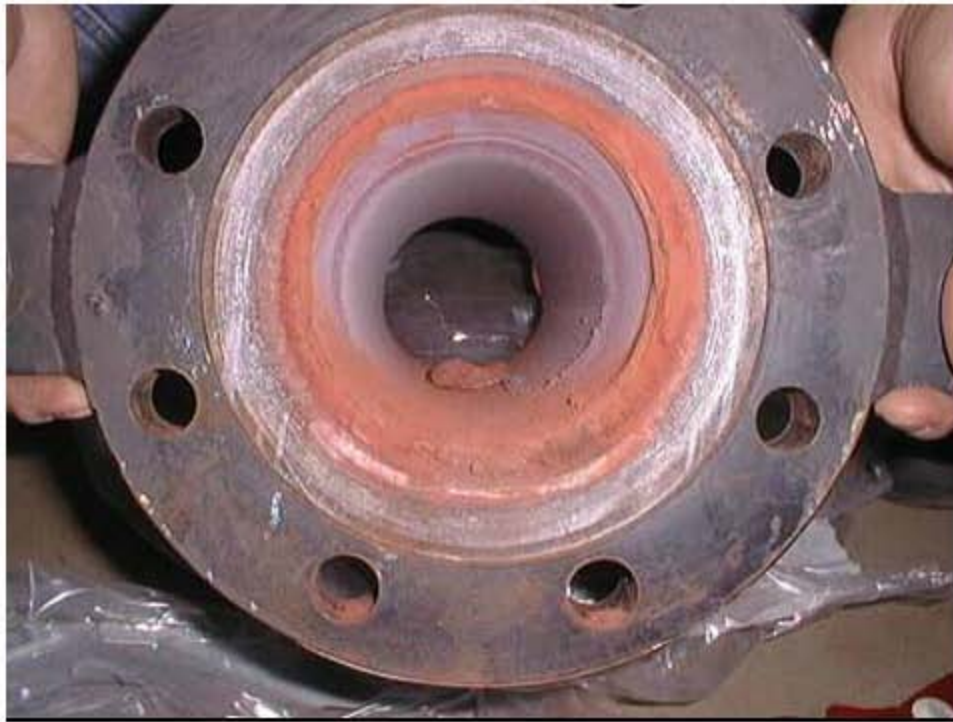
Solids deposits at the inlet of the film cooler are shown in Figure 4.35. Photographs of the solids deposits throughout the transition line are given in Figures 4.36 - 4.41. The film cooler and

**Figure 4.39.** Transition line bellows inlet after Configuration Test 2 [30].

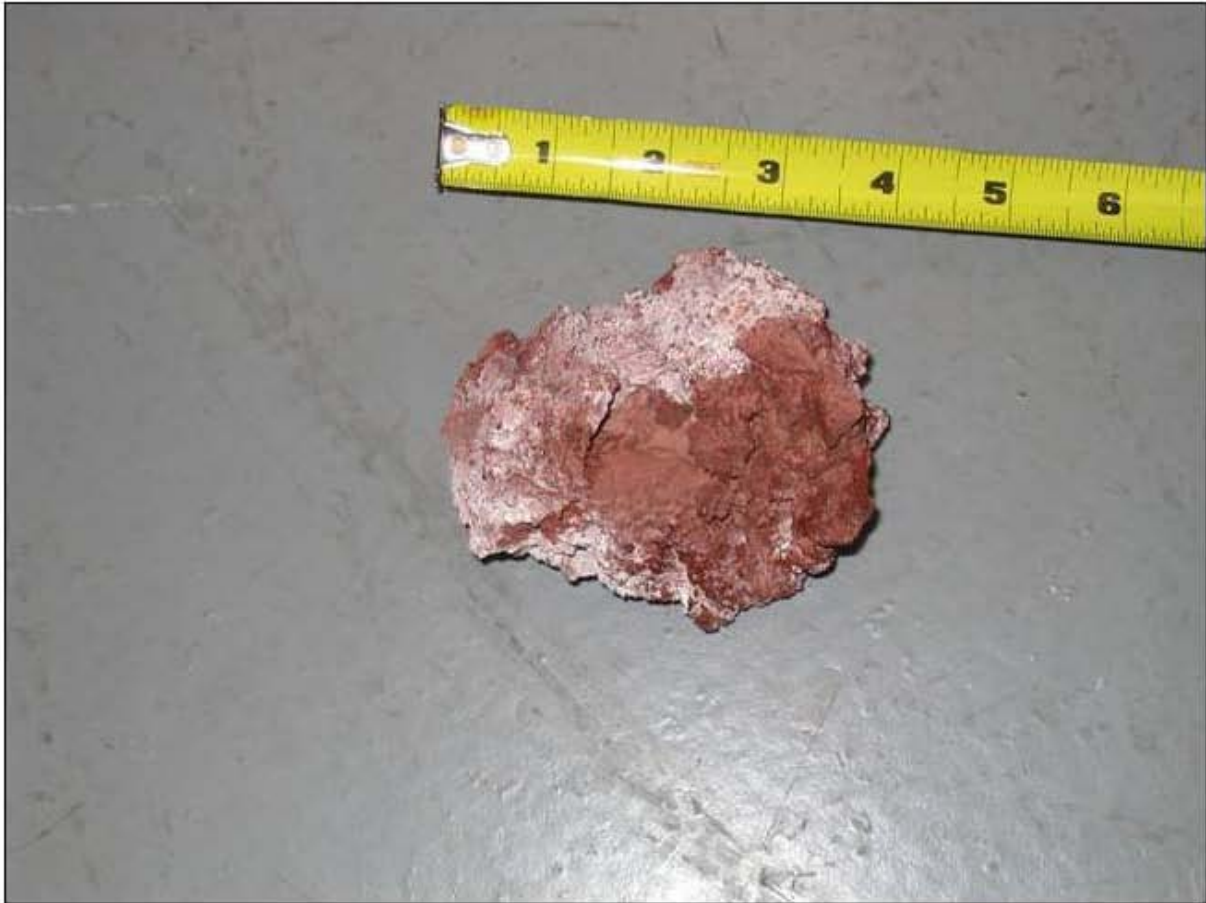
At around 162.3 hours into Test 3, melter feeding was interrupted and the transition line bellows was removed due to clogging; a 4"-diameter solid chunk (shown in Figure 4.43.a) and a small amount of debris totaling 0.254 kg were removed from the bellows. The film cooler was rodded out about one hour prior to the solids removal at the bellows. After the film cooler was cleaned, the transition line was tapped and the deposit moved down the transition line and lodged in the bellows. A macro image of the material, which is shown in Figure 4.43.b, indicates a reddish glassy admixture inundated with pores and periodically encrusted with a whitish substance. An SEM/EDS spectrum of this sample is presented in Figure 4.43.c. Observations with respect to this sample can be summarized as follows:

**Figure 4.43.a. View of large debris removed from transition line bellows inlet during Configuration Test 3 [30].**

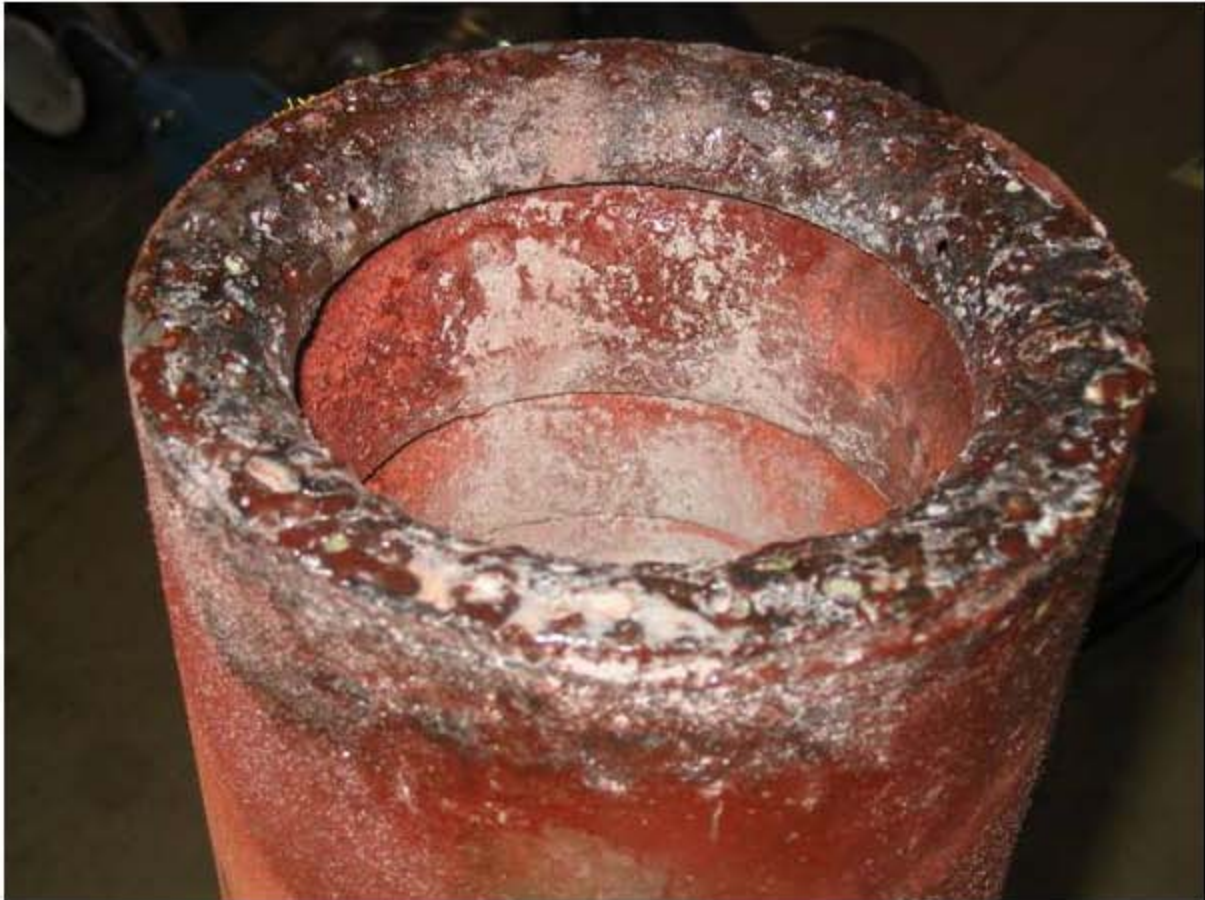
The mass of solids removed from the film cooler and transition line segments was 0.57 kg and 1.5 kg, respectively. Photographs of the film cooler inlet are shown in Figures 4.45 and 4.46. Photographs of the solids deposits throughout the transition line are given in Figures 4.47 - 4.53. The white deposits seen in the figures are presumed to be alkali halides (sodium chloride was spiked into the feed during Test 10). The film cooler and all sections of the transition line were cleaned before reassembly. The cleaned film cooler inlet is shown in Figure 4.54.

**Figure 4.46. Close-up of film cooler inlet after Configuration Test 10 [30].**

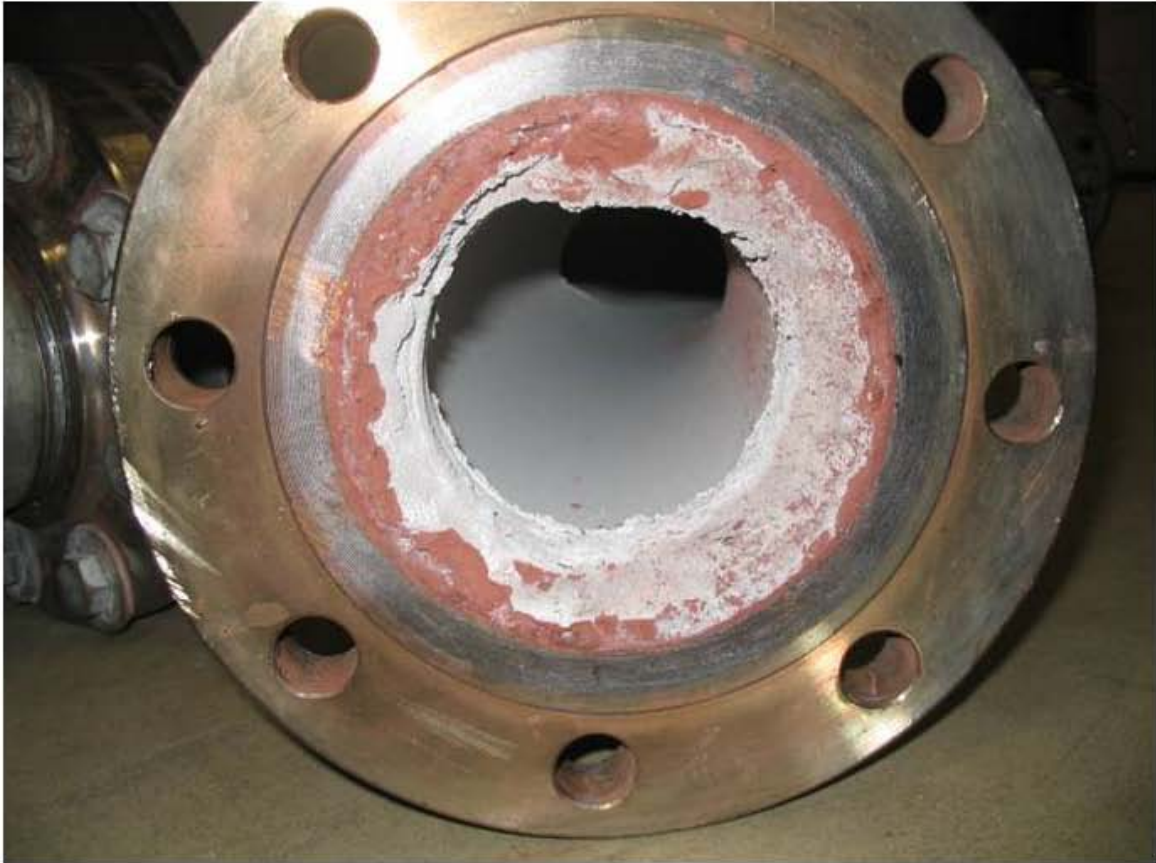
**Figure 4.47. Transition line section #1 outlet after Configuration Test 10 [30].**

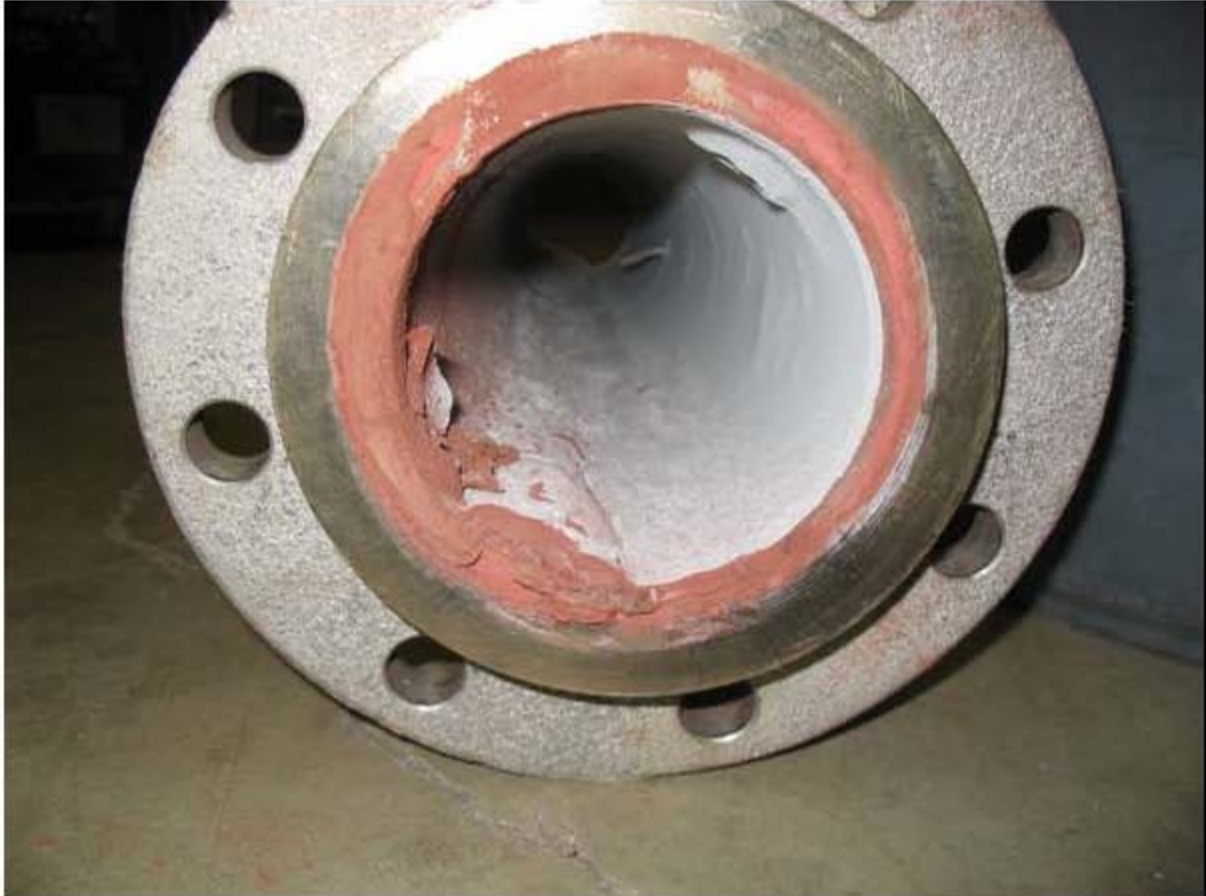
**Figure 4.50. Transition line section #3 outlet after Configuration Test 10 [30].**

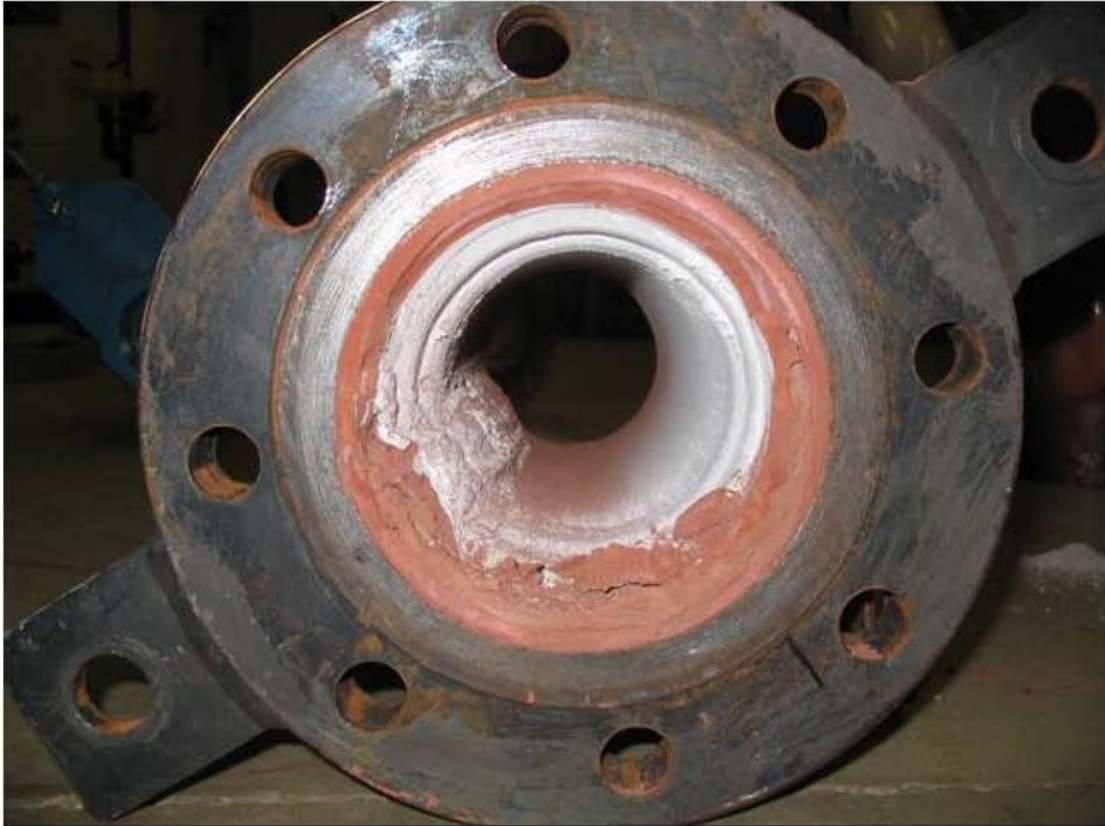
**Figure 4.51. Transition line bellows inlet after Configuration Test 10 [30].**

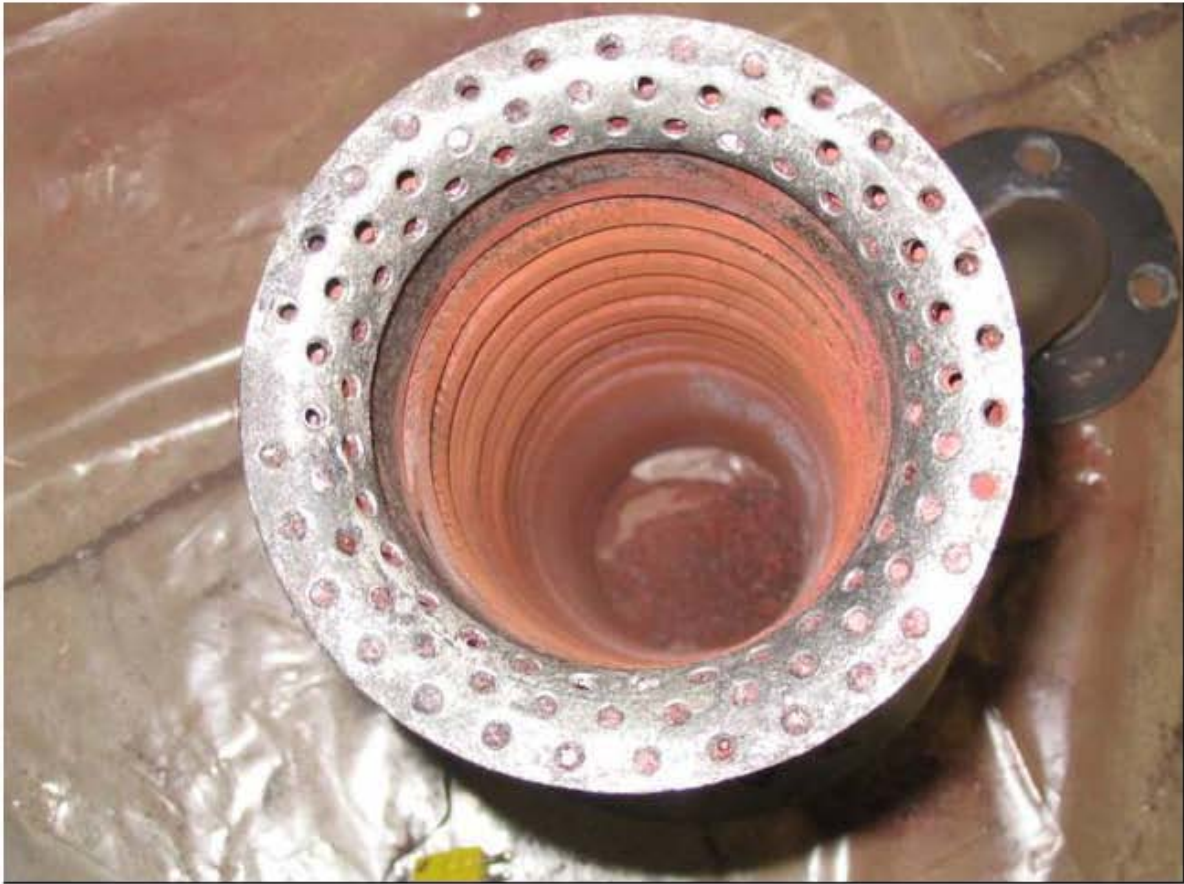
**Figure 4.54. Film cooler inlet (post-cleaning) after Configuration Test 10 [30].**
