Chamberlain Heights Redevelopment: A Large Scale, Cold Climate Study of Affordable Housing Retrofits

K. Donnelly and M. Mahle
*Consortium for Advanced Residential Buildings
(CARB)*

March 2012

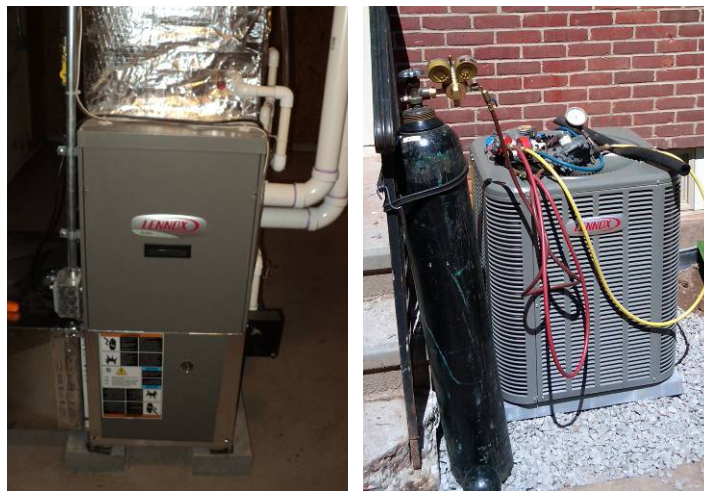
Figure 14. 94 AFUE NG condensing furnace and technician equipment for line purging

Each unit previously had an 80 AFUE gas boiler with wall-mounted convectors. It was a goal of the project team to eliminate tenant installation of window-mounted air conditioners, so space cooling options were investigated. Central air conditioning proved the most cost effective, which led the team to select a forced air system throughout: minimum 94 AFUE condensing gas furnaces, 39 kBtu/h (smallest available unit) with modulating capacity; a humidistat control integrated into the air handler to detect high levels of humidity and adjust the airflow to target the latent load without overcooling the space; and 1½-ton (smallest available) SEER 16 outdoor condensing units (see Figure 14). Cost benefit analysis for Climate Zone 5 showed that lower SEER units would be more cost effective, so SEER 14.5 units were ultimately installed. The outdoor units were charged with HCF-410A refrigerant using a thermal expansion valve during favorable outdoor temperatures (approximately 70°F).

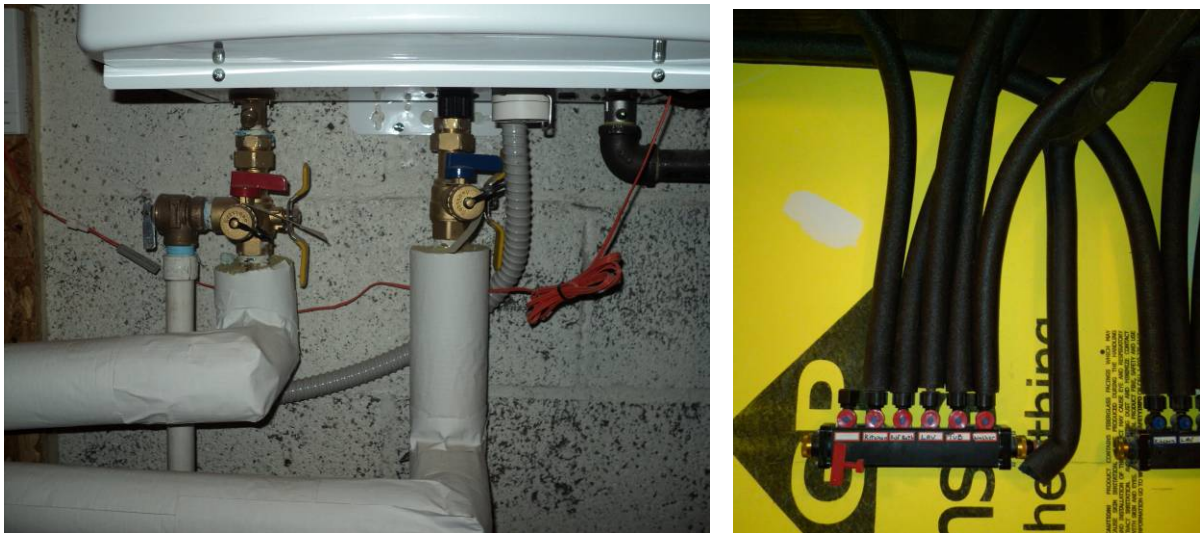
Figure 16. Insulated copper at tankless unit and insulated PEX at branch runs

The installed hot water system eliminates standby losses by replacing the indirect tank off the existing boiler with a tankless water heater (0.94 EF). Additionally, all pipes were insulated with a R-5 minimum, and PEX branch runs were no longer 22 in. from source to fixture. Additional water savings features installed are: (1) 1.75-gpm low-flow showerheads, (2) 1.5-gpm low-flow lavatory faucets, and (3) efficient dishwashers that use less than 6 gallons per cycle (see Figure 16).

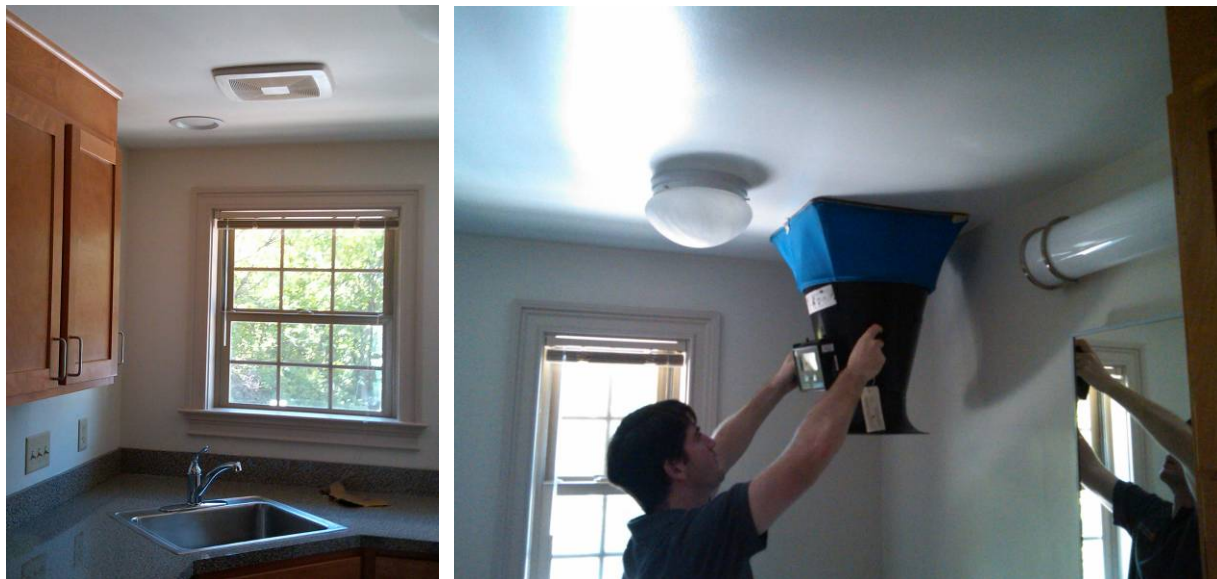
The ENERGY STAR bathroom exhaust fans are rated for up to 80 cfm, and the first phase of 19 units tested showed actual flow rates of 55–73 cfm. The contractor and SWA raters adjusted each unit's fan timers to meet the ASHRAE 62.2 standard whole-house ventilation rates, based on actual measured flow rates. ASHRAE also requires a minimum of 50 cfm for intermittent bath exhaust operation, which has been met in all tested units to date.

Affordable housing criteria required kitchen ventilation range hoods to remove point source pollutants, but allows hoods to be recirculating. ASHRAE requires kitchen exhaust to be vented to the outside, but accepts either room exhaust or vented range hoods. The target flow rate for intermittent kitchen exhaust is 100 cfm. The project installed 110 cfm rated ENERGY STAR ceiling exhaust fans in the kitchen ceilings to remove moisture and pollutants as well as recirculating range hoods to filter grease and particulates (see Figure 17). Testing by SWA raters on early units showed actual flow rates of 83–97 cfm. CARB is working with the contractor to identify solutions that would allow the fans to perform as rated, which may include streamlining flex duct runs in the attic. Although points are awarded for meeting the target flow rates, certification is not jeopardized by failure to do so. The team is seeking to improve performance as a means to control cooking moisture and pollutants.

Figure 17. Kitchen room fans and testing bath fan performance

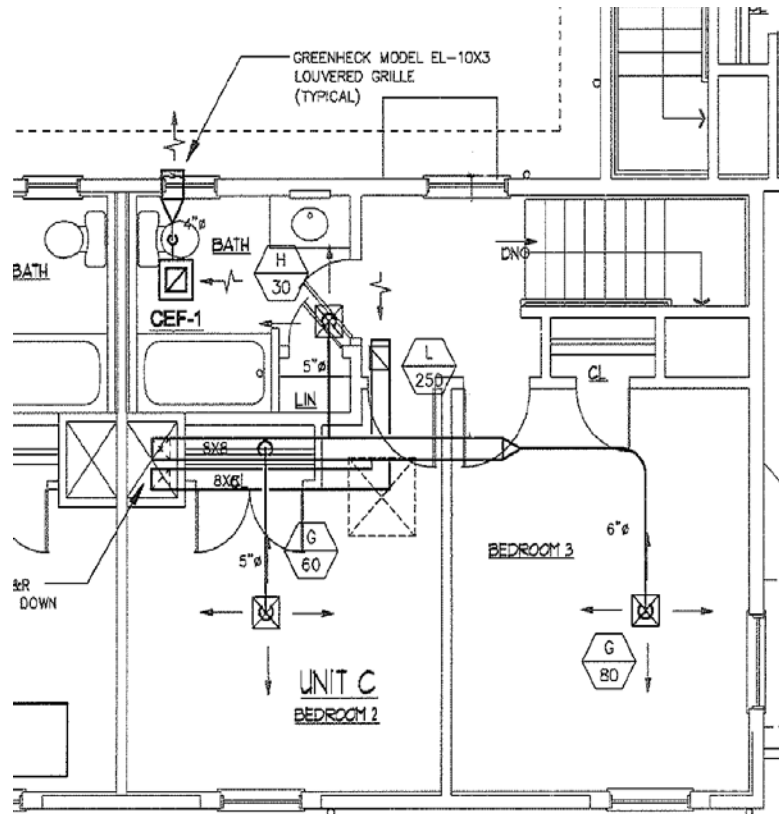
Figure 20. Building type B2 2nd floor compact duct layout

The decision to switch from hydronic heating to a forced air system for heating and cooling stemmed from a project goal to eliminate tenant-installed window air-conditioning units. The developer's pricing analysis showed that installing a condensing gas furnace with high-efficiency air handler and split condensing unit was the most cost-effective space conditioning solution. CARB used the opportunity of a fresh install to use a compact duct design. Confidence in the building's improved thermal envelope allowed the team to deliver conditioned air to the interior edges of rooms rather than using longer duct runs to deliver air at exterior windows. As a result, the longest duct laterals in the project are 8 feet. Compact duct layout is one of the techniques

developed in high-performance new construction projects that proved extremely applicable to the Chamberlain Heights retrofit (see Figure 20).
