(6) Document Title: 241-AY-101 Tank Construction Extent of Condition Review for Tank Integrity
 (7) USQ No.: R- N/A
JRR 8/26/13 per e-mail with J. Gunter
 USQ Evaluator Sign/Date

241-AY-101 Tank Construction Extent of Condition Review for Tank Integrity

Abstract: This report provides the results of an extent of condition construction history review for tank 241-AY-101. The construction history of tank 241-AY-101 has been reviewed to identify issues similar to those experienced during tank AY-102 construction. Those issues and others impacting integrity are discussed based on information found in available construction records, using tank AY-102 as the comparison benchmark. In tank 241-AY-101, the second double-shell tank constructed, similar issues as those with tank 241-AY-102 construction reoccurred. The overall extent of similiary and affect on tank 241-AY-101 integrity is described herein.

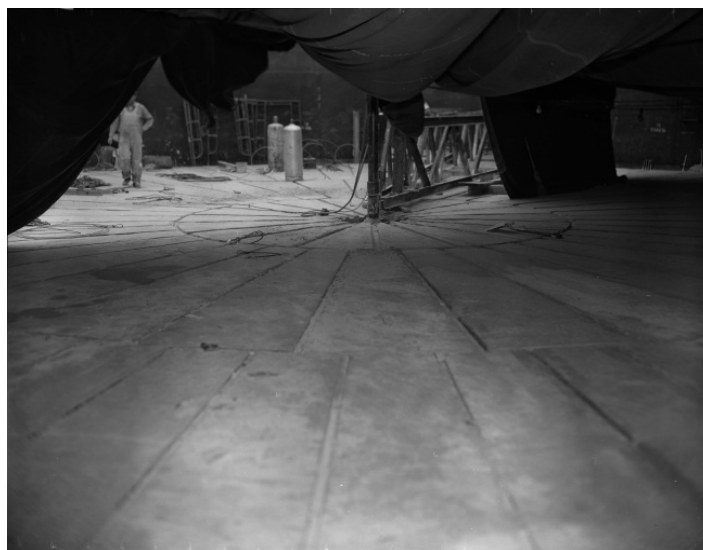
**Figure 4-6. Completed Refractory in Tank AY-101
(Photo No. 8124) (Taken 3/27/1969)**

Figure 4-6 shows the completed refractory in tank AY-101, with air distribution slots visible.

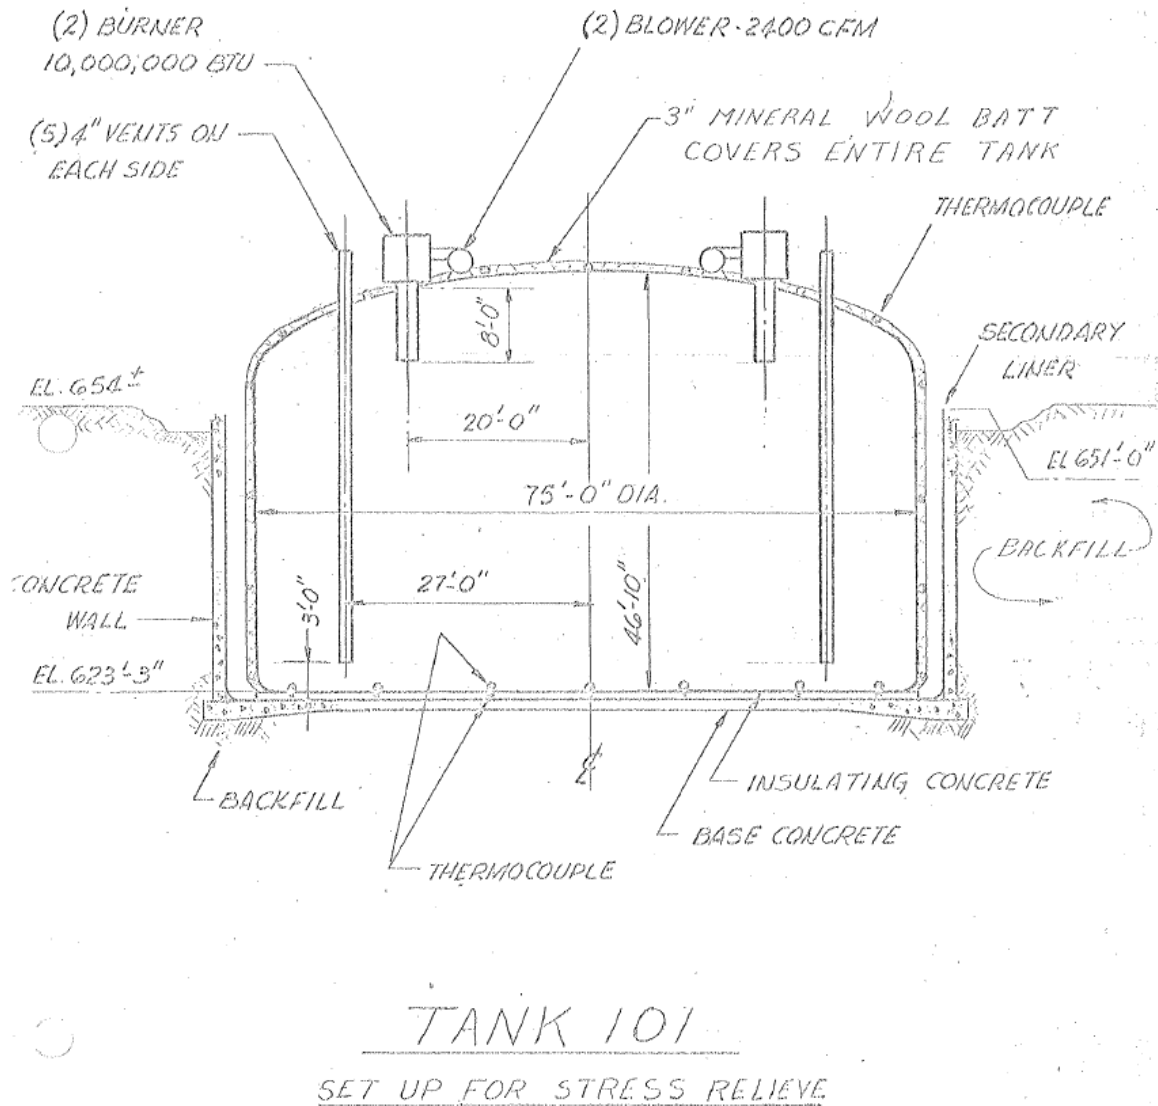
Figure 4-11. Configuration of Stress Relief Equipment in Tank AY-101

During stress relieving of tank AY-101, it was vented from the bottom rather than from the top as in tank AY-102. Ten 4 in. vent pipes extended near the bottom of the tank to narrow the temperature differential between the dome and bottom by more effectively using convection heating. Figure 4-11 shows the equipment configuration of tank AY-101 for stress relief (RPP-ASMT-53794, Section 1.16).

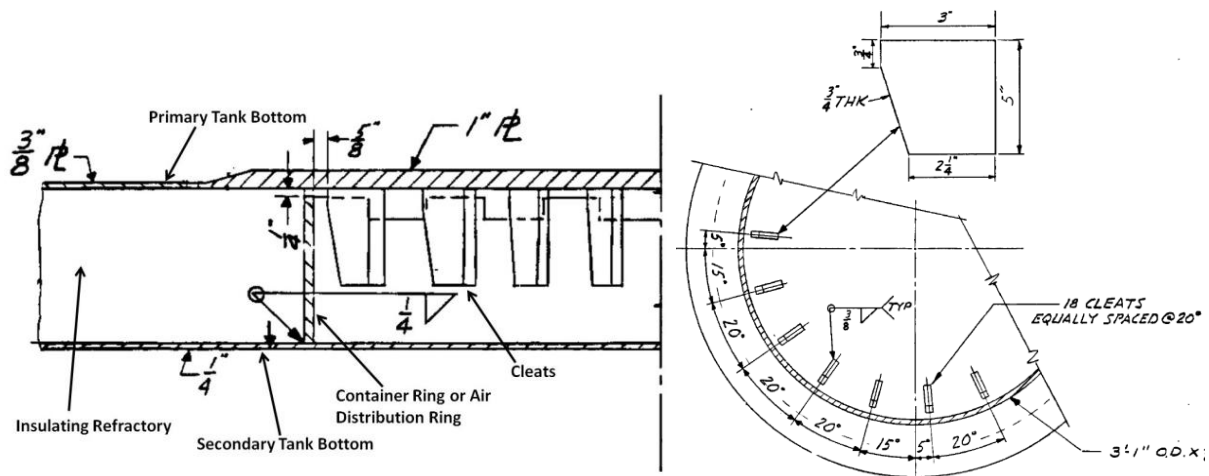
Figure 5-1. Primary Tank Bottom Cleats Engaged in Container Ring

“The difference in elevation between the secondary and primary tank bottoms is increased approximately two inches because of variations in the level of the secondary tank bottoms. This, in turn, raises the cleats within the container ring (see Dwg. H-2-64449, Detail 6), causing the 3 in.-high cleats to become ineffective.”

The tank cleats are designed to help center the primary tank bottom onto the refractory after welding was completed. The underside of the primary tank has 18 cleats welded in a circular pattern positioned to clear the container ring (i.e., air distribution ring), which is welded in the center of the secondary liner. Figure 5-1 shows the orientation represented on drawing H-2-64449 to illustrate the configuration and purpose of the cleats.

The configuration in Figure 5-1 does not depict the actual condition faced by the tank fabricator due to the increased thickness in the refractory. Insufficient engagement between the cleats and the 7-3/4 in. tall container ring would have inhibited the fabricator’s ability to center the primary tank bottom and prevent any shift during construction. With a refractory thickness of

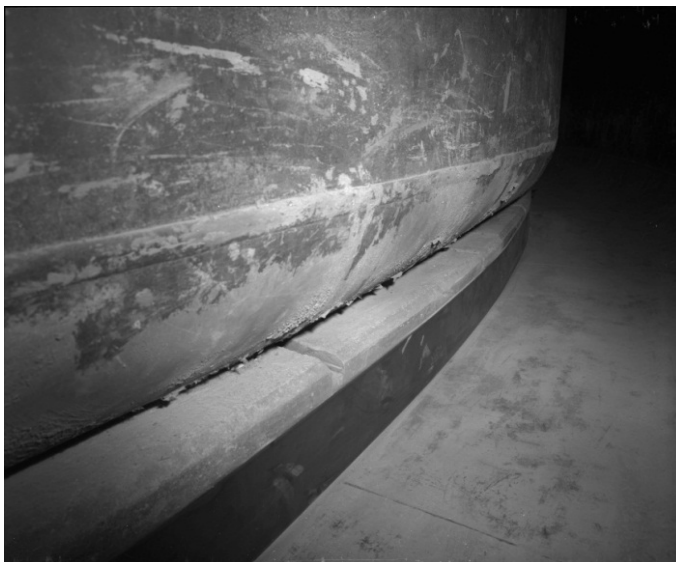
The QA log entry from August 4, 1970 indicated that pouring of the perimeter concrete ring support in tank AY-101 was completed. Figure 5-7 shows the finished perimeter concrete support ring as seen in tank AY-102. The photo is representative of the finished concrete support ring in tank AY-101.

Figure 5-7. Tank AY-102 Finish Perimeter Concrete Support Ring

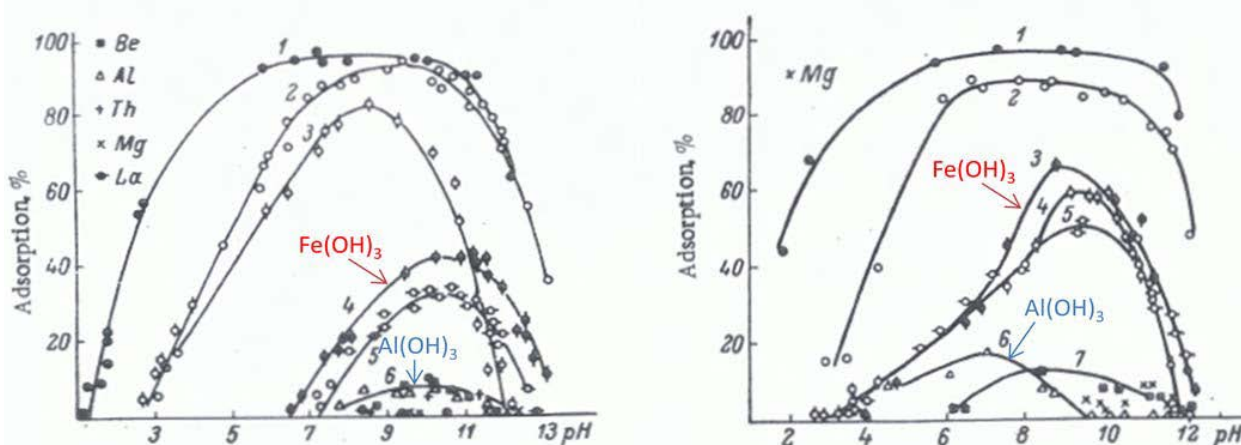
Adsorption on degraded refractory could be more significant. For example, Pacific Northwest National Laboratory (PNNL) evaluated the cesium adsorption of K Basin sludge in PNNL-21836, *Characteristics of STP Pre-2004 Archived KE Basin Sludge Samples Before and After Re-Jarring in the RPL – April 2012*. Figure 3.5 from this report (reproduced below as Figure 5-9) shows the ¹³⁷Cs adsorption by various freshly precipitated and aged metal hydroxides versus pH. Compounds identified in the damaged refractory, Fe(OH)₃ and Al(OH)₃, can remove a significant fraction of ¹³⁷Cs at solution pH of 6 to 9.

Figure 5-9. Adsorption of ¹³⁷Cs on Freshly Prepared Metal Hydroxides (left) and on the Metal Hydroxides after Ten Days of Aging (right) as a Function of the pH of the Solution.
