241-SY Tank Farm Construction Extent of Condition Review for Tank Integrity

T.J. Barnes, K.D. Boomer, J.R. Gunter, T.J. Venetz
Washington River Protection Solutions LLC
Richland, WA 99352
U.S. Department of Energy Contract DE-AC27-08RV14800

Abstract: This report provides the results of an extent of condition construction history review for tanks 241-SY-101, 241-SY-102, and 241-SY-103. The construction history of the 241-SY tank farm has been reviewed to identify issues similar to those experienced during tank 241-AY-102 construction. Those issues and others impacting integrity are discussed based on information found in available construction records, using tank 241-AY-102 as the comparison benchmark. In the 241-SY tank farm, the third DST farm constructed, refractory quality and stress relief were improved, while similar tank and liner fabrication issues remained.

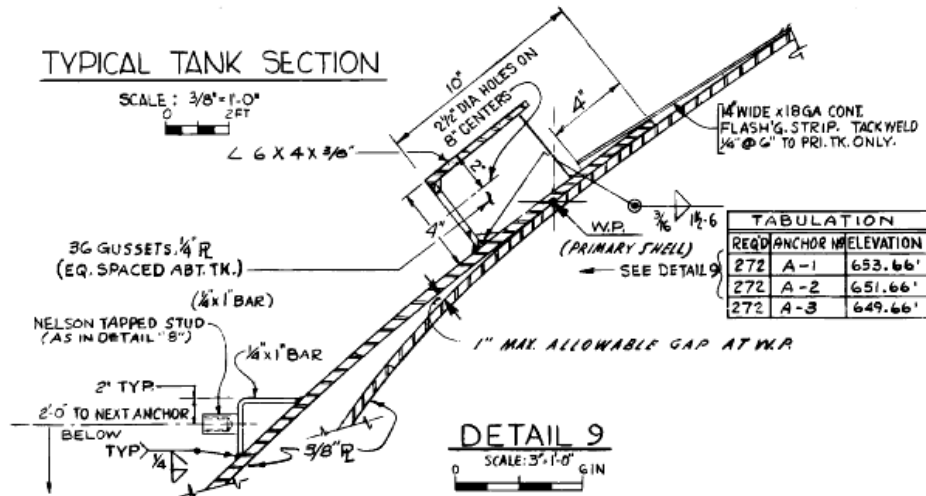
Figure 4-16. Detail 9 From H-2-37772, Showing the Intersection Between the Secondary Liner and Primary Tank Dome

Once the hydrostatic test was completed, the need for further access into all portions of the annulus was limited. The secondary top knuckle was installed and welded to the secondary liner vertical wall section. The secondary top knuckle is not welded to the primary tank. By design, a 1 in. maximum gap exists between the primary

tank dome and termination of the secondary liner. To prevent the collection of debris or concrete during the remaining construction, metal flashing was installed over the outside of the secondary top knuckle by tack welding to the outside of the primary tank as shown in drawing H-2-37772, Detail #9 in Figure 4-16.

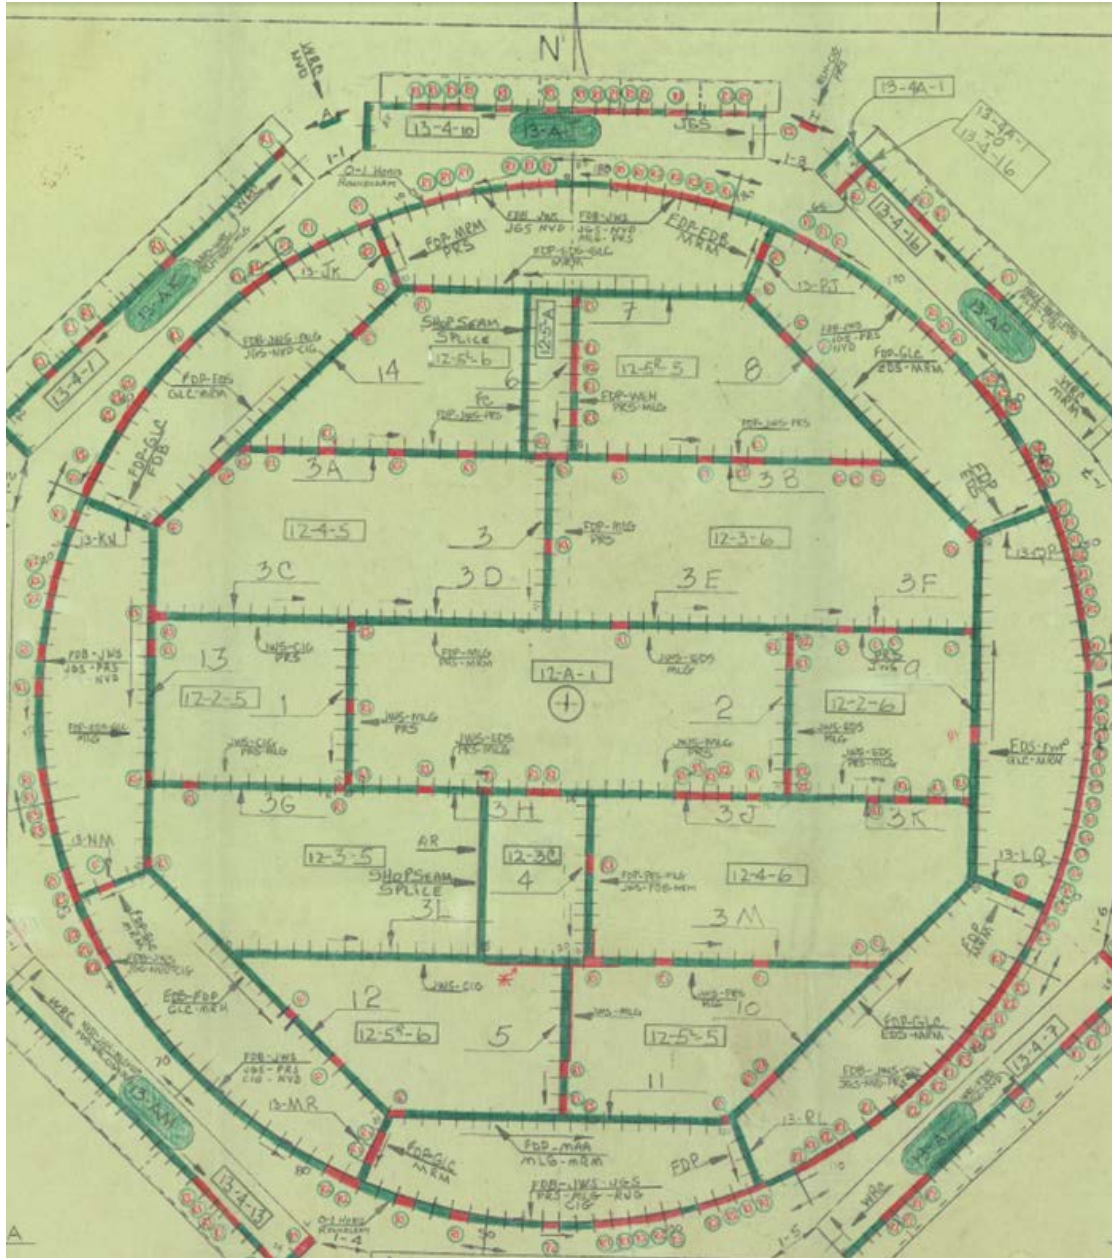
Figure 5-1. Tank SY-101 Primary Weld Map

An example of a primary bottom weld map is shown in Figure 5-1. Each red mark on a weld section represents a weld that was repaired at least once. The circles next to the repaired weld section have values in them such as R1, R2, etc. which represents the number of times a

particular weld section was repaired. The circle around the weld repair value indicates that the weld was accepted. Welds were inspected in 1 ft. long sections; each inspected section is represented with a hash mark in the weld maps. Rejected welds were ground out, re-welded, and re-inspected. The weld maps for all 241-SY tank farm primary and secondary bottoms and side walls can be seen in Appendix B.

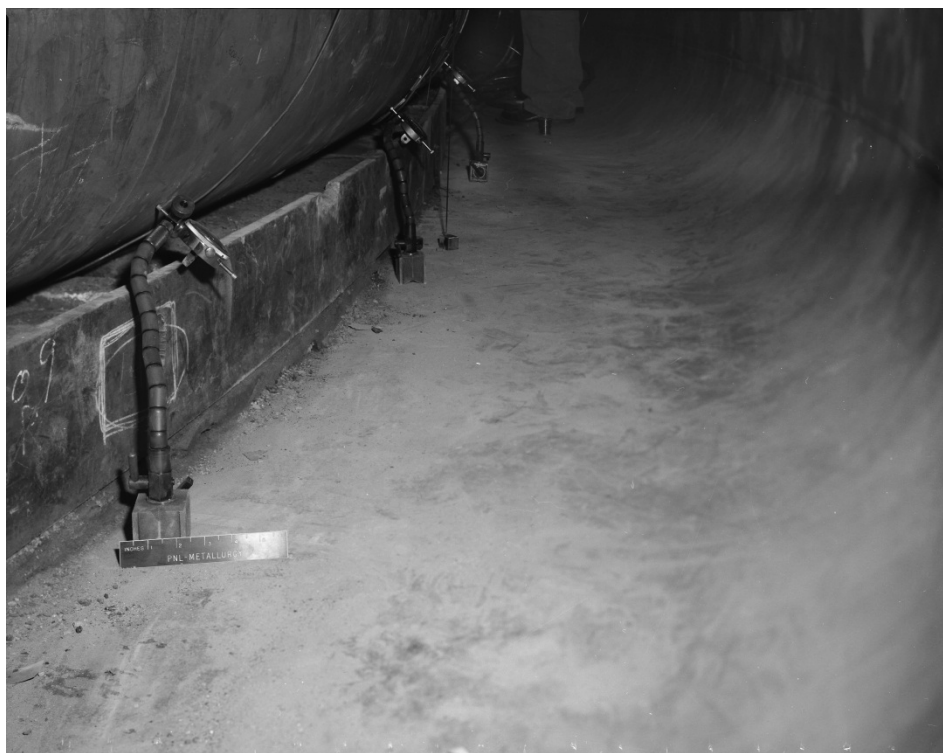
Figure 5-6. Battelle Strain Gauges on Primary Tank SY-103 (Photo 756534-20) (Taken 9-12-1975)

Figure 5-6 shows strain gauges ready to take strain measurements at the lower knuckle of primary tank SY-103 during a structural integrity study of the primary tank bottom.

Additionally, after a review of the procedure used by Vitro Engineering during initial strain gauge testing, it was noted in BNWL-B-471 that there was room to doubt the validity of the results for the following reasons, *“After consultation with Battelle-Northwest, analysis of the test procedure showed inadequate temperature compensation, long leads effects (two-wire readout) and possible capacitance effects caused by water surrounding the strain gage (sic) leads.”* These factors were not accounted for during the initial strain gauge monitoring. An independent

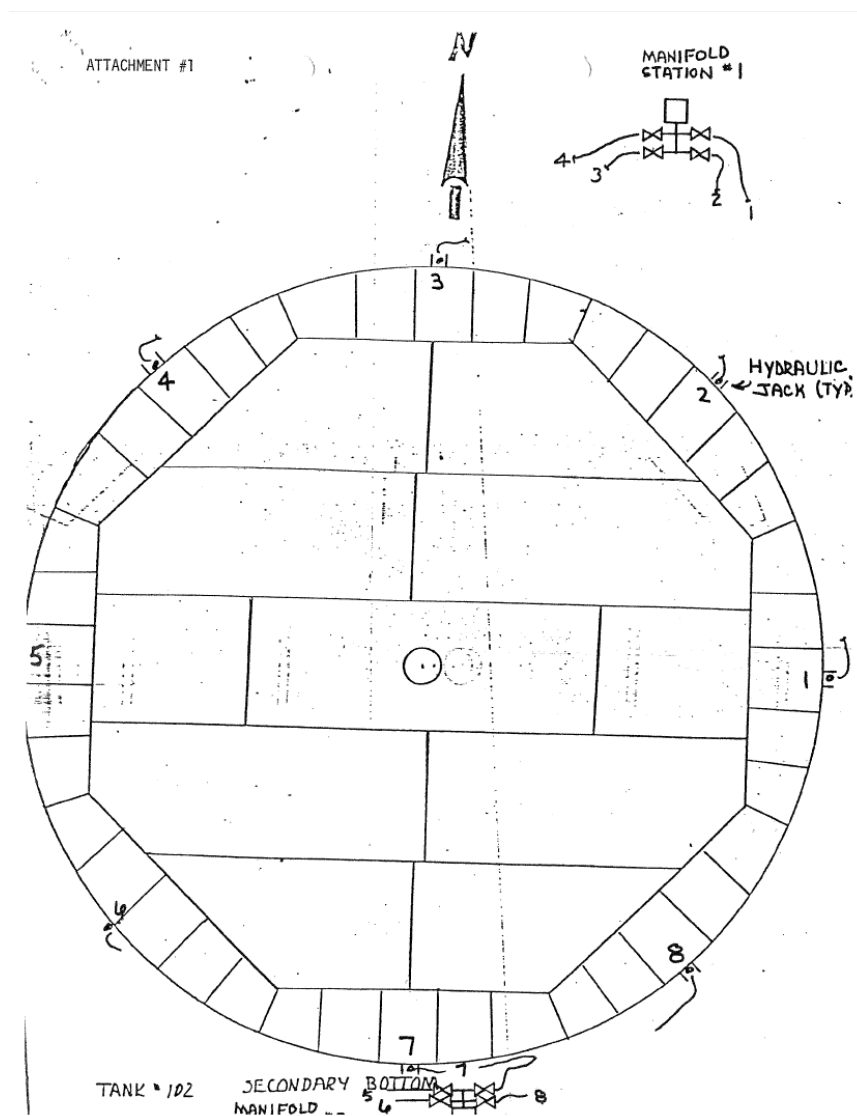
Figure 5-8. Tank Bottom Jack Location

During the lowering process of the tank SY-102 secondary bottom, eight hydraulic jacks were set up around the perimeter of the tank bottom as seen in Figure 5-8. Four hydraulic jacks were operated off each of two manifolds, using one operator per manifold. A lack of hydraulic jack control led to distortions of up to 18 in. when four of the jacks were lowered 8 in. relative to the other four jacks. NCR B-101-19-2307-5 was generated and can be found along with the attachments depicting the tank bottom distortion in Appendix C, App Figure C-14.

The lowering procedure was noted as the cause for the non-conformance. The procedure was changed to minimize any future issues.

“Conditional accept provided that:

- 1. The subsequent liquid penetrant examination required after lowering is acceptable.*
- 2. There are no unacceptable permanent distortions.*
- 3. With load of primary tank bottom on refractory and before primary bottom is lowered, inspect and repair refractory cracks and depressions that are greater than the tolerances specified on the drawings and in the construction specifications.”*

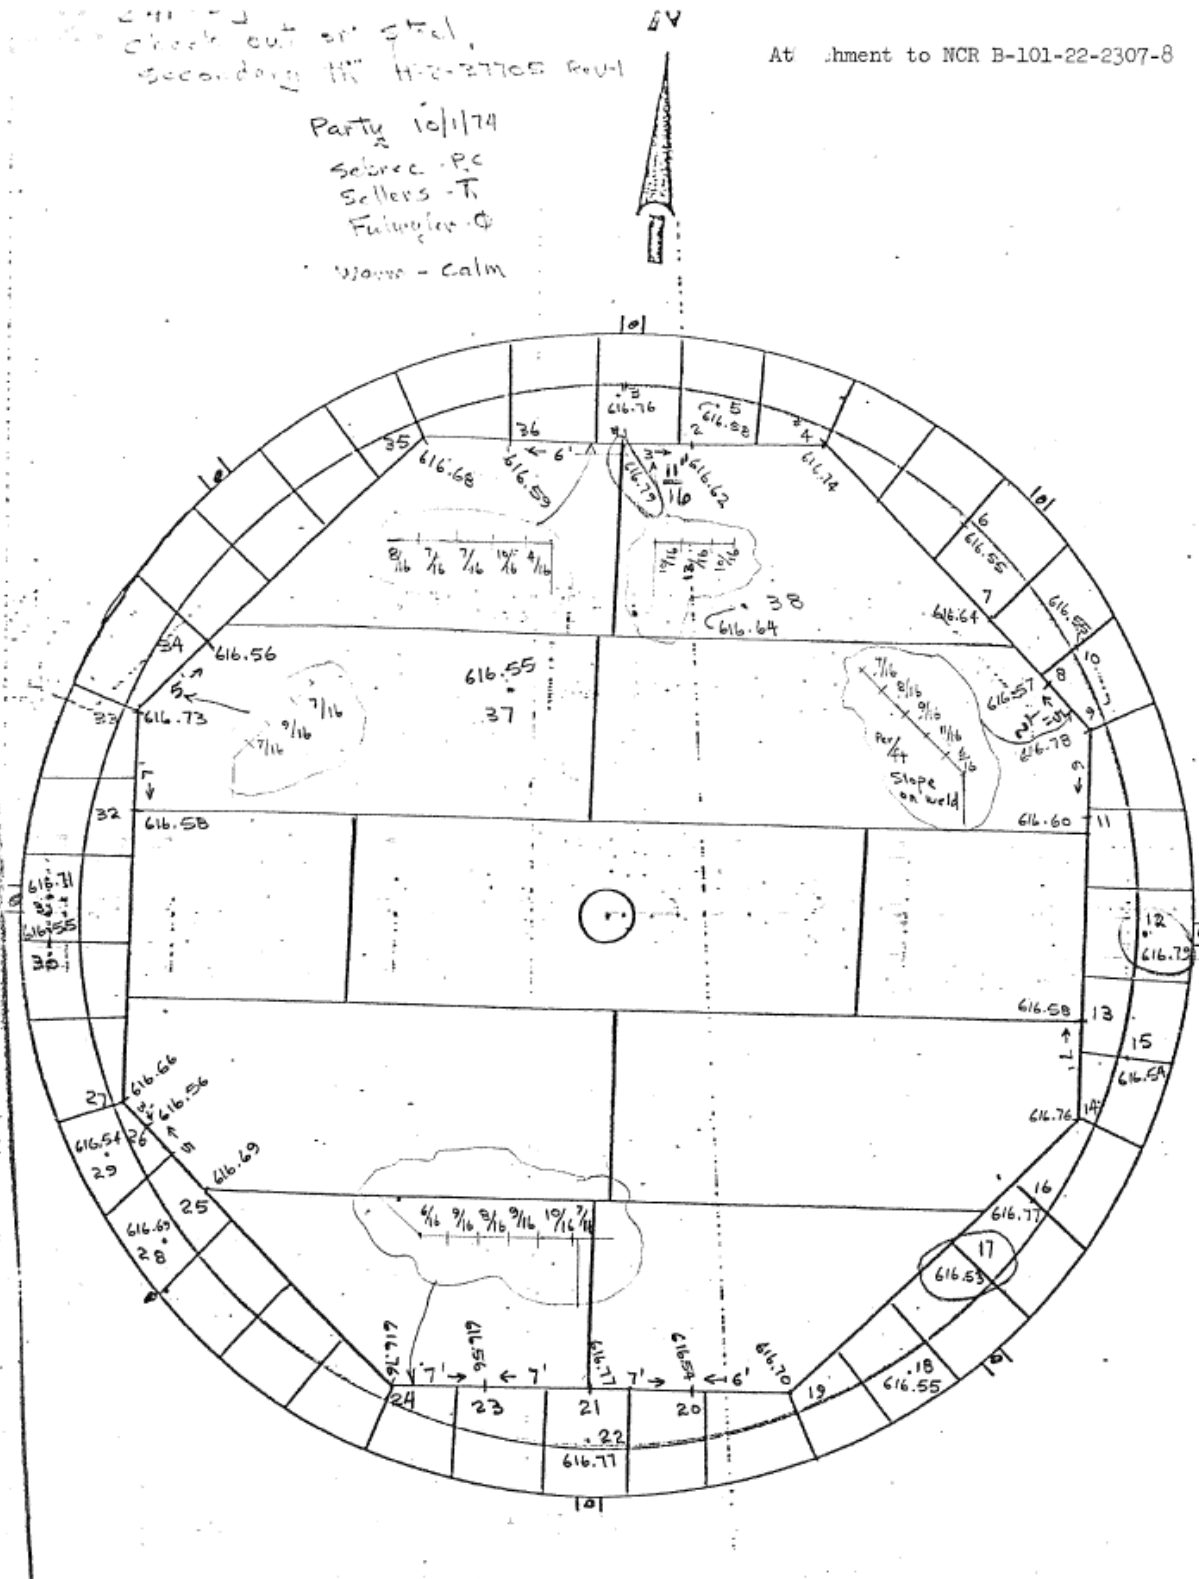
App Figure C-4. NCR B-101-20-2307-6, 241-SY Tank Farm Salt Cake Storage Facilities

At least two out-of-tolerance bulges were found in the tank SY-102 secondary liner bottom as noted in NCR-B-101-20-2307-6 (Appendix C, App Figure C-4), with the worst bulge being 5/8 in. per ft. The suggested disposition and justification of acceptance is identical to tank SY-101, NCR B-101-22-2307-8 above. Tank SY-102 also had two bulges within the tangent point of the knuckle curvature (NCR-B-101-21-2307-7, Appendix C, App Figure C-5).

“Conditionally accept provided that:

1. The subsequent liquid penetrant examination required after lowering is acceptable.
2. With load of primary tank bottom on refractory and before primary bottom is lowered, inspect and repair refractory cracks and depressions that are greater than the tolerances specified on the drawings and in the construction specifications.

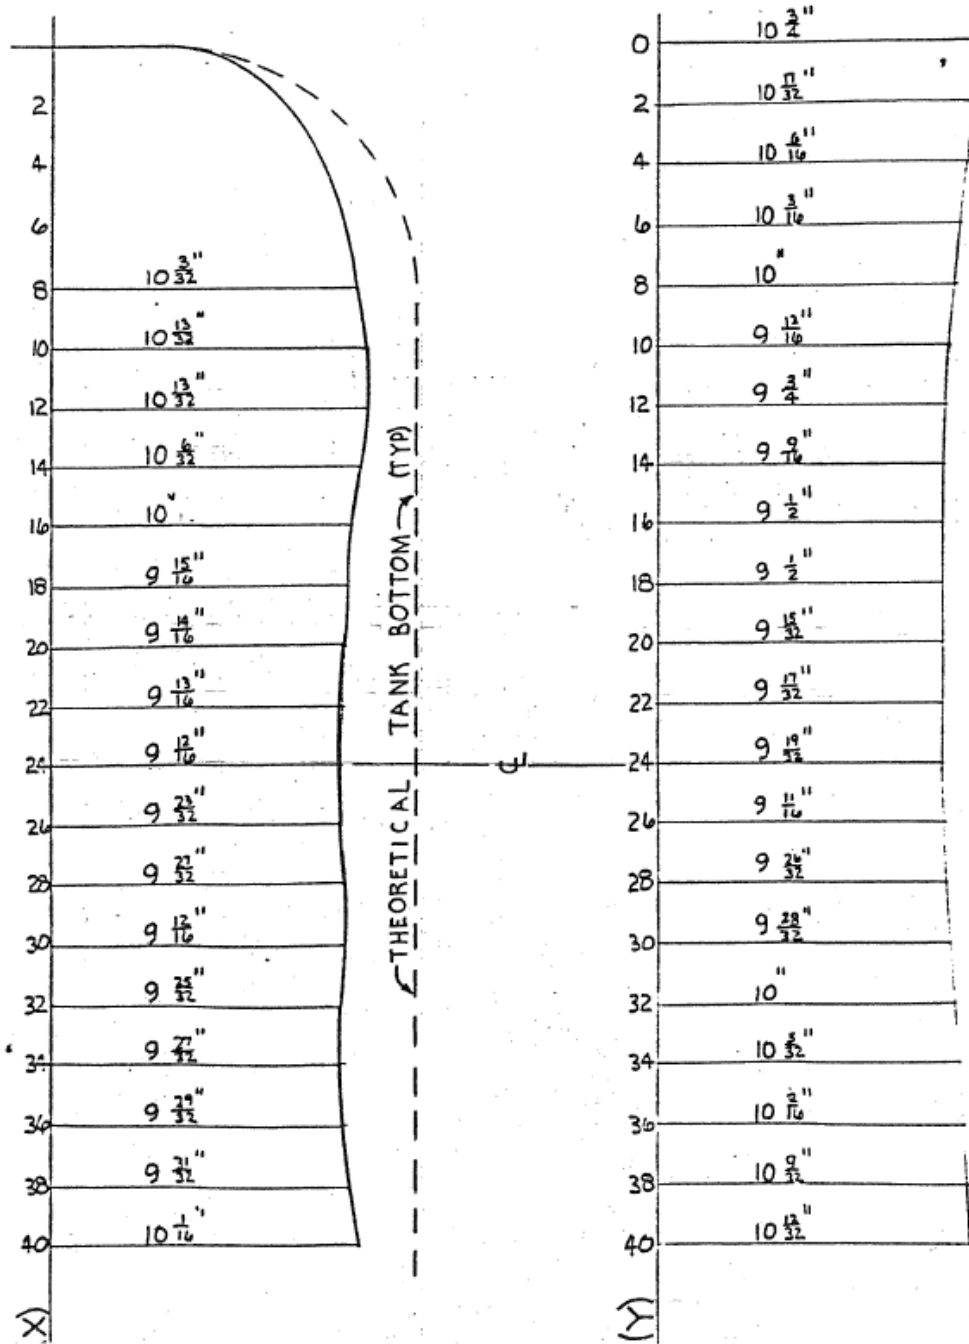
DISTORTION AREA "A" - PROFILE

No slope was given for the two bulges. Figure 5-3 is a sketch of one of the bulges noted in NCR B-101-21-2307-7 (see Appendix C, App Figure C-5). Assuming the measurements are taken from the upper tangent point, the distance to the theoretical tank bottom is 12 in.

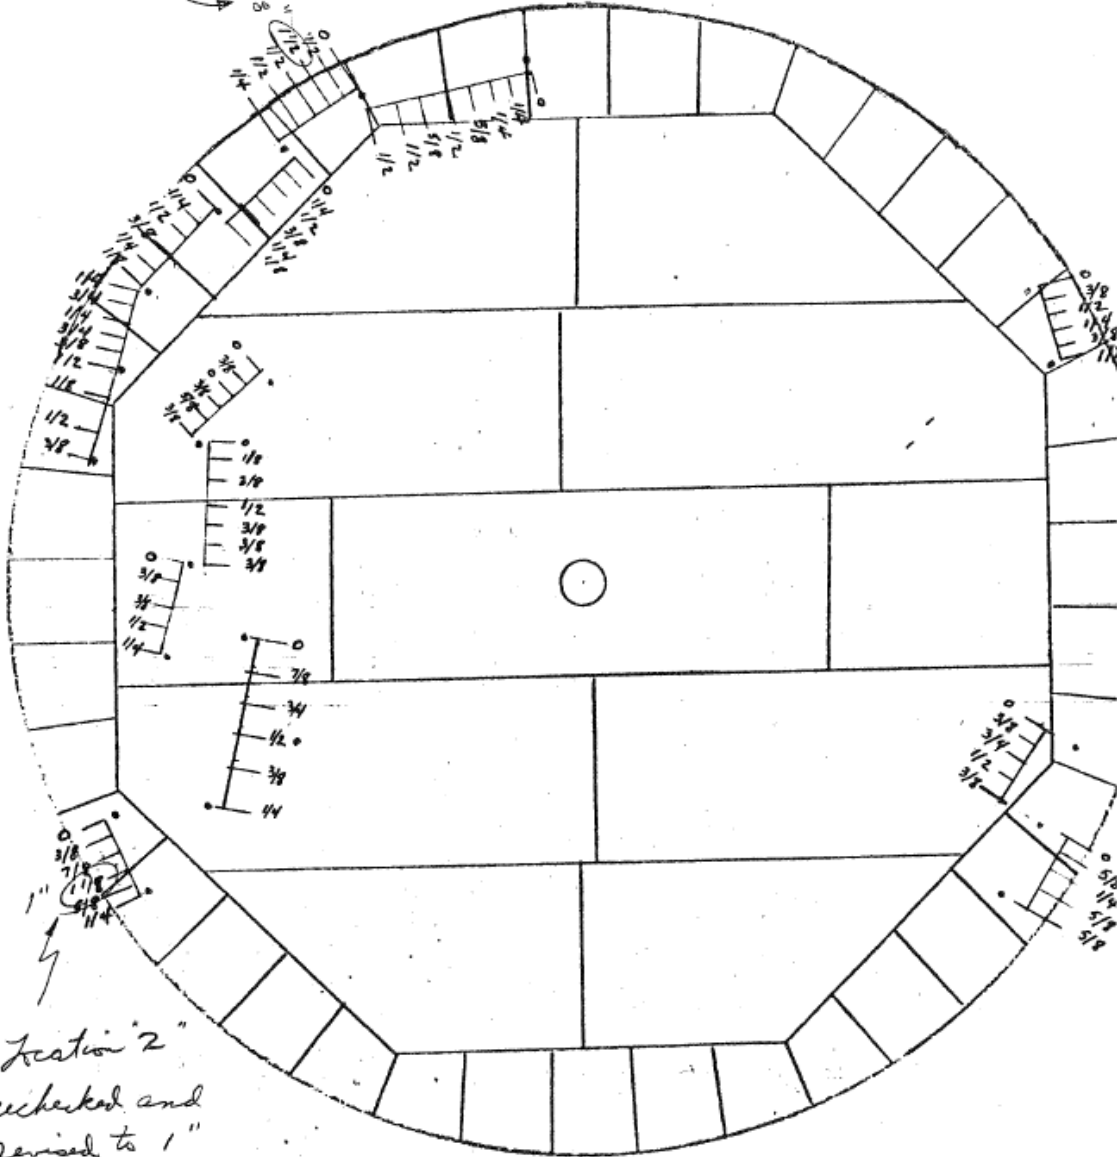
Location "2"
rechecked and
revised to 1"
by 12/13/74

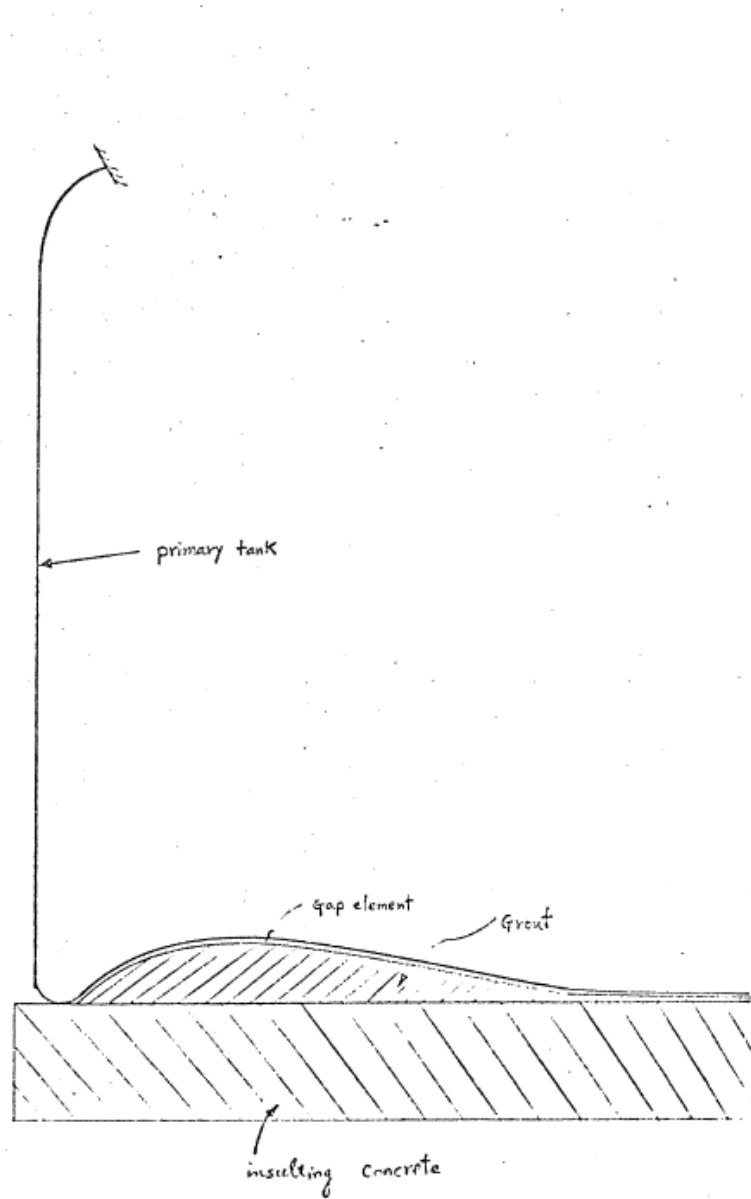
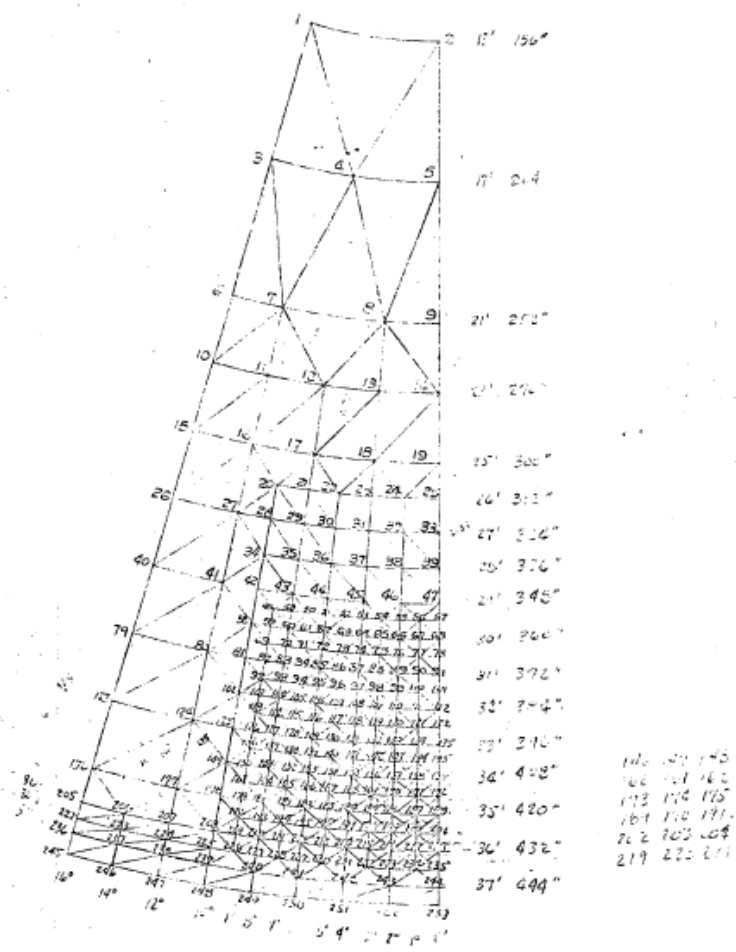
The out-of-tolerance bumps in the bottom of the tank is a three-dimensional and non-axisymmetric problem with axisymmetric load. A two-phase analysis for the project is being accomplished for cost effectiveness and to meet time requirements. The first phase (completed) was to analyze an axisymmetric model (see Fig. 1) with combining axisymmetric load from Item I. The 147 gap elements (stiff 12 from ANSYS) for the boundary condition in the bottom of the tank were used to make an analogy with actual behavior of the bottom tank. The 207 axisymmetric conical shell elements (stiff 11 from ANSYS) were used to represent the primary tank. The second phase is to make and analyze a three-dimensional mathematical model (see Fig. 2) with gap element at the bottom of tank by using an edge boundary condition. These conditions were derived from the first phase and considered to be of no effect in the stress distribution of critical regions (elements 218-234-235, 91-100-101 Fig. 2 using ANSYS computer program). The analysis considers the resistance of bump due to thermal growth. The friction coefficient is assumed to be 0.1.

The maximum wet compressive stress in the bottom of the tank from Phase I study is 18.9 ksi (allowable stress for D+L + H.S. + T = 30.53 ksi). The maximum set tension stress in the bottom of the tank from phase I study is 4.3 ksi - both well within limits.

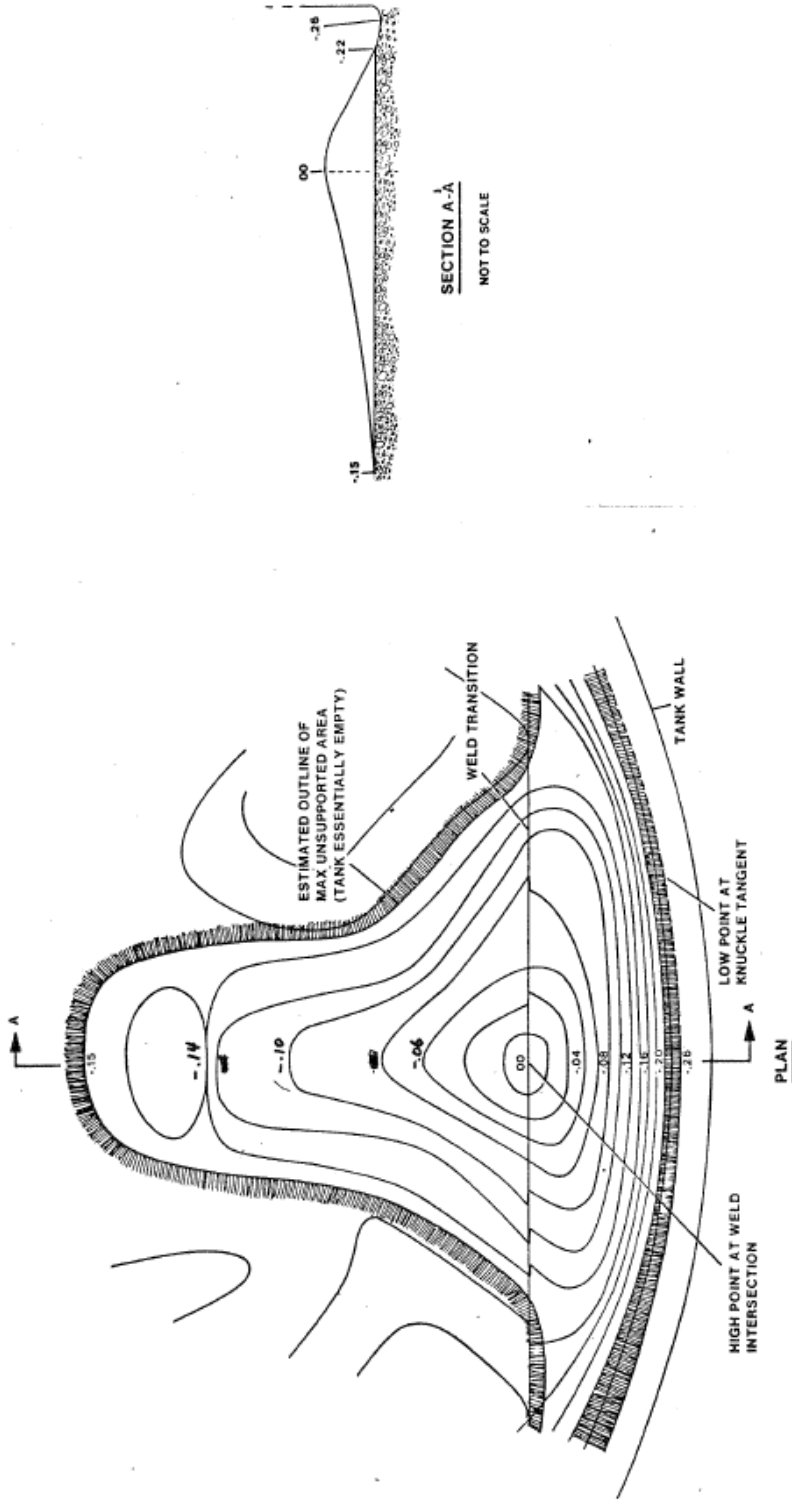
241-SY-101 BUMP

VARIABLES	241-SY* SPECIFICATION	241-AW** SPECIFICATION	241-SY-101 TANK CONDITION
BUMP SLOPE	3/8 IN/FT	3/8 IN/FT	3/4 IN/FT
BUMP HEIGHT	3"	3"	3.12"
7/8" PLATE ROOT RADIUS	-	436"	75"
7/8" PLATE CROWN RADIUS	-	347"	200"
1/2" PLATE ROOT RADIUS	-	249"	≈ 500"
1/2" PLATE CROWN RADIUS	-	198"	200"

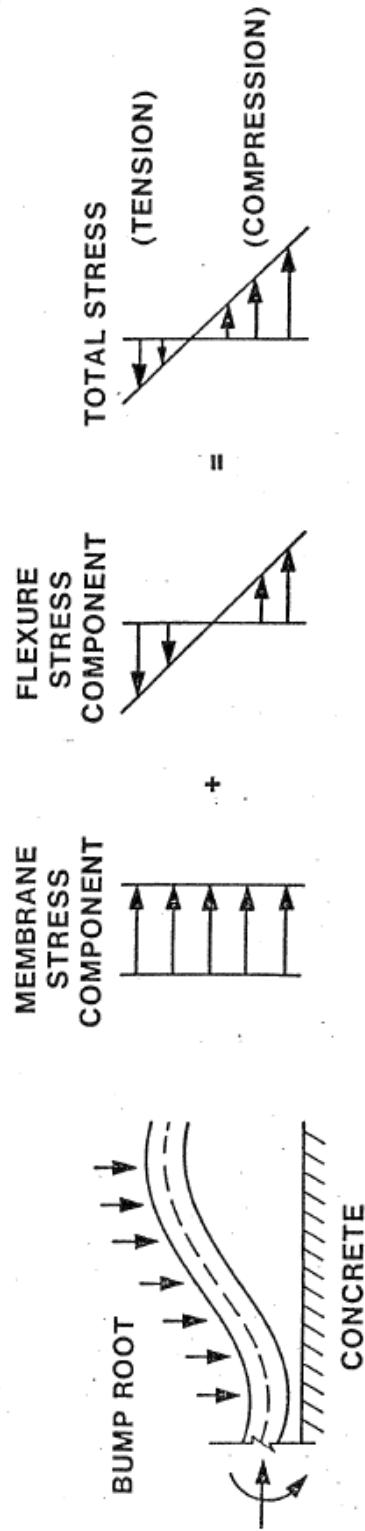
ILLUSTRATION OF EFFECTS OF MEMBRANE AND FLEXURE STRESS COMPONENTS AND FLEXURE STRESS COMPONENT SUPERPOSITION IN THE BUMP ROOT

UNDER THE ASSUMPTION THAT THE BUMP WILL FLATTEN BY HYDROSTATIC PRESSURE, THE RESULTANT STRESS DISTRIBUTION IN THE BUMP ROOT WILL BE COMPOSED OF A MEMBRANE STRESS AND FLEXURE STRESS COMPONENT WITH THE RESULTANT STRESS BEING TENSILE ON THE INSIDE FACE

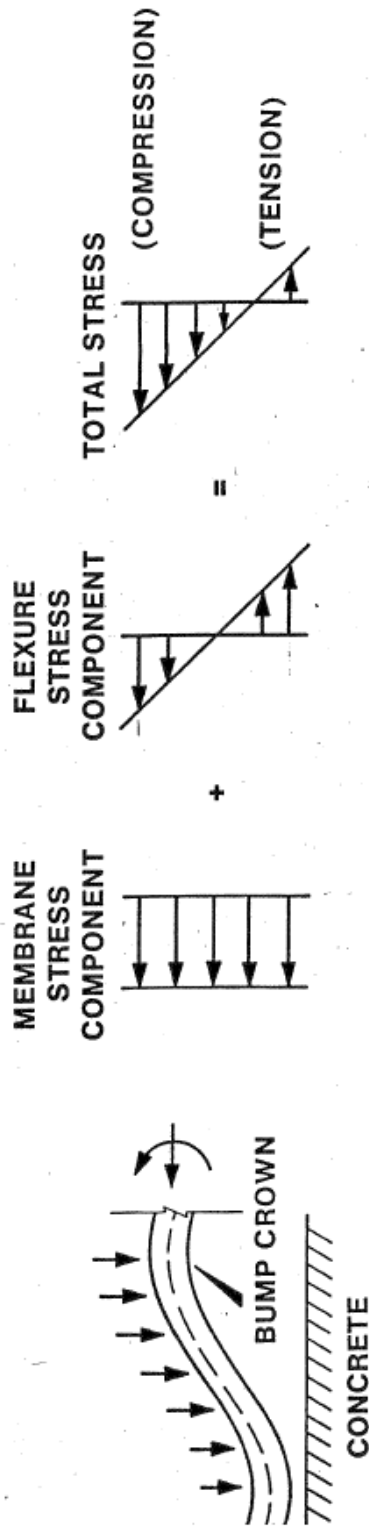
ILLUSTRATION OF EFFECTS OF MEMBRANE AND FLEXURE STRESS COMPONENT SUPERPOSITION IN THE BUMP CROWN

UNDER THE ASSUMPTION THAT THE BUMP WILL FLATTEN BY HYDROSTATIC PRESSURE, THE RESULTANT STRESS DISTRIBUTION IN THE BUMP CROWN WILL BE COMPOSED OF A MEMBRANE STRESS AND FLEXURE STRESS COMPONENT WITH THE RESULTANT STRESS BEING COMPRESSIVE ON THE INSIDE FACE

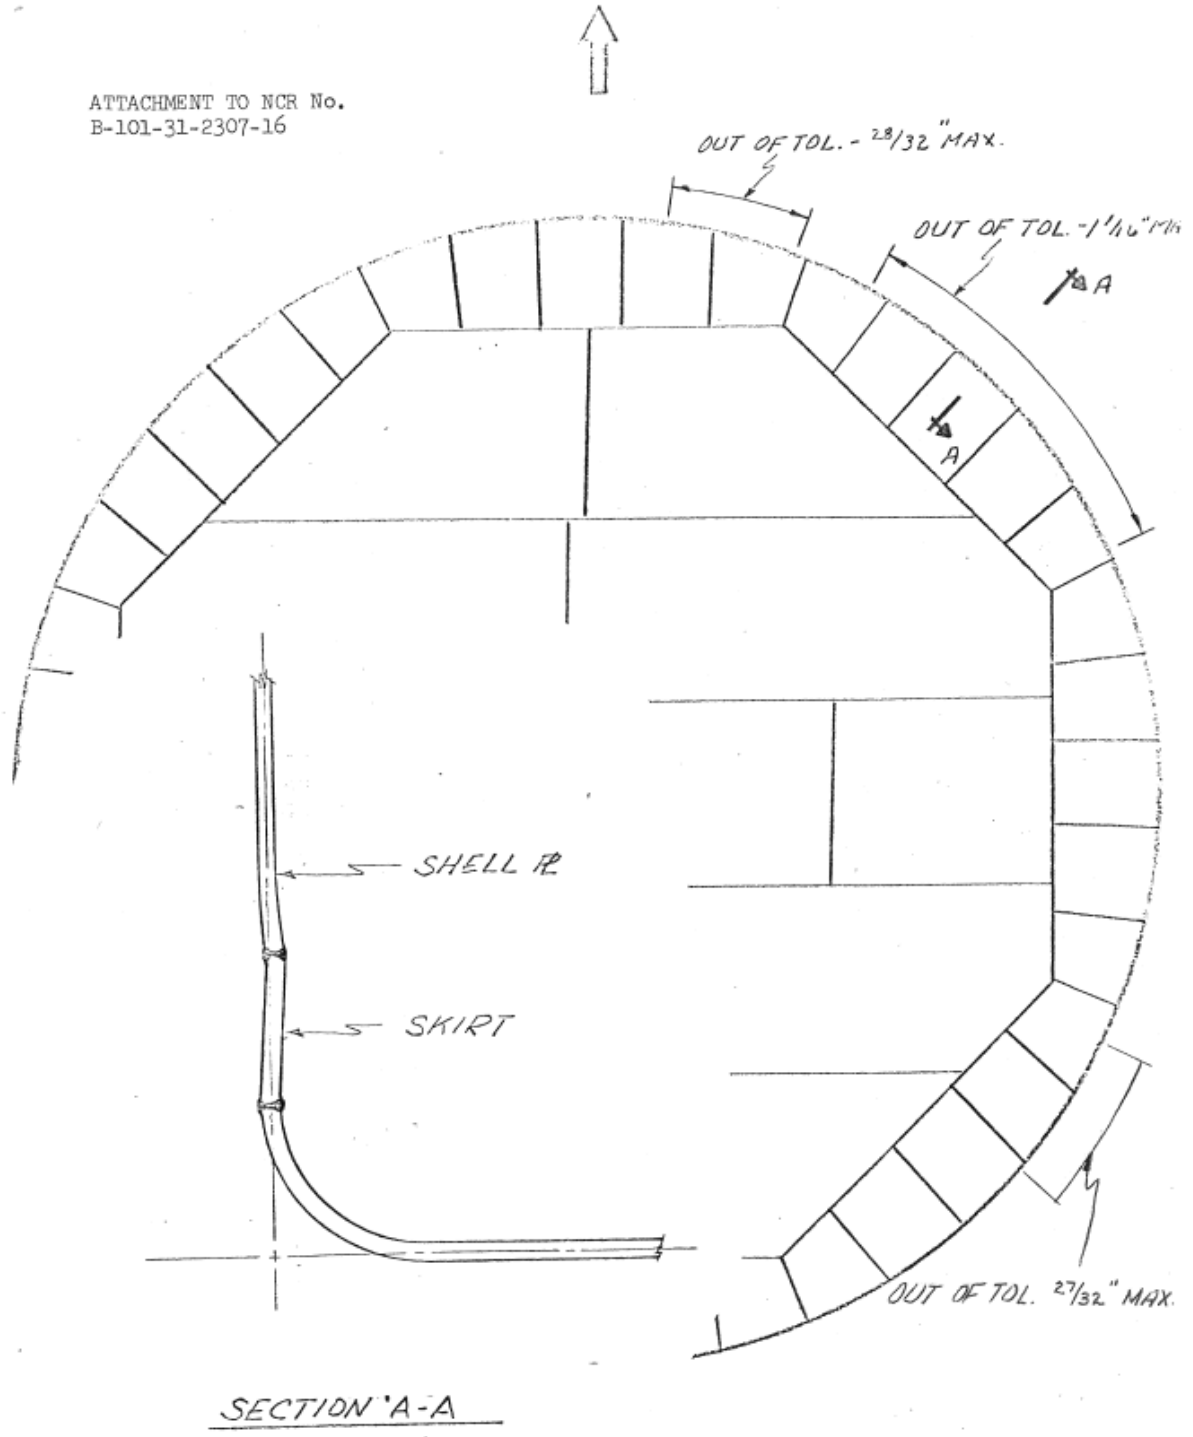
ATTACHMENT TO NCR No.
B-101-31-2307-16

App Figure C-21. Tank SY-102 Secondary Liner Circumference Deficiency Report

(7) CAUSE OF NONCONFORMANCE AND CORRECTIVE ACTION TO PREVENT RECURRENCE		
Cause - The tolerance discrepancy was caused by the shop fabricated knuckle having more than a 90° bend. This was due to the shop not being able to hold the 1 foot ring section vertical over the knuckle arc length. Corrective action - This condition existed to some degree on 3 secondary tank knuckles. On primary tank the first rings were installed in the field correcting the problem. E <u>[Signature]</u> 3-29-75 SIGNATURE AND TITLE DATE

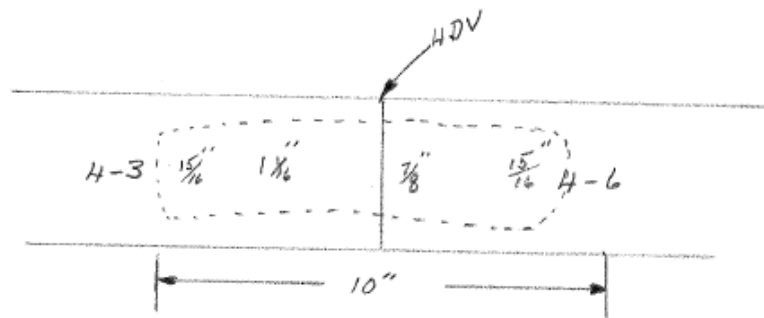
TK-103
4TH RING

App Figure C-23. Tank SY-103 Primary Local Distortion Deficiency Report

DEFICIENCY REPORT	
Date Initiated <u>6-27-75</u> Initiated By <u>R. FORD</u>	Report No. <u>31</u> Page <u>1</u> of <u>2</u>
TK 103	
<p>PART A: LOCAL AREA NOTED ON ATTACHED SKETCH EXCEEDS DESCRIPTION: LOCAL DISTORTION TOLERANCES OF $\frac{1}{2}$" NOTED IN VITRO SPECIFICATIONS B-101-C1 PAR. 14.2-E.</p>	
<p>CAUSE: DUE TO THE PRESSURE CREATED WHILE FITTING & WELDING MAKE UP ROOF PLATE. THIS AREA WAS CHECKED FOR TOLERANCES BEFORE ROOF PLATES WERE ERECTED & THEY CHECKED OUT OK.</p>	
<p>PART B: 1. PLACE AREA ON HOLD. CORRECTIVE ACTION: 2. CB+1 RECOMMENDS TO CUSTOMER TO LEAVE AREA AS IS FOR THE FOLLOWING REASONS.</p> <ul style="list-style-type: none"> A. ASME DOES NOT ADDRESS ITSELF TO LOCALIZED DEFORMATIONS. B. ASME, SECTION VIII, DIVISION 1, SECTION UG-80 DOES ADDRESS ITSELF TO PRESSURE VESSEL OUT OF ROUNDNESS OF CYLINDRICAL SHELLS. TOLERANCES GIVEN ARE 1% OF DIAMETER WHICH IS MET. ALLOWABLE FOR THIS TANK WOULD BE APPROXIMATELY 8". C. SPECIFICATION DIAMETER TOLERANCES ARE MET. D. SHELL SWEEP BOARD TOLERANCES ARE MET. E. WITH THE EXISTING LOCALIZED DEFORMATION THE TANK REMAINS STRUCTURALLY SOUND AND WILL NOT HAVE ANY DETRIMENTAL EFFECTS DURING OR AFTER FURTHER FABRICATION OPERATIONS (STRESS RELIEF & DOME CONCRETING). F. ANY COSMETIC VALUE WILL BE LOST AFTER THE TANK IS ENCLOSED. G. REPAIR OF THE AREA WOULD ENTAIL CUTTING VERTICAL AND HORIZONTAL SEAMS, WITH EXTRA BUILDUP OF PLATE EDGES AND REWELDING, WHICH BASED ON PREVIOUS SIMILAR REPAIRS WOULD CREATE GREATER DISTORTIONS THAN EXIST. <p>3. CUSTOMER TO ALLOW OR REJECT THE LEAVE AS IS RESOLUTION BASED ON 2. ABOVE.</p>

<p>Deficiency has been resolved: <u>REFER TO J.A.J. F.T.M.# 53</u> <u>Richard Ford</u> <u>8-6-75</u> Quality Control Date</p>

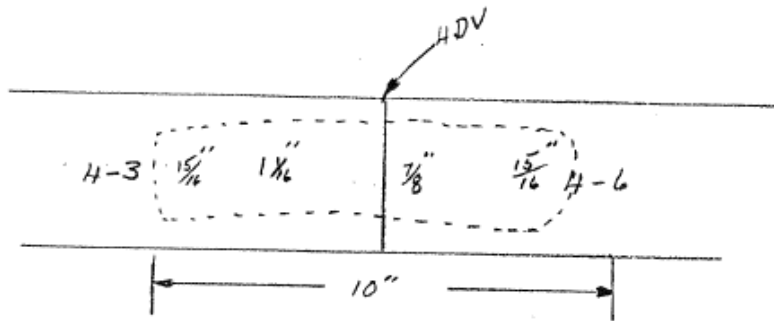
TK-103
4TH RING

App Figure C-24. NCR B-101-38-2307-22, 241-SY Tank Farm Salt Cake Storage Facilities

(1) PROJ/WO NO. B-101	(2) TITLE 241-SY TANK FARM SALT CAKE STORAGE FACILITIES	(3) NCR NO. B-101-38-2307-22																								
(4) DESCRIPTION OF NONCONFORMANCE - REFERENCE - SUGGESTED DISPOSITION AND JUSTIFICATION																										
Reference: Construction Specification B-101-C1 Attachment Discrepancy: On Primary Tank #103, a local area as noted on attached sketch exceeds vertical distortion tolerances of specification B-101-C1, Paragraph 14.2.e. Suggested Disposition and Justification: (See Attached Sheet)																										
HOLD TAG APPLIED: <input type="checkbox"/> YES <input checked="" type="checkbox"/> NO																										
<table style="margin-left: auto;"> <tr> <td style="border: 1px solid black; padding: 2px;">A</td> <td style="border-bottom: 1px solid black; padding: 2px;">JM Johnston</td> <td style="border-bottom: 1px solid black; padding: 2px;">7-7-75</td> </tr> <tr> <td></td> <td style="padding: 2px;">INSPECTOR OR ORIGINATOR</td> <td style="padding: 2px;">DATE</td> </tr> <tr> <td style="border: 1px solid black; padding: 2px;">B</td> <td style="border-bottom: 1px solid black; padding: 2px;"><i>Donald May</i></td> <td style="border-bottom: 1px solid black; padding: 2px;">7/7/75</td> </tr> <tr> <td></td> <td style="padding: 2px;">TITLE III SUPERVISOR</td> <td style="padding: 2px;">DATE</td> </tr> </table>			A	JM Johnston	7-7-75		INSPECTOR OR ORIGINATOR	DATE	B	<i>Donald May</i>	7/7/75		TITLE III SUPERVISOR	DATE

(7) CAUSE OF NONCONFORMANCE AND CORRECTIVE ACTION TO PREVENT RECURRENCE																										
Cause: Distortion was the result of bad fit and weld sequence. Corrective Action: Future seams are to be fit closer and tacked completely prior to final welding.																										
<table style="margin-left: auto;"> <tr> <td style="border: 1px solid black; padding: 2px;">E</td> <td style="border-bottom: 1px solid black; padding: 2px;"><i>[Signature]</i></td> <td style="border-bottom: 1px solid black; padding: 2px;">8-5-75</td> </tr> <tr> <td></td> <td style="padding: 2px;">SIGNATURE AND TITLE</td> <td style="padding: 2px;">DATE</td> </tr> </table>			E	<i>[Signature]</i>	8-5-75		SIGNATURE AND TITLE	DATE																		
E	<i>[Signature]</i>	8-5-75																								
	SIGNATURE AND TITLE	DATE

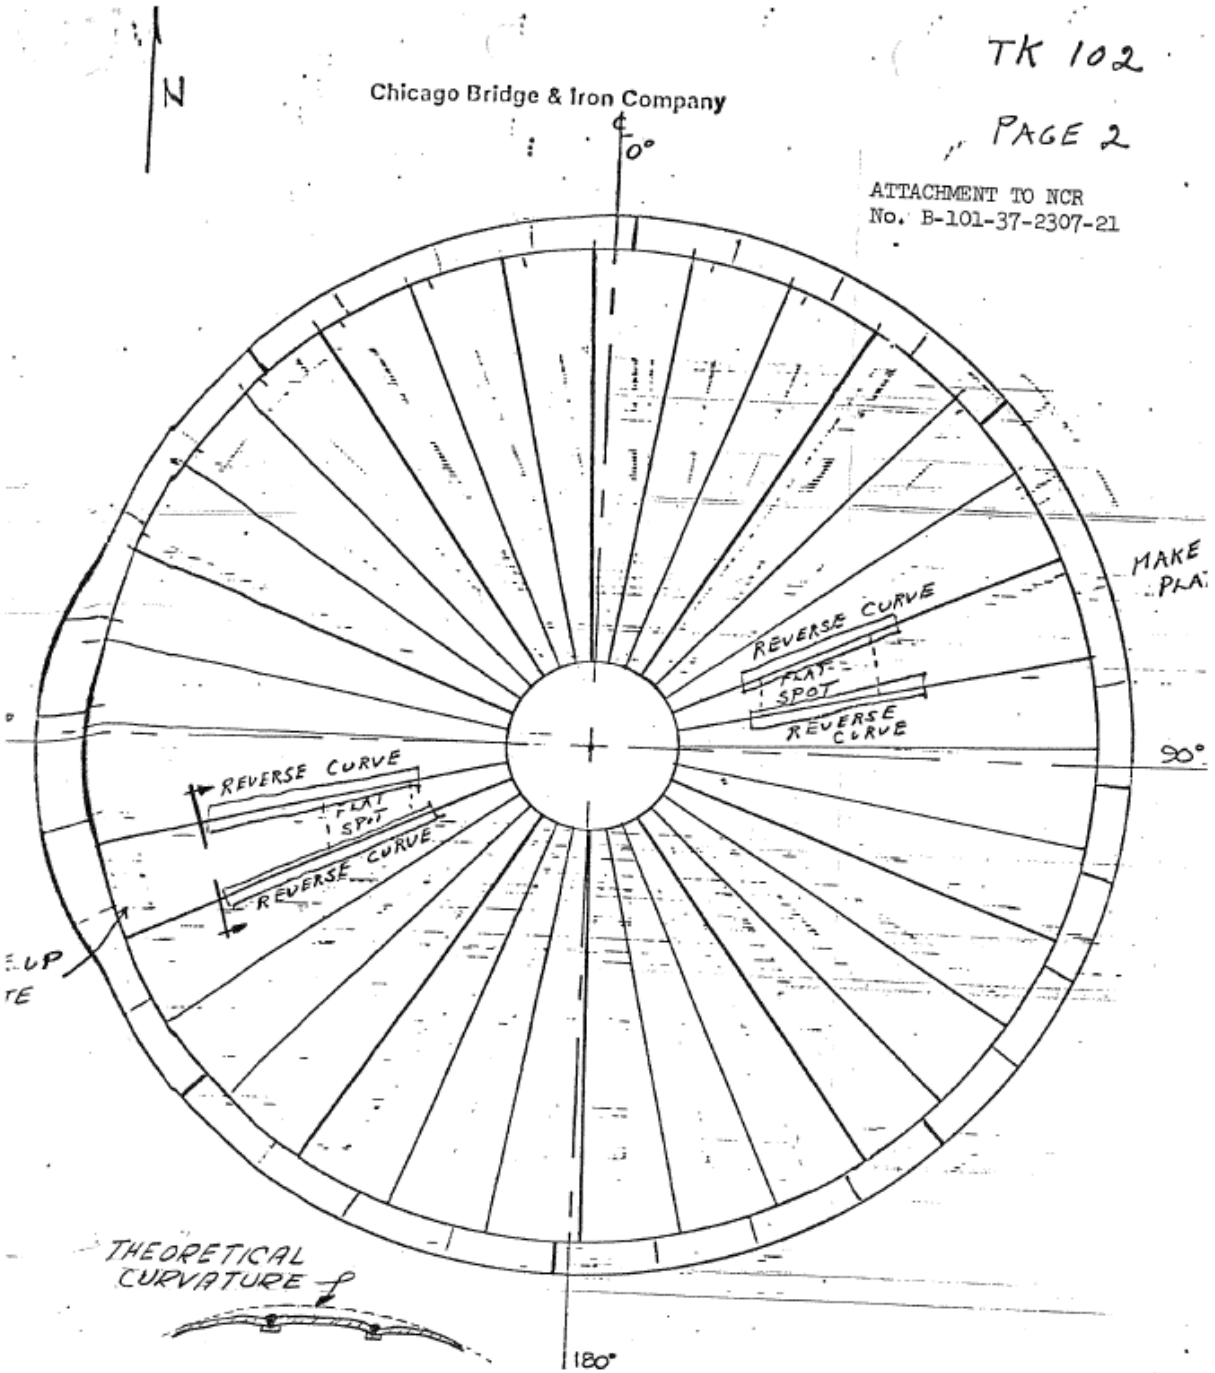
ATTACHMENT TO NCR
No. B-101-37-2307-21

App Figure C-25. NCR B-101-37-2307-21, 241-SY Tank Farm Salt Cake Storage Facilities

OPERATING CONTRACTOR P/E	DATE																		
D-1	<u>A. J. Hassila</u>	<u>7/8/75</u>																		
	AEC	DATE																		
(7) CAUSE OF NONCONFORMANCE AND CORRECTIVE ACTION TO PREVENT RECURRENCE																				
Deformation caused by welding sequence and insufficient restraints while welding last roof closure seams. Future seams to have additional strong backs prior to welding.																				
<table style="width:100%; border: none;"> <tr> <td style="text-align: center;">E</td> <td style="text-align: center;"><u>J. E. Fawcett</u></td> <td style="text-align: center;"><u>7/16/75</u></td> </tr> <tr> <td></td> <td style="text-align: center;">SIGNATURE AND TITLE</td> <td style="text-align: center;">DATE</td> </tr> </table>		E	<u>J. E. Fawcett</u>	<u>7/16/75</u>		SIGNATURE AND TITLE	DATE													
E	<u>J. E. Fawcett</u>	<u>7/16/75</u>																		
	SIGNATURE AND TITLE	DATE

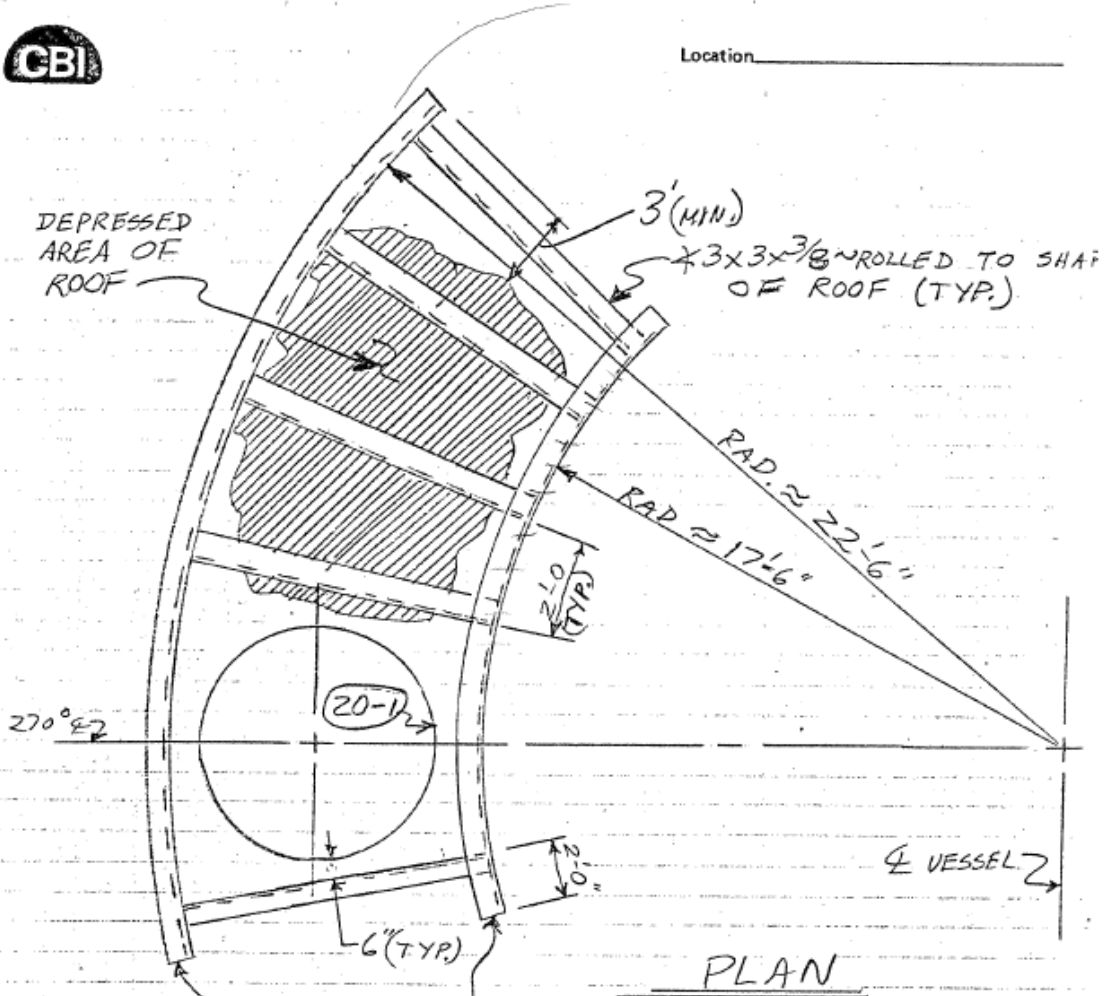
PLAN

Since the other 20-1 penetration at 90° centerline is not having similar problems, we assume that the cause of the settlement

$\times 6 \times 4 \times \frac{3}{8}$ PREFERRED (FIELD MAY TRY $\times 3 \times 3 \times \frac{3}{8}$ IF REINFORCING STEEL WILL INTERFERE WITH 6" \times).
 NOTE: CIRCUMFERENTIAL \times S MUST BE FORMED TO THE CORRECT RADIUS.
