*A Structural Integrity Assessment of the Tank Farm
Waste Transfer System*

Savannah River National Laboratory
Materials Science and Technology

Publication Date: March, 2006

WSRC-TR-2005-00532

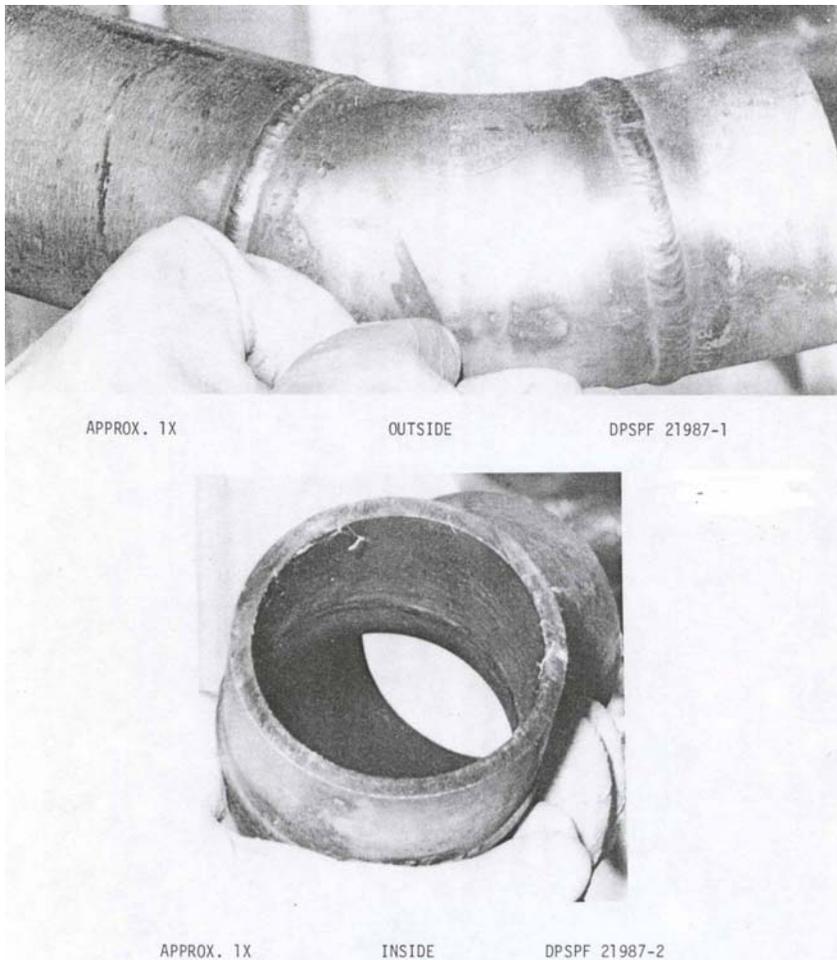
A visual examination and wall thickness measurements were performed on seven sections of the core pipe and one jacket section. The results of these examinations are shown in Table 12. Examples of carbon steel and stainless steel elbows are shown in Figures 24 and 25, respectively. No significant corrosion or reduction in wall thickness was noted on any of the sections, although a small degree of pitting corrosion was observed on the interior of one of the carbon steel elbows. All measured wall thicknesses were greater than 87.5% of the nominal wall thickness that was required in the specification.

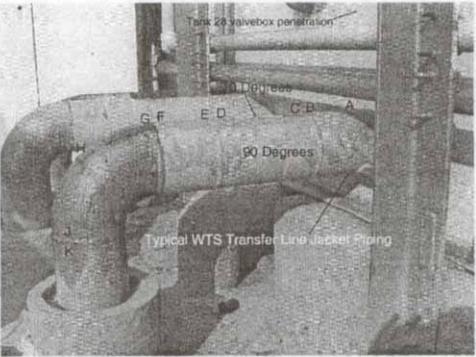
Tank 28 valvebox penetration

EXAMINATION RESULTS				
Location	0°	90°	180°	270°
A	0.301"	0.299"	0.314"	0.311"
B	0.296"	0.309"	0.315"	0.312"
C	0.271"	0.280"	0.276"	0.278"
D	0.270"	0.297"	0.291"	0.286"
E	0.294"	0.292"	0.272"	0.281"
F	0.286"	0.286"	0.270"	0.291"
G	0.290"	0.293"	0.272"	0.300"
H	0.252"	0.290"	0.281"	0.289"
I	0.273"	0.289"	0.297"	0.289"
J	0.280"	0.292"	0.283"	0.292"
K	0.265"	0.269"	0.283"	0.264"

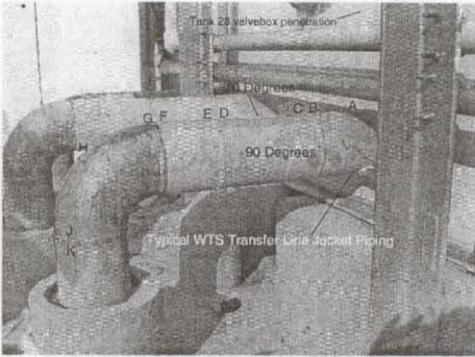
Tank 28 valvebox penetration

EXAMINATION RESULTS				
Location	0°	90°	180°	270°
A	0.281"	0.271"	0.271"	0.280"
B	0.276"	0.282"	0.273"	0.272"
C	0.291"	0.289"	0.284"	0.278"
D	0.287"	0.291"	0.277"	0.287"
E	0.300"	0.282"	0.265"	0.288"
F	0.296"	0.281"	0.265"	0.290"
G	0.269"	0.297"	0.304"	0.301"
H	0.253"	0.280"	0.289"	0.290"
I	0.244"	0.278"	0.290"	0.290"
J	0.267"	0.287"	0.283"	0.300"
K	0.277"	0.280"	0.282"	0.288"
