WSRC-TR-96-0217

DWPF Materials Evaluation Summary Report (U)

Publication Date: September 12, 1996

**Westinghouse Savannah River Company
Savannah River Site
Aiken, SC 29803**

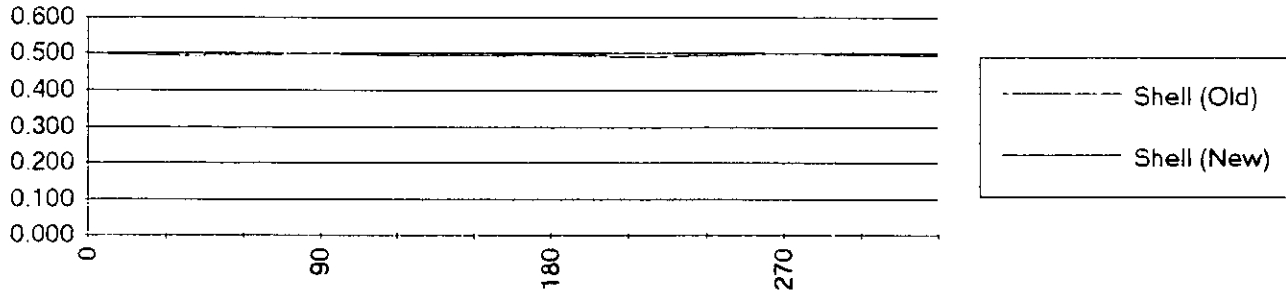
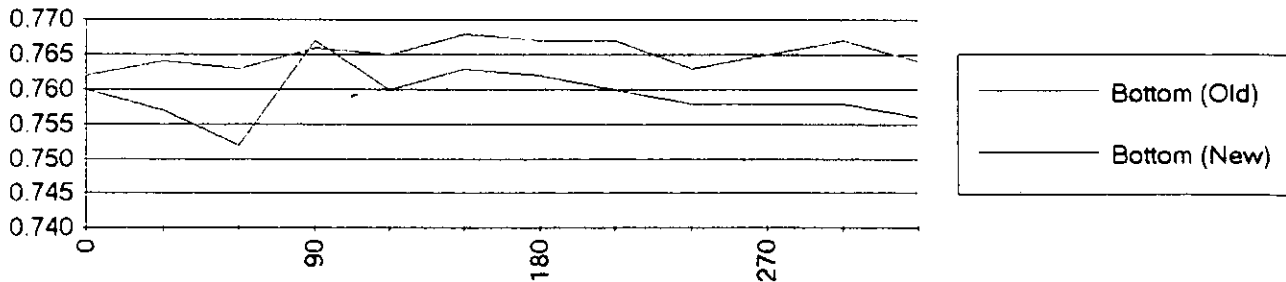
Figure 1. Comparison of UT wall thickness data for PRBT tank shell and bottom before (i.e. "old") and after (i.e. "new") DWPF cold chemical runs.

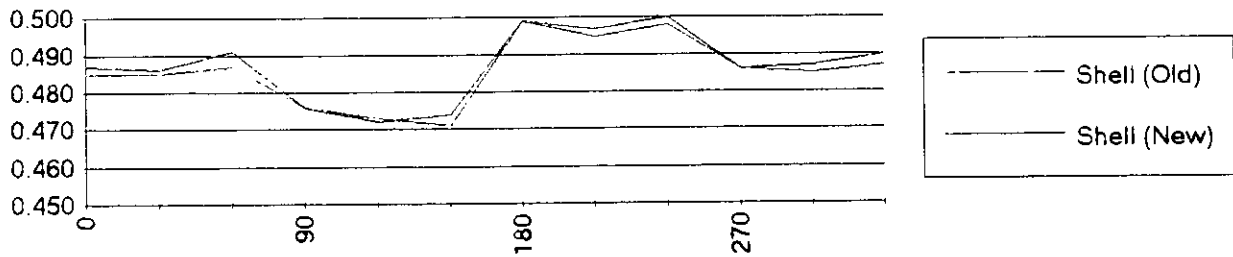
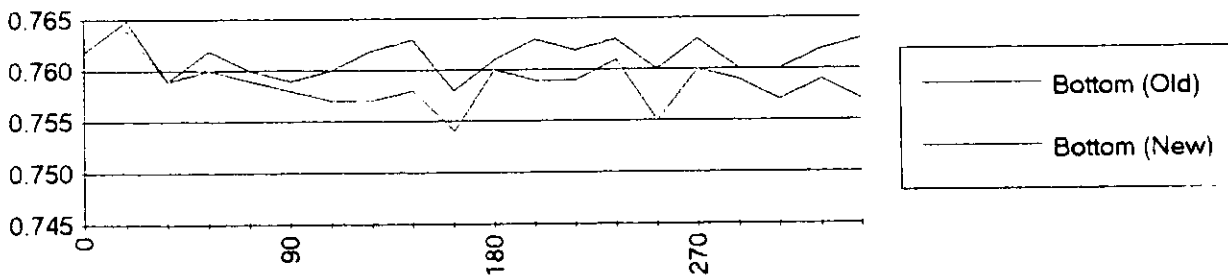
Figure 2. Comparison of UT wall thickness data for SRAT tank shell and bottom before (i.e. "old") and after (i.e. "new") DWPF cold chemical runs.

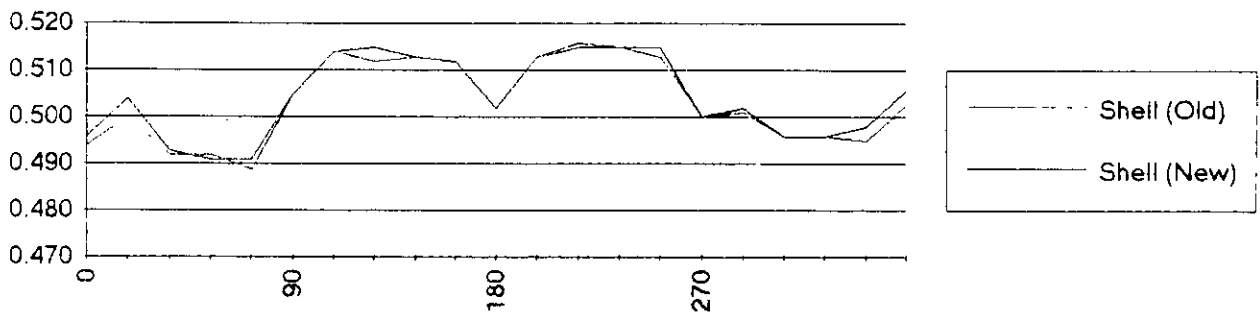
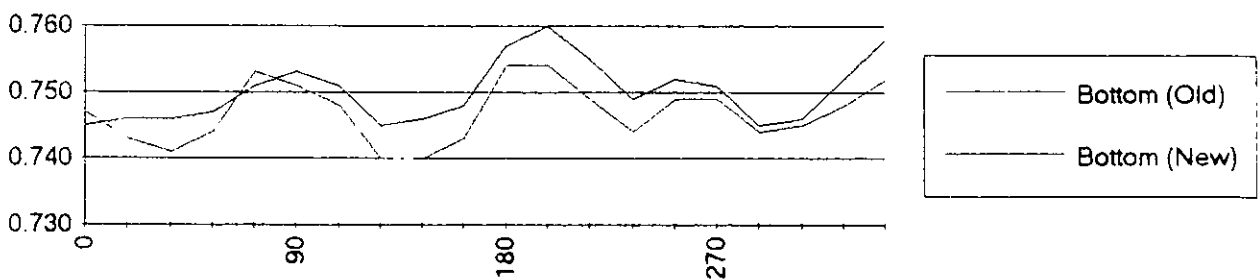
Figure 3. Comparison of UT wall thickness data for SME tank shell and bottom before (i.e. "old") and after (i.e. "new") DWPF cold chemical runs.

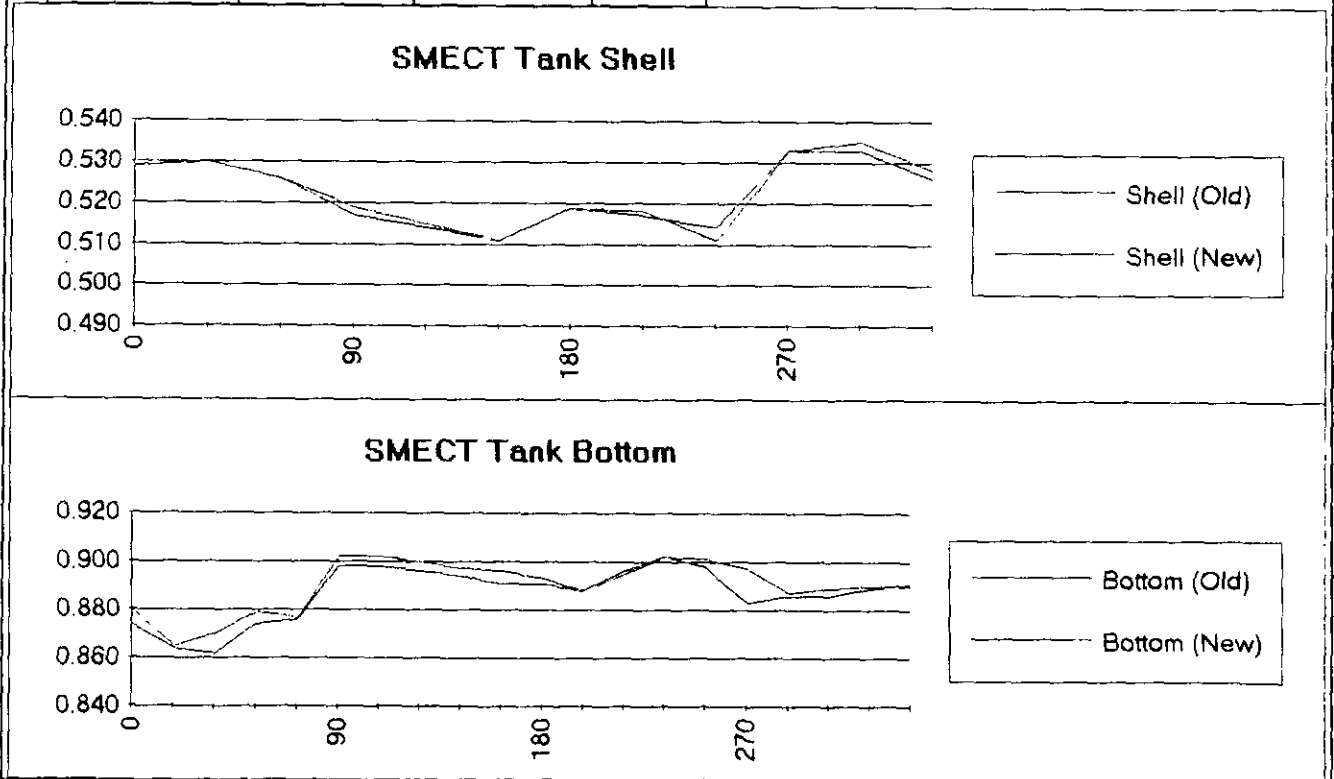
Figure 4. Comparison of UT wall thickness data for SMECT tank shell and bottom before (i.e. "old") and after (i.e. "new") DWPF cold chemical runs.

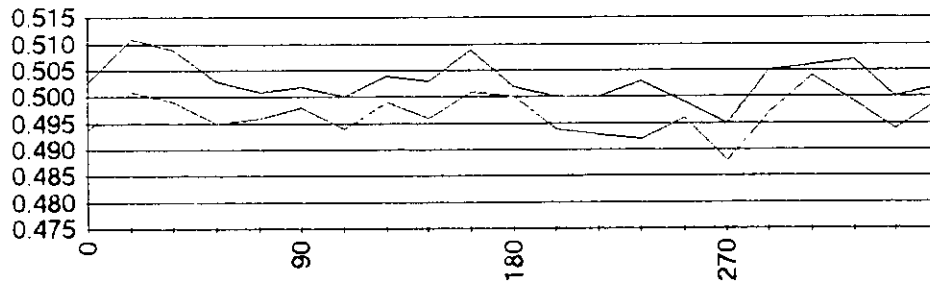
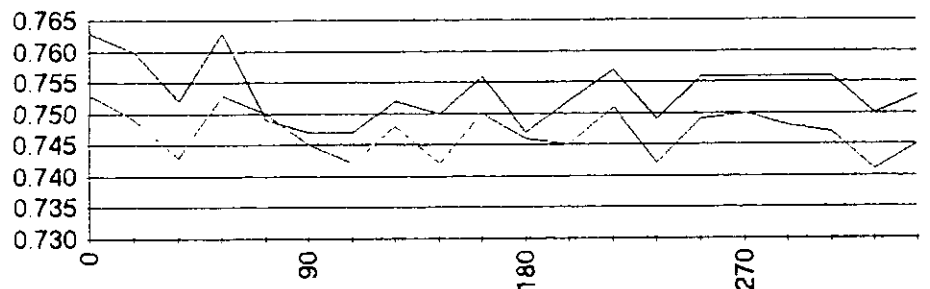
Figure 5. Comparison of UT wall thickness data for MFT tank shell and bottom before (i.e. "old") and after (i.e. "new") DWPF cold chemical runs.

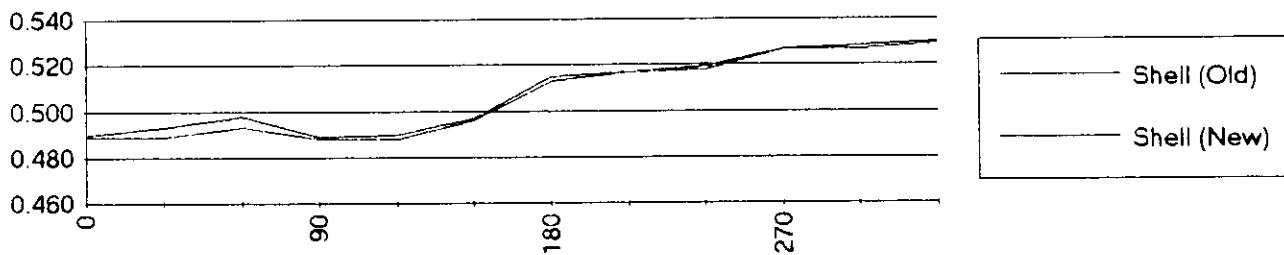
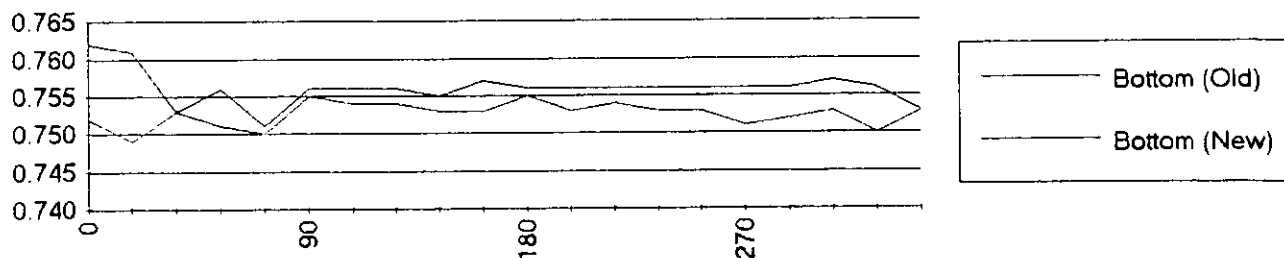
Figure 6. Comparison of UT wall thickness data for OGCT tank shell and bottom before (i.e. "old") and after (i.e. "new") DWPF cold chemical runs.

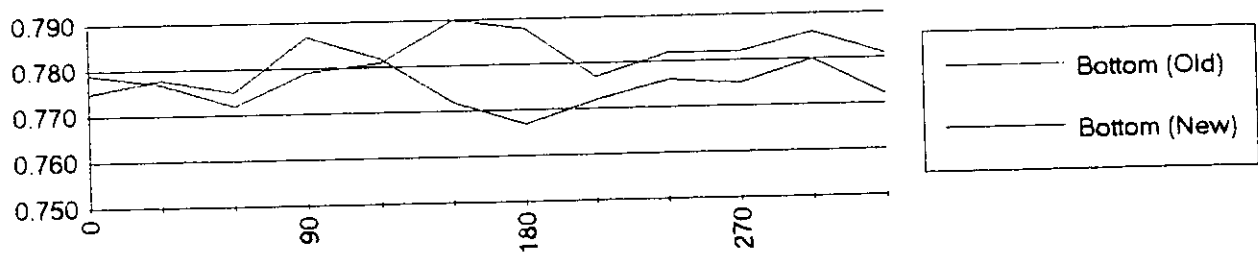
Figure 7. Comparison of UT wall thickness data for RCT bottom shell before (i.e. "old") and after (i.e. "new") DWPF cold chemical runs.

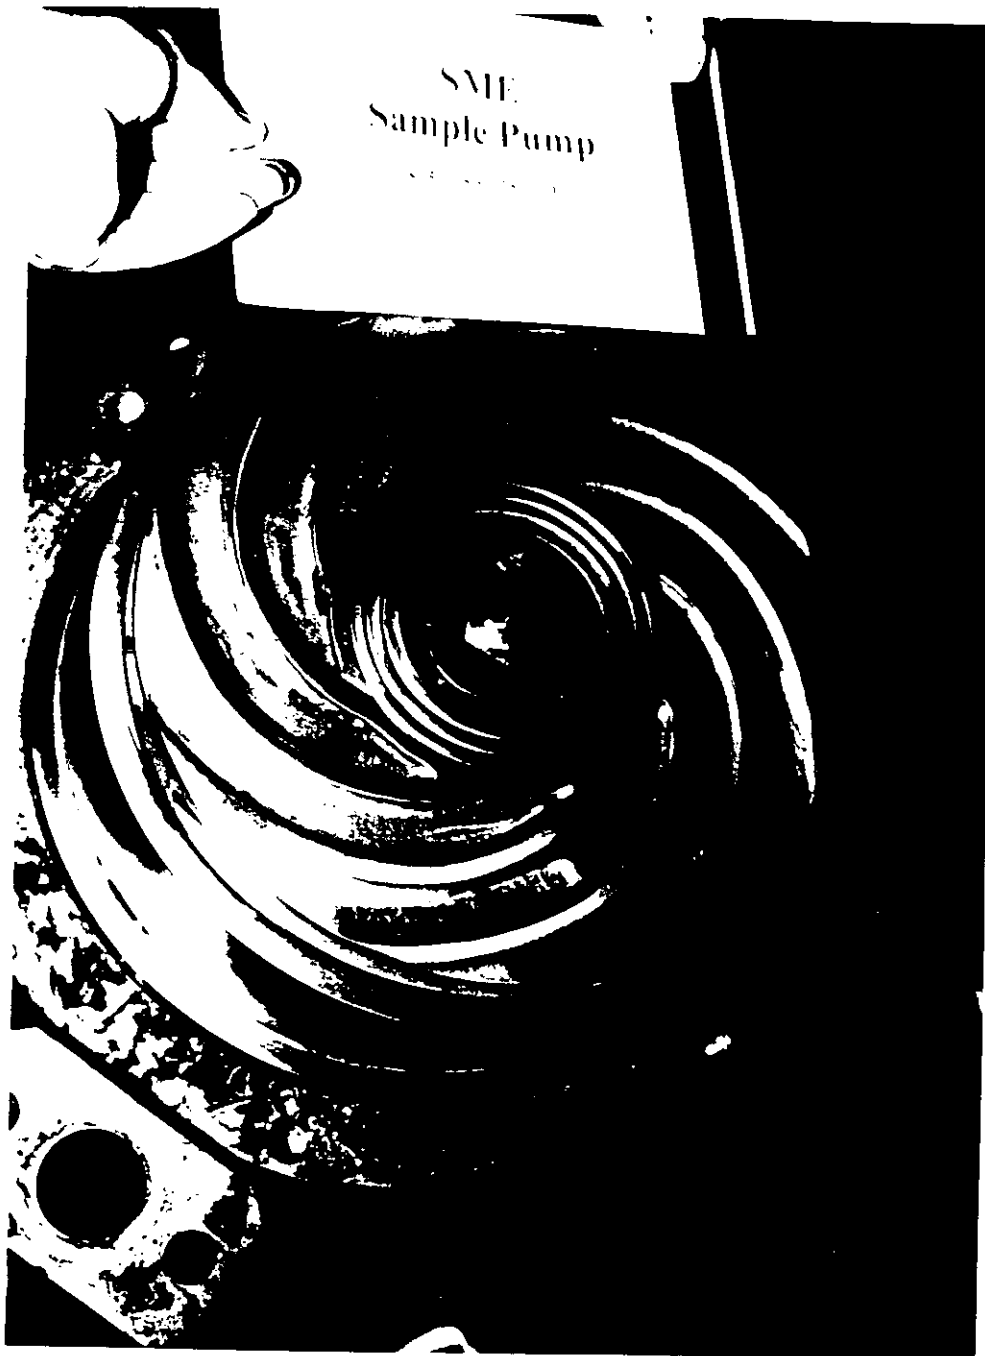
Figure 14b. Photograph showing a bottom view of the impeller from the SME sample pump (WSRC-FM-95-0006-34).

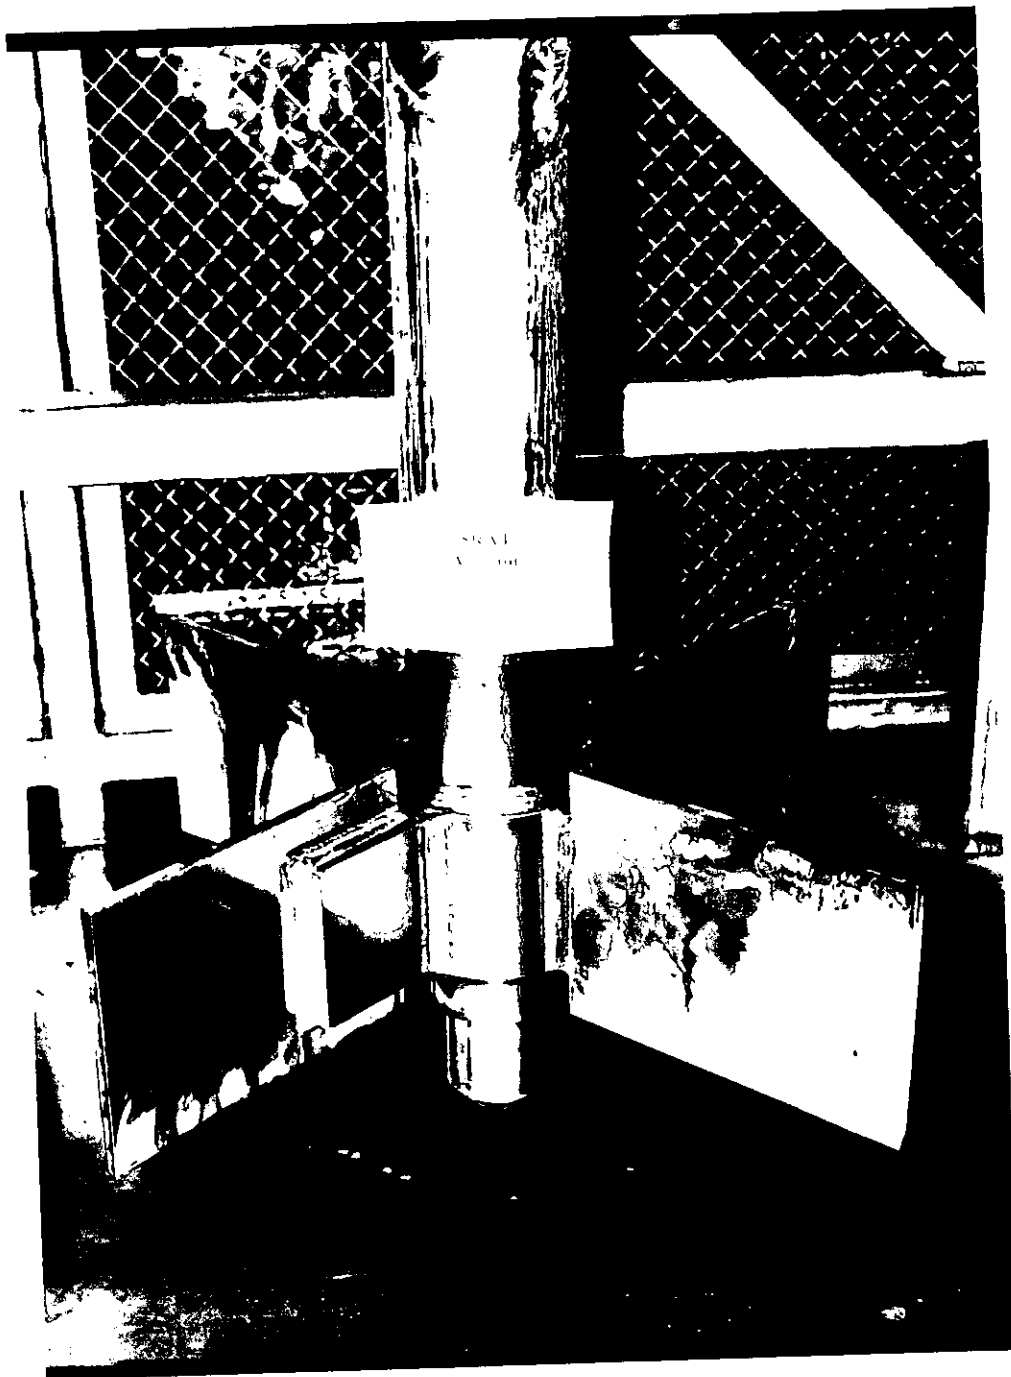
Figure 18b. Photograph of the SRAT lower agitator blades (WSRC-FM-95-0048-12).

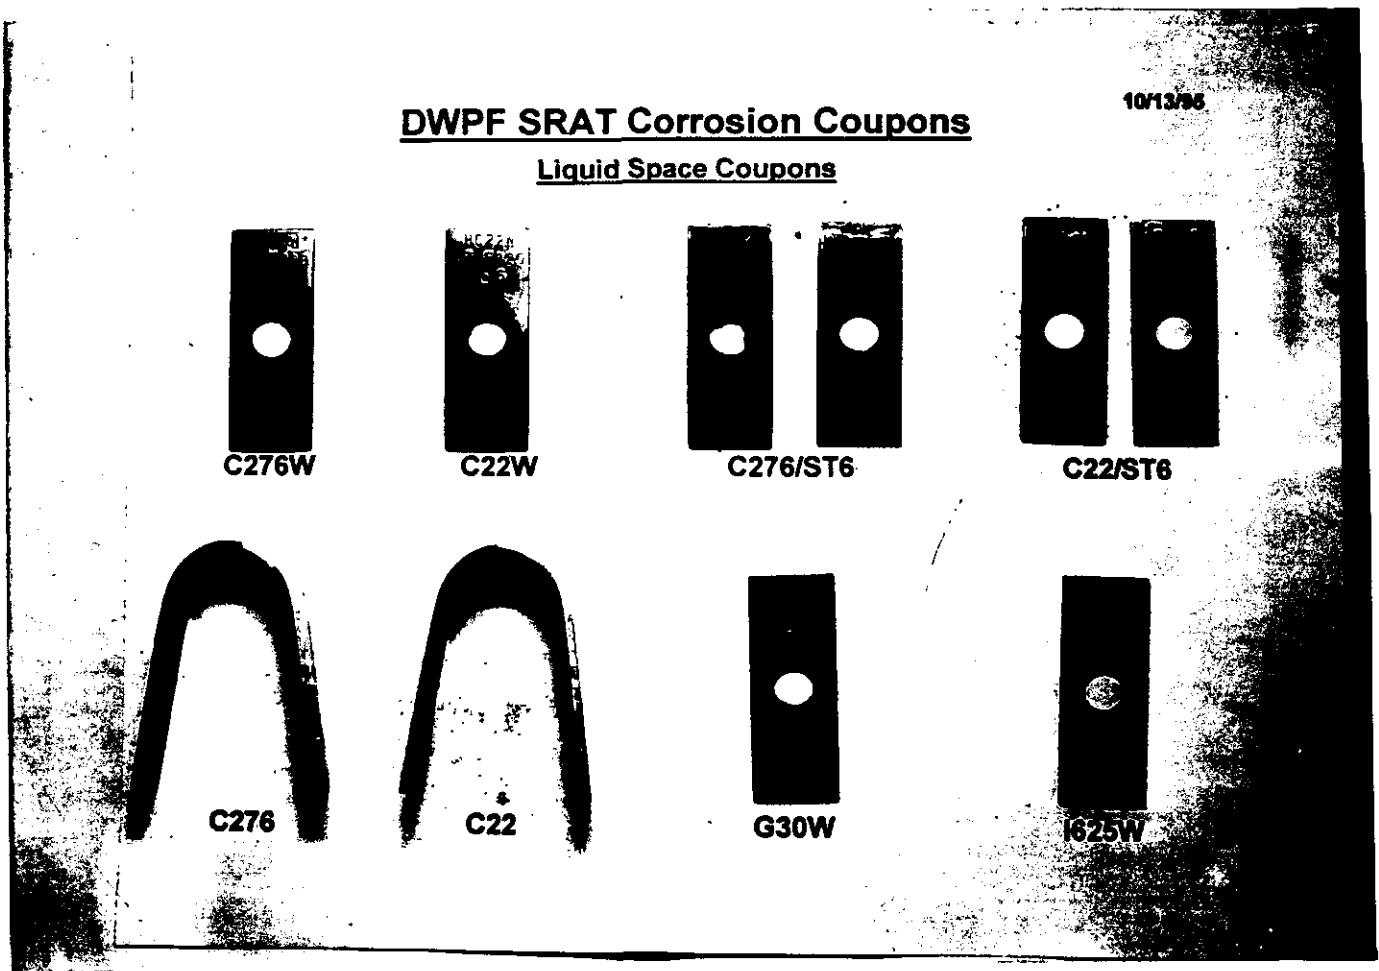
Figure 28b. SRAT liquid space corrosion coupons after cleaning.
(Negative # WSRC-FM-96-0067-07)

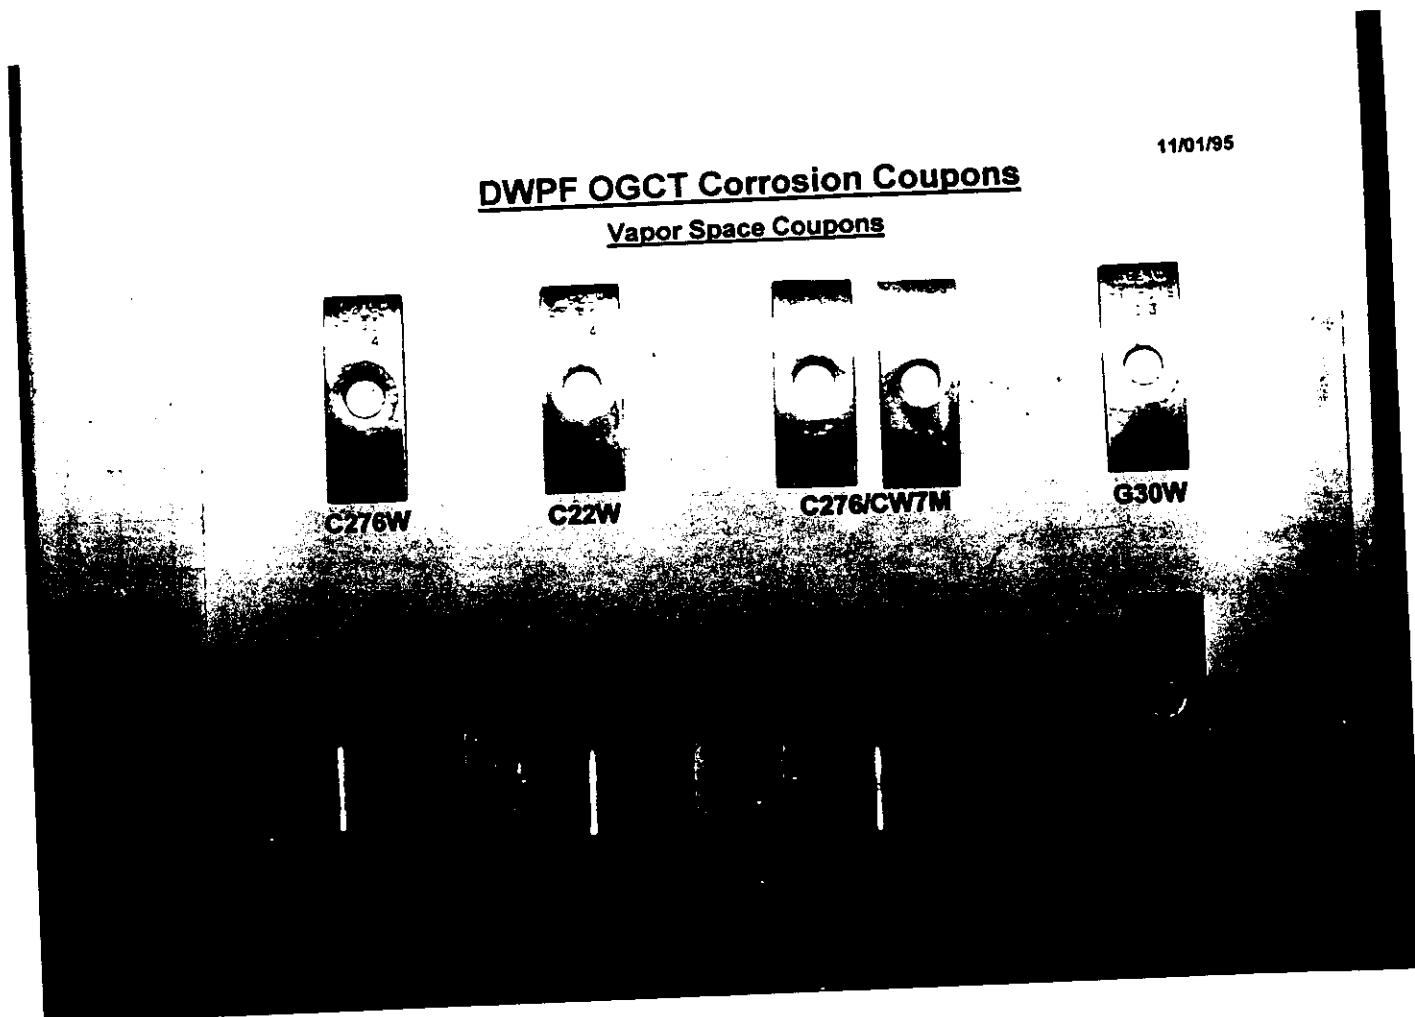
Figure 29a. OGCT vapor space corrosion coupons after cleaning.
(Negative # WSRC-FM-96-372-11)

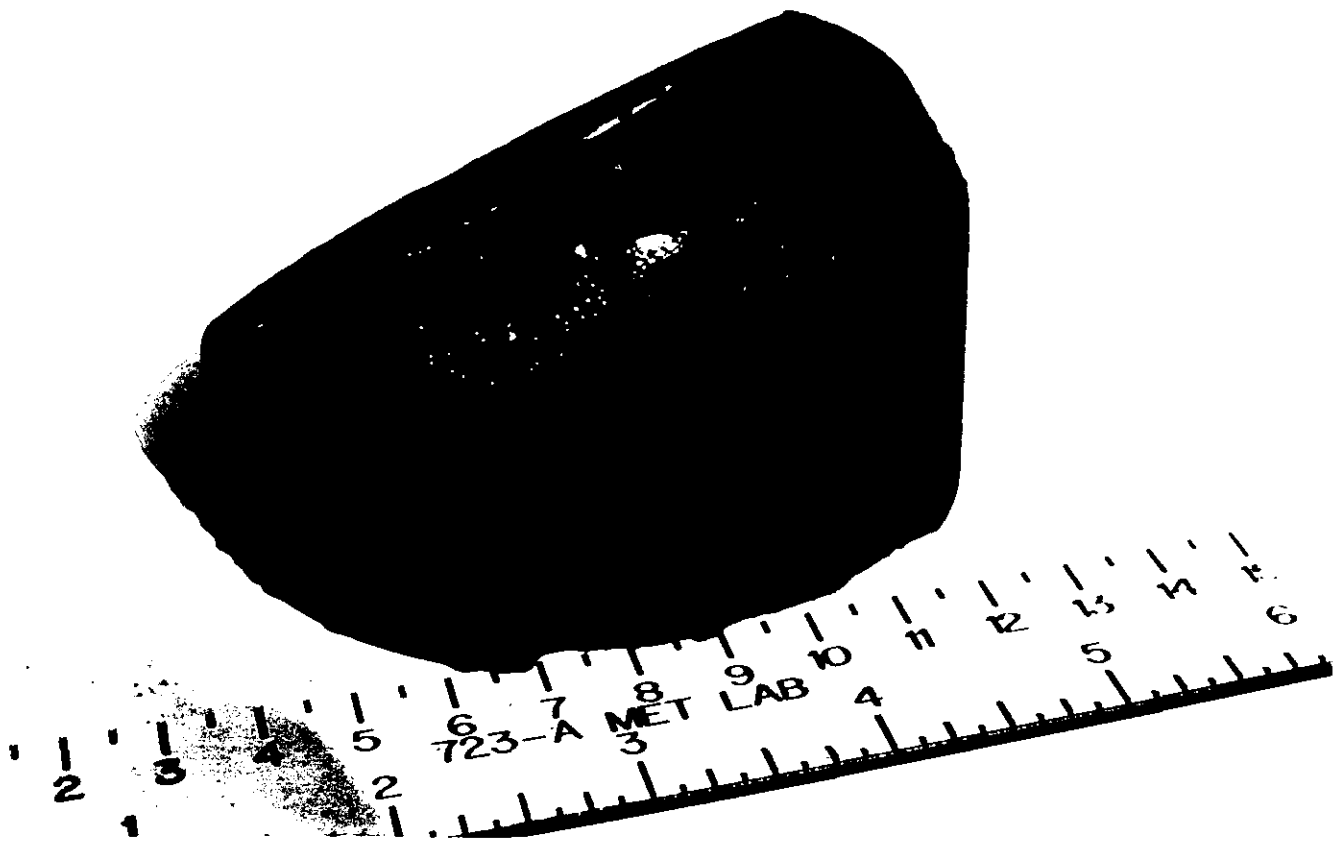
Figure 2a. Large pit on the side of the borescope outer housing (WSRC-FM-95-0050-05).

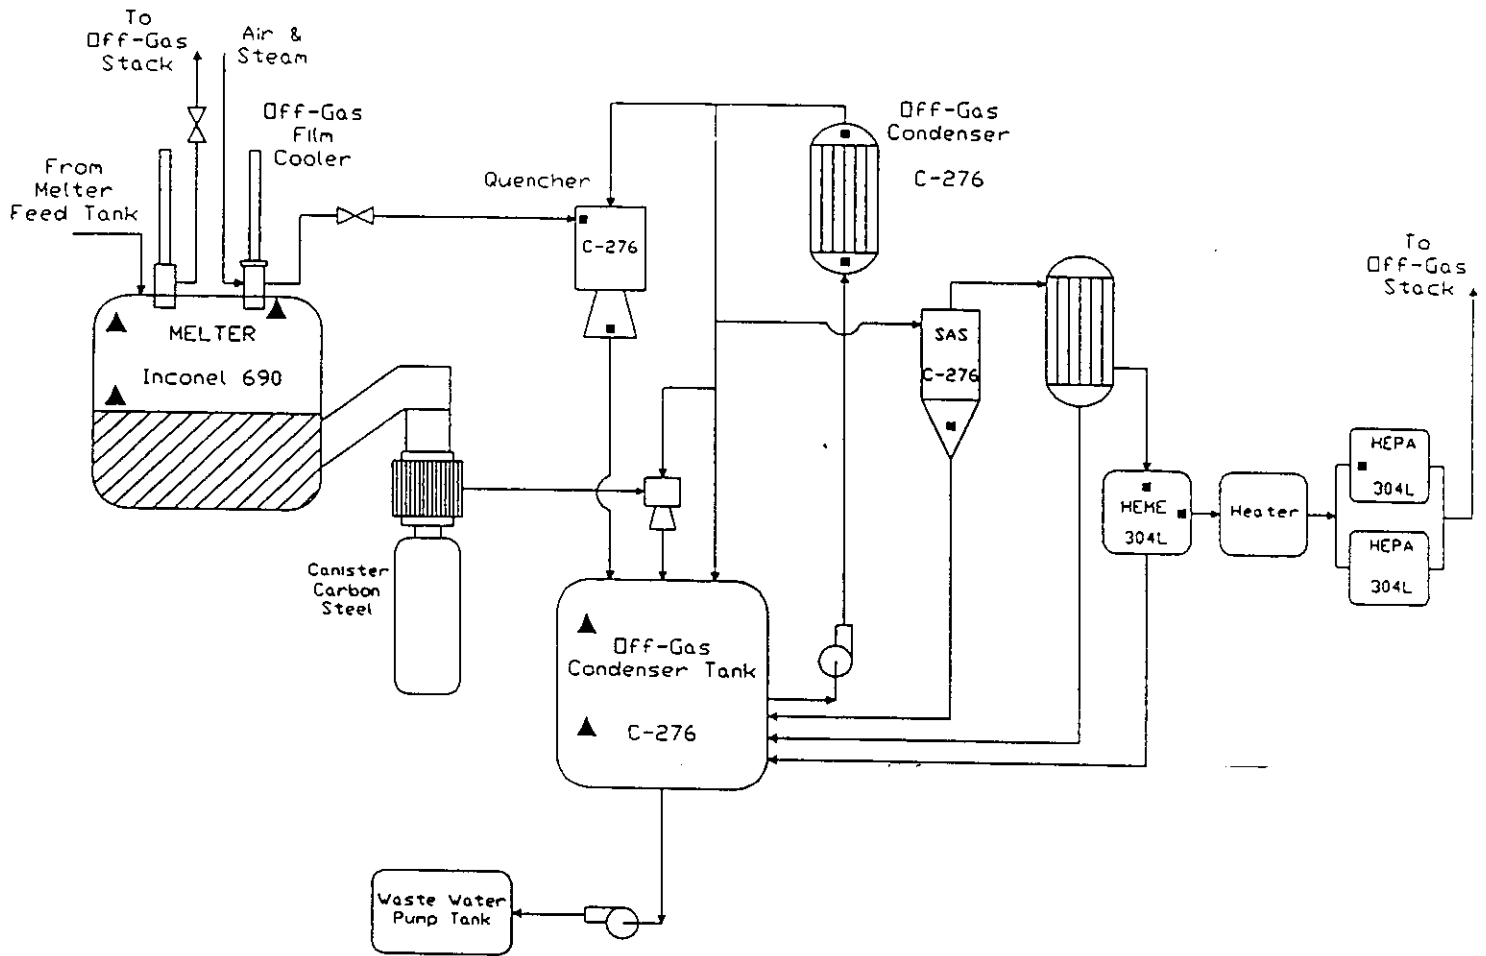
Figure 1. Schematic of the IDMS melter and off-gas system showing location of corrosion coupon racks and IDMS materials of construction.

Corrosion coupon racks were removed from the off gas system, visually examined for evidence of corrosion and then reinstalled (Figure 1). Only the coupons from the quencher inlet were taken to the lab for further metallurgical evaluation. No evidence of significant corrosion was observed on any of the coupons. A metallurgical examination of the original corrosion coupons, which were placed in the IDMS feed preparation, melter and off gas systems, was performed in 1993. Results from this metallurgical evaluation did not reveal any evidence of pitting, general, stress corrosion cracking or crevice attack of any of the DWPF materials of construction [5]. However, both the Hastalloy C-276 and Allcorr coupons removed from the quencher inlet showed evidence of end grain attack. These are the materials of construction for the DWPF primary and backup quenchers, respectively. Exposure of end grains was minimized in the design of the IDMS and DWPF quenchers therefore, the potential for corrosion of the DWPF quenchers is low. The nozzle is the only component in the quencher that could potentially be vulnerable to this type of attack. Corrosive gasses are swept away from the tip of the nozzle, and therefore, end grain attack is not anticipated. Inspection of the DWPF primary [6] and IDMS [2,3] quenchers did not reveal any end grain attack of the nozzles.
