KAPL-2203

CORROSION OF ZIRCALOY IN CREVICES UNDER NUCLEATE BOILING CONDITIONS

W. Kermit Anderson, M. J. McGoff

April 13, 1962

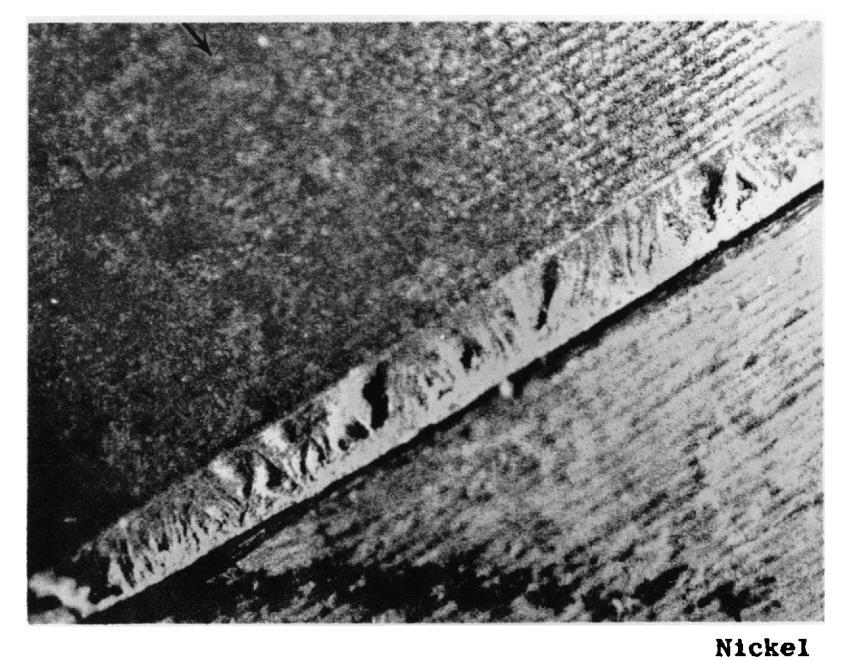
<u>Results in Ammoniated, Hydrogenated Water</u>. The test specimen removed from the ammoniated water showed a ring of creany-white corrosion product at the bond and some creany-white patches on the Zircaloy-2 (Figure 10). Under 30X magnification, the creany-white product seemed to originate in

FIGURE 10. Corrosion of Nickel - Zircaloy-2 Diffusion Bond.

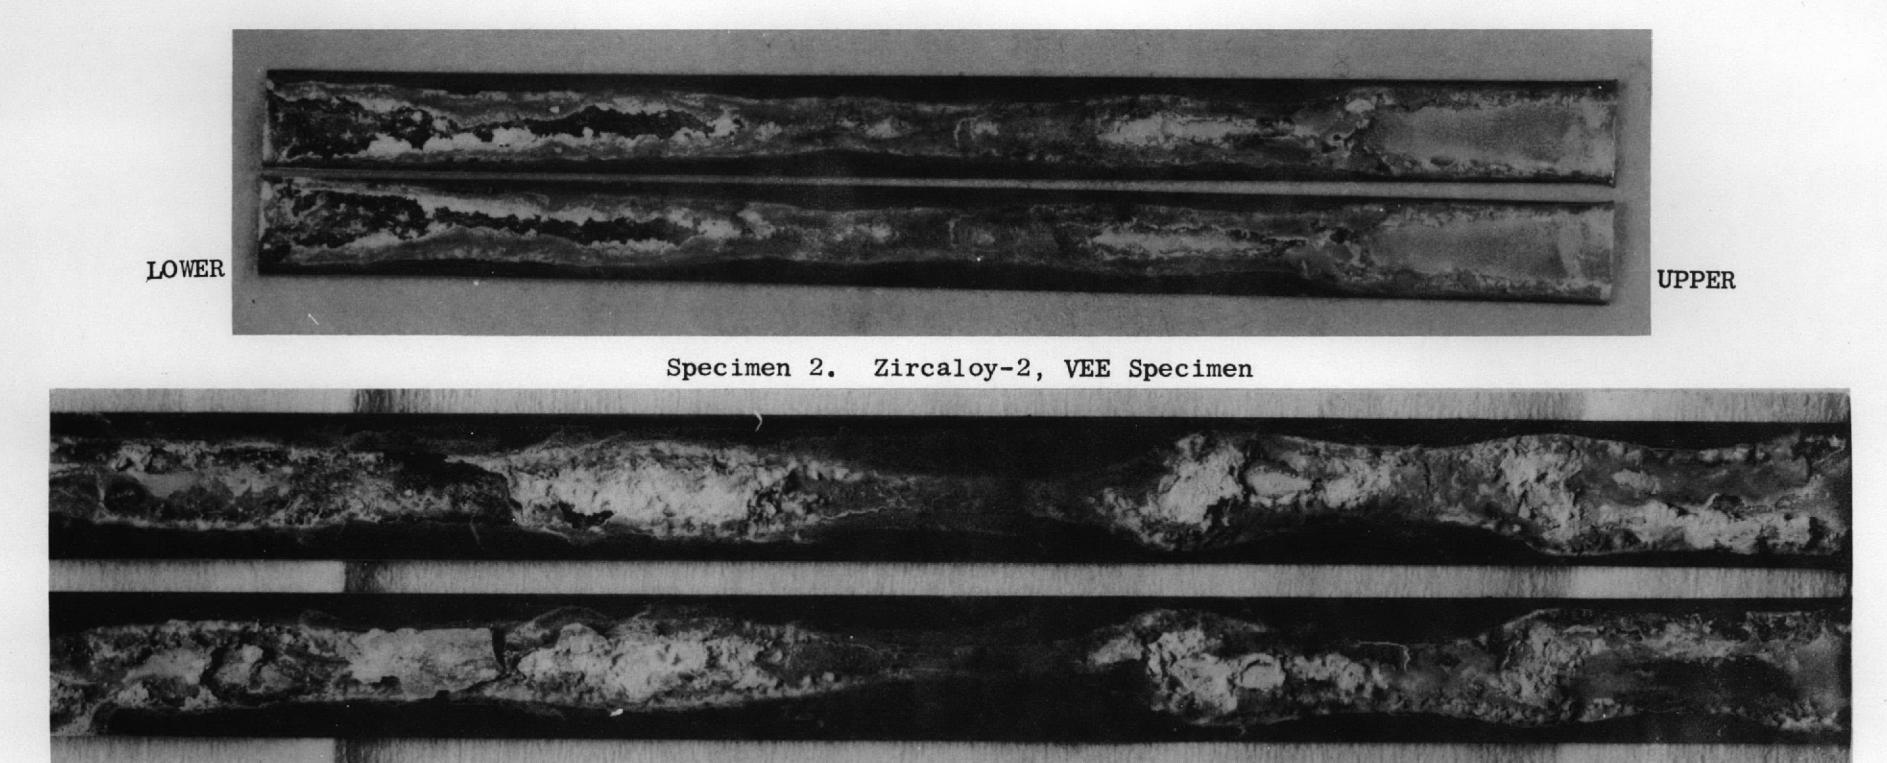
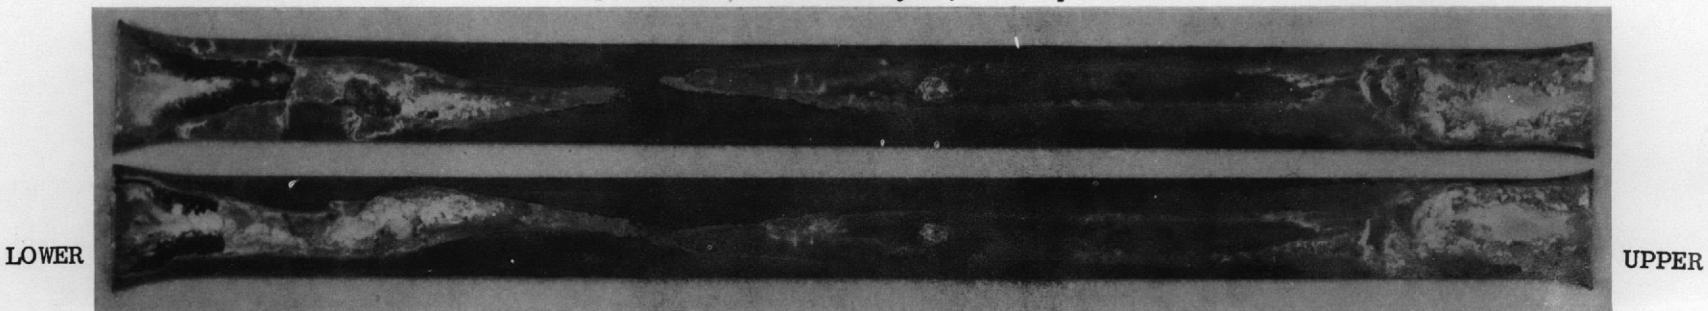
Figure 33 shows inner faces of specimens 2, 5, and 3. The white oxide visible in these photographs is largely hydrated alumina (boehmite) of the chemical composition $Al_2O_2(OH)_2$. It has been established that this aluminum oxide deposit probably came from the parts of a charging pump that had been used to pump water into the loop. Spectrographic analyses and X-ray diffraction data have been used to establish the composition of all three of these oxide deposits on specimens 2, 5, and 3.

Specimen 5. Zircaloy-4, VEE Specimen

Specimen 3. Zircaloy-4 parallel-faced specimen exposed after precrudding with ammonia precipitated iron oxide

FIGURE 33. Slightly Magnified Surfaces of Crevice Interiors from Specimens 2,5, and 3 Used in the 1000-hr Test in pH 10.5 Ammoniated Water. The lower ends were upstream; Upper marks the geometric UP direction in the chambers.

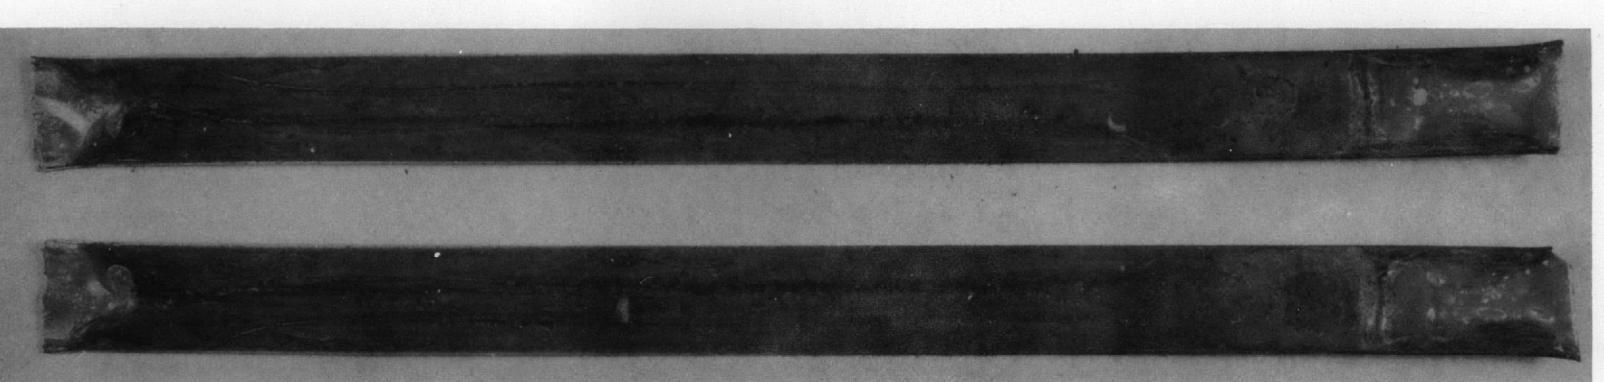
A. Interior View of Crevice from Specimen 14. Zircaloy-2, VEE-Specimen

Figure 34 shows photographs of the interior surfaces of shearedout parts of specimens 14, 15, and 13. All specimens show deeply eroded or corroded surfaces; however, the Zircaloy-2 (specimen 14) appears to have suffered less attack than did the Zircaloy-4 in either the VEEshaped, uncrudded or the parallel-walled, crudded specimens (Figures 33b and 33c, respectively).

FIGURE 34. Interior View of Crevices Exposed for 200 hr to the Action of pH 10.5 Lithiated Water. Tsat was probably reached in these crevices over most of their interior length, making temperature near 587F. KS-46255

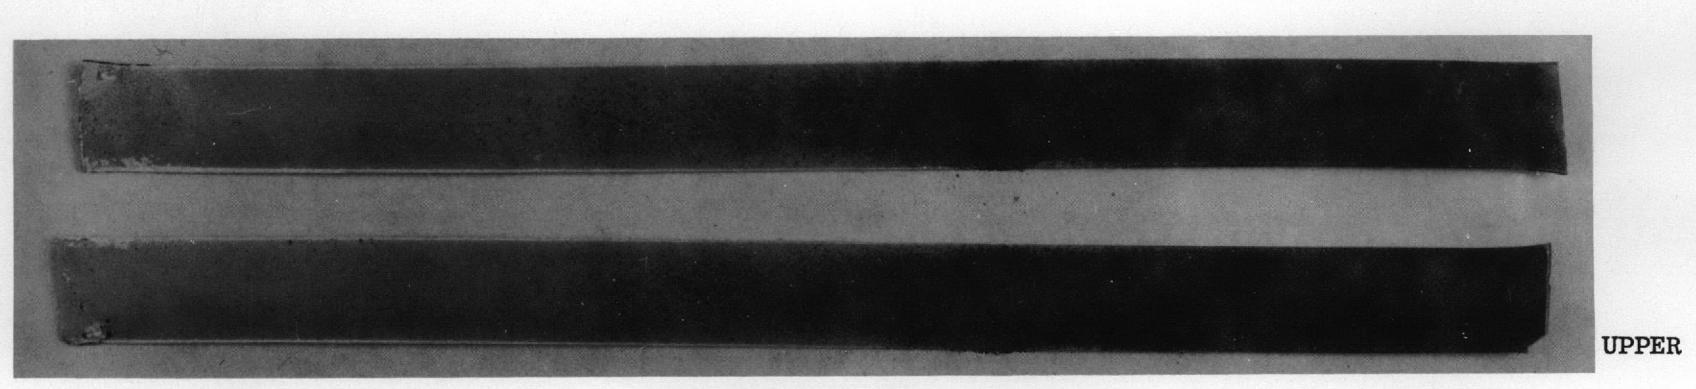
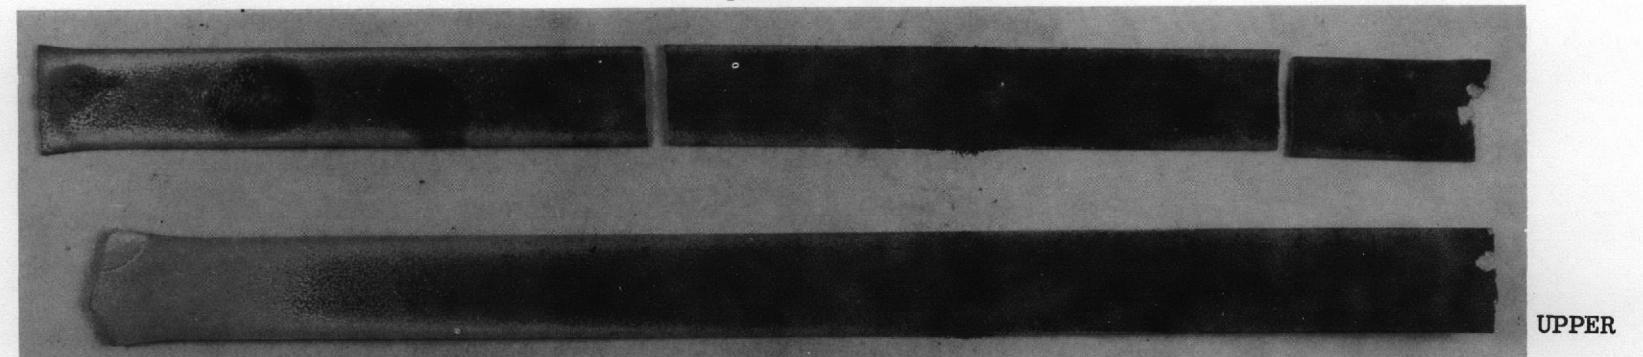
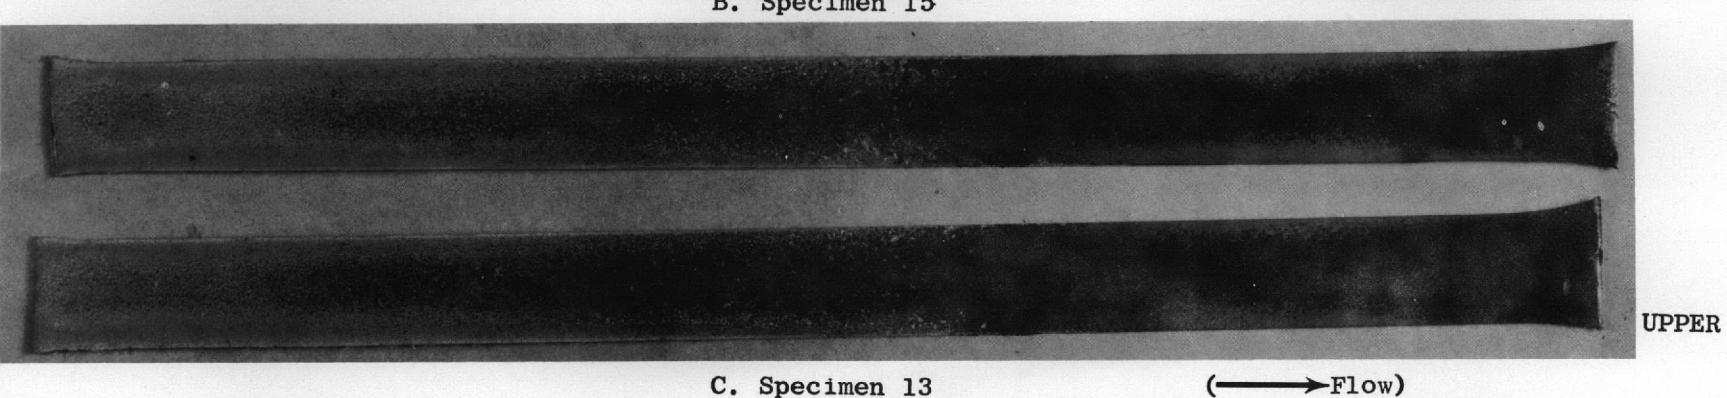
FIGURE 35. Outside Surfaces of Crevice Specimens Used in Test with pH 10.5 Lithiated Water. The beginnings of white product deposits are visible on the upstream ends of these specimens. KS-46256 Unclassified

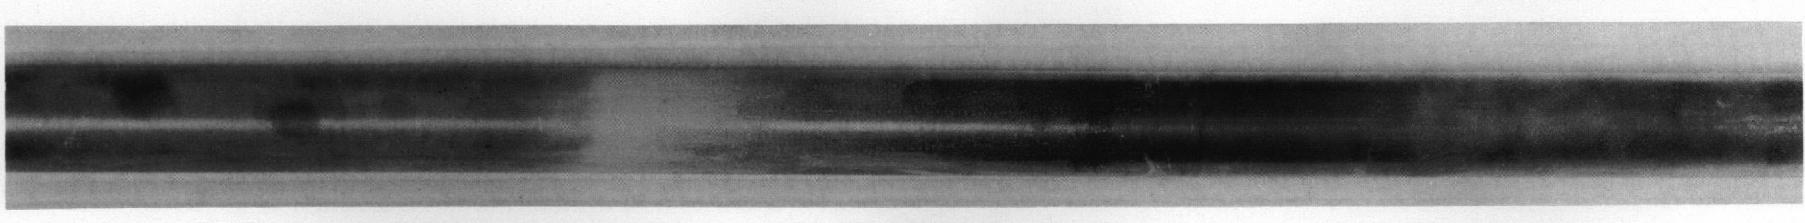
A. Specimen 2

FIGURE 36. Nonadherent White Zirconium Oxide Product Formed in Ammoniated Water Test on Upstream Bus Bars. KS-45673 Unclassified

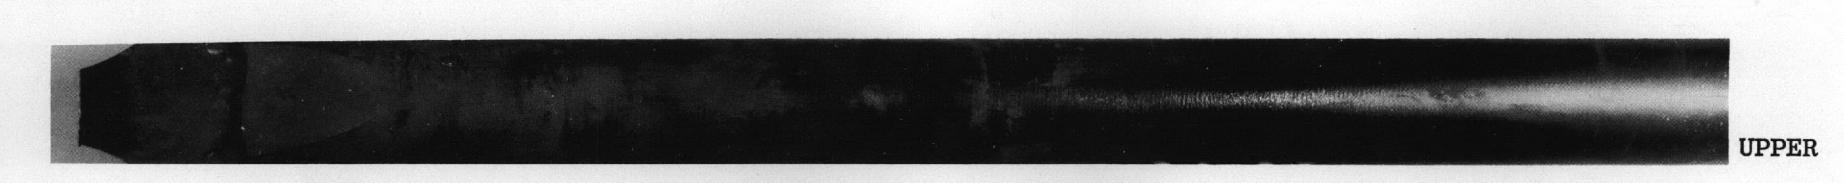
FIGURE 38. Red Iron Oxide Deposit on Upstream Bus Bar of Specimen 13, the Precrudded Test in Lithiated Water (1X). KS-45808

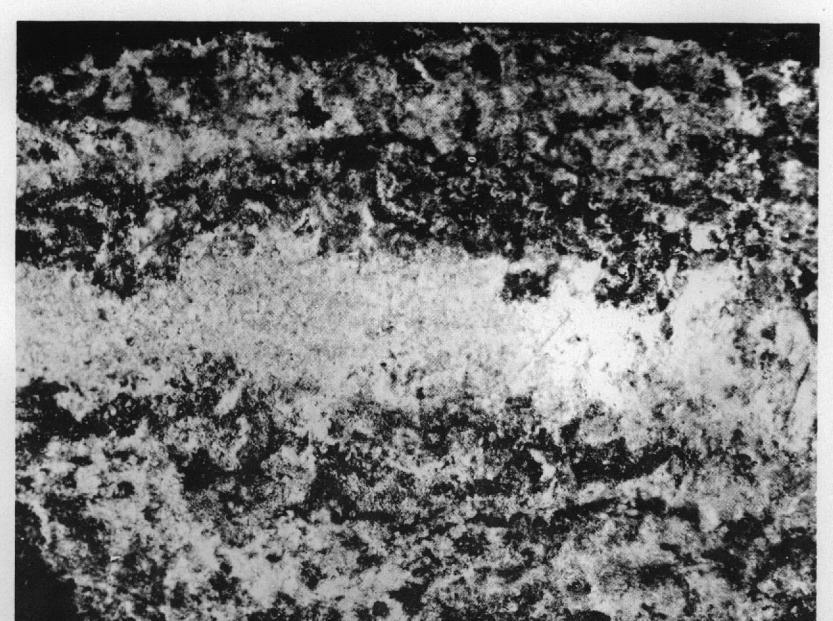
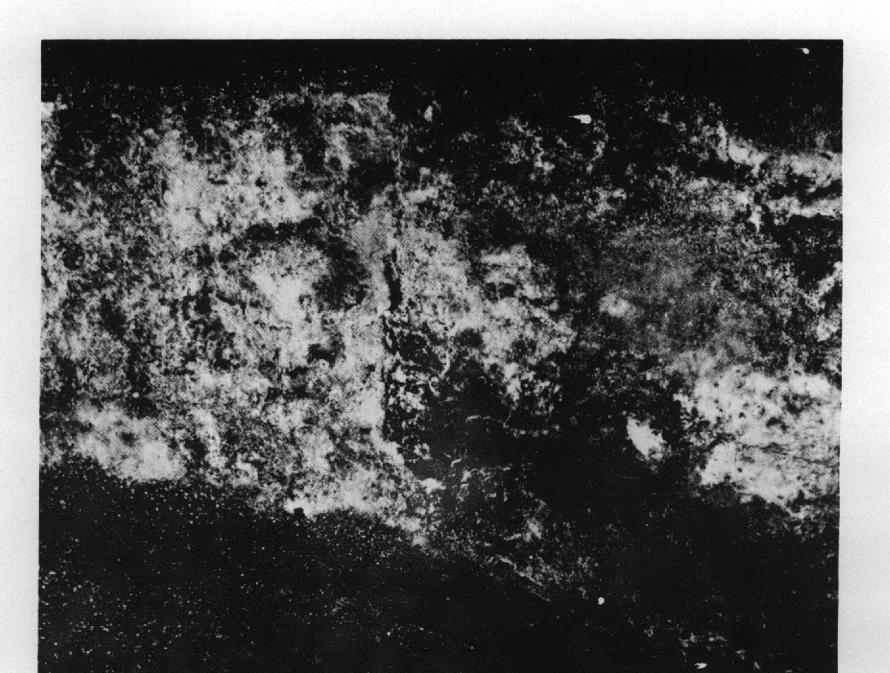
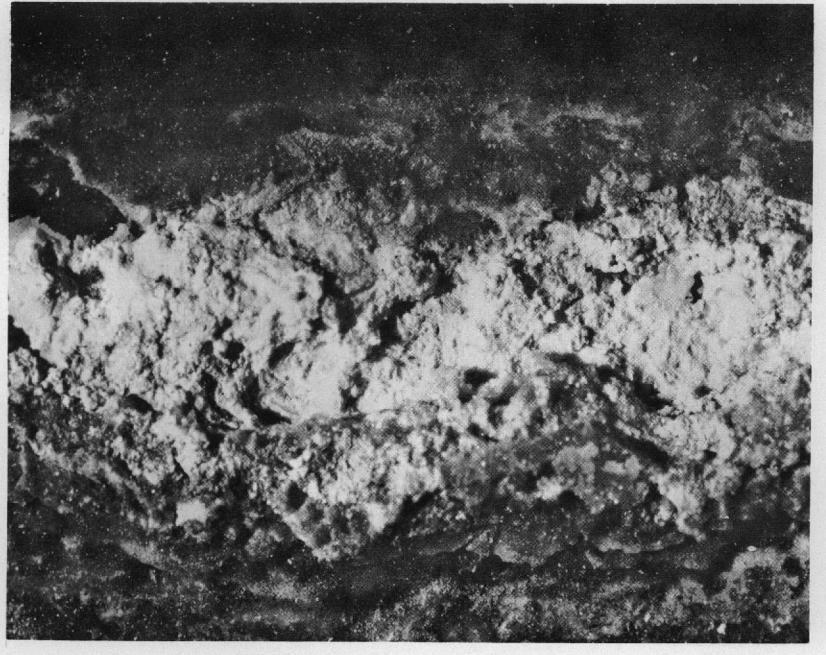
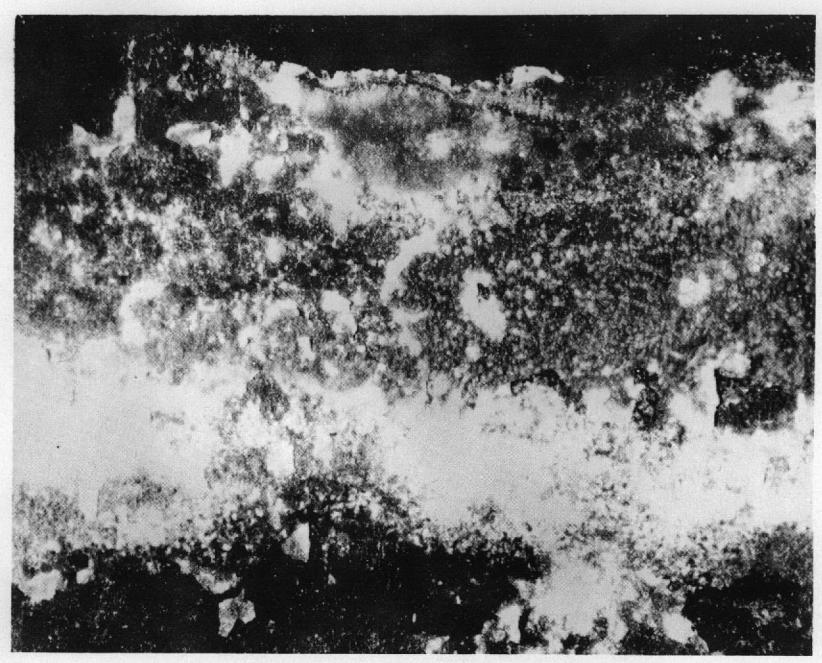
FIGURE 39. Typical Appearance of Inner Surfaces of Crevices in Specimens from Test MDO-BMD-8A after Exposure for 1000 hr in pH 10.5 Ammoniated Water. The oxide deposit is boehmite, a hydrated aluminum oxide.

removal of easily detached oxide with a small microspatula, is also shown in Figure 39D. This view is of the same area shown in the unscraped state in Figure 39C.

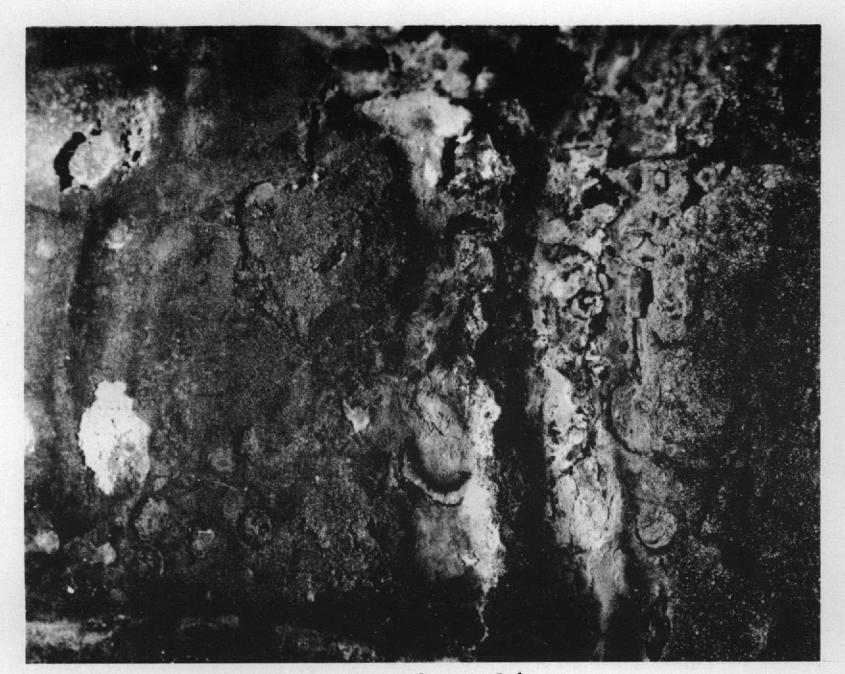
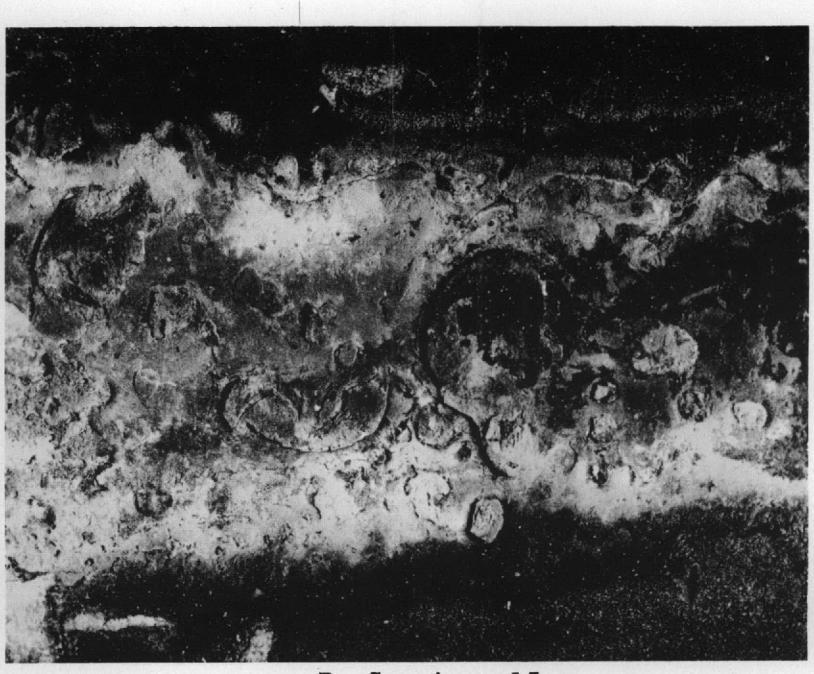
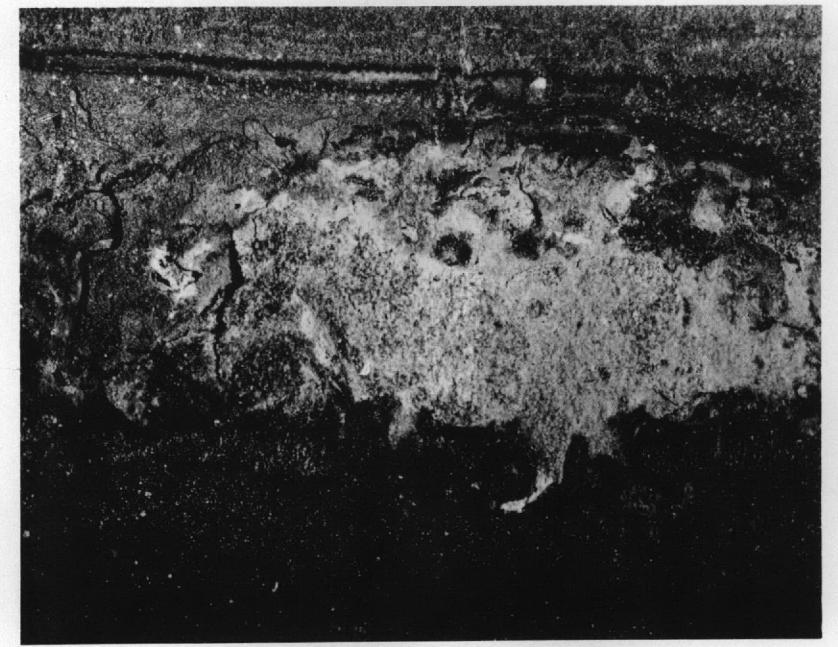
FIGURE 40. Views at 12.5X of Selected Regions on Interior of Crevices Tested for 200 hr in 587F pH 10.5 Lithiated Water.

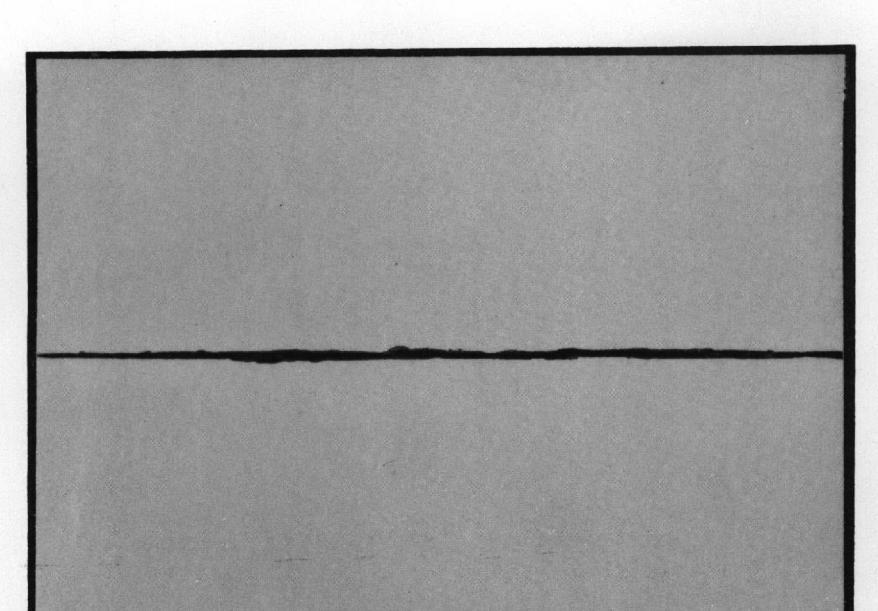
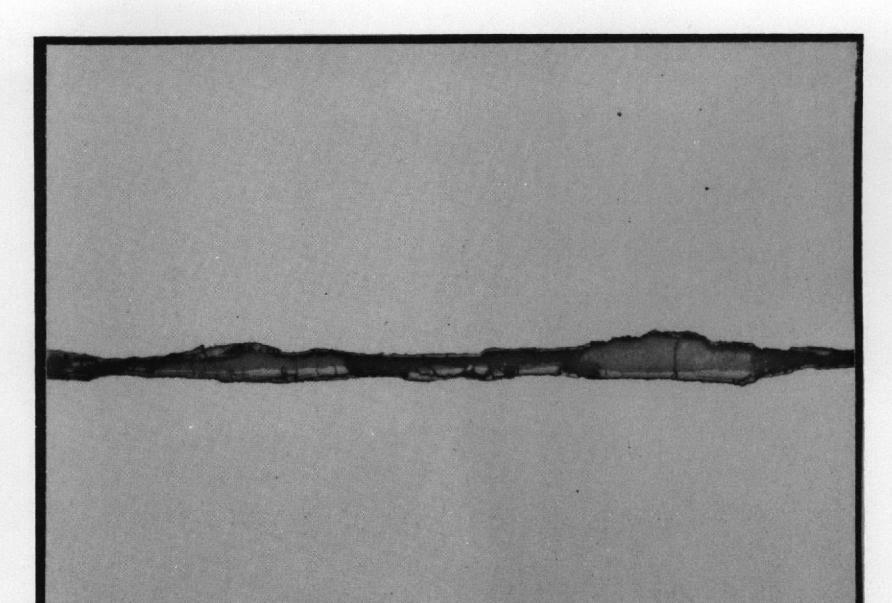
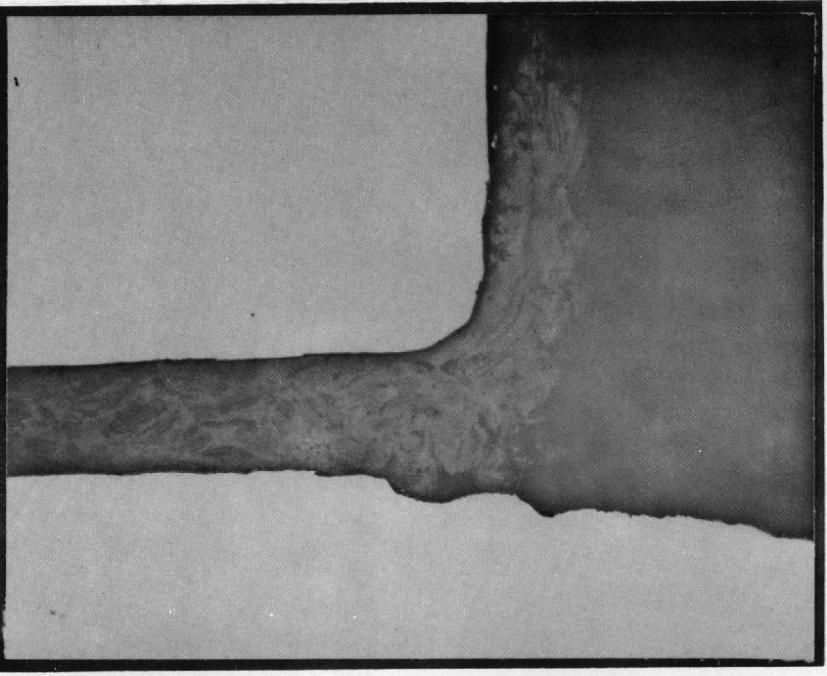
B. Inner crevice wall near center

C. Inner crevice wall near closed edge of VEE

FIGURE 41. Transverse Views of Specimen 5 Photographed after Wet-Polishing at 250X. Corrosion of inner surfaces of the VEE-shaped crevice is more drastic toward the closed edge.

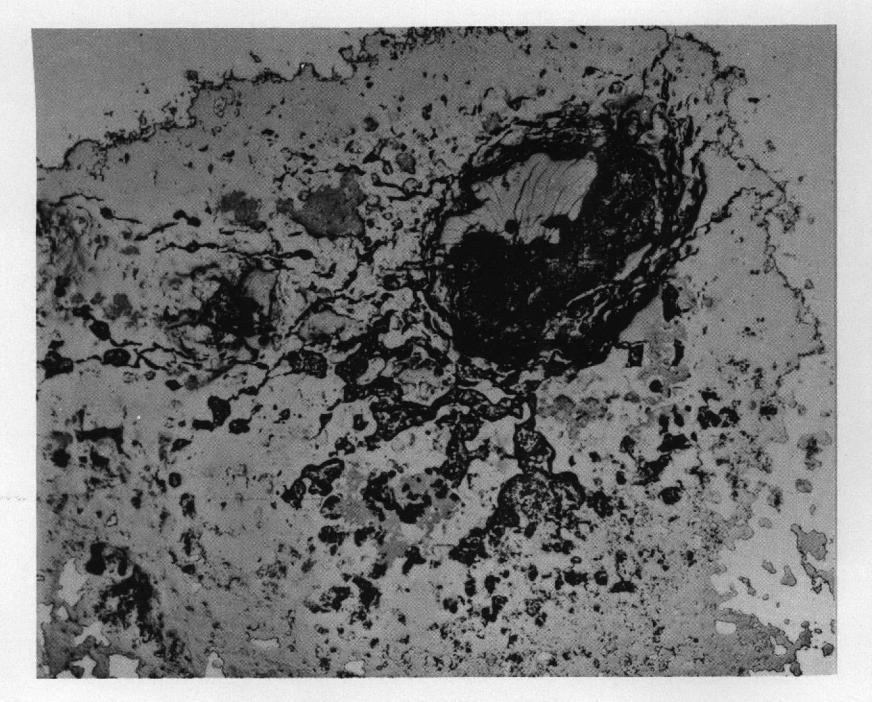
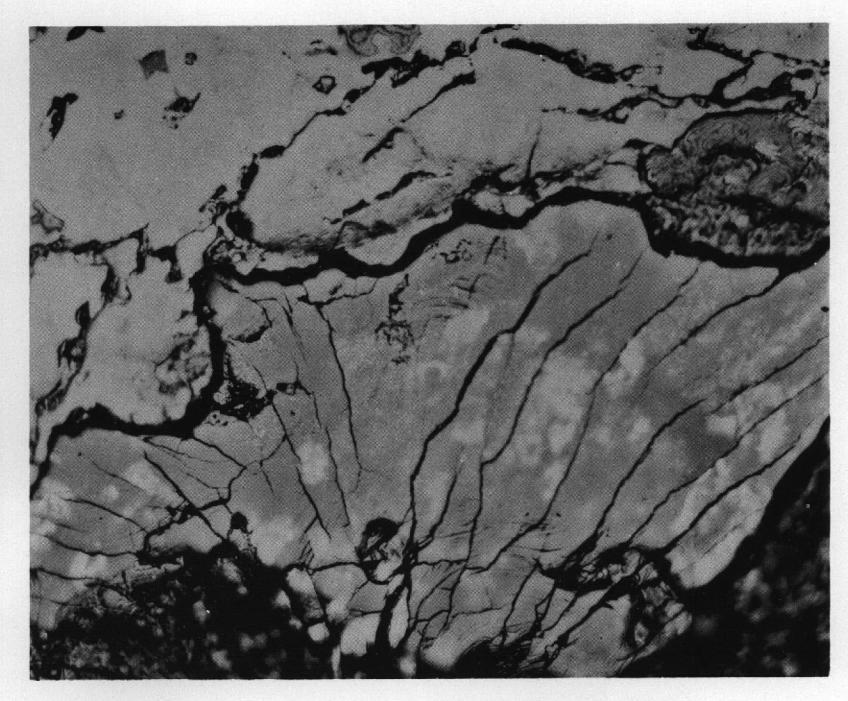
A piece from specimen 2, the Zircaloy-2 crevice specimen tested for 1000 hr in an ammonia environment, was mounted with the inner oxidized face of the crevice wall to be polished. This mount was polished, and a view of an obviously pitted region is shown in Figure 42. Figure 42A, taken at 50X, shows a large pit. Figure 42B is a 250X enlargement of the oxide region within the pit at about 11 o'clock as picture A is oriented. Electron-beam microprobe studies indicate this oxide to be largely ZrO₂.

The depth of the pits shown in Figure 42A was estimated by sectioning the mount in the region shown in Figure 42. Results are shown in Figure 44. View A, at 100 times magnification, shows a fairly wide area (0.04 in.) within the area shown in Figure 42. The depression (pitting) at this point is approximately one mil in depth. View B, at 250 times magnification, shows the thin, broken oxide layer in contact with the metal.

A. View of pit, 50X KS-46261

B. Pit region at 11 0'clock, 250X FIGURE 42. Photographs of Deep Pit in Specimen 2. Unclassified

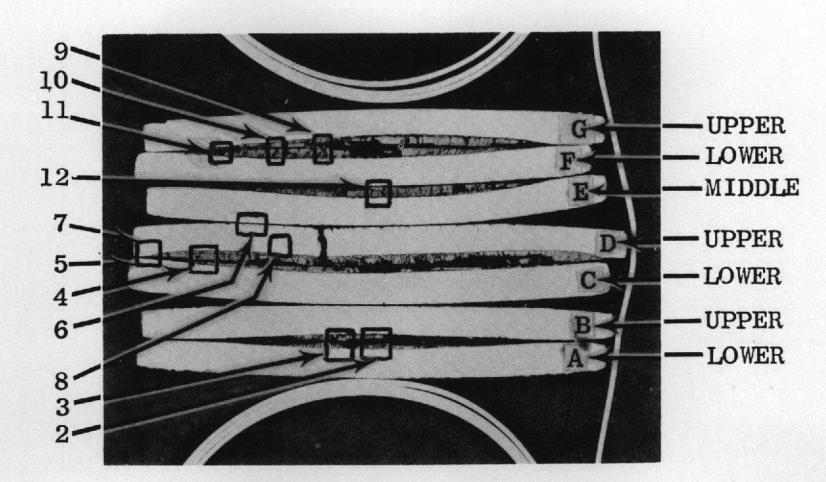
Figure 46 shows a 7X photograph of the mount used to study specimens 14, 15, and 13. The two sections lettered A and B at the bottom of the picture were taken in the vicinity of the bottom and the top, respectively, of specimen 13, the crudded, parallel-walled crevice specimen. (The top of the specimen was exposed to steam, the bottom to water.) Views C and D are, respectively, the same for specimen 14, the Zircaloy-2, VEE-crevice specimen. Views E, F, and G are sections from specimen 15, the Zircaloy-4,

VEE-crevice specimen. Views F and G are bottom and top views, respectively. View E is a mount taken from near the center of the specimen. The numbers in Figure 46 designated locations of correspondingly designated photomicrographs in the ensuing figures.

A second look at Figure 46 shows that all of the transverse sections of the specimens from the lithiated-water test are bowed. The convexity can be explained by the assumption that the surfaces of the test pieces had been under compressional stress at the conclusion of fabrication. When the inner surfaces had been eaten away by corrosion, an unbalance was produced which caused the bowing. The strain produced may have caused surface cracks to form. Such cracks are shown in the 250X picture of Figure 50. This area is located at the outer edge of specimen 14 and is indicated by the number 6 in Figure 46.

FIGURE 46. 7X Photograph of Mount Containing Key to Location for Micrographs of Specimens 14, 15, and 13.

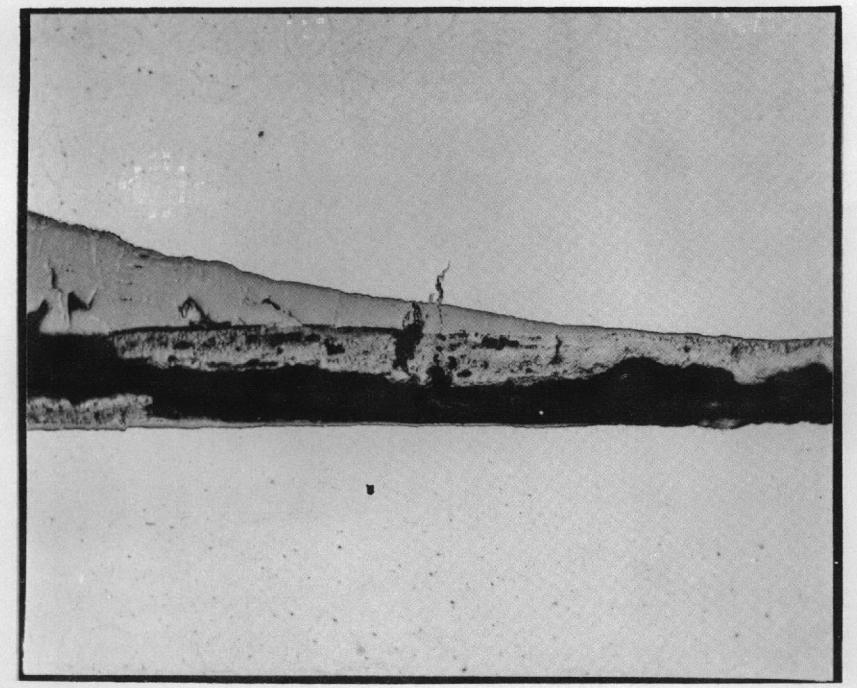
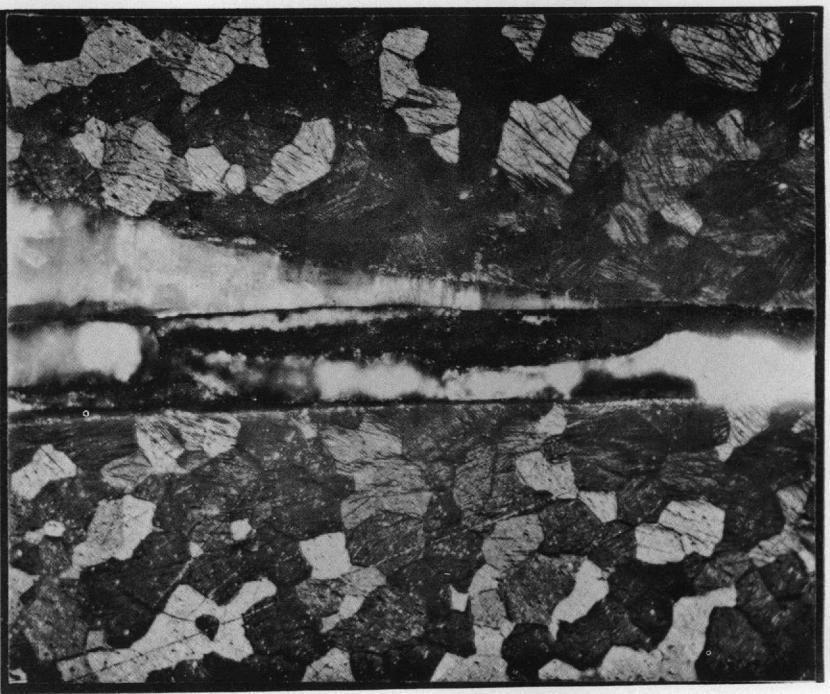
Figure 47 shows two pictures at 250X magnification of a region marked with the numbers 5 and 7 in Figure 46. These pictures are of a region of specimen 14. View A uses normal illumination; view B is taken with polarized light. Two types of oxide appear to be present in these photographs a thin, outer layer that may be a partial covering of alumina, and the thick, general-coverage oxide that has been determined to be ZrO_2 .

FIGURE 47. Photographs at 250X of a Region Near the Outer Edge of Specimen 14 (Regions 5 and 7, Figure 46).

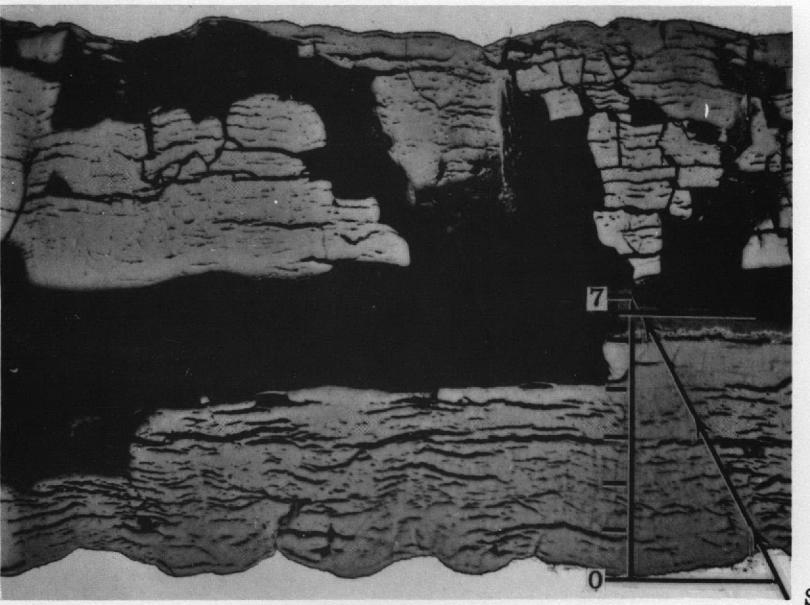
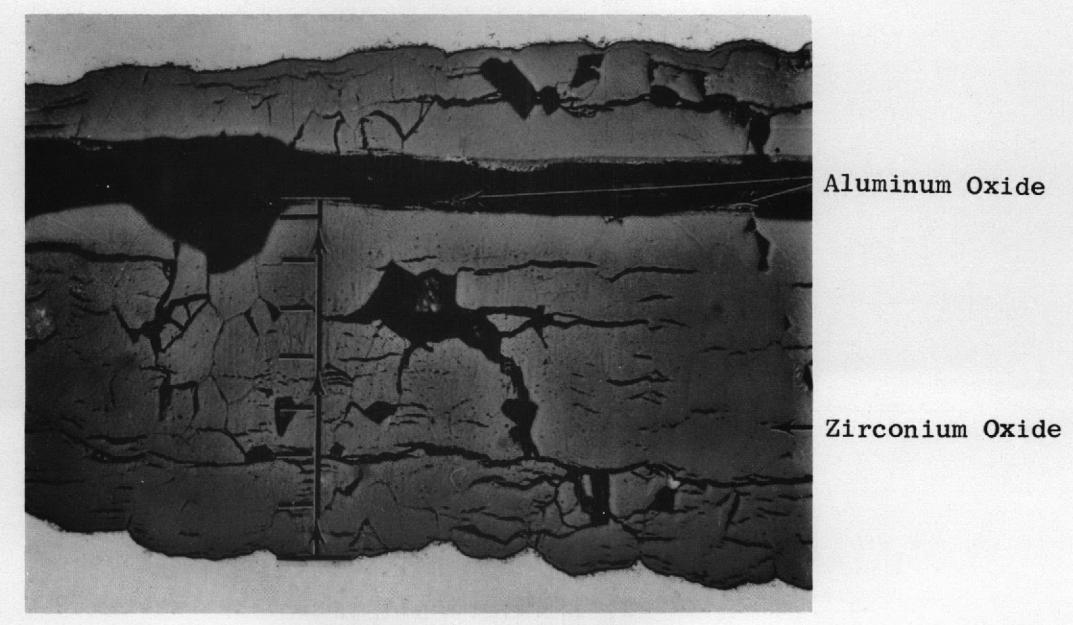
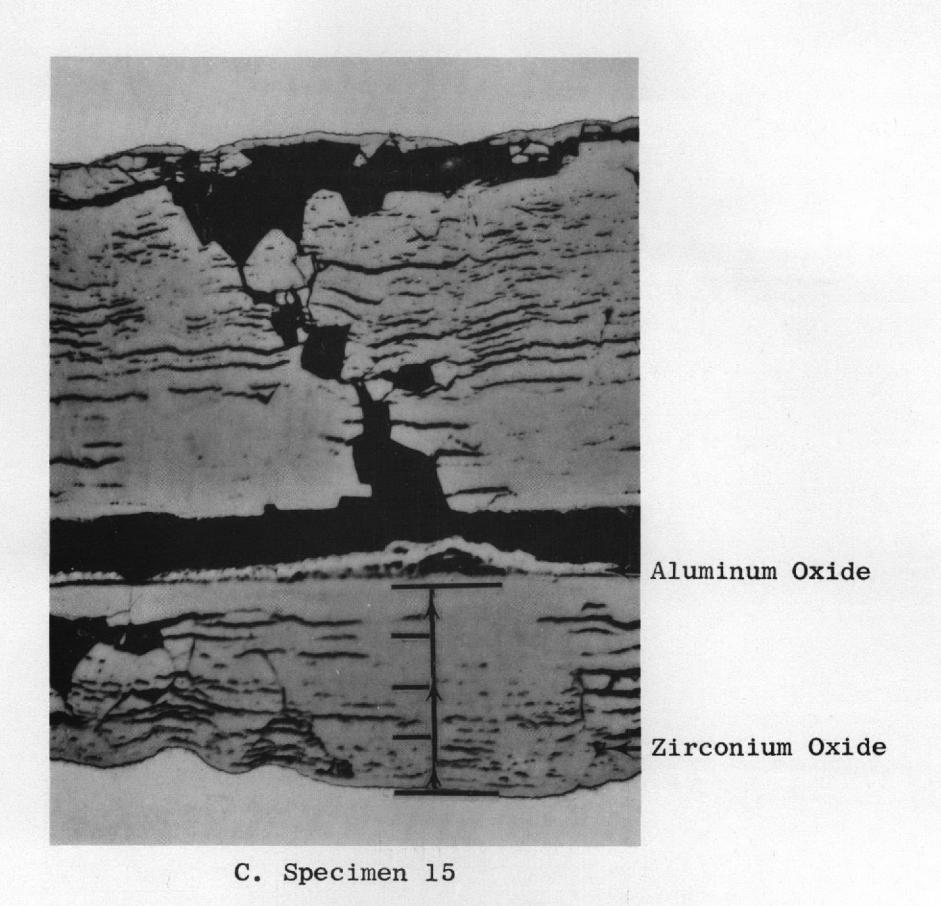
Figure 56 localizes the lines surveyed in these profile scans. Picture A of Figure 56 shows a 250X magnification of region 3, which is a portion of specimen 13. Picture B in the same figure displays the area marked 4 on Figure 46. This picture shows the location and direction of an electron-beam scan across the deep oxide layer found in this region; this layer was deposited on the surface of the lower part of specimen 14 (this was the Zircaloy-2, VEE-crevice specimen). Picture C shows the orientation and location of the electron-beam scan across the oxide layer on the lower portion of specimen 15 (Zircaloy-4, VEE, Region 10, Figure 46).

FIGURE 56. Photomicrographs Locating Electron-Beam Microprobe Scans on Specimens 14, 15, and 13, 250X.

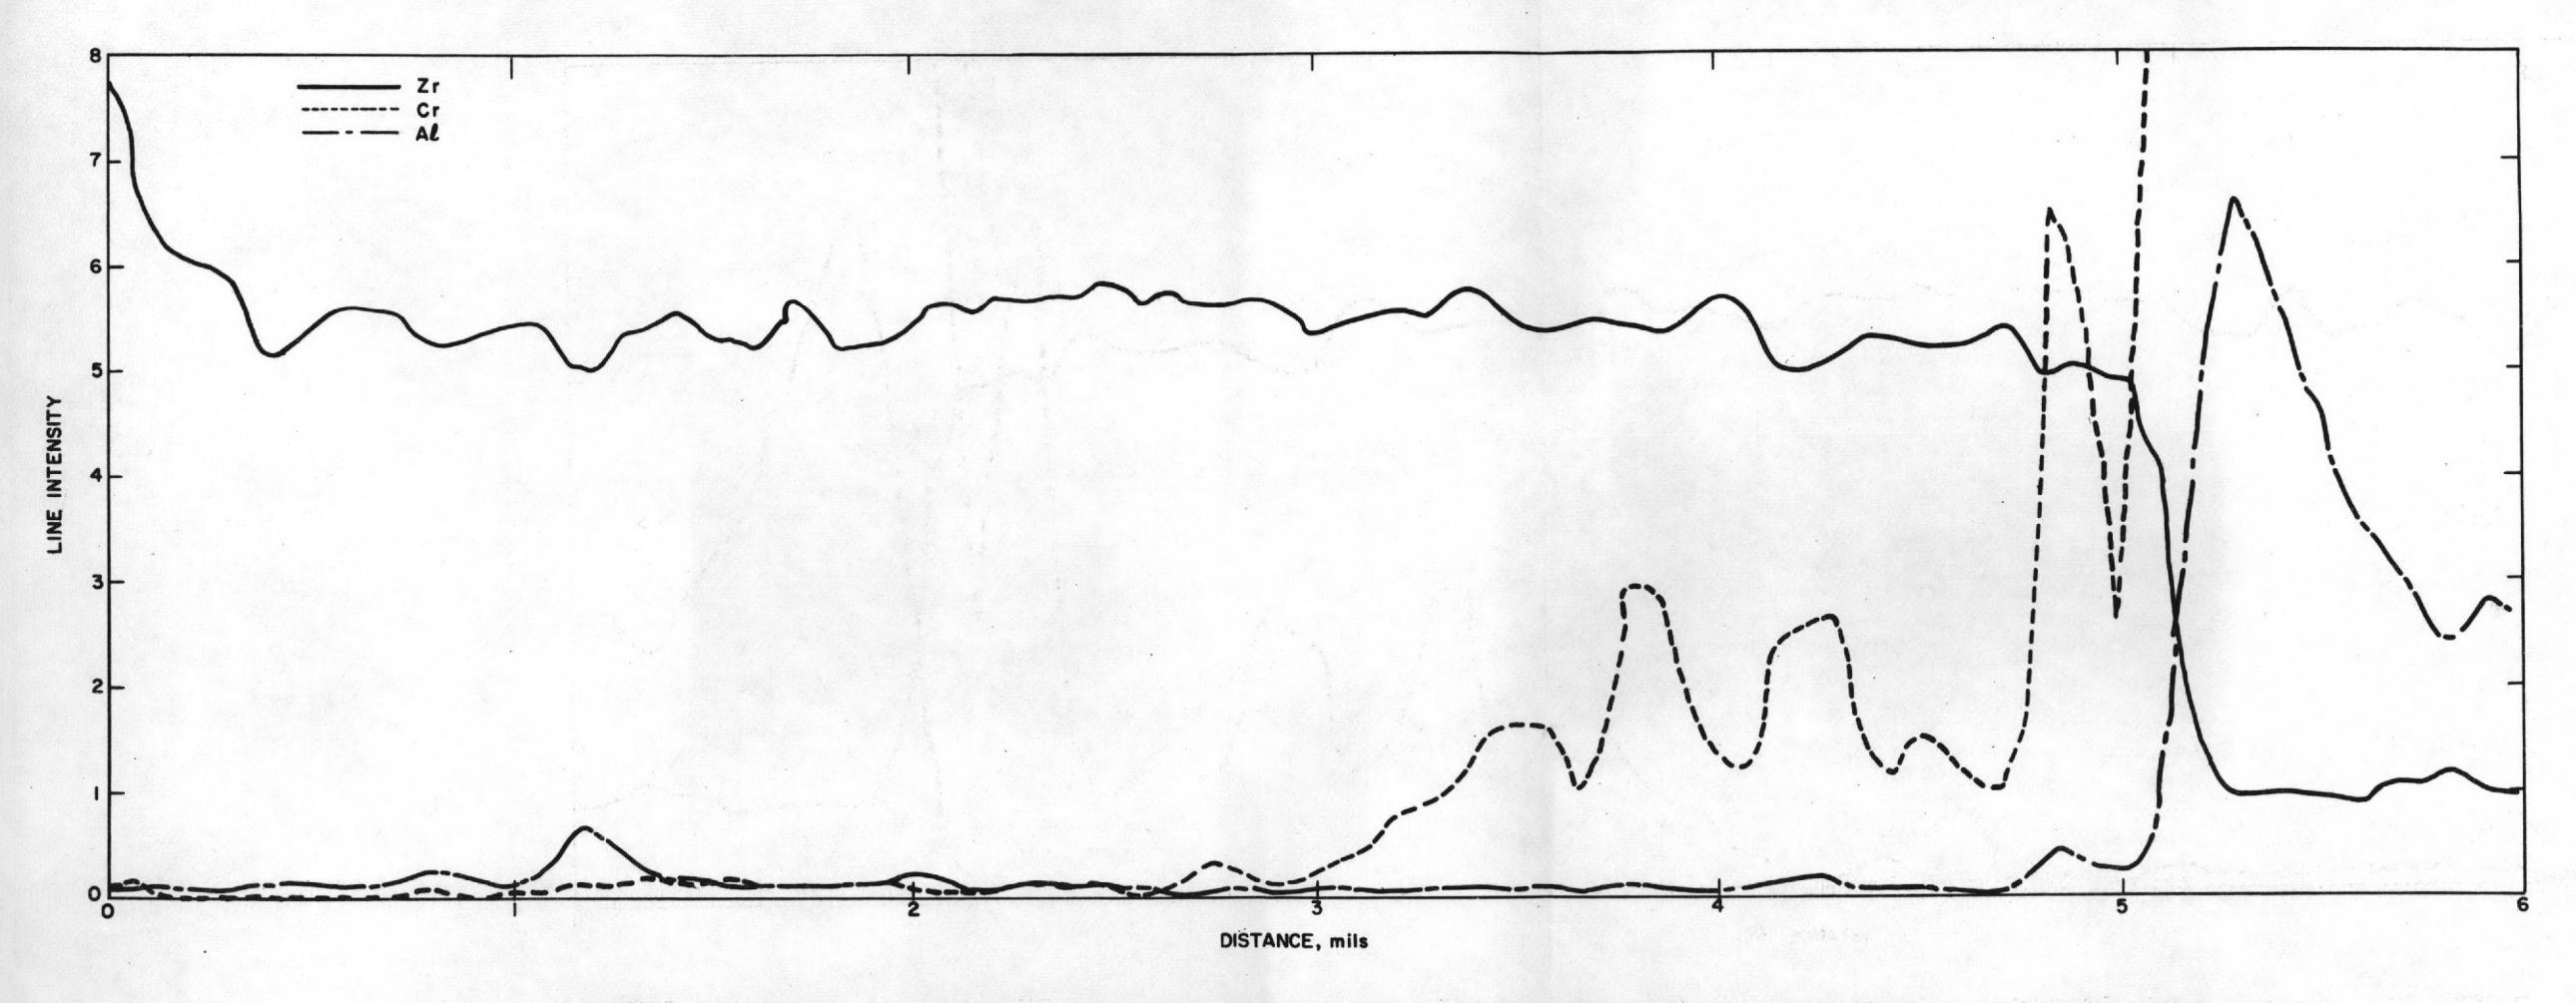
Graphical representation of data from one electron-beam scan, described by Figure 56C on specimen 15, is given in Figure 57. For example, the Y-axis of the grid superimposed on Figure 56C shows that the major metallic component in the first 4.5 mils of oxide above the metal is zirconium; hence this portion of the oxide is ZrO_2 . From 4.5 mils on this grid to 5.5 mils, the material has aluminum and chromium as its major metallic components and is therefore undoubtedly Al_2O_3 , contaminated by crud from the stainless steel loop.

FIGURE 57. Sketch of Recorder Trace for Electron-Beam Microprobe Analysis for Specimen 15, Figure 56C. KS-46274 Unclassified
