WT-1194

Operation **TEAPOT**

DAMAGE TO CONVENTIONAL AND SPECIAL TYPES OF
RESIDENCES EXPOSED TO NUCLEAR EFFECTS

Report to the Test Director

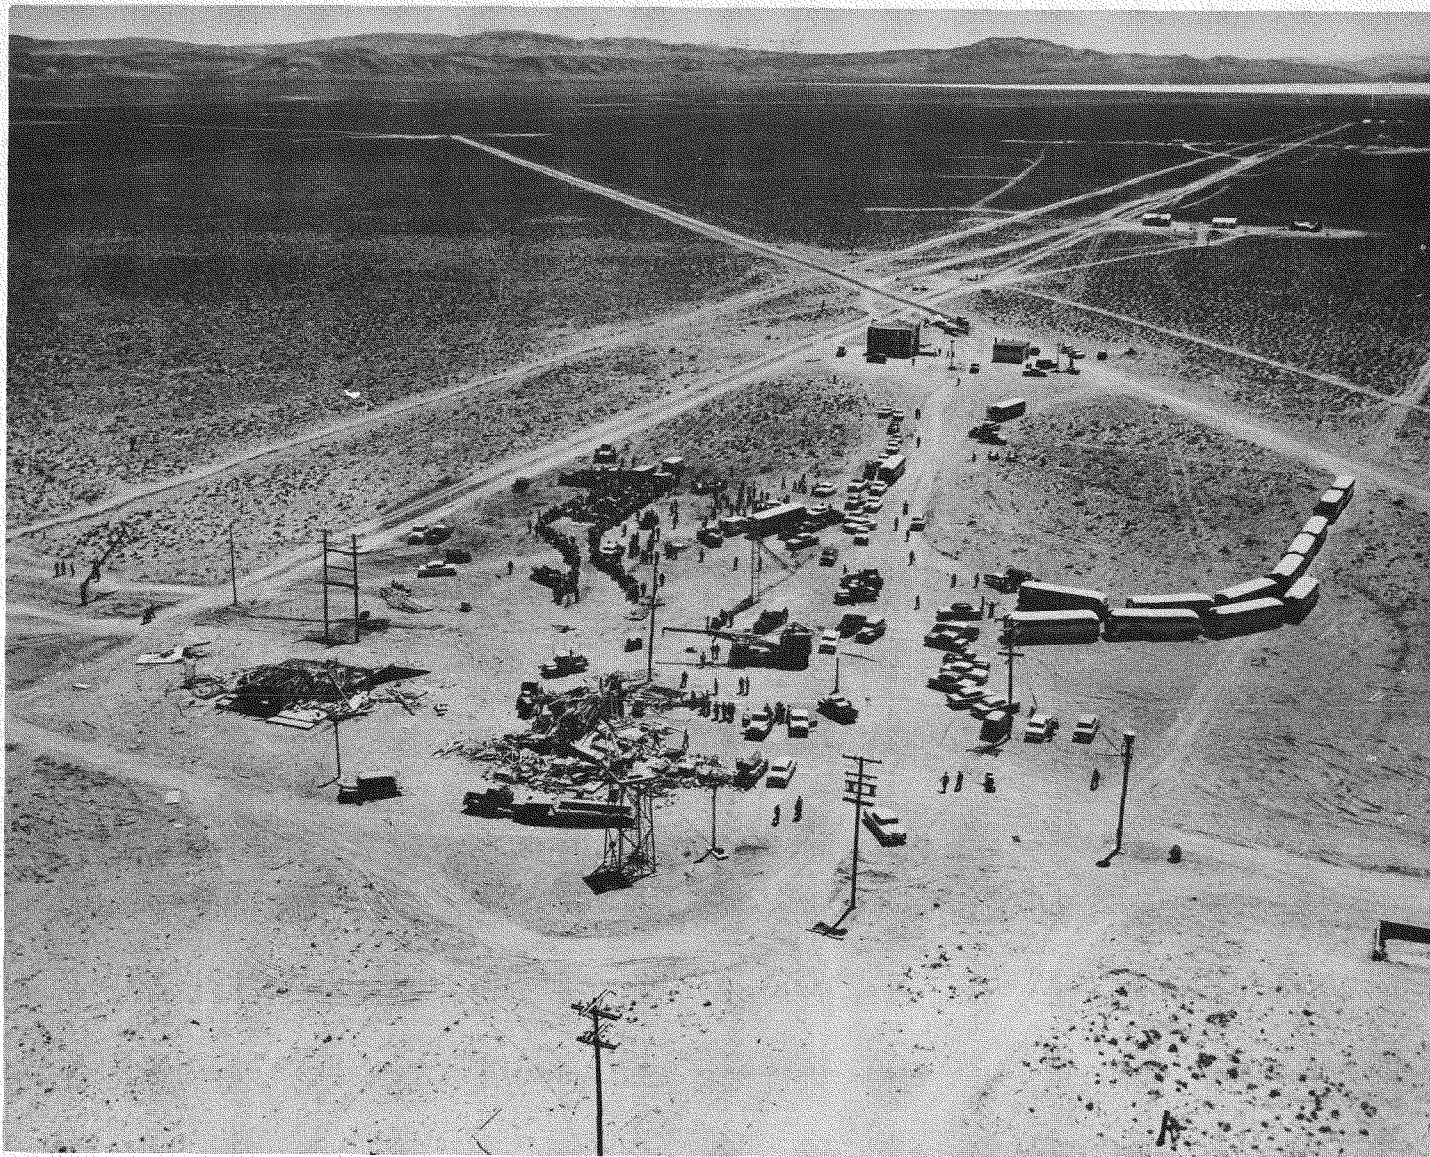
Fig. 3.1—Main FCDA test line, postshot, looking from GZ.

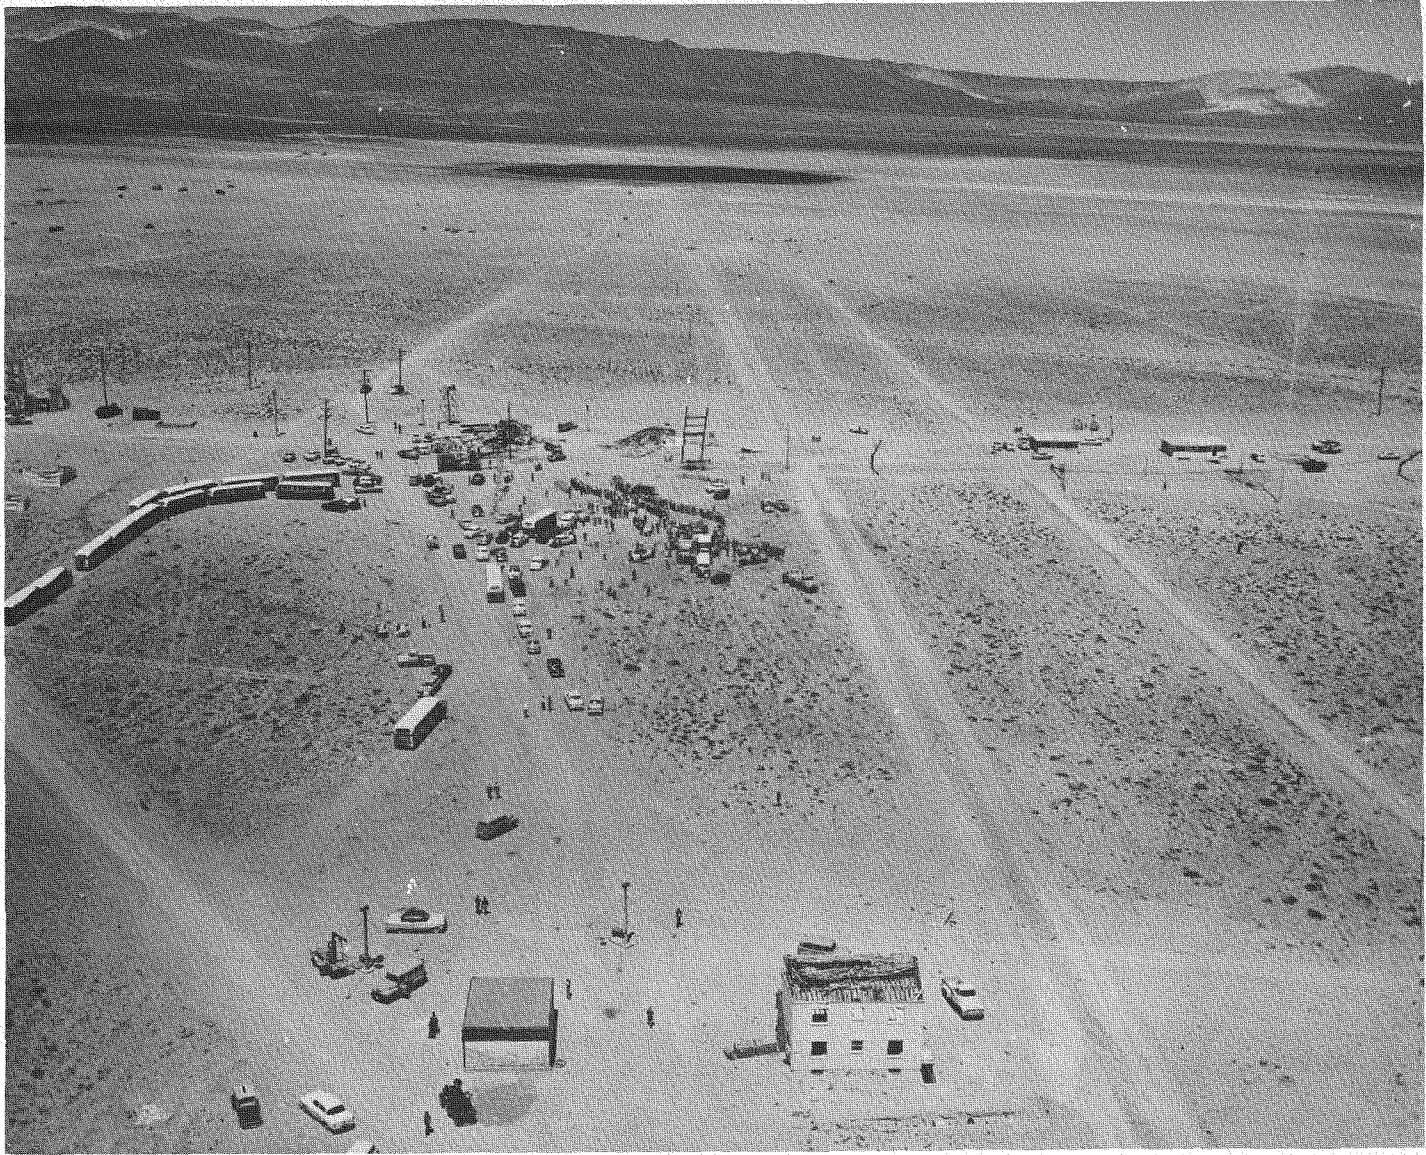
Fig. 3.2—Main FCDA test line, postshot, looking from middle distance toward GZ.

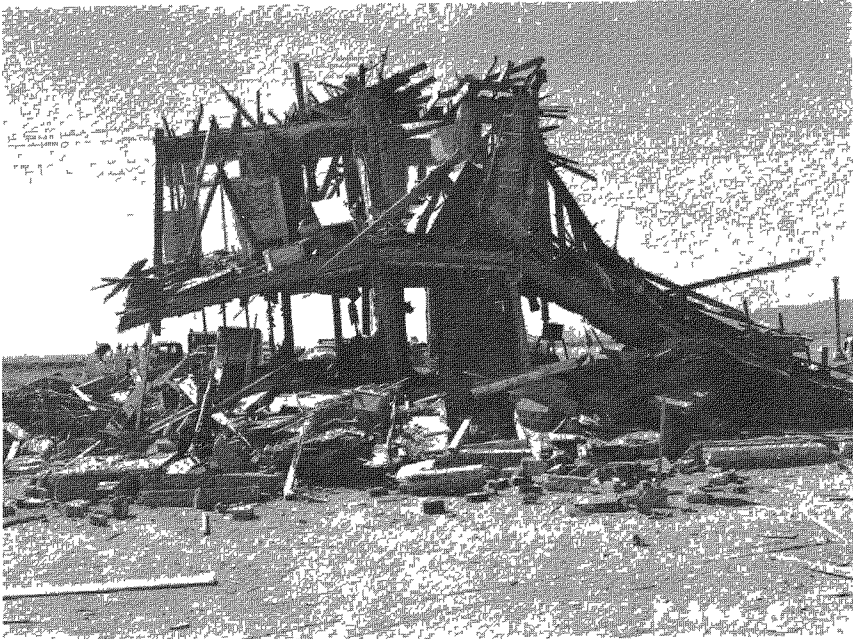
The aboveground portion of the house was demolished beyond repair (Fig. 3.3). The exterior brick and cinder-block walls had exploded outward into the yard around the house, very little masonry debris falling on the floor framing. The chimney fell to the side of the house and lay on the ground broken into large sections. The roof was demolished and blown off, the rear side of the roof being lifted off and deposited on the ground on the far side of the house about 50 ft to the rear. Some of the bearing partitions, those around the staircase and first-floor hall and those on the second floor, remained standing but were badly racked. The stair from first to second floor remained standing. The second floor partially collapsed on the first

Fig. 3.3—Two-story brick house (31.1-a1) at 4700 ft, postshot.

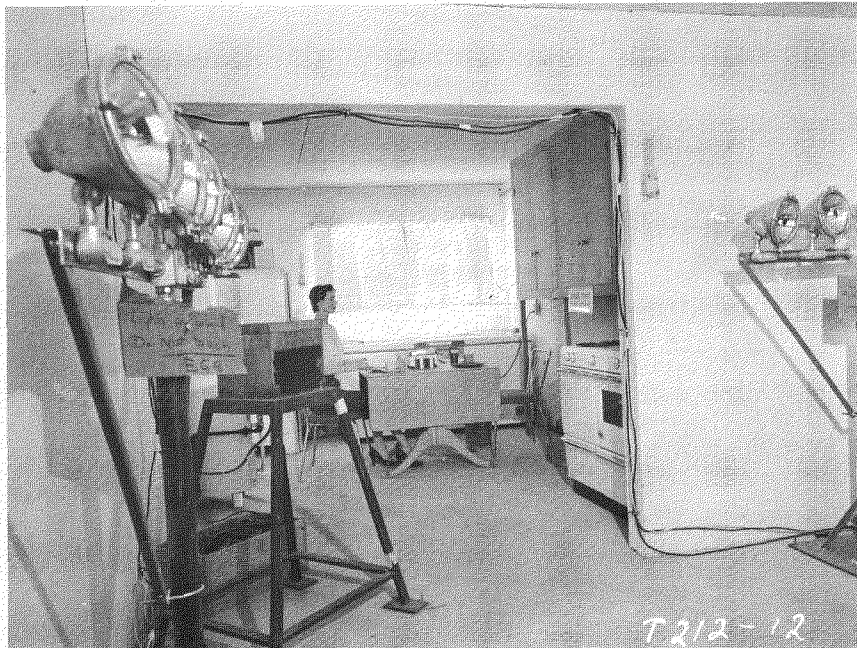
Fig. 3.14—One-story precast lightweight concrete house (31.1-e1) at 4700 ft, preshot. Interior view looking toward the kitchen in rear.

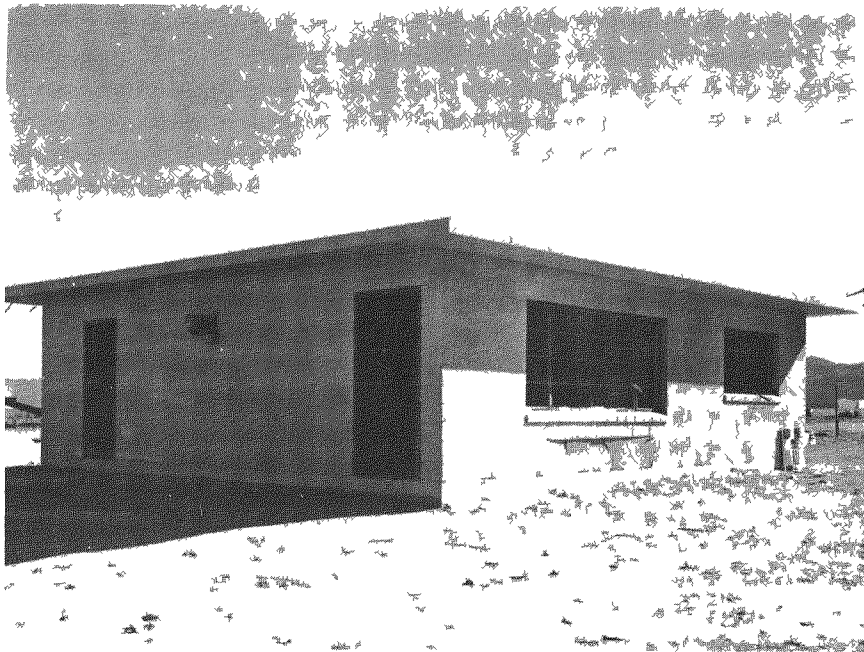
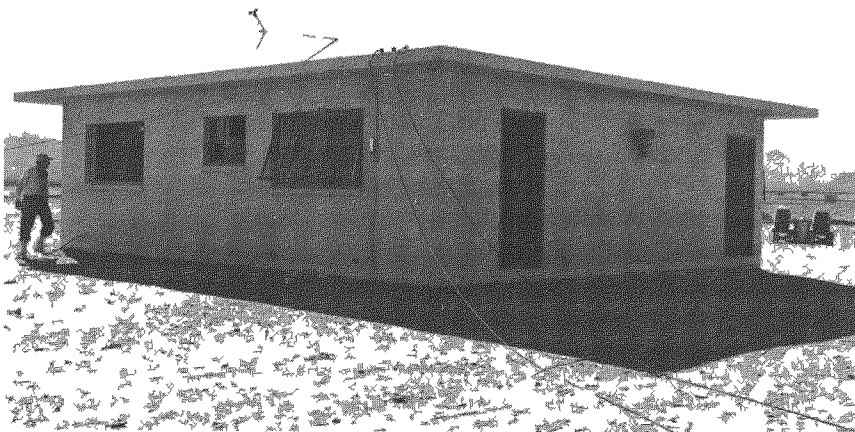
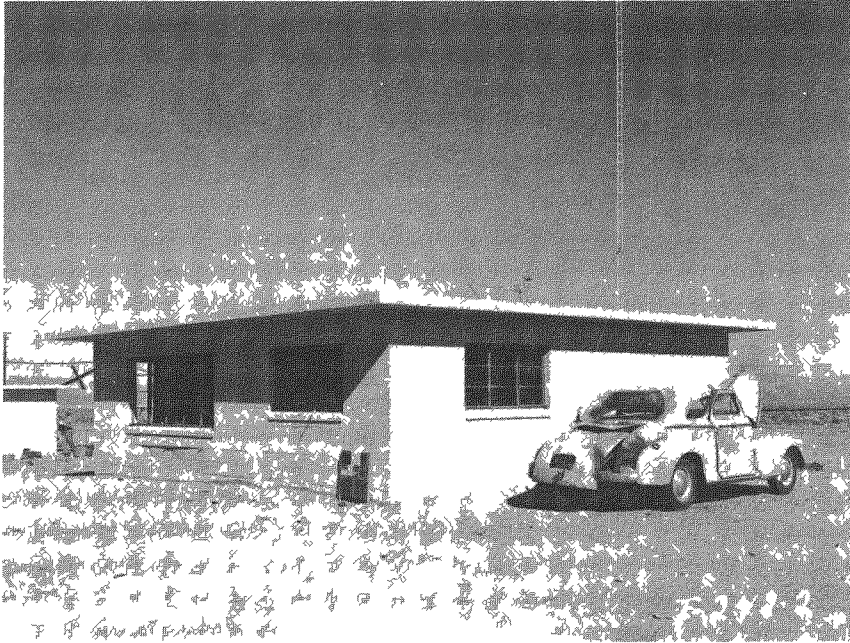
The building withstood the blast with only minor structural damage. Replacement of doors and windows would make this house available for occupancy. (See Figs. 3.17 to 3.20.)

Fig. 3.17—One-story reinforced lightweight concrete-block house (31.1-f1) at 4700 ft, postshot.

Fig. 3.18—One-story reinforced lightweight concrete-block house (31.1-f1) at 4700 ft, postshot.

Fig. 3.19 — One-story reinforced lightweight concrete-block house (31.1-f1) at 4700 ft, postshot.

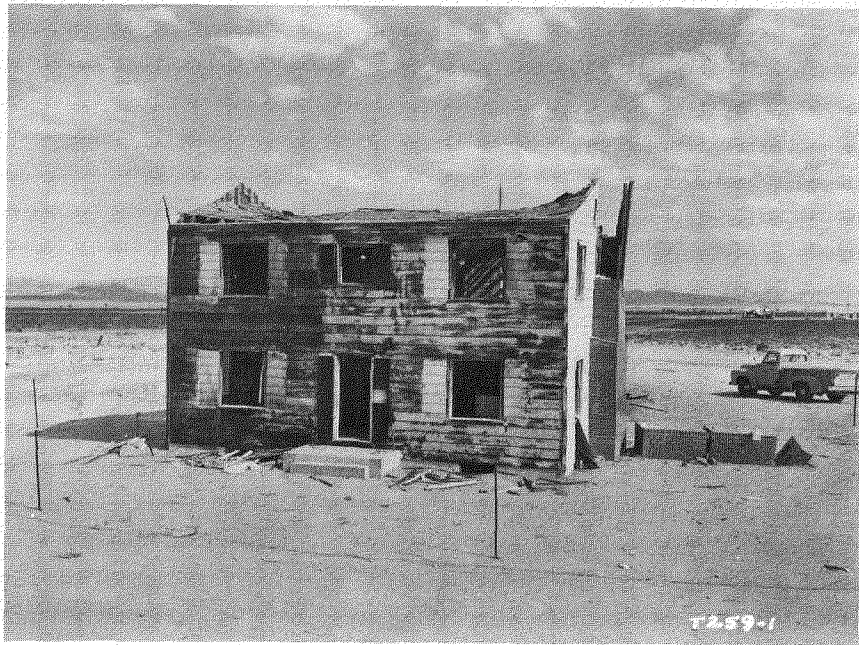
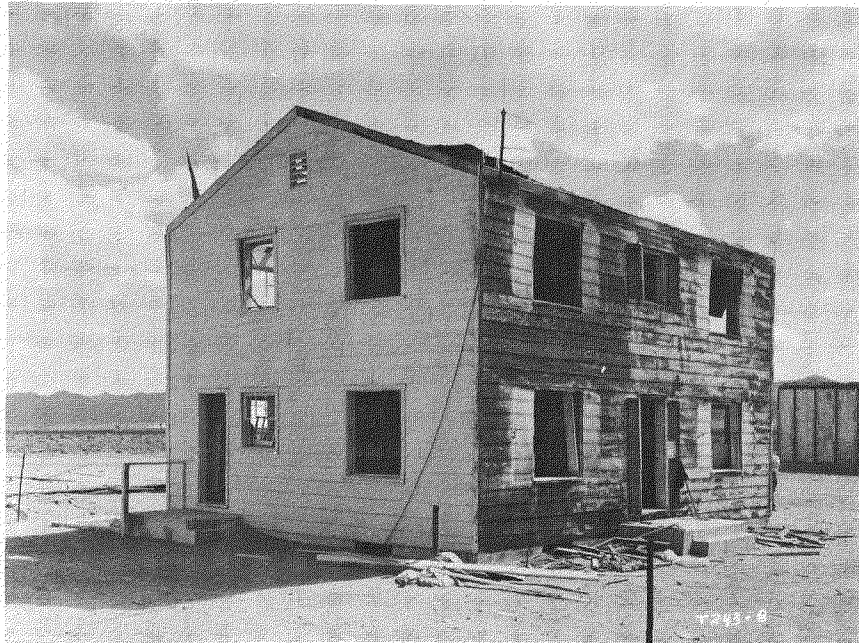
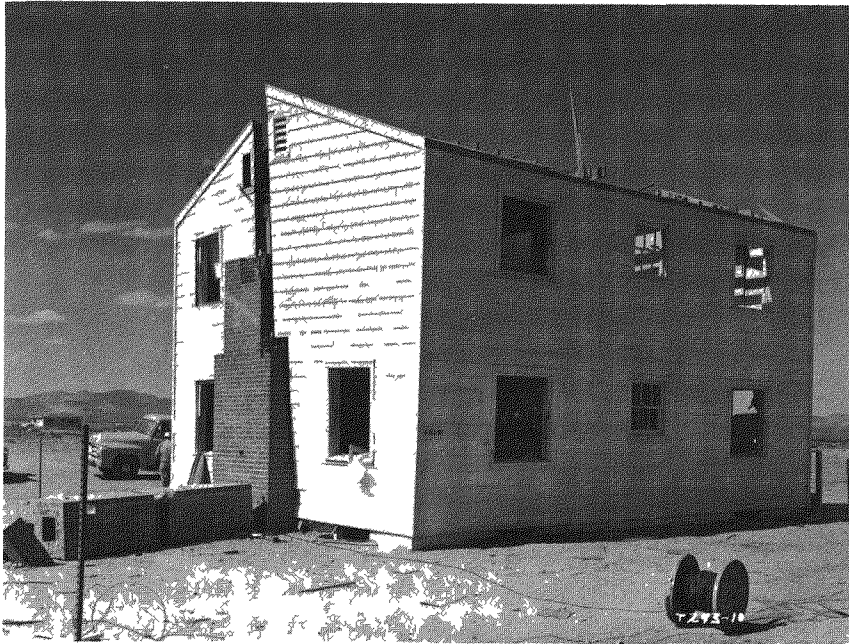
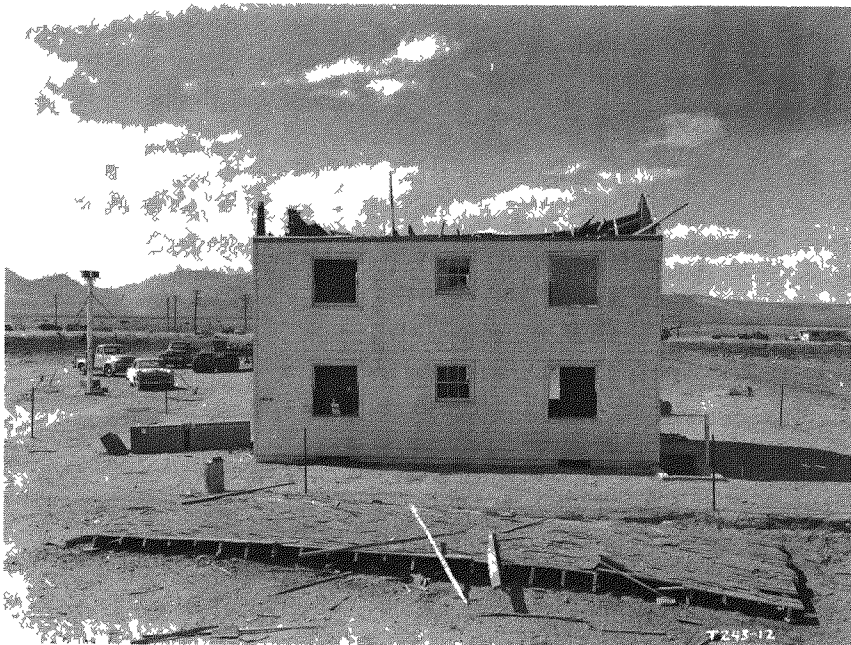
The superstructure of the house suffered severe damage; the house would not be suitable for occupancy without extensive and economically inadvisable major repairs. (See Figs. 3.21 to 3.31.) Certain of the redesigned features appeared to perform their function well, particularly the reinforced-concrete foundation wall, the shear walls supporting the main girders in lieu of pipe columns, the improved connections between the frame walls and concrete foundation walls, and, except on the front of the house, the improved window-frame anchorage. The strengthened superstructure, however, was still inadequate to resist the overpressure of approximately 4 psi to which it was subjected.

Fig. 3.21 — Two-story frame (strengthened) house (31.1-b1) at 5500 ft, postshot.

Fig. 3.22 — Two-story frame (strengthened) house (31.1-b1) at 5500 ft, postshot.

Fig. 3.23 —Two-story frame (strengthened) house (31.1-b1) at 5500 ft, postshot.

Fig. 3.24 —Two-story frame (strengthened) house (31.1-b1) at 5500 ft, postshot.

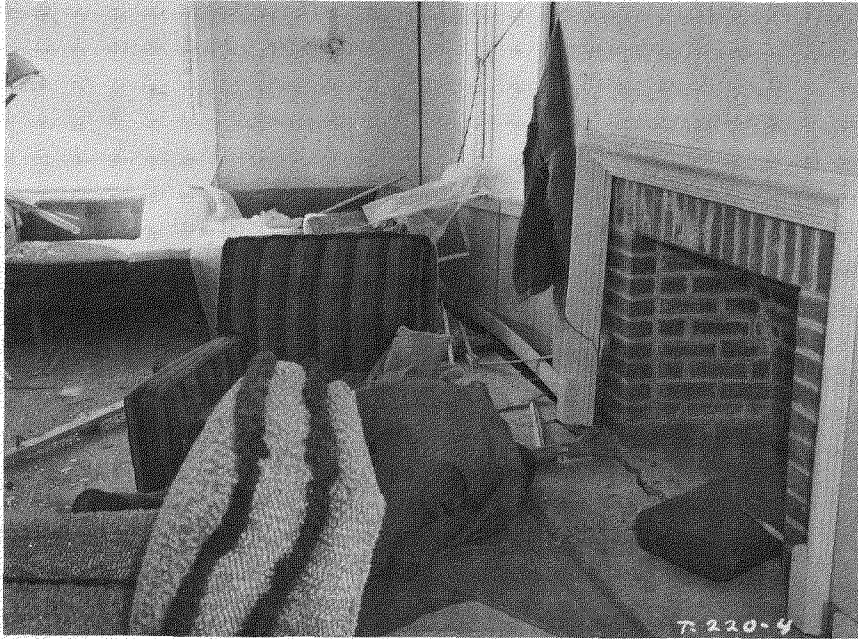
Fig. 3.25—Looking toward rear of living room in the two-story frame house (31.1-b1) at 5500 ft, postshot. The exterior wall to rear of chimney bulged several inches and pulled away from floor framing. Note split hearth.

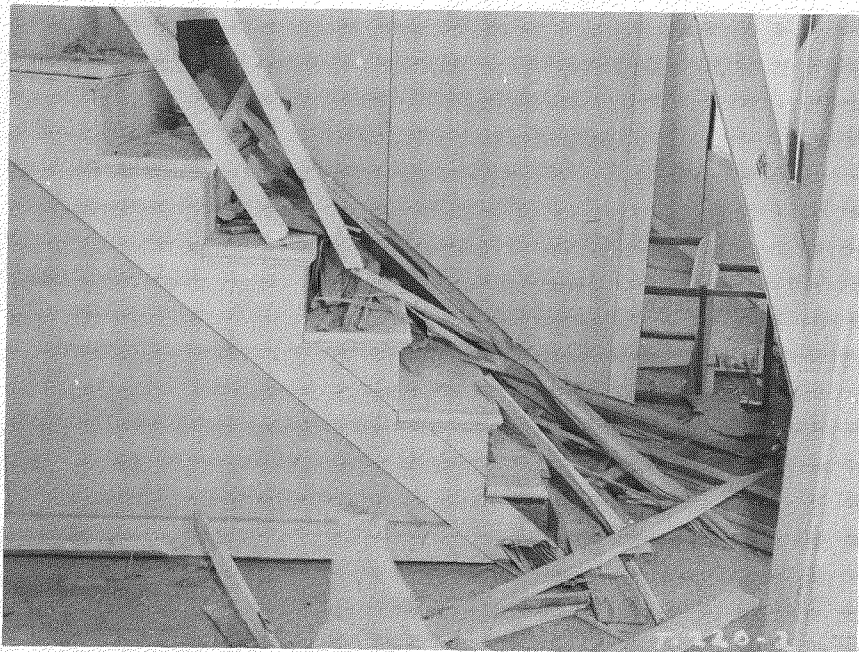
Fig. 3.28—Stair to second floor of the two-story frame house (31.1-b1) at 5500 ft, postshot.

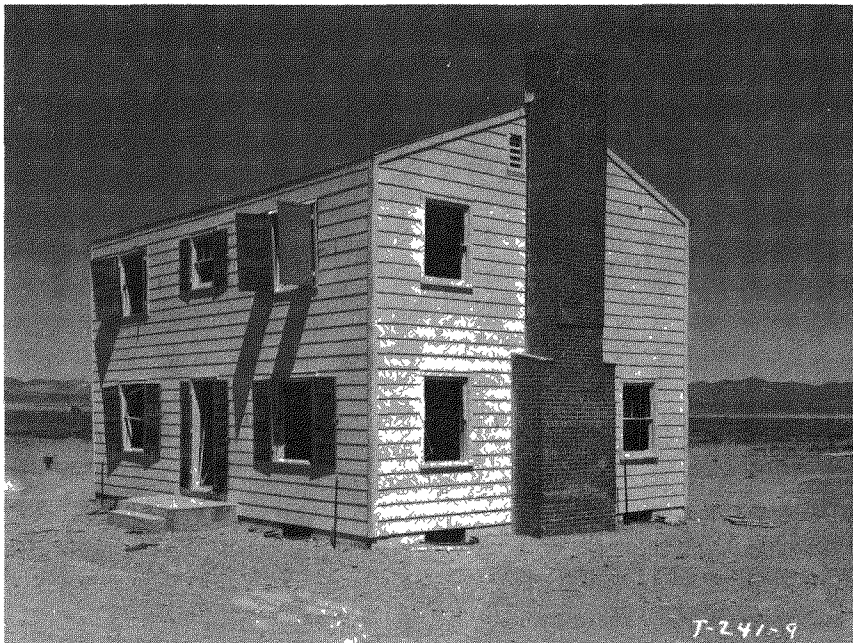
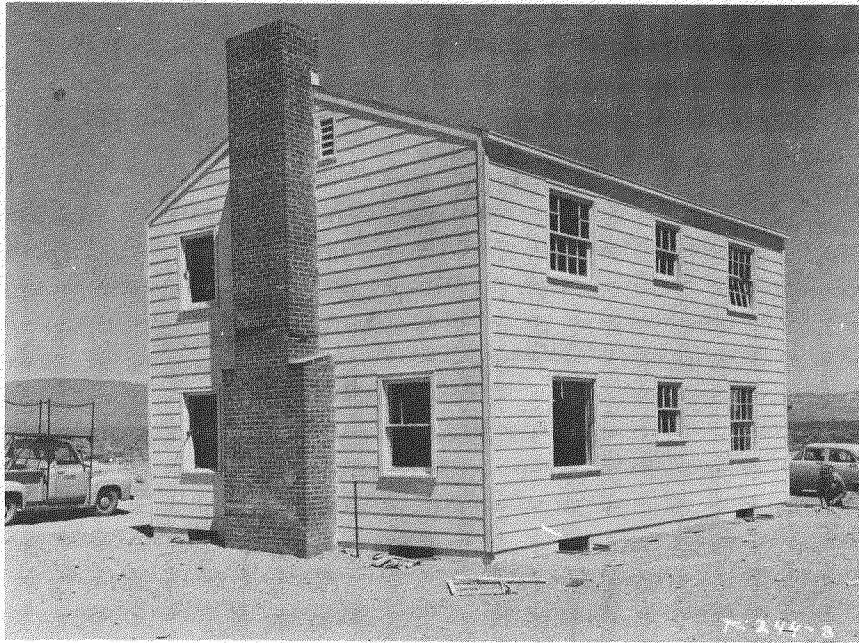
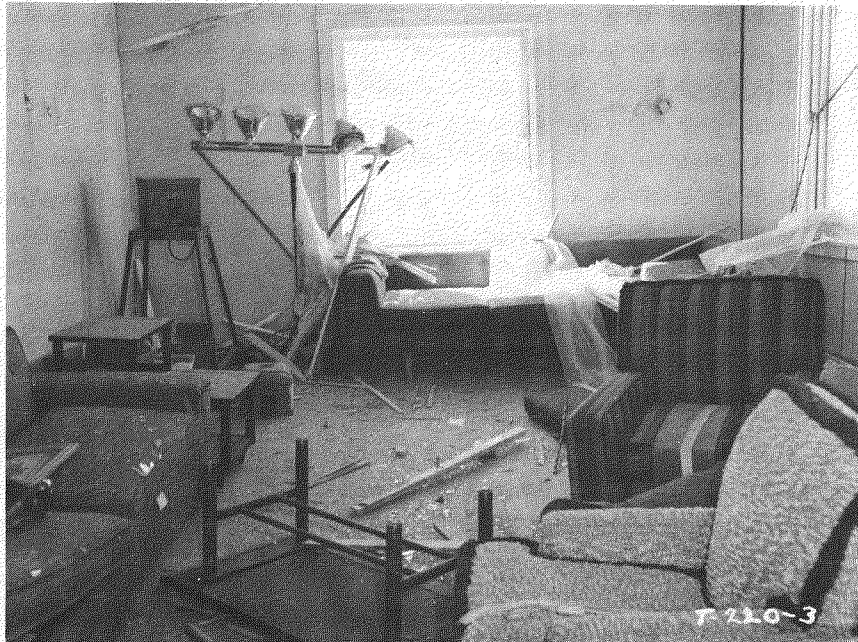
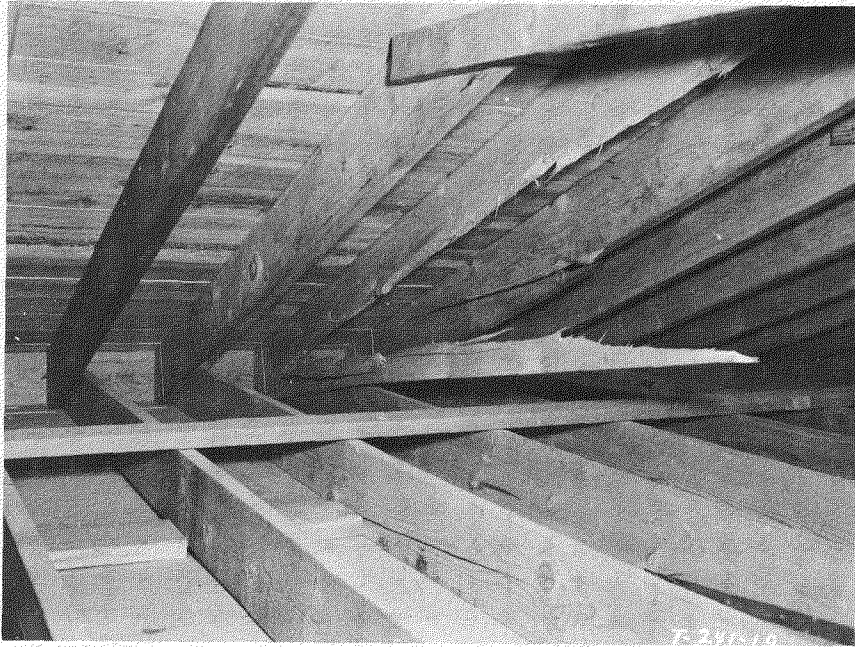
Because of its greater distance from GZ (hence lower overpressure), this dwelling suffered less damage than the dwelling located at 5500 ft (Figs. 3.32 to 3.41). Although the roof was not blown off, it was severely damaged. A number of the roof rafters on both sides of the ridge member were split and the 1 by 12 in. ridge member was badly split. The roof sheathing and most of the asphalt-strip shingles remained intact, although, when the front gutter was blown off (its broken sections being deposited 100 to 150 ft to the rear of the house), it peeled off shingles a foot or two back from the eave and shingles were peeled off a foot or more at the rear side of the ridge of the roof. The gutter and shingles on the rear half of the roof remained intact. The ceiling joist suffered only minor damage, but the ceiling framing was lifted about 6 in. from its attachment to the bearing partition dividing the front and rear bedrooms. The center girder over the master bedroom ceiling was lifted 2 in. out of its supporting stirrups and was pulled away from the ceiling joists. The nails fastening the strap-iron joist ties over the center girder were sheared off on the blast side of the house at some joists.

Fig. 3.32—Two-story frame (strengthened) house (31.1-b2) at 7800 ft, postshot.

Fig. 3.33—Two-story frame (strengthened) house (31.1-b2) at 7800 ft, postshot.

Fig. 3.34—Living room of the two-story frame house (31.1-b2) at 7800 ft, postshot.

Fig. 3.35 — Attic framing in the two-story frame house (31.1-b2) at 7800 ft, postshot.

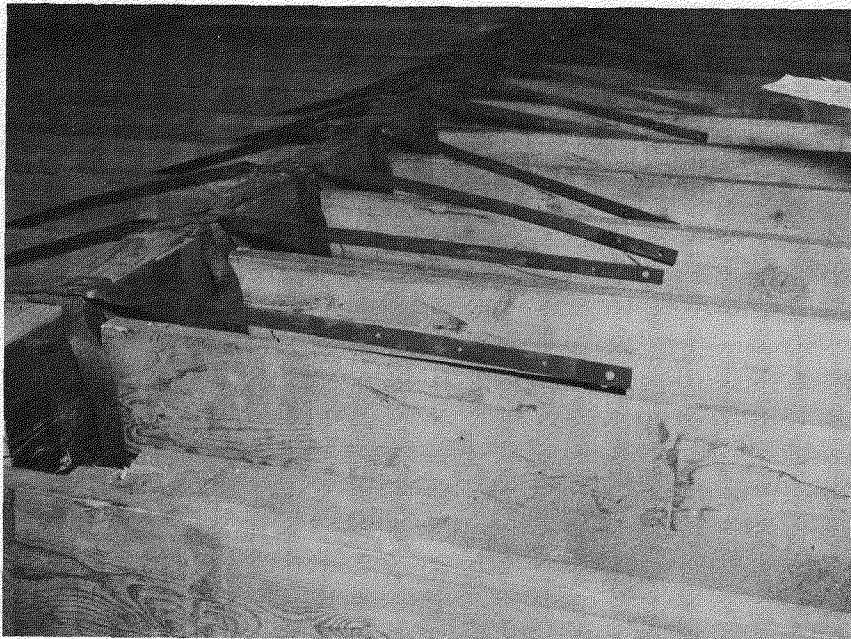
Fig. 3.36 — Strap iron joist ties over the center girder over the master bedroom in the two-story frame (strengthened) house (31.1-b2) at 7800 ft, postshot.

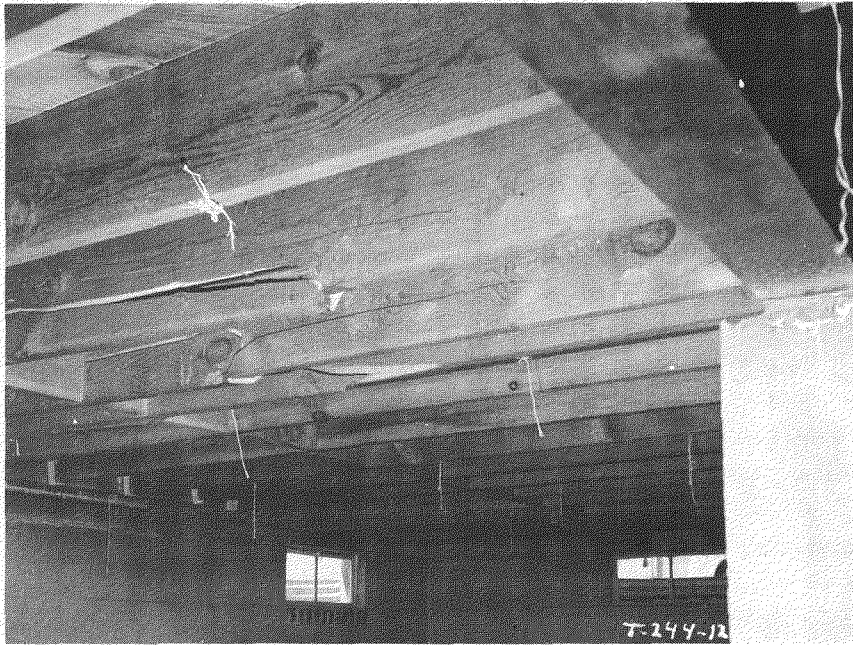
Fig. 3.39—First-floor framing in the two-story frame house (31.1-b2) at 7800 ft, postshot.

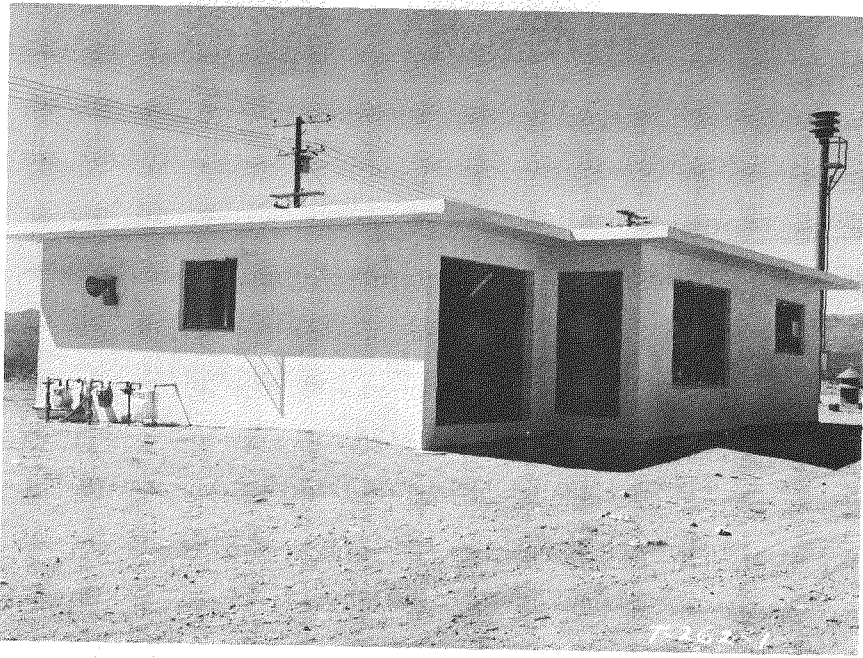
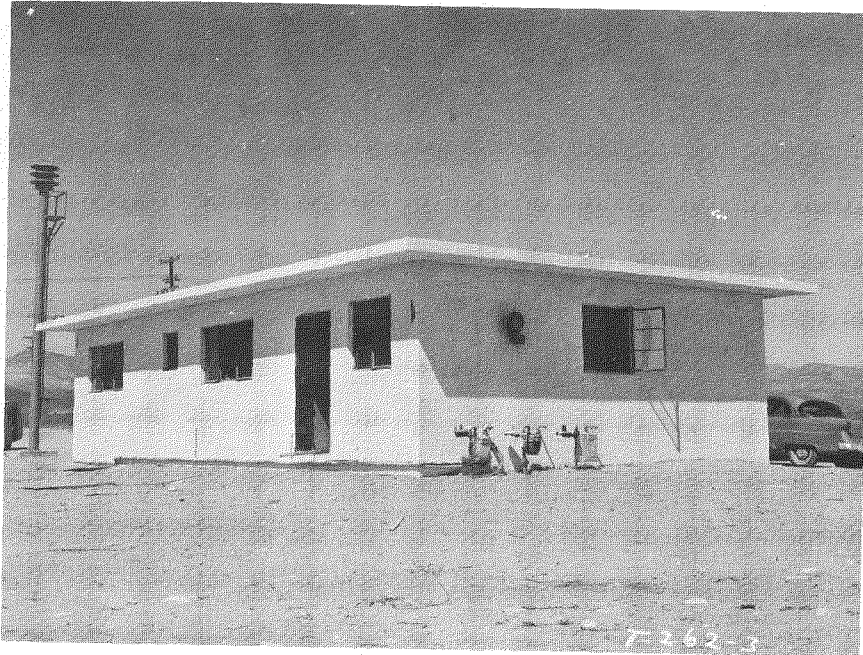
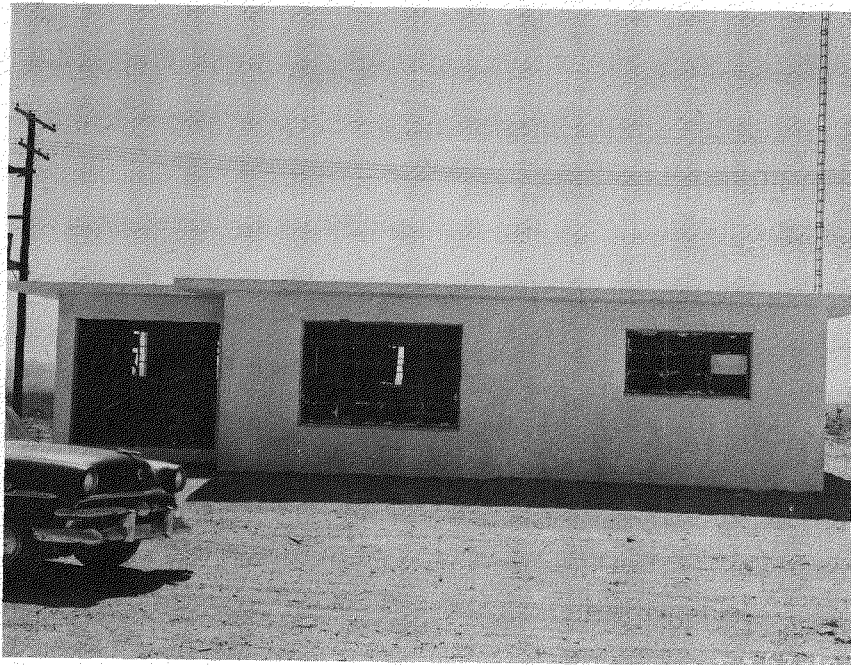
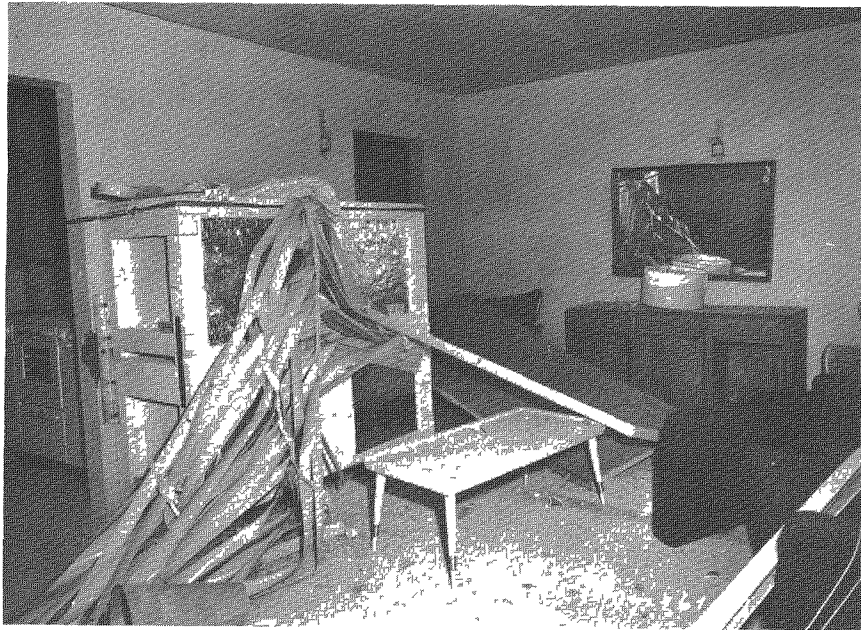
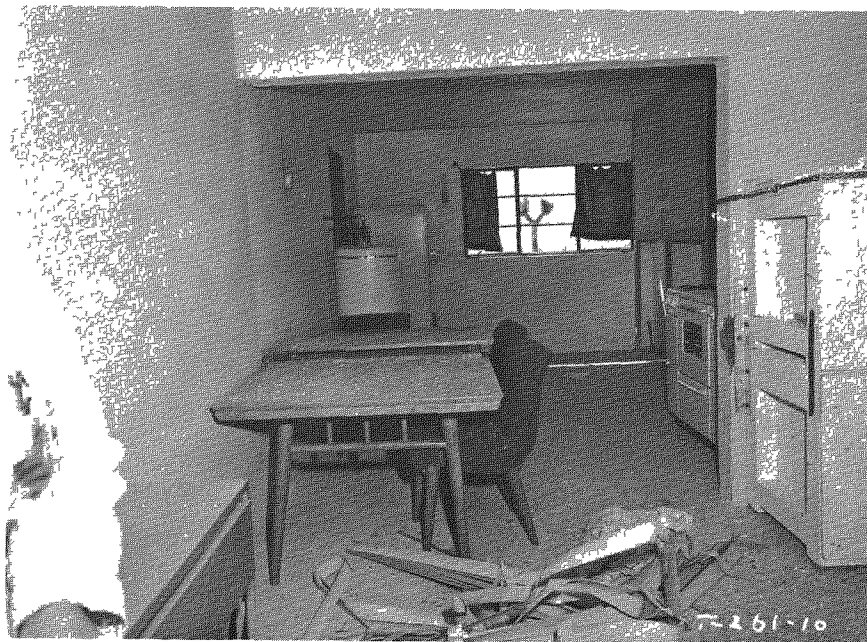
This house was a counterpart of the house described under Sec. 3.3.3. The building structurally withstood the blast in very good condition, and replacement of doors and windows could make it available for occupancy. (See Figs. 3.45 to 3.50.)

Only very minor structural damage was noted; some spalling of the concrete occurred at the lug connections. All glass in the front sash was blown in; some glass was blown out of other windows in side and rear walls; steel window sashes remained in place but were distorted in shape; and the Venetian blinds were blown across the rooms into a mass of rubbish. The exterior doors and the garage door were demolished.

Fig. 3.45 — One-story precast lightweight concrete house (31.1-e2) at 10,500 ft, postshot.

Fig. 3.46 — One-story precast lightweight concrete house (31.1-e2) at 10,500 ft, postshot.

Fig. 3.47—One-story precast lightweight concrete house (31.1-e2) at 10,500 ft, postshot.

Fig. 3.49—Interior of one-story precast lightweight concrete house (31.1-e2) at 10,500 ft, postshot.

Fig. 3.50—Interior of one-story precast lightweight concrete house (31.1-e2) at 10,500 ft, postshot.

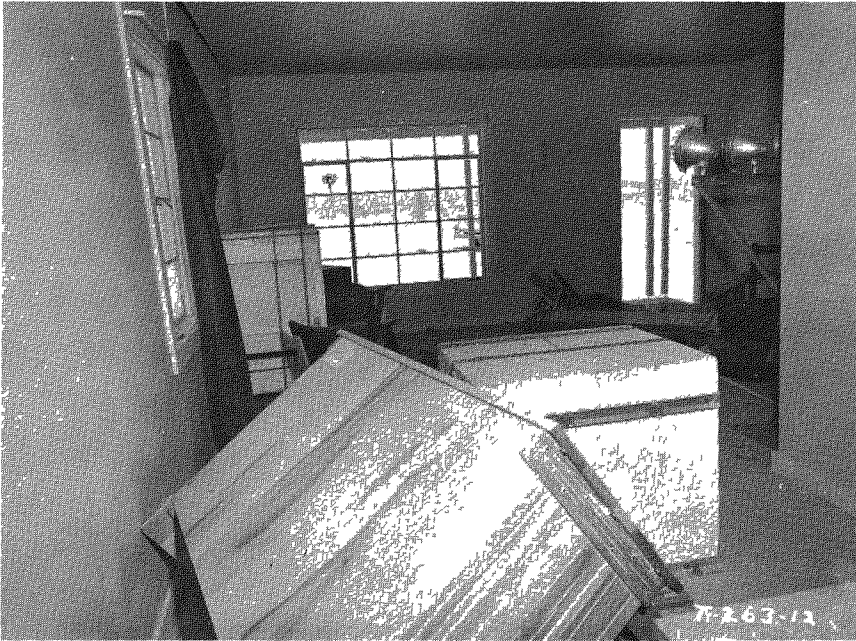
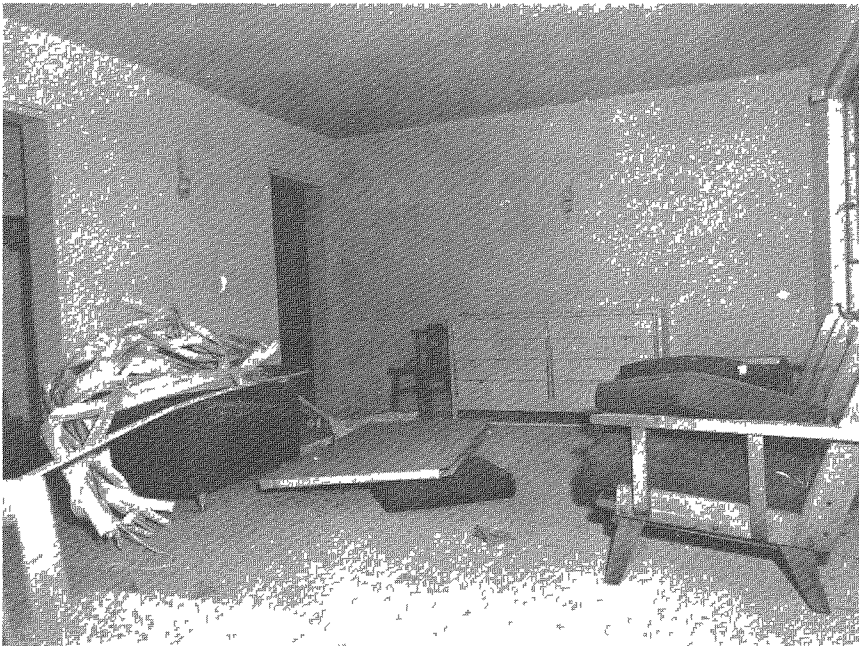
This house was a counterpart of the house described under Sec. 3.3.4. The building structurally withstood the blast in excellent condition, and replacement of the doors and windows could make it available for occupancy. (See Figs. 3.51 and 3.52.)

There was no apparent damage to the structural parts of the building. The front door was blown across the room, and the rear door was broken at the lock. The glass in the front and side windows was blown in, and glass in the rear windows was blown out. The steel sash was warped and twisted but remained in place.

Fig. 3.51 —Interior of one-story reinforced lightweight concrete-block house (31.1-f2) at 10,500 ft, postshot.

Fig. 3.52 —Interior of one-story reinforced lightweight concrete-block house (31.1-f2) at 10,500 ft, postshot.

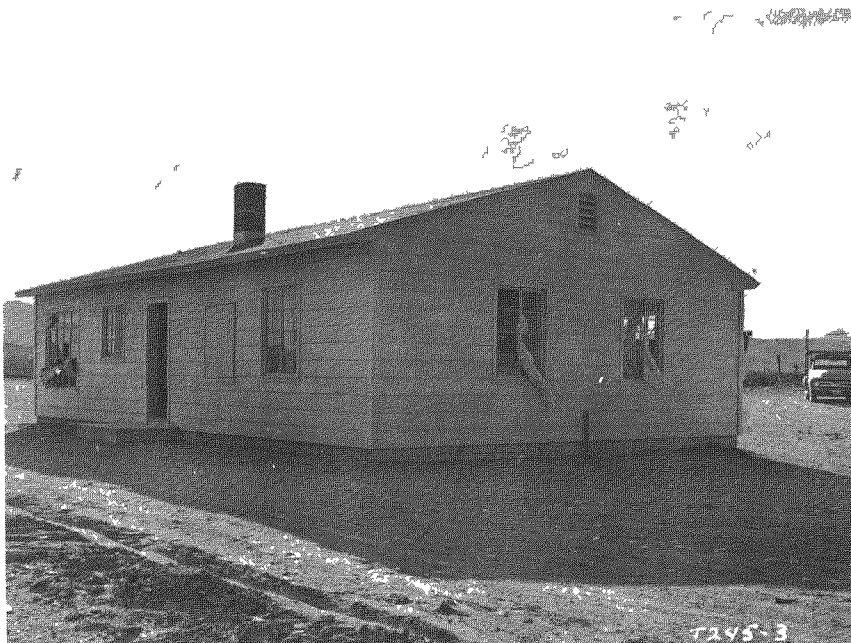
This house was a counterpart of the house described under Sec. 3.3.2. Structurally the house did not suffer heavy damage (Figs. 3.53 to 3.55). A 2 by 4 in. stud located between the front door and window in the living room was cracked; the west side wall bulged out 4 in. at the ceiling line owing to lack of continuity of framing and the exterior siding split at the same line; the midspan rafter support beam on the front side was broken; and there was evidence of racking of the structure. Considerable damage was done to the plasterboard walls and ceilings. Glass in the front windows was sent flying; some glass was broken out of all the windows. The steel window sashes remained in place with only minor distortion. The steel Venetian blind from the front living-room window was blown through the rear window, smashing the glass. The front door was blown from its hinges across to the rear of the room. The porch roof was lifted 6 in. off its post supports. Many glass fragments were imbedded in the walls.

Fig. 3.54 —One-story frame rambler house (31.1-c2) at 10,500 ft, postshot.

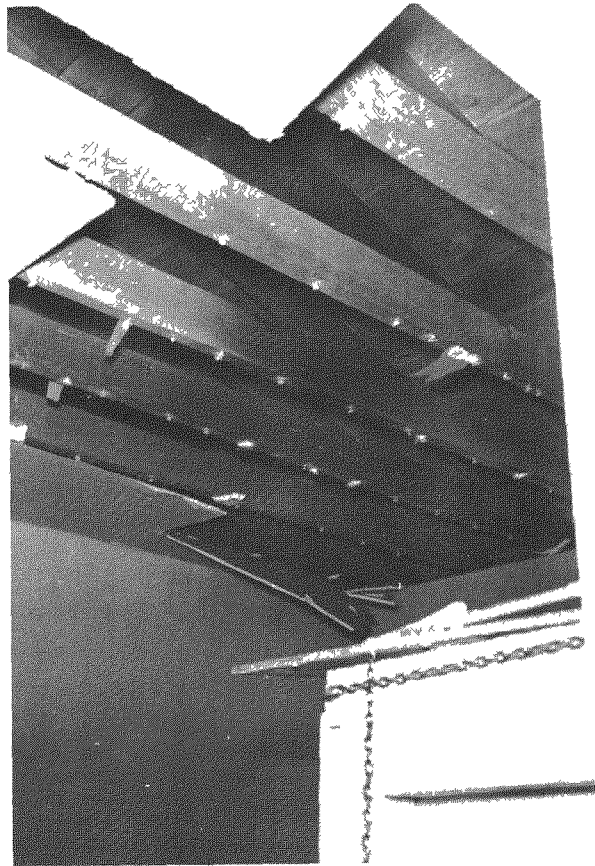
Fig. 3.55—Ceiling material blown down by blast in one-story frame rambler house (31.1-c2) at 10,500 ft, postshot.
