AMCHITKA BIOENVIRONMENTAL PROGRAM

GEOMORPHOLOGY AND PLANT ECOLOGY:  
AN ASSESSMENT OF THE IMPACT OF AEC  
NUCLEAR TESTS ON AMCHITKA

K. R. Everett  
Institute of Polar Studies  
The Ohio State University

March, 1975

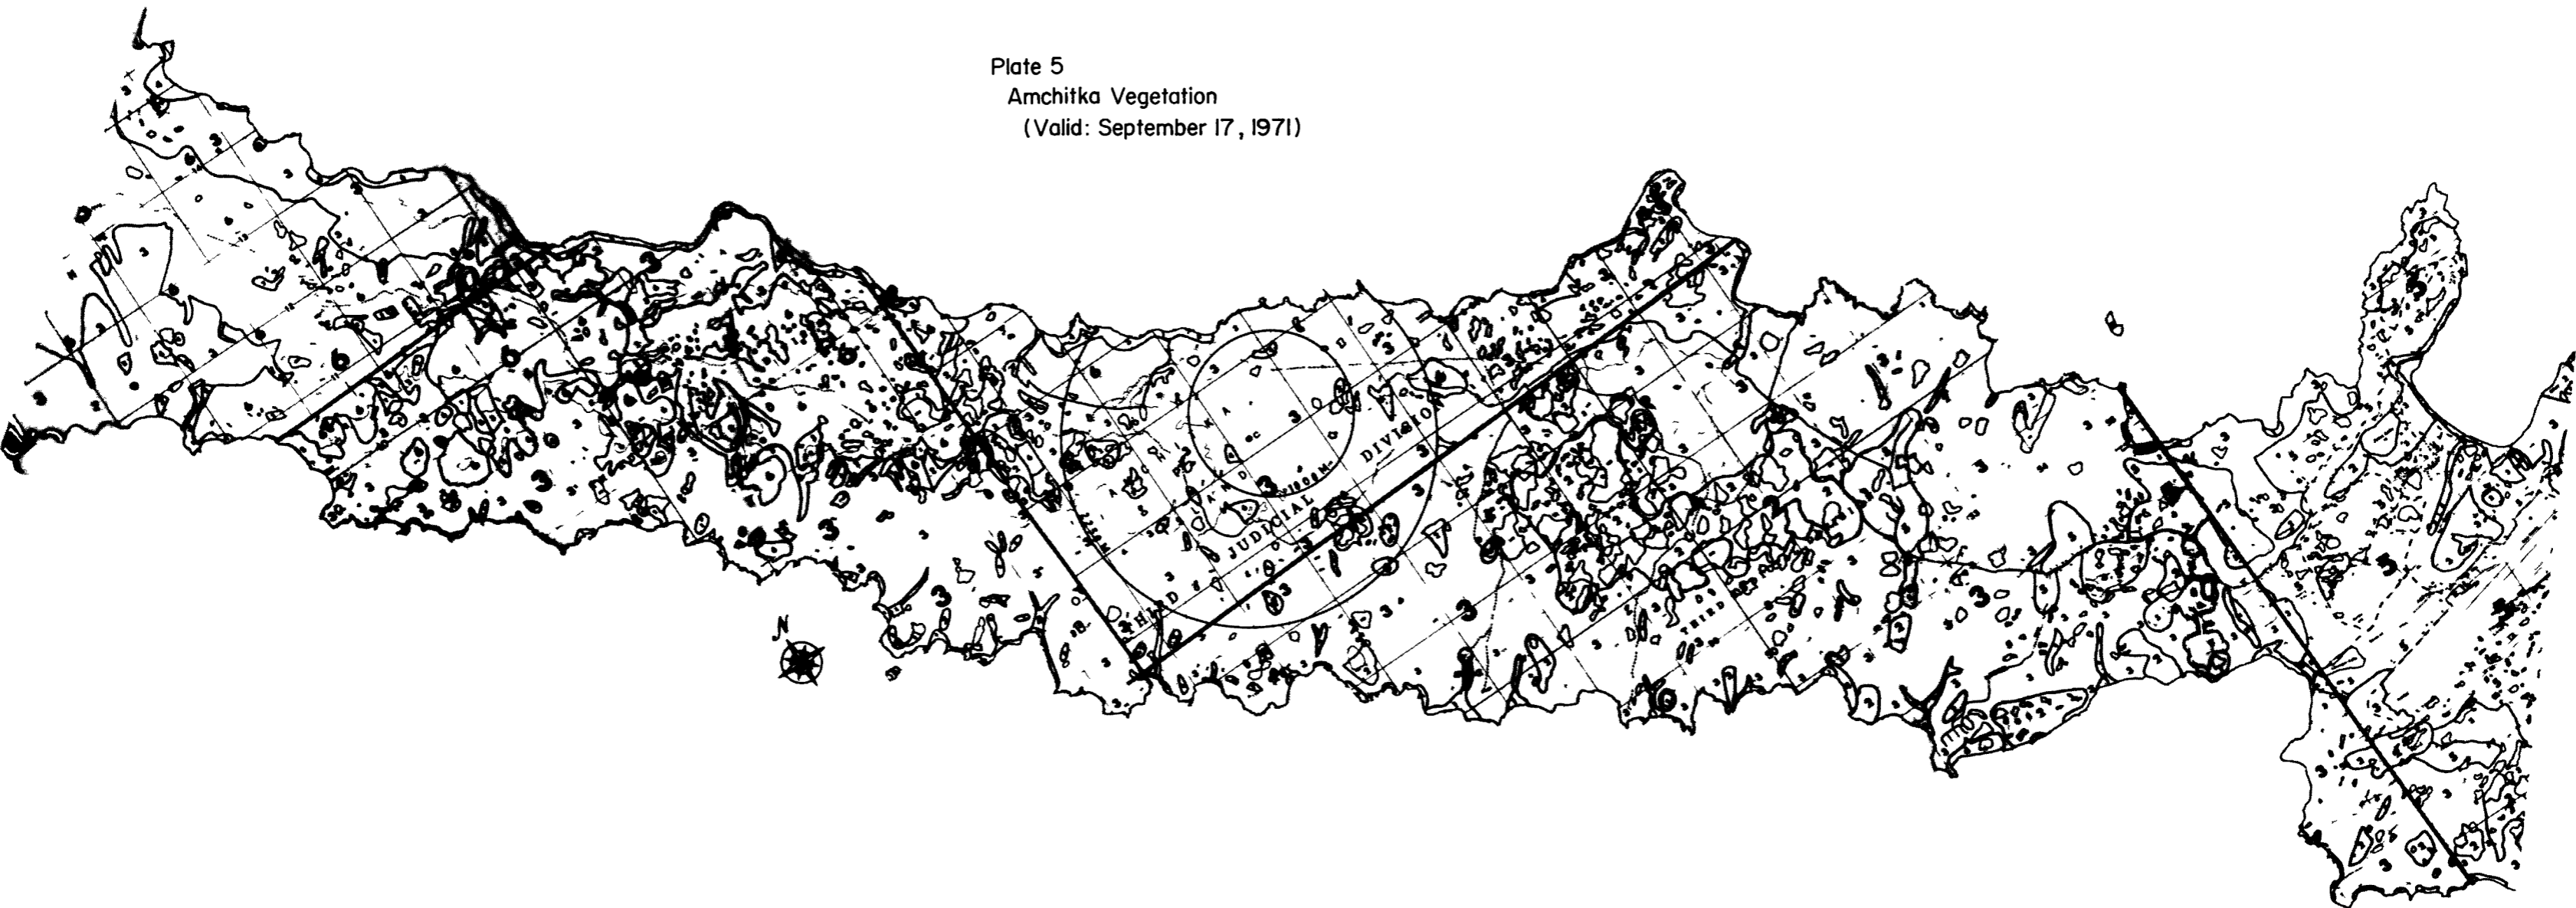
Plate 5  
Amchitka Vegetation  
(Valid: September 17, 1971)

(a) Minimum values cover only the area in which fracture traces appeared at the surface and in which subsidence occurred. Maximum values cover an area sufficiently large to include most of the localized surface disturbances shown. These areas correspond roughly to the circled areas on Plate 5.

Most of the mapped and observed Cannikin-related impacts, including the most seriously affected terrestrial vegetation, are located within a circular area of 1000-meter radius centered at a point approximately 400 meters ENE of Cannikin SZ (see Plate 5).

The largest area disturbed within the crowberry meadow community underwent "tundra fluff", but this change was temporary and no productivity change is anticipated. Of the other disturbances, only the formation of Cannikin Lake is of much consequence. A summation of predictions for the Cannikin-induced changes over the 314-hectare area within 1000 meters of SZ indicates a predicted loss of 5918 kg of annual biomass (a 4.1 percent decline). Since most of the loss is due to flooding of the new lake, on the basis of this low figure we can predict only a 1 percent decline productivity for a larger area with a 2250-meter radius centered on Cannikin SZ. This larger area contains approximately 90 percent of the observed and mapped disturbances involving terrestrial plant communities (excluding sea cliff and rock fall areas). Both circular areas are shown on the vegetation map, Plate 5.
