**Final Technical Report**

**Stress-Assisted Corrosion in Boiler Tubes  
(DE-FC36-02ID14243)**

**Project Period (03/01/2002 – 02/28/2006)**

**04/30/2006**

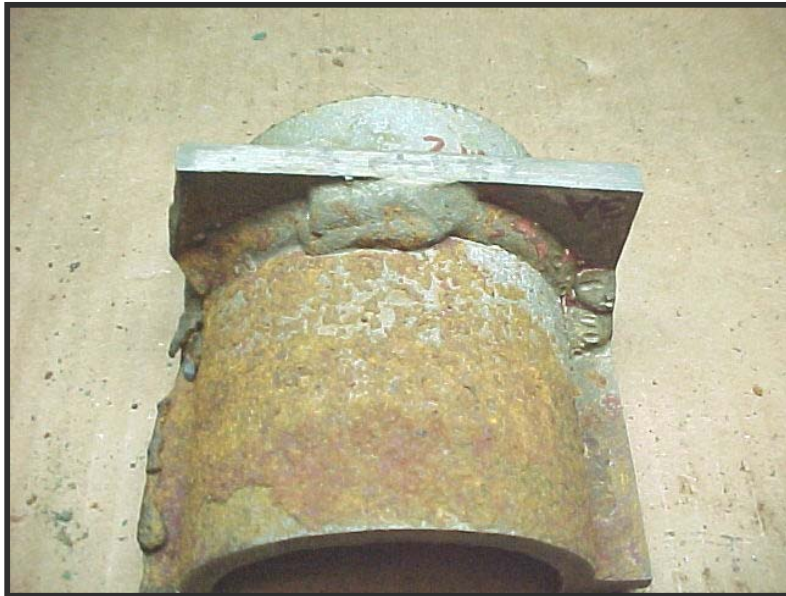
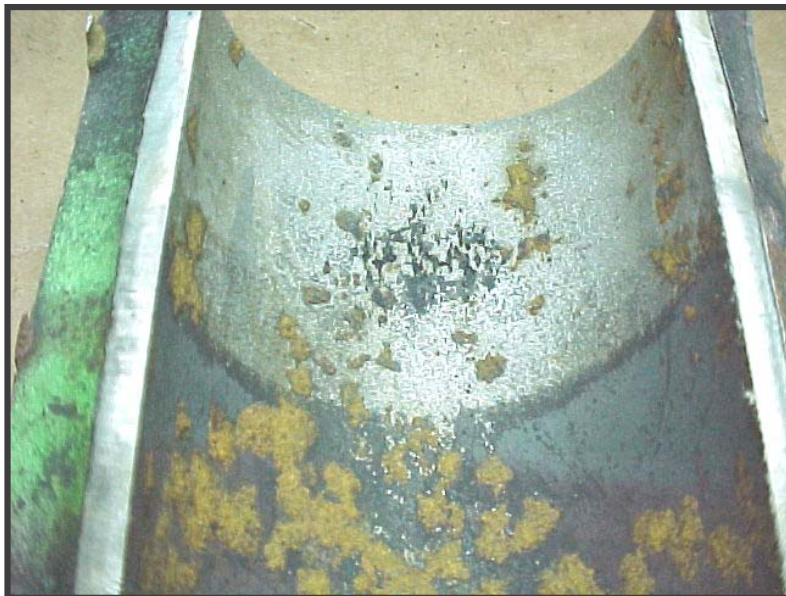
Figure 3.2.3. Attachment weld (top) and appearance of the internal surface opposite the weld following acid cleaning.

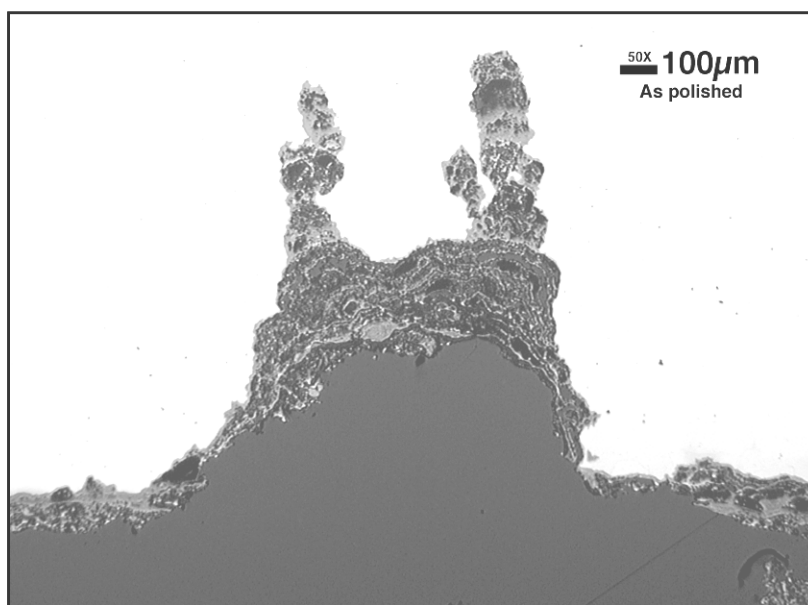
Figure 3.2.7. SAC indications that appear to be propagating from a pit on the tube ID. As-polished.

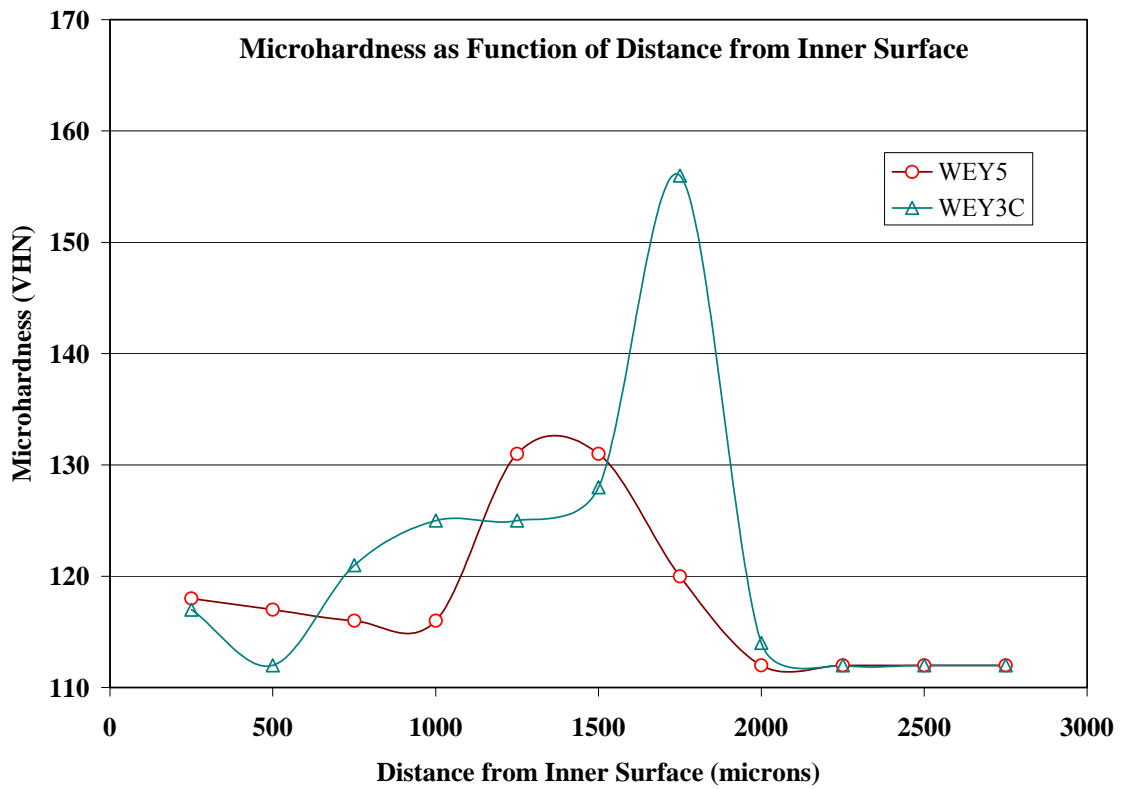
Figure 3.2.16. Microhardness data for tubes from one particular recovery boiler showing vickers hardness number as a function of distance away from the inner tube surface. There is clear indication of softer layer at the inner as well as outer surface of the tube whereas the hardness is higher in the middle.

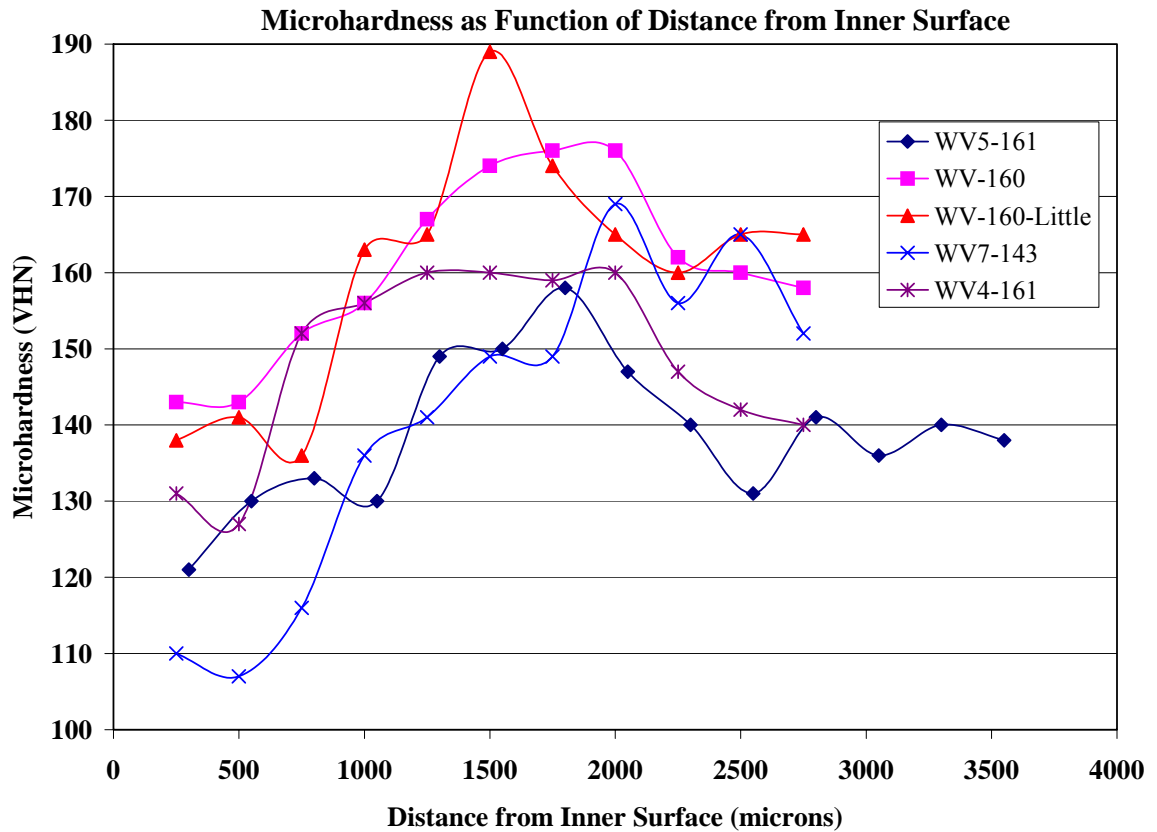
Figure 3.2.17. Microhardness data for a set of tubes from a recovery boiler showing Vickers hardness number as a function of distance away from the inner tube surface. There is clear indication of softer layer at the inner as well as outer surface of the tube whereas the hardness is higher in the middle.

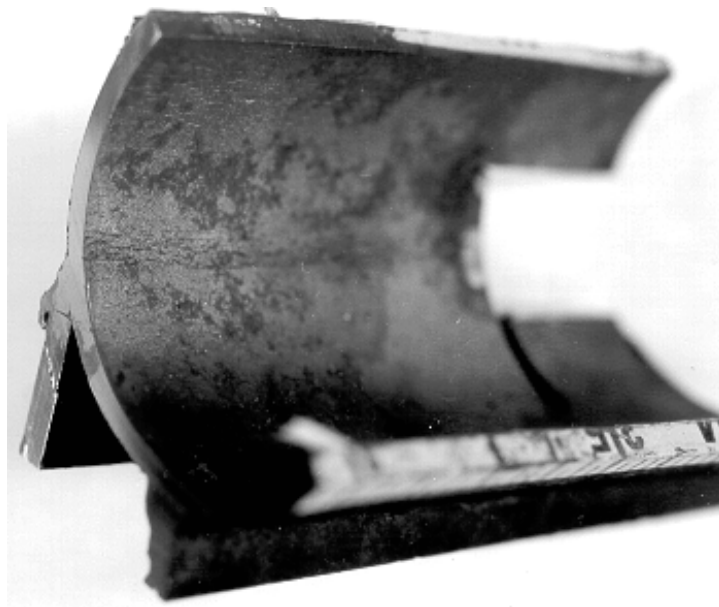
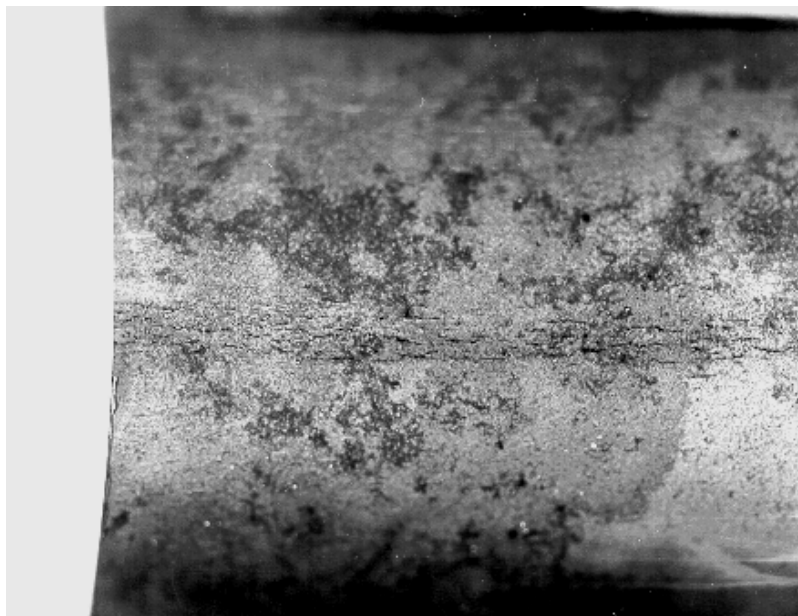
Figures 3.2.21. Section of tube-A showing longitudinal SAC cracks on their inner surface under the longitudinal attachment weld.

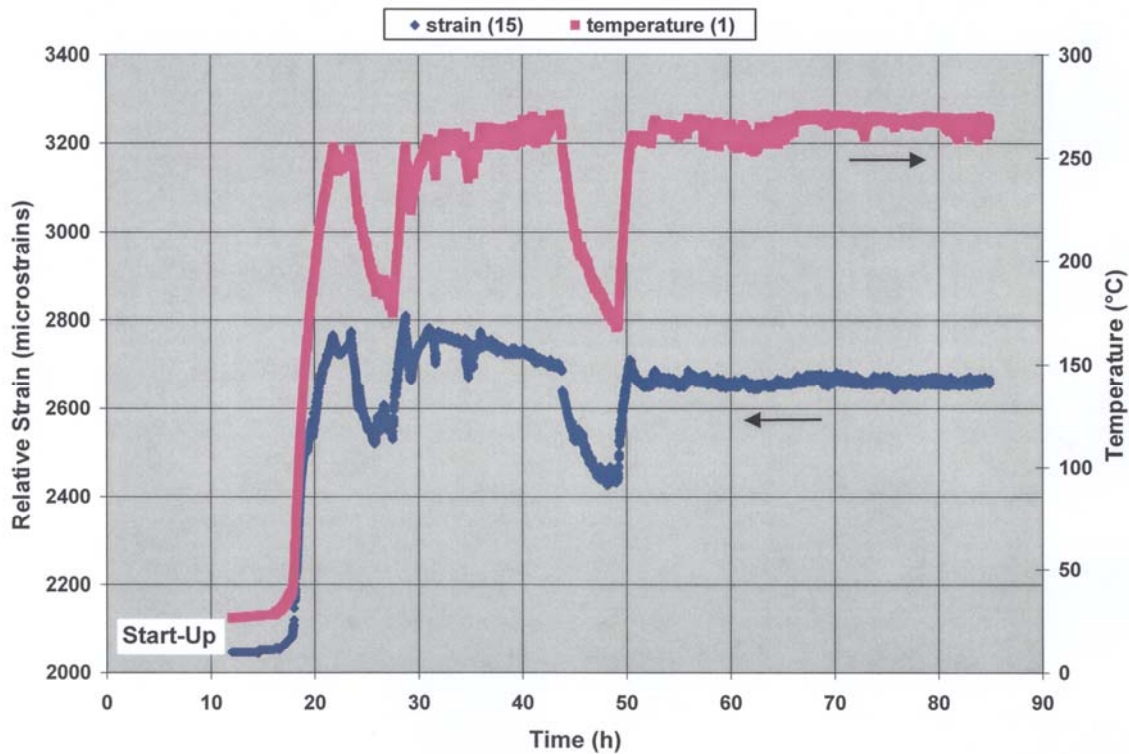
Considering the initial pressurization of the boiler tubes along with significant changes in temperature (and development of temperature gradients), start-up of the boiler is considered an aggressive stress/strain event that perhaps contributes to the initiation and propagation of SAC. Figure 3.3.7 is a set of data representing the initial start-up of the boiler after the strain gages and TCs had been installed. In the start-up process, the temperature recorded by the TCs changes from near ambient to over 250°C in only 3-4 hours. Following some equipment “shakedown” that caused the water temperature to be somewhat irregular over the subsequent ~30 hours, the boiler approached steady state operation.

Fig. 3.3.7. Strain (gage #15) and temperature (TC #1) profiles representing the initial boiler start-up following installation of the gages.

Among all the strain gages available, data for gage #15 is plotted in Figure 3.3.7 because this gage exhibited the largest net strain change in response to the start-up conditions. In this case, the maximum strain occurred coincident with the end of the initial upset associated with the shakedown procedure (at about 42 h on the time axis). For some gages, the maximum strain was coincident with the end of the second shakedown upset (at about 50 hours in Figure 3.3.7), but none of the other gages exhibited a greater net change in strain than that for gage #15.

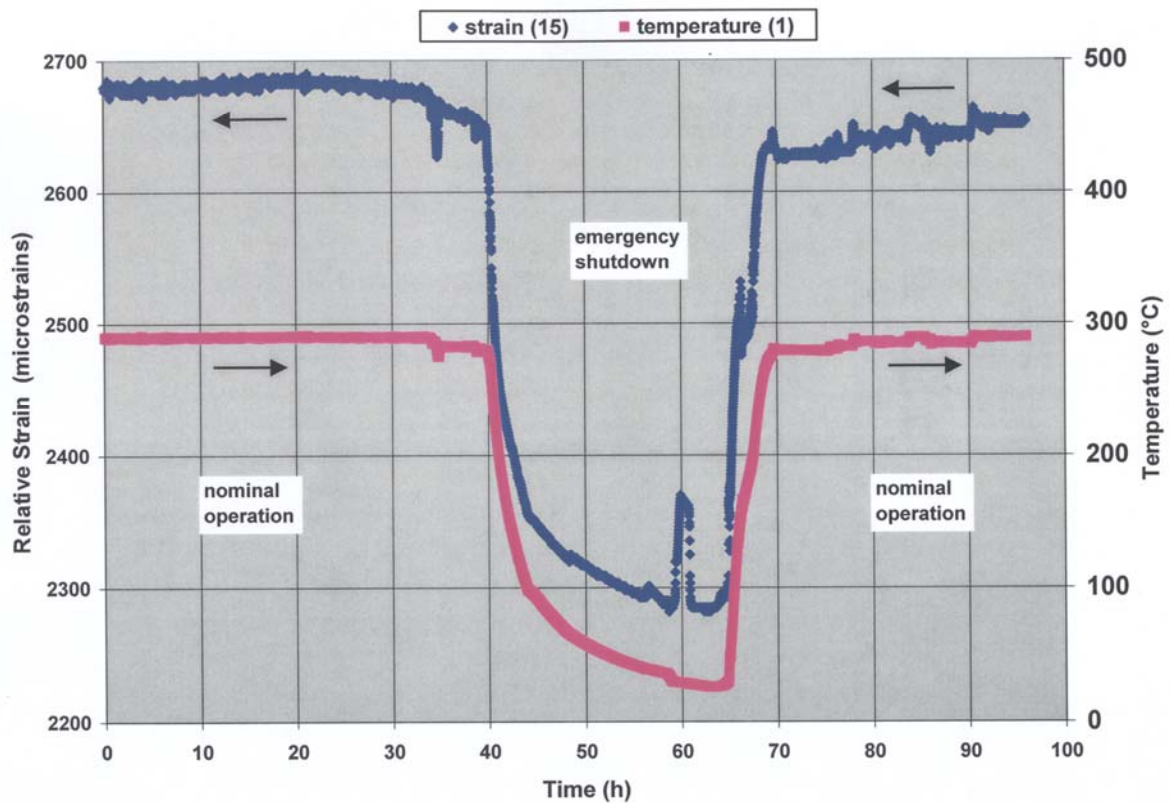
Figure 3.3.8 shows a representative strain and temperature profile for one of the ESP events at the mill. In this case, strain gage #15 does not represent the largest strain change for the event, but the strain profiles for all of the gages are qualitatively identical during the ESPs, and reference to gage #15 permits ready comparison with other data in this document.

Fig. 3.3.8. Strain (gage #15) and temperature (TC #1) profiles representing the emergency shutdown and restart conditions in the boiler.

In Figure 3.3.8, the ESP begins at about 40 h into the time frame depicted, with restart of the boiler beginning about 24 h later. The brief strain excursion that occurs shortly before restart – at about 60 h in the graph – represents a cold (no corresponding temperature increase) pressure test at the operating pressure of the boiler. This result indicates that the mechanical strains associated with the temperature changes of boiler operation are substantially larger in magnitude than the mechanical strains associated with pressurization of the tubes.

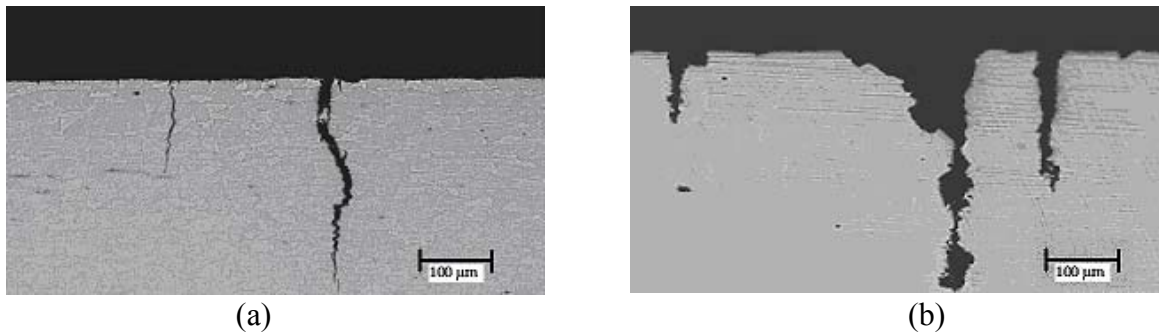
Carbon steel cracks under slow strain rate tests in pure water at high temperatures were typically transgranular with sharp crack tips. However, the field SAC cracks in industrial boilers were typically bulbous and blunt, as is shown in Figure 3.5.23. Interrupted tests were carried out to simulate the effect of boiler shutdown conditions on crack growth and morphology. Representative results are shown in Figure 3.5.24. It can be seen that relatively short interruptions (10 hours) in SSRT tests, where the temperature was lowered to 80°C and water was aerated for 10 minutes with oxygen, flowing at 1.0 L/min, produced active corrosion around the sharp crack tips. Numbers of bulbous growths correspond to number of interruptions. Sharp stress corrosion cracks continued from the blunt tip on subsequent application of test conditions. This elucidates how the sharp corrosion fatigue cracks and the stress assisted corrosion (SAC) cracks with bulbous features in different types of boilers may have the same growth mechanism but different shape due to different boiler operation history.

Figure 3.5.22 Cracks from SSRT tests done in pure water at 300°C (a) sharp crack from test without interruption. (b) Crack from test with interruptions to simulate boiler shutdown.

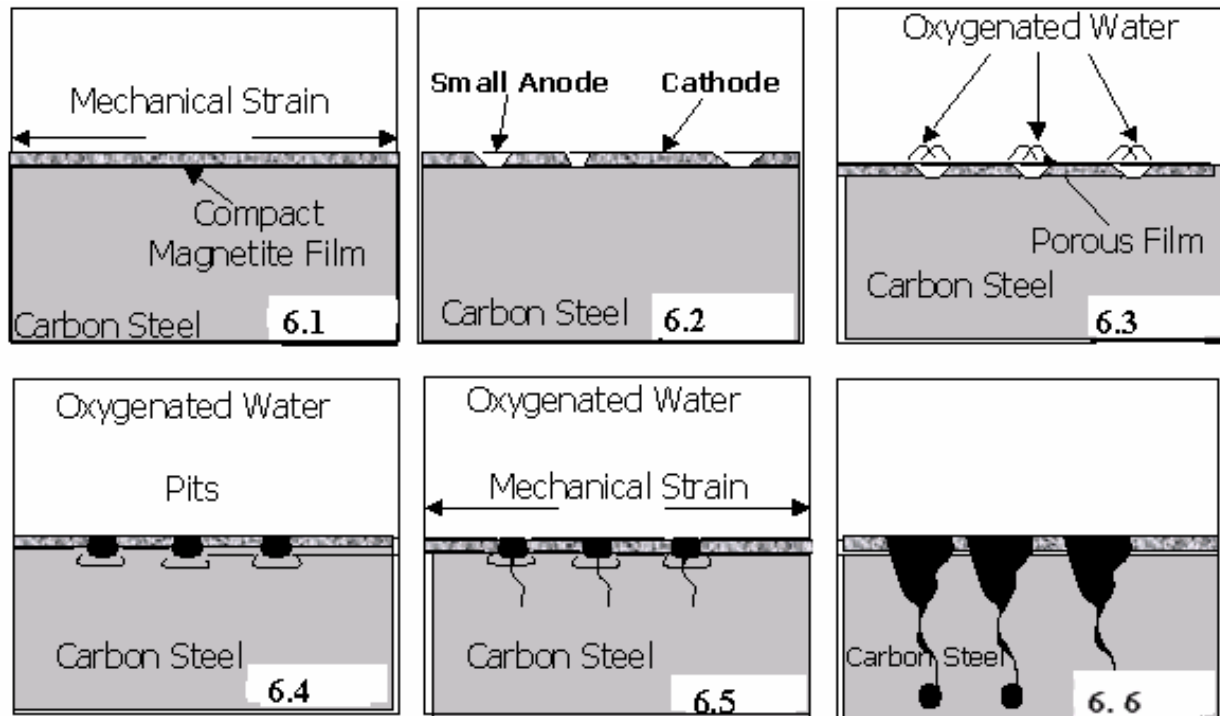
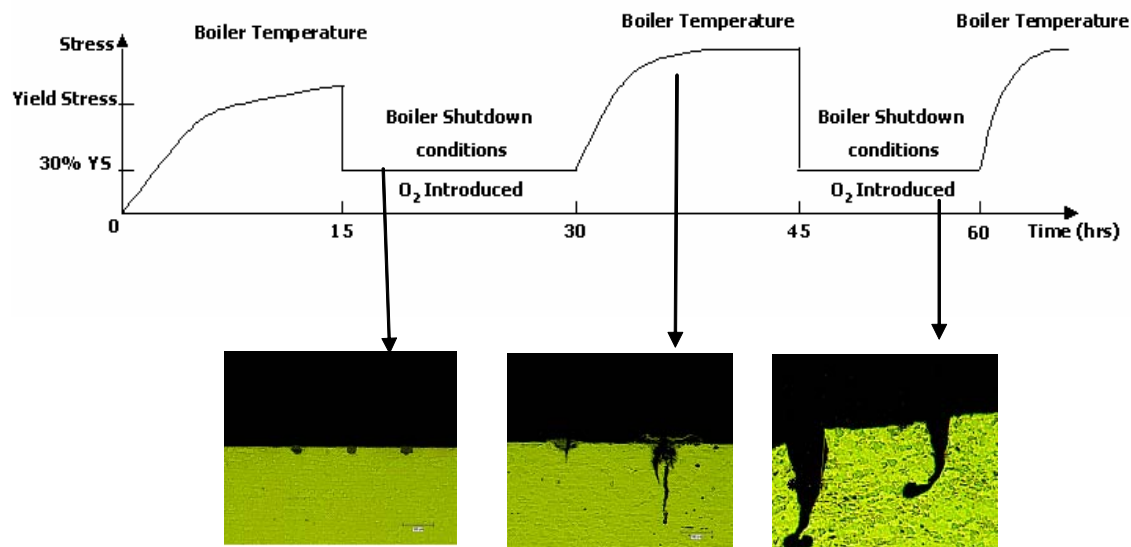
During boiler shutdown if oxygen enters the boiler water system, this may produce typical SAC morphology for cracks. In the presence of oxygen the crack tips corrode preferentially and may lead to the formation of bulbous crack morphology, as shown schematically in Figure 3.5.23.

Results show that small pits initiate during first loading, as shown in Figure 3.5.23. Cracks propagate during second loading mostly from the initial pits. Crack tips were attacked in cases where oxygen was introduced in autoclave during shutdown. In cases where cracks were initiated but oxygen was not introduced during shutdown, cracks did not show any sign of crack blunting. The crack shapes of simulated SAC during different stages are exactly the same as we derived in our proposed SAC mechanism as shown in Figure 3.5.25.

**Figure 3.5.23.** Interrupted slow strain rate tests (ISSRT) to simulate boiler start up and shutdown conditions. During shutdown simulation, stress was lowered to 30% of yield stress and oxygen was introduced in the autoclave. Micrographs in this figure show crack morphology at certain time during these tests.

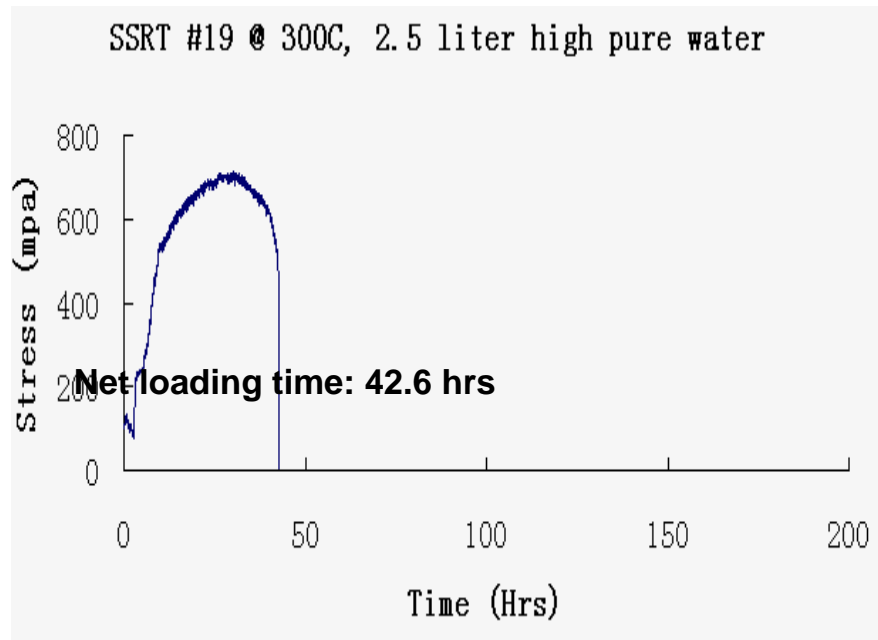
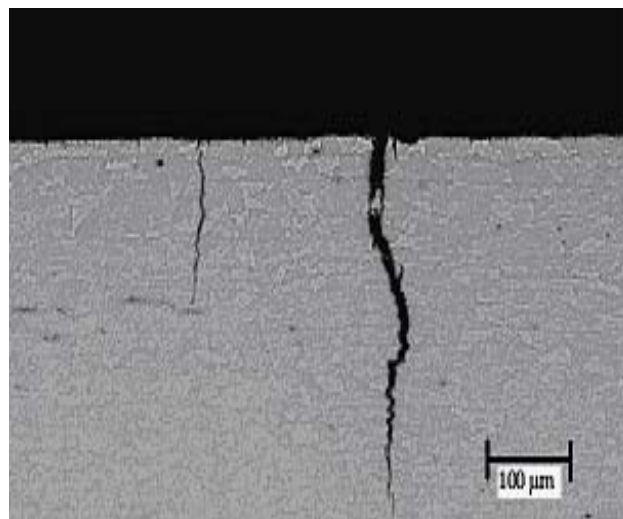
Figure 3.5.24 Sharp crack in SA210 sample tested via slow strain rate test (SSRT) method in boiler water environment.

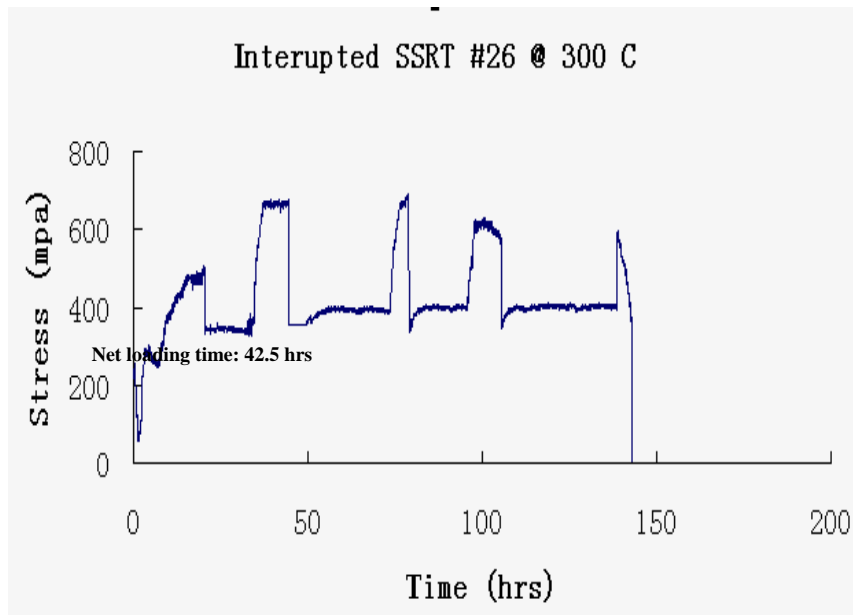
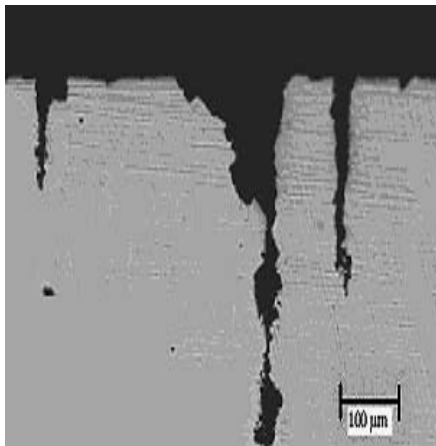
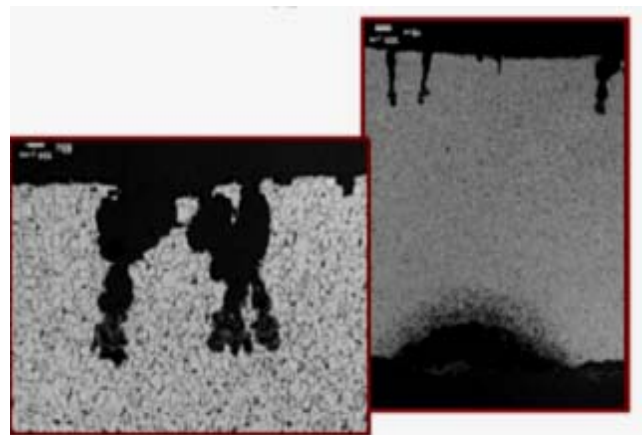
Figure 3.5.25 Bulbous SAC crack in SA210 sample tested in interrupted slow strain rate test (ISSRT) method in boiler water environment. (A) simulated cracks were similar morphology to the cracks in (B) found in boiler tubes.

- ◆ Sharp corrosion fatigue cracks and blunt SAC cracks seem to have the same initiation and growth mechanism; however the shape differs due to the differences in the shutdown conditions. Availability of oxygen during the shutdown may lead to crack blunting due to preferential corrosion and result into the bulbous shape of SAC cracks.

- ◆ Stress assisted corrosion in industrial boilers can be controlled by controlling O<sub>2</sub> to levels below 5 ppb and stress localization near attachment welds below the threshold values need to damage magnetite film in local areas.
