***Structural Integrity Program for
the 300,000-Gallon Radioactive
Liquid Waste Storage Tanks at
the Idaho Nuclear Technology
and Engineering Center***

April 2003

***Idaho National Engineering and Environmental Laboratory
Bechtel BWXT Idaho, LLC***

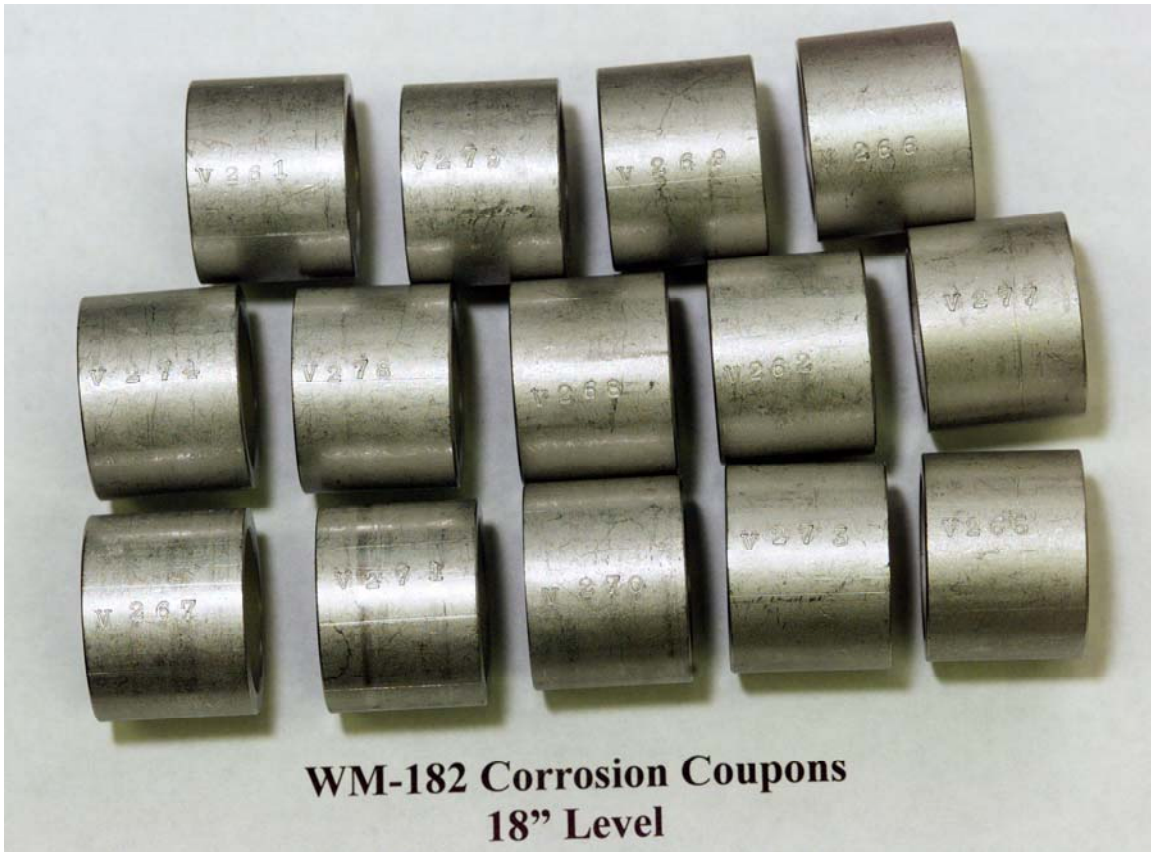
Figure C-5. Tank WM-182 coupons at the 45-cm (18-in.) level after 30.5 years of exposure (PD01-0406-9).

construction, which involves welding together and situating of metal plates so that the end grains are not exposed to the contents of the tank. Very slight pit initiation parallel to the extrusion marks on the surface of the seamless pipe coupons also was shown. Because fabrication of the plate used for tank construction is similar to that for the coupons, similar attack could have occurred in the vessel.⁷

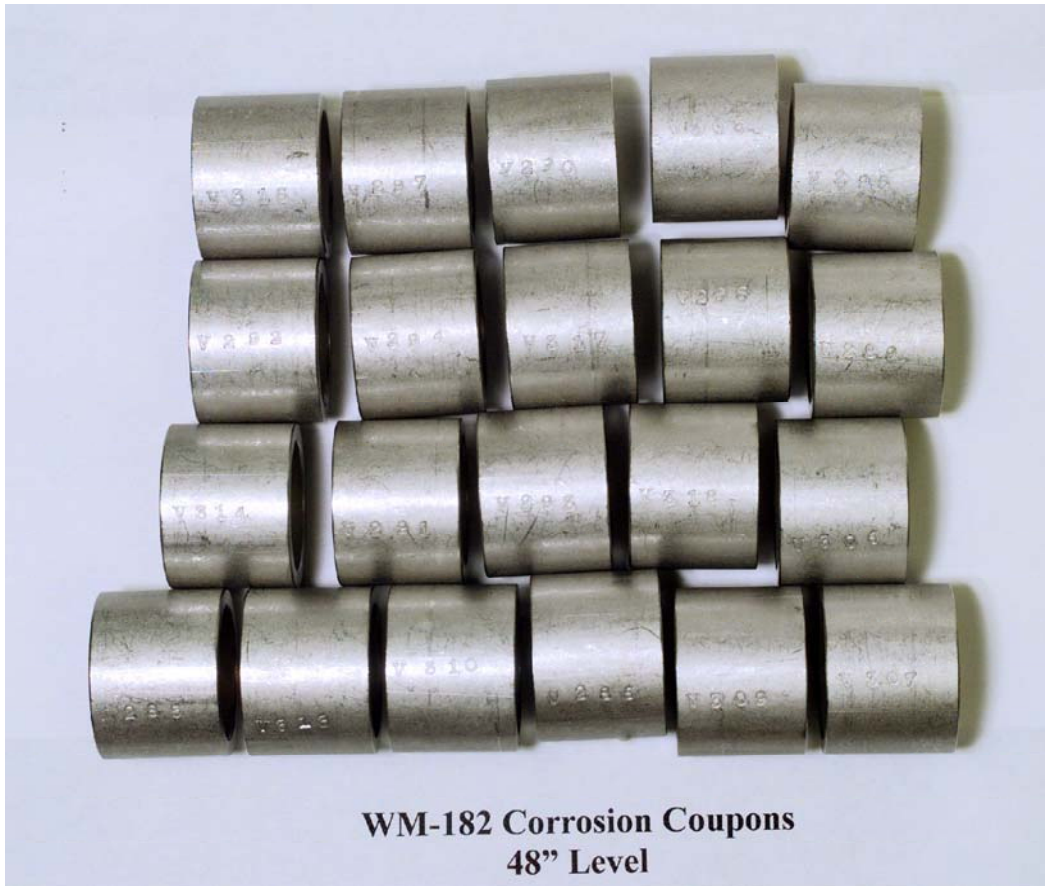
Figure C-6. Tank WM-182 coupons at the 122-cm (48-in.) level after 28.3 years of exposure (PD01-0406-8).

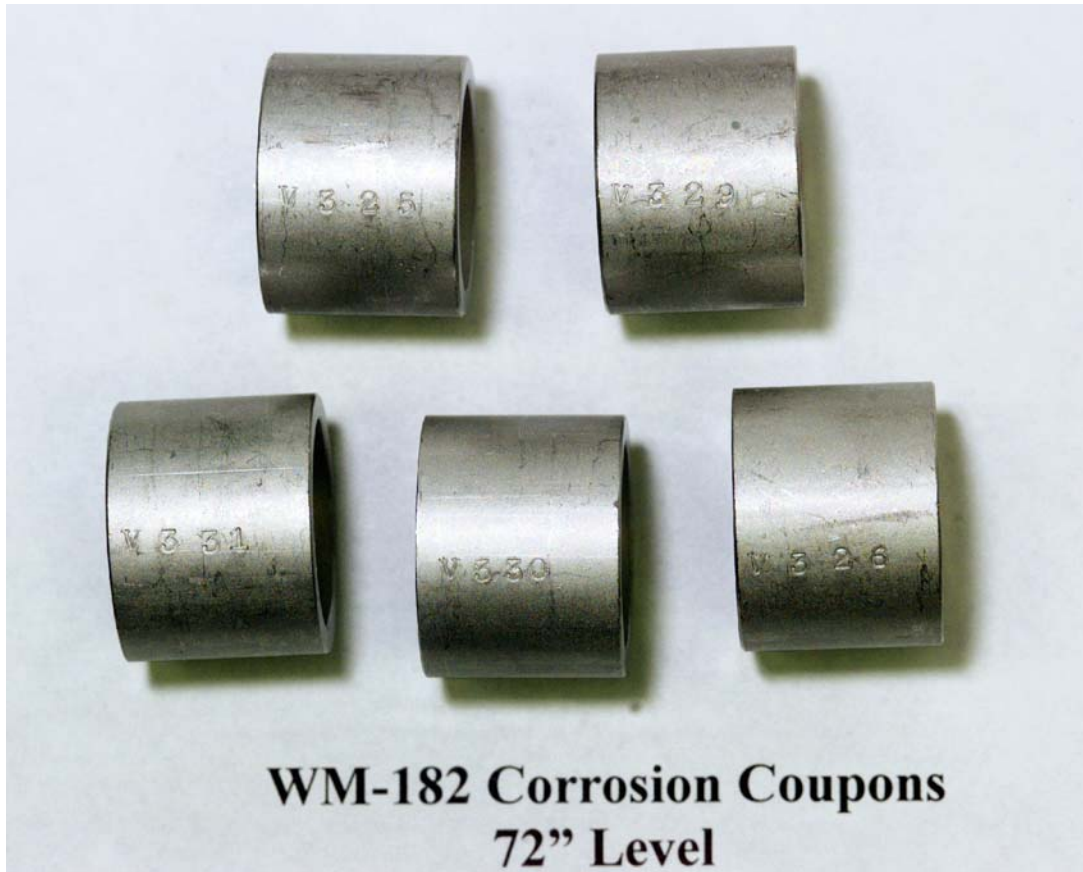
Figure C-7. Tank WM-182 coupons at the 183-cm (72-in.) level after 26.5 years of exposure (PD01-0406-10).

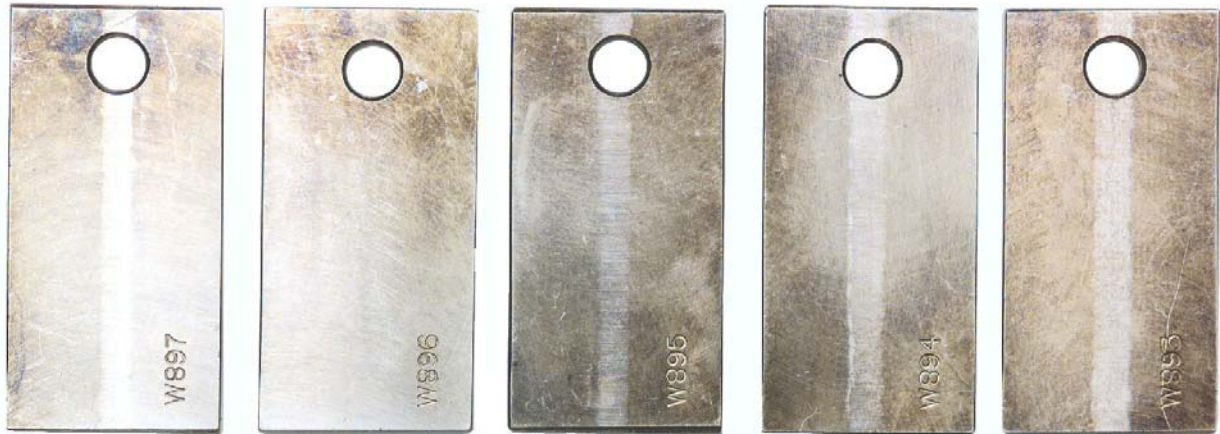
**WM-183 (BOTTOMS)
TYPE 304L SS - 11.5 Yr EXPOSURE**

Because Tank WM-183 was also being taken out of service, all of the remaining 44 coupons were retrieved including five from the tank bottom, 17 from the 45-cm (18-in.) level above the bottom, nine from the 122-cm (48-in.) level above the bottom, and 13 from the 183-cm (72-in.) level above the bottom.⁸ The coupon sets retrieved from each of the four levels are shown in Figures C-8 through C-11.

Figure C-8. Tank WM-183 coupons at the 0-in. level after 11.5 years of exposure (PD01-0066-25).⁸

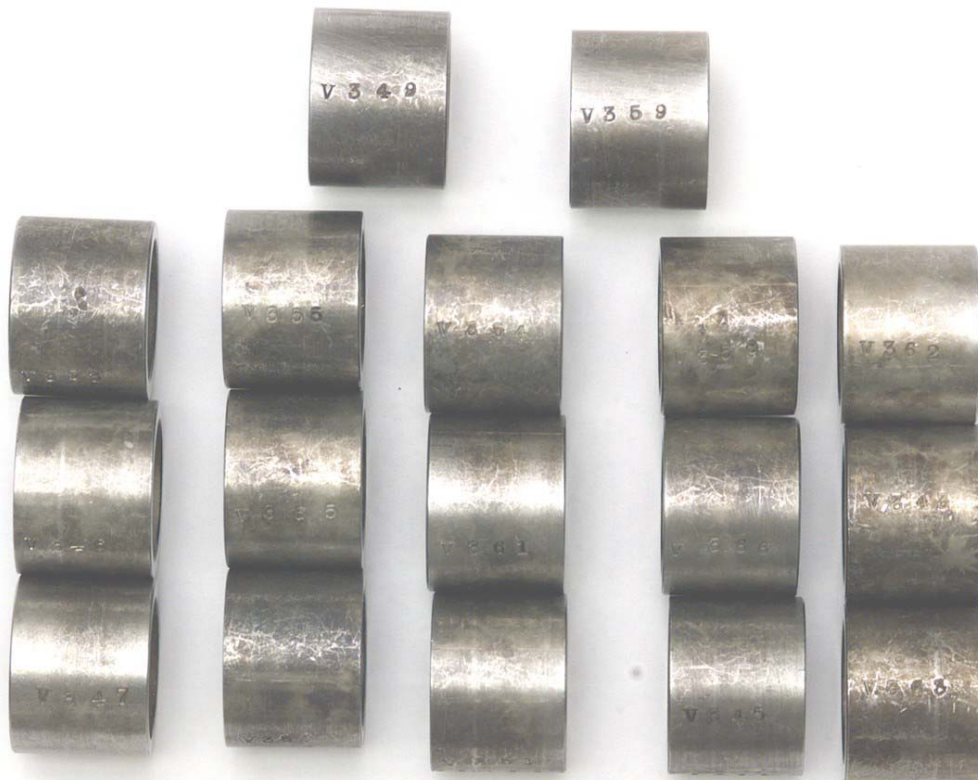
**WM-183 (18 IN LEVEL) – TYPE 304L SS
38.5 YEARS EXPOSURE**

Figure C-9. Tank WM-183 coupons at the 45-cm (18-in.) level after 38.5 years of exposure (PD01-0066-31).⁸

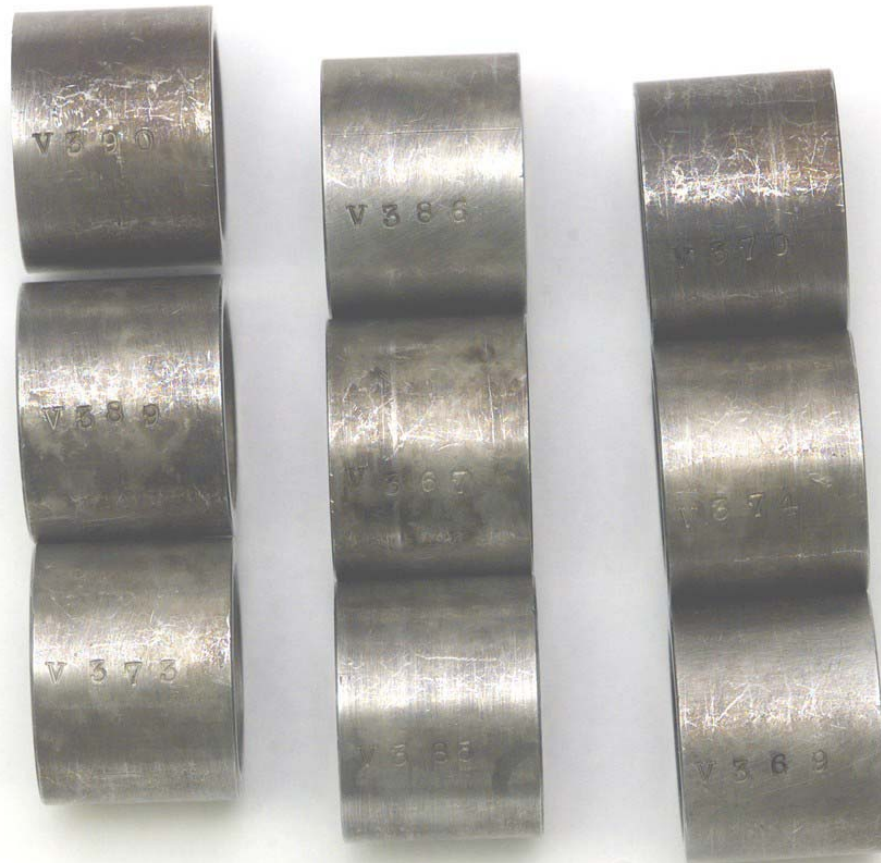
**WM-183 (48 IN LEVEL) – TYPE 304L SS
35.2 YEARS EXPOSURE**

Figure C-10. Tank WM-183 coupons at the 122-cm (48-in.) level after 35.2 years of exposure (PD01-0066-01).⁸

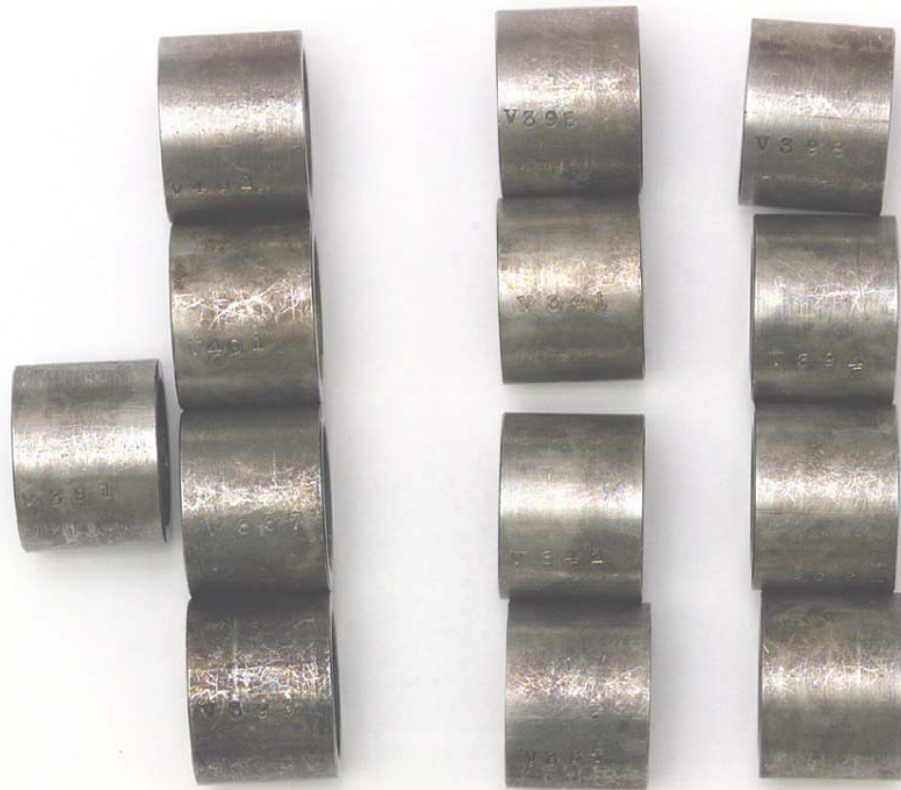
The highest average corrosion rate for a set of coupons exposed at any level in Tank WM-183 was 4.1×10^{-3} mils per year at the bottom of the tank.⁸ At that rate, the metal loss for the tank calculates to 0.18 mils over the 42.8 years of service up to 1999. The maximum corrosion rate observed for any single coupon from the tank was 3.3×10^{-2} mils per year at the 0-in. level, which calculates to a metal loss of 1.41 mils over the 42.8 years of vessel service up to 1999. Tank WM-183 has a corrosion allowance of 50 mils (0.050 in.).

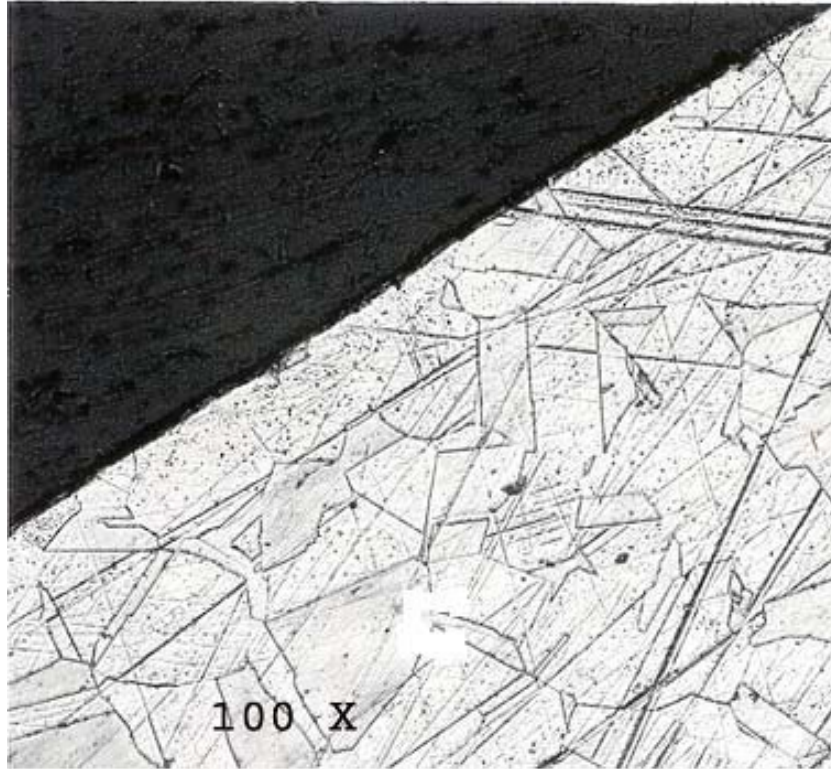
Figure C-16. Magnification (100×) of typical surface roughness on Coupon V349 at the 45-cm (18-in.) level in Tank WM-183 (PD03-0029-19).⁸

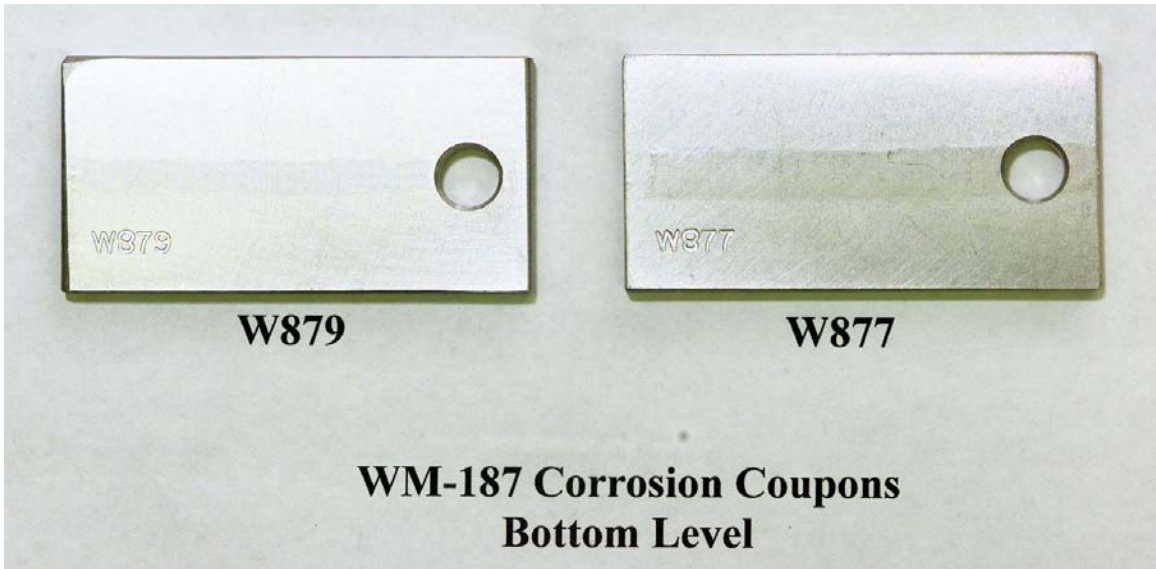
The highest average corrosion rate for a set of coupons exposed at any level in Tank WM-187 was 0.029 mils per year and occurred at the 183-cm (72-in.) level. At that rate, the maximum average metal loss calculates to 1.23 mils (0.0012 in. or 0.38% of the internal thickness of the tank wall) over 41.6 years of tank service. The maximum corrosion rate observed for any single coupon from this tank was 0.030 mil per year and also occurred at the 183-cm (72-in.) level. Calculations using this maximum corrosion rate indicate a metal loss from the internal surfaces of the tank of 1.25 mils (0.0013 in. or 0.40% of the internal thickness of the tank wall) over the 41.6 years of tank service.⁹ Tank WM-187 has a corrosion allowance of 50 mils (0.050 in.).

Figure C-22. Tank WM-187 coupons at the 0-in. level after 13.4 years of exposure (PD01-0406-14).

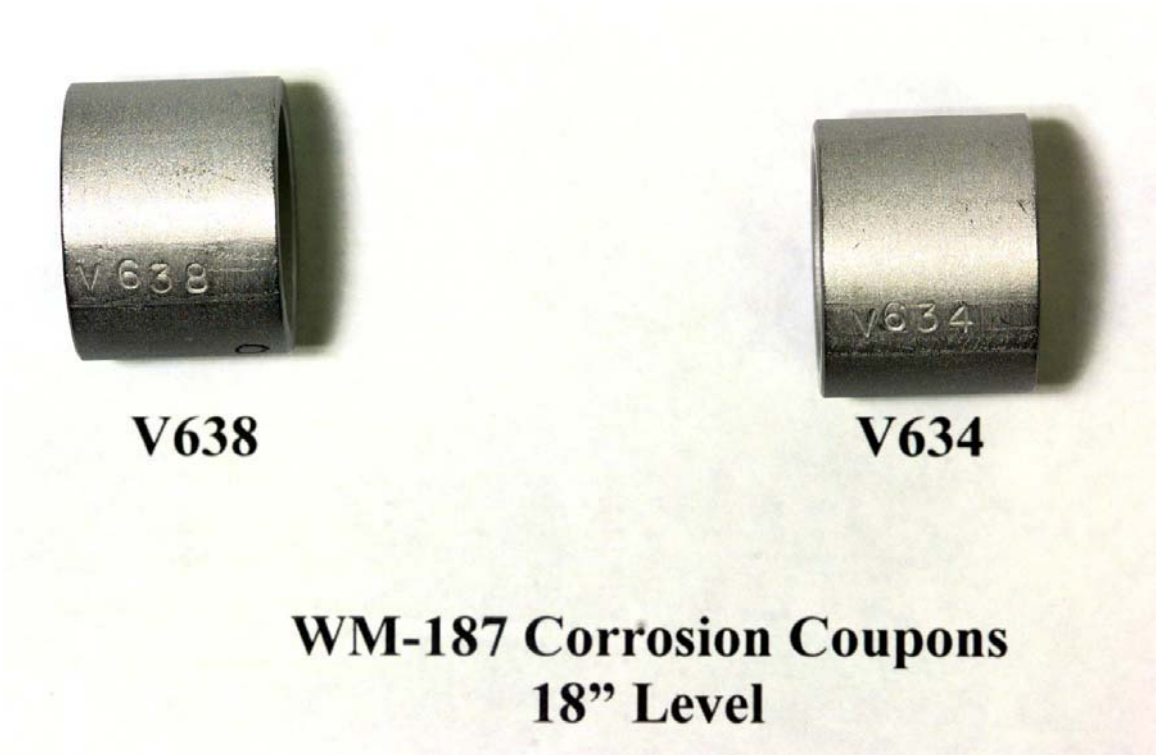
Figure C-23. Tank WM-187 coupons at the 45-cm (18-in.) level after 38.6 years of exposure (PD01-0406-16).

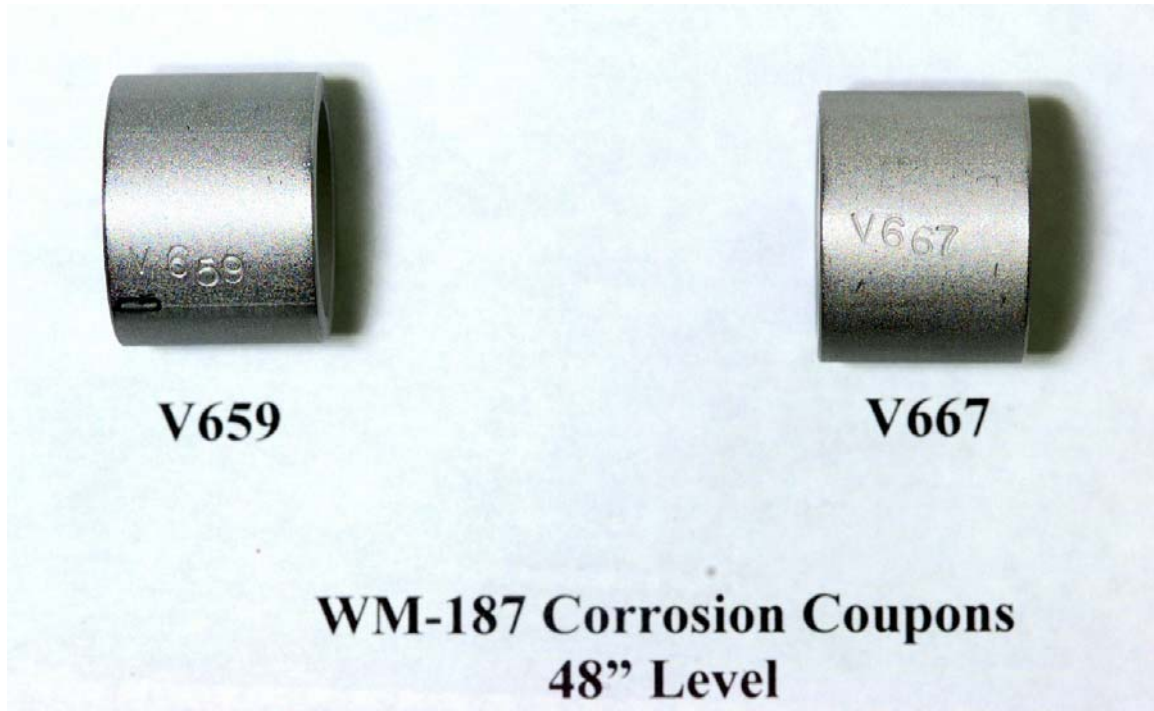
Figure C-24. Tank WM-187 coupons at the 122-cm (48-in.) level after 36.7 years of exposure (PD01-0406-15).

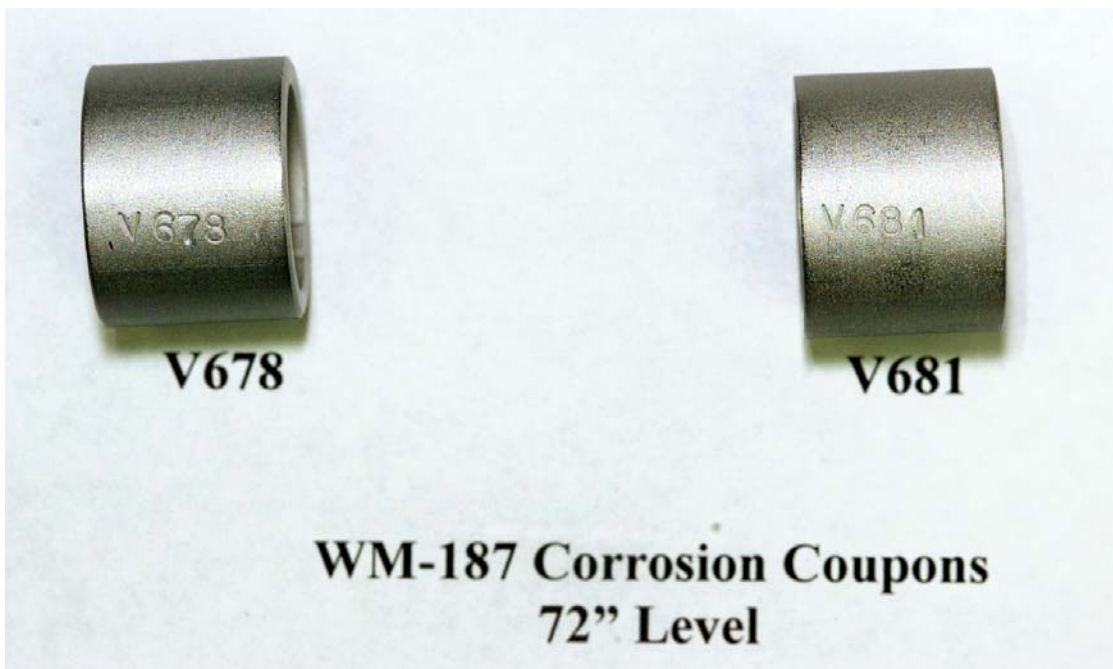
Figure C-25. Tank WM-187 coupons at the 183-cm (72-in.) level after 28.4 years of exposure (PD01-0406-12).

coupons at the 183-cm (72-in.) level, while the bottom coupons had the lowest corrosion rate. This rate is similar to the rates found on the coupons retrieved from Tank WM-182.

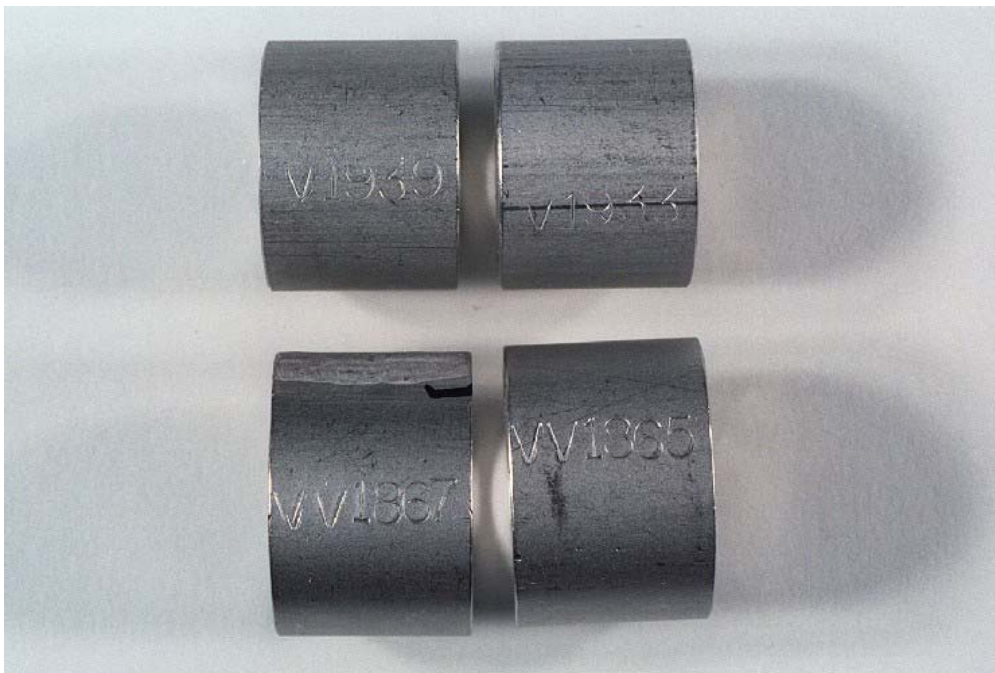
The highest average corrosion rate for a set of coupons exposed at any level in Tank WM-189 was 0.009 mil per year and occurred at the 183-cm (72-in.) level.⁹ At that rate, the average metal loss calculates to 0.320 mil (0.0003 in. or 0.10% of the internal thickness of the tank wall) over 35.4 years of tank service. The maximum corrosion rate observed for any single coupon from this tank was nearly the same at 0.01 mil per year and also occurred at the 183-cm (72-in.) level. This rate occurred on a coupon containing a weld. Calculations using this maximum corrosion rate indicate a metal loss from the internal surfaces of the vessel of 0.354 mil (0.0004 in. or 0.13% of the internal thickness of the tank wall) over the 35.4 years of tank service. While the individual coupon corrosion rates from each level were very close to

Figure C-28. Tank WM-189 corrosion coupons at the 45-cm (18-in.) level retrieved in 2001 (PN02-0152-1-7).⁹

each other, the coupons containing welds tended to generate higher corrosion rates because most localized corrosion was occurring at the weld heat-affected-zone. Tank WM-189 has a corrosion allowance of 50 mils (0.050 in.).⁹

Visual examination of the corrosion coupons under a binocular microscope showed pit initiation similar to that in Tank WM-187. Examination of the three welded coupons at the tank bottom, in place since 1988, revealed only minor end-grain attack on the longitudinal edges of the rectangular coupons. This end-grain attack is not expected to be a problem in the tanks because the end grains of the tank plates are not exposed to the waste solution.⁹

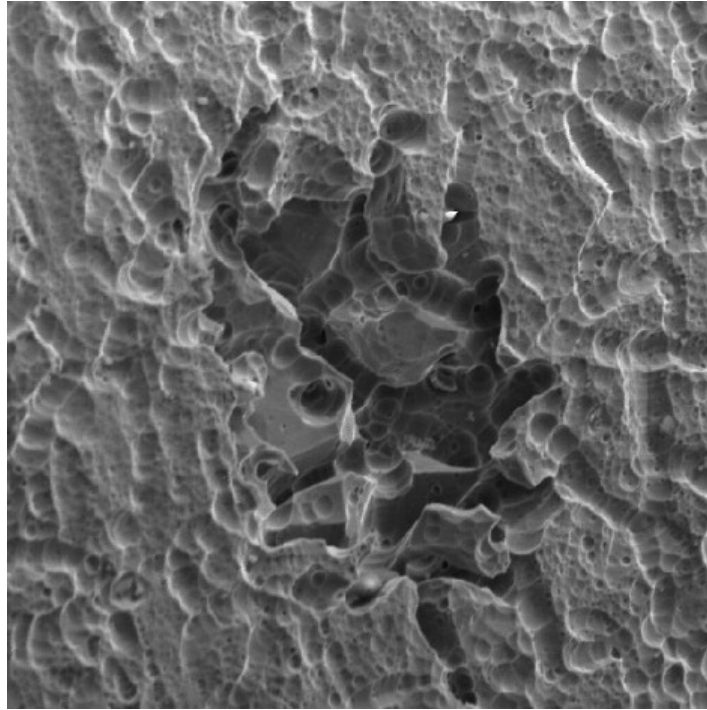
The coupons were examined both with a binocular microscope and an optical interferometer to examine the surface and measure pit depths. Figure C-29 contains an interferometer depiction of a pit on Coupon VV1867. Figure C-30 is a SEM photograph of attack at the heat-affected zone on Coupon VV1867. The corrosion attack on the coupon is very typical of what was seen on all of the coupons. The pits appear etched and have broader and shallower edges than those found in Tank WM-183. Most of the coupons have end-grain corrosion initiating, but it is not very pronounced.⁹

Figure C-30. Scanning electron microscope photograph (680×) of heat-affected zone attack on Coupon VV1867 in Tank WM-189 (PD03-0029-28).⁹

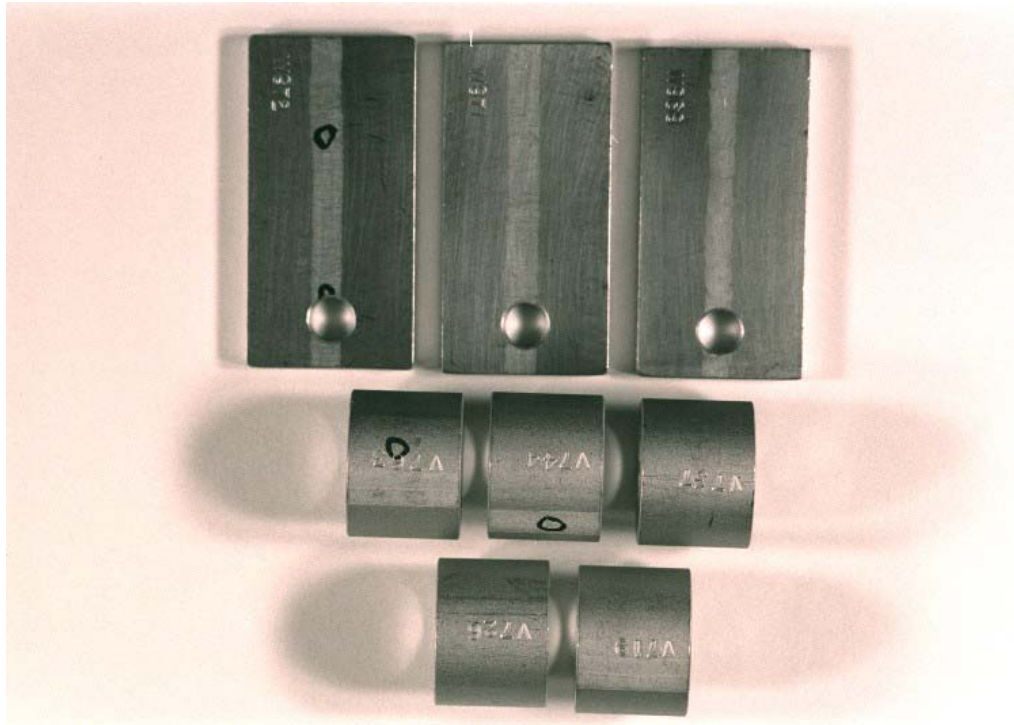
Figure C-31. Tank WM-188 corrosion coupons retrieved in 2002 (PN02-389-1-17).⁹

The highest calculated average corrosion rate for a set of coupons exposed at any level in Tank WM-188 was 0.042 mil per year and occurred at the 122-cm (48-in.) level.⁹ At that rate, the maximum average metal loss calculates to 1.58 mils (0.0016 in. or 0.51% of the internal thickness of the tank wall) over 37.9 years of tank service. The maximum corrosion rate observed for any single coupon from this tank was nearly the same at 0.043 mil per year and also occurred at the 122-cm (48-in.) level.⁹ Calculations using this maximum corrosion rate also indicate a metal loss from the internal surfaces of the tank of 1.63 mils (0.0016 in. or 0.51% of the internal thickness of the tank wall) over the 37.9 years of tank service. Tank WM-188 has a corrosion allowance of 50 mils (0.050 in.).

Visual examination of the corrosion coupons under a binocular microscope showed pit initiation similar to the coupons in Tank WM-187. Examination of the three welded tank bottom coupons, in place since 1988, revealed minor end-grain attack on the longitudinal edges of the rectangular coupons. The highest corrosion rates were found on the coupons at the 183-cm (72-in.) and 122-cm (48-in.) levels, while the bottom coupons had the lowest corrosion rate. This is similar to the results found on the coupons retrieved from Tanks WM-182 and WM-187.

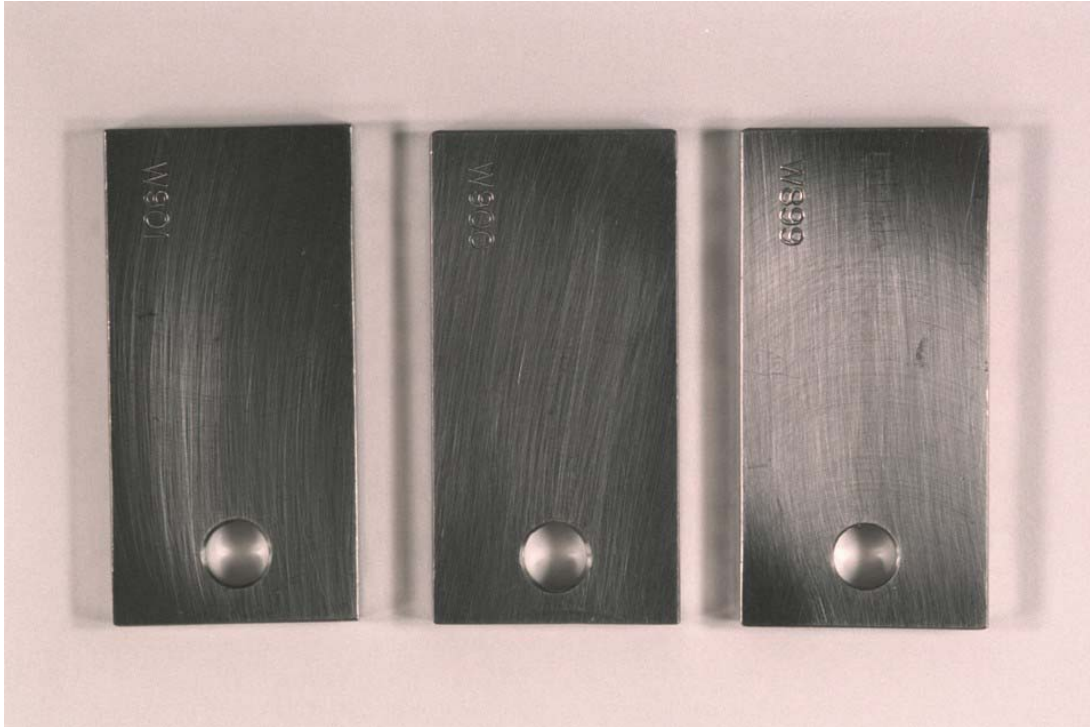
The average corrosion rate for the bottom coupons in Tank WM-180 was 0.0003 mil per year and occurred at the bottom level.⁹ At that rate, the maximum average metal loss calculates to 0.014 mil (0.000014 in. or 0.005% of the internal thickness of the tank wall) over 47.7 years of vessel service. The maximum corrosion rate observed for any single coupon from this tank was 0.0004 mil per year and also occurred at the bottom level. Calculations using the maximum corrosion rate for the tank indicate a metal loss from the internal surfaces of 0.019 mil (0.00002 in. or 0.006% of the internal thickness of the tank wall) over the 47.7 years of tank service. Tank WM-180 has a corrosion allowance of 50 mils (0.050 in.).

Examination of the three welded coupons at the tank bottom, in place since 1988, revealed no indications of localized corrosion. While the low corrosion rate and lack of localized corrosion on the bottom coupons are good indicators that the tank is in excellent condition, the data from the Tank WM-180 pipe section coupons are missing. Similarly, Tank WM-187 had no indications of localized corrosion on its bottom coupons, but did on the pipe section coupons. Lacking the pipe section coupons, a complete evaluation of Tank WM-180 cannot be made.⁹

Figure C-34. Tank WM-180 corrosion coupons retrieved in 2002 (PN02-389-1-3).⁹

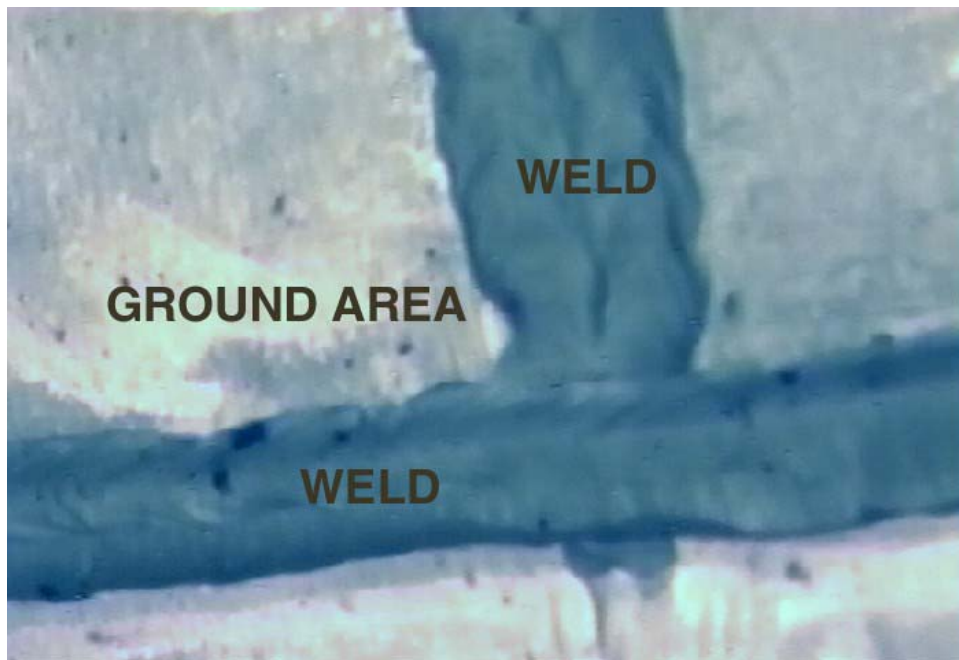
photographs shown in Figures D-4 through D-6 were taken using this system.⁴ The inspection concentrated on accessible areas containing welds that are considered the most likely areas for the initiation of localized corrosion. The inspection technique was to scan the walls for visual evidence of localized corrosion. The intersection of two welds of a typical weld area is shown in Figure D-4. This area would be exposed to high heat input from the intersecting welds that will increase susceptibility to intergranular corrosion. The weld joint area also would be an area of high residual tensile stress. No evidence is indicated of intergranular corrosion or cracking in the weld heat-affected zone within the limitations of the camera resolution and lighting techniques. Black spots on the surface of the weld and base metal appear to be surface deposits, but this cannot be confirmed with a two-dimensional inspection technique. The shiny area to the left of the weld intersection appears to be a grinding mark from the original fabrication.

Figure D-4. Weld intersection in Tank WM-188 (PD03-0029-05).⁵

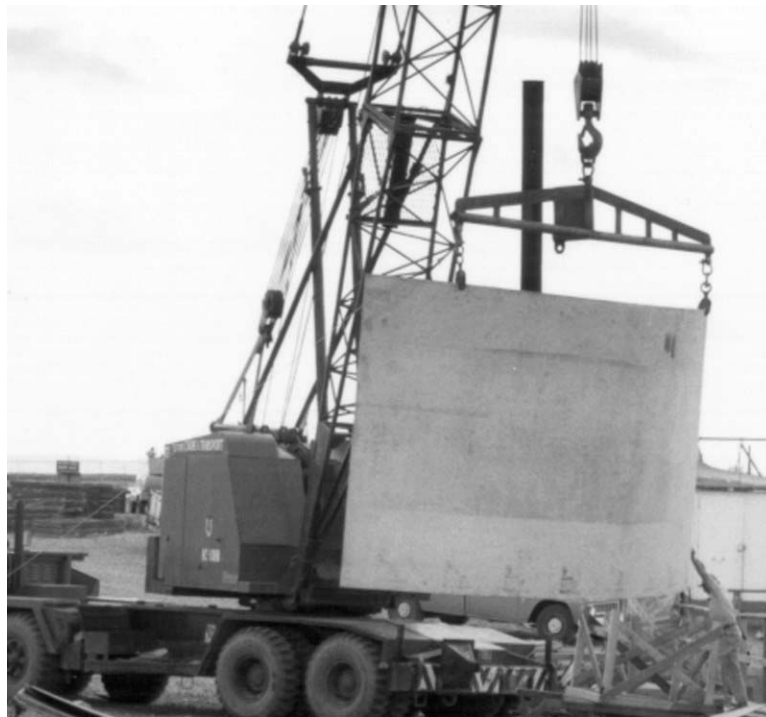
Figure D-5 shows a horizontal weld with indentations in the plate next to the weld. The indentations are believed to be marks where a mechanical lifting device was fastened to the plate, as shown in Figure D-6. Other spots on the surface are shown that cannot be measured for convexity or concavity because the two-dimensional video image could not be interpreted.

Figure D-6. Hoisting of plate section showing lifting device (63-6763).⁵

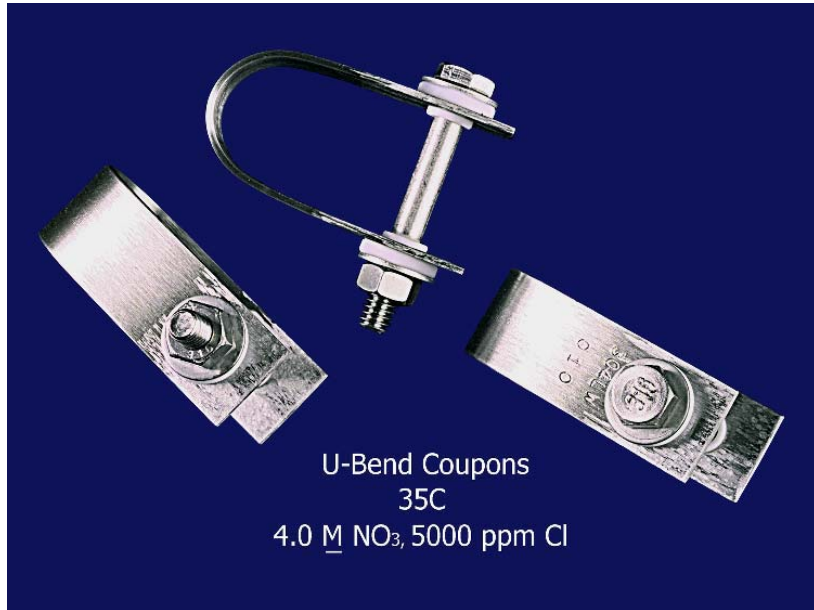
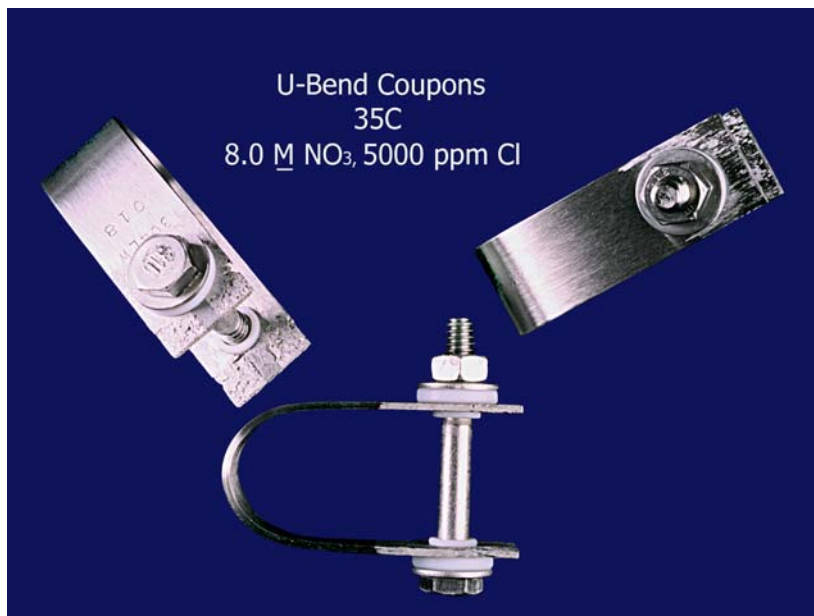
Figure E-1. U-bend coupons from first phase of 2001 corrosion testing (PD010403-2-15 and PD010403-3-15).⁸

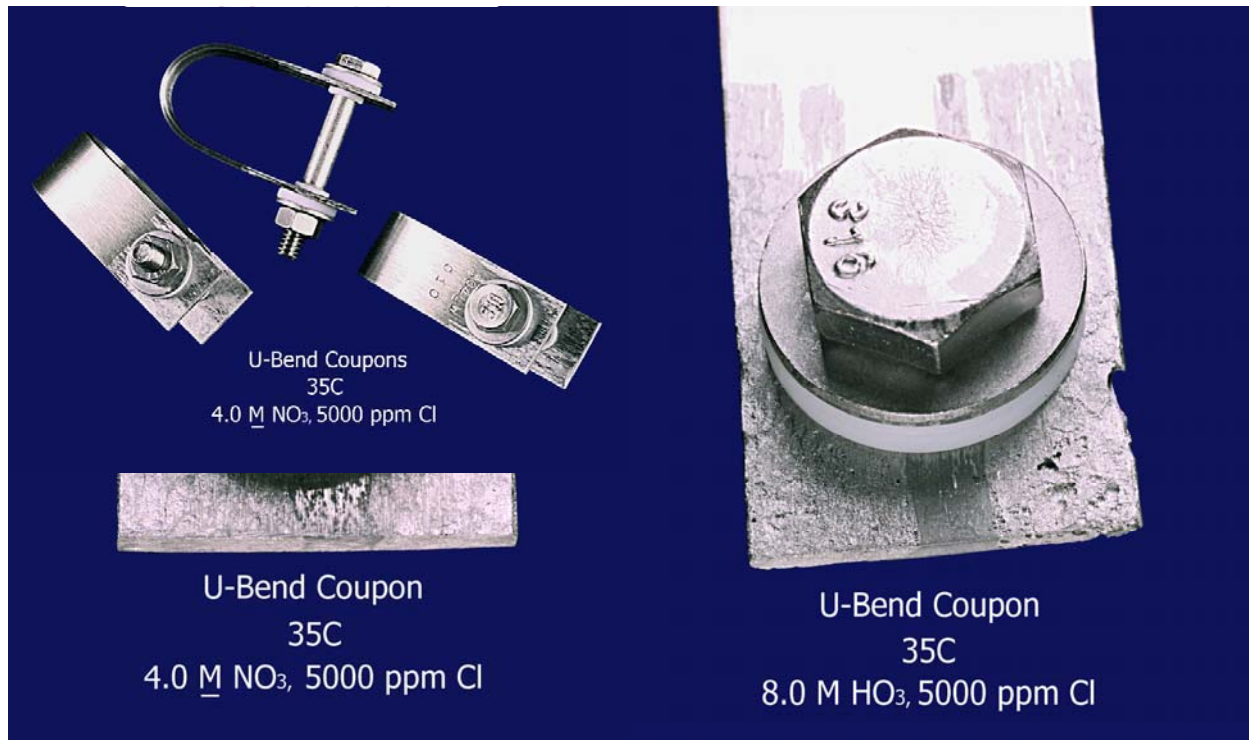
Figure E-2. Close-up of U-bend coupons from first phase of 2001 corrosion testing (PD010403-4-22 and PD010403-4-25).⁸

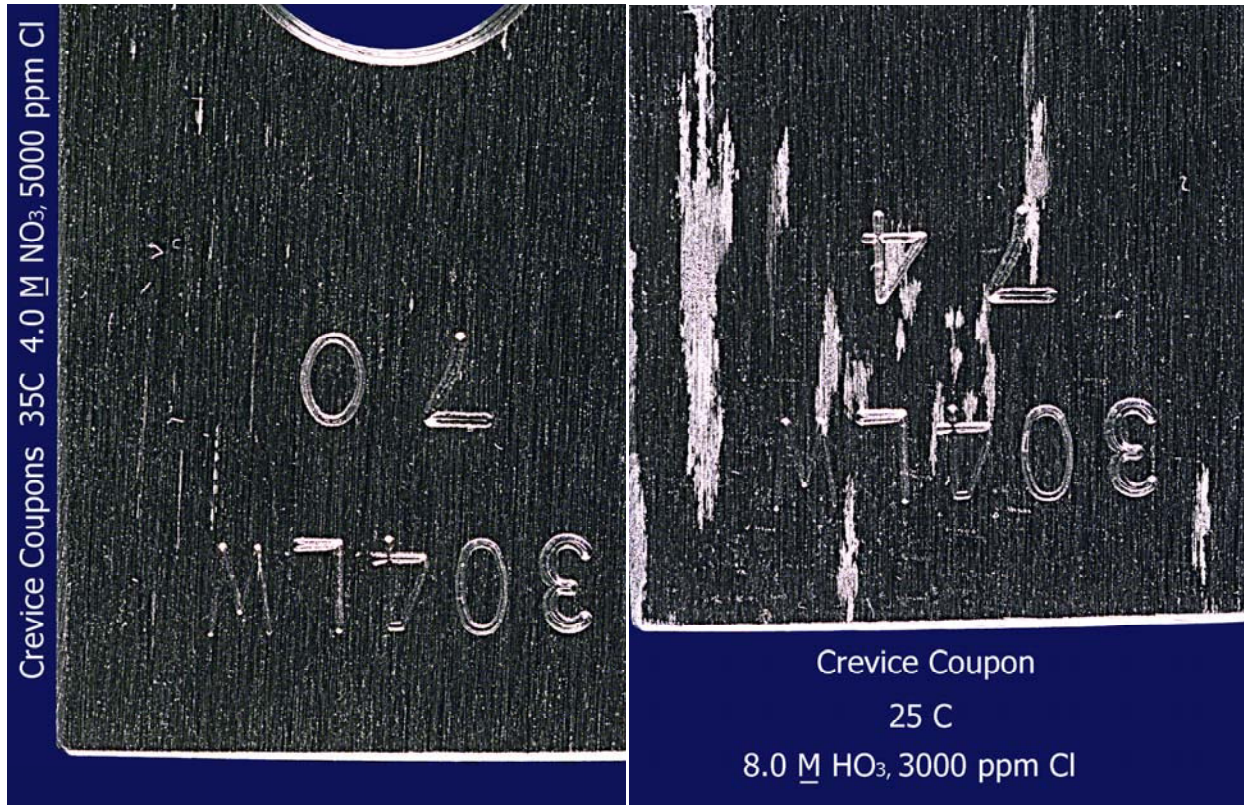
Figure E-3. Crevice coupons suspended above solution noted (PD010403-3-20 and PD010403-4-21).
