Examination of the 1970 National Bureau of Standards Underground Corrosion Test Welded Stainless Steel Coupons from Site D

L. R. Zirker
M. K. Adler Flitton
T. S. Yoder
T. L. Trowbridge

January 2008

**Idaho National Laboratory
Environmental Management Science Program
Idaho Falls, Idaho 83415**

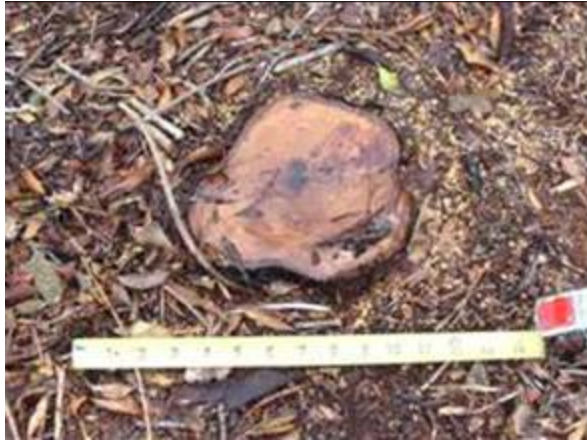
When the team began excavating the 1970 trench, groundwater was struck at about 10-in deep. The slurry of sand and water along with sizeable tree roots made the coupon removal difficult and severely retarded the excavation of the samples, as shown in Figures 9 and 10. The Coast Guard facilities manager related that the removal of drainage ditches and changing the roadways over the years has radically changed the groundwater. All of the coupons were under water, and the trench had to be pumped to facilitate retrieval. As a result of the high groundwater conditions, only the 1970 trench with its 51 coupons were recovered.

Figure 9. Trees and roots made for difficult excavation.

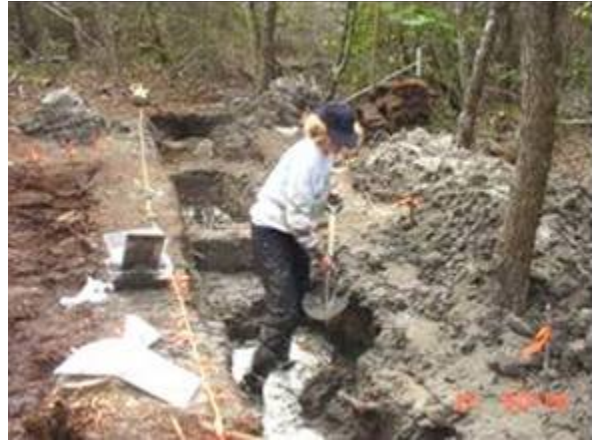
Figure 10. Slurry of soil and water made for difficult excavation.

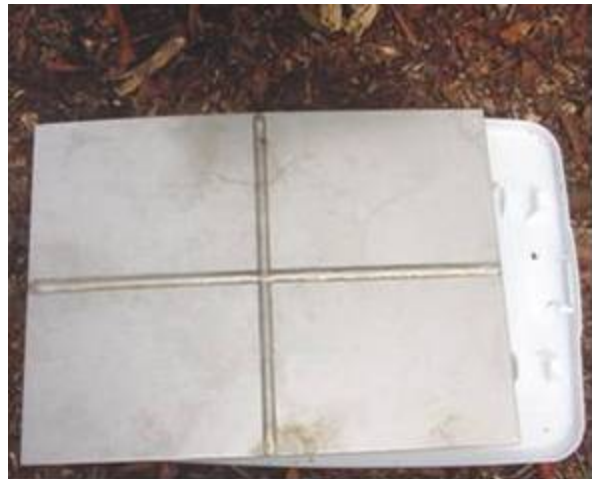
Figure 12. Cross-bead welded plate after retrieval.

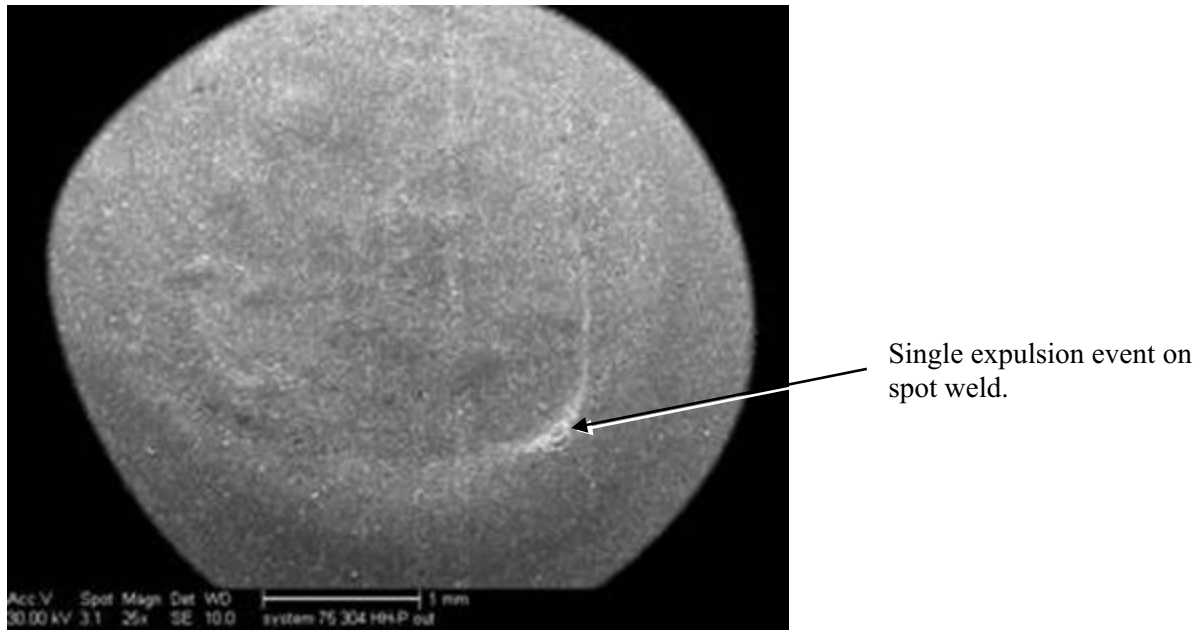
Figure 35. System 75 (Type 304) ESEM 25X photograph of spot weld.

Single expulsion event on spot weld.

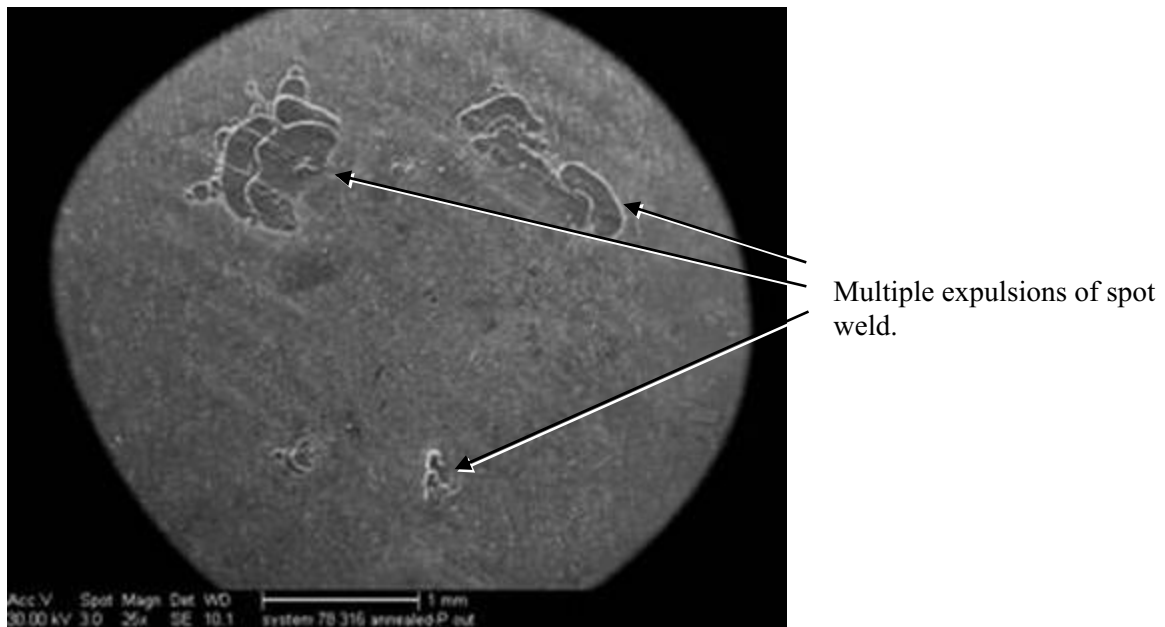
Figure 36. System 78 (Type 316) ESEM 25X photograph of spot weld.

Multiple expulsions of spot weld.

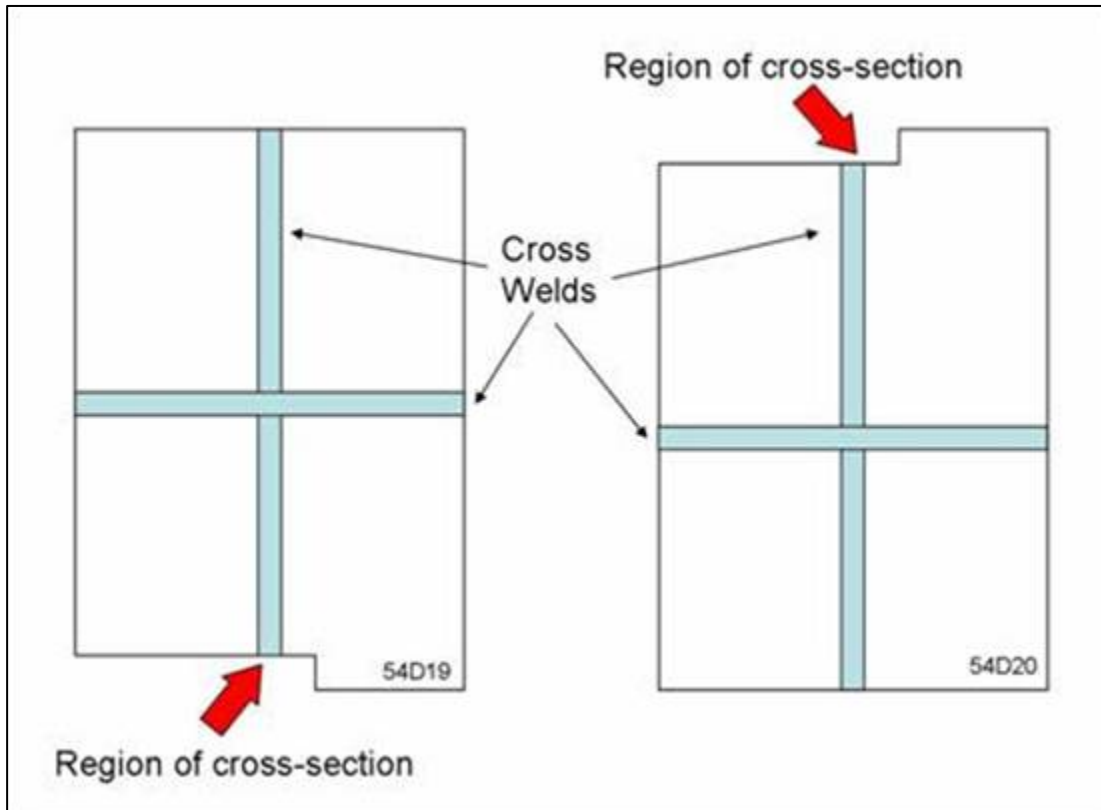
The following sketch, Figure 48, shows the locations on the plates where sections of both cross bead plates were removed for metallurgical analysis. These were also the locations of the pitting on the plates as illustrated in the metallographic cross sections of the welds, Figures 49-51.

Figure 48. Locations on plates where pits were located and where sections were removed.

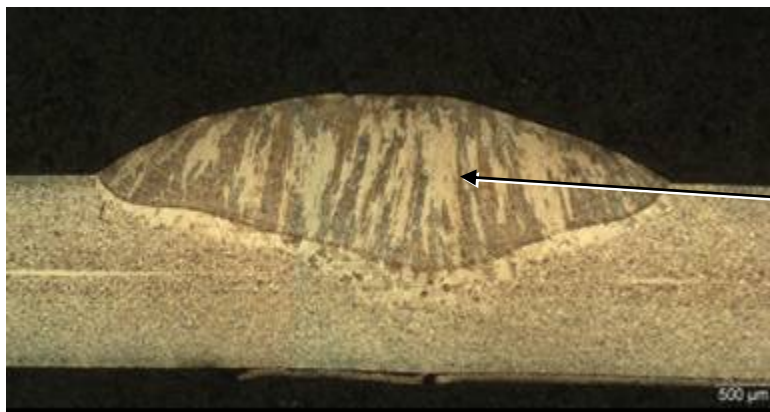
The plate is 0.06-in thick and the weld is about 0.2-in wide. (Lippold et al., 2007).

Figure 49. End view of cross sectioned weld about 1-in from the edge of the plate, sample 54D19.

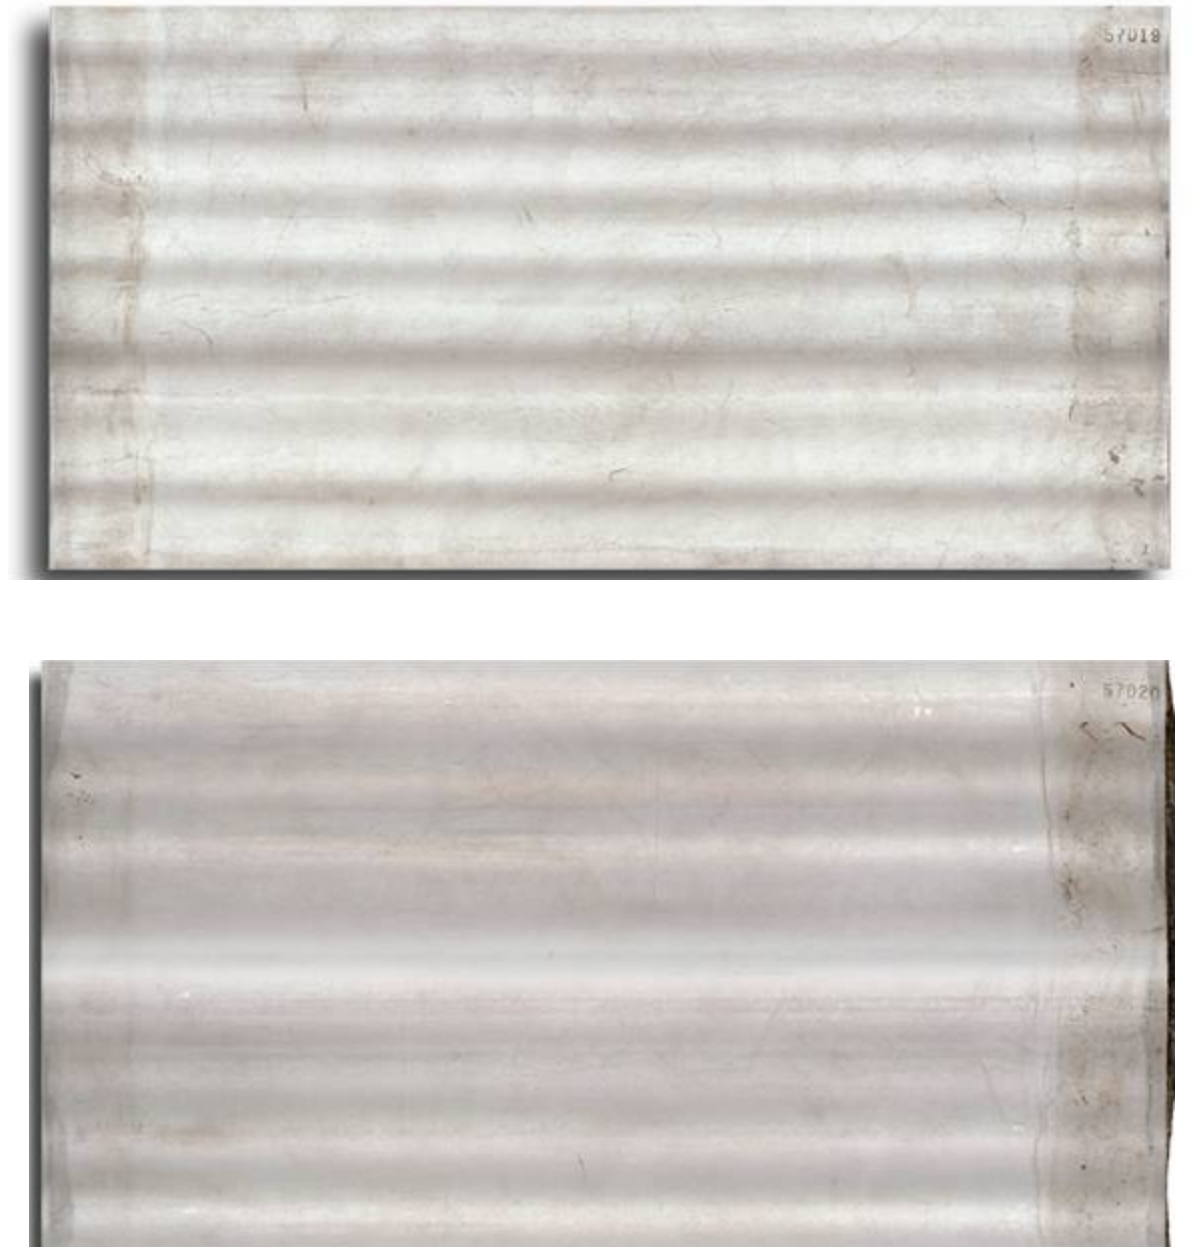
Figure 53. System 57 collages, coupons 57D19 and 57D20.

To better show a comparison of the corrosion on the two system 57 welded coupons, a series of photographs were taken of both coupons. These photographs were digitally combined to form a collage of the whole tube. The tubes show minor staining from under the cap. These two are shown in Figure 53.

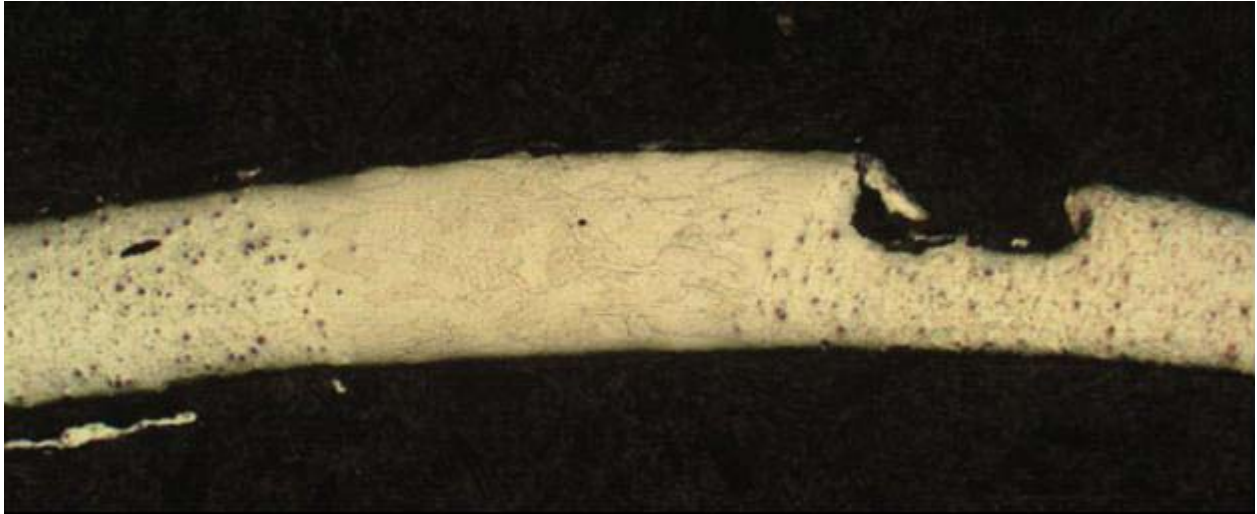
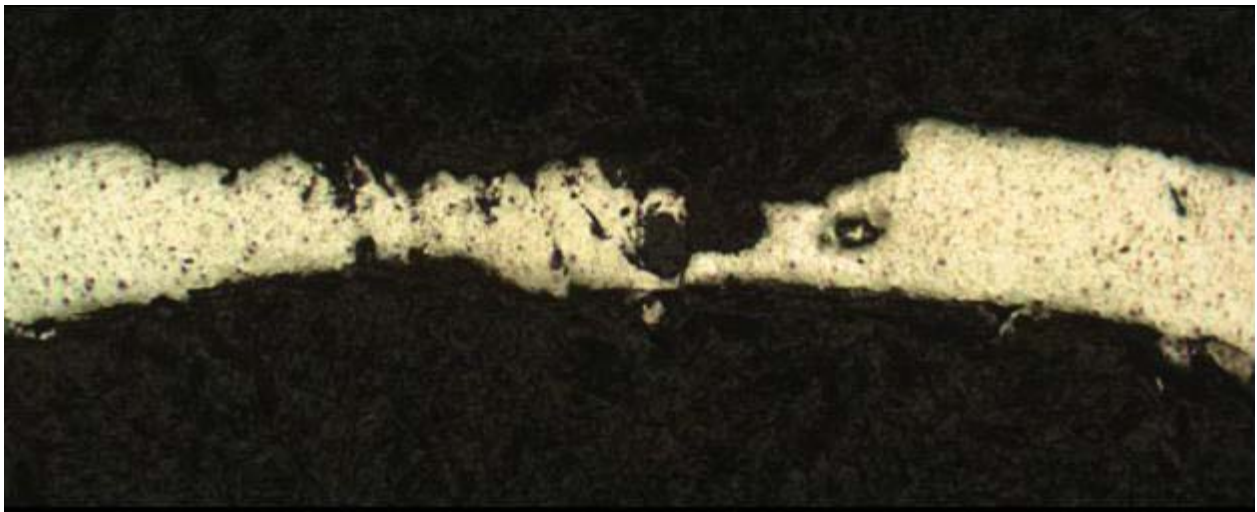
In contrast, attack of the Type 409 tube samples was very severe with complete penetration through the tube wall (Figures A.2 and A.3). In general, the HFI welded tube appeared to be more severely attacked. Corrosion was associated with both the weld and the base metal. The corrosion was directional along the axis of the tube, indicating that the rolling direction and segregation during thermo-mechanical processing of the tube influences the rate of corrosion. The more severe corrosion in the HFI-welded tubes is most likely related to the condition of the base metal, rather than some effect of the welding procedure.

Figure A.10. Cross sections of seam welds in Type 409 tubes. Top – GTA weld, Sample 62D19. Bottom – High-frequency induction weld, Sample 63D20. Magnification, 25X.
