# **SANDIA REPORT**

SAND2009-0180

## **Technical Advisory Team (TAT) Report On the Rocket Sled Test Accident of October 9, 2008**

Prepared by Sandia National Laboratories for the NNSA Accident  
Investigation Board

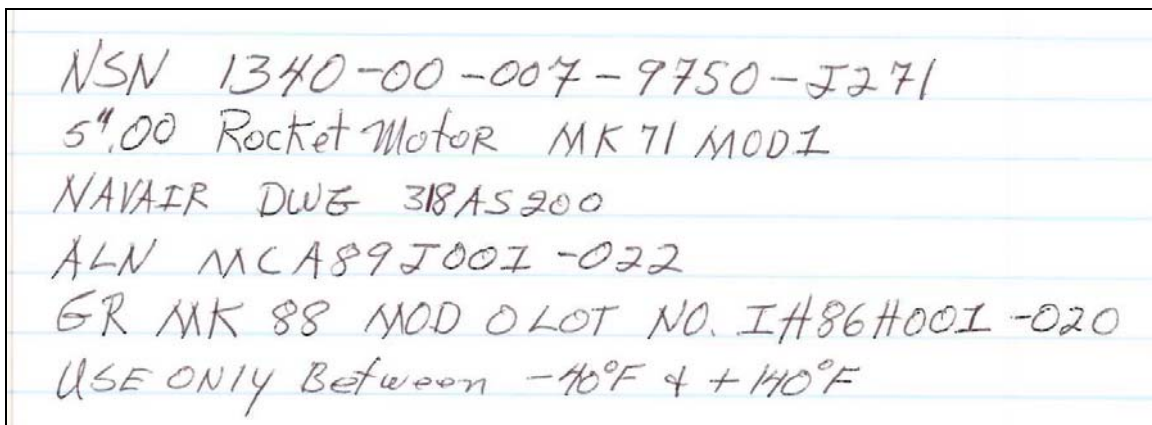
**Figure 1. Data Taken from Spent Rocket Motor**

The markings on the actual rocket motor under consideration indicate that it was an Mk-71, Mod 1 system. Figure 1 was taken from the actual motor by Ed Garavaglia (Sandia National Laboratories) for verification.

Two igniter types are used in the Mk 71 motor (Naval Air Systems Command). The Mod 2 version of this rocket contains an igniter that is certified to not be susceptible to ESD and hazards of electromagnetic radiation ordnance (HERO). The Mod 1 version of this rocket motor (this motor type) is considered ESD and HERO susceptible, meaning that ESD and electromagnetic (EM) energies should be considered as potential ignition sources.

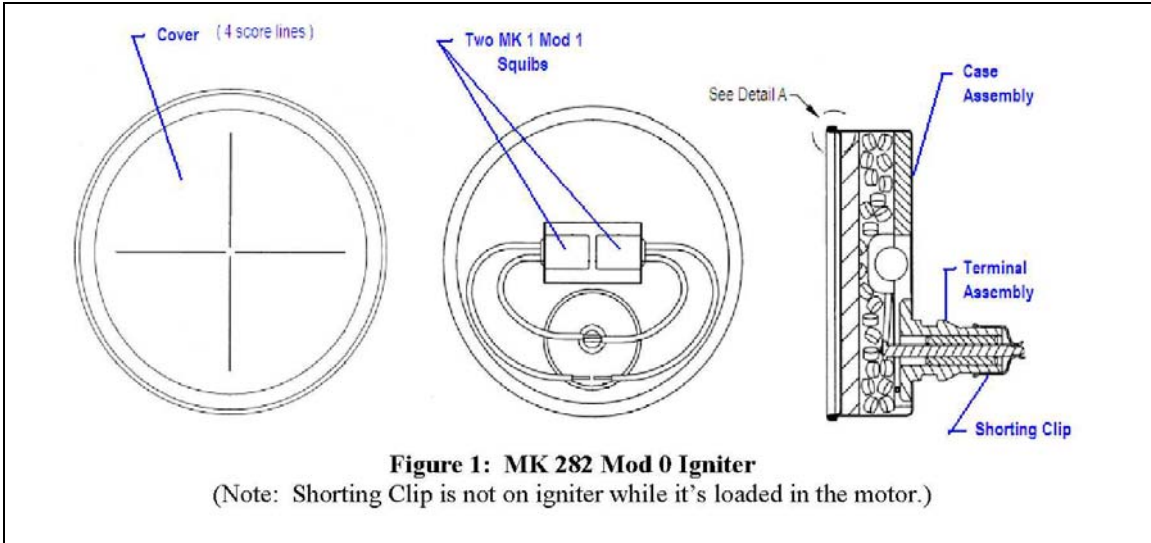
**Figure 2. Mk 282 Mod 0 Igniter**

The igniter used in this rocket motor was an Mk 282 Mod 0 igniter (assuming original equipment). This igniter (see Figure 2) consists of a steel can containing two each Mk 1 Mod 0 electric squibs connected electrically in parallel and filled with approximately 35 grams of  $\text{BKNO}_3$  propellant (see Appendix B).

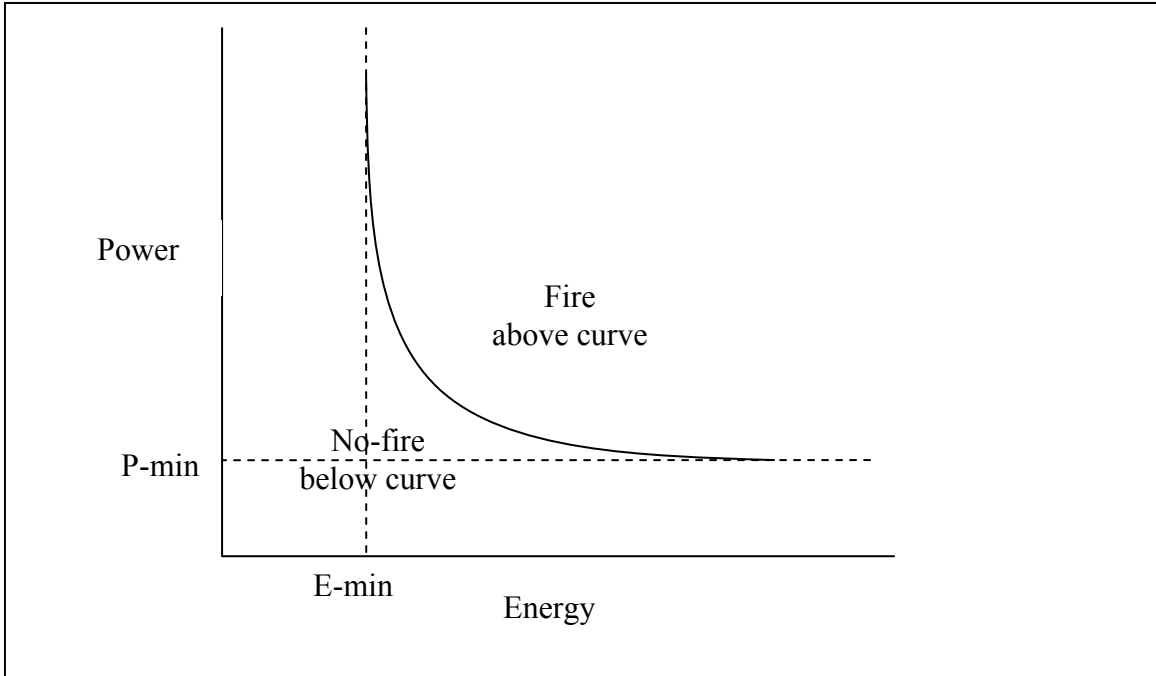
**Figure 4. Power and Energy Relationship for Mk 1 Mod 0 Squib**

This initiation requirement for this squib can, at first order, be described via a hyperbolic relationship between power and energy, along with some associated statistical uncertainty. If the energy AND power are at minimum levels, the initiator will fire—this relationship is regular, but not constant except for very high levels of power (where minimum energy should be constant) or very high levels of energy (where minimum power should be constant).

Typically, when testing for these parameters, a multitude of measurement obstacles must be overcome. A variety of strategies and standards have been developed over the years to attend to these obstacles, but coupled with manufacturing variations, these processes naturally lead to a statistical assessment of the power and energy parameters. As well, various techniques provide for specific results for a particular configuration. Therefore, absolute results from various techniques will not be exactly the same. For example, results from a capacitor discharge test technique will produce comparable values for a capacitor discharge firing circuit. However, a capacitor discharge is neither constant power nor constant energy and, therefore, it cannot be easily plotted on the curve in Figure 4 below. If, however, the curve is known entirely, then the likelihood of initiation can be derived mathematically.

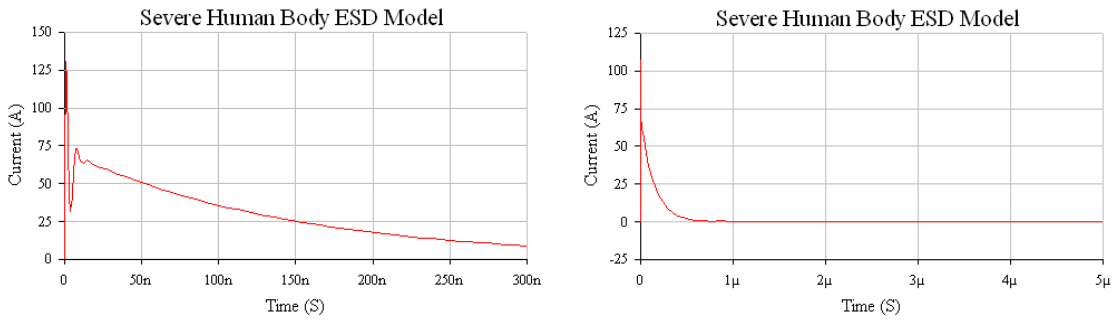
**Figure 8. Waveforms Extended in Time**

Allowing these waveforms to extend out in time and settle to zero, and then integrating, we get a value of 0.123 mJ per squib. (See Figure 8.)

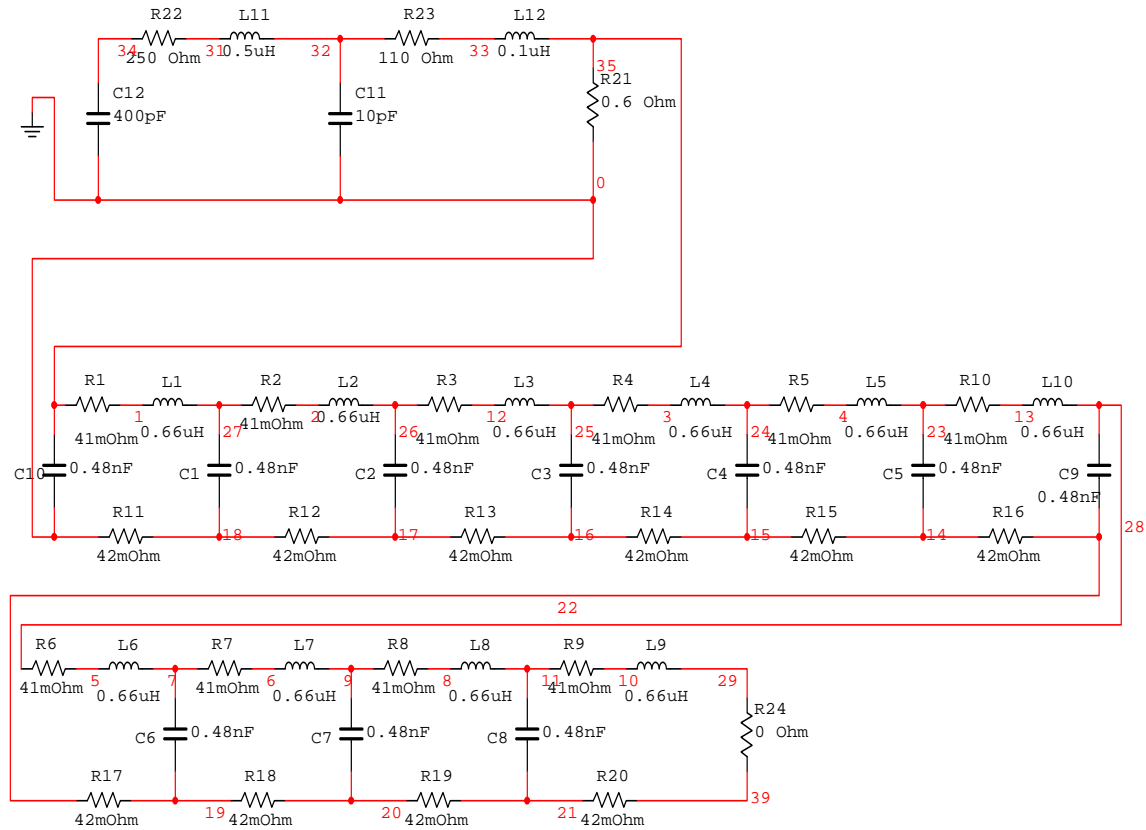
**Figure 10. Circuit Representation**

The energy accumulated in one squib from this configuration is negligible.

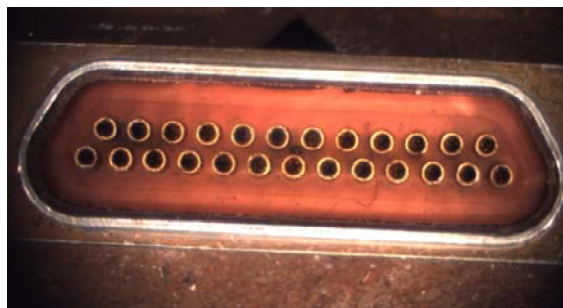
**Figure 11. Clean, New Connector**

- The HiCap recorder has an exposed miniature MDM 25-pin connector with metallic exposed pins labeled as Connector J2. The case of the J2 connector is electrically connected to the housing and, therefore, to the rocket body. There was potential evidence of arcing present on the connector body next to J2 - Pin 4 (see Figure 11, Figure 12, Figure 13, and Figure 14 below), although extensive chemical analysis of this evidence is still in process to definitely identify the marks as char or not. Although evidence of charring would greatly substantiate this proposed scenario, the TAT believes the proposal is still valid without evidence of charring. Not all short circuits will produce combustion products.

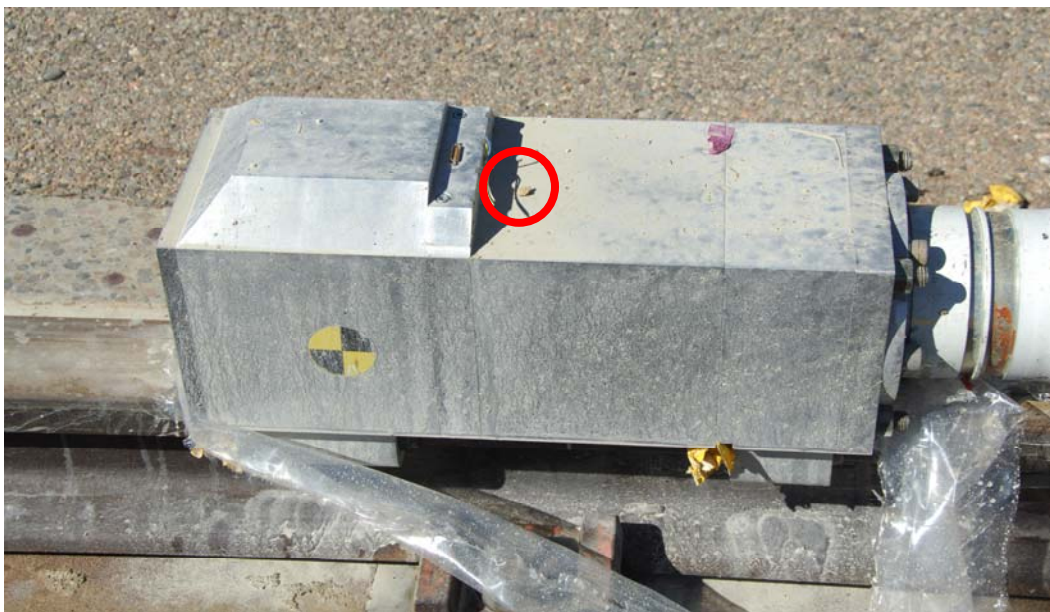
**Figure 18. HiCap Recorder Showing Loose Signal Wires**

- The battery ground was brought outside the package with a dedicated wire that was one of a pair of wires used to trigger the HiCap recorder to start recording. The battery ground was NOT current limited. This connection was found to be grounded to earth ground at the junction/panel box due to a short in the facility wiring. Note that the facility wiring should have been isolated from ground, but due to a fault in the facility wiring, it was, in fact, grounded. The wire was connected to the panel box as shown below in Figure 17.

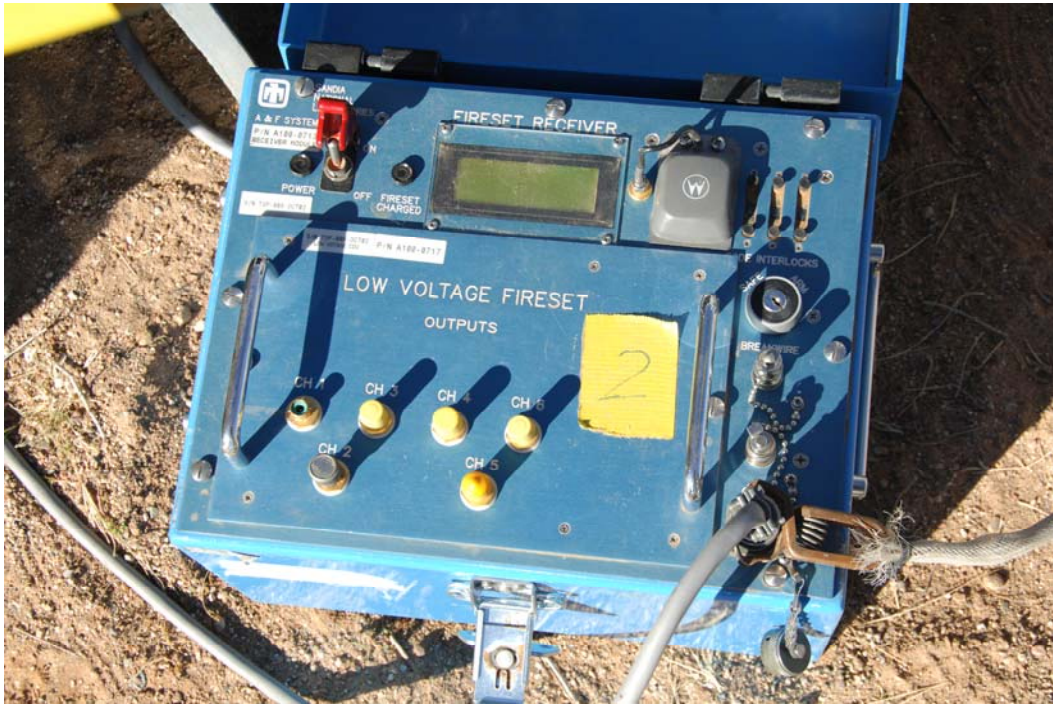
Figure F-1. Fire Set Planned for Use to Initiate Rocket Motor Initiators
