Failure Analysis: Wastewater Drum Bulging

P. R. Vormelker
Savannah River National Laboratory
PO Box 616 Building 773-41A
Aiken, South Carolina
Phone: (803) 725-4469
Fax: (803) 725-4553
e-mail: phil.vormelker@srnl.doe.gov

Abstract

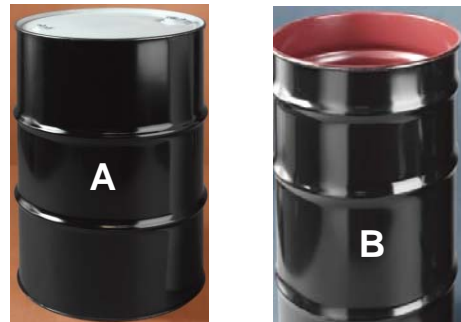
health hazard diamond which designates that a NFPA hazard determination was made for the wastewater in these drums. The 55 gallon drums were manufactured from carbon steel with an epoxy phenolic coating on the interior as shown in Figure 5. The drums are approximately 35 inches tall and 23 inches in diameter. The epoxy phenolic coating has a one mil nominal thickness.

Figure 5. Exterior view of new 55 gallon carbon steel tight head drum (A) in left photo with red epoxy phenolic lined drum (B) shown in right photo (Vendor photographs). Note that the B drum has an extra rolled hoop near the top. SRS drums have two roll hoops as shown in A.
