Bioassay Vessel Failure Analysis

Philip R. Vormelker
Savannah River National Laboratory
PO Box 616 Building 773-41A
Aiken, South Carolina
Phone: (803) 725-4469
Fax: (803) 725-4553
e-mail: phil.vormelker@srl.doe.gov

Abstract

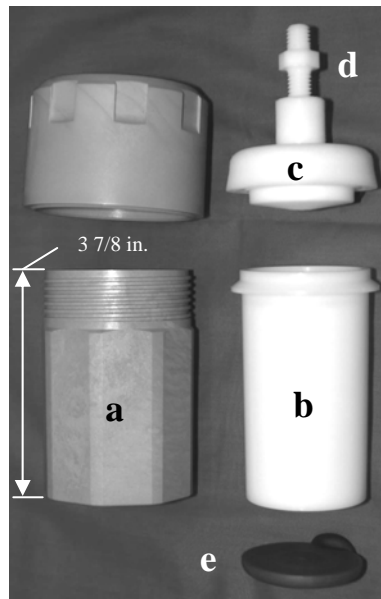
The vessel design, Figure 2, includes an inner vessel with a slip on cap that holds the pressure relief device. The pressure relief device includes a threaded nozzle with an internal hole and a pressure relief disk. The threaded nozzle is made of PTFE

Figure 2. Components of outer (a) and inner (b) vessels and caps. The inner vessel cap (c) includes a threaded pressure relief nozzle (d). Thermal shield (e) is inserted in bottom of outer vessel.

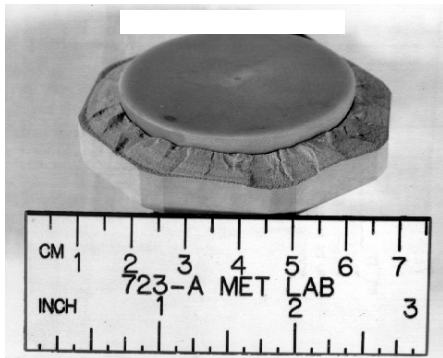
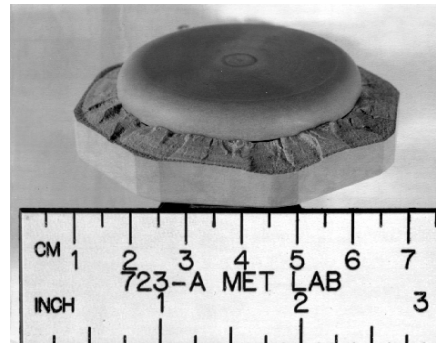
Figure 3 shows that the bottom of the outer vessel fractured with no visible cracking in the upper part of the vessel. The cap did not fail. In Figure 4, the thermal shield is inserted into the bottom piece of the vessel in the upright position. The top surface of the shield is above the fractured surface. However, when the shield is shown upside down (Figure 5), the position of the fractured surface is near the bottom edge of the shield. This substantiates the manufacturer position that the vessels will fail with an inverted thermal shield. When the thermal shield is installed correctly, the installed inner vessel and cap will look like Figure 4. When installed incorrectly, there is a slight gap, approximately 1/16 inch, as shown in Figure 5. The upside down position of the thermal shield would therefore impose additional compressive stresses on the inner vessel.

Polytetrafluoroethylene (PTFE) is used for the inner vessel (Figure 5) primarily for its superior chemical inertness. The actual material is Dyneon TFM™ PTFE 1700, a modification of Dupont PTFE. The mechanical properties of the Dyneon TFM™ PTFE 1700 (Table 1) show that tensile strength is approximately 5800 psi and the elongation is 650% at room temperature [3]. At 204°C and 260°C, the tensile strength drops significantly to 1250 psi and 870 psi, respectively. The 870 psi value is based on Dupont PTFE data [4] and may be slightly higher than that for the Dyneon PTFE. Elongation values above room temperature are not available but are assumed to be higher than those at room temperatures. While there is no definitive glass transition temperature for PTFE, the softening temperature is 260°C and also the continuous use temperature for this version of PTFE. This is above the standard bioassay test temperature of 220°C.

Figure 5 Inner vessel shown inserted into outer vessel with inverted thermal shield as shown in lower photo. Note $\sim 1/16$ inch gap at B between inner vessel and top of outer vessel.

Three bioassay vessels failed in the SRS bioassay laboratory facilities during October-December, 1999. The first vessel failure is attributed to incorrect placement of the thermal shield disk. A bright color stripe is suggested for use at the top of the inner vessel to allow quick identification of improper placement of the thermal shield. The second vessel failure is attributed to overpressurization based on calculations and failure of the pressure sensor. No flaws were found in this vessel that would impair structural integrity. Overpressurization could be due to high inner vessel pressure and/or moisture in the annular space. Although the failed vessel from October 2 was not available, it is similar in appearance to the December 13 failure and high pressures are suspect. A digital display of the temperature and pressure may be necessary to allow the operator to respond to faulty sensors. The use of thicker, cylindrical vessels or poly-reinforcement type webbing wrapped around the outer vessel would provide additional pressure protection. If possible, content weight should be reduced to allow a lower operating pressure. Since moisture can cause pressure in the annular space, the vessels need to be as dry as possible to minimize pressure buildup. Because thermal aging of the vessels may be detrimental to their performance, it is recommended that additional tests be performed in order to determine the cycle life. Testing is also needed to verify uniform heating and pressure generation at maximum temperatures for all vessel locations.
