DESTRUCTIVE EXAMINATION OF SHIPPING PACKAGE 9975-02028

Publication Date: December 2009

**Savannah River Nuclear Solutions
Savannah River Site
Aiken, SC 29808**

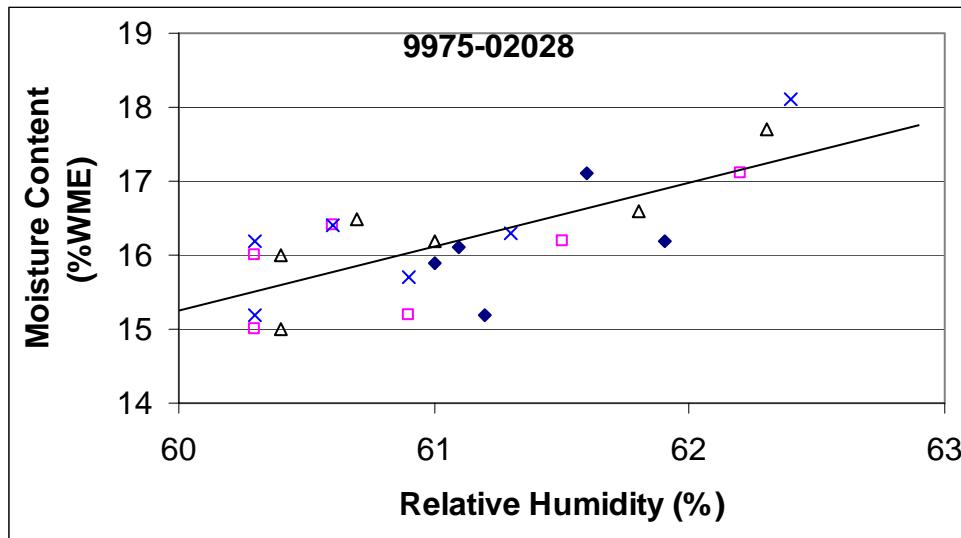
Consistent with recent efforts to correlate moisture content of fiberboard with humidity in the surrounding air, several sets of data were taken to correlate these two parameters. The fiberboard was placed back in the drum with a narrow channel cut down the side. A humidity probe was placed in this channel such that it could be raised and lowered with the drum closed. The edge of the drum lid was taped to seal around the gap created by the humidity probe cable. After the humidity came to equilibrium, humidity readings were taken at several elevations along the fiberboard, and the fiberboard was then removed to measure the moisture content at those same locations. This process was repeated several times to show the consistency in the results. These data is summarized in Figure 5. The trendline in this figure highlights the expected relationship of humidity increasing with the moisture content. However, the range of data is too narrow to place much confidence in the magnitude of the trendline slope.

Figure 5. Correlation between fiberboard moisture content and relative humidity of the adjacent air. Measurements were taken along the fiberboard OD surface.

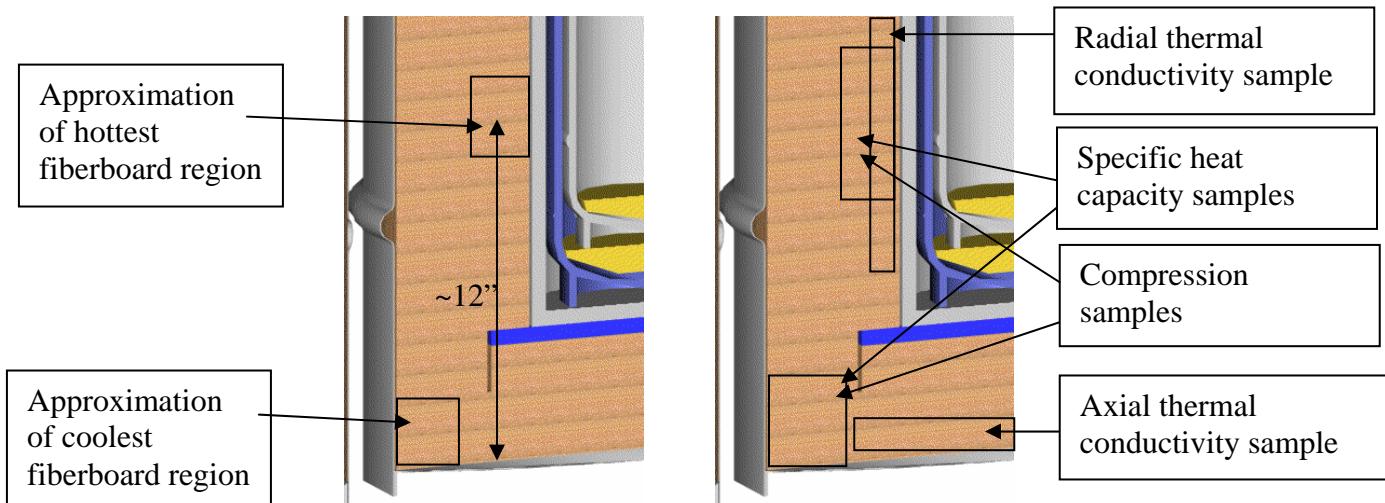
Samples of fiberboard were removed from the bottom fiberboard subassembly to measure compressive strength, specific heat capacity and thermal conductivity. The source location(s) of these samples is illustrated in Figure 6. The thermal conductivity sample from the bottom center of the subassembly is oriented for heat flow in the axial direction (perpendicular to the glue joints). The thermal conductivity sample from the side is oriented for heat flow in the radial direction (parallel to the glue joints). Testing on each sample was performed at a nominal (mean) temperature of approximately 25°C (77°F), with no environmental conditioning. Physical data on the fiberboard samples are recorded in Table 2.

Figure 6. Illustration of fiberboard regions of the bottom subassembly to be tested. Multiple samples (where used) were removed from the illustrated locations at different circumferential positions. Not to scale.

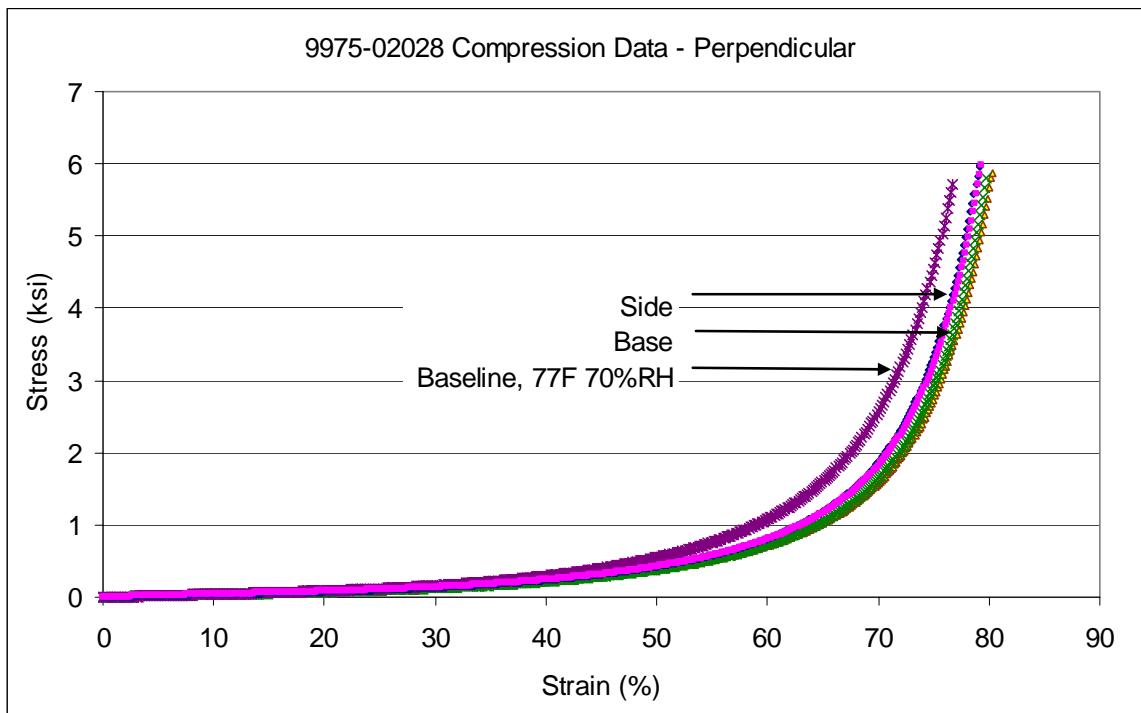
The compression test data are shown in Figures 7 and 8, along with select baseline data. For both the perpendicular and parallel orientations, the compression strength of the 9975-02028 samples is similar to the baseline samples conditioned at 77°F and 70% RH. A series of photographs showing typical compression behavior under parallel loading is shown in Figure 9.

Figure 7. Fiberboard compression test data, compared with typical baseline (77°F, 70% RH) data, in the perpendicular orientation (i.e. load applied perpendicular to the fiberboard layers).

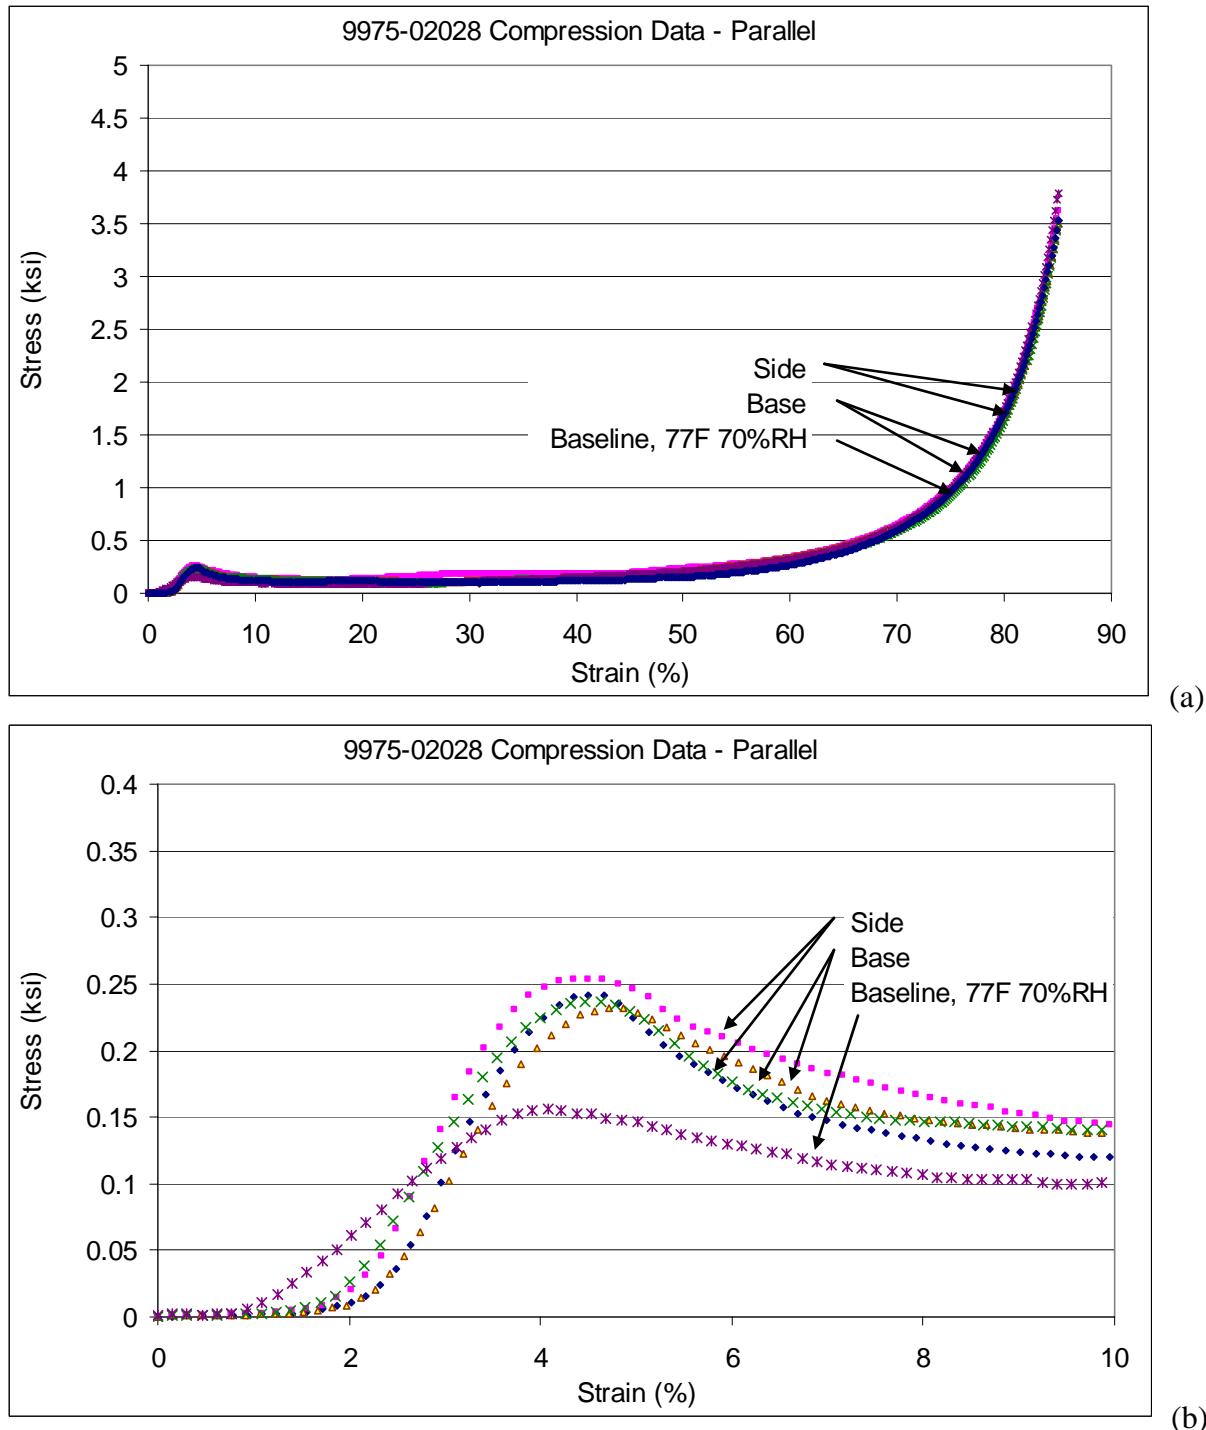
Figure 8. Fiberboard compression test data, compared with typical baseline (77°F, 70% RH) data, in the parallel orientation (i.e. load applied parallel to the fiberboard layers). The full curves are shown in (a), while the initial buckling region is expanded in (b).

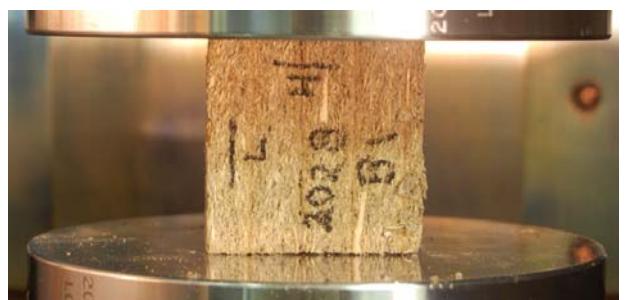
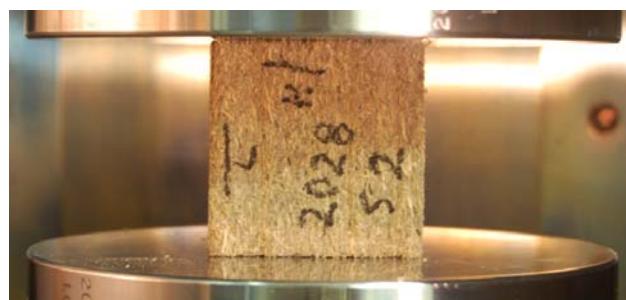
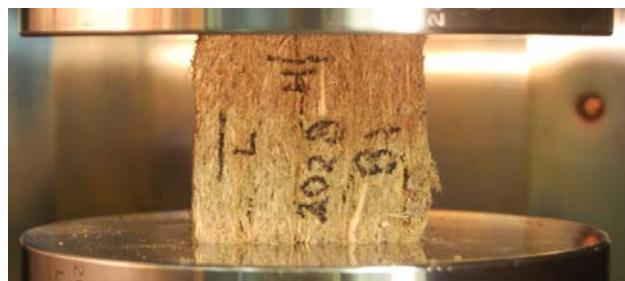
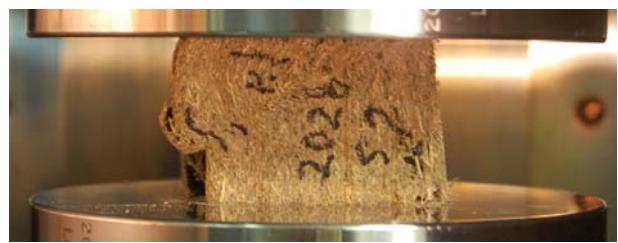
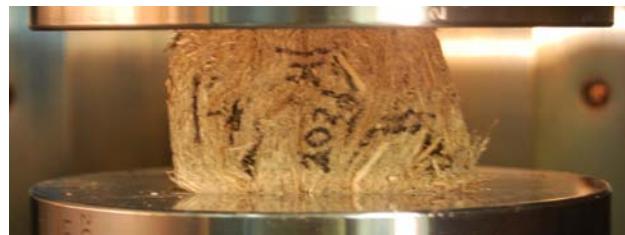
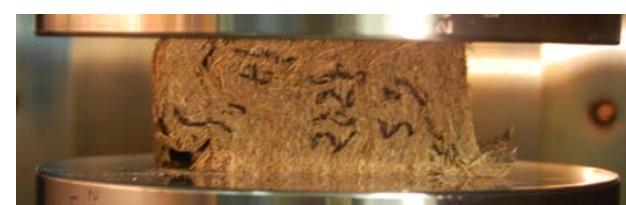
(a) Sample B1 from base of subassembly

(b) Sample S2 from side of subassembly

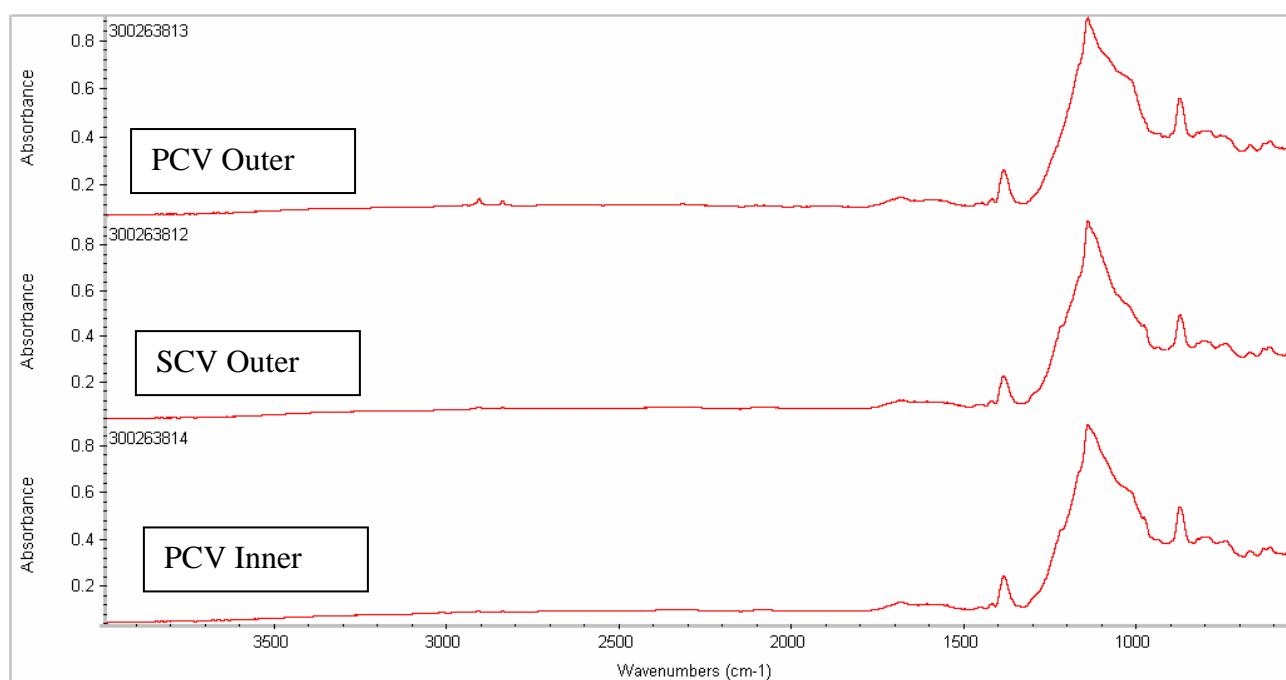
FT-IR spectroscopy generically identified the composition of each O-ring as consistent with a Viton® type fluoroelastomer (Figure 11). Viton® A produces a spectrum nearly identical to Viton® GLT, the base polymer for the specified O-ring compound (Parker Seals V0835-75) and the two are difficult to distinguish by FT-IR analysis alone. Additional test techniques (e.g. dynamic mechanical analysis,

Figure 11. FT-IR spectra for the three tested O-rings. Each spectrum is consistent with a Viton® type fluoroelastomer.

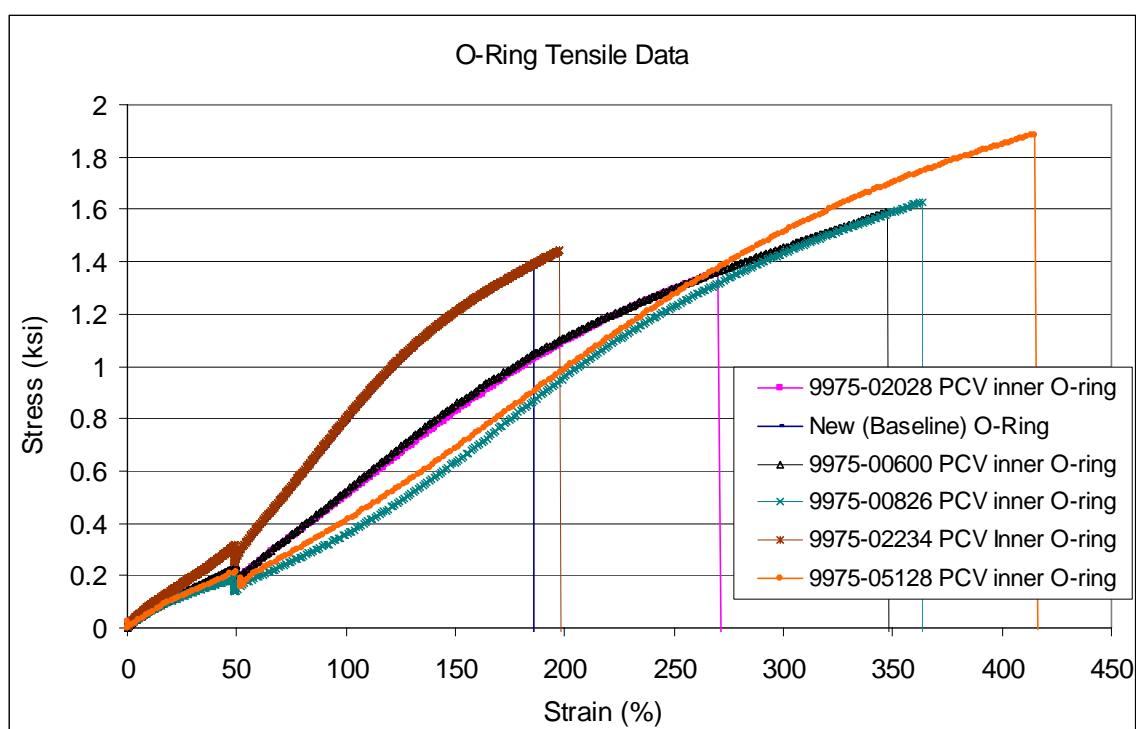
The PCV inner O-ring was tensile tested in accordance with ASTM D1414, using a cut (single strand) sample. The test was interrupted at 50% strain to visually examine the O-ring for signs of cracking or other degradation. None were observed. The stress-strain curve for the PCV inner O-ring is shown in Figure 14 along with curves from a new O-ring and from previous destructive examinations. The O-ring from package 9975-02028 displayed tensile properties (strength and elongation) consistent with that observed in previous examinations. The elongation (271%) of this O-ring exceeds the minimum value specified in AMS-R-83485 for new O-rings (120%), while the tensile strength (1.4 ksi) is slightly less than the value specified (1.6 ksi) [12]. While Parker Seals does not change the formulation of these O-rings, there are batch variations.

Figure 14. Tensile data for PCV inner O-ring from 9975-02028, compared to a new O-ring and the PCV O-rings from previously examined packages.

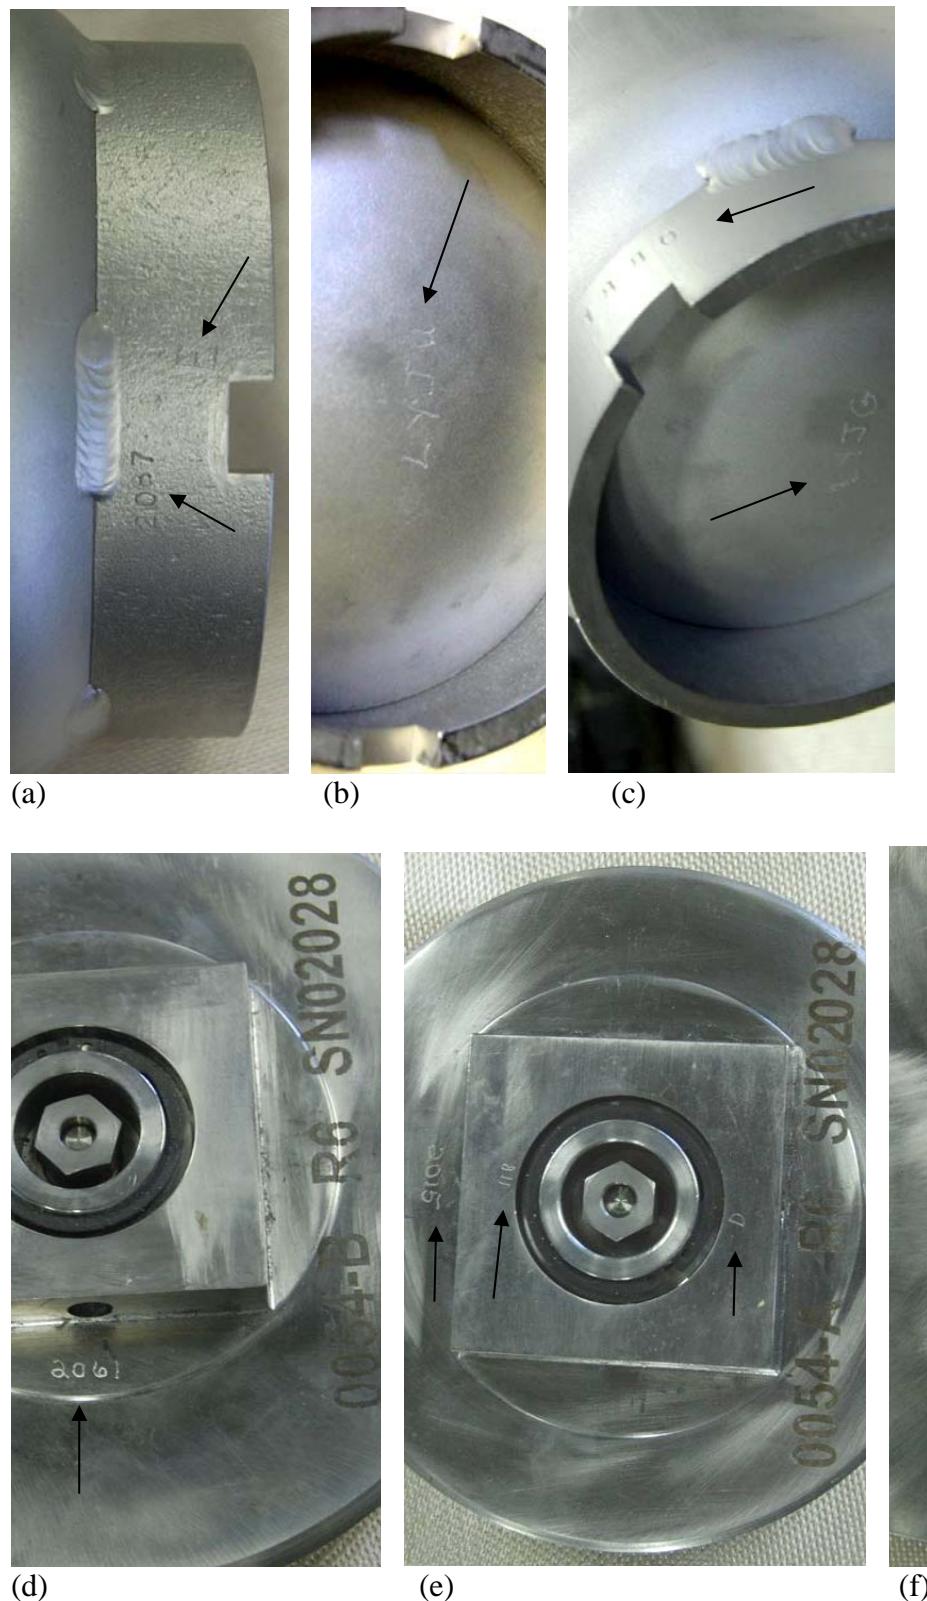
A general visual examination was performed on all metallic components. Aside from the corrosion of the lead shield (discussed above) no significant damage or degradation was observed, although a small spot (~1/8 inch diameter) on the PCV exterior surface had the appearance of a stain or superficial rust (Figure 15). Several components were observed to have fabrication markings. Various markings were stamped or engraved on the containment vessels and lids (Figure 16). These markings appear to be identification numbers used during manufacture, prior to association of the parts with a final package number.

Figure 16. Fabrication markings (at arrows) on SCV (a, b), PCV (c) SCV lid (d) and PCV lid (e, f)
