NUREG/CR-3950  
PNL-5210  
Vol. 7

# Fuel Performance Annual Report for 1989

Prepared by  
W. J. Bailey, F. M. Berting/PNL  
S. Wu/NRC

**Pacific Northwest Laboratory**  
Operated by  
Battelle Memorial Institute

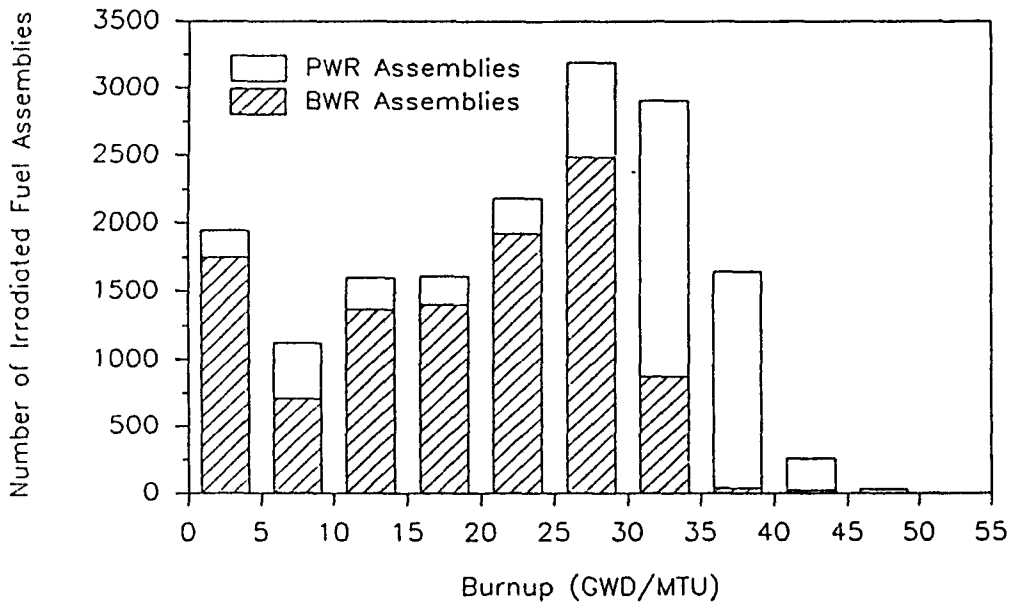
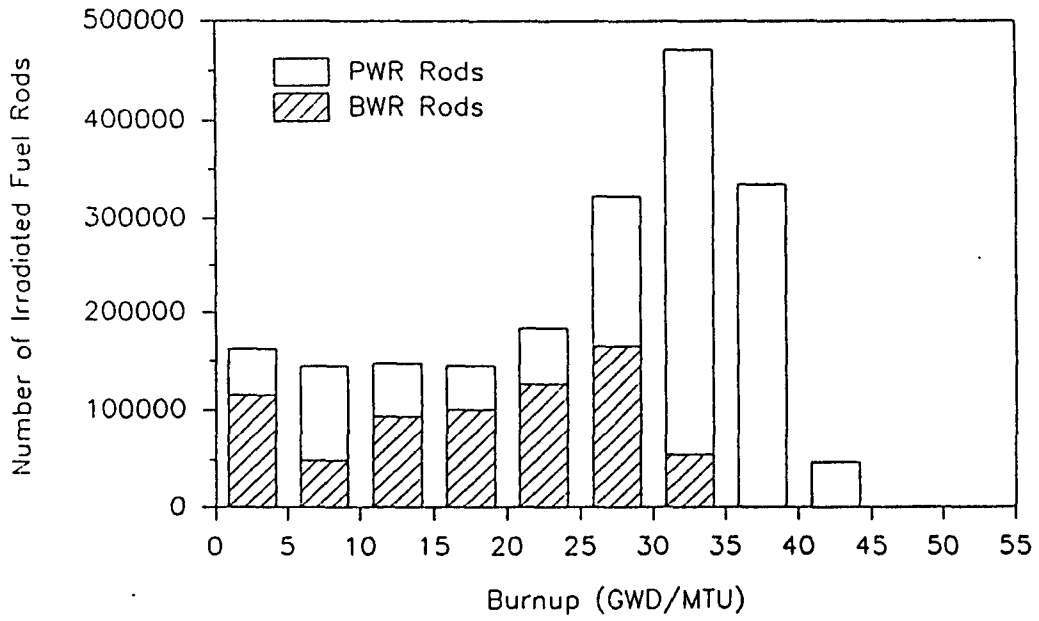
FIGURE 1. Distribution of Irradiated Advanced Nuclear Fuel Corporation's Fuel by Exposure Through the End of 1989<sup>(1)</sup>

The exposure distribution of ANF fuel rods and assemblies, as of the end of 1989, is shown in Figure 1.<sup>(1)</sup> The highest exposure levels reached by ANF fuel to date are 41.1 GWd/MTU in 1985 for a group of BWR fuel rods irradiated at Big Rock Point in Michigan and 50.0 GWd/MTU in 1986 for PWR fuel irradiated at Tihange-1 in Belgium. ANF's BWR 9x9 fuel assemblies and PWR 17x17 fuel assemblies reached new high burnups in 1989: BWR 9x9 fuel at Gundremmingen-3 in Germany reached 40.0 GWd/MTU and PWR 17x17 fuel at Donald C. Cook-2 in Michigan reached 44.0 GWd/MTU.

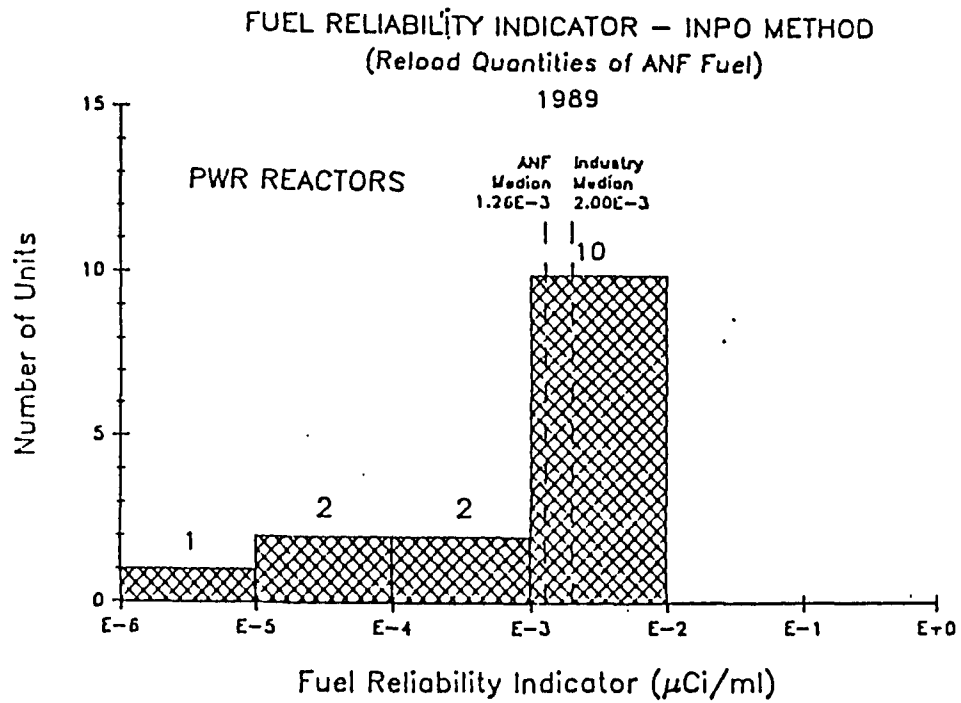
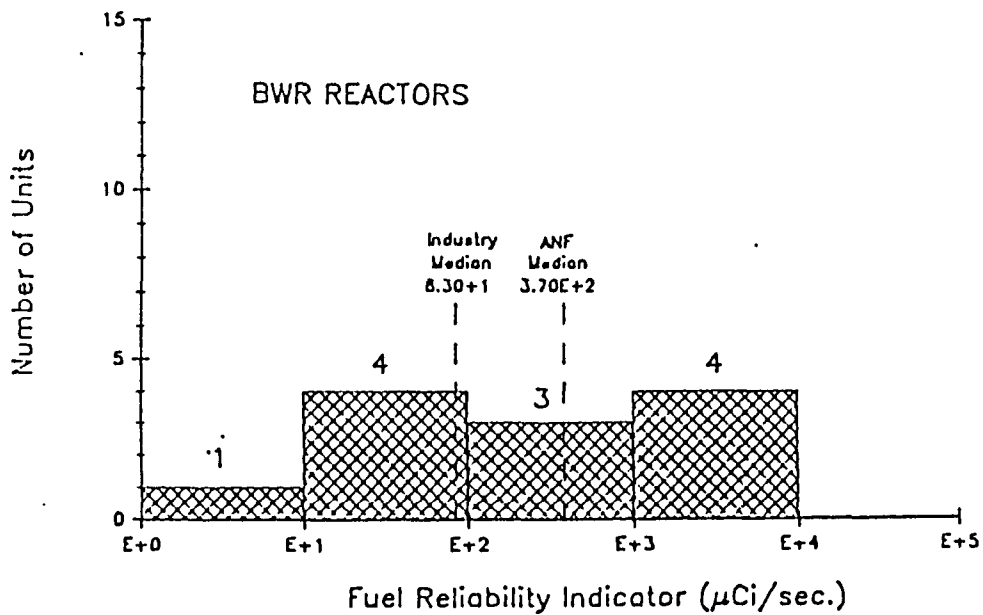
**FIGURE 2.** Advanced Nuclear Fuel Corporation PWR Fuel Reliability Indicator (FRI), Using the Institute of Nuclear Power Operations (INPO) Method: Annual Distribution of FRI for PWRs in 1989. (Note:  $1.2E-04$  is equivalent to  $1.2 \times 10^{-4}$ )<sup>(1)</sup>

To assess the reliability of ANF fuel, ANF uses the INPO FRI described above. The FRI distribution for ANF PWR and BWR fuel is shown in Figure 2<sup>(1)</sup> and is derived from the 1989 yearly average for each reactor that operated with ANF fuel in the core. The median value for all PWR reactors containing ANF fuel is  $1.26 \times 10^{-3}$   $\mu\text{Ci/ml}$ , which compares well with the INPO PWR median value of  $2.0 \times 10^{-3}$   $\mu\text{Ci/ml}$ . The median value for BWR reactors containing ANF fuel in 1989 is  $3.70 \times 10^{-2}$   $\mu\text{Ci/ml}$ , with the industry median being  $8.30 \times 10^{-1}$   $\mu\text{Ci/ml}$ . ANF did not have any failures attributed to design or manufacturing in 1989. The five-year trend in the ANF FRI indicates a continued improvement in fuel performance.
