LA-10446-MS

Radiation Monitor for Surveillance of Moving Vehicles

ABSTRACT

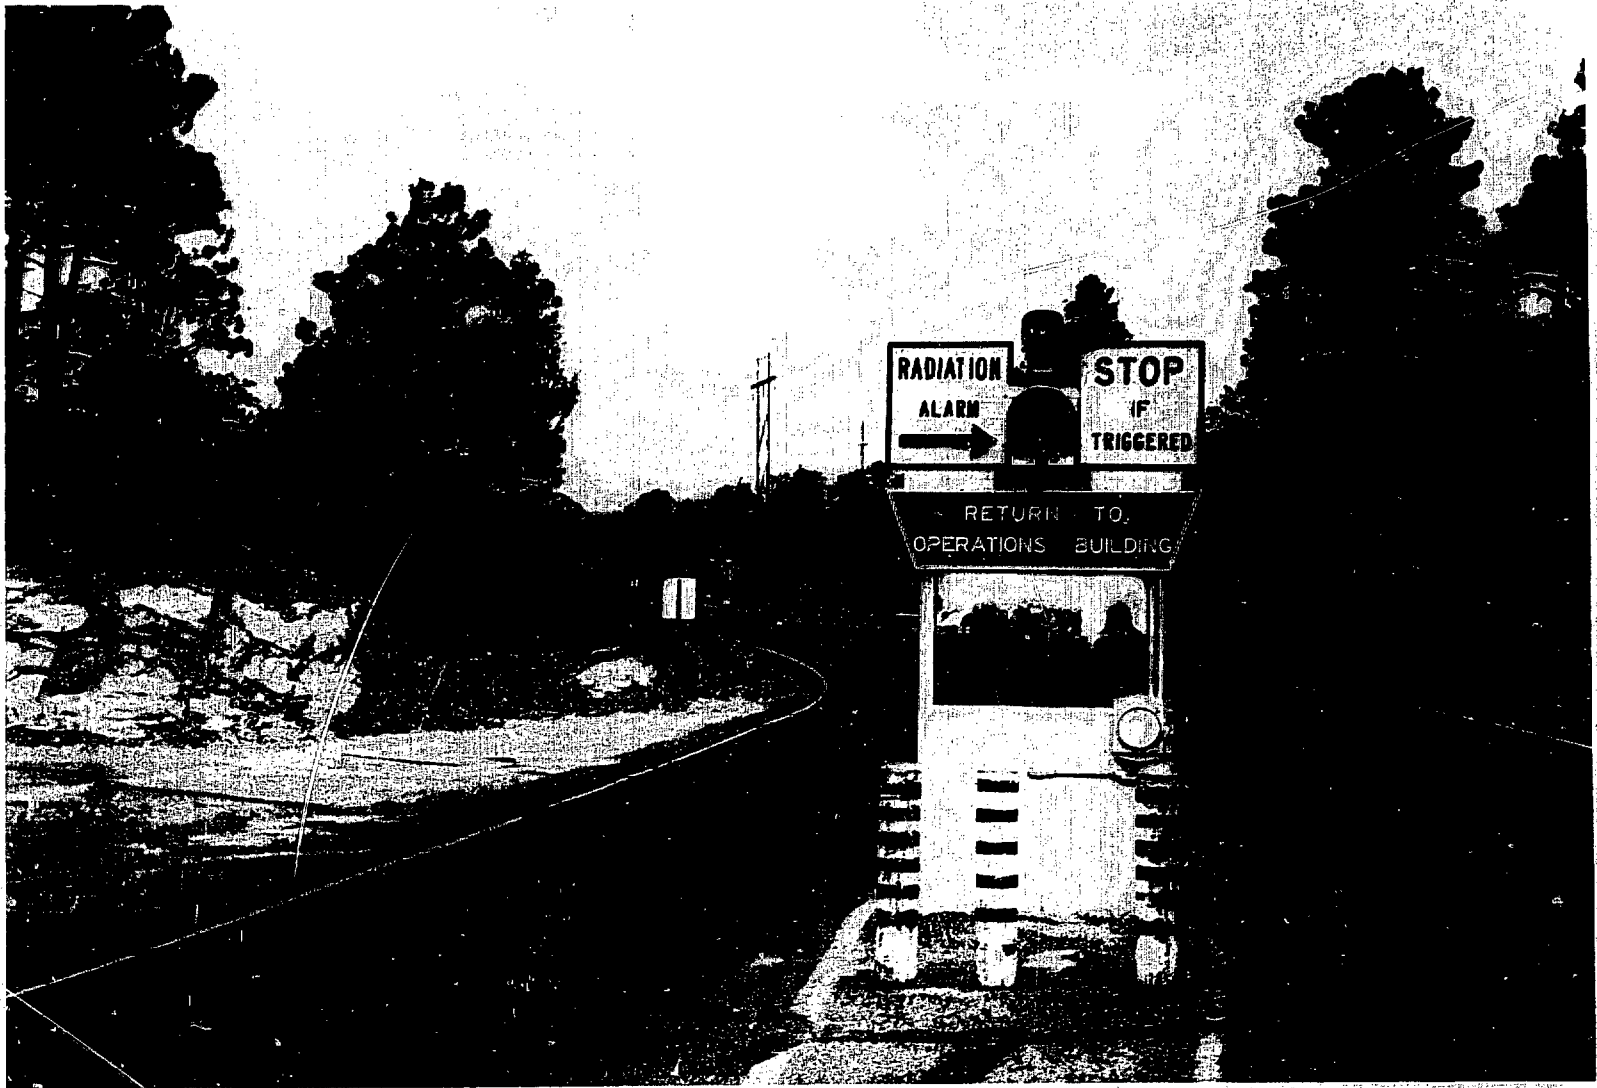
Figure 1. The guard station with alarm light and Klaxon. The system electronics are mounted inside the station.

station in the exit lane. The electronics package was mounted in the guard station with connection to the detector by buried conduit. An alarm light and a Klaxon horn were mounted on the roof along with instructions to stop at the guard station on alarm. Fig. 1 shows the guard station with attendant signs, light, and Klaxon horn.

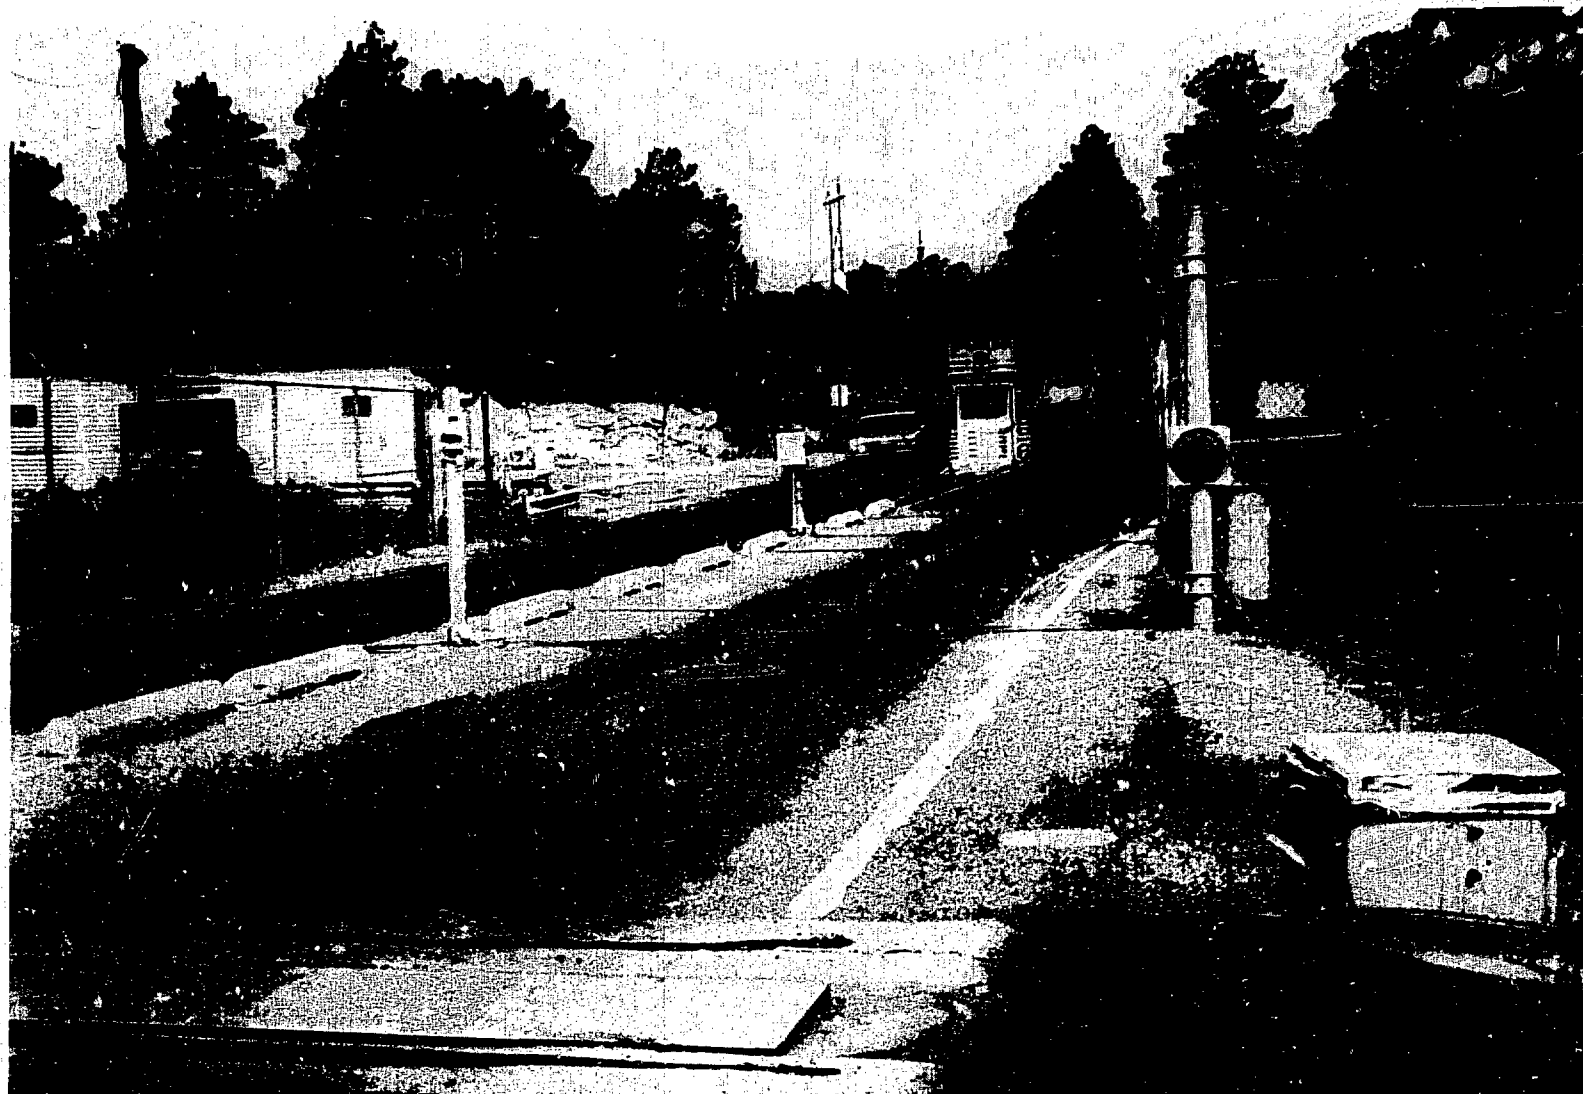
Figure 2. The monitoring point. In the foreground left is the speed depression and in the foreground right the camera box. The covered manhole for the detector is at the center.

Just prior to installation of the system, the guards were removed from this location. This necessitated, besides changing the signs, transferring the alarm signal and alarm reset by telephone line to the Health Physics Office over 1/2 mile away. Since vehicle exit speeds immediately increased from about 15 mph to over 45 mph, a speed-limiting depression, 3 ft wide and about 3 in. deep, was cut into the road. As additional incentive to return for monitoring after an alarm, a box containing a Polaroid SX-70 camera with telephoto lens and flash was located so as to photograph the vehicle and, in particular, the license plate. Fig. 2 shows the monitoring point.

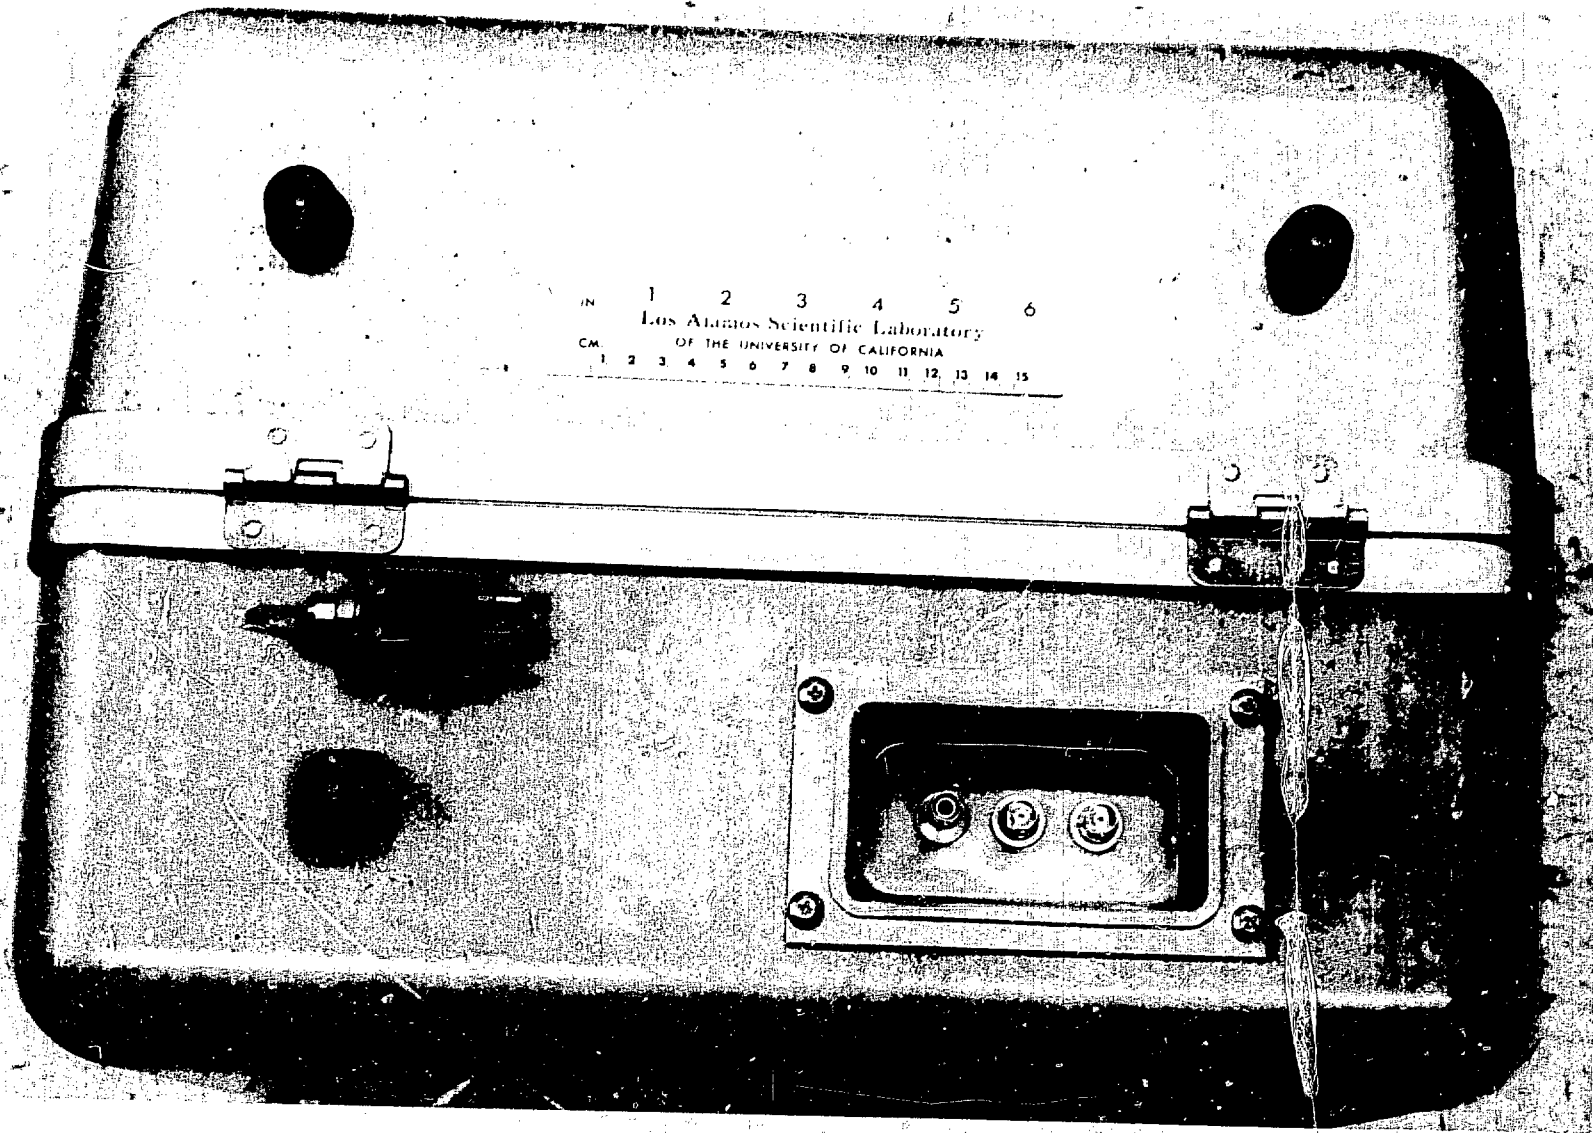
Figure 3. The detector case, showing power and signal connectors.

A waterproof plastic case approximately 16 in. x 16 in. x 18 in. high was selected to protect the detector and is shown in Fig. 3. The case was initially filled with polystyrene foam insulation and a space hollowed out for the photomultiplier-preamp assembly so that a minimum of 3 in. of insulation protects the photomultiplier from thermal stress as shown in Fig. 4. The detector box is located in a 24-in.-diameter manhole, as close to the road level as possible, with a 1-in.-thick sheet of beaded polystyrene positioned between the box and the aluminum manhole cover to reduce thermal coupling. Lead sheets are placed around and under the box to achieve about 1/2 in. of shielding from the surrounding soil that reduces background by approximately 30%.

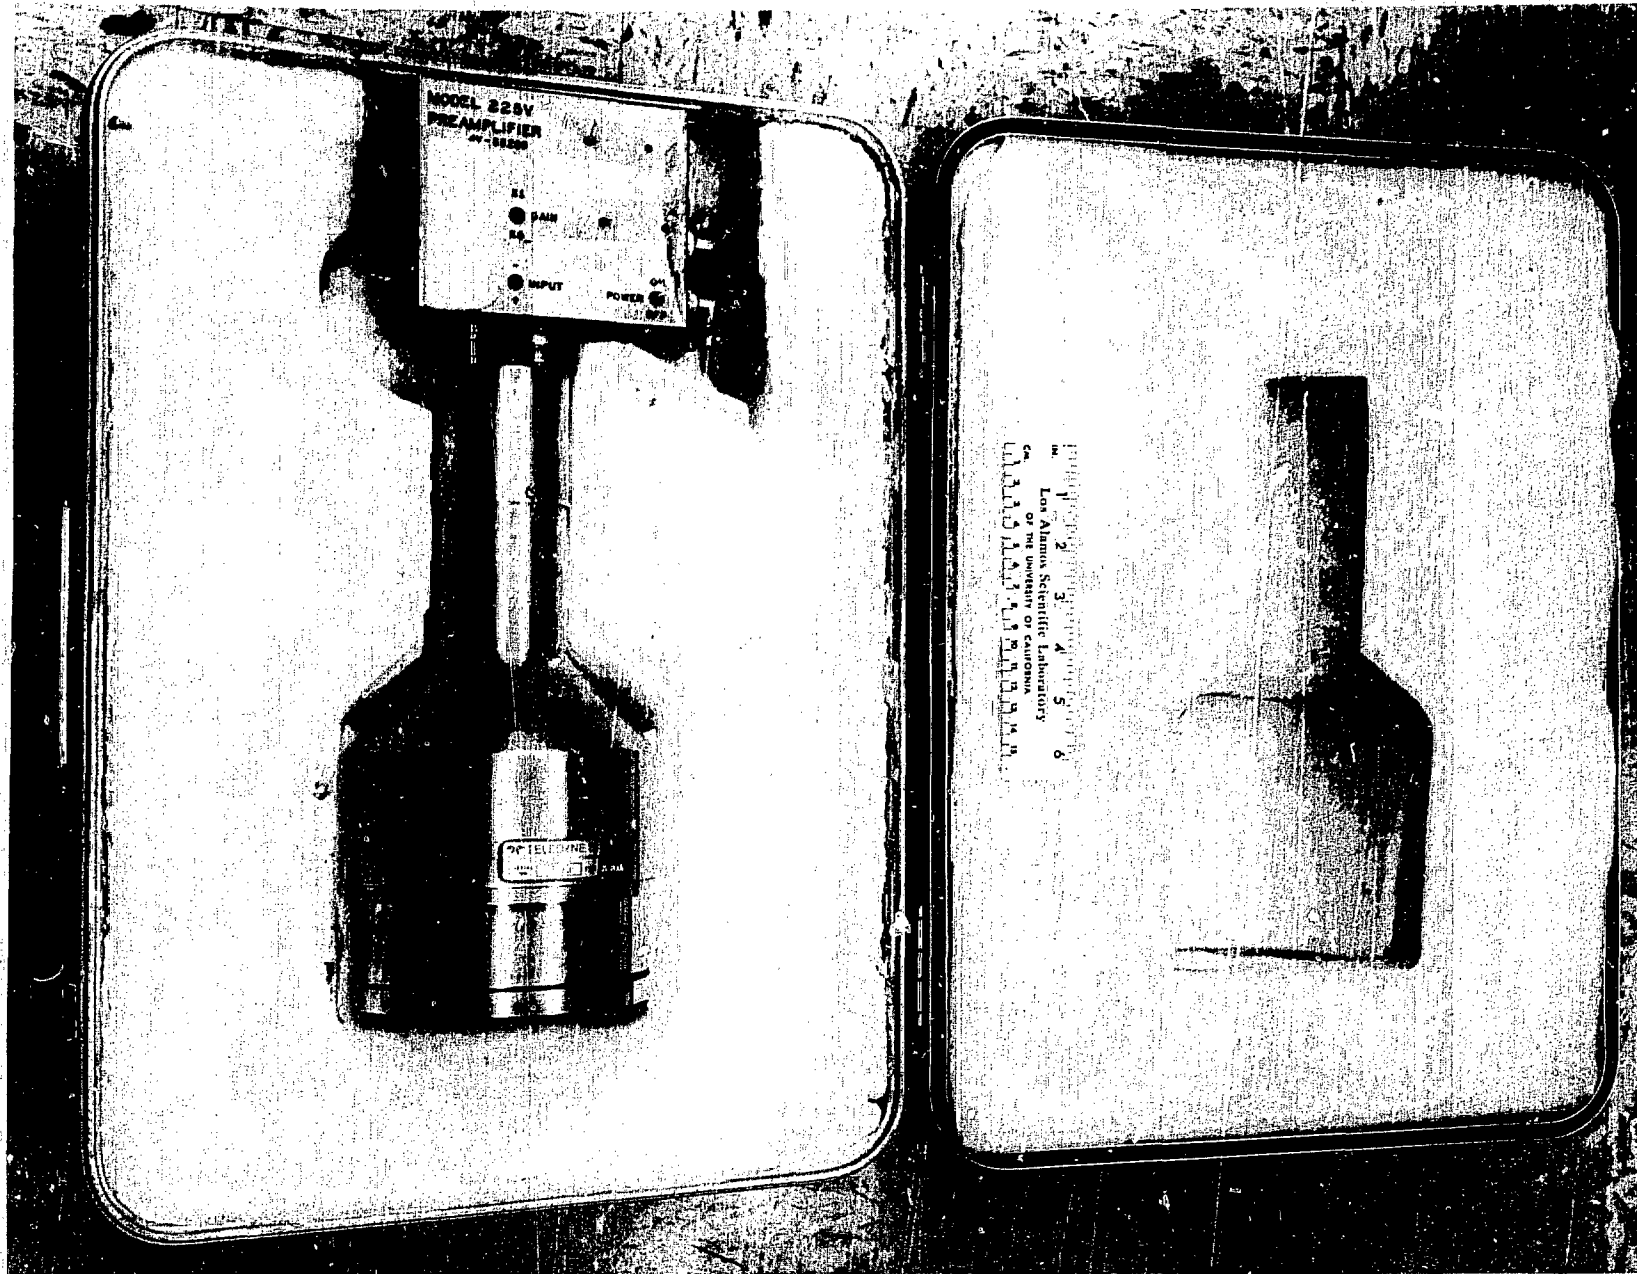
Figure 4. The detector case interior showing the photomultiplier and preamplifier.

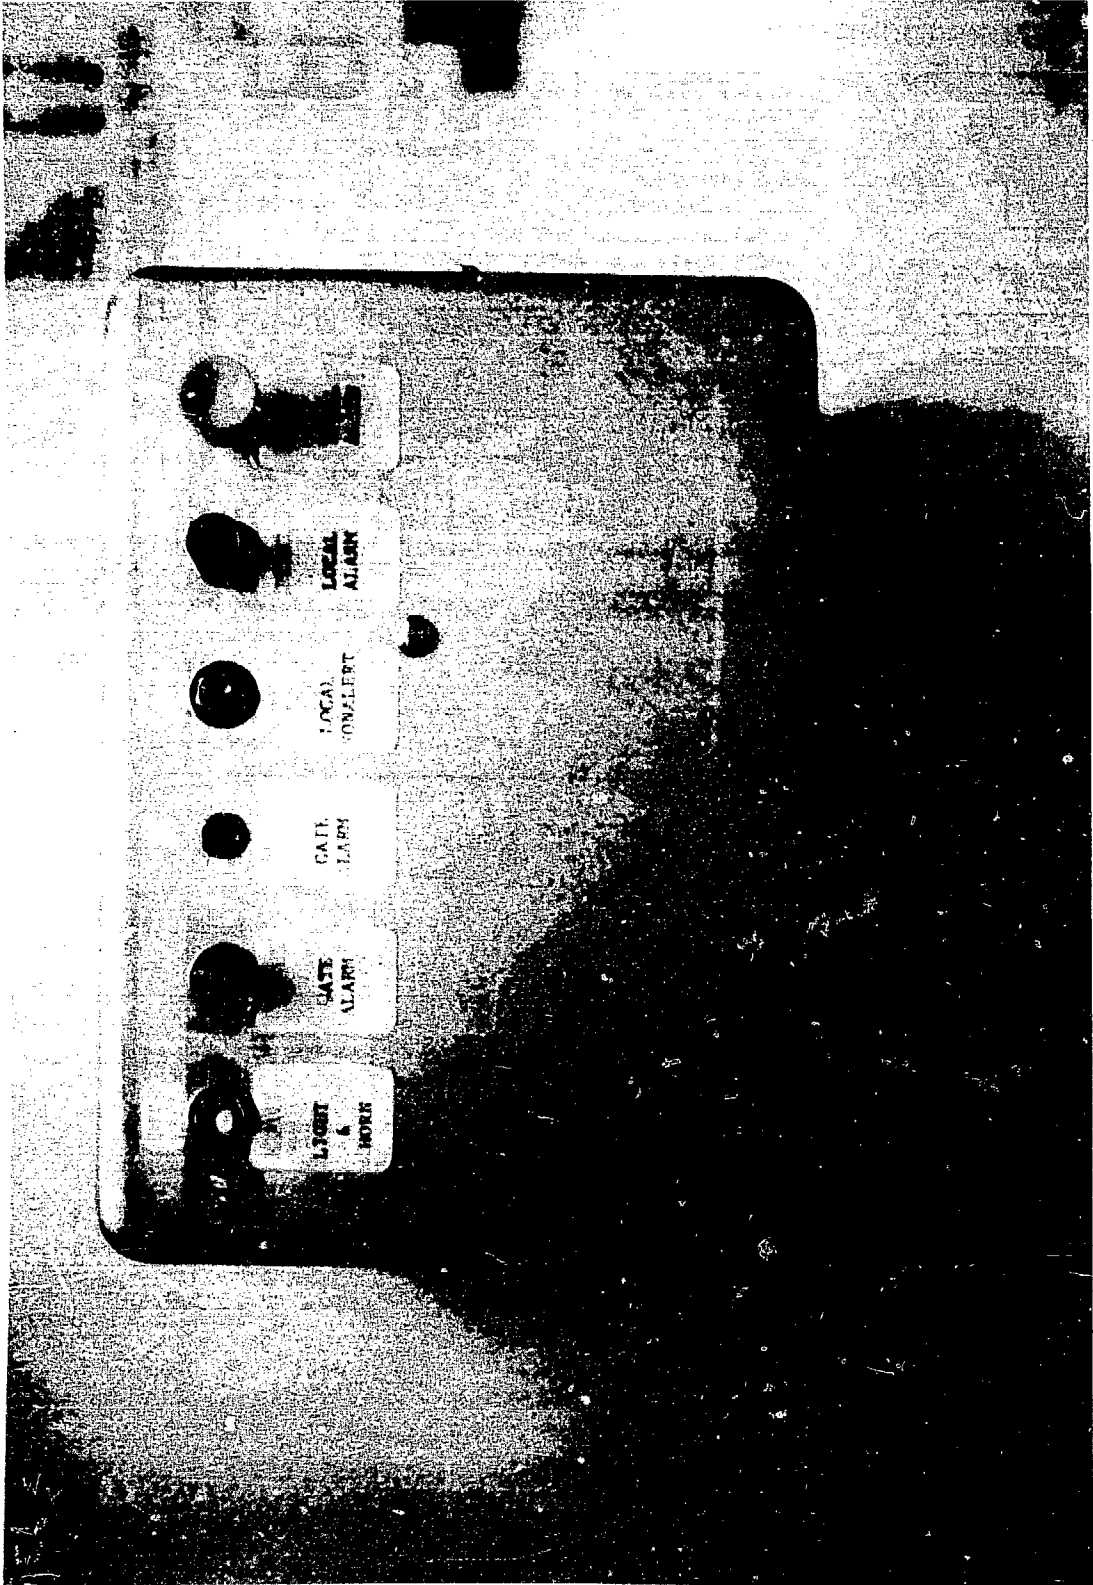
Figure 6. The remote alarm box.

an alarm. If a vehicle is present, as indicated by the loop vehicle detector, the alarm controller is activated, causing the warning light to be turned on, the Klaxon horn to be sounded, and a photo to be taken. Alarm is also sounded in the Health Physics offices from which point appropriate action is initiated. Fig. 6 shows one of the remote alarm boxes. Alarm reset and a partial system disable can be accomplished from the remote office locations.

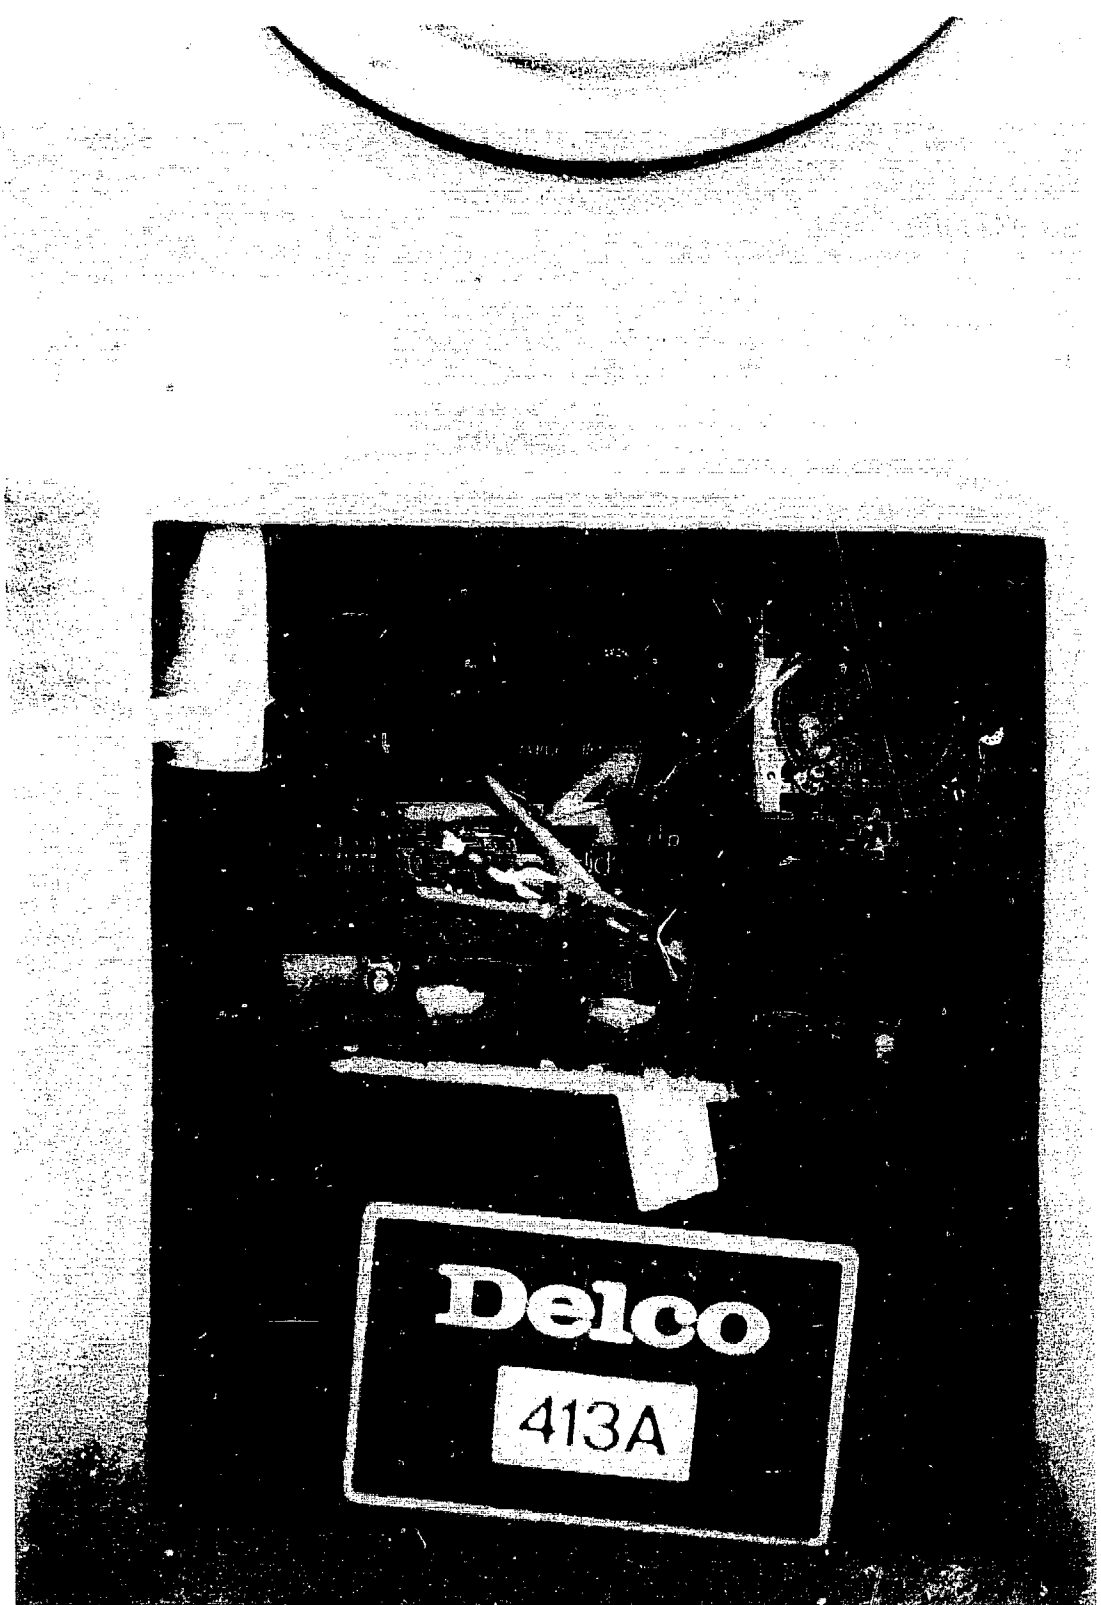
Figure 9. Lower camera unit compartment.

Later, the flash batteries were replaced by a dummy plug, and the power source is now a 6-volt storage battery in the lower compartment (Fig. 9). This battery also supplies power for the previously mentioned relays. The lower compartment also houses a 5-amp charger controlled by a clock timer.
