STALLING CHARACTERISTICS OF THE SUPERMARINE

SPITFIRE VA AIRPLANE

By J. R. Vensel and W. H. Phillips

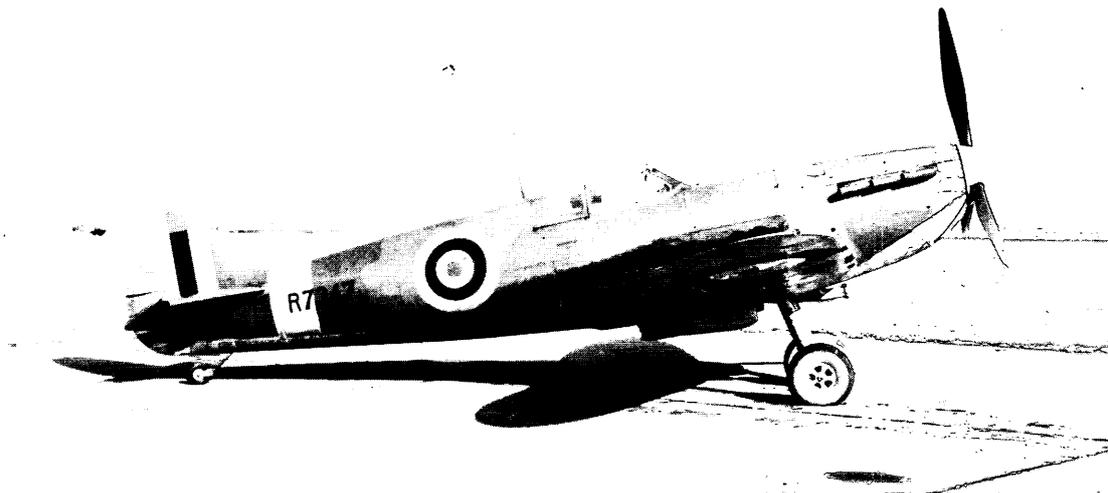
Figure 1.- Side view of the Supermarine Spitfire airplane.

The Supermarine Spitfire is a single-engine, single-place, low-wing cantilever monoplane with retractable landing gear and partial-span split flaps. (See figs. 1, 2, 3, and 4.)
