NACA RM No. E8J28

ALTITUDE-WIND-TUNNEL INVESTIGATION OF WESTINGHOUSE 19B-2
19B-8, AND 19XB-1 JET-PROPULSION ENGINES

I - OPERATIONAL CHARACTERISTICS

By William A. Fleming

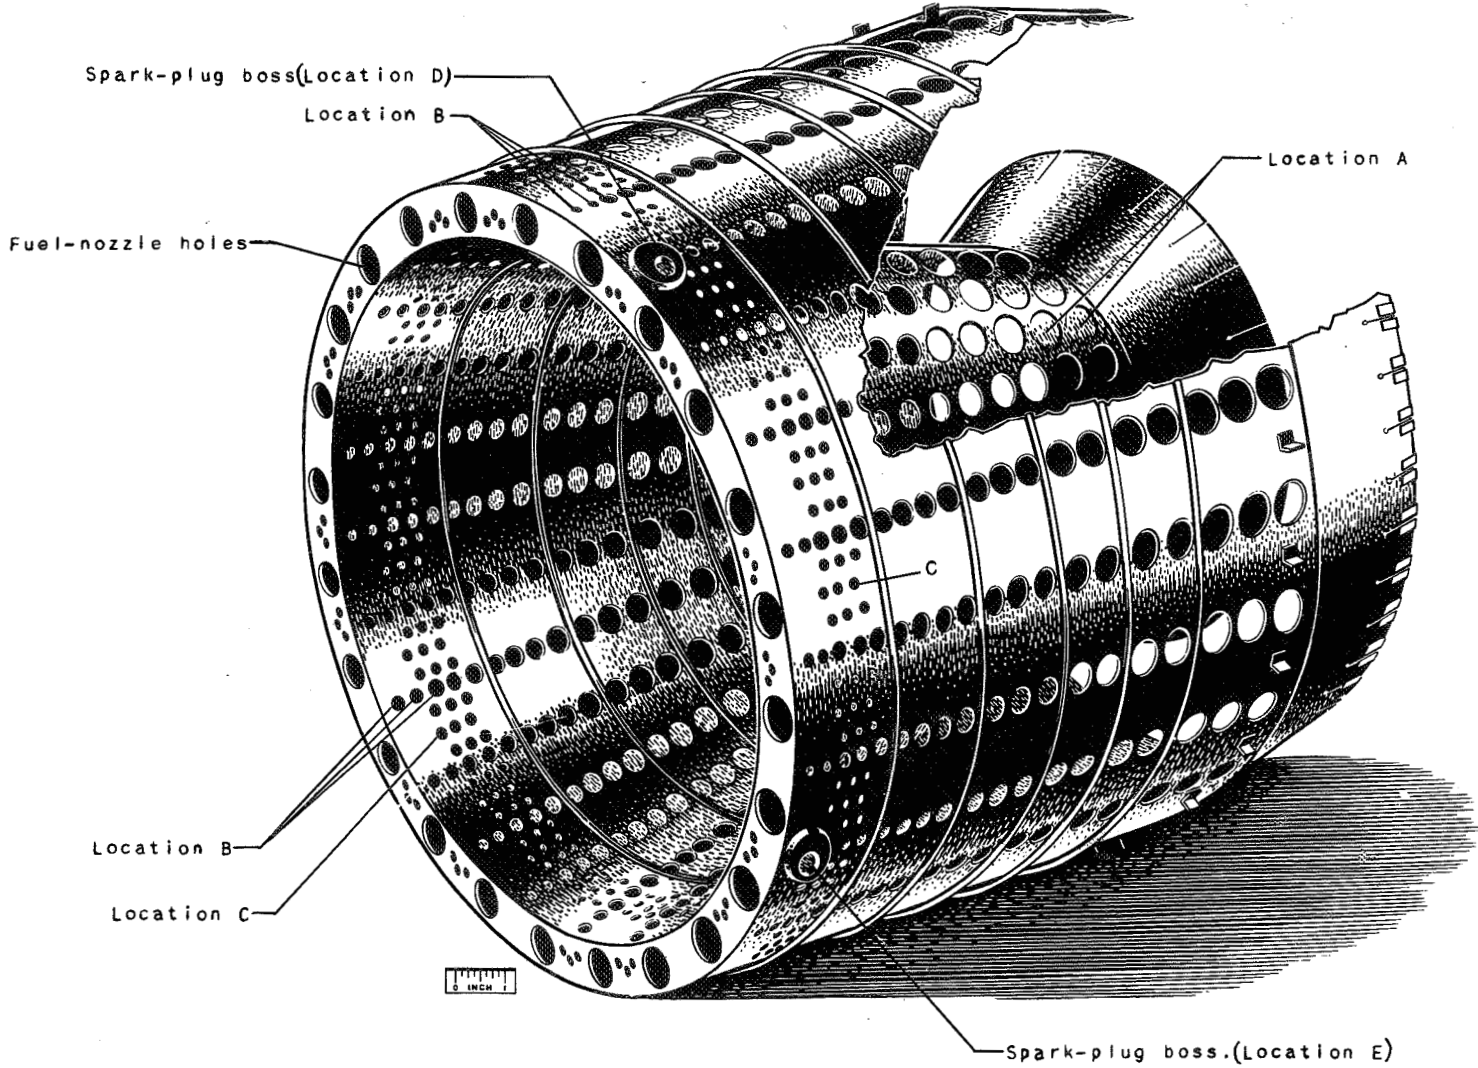
Figure 1. - Combustion-chamber basket of Westinghouse 19B and 19XB jet-propulsion engines.

The **combustion** chamber is an **annulus** in which is mounted an **annular** combustion basket (fig. 1) containing holes that meter the charge air to the primary and **secondary** burning zones, **Fuel** is supplied to the **combustion** chamber through 24 fuel nozzles **circumferentially** mounted in a manifold at the **forward** end of the **chamber**. The tail pipe is equipped with a movable inner cone with a total travel of 5 inches. When the inner cone is moved **from the** "in" position to the **"out" position**, the nozzle area decreases **from** approximately 140 to 105 **square** inches. A single-stage turbine drives the compressor.

When the $1\frac{1}{2}$ -inch nozzle extensions were installed in the 19B-8 engine, one spark plug was placed $4\frac{1}{8}$ inches from the face of the fuel manifold between two longitudinal rows of holes in the combustion basket and in line with a fuel nozzle (location D fig. 1). The other spark plug was placed $2\frac{1}{8}$ inches from the fuel manifold in line with a row of holes in the combustion basket (location E, fig. 1). The hole immediately upstream of and in line with the spark plug was covered. The 19B-8 engine was much easier to start after these changes had been made.

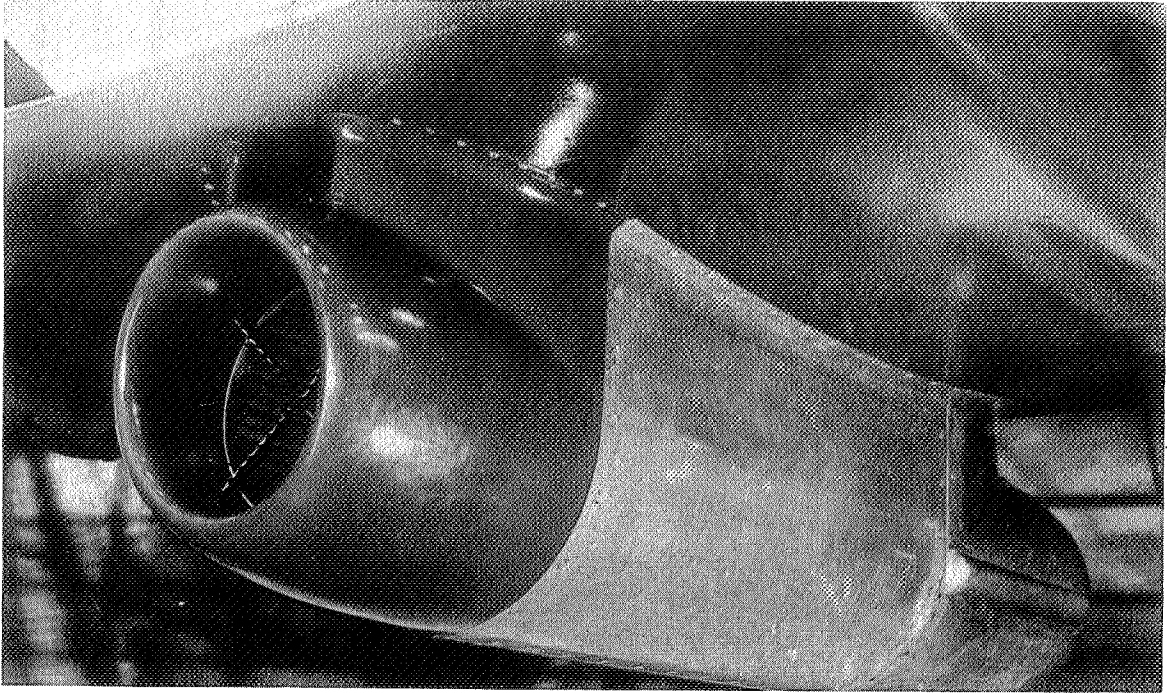
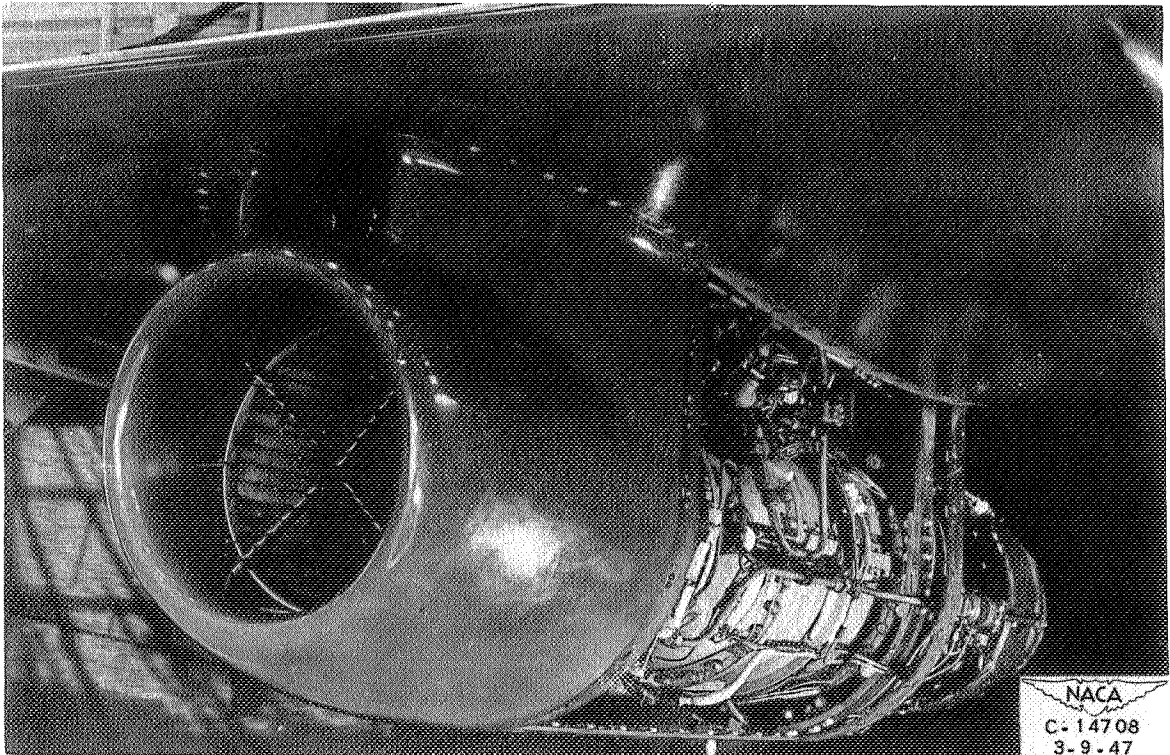
(a) With cowling.

(b) Without cowling.

Figure 2. - Installation of Westinghouse 19-B jet-propulsion engine in wing nacelle for investigation in altitude wind tunnel.

The engine was installed in a nacelle mounted **under** a stub wing **having a 7-foot span**, which was cantilevered **from one side of the** 20-foot-diameter test section of the wind tunnel (fig. 2). The engine air was admitted at the front of the nacelle and cooling air **was** admitted through a **small** inlet duct beneath the leading edge of the **wing**. For the static **tests** the portion of the cowling enclosing the tail pipe and the rear of the **combustion** chamber **was** removed because the test-section air velocity was too **low** to **insure sufficient cooling-air flow through the** cowling. A **6-mesh screen** made of **0.032-inch-diameter** steel wire **was** bolted to the front flange of the oil cooler to protect the **compressor from flying objects** in the **tunnel**. Temperature and pressure **measurements** were taken at **seven** stations **in** the engine (fig. 3) to obtain information on the **individual components** and the over-all operating **characteristics**.

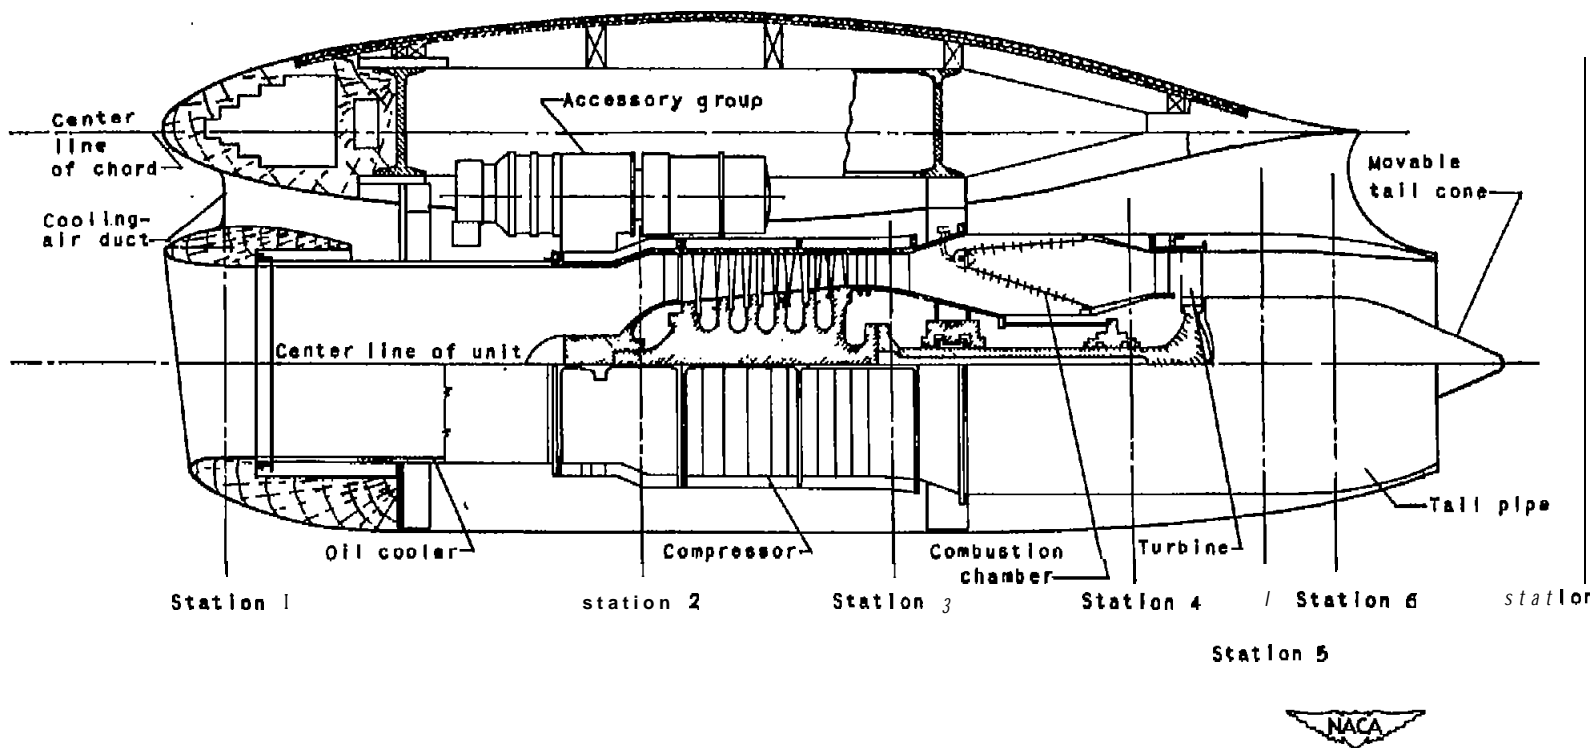
Figure 3. - Side view of Westinghouse 19-B jet-propulsion installation showing measuring stations.

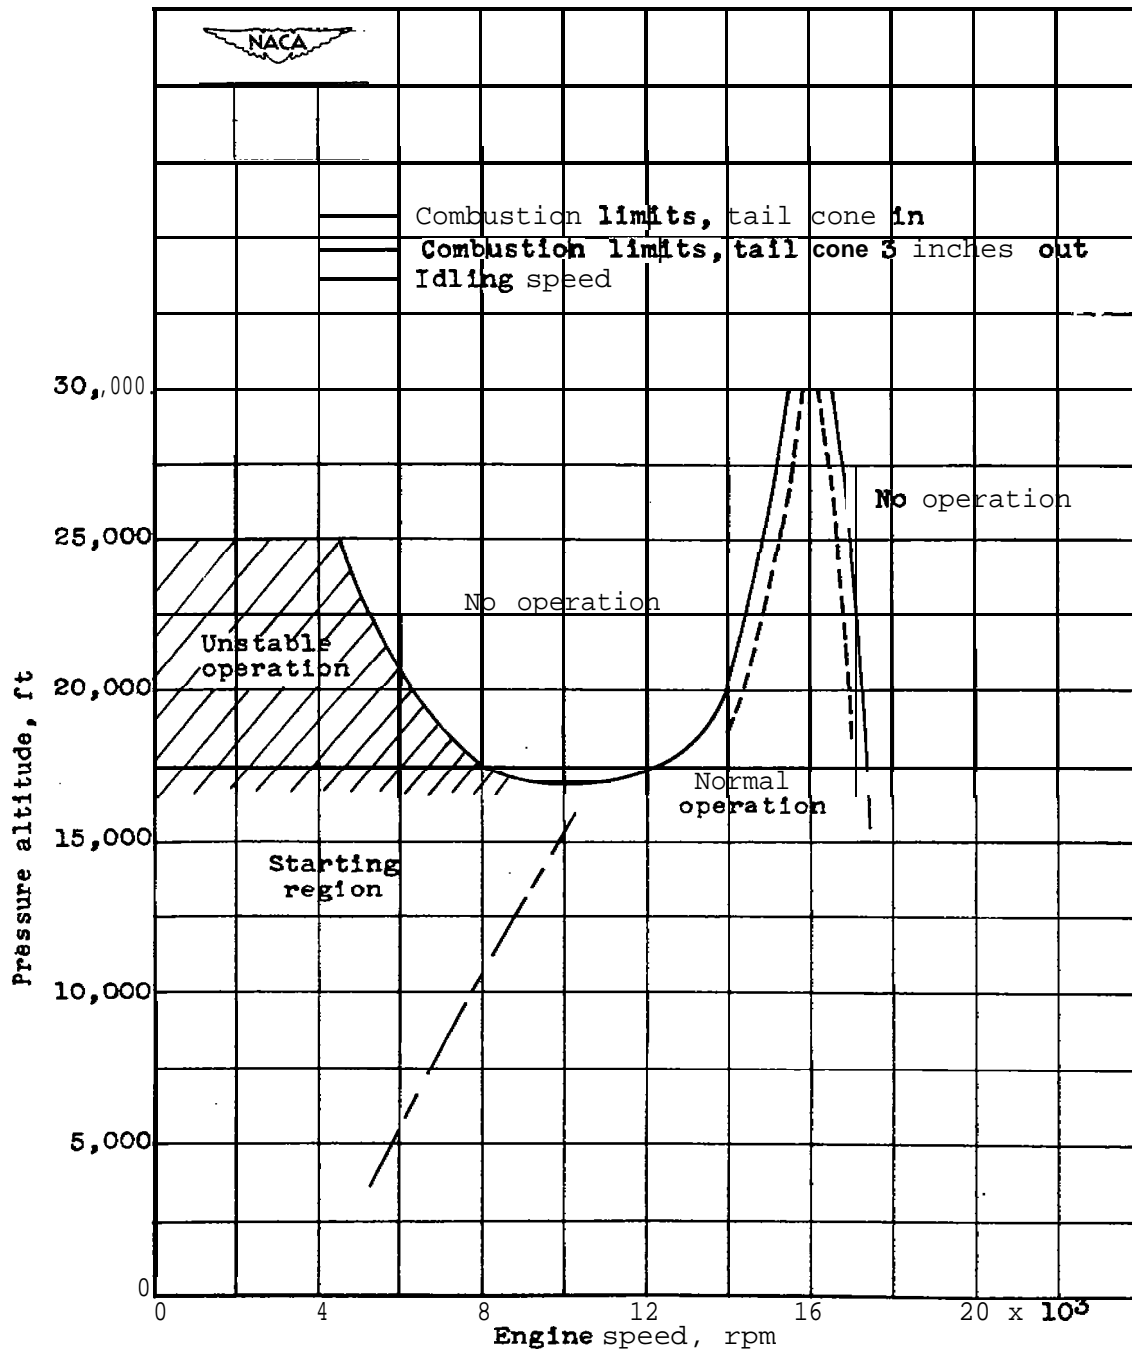
Figure 4.- Variation of operating range with pressure altitude at an airspeed of 20 miles per hour with tail cone in and 3 inches out with original configuration. Westinghouse 19B-2 jet-propulsion engine.

576 both **maximum and minimum** operable speeds (fig. 4). The idling speed of the engine, the **lowest** speed at which the engine could be operated without burning in the tail pipe **and excessive tail-pipe temperatures**, is shown by the dashed curve. The operating range with the tail cone moved in **extended** from approximately 14,000 to 17,300 rpm at a pressure altitude of 20,000 feet and from 15,500 to 16,500 rpm at **30,000** feet. When the tail-pipe-nozzle area was decreased to a **minimum** by moving the tail cone 5 inches out, the operable range at 20,000 feet was greatly reduced. With the tail-pipe-nozzle area fully reduced, the engine would not operate at 30,000 feet. **When the airspeed in the tunnel was raised, the operating range was slightly** increased in all cases.

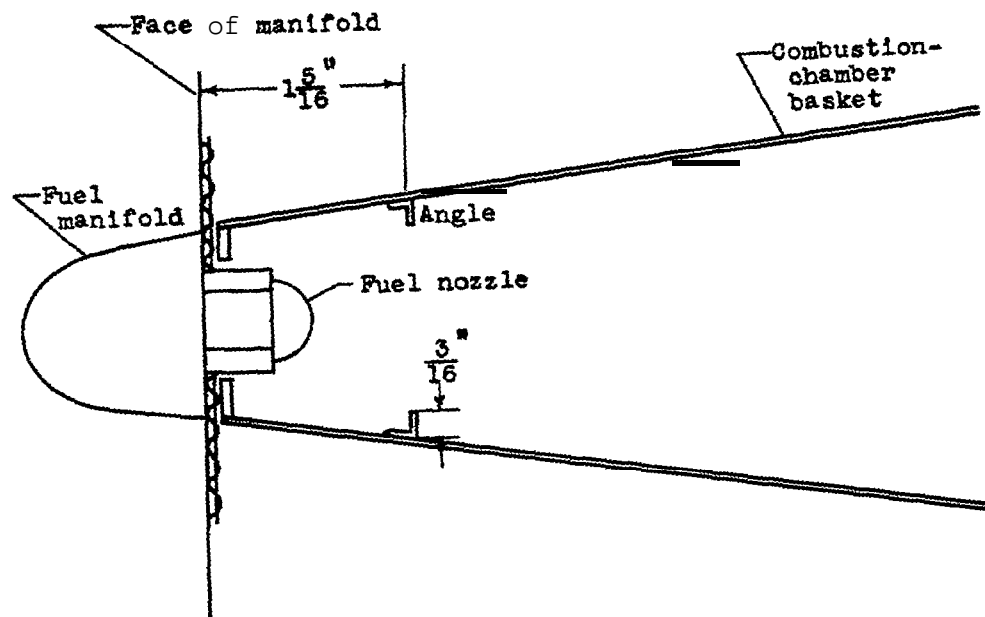
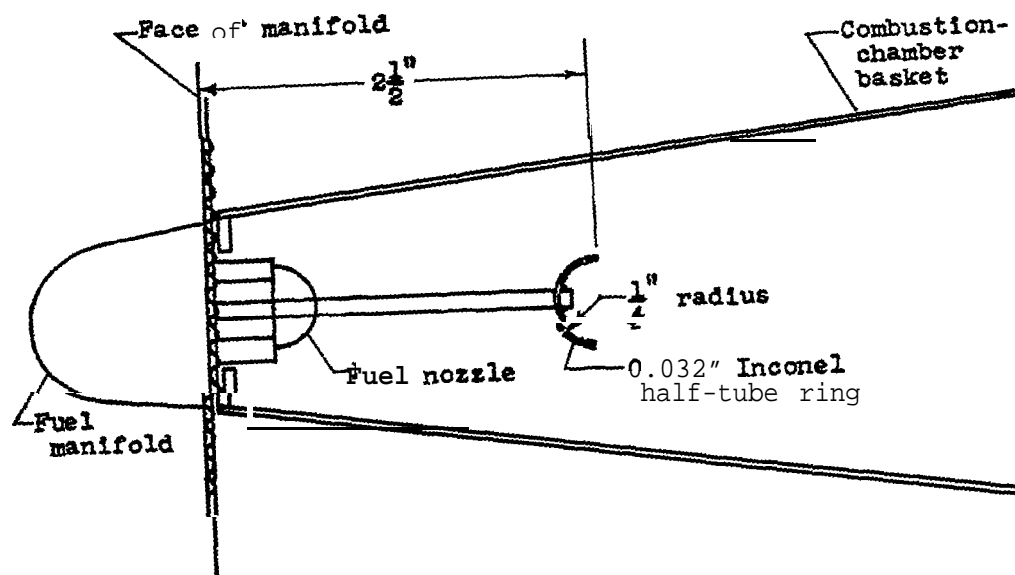
(a) Position of steel angles.

(b) Position of half-tube ring.

Figure 5.- Sketches showing two modifications installed in combustion chamber of Westinghouse 19B-2 jet-propulsion engine.

In order to induce more turbulence in the **primary** burning zone, the combustion chamber was then modified by welding $\frac{1}{4}$ - by $\frac{3}{16}$ - by $\frac{1}{32}$ -inch **stainless-steel** angles to the sides of the **combustion** chamber approximately $1\frac{5}{16}$ inches **downstream of the fuel manifold** (fig. 5(a)). Tests of this arrangement were made using $10\frac{1}{2}$ -gallon, **45°-angle** spray nozzles directly attached to the face of the manifold. The operating range of the engine with this modification was about the same as with the original **configuration**. The **minimum** engine speed above 17,000 feet **and the maximum engine** speed above 20,090 feet were limited by **combustion** blow-out.

After the angles were welded in the combustion chamber (fig. 5(a)) and the $10\frac{1}{2}$ -gallon, 45° -angle spray nozzles were installed, the 19B-2 engine was very difficult to start. In order to start the engine, the method just described for the 19B-8 engine was adopted. Higher turbine-inlet and tail-pipe temperatures were obtained than with the 19B-8 engine, however, and flames extended from 15 to 20 feet behind the tail pipe during acceleration through the starting region.

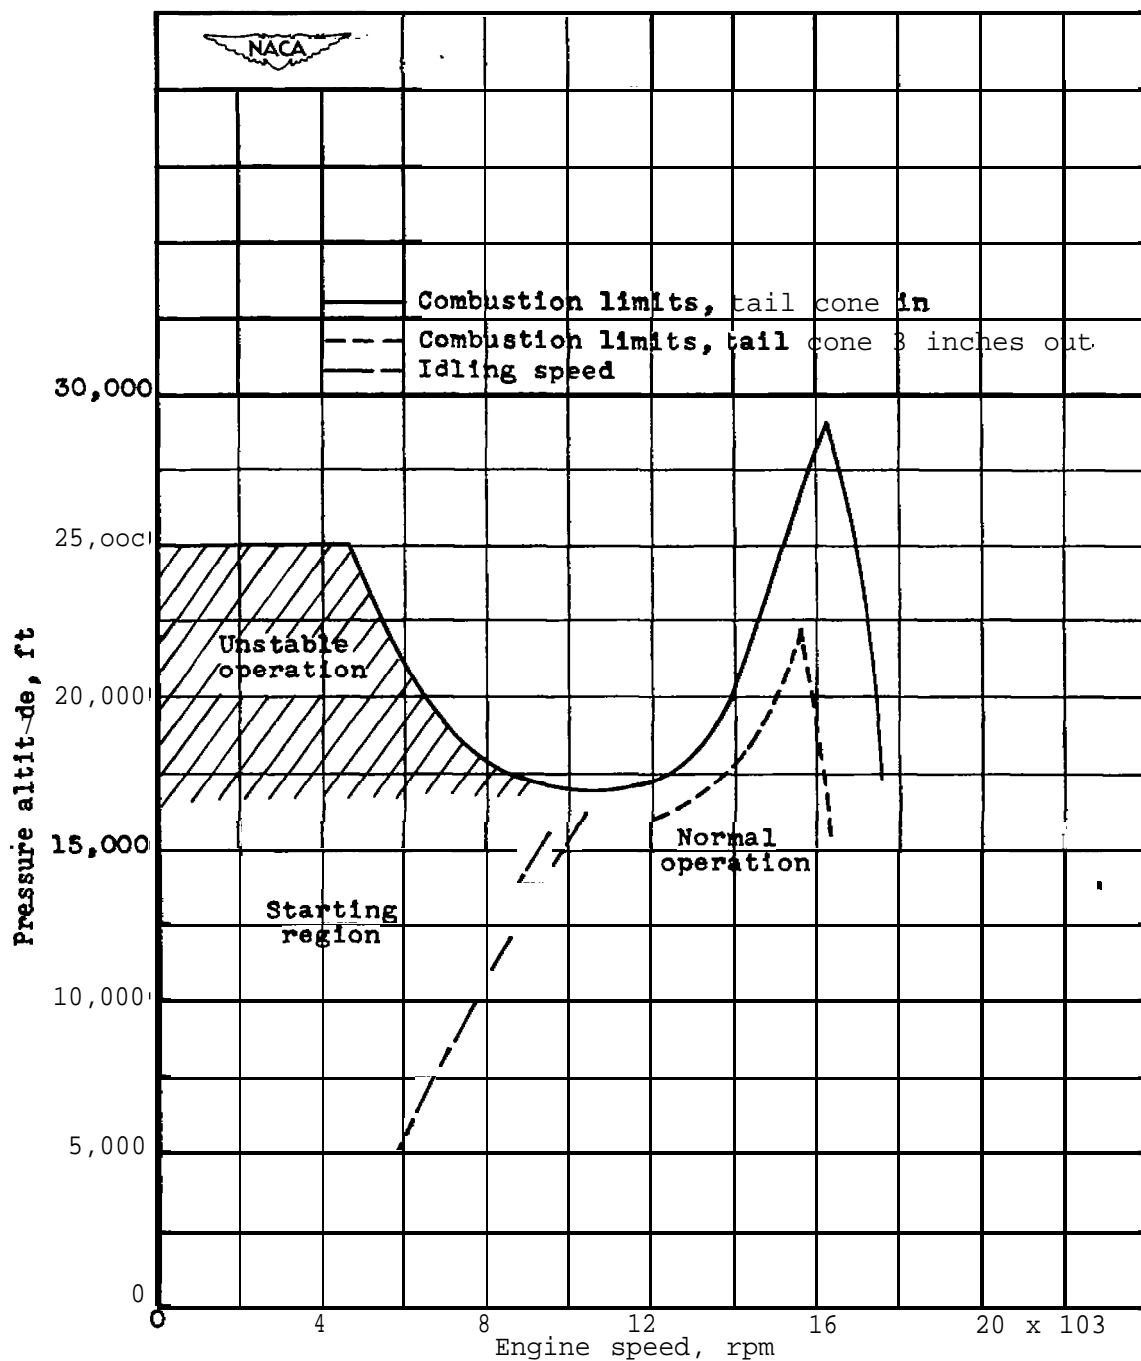
Figure 6.- variation of operating range with pressure altitude at an airspeed of 20 miles per hour with tail cone in and 3 inches out with original configuration. Westinghouse 19B-8 jet-propulsion engine.

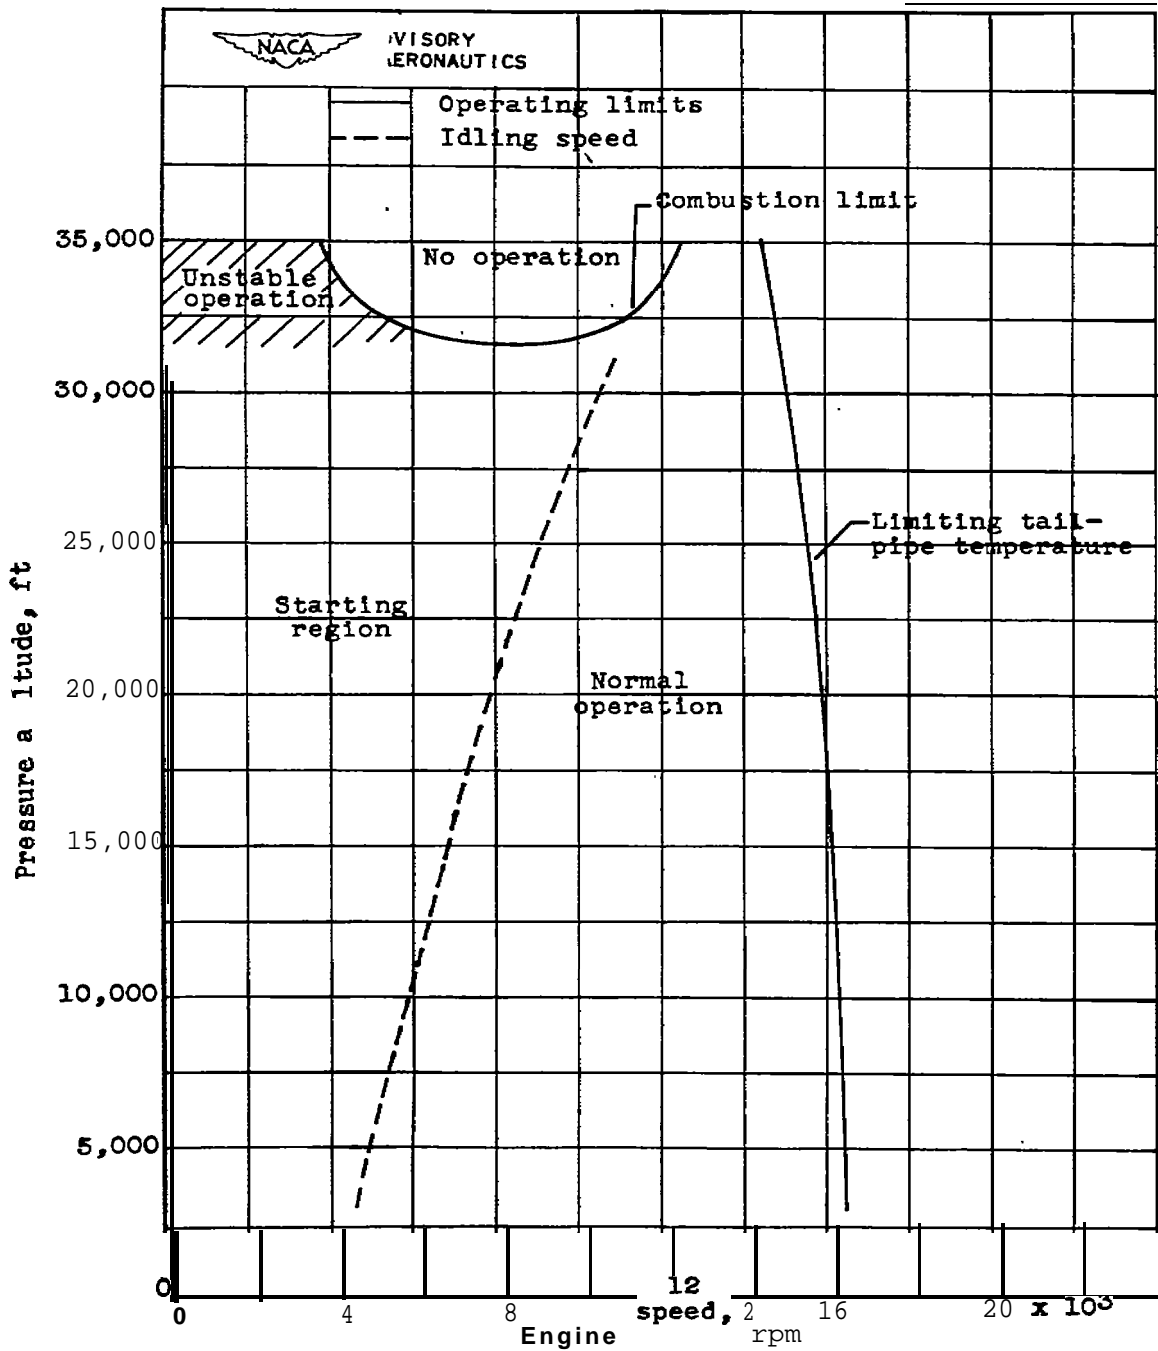
Figure 7.- Variation of operating range with pressure altitude at an airspeed of 20 miles per hour with original configuration. Westinghouse 19XB-1 jet-propulsion engine.

19XB-1 engine. - The operating range of the **19XB-1** engine, which was considerably greater at high altitudes than that of the **19B** engines (fig. 7), extended from **10,500 to 15,000 rpm** at a pressure altitude of 30,000 feet and from **12,500 to 14,400 rpm** at 35,000 feet. The **maximum** speed at which the engine could be safely operated was limited by the requirement that a turbine-inlet temperature of **1500° F** should not be exceeded. Combustion blow-out at the **minimum** operating speed was encountered at **35,000 feet**. Below this altitude a blue flame was emitted from the **bottom** of the tail pipe at low engine speeds, a condition that made maintenance of a constant engine speed difficult. The flame was apparently caused by the concentration of fuel in the **bottom** of the **combustion** chamber. The **fuel manifold** pressures encountered at these low-speed conditions were less than 10 pounds per square inch gage and the fuel was probably being improperly **atomized** by the nozzles. The idling speed of the engine is shown by the dashed curve in figure 7. The idling speed of the engine was the lowest speed at which the engine could be operated without burning in the tail pipe. When the **airspeed** was raised in the tunnel, the operating range increased slightly as with the **19B** engines.

19XB-1 engine. - The combustion characteristics of the **19XB-1** engine were **much** better than the **19B** engines and considerably less afterburning was encountered at high altitudes. The unstable **oper-**ating **range** of the **19XB-1** engine encountered above **8 pressure** altitude of 30,000 feet is shown by the hatched area in figure 7.
