# LONG-TERM SURVEILLANCE PLAN FOR THE MEXICAN HAT DISPOSAL SITE MEXICAN HAT, UTAH

February 1996

**Prepared for  
U.S. Department of Energy  
UMTRA Project Team  
Environmental Restoration Division  
Albuquerque, New Mexico**

**Prepared by  
Jacobs Engineering Group Inc.  
Albuquerque, New Mexico**

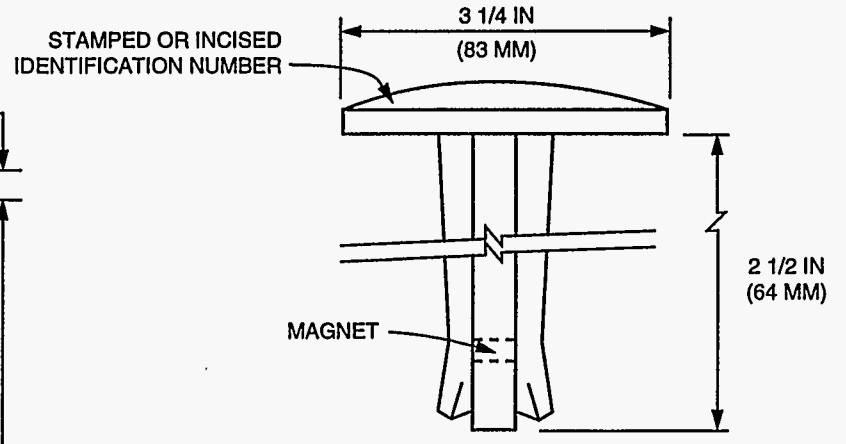
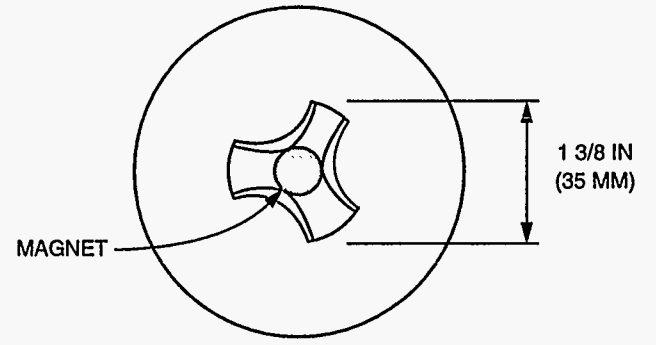
DETAIL  
BERNTSEN RT-1  
MARKER

SCHEMATIC - NOT TO SCALE

SIDE VIEW

BOTTOM VIEW

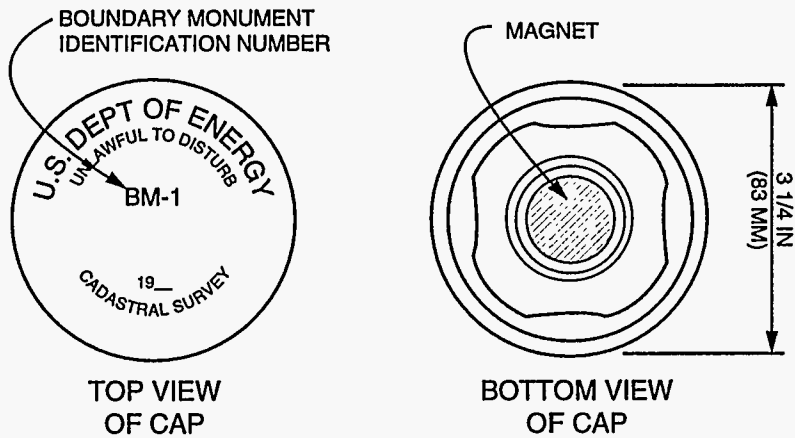
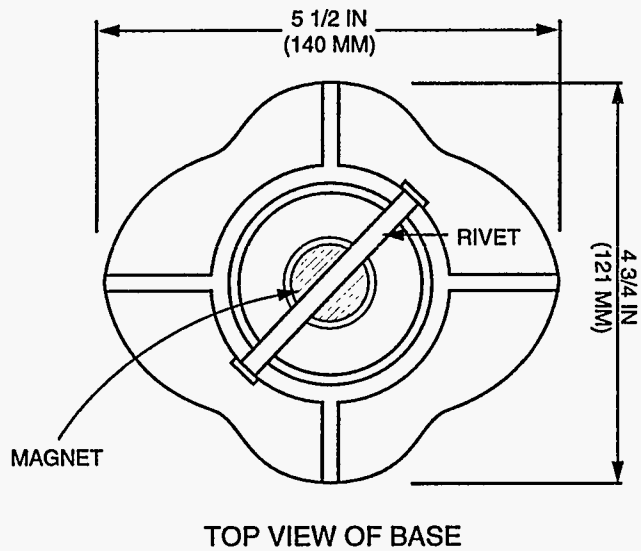
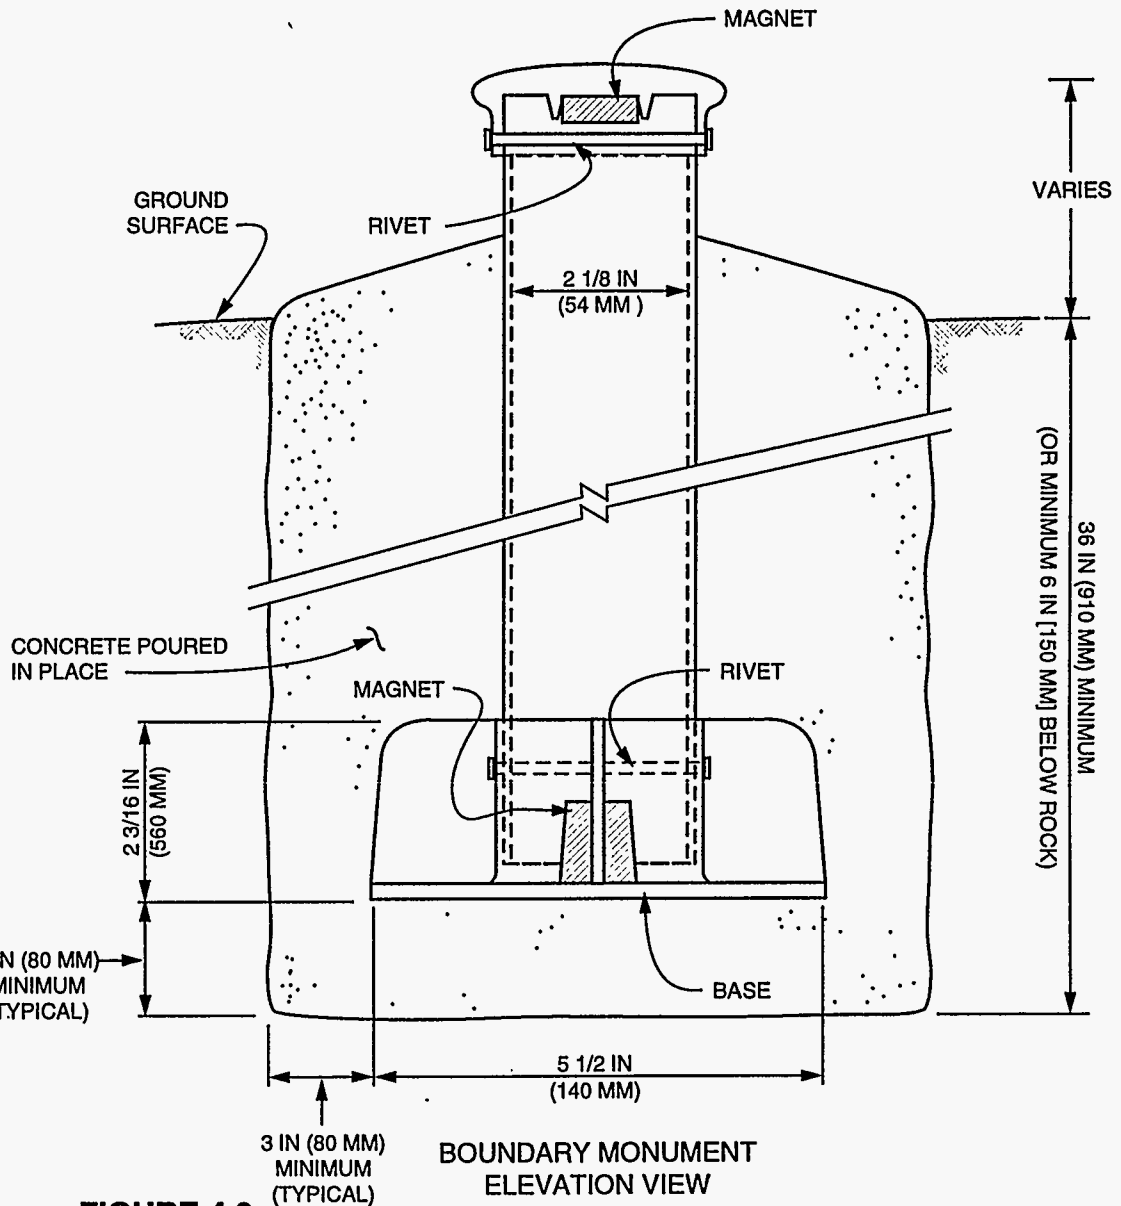
**FIGURE 4.2  
TYPICAL BOUNDARY MONUMENT  
MEXICAN HAT, UTAH, DISPOSAL SITE**

**BERNTSEN FEDERAL ALUMINUM BOUNDARY MONUMENT, MODEL A-1, STANDARD LOGO CAP**

SCHMATIC - NOT TO SCALE

Twelve boundary monuments (BM-1 through BM-12) were placed around the Mexican Hat disposal site. Each boundary monument is a Berntsen federal aluminum survey monument, Model A-1, set in a poured-in-place concrete cylinder as shown by Figure 4.2. The base of each boundary monument is a minimum of 3 ft (1 m) below the land surface or a minimum of 6 inches (150 mm) below hard rock. The top of each monument is a variable height above the land surface depending on the location of the monument. Ceramic magnets are epoxied in the cap and base of each monument and are vertically oriented so that they can be easily detected if they become covered. The survey coordinates and elevations of the boundary monuments are presented in Table 4.1.

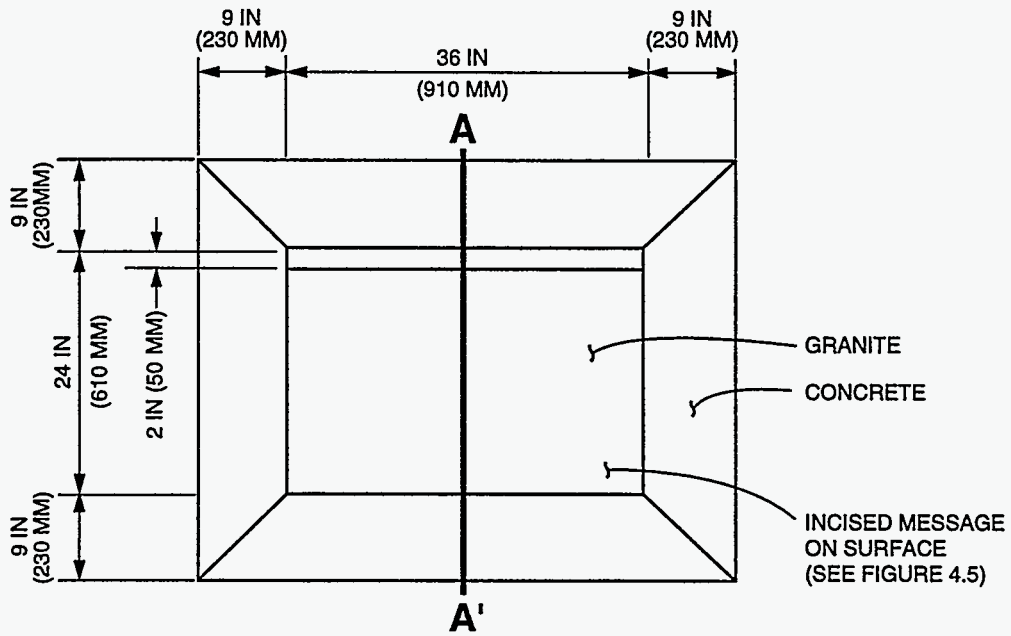
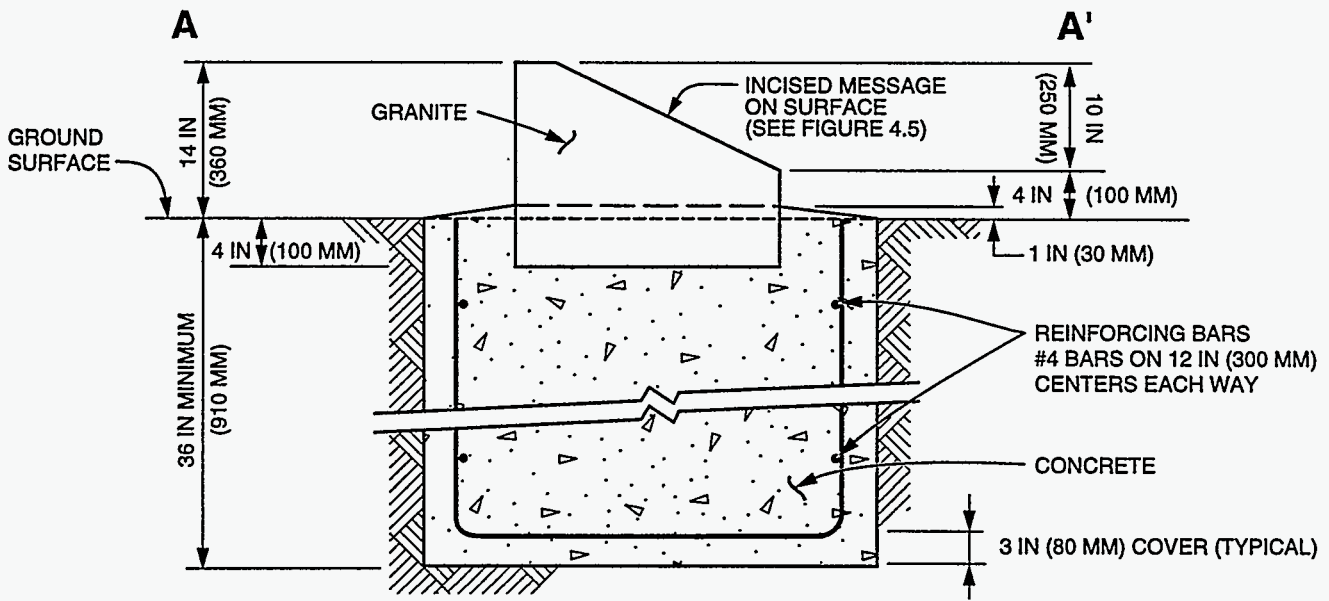
**FIGURE 4.3**  
**SITE MARKER AT DISPOSAL SITE ENTRANCE**  
**MEXICAN HAT, UTAH**

PLAN VIEW

SECTION A-A'

Two unpolished granite site markers were installed at the Mexican Hat disposal site. Site marker SMK-1 is at the entrance to the disposal site and is set in a bed of reinforced concrete that extends a minimum of 3 ft (1 m) below the land surface (Figure 4.3). Site marker SMK-2 was placed on the crest of the disposal cell and set in a bed of reinforced concrete that extends to the top of the radon barrier (Figure 4.4). The inscriptions on the site markers (Figure 4.5) identify the general location of the Mexican Hat disposal cell, the closure date for the disposal cell (20 July 1994), the dry tonnage of tailings (4,400,000 short tons [4,000,000 metric tons]) in the disposal cell, and the curies of radioactivity

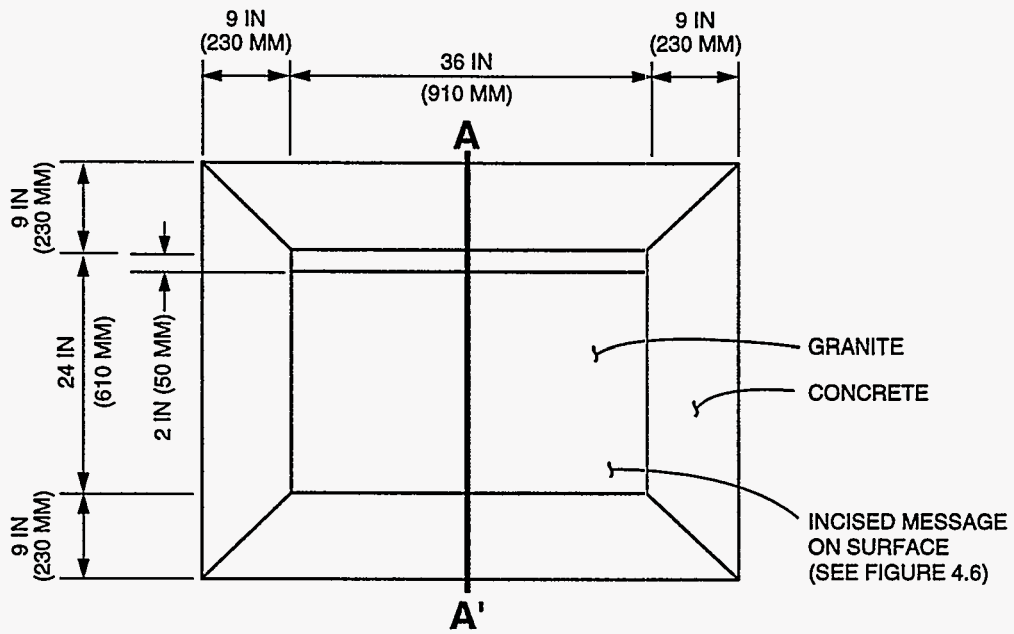
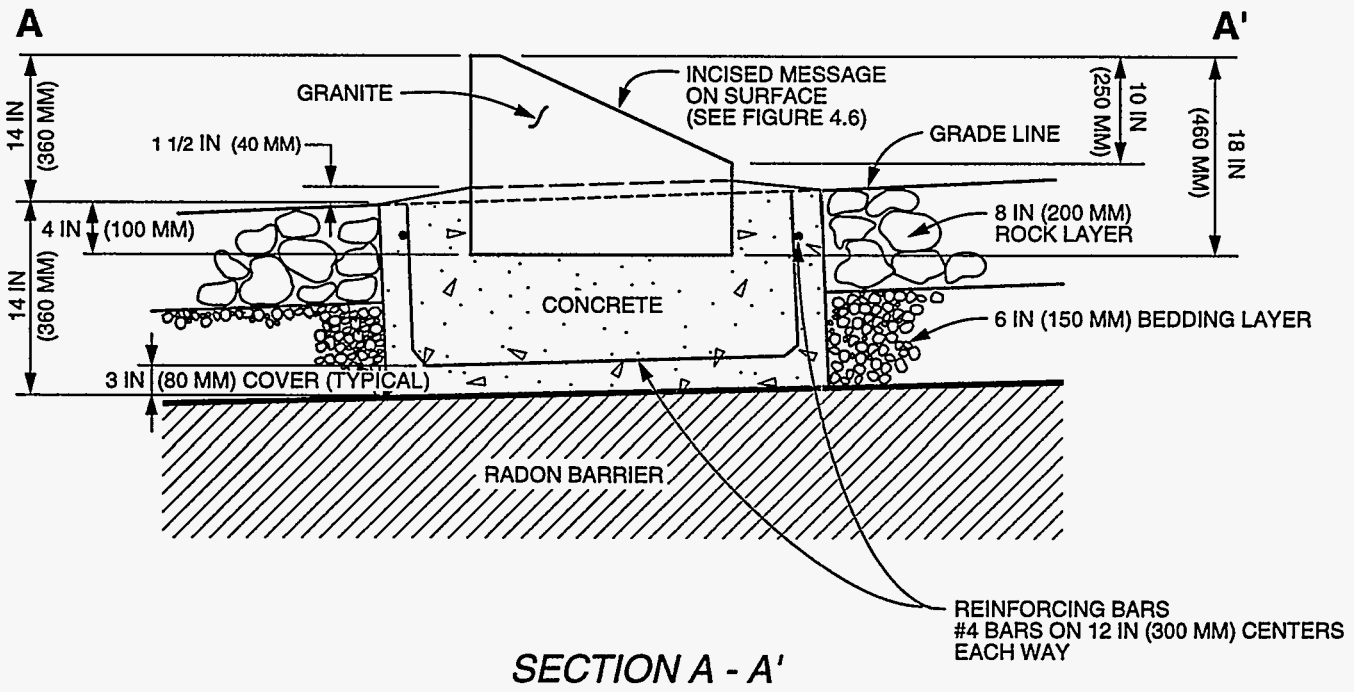
PLAN VIEW

SECTION A - A'

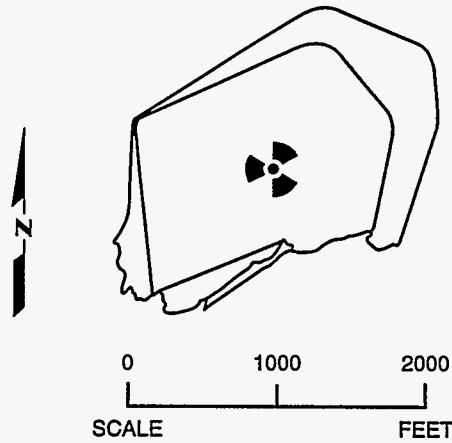
### *INCISED MESSAGE*

DATE OF CLOSURE: JULY 24, 1994  
DRY TONS OF TAILINGS: 4,400,000  
RADIOACTIVITY: 1800 CURIES, RA-226

NOTE: MINIMUM DEPTH OF INCISING IS 1/4 IN (6 MM).
