# SANDIA REPORT

SAND98-1014 • UC-906

## Development and Validation of Nondestructive Inspection Techniques for Composite Doubler Repairs on Commercial Aircraft

Dennis Roach, Phil Walkington

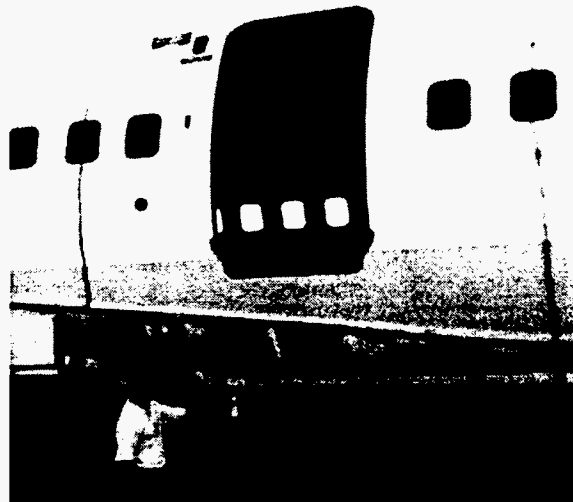
**(a) Structural Configuration of Passenger Door Area**

**(b) Section Cut from Retired L-1011 Aircraft for Full Scale Tests**

**Figure 3: L-1011 Door Surround Structure Test Article**

The primary test articles were large fuselage sections cut from retired All Nippon Airways (ANA) L-1011 aircraft. The fuselage test article included a passenger door (P3 passenger door) cut-out and contained all substructure frame, longeron, and stringer elements. Figure 3 shows a photograph of one of the door surround structure sections prior to being cut from the L-1011 fuselage. Each test article, which matched the P3 door

Ultrasonic Inspections on L-1011 Fuselage Test Article - In June, Delta Air Lines and Textron installed the Lockheed-designed composite doubler on a door surround structure fuselage section which was cut from a retired L-1011 aircraft (see Fig. 3). The fuselage section with composite doubler installed is shown in Figure 21. A UT inspection procedure was developed by the AANC and approved for use on L-1011 aircraft by Lockheed-Martin [29]. This procedure was applied to the doubler on the door surround

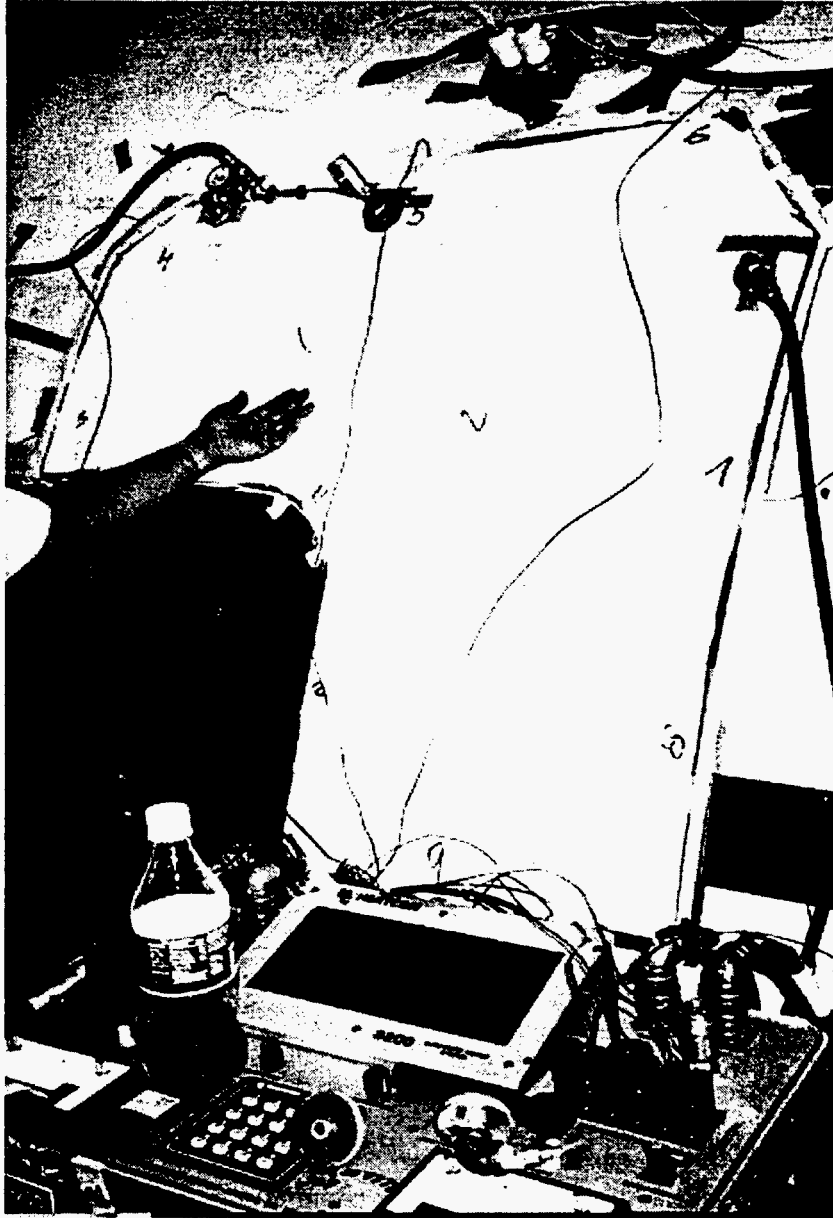
**Figure 8: Doublor Cure Process - Heat Blanket, Insulation, and Vacuum Bag Assembly**

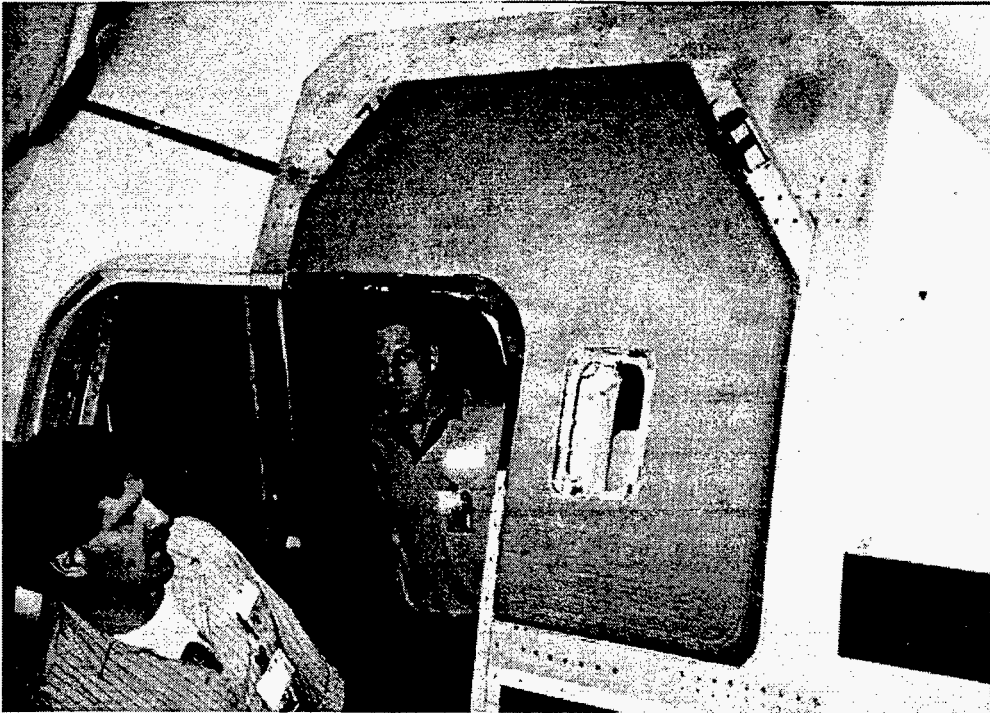
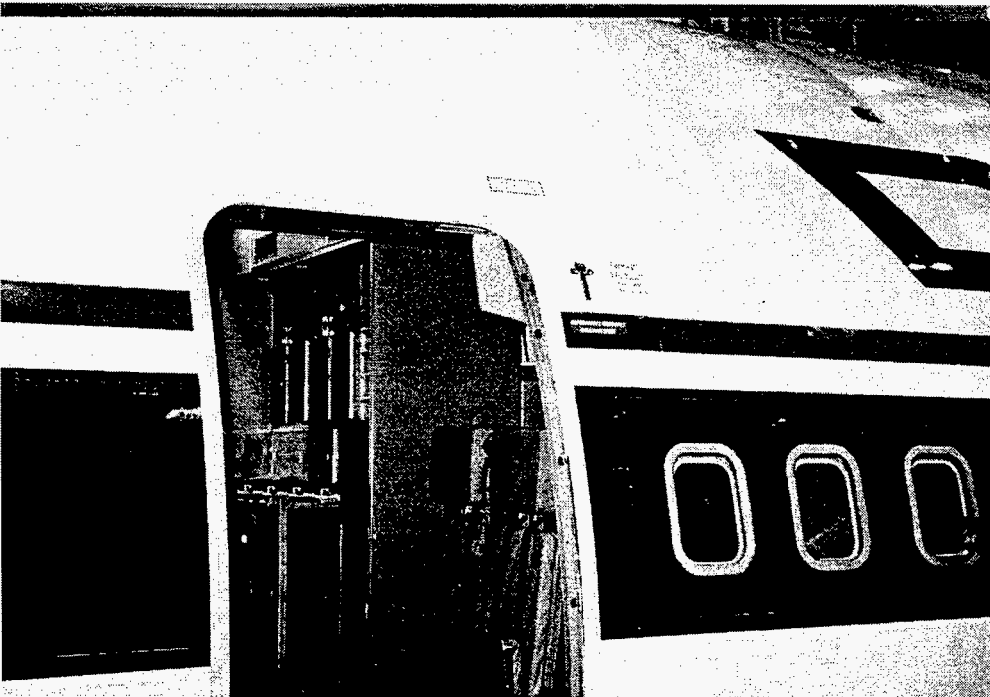
**(a) Door Corner Doubler Prior to Application of Delta Paint Scheme**

**(b) View of Doubler After First 45 Days of Operation**

**Figure 9: Overall View of Composite Doubler on Delta Aircraft Fuselage**

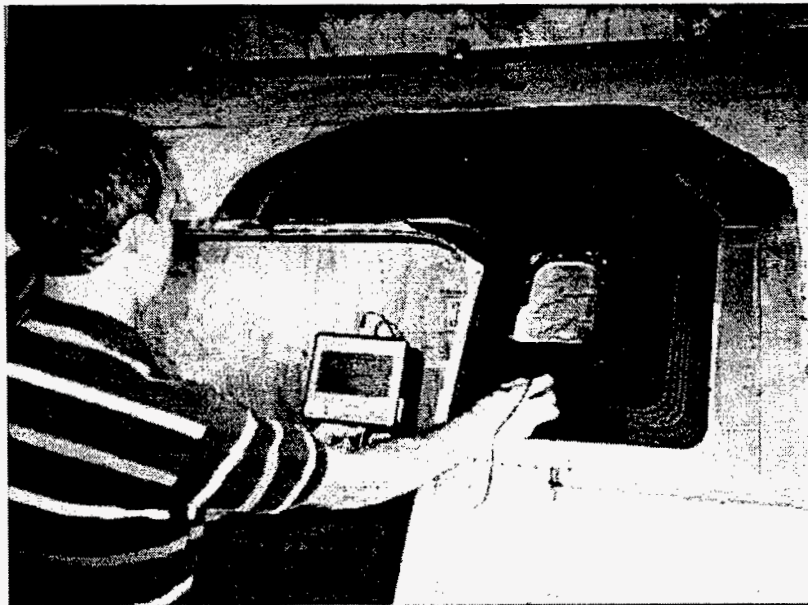
**Figure 21: Pulse-Echo Ultrasonic Inspection of Door Corner Composite Doubler Using a Quantum A-Scan Device**

Figure 21 shows a Quantum device being used to perform a pulse-echo UT inspection of a composite doubler bonded to an L-1011 fuselage structure. Figure 22 contains two A-scan signals produced by the hand-held transducer inspection (gel couplant) of another doubler specimen which contained intentional, engineered flaws at discrete locations. Changes in the A-Scan signal (i.e. lack of reflected signal from aluminum back wall), caused by the presence of the disbond, are clearly visible. Key portions of the signal in Figure 22 are identified to highlight how the A-Scan can be used to detect disbonds and delaminations. The primary items of note are: 1) the unique signature of the amplitude vs. time waveform which allows the user to ascertain the transmission of the ultrasonic pulse through various layers of the test article and which indicates a good bond, and 2) the absence of signature waveforms indicating a disbond.

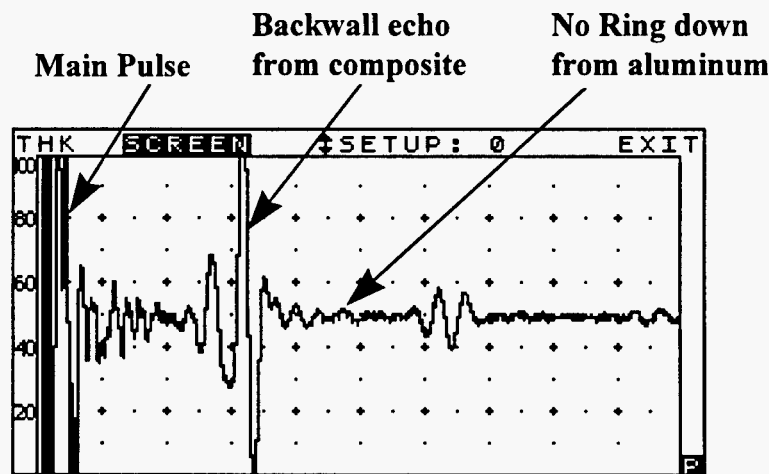
**No Disbond Present**

**Disbond Present**

**Figure 22: A-Scan Waveform from Bonded and Disbonded Portions of a Composite Doubler Test Specimen**

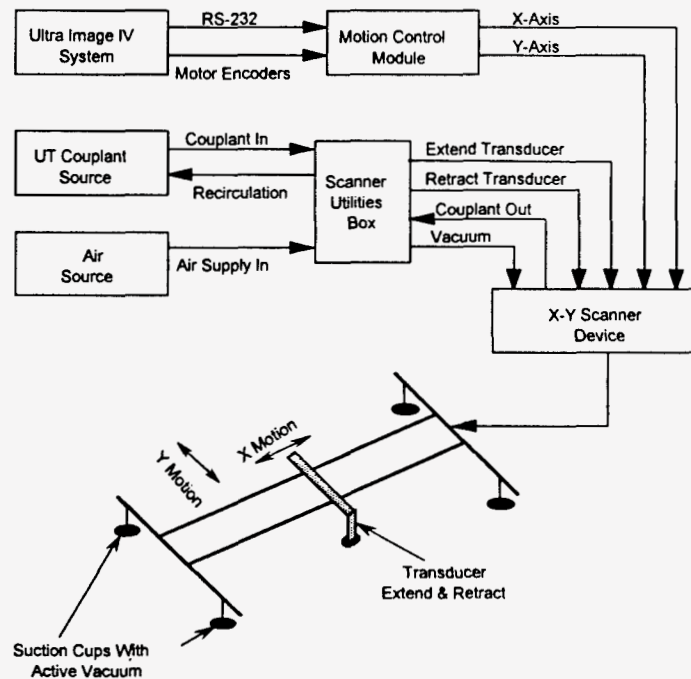
**Figure 24: Interconnection Diagram for Components in Automatic Scanner System**

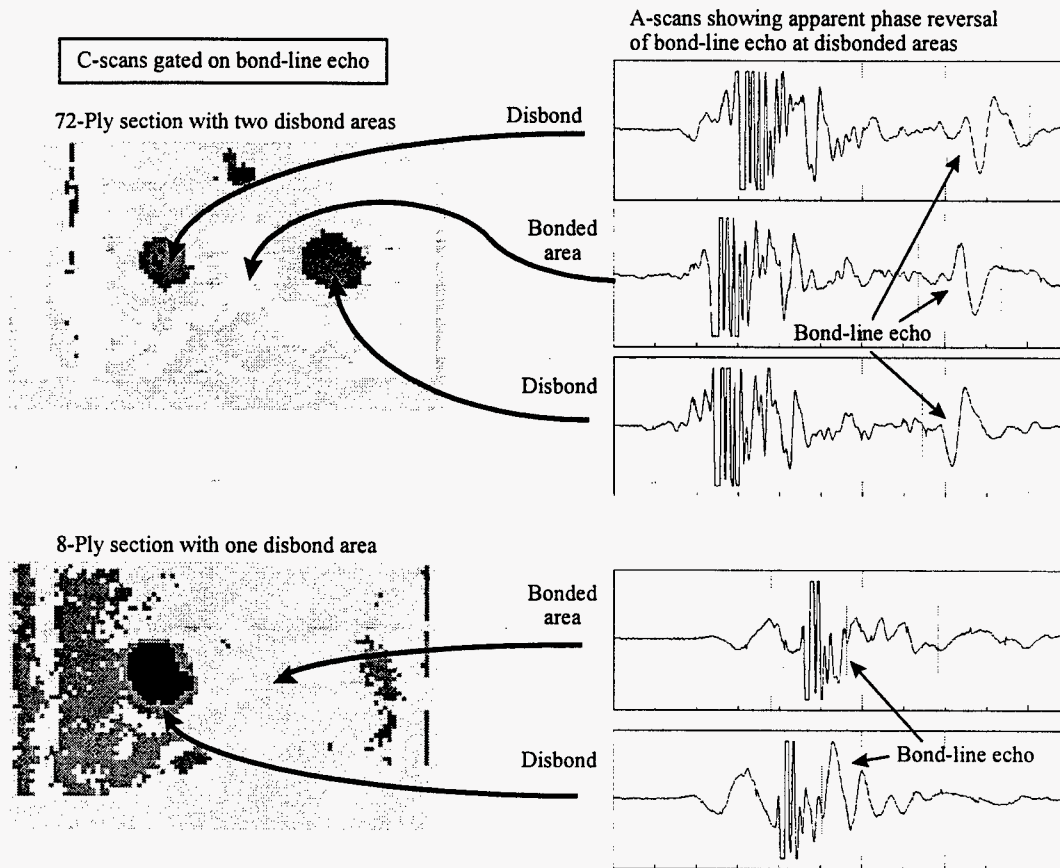
**Figure 33: C-Scans and UT Waveforms Recorded at Bond and Disbond Regions for Two Extreme Laminate Thicknesses of a Calibration Test Sample**

Improvements in Flaw Detection - C-scan images generated using the modified 1" diameter, 2" focus transducer on 72-ply and 8-ply sections of a calibration test sample are shown in Figure 33. The range gate was set on the positive half cycle amplitudes of the bond-line echo. Also shown in Figure 33 are waveforms recorded at the locations of the disbond and at a "normal" bonded area. The echo response using the modified focus transducer clearly displays an apparent phase reversal and increase in the positive half cycles of the echo at the bondline (disbond location). By setting a Time-of-Flight gate for only negative cycles of the echoes, a robust and unambiguous C-scan image of the disbanded areas in the Boron-Epoxy/aluminum interface are produced as illustrated in Figure 34.

The results presented in Figures 33 and 34 were recorded by an ultrasonic data acquisition system with the samples placed in a water immersion tank. However, the modified focus transducer described here can be deployed in the portable ultrasonic data

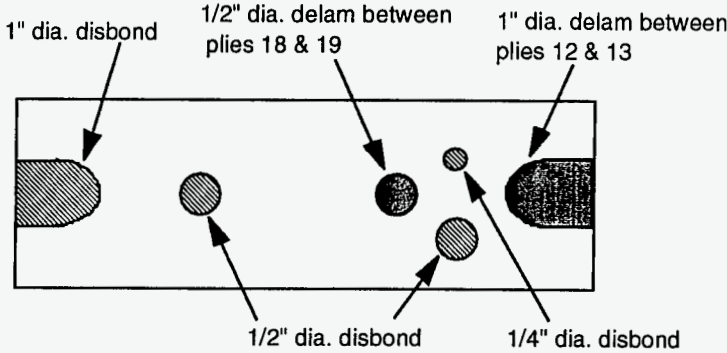
**Nondestructive Inspection  
Validation Test Specimen**

- 24 ply laminate on 0.071" thick 2024-T3 skin
- [0,+45,-45,90]<sub>6</sub> ply lay-up

- Delaminations Between Adajacent Plies
- Disbonds Between Aluminum and Composite Laminate

**Figure 38: Pulse-Echo Ultrasonic C-Scan of 24 Ply Bonded Composite Doubler Specimen with Engineered Flaws**

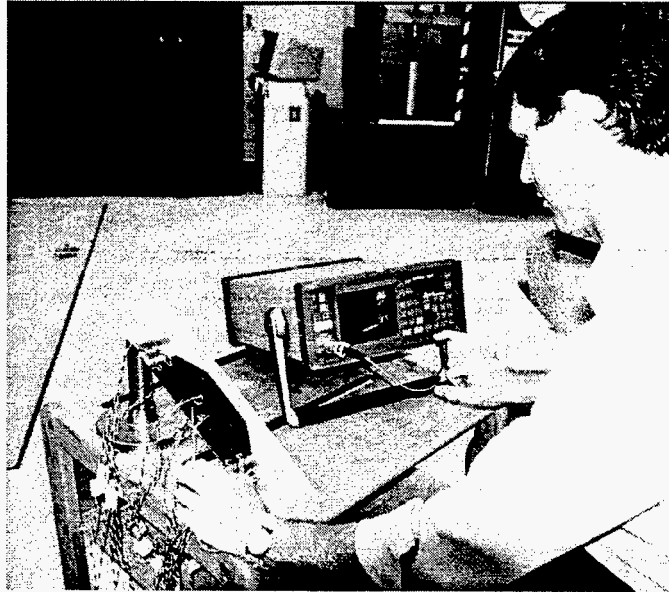
**Figure 48: Resonance Mode Inspection (Staveley Bondmaster Device) of Composite Doubler on Fatigue Coupon**

Resonance Inspection of Composite Doublers - In this study, high frequency ultrasonic resonant bond inspection was evaluated on the array of composite doubler test specimens. A Staveley Sonic Bondmaster instrument was used to perform the inspections. Figure 48 shows the Bondmaster being applied to the composite doubler fatigue coupons described in Section 1.4 and reference [20]. In this inspection, a narrow banded 0.5" diameter transducer was driven at its resonant frequency of 330 kHz. The transducer is placed on the composite doubler with the use of gel couplant. Reference [40] describes how a transducer verifies the amplitude signal (sound pressure) at a point of reception. The Boron-Epoxy has a damping affect on the transducer. The primary results are increased bandwidth, shift in resonant frequency, and change in signal amplitude. The transducer is nulled on an unflawed composite area on a calibration standard. The transducer is then moved to the composite doubler being inspected. Changes in the acoustic impedance of the transducer as it moves over a flawed area is detected. The flaw changes the standing wave pattern in the material. These changes are subsequently detected as differences in the acoustic impedance at the surface of the material caused from the loss of material damping. Changes in the acoustic impedance create changes in the electrical impedance which are monitored by the instrument and displayed in the form of an amplitude/phase plot. In the general sense, the phase information is related to the depth of the disbond in the doubler or a thickness variation caused by the slope in the taper. Signal amplitude is predominately affected by the relative size or severity of the disbonds in the composite doubler. Sensitivity, the angle of the dot movement (rotation), and operating frequency can be adjusted on the instrument to maximize the differences between flawed and unflawed inspection sites.

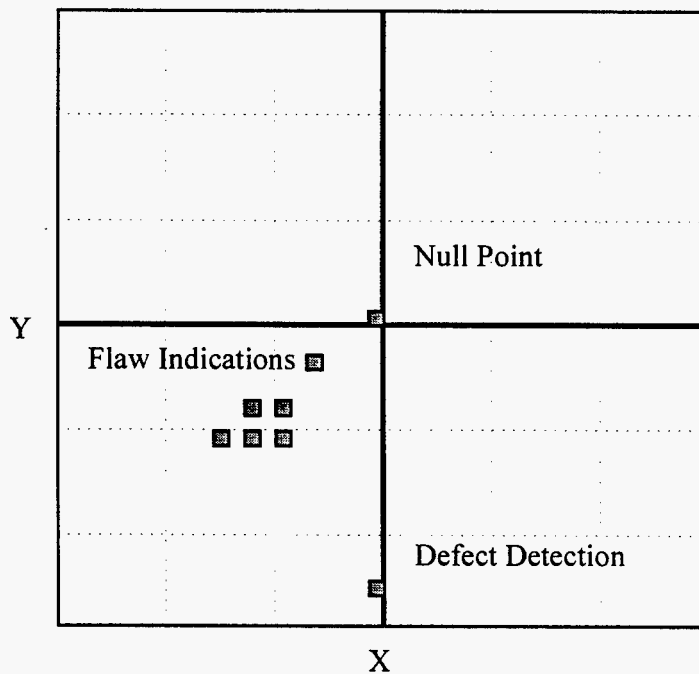
**Figure 49: Representative Bondtester Output for Disbond and Delamination Inspections on 13 Ply Fatigue Coupons**

Figure 49 shows some sample output from the Bondmaster device and how the screen plots are used to detect the presence of a flaw. Appendix B contains an inspection procedure for performing resonance mode inspections. Following is a brief summary of the high frequency bondtester inspection results on a composite doubler coupon specimen which was subjected to 144,000 fatigue cycles.

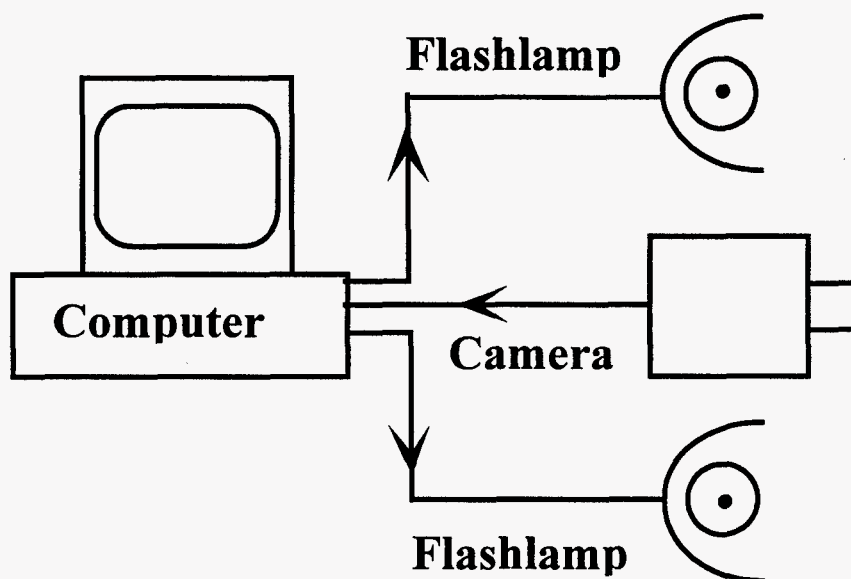
Thermal wave imaging is accomplished using high-power flash lamps, an infrared (IR) video camera, and image processing hardware and software, all of which are controlled by a personal computer. A schematic diagram of such a system is given in Figure 50. The flashlamps put out a short, high-power pulse of light, which raises the surface temperature of the aircraft approximately ten degrees when it is absorbed by the surface.

**Figure 50: Schematic Diagram Of The Pulse-Echo Thermal Wave Infrared Imaging System**

This temperature pulse propagates into the material as a thermal wave and gets reflected by any defects which may be present in the material. After a time delay determined by the depth of the defect, these thermal waves reflect and affect the temperature distribution on the aircraft surface. The resulting temperature distribution is then recorded by the IR camera and displayed on the computer monitor. In practice, the computer actually obtains several images at progressively later times after each flash. This method is particularly useful for imaging and determining the depths of disbonds and delaminations in Boron-Epoxy repair doublers on aircraft structures. A photograph of the Thermal Wave Imaging System being applied to an aircraft inspection is shown in Figure 51.

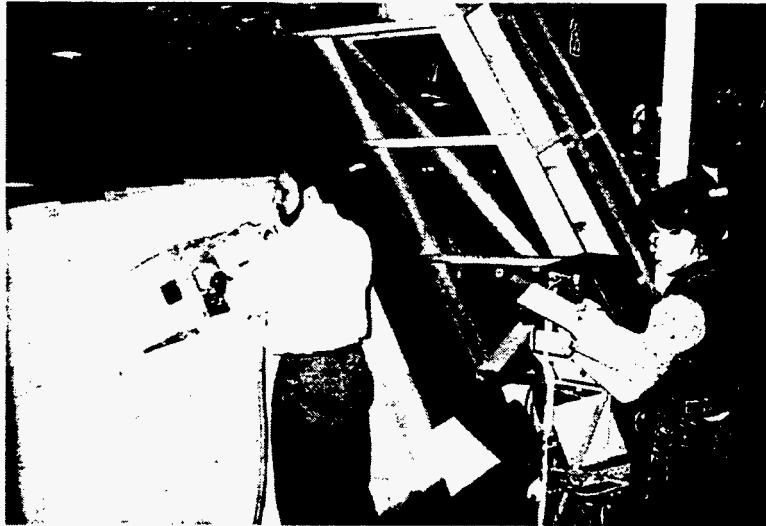
**(a) Close-Up View of TWI Equipment**

**(b) Application of Thermography on 747 Aircraft**

**Figure 51: Thermal Wave Imaging System Inspecting an Aircraft**

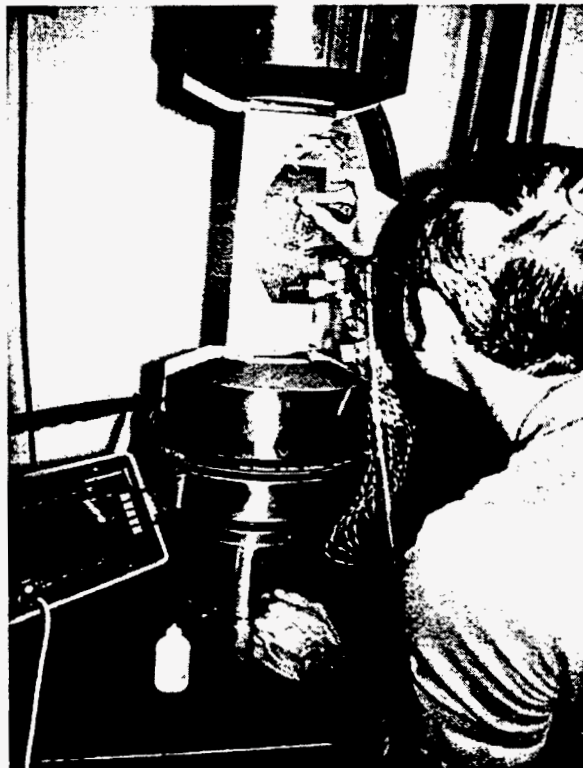
**Figure 57: Application of Eddy Current Equipment to Detect Cracks Beneath Composite Doublers**

In order to adequately address the damage tolerance needs, these EC viability demonstrations must be expanded into more focused testing to assess sensitivity and reliability issues. Structured EC testing was performed in this study in an attempt to quantify EC performance through composite doublers. Both sliding and surface (pencil) probes were used in this inspection series. The sliding probe is best suited for these type of inspections and have the lower frequencies needed to penetrate the doubler layer. Figure 57 shows the Staveley 19e2 eddy current device being applied to one of the composite doubler fatigue coupon specimens (see Fig. 17). A 30 kHz pencil probe was able to reliably detect the crack tip - which was changing during the course of the fatigue testing - through a 13 ply doubler. Eddy current and microscopic inspections on the back side of the specimen (non doubler side) confirmed the accuracy of the EC inspections through the doubler. The reference [50] eddy current inspection procedure was prepared to guide the application of EC to composite doublers. This procedure is also provided in Appendix C of this report.

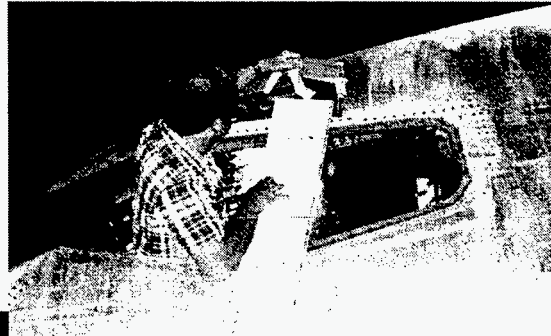
Positioning Film for Cockpit Window Post Inspection

Locating X-Ray Source for Door Frame Crack Inspection

**Figure 63: Aircraft Fuselage Inspection for Cracks Using X-Ray**

Radiographic inspection is a nondestructive method of inspecting materials for surface and subsurface discontinuities [39]. The method utilizes radiation in the form of either x-rays or gamma rays, which are electromagnetic waves of very short wavelength. The waves penetrate the material and are absorbed depending on the thickness or density of the material being examined. By recording the differences in absorption of the transmitted waves, variations in the material can be detected. Figure 63 shows an application of X-radiography in a hangar environment.

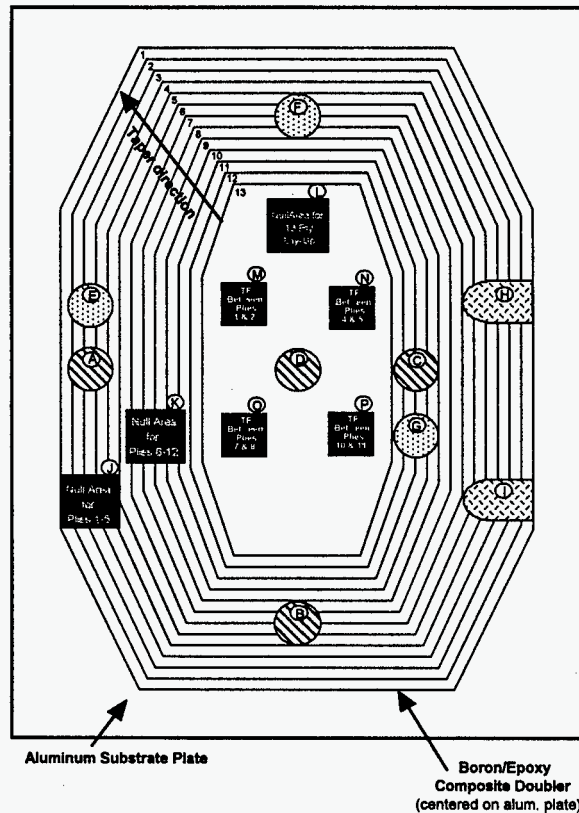
**Figure 65: Configuration of Composite Doubler Reference Standard to Support Disbond and Delamination Inspections**

1. Pull Tab - These inserts, which are removed after the adhesive curing process, produce a true "air gap" disbond or delamination in a specimen. A piece of stainless steel shim stock (0.003" to 0.004" thick) is placed between adjacent composite plies or between the base of a laminate and the mating aluminum structure. The stainless steel shims should be treated with a chemical release agent to prevent any permanent bond to the adhesive. Prior to their use, the coated pull tabs should be baked at a temperature which is greater than the doubler cure temperature. This will assure the performance of the release agent during the doubler installation.
2. Pillow Insert - Special inserts can be placed in the laminates during the lay-up operation to produce interply delaminations. The inserts will interrupt an inspection

signal and simulate an air gap between adjacent plies. Teflon, or a stacked assembly of sheet materials ("pillow"), can be used as inserts. Pillow inserts are composed of Kapton tape surrounding 3 layers of tissue paper. This pillow insert assembly can be fabricated with a total thickness of 0.008" - 0.009". This helps to minimize the amount of local deformation of the doubler in the area of the inserts. Teflon or pillow inserts can be fabricated with unusual or "random" shapes in order to model real life flaws.

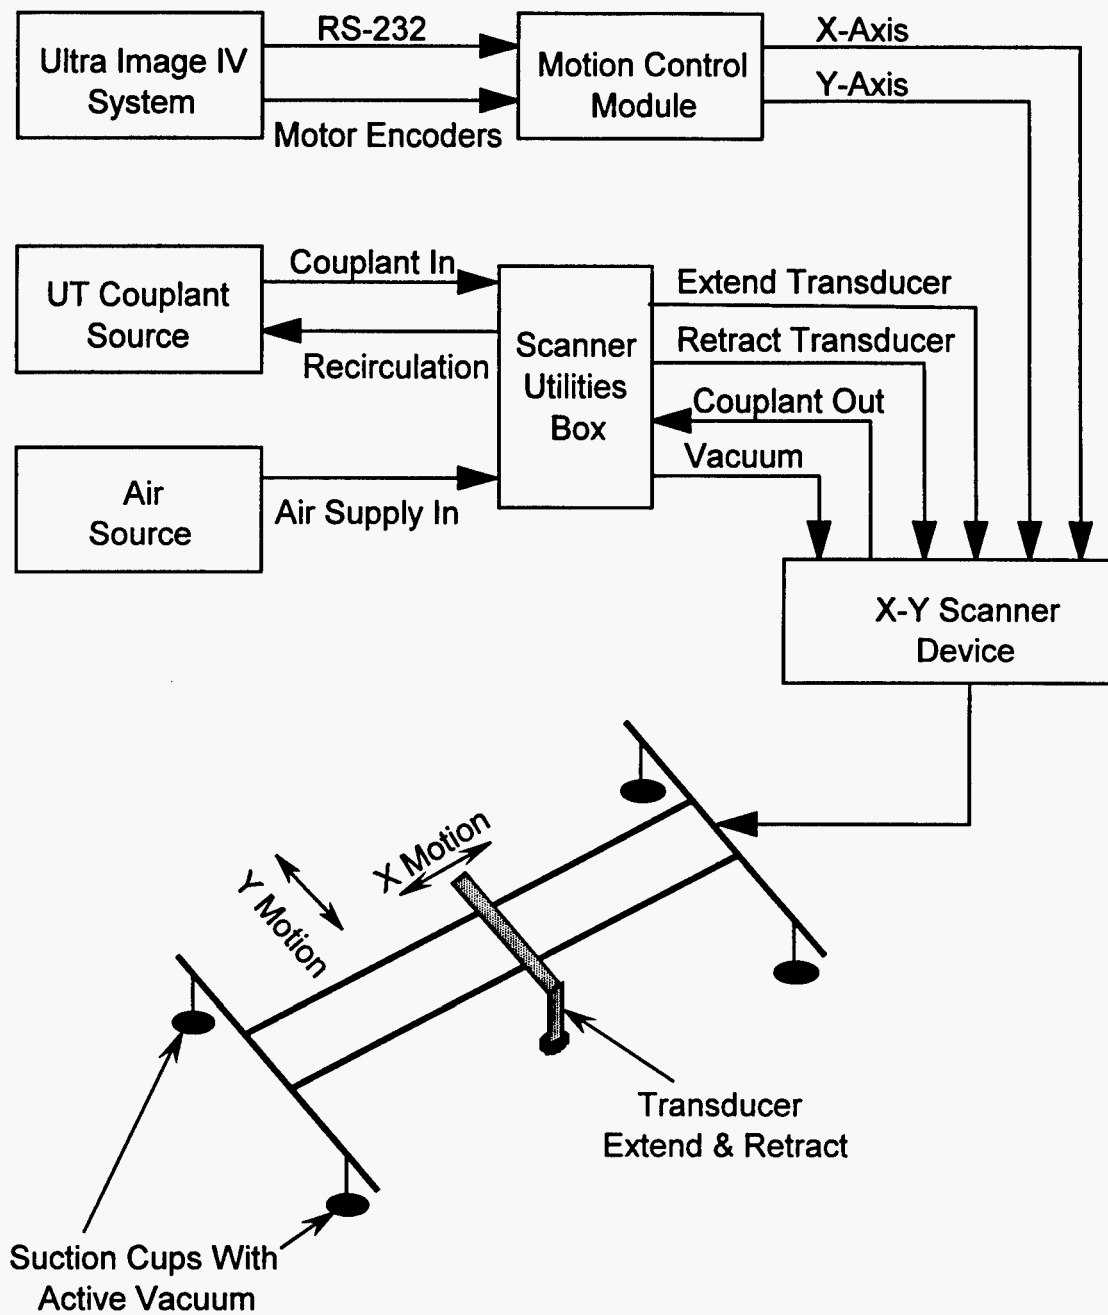
**Figure A-1(a): Automatic Scanner System Interconnection Diagram**

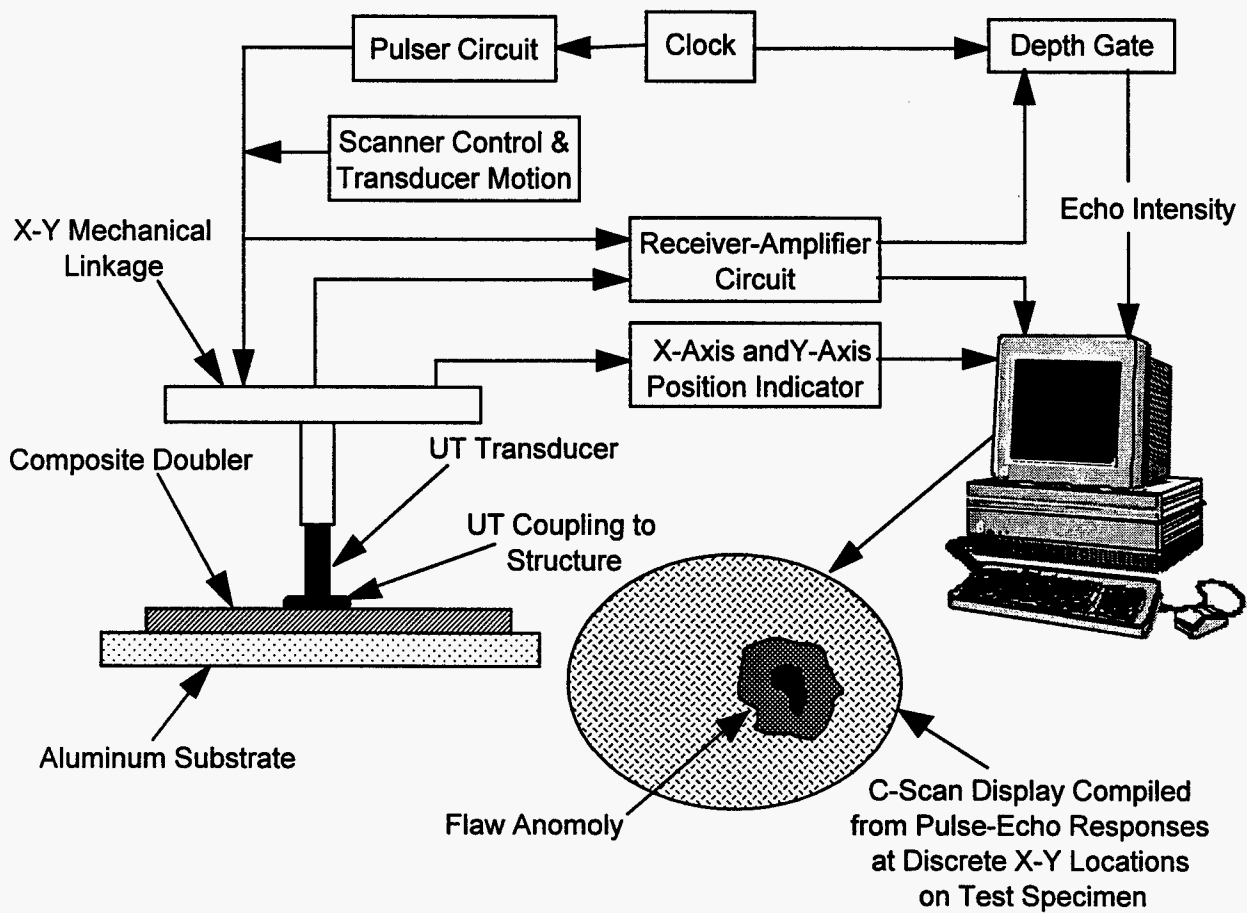
**Figure A-1(b): Schematic of C-Scan Setup for Pulse-Echo Ultrasonic Inspection**

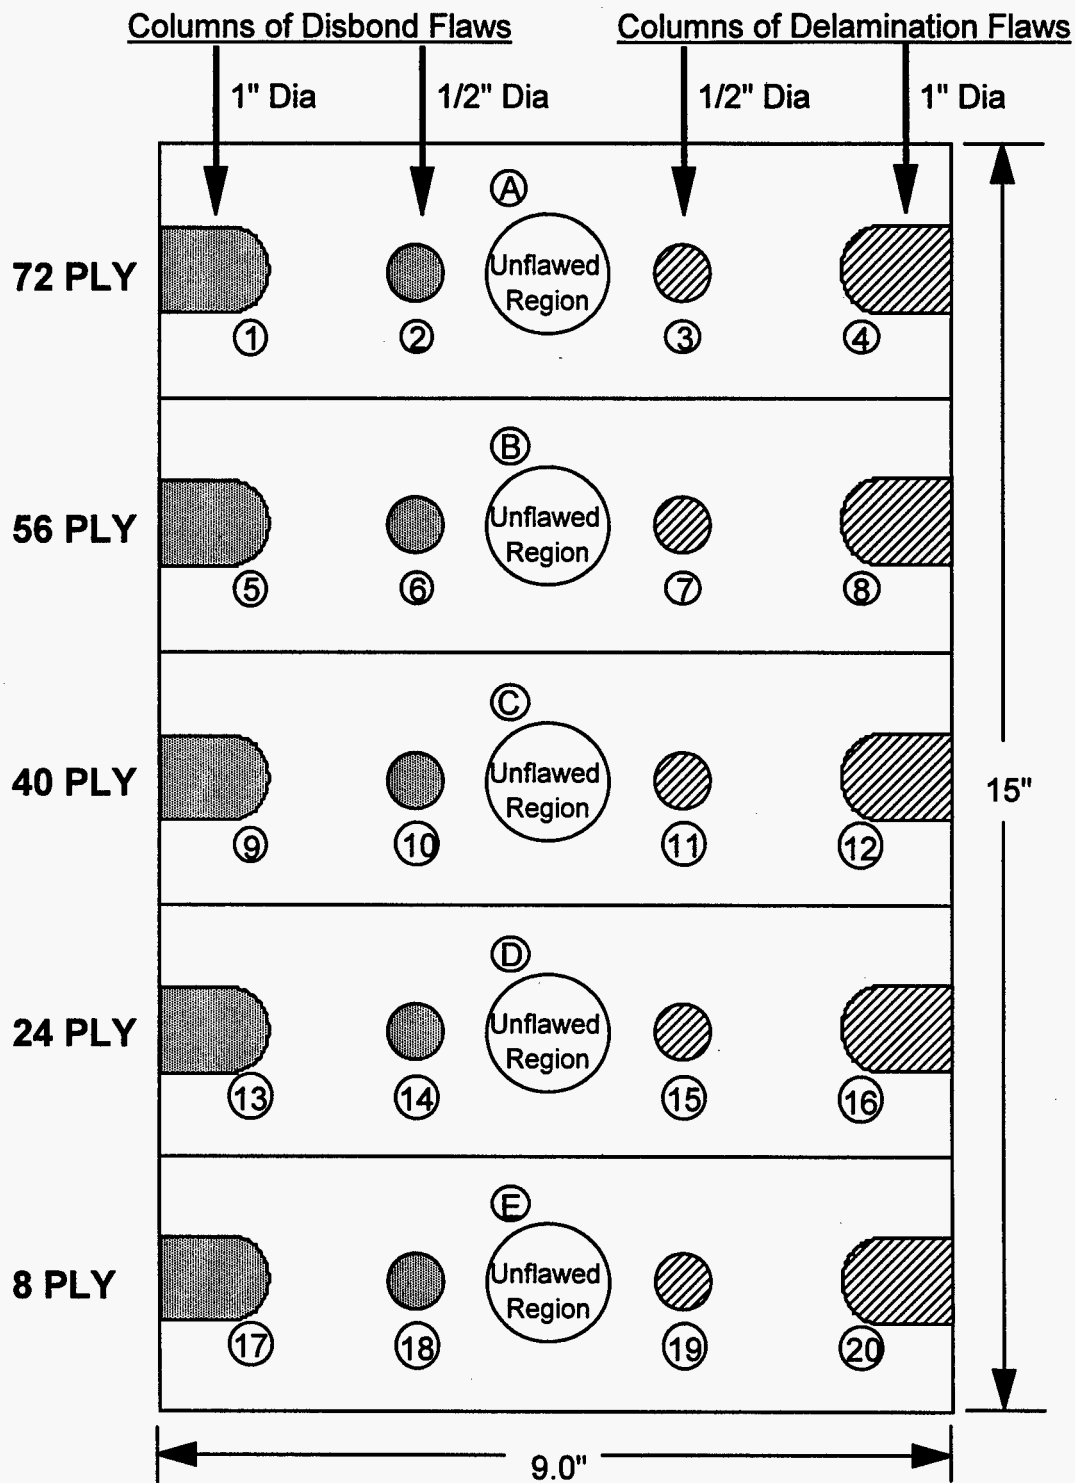
[0, +45, -45, 90]<sub>n</sub> Ply Lay-Up

Figure A-3(a): Composite Doubler Calibration Standard for Ultrasonic Inspections

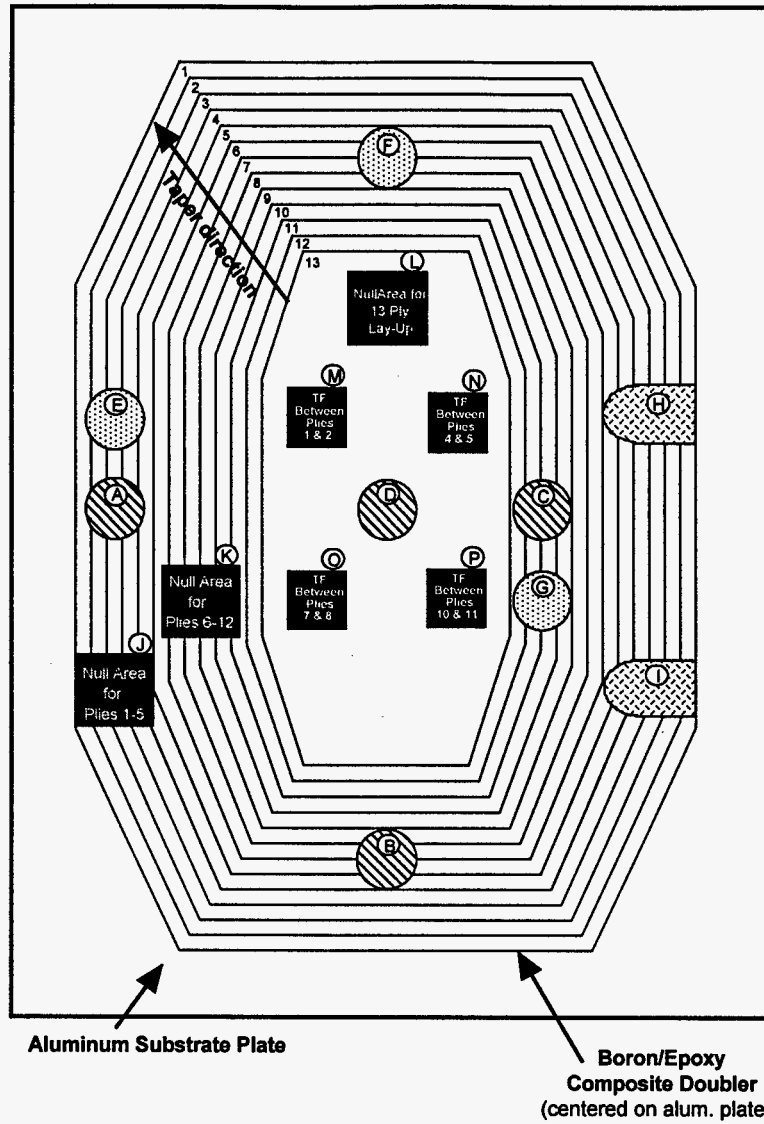
**Figure B-1: Configuration of Boron-Epoxy Composite Doubler Reference Standard to Support Ultrasonic Inspections**

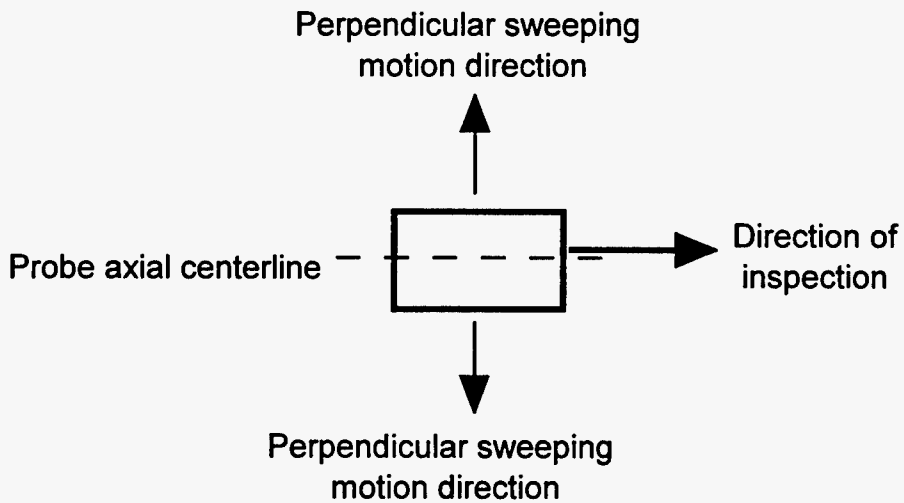
**(a) Lap joint reference flaw configuration originating from the shank of each fastener**

**(b) Top view of eddy current sliding probe.**

**Figure C-3: Motion of Sliding Probe Over Fasteners**

- 5.10 Scan the probe over fasteners No. 3 and 4 in Figure 3a while monitoring the instrument signal pattern. (NOTE: The instrument display may need to be recorded and cleared after scanning each fastener. This will allow the scanned signal for each fastener to be clearly identified). The instrument signal should be similar to Figure 5. There must be at least one vertical and/or horizontal division separation between the non-defect signal and the off-angle reference notch signals. If a one division separation is not found, adjust the gain controls to produce the desired separation. (NOTE: These two signals are considered the worst case inspection situations. All other flaw signals should have, at a minimum, a one division separation).
