EWI Project No. 46211GTH
Electronic File Name: 41633R52.pdf

Internal Repair of Pipelines 24-Month Technical Progress Report

Reporting Period:
March 31, 2004 through September 30, 2004

Submitted By:
Edison Welding Institute
1250 Arthur E. Adams Drive
Columbus, OH 43221

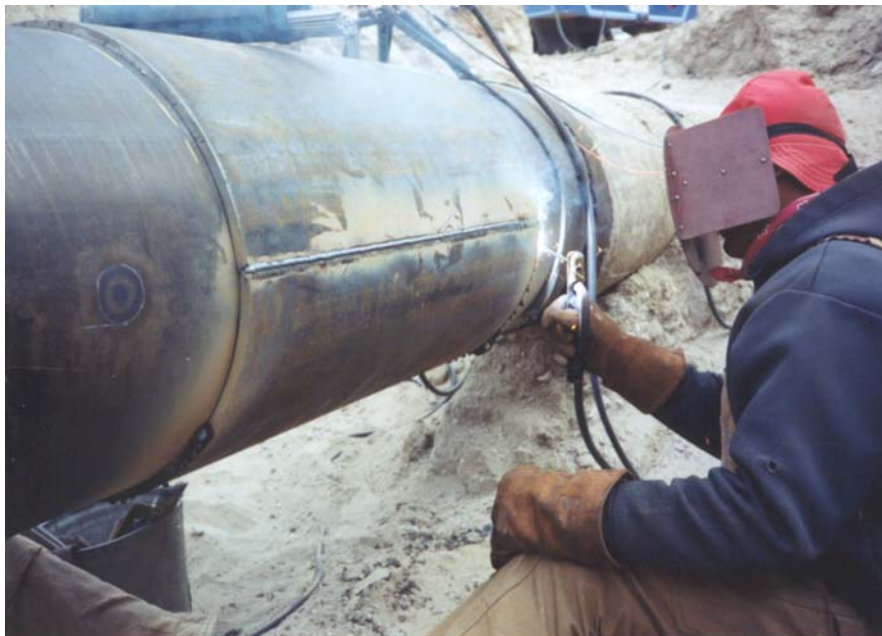
Gas transmission pipeline repair by direct deposition of weld metal, or weld deposition repair, is a proven technology that can be applied directly to the area of wall loss (e.g., external repair of external wall loss - Figure 1) or to the side opposite to the wall loss (e.g., external repair of internal wall loss - Figure 2).

Figure 1 - Installation of a Full-Encirclement Repair Sleeve

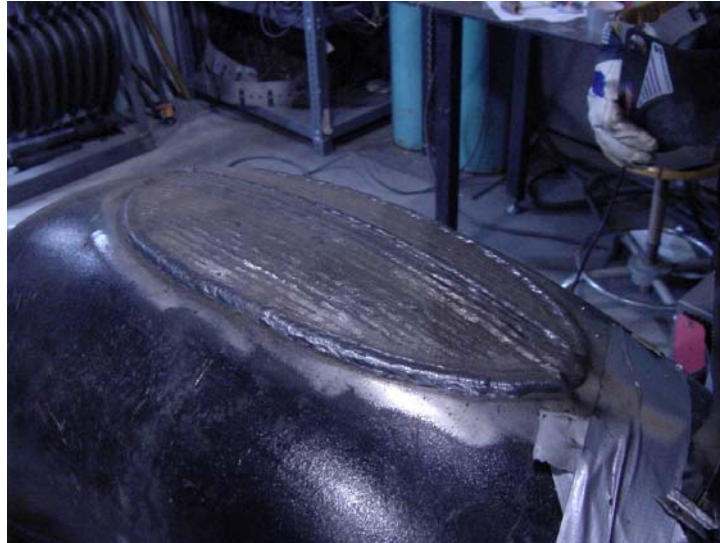
Figure 2 - External Weld Deposition Repair of Internal Wall Loss in 90° Elbow

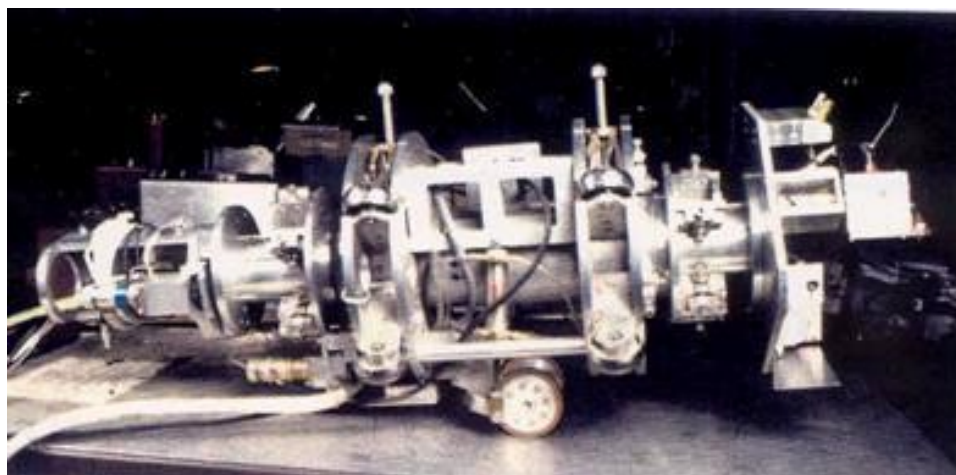
There are no apparent technical limitations to applying this repair method to the inside of an out-of-service pipeline. It is direct, relatively inexpensive to apply, and requires no additional materials beyond welding consumables. However, application of this repair method to the inside of an in-service pipeline would require that welding be performed in a hyperbaric environment. Deposited weld metal repairs are also used to repair circumferentially oriented planar defects (e.g., intergranular stress corrosion cracks adjacent to girth welds) in the nuclear power industry. Remote welding has been developed primarily to meet needs in the nuclear power industry, though working devices have been built for other applications, including repair of gas transmission pipelines. An example of such equipment is shown in Figure 3.

Figure 3 - Osaka Gas System for Remote Robotic Internal Repair of Root Weld Defects in Gas Transmission Pipelines

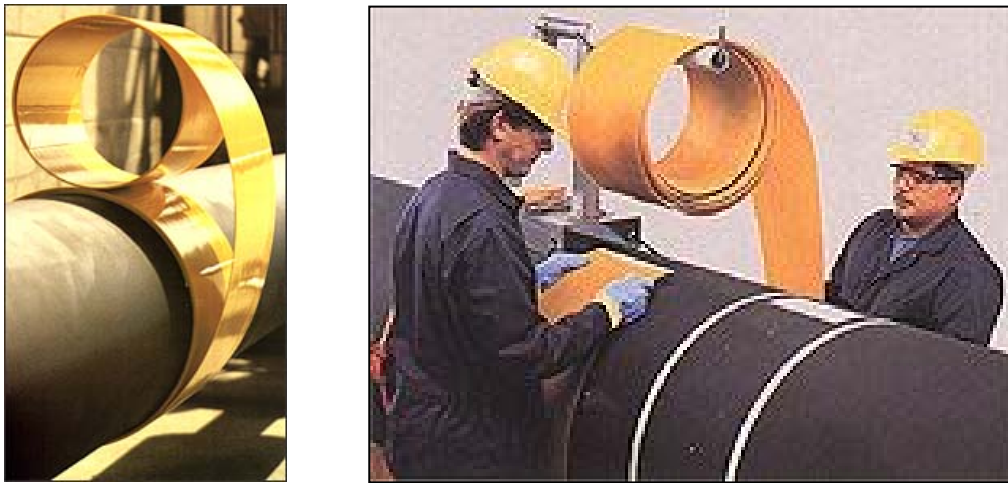
Fiber-reinforced composite repairs are becoming widely used as an alternative to the installation of welded, full-encirclement sleeves for repair of gas transmission pipelines. These repairs typically consist of glass fibers in a polymer matrix material bonded to the pipe using an adhesive. Adhesive filler is applied to the defect prior to installation to allow load transfer to the composite material. The primary advantage of these repair products over welded, full-encirclement sleeves is the fact that welding is precluded. An illustration of the most commonly used of the fiber-reinforced composite devices, Clock Spring®, is shown in Figure 4.

Figure 4 - Clock Spring® Fiber-Reinforced Composite Device for Pipeline Repair

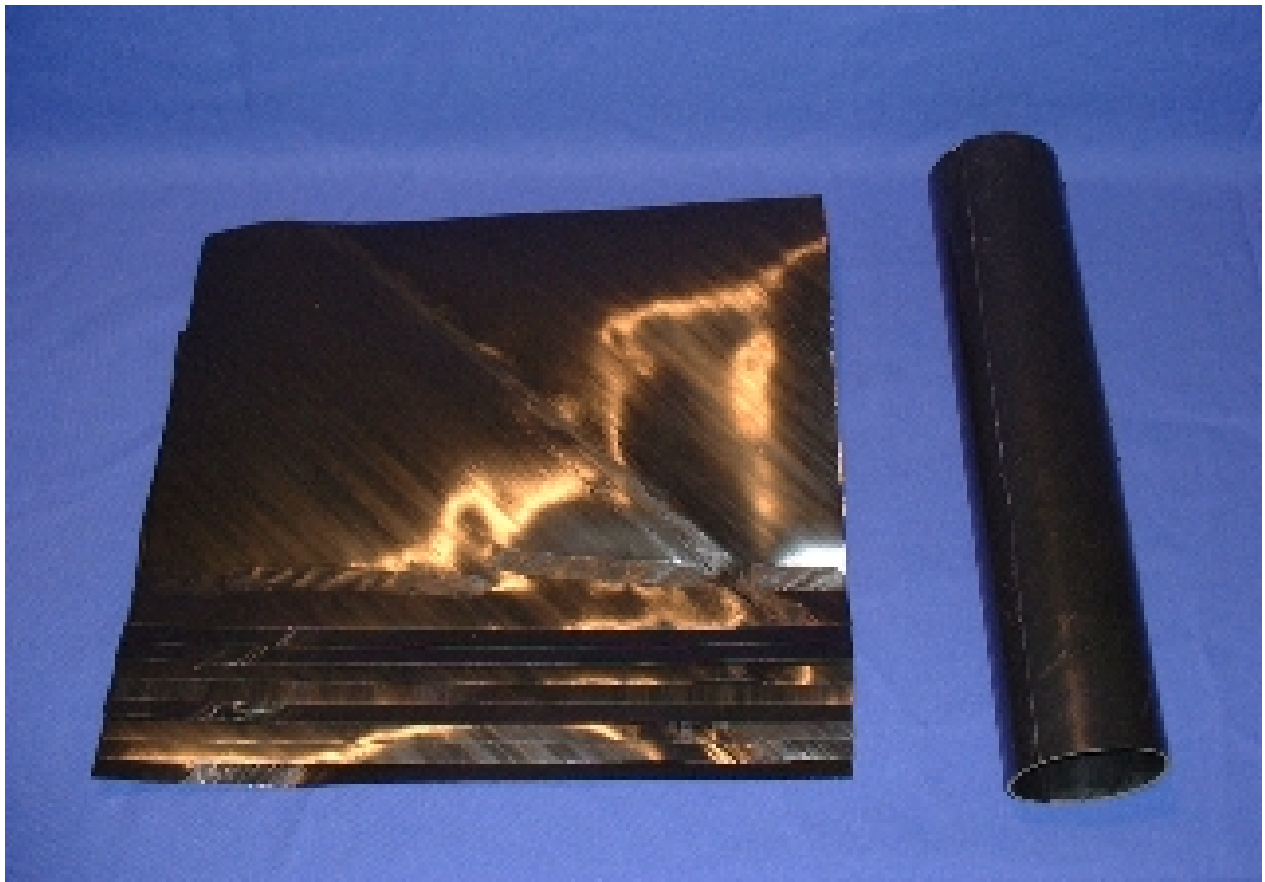
in the form of overlapping, pre-pregnated tapes of unidirectional glass and polymer. Glass-high density polyethylene (HDPE) material was also considered. The glass-polypropylene material was selected after problems bonding the glass-HDPE material to steel were encountered. Heat and pressure were used to consolidate the plies glass-polypropylene material into a liner (Figure 7). The resulting wall thickness of the liner is 2.85 mm (0.11 in.).

Figure 7 - Lay-Up and Forming of Fiber-Reinforced Composite Liner

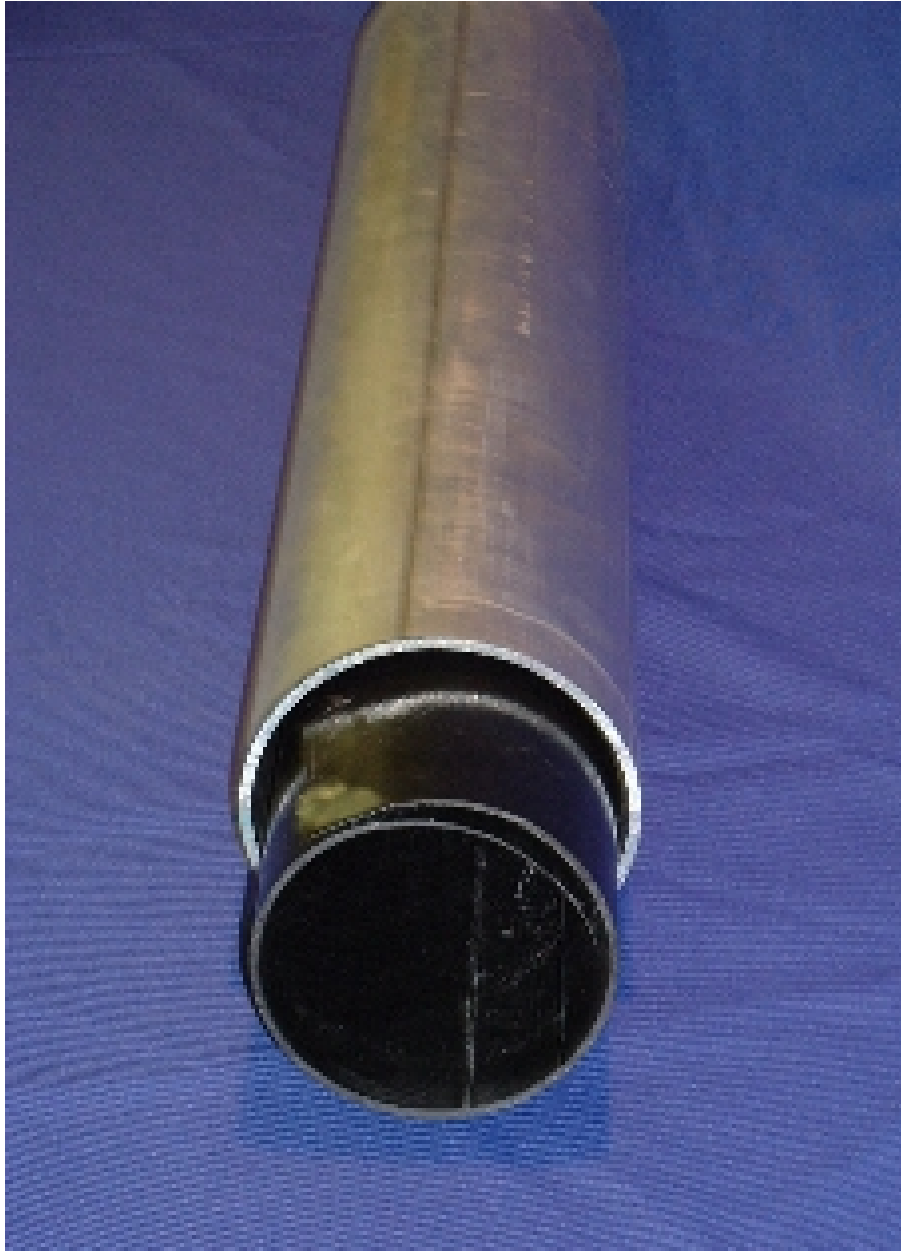
A supply of 114.3 mm (4.5 in.) outside diameter (OD) by 4 mm (0.156 in.) wall thickness, API 5L Grade B pipe material was procured and cut into four 1.2 m (4 ft.) long sections. After the inside surface was degreased, lengths of lining were installed into two of the pipe sections (Figure 8).

Figure 8 - Insertion of Liner into 114.3 mm (4.5 in.) Diameter Pipe

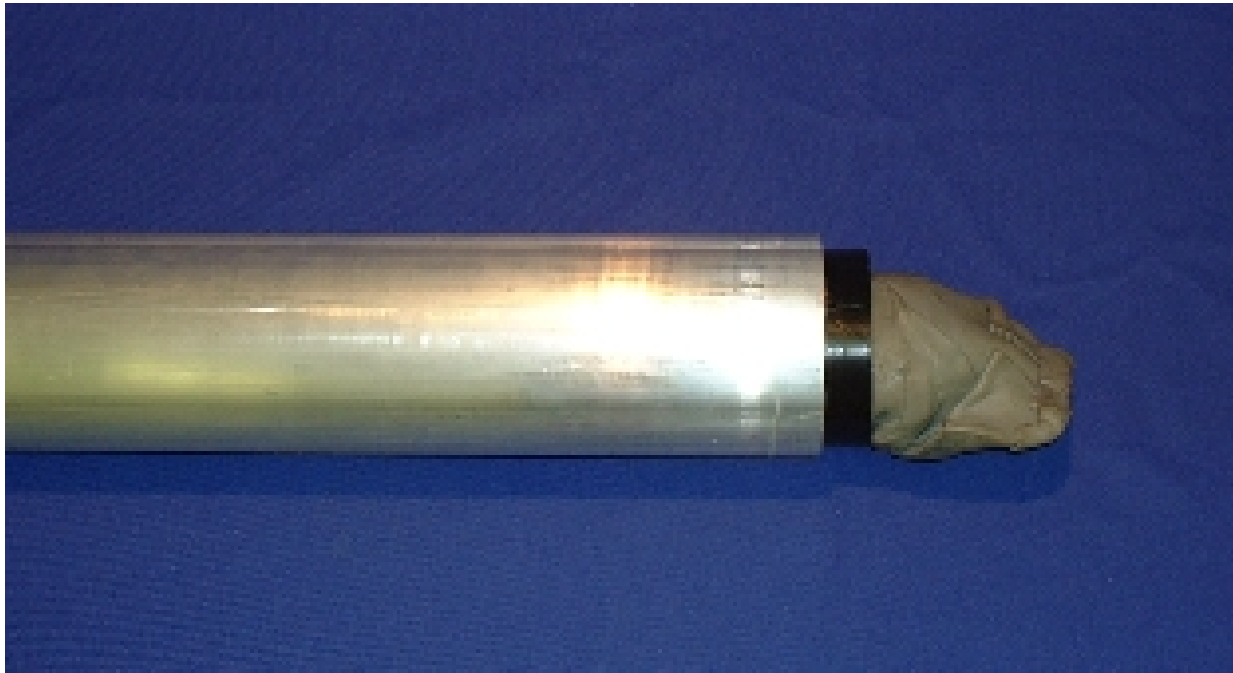
The installation process consisted of inserting a silicon rubber bag inside the liner (Figure 9) and locating the liner inside the pipe. The silicon bag was then inflated to press the liner against the pipe wall.

Figure 9 - Silicon Rubber Bag Inserted into Liner

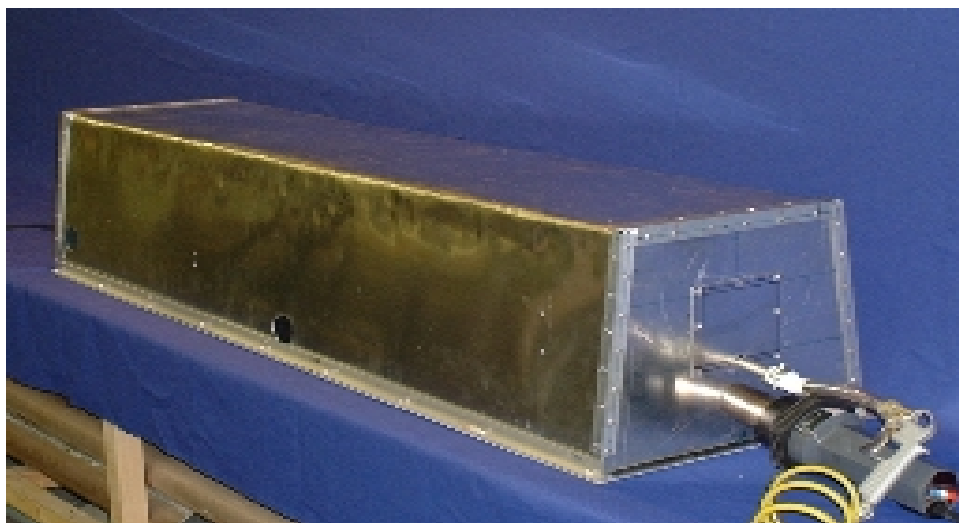
For these experiments, the entire pipe sections were then heated to 200°C (392°F) in an oven (Figure 10) to fuse the liner to the pipe wall.

Figure 10 - Oven Used to Heat Pipe and Liner to 200°C (392°F)

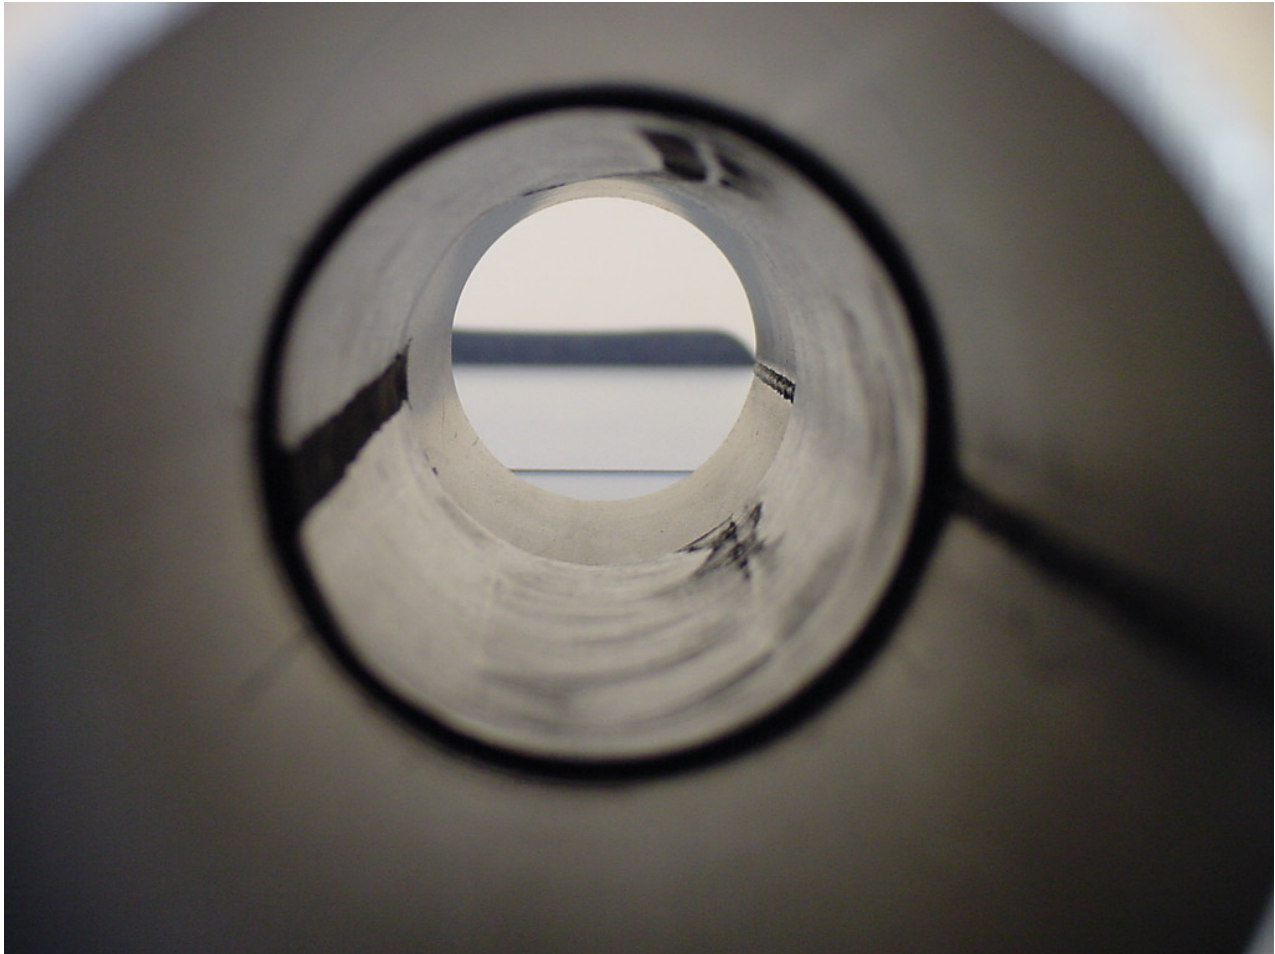
Possible choices for liner installation in the field include infra-red (IR) heaters on an expansion pig or a silicon bag inflated using hot air. An installed liner is shown in Figure 11.

Figure 11 - Liner Inserted into Center of 114.3 mm (4.5 in.) Diameter Pipe

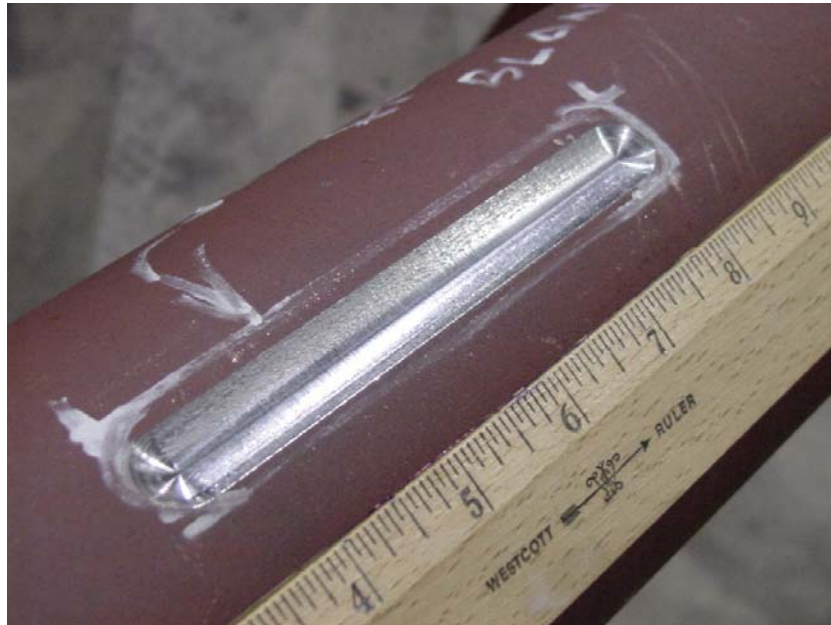
Using the RSTRENG software⁽¹⁾, dimensions of simulated general corrosion and a deep, isolated corrosion pit both with a 30% reduction in burst pressure were calculated then introduced into pipe sections with a milling machine. Using an end mill, long shallow damage representative of general corrosion (Figure 12) was introduced into one pipe section lined with fiber-reinforced composite liner and one without.

Figure 12 - Long, Shallow Simulated Corrosion Damage

repair process evaluation. Both types of corrosion damage were introduced into pipe sections with a milling machine. Using a ball end mill, long shallow damage representative of general corrosion (as shown in Figure 12) was originally introduced into pipe specimens. Using an end mill with rounded corners, short, deep damage representative of a deep isolated corrosion pit (as shown in Figure 13) was introduced pipe specimens as well. Over time, external corrosion will continue to decrease pipeline wall thickness.

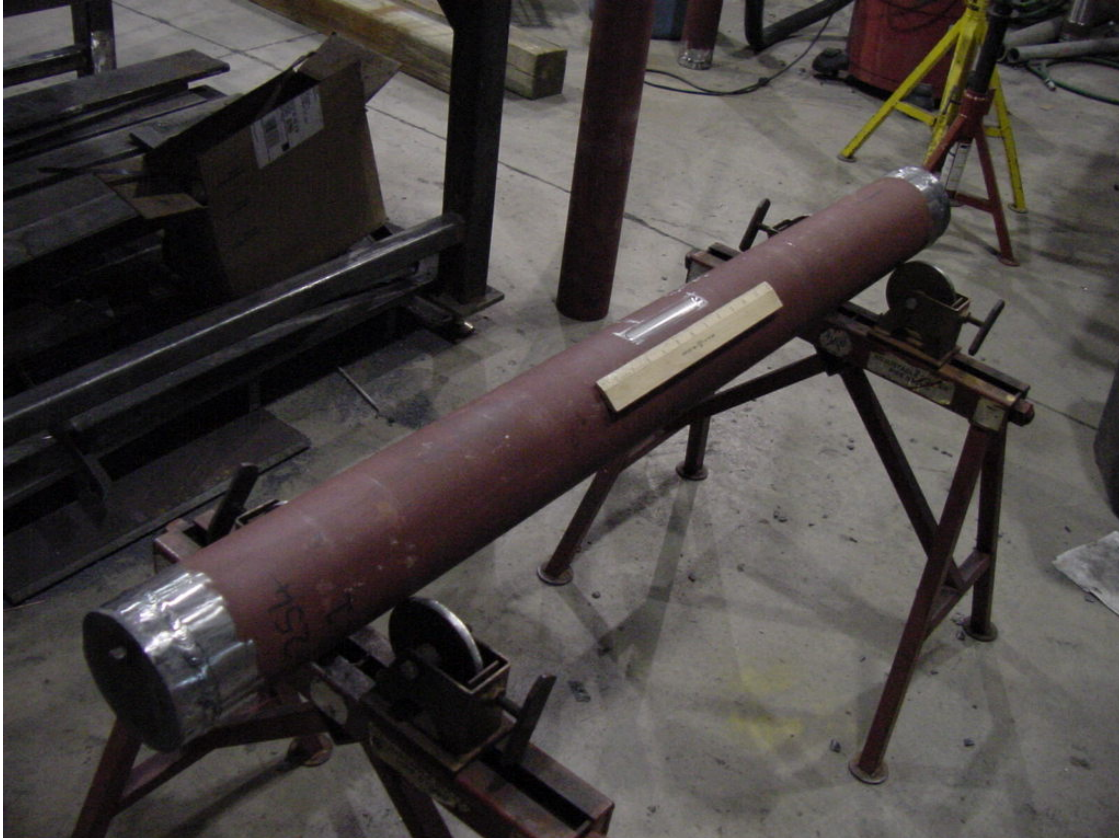
End caps were then welded to all four pipe sections as shown in Figure 14. Following the installation of end caps, all four pipe sections were hydrostatically pressurized to failure.

Figure 14 - 114.3 mm (4.5 in.) Diameter Pipe Section with End Caps Welded and Simulated Corrosion Damage

Grade B pipe and one section of 508 mm (20 in.) diameter by 6.4 mm (0.25 in.) wall API 5LX-52 pipe, were assembled as shown in Figure 14 to prepare for burst testing. All four un-repaired pipe sections were then hydrostatically tested until failure.

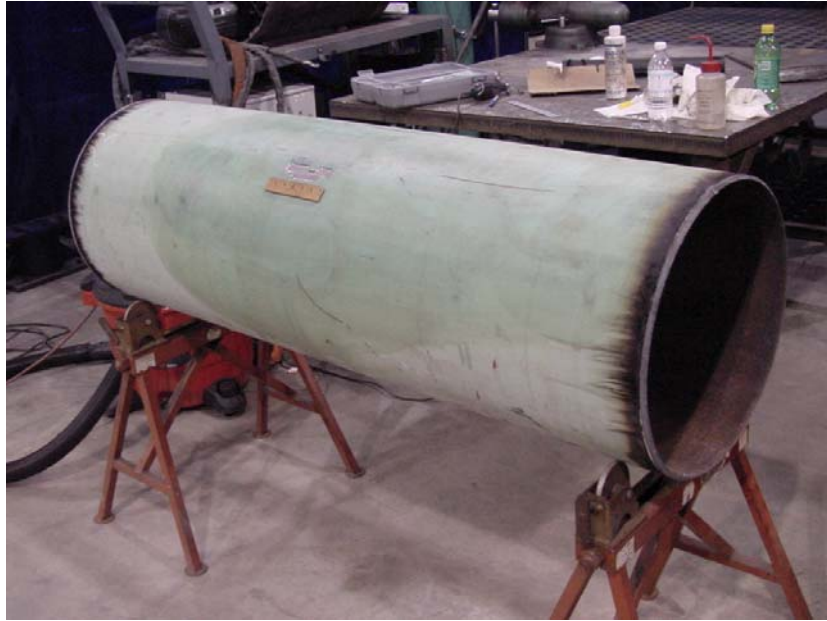
During the last reporting period, using pipe sections with simulated corrosion damage, EWI hydrostatically tested a pipe section that was repaired with a carbon fiber-reinforced liner, which was fabricated in-house. EWI procured raw carbon fiber material and fabricated a 11.42 mm (0.45 in.) thick reinforcement patch using a "wet lay-up" process with a vinylester resin system. For the carbon fiber-reinforced liner repair simulation, a 508 mm (20 in.) diameter by 6.35 mm (0.25 in.) wall, API 5LX-52 pipe section was used (Figure 15).

Figure 15 - 508 mm (20 in.) Diameter API 5L-X52 Pipe Section Used for Carbon Fiber Liner Repair Test

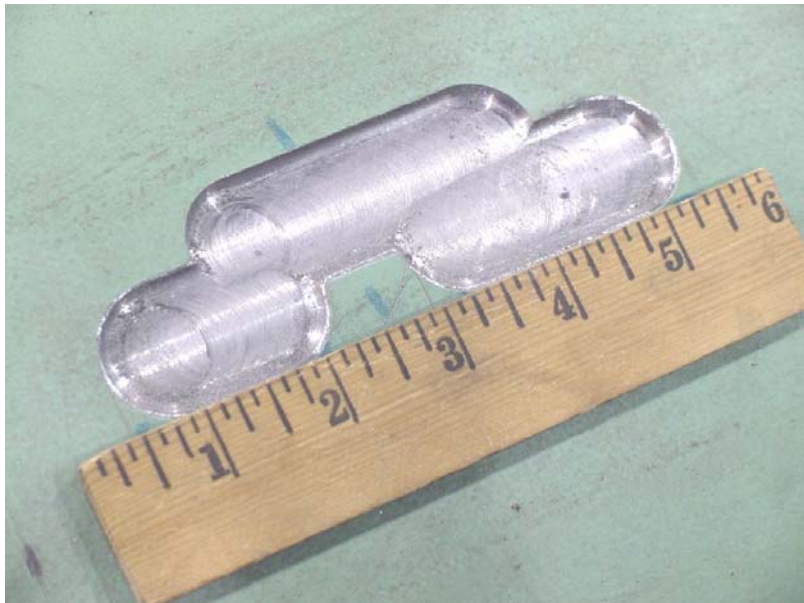
With a ball end mill, long shallow damage representative of general corrosion was introduced into the pipe section. The simulated defect was 127 mm (5 in.) long and 3.45 mm (0.136 in.) deep (Figure 16) and effectively reduces the wall thickness down to 54%. The predicted burst pressure for this pipe material with a similar un-repaired defect is 6.72 MPa (974 psi).

Figure 16 - Simulated Corrosion Defect for Carbon Fiber Liner Repair Test in 508 mm (20 in.) Diameter Pipe

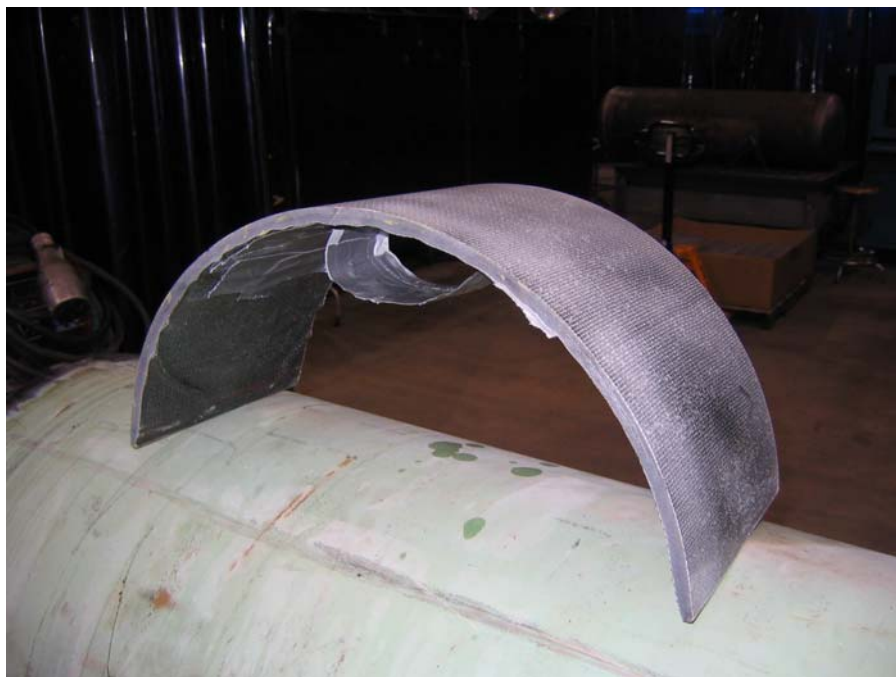
To facilitate patch installation, the outer surface of the patch was grit-blasted using 50 - 80 grit Alumina to remove surface resin (Figure 22). Similarly, the installation area inside the pipe was grit-blasted to a near-white blast with 50 - 80 grit Alumina (Figure 23). After cleaning, a liberal coating of 3M DP460 epoxy adhesive was applied to the internal faying surface and a thin coating was applied to the patch faying surface (Figure 24).

Figure 22 - Completed Repair Patch with Grit-Blasted Outer Diameter

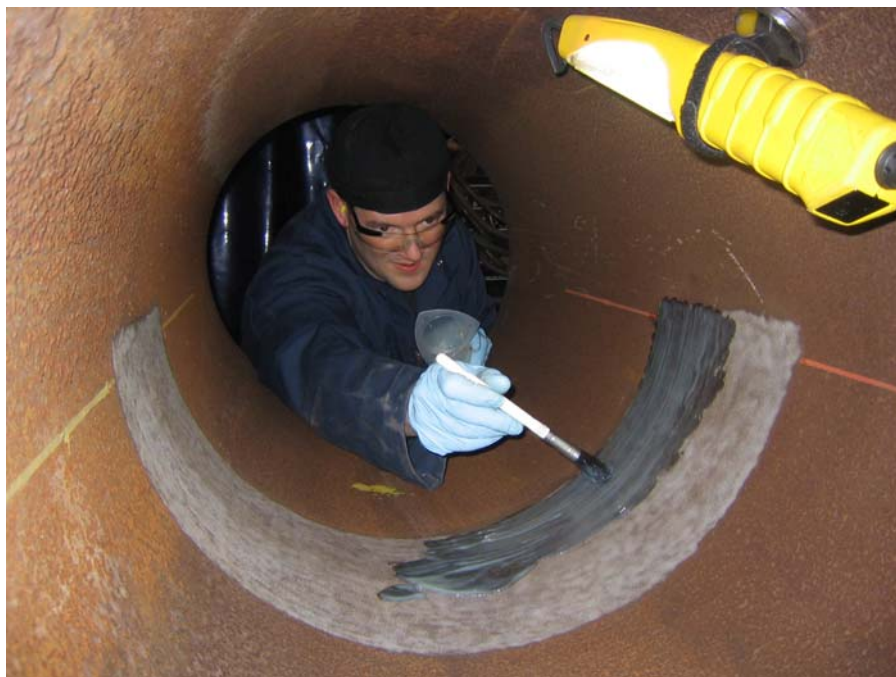
Figure 23 - Application of 3M DP460 Adhesive to Grit-Blasted Inside Diameter of Pipe

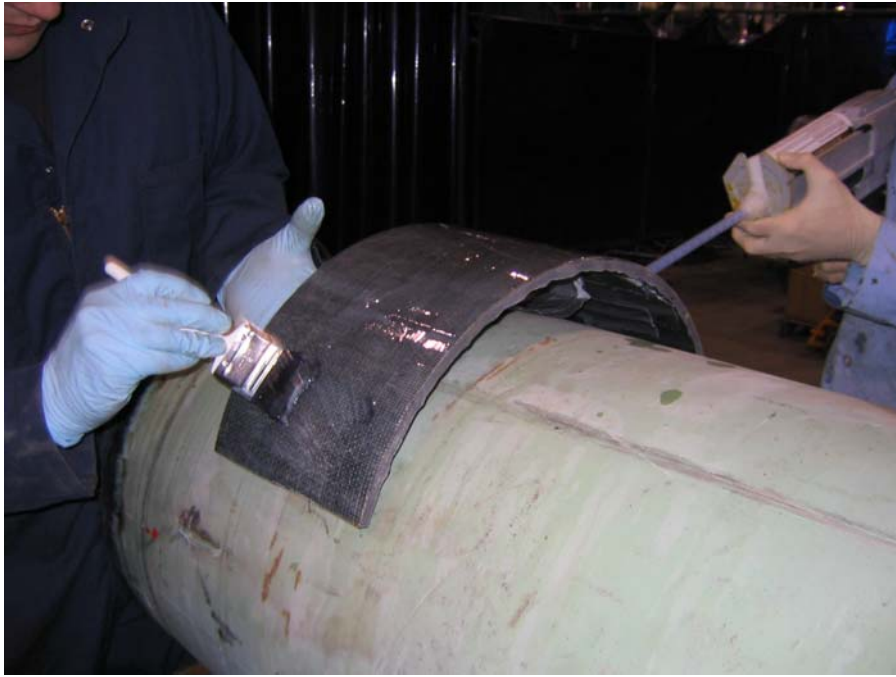
Figure 24 - Application of Adhesive to Repair Patch

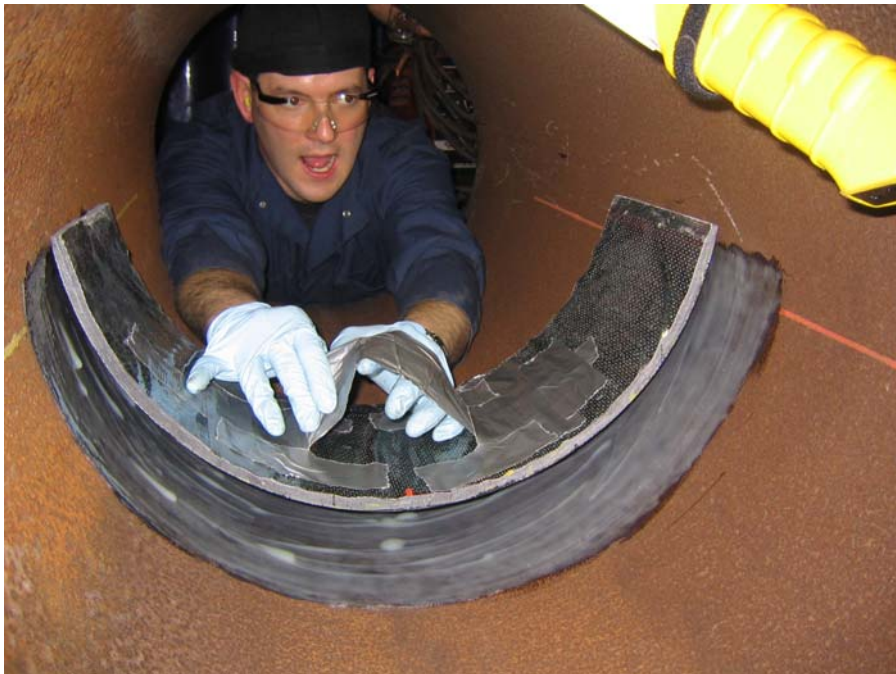
The patch and pipe section were mated as shown in Figure 25.

Figure 25 - Installation of Repair Patch

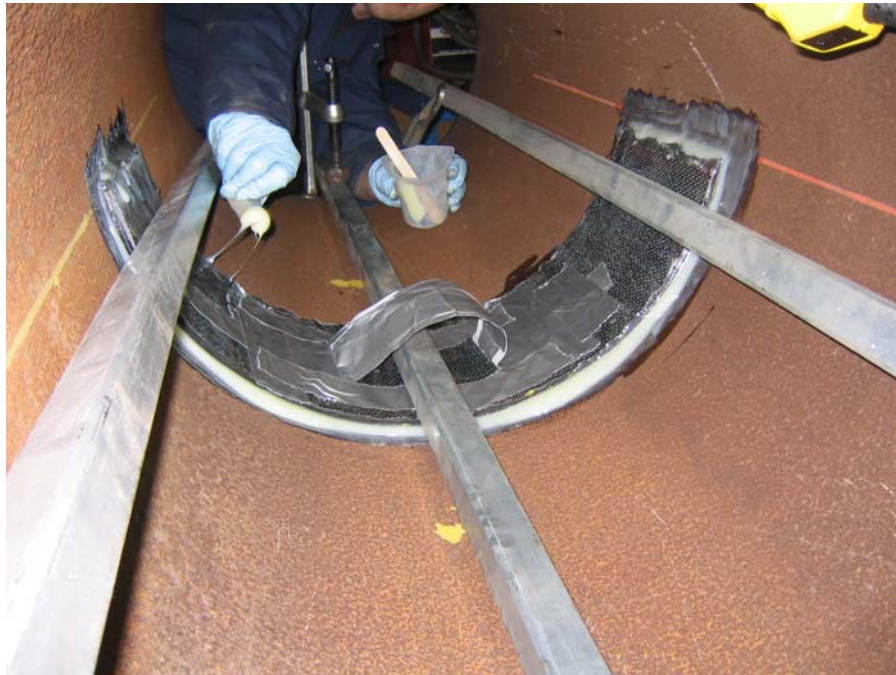
Bar clamps were used along the axis of the pipe to hold the patch in place for cure. Figure 26 shows the adhesive squeeze-out being removed prior to forming a fillet as shown in Figure 27

Figure 26 - Clamping Bars Used to Hold Repair Patch in Place

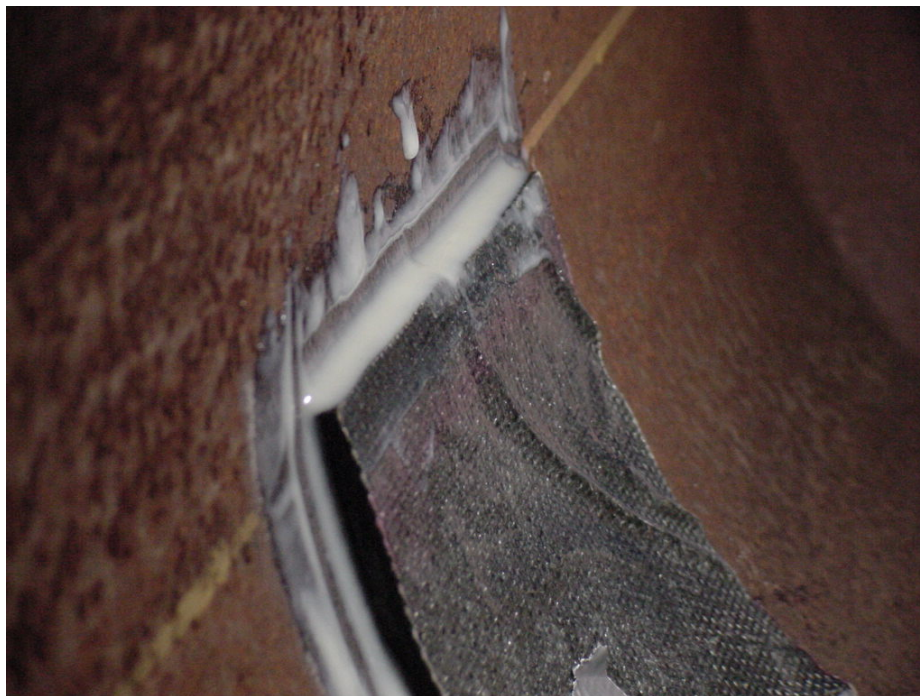
Figure 27 - Adhesive Fillet Around Repair Patch

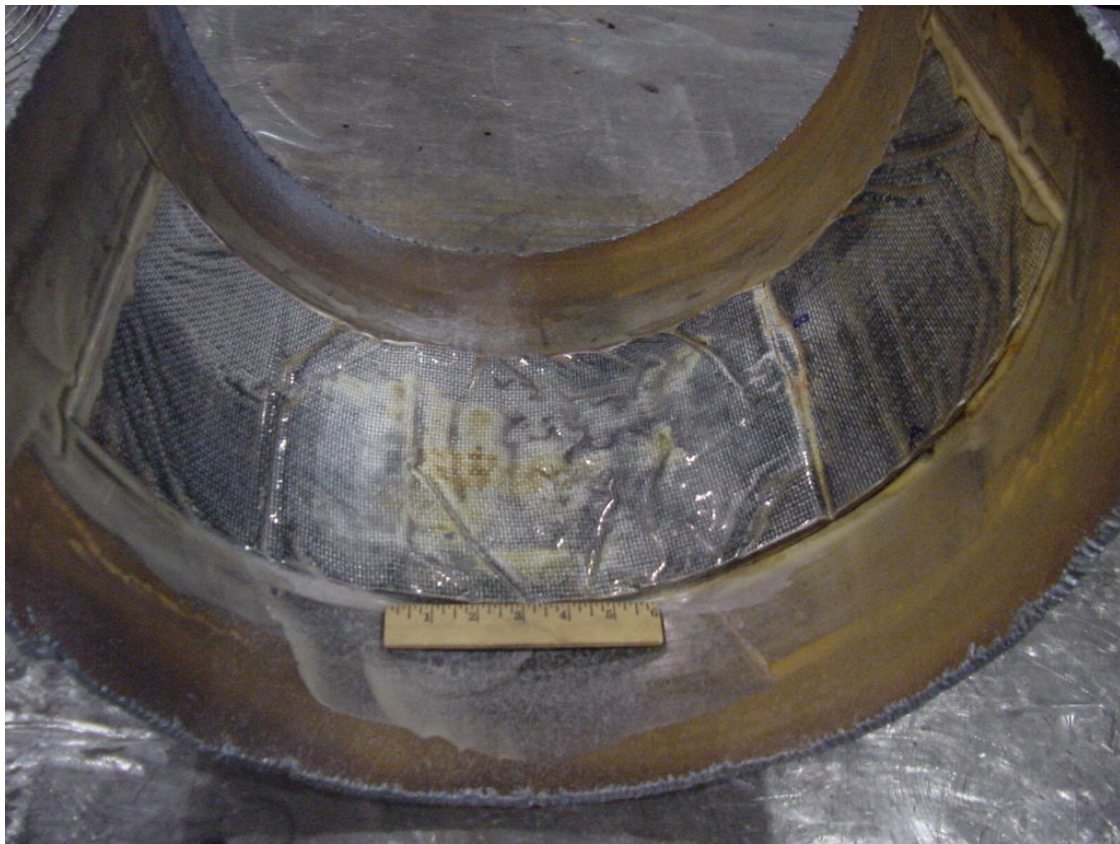
For optimization and validation activities this reporting period, a 508 mm (20 in.) diameter pipe section with simulated corrosion damage was repaired with a carbon fiber-reinforced patch in a "pressure bandage" configuration (Figure 28). The patch design was manufactured using the same materials and procedures developed during the last reporting period. The only difference was in the configuration of the patch. As shown in Figure 28, the patch resembles a "pressure bandage" wherein there is a solid 254 mm by 254 mm (10 in. by 10 in.) solid thickness of composite in the middle with wings of composite material that necked down toward the outside of both ends of the patch. The "pressure bandage" patch was allowed to cure for approximately two weeks after fabrication. After the patch was installed in the pipe section, it was allowed to cure for another week before hydrostatic testing until failure.

Figure 28 - Pressure Bandage Carbon Fiber-Reinforced Patch Configuration

During this reporting period, the first round of optimization and validation activities were initiated. A 508 mm (20 in.) diameter pipe section with simulated corrosion damage was repaired with a carbon fiber-reinforced patch in a "pressure bandage" design configuration (Figure 28). The "pressure bandage" patch was allowed to cure for approximately two weeks before installation. After the patch was installed in the pipe section, it was allowed to cure for another week before hydrostatic testing until failure. As in previous reporting periods, two 508 mm (20 in.) diameter pipe sections were hydrostatically tested until failure in the virgin condition (with no simulated damage) and in the un-repaired condition with simulated corrosion damage. RSTRENG was also used to predict burst pressures.

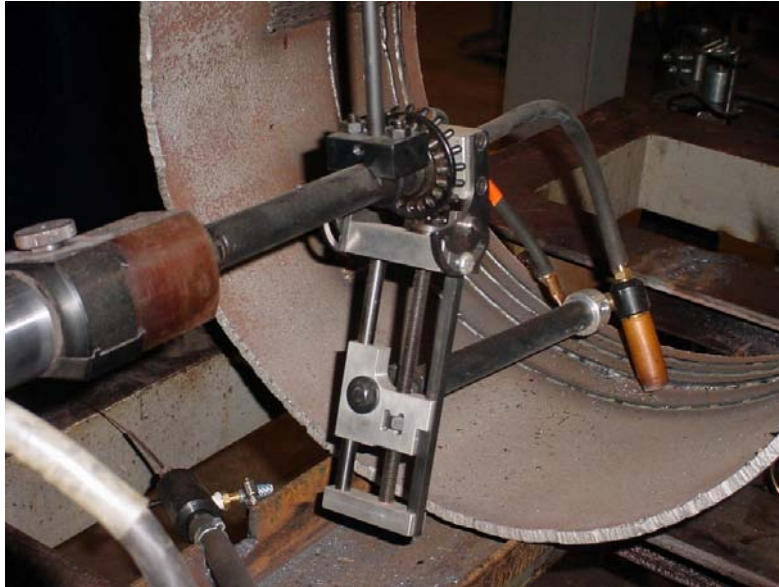
Each system had motion control limitations and individually would not be appropriate candidates for an internal repair welding system. The internal bore cladding system manufactured by Bortech (Figure 30 and Figure 31) was designed for spiral cladding the inside of pipe that is preferably in the vertical position.

Figure 31 - Bortech Torch and Torch Height Control

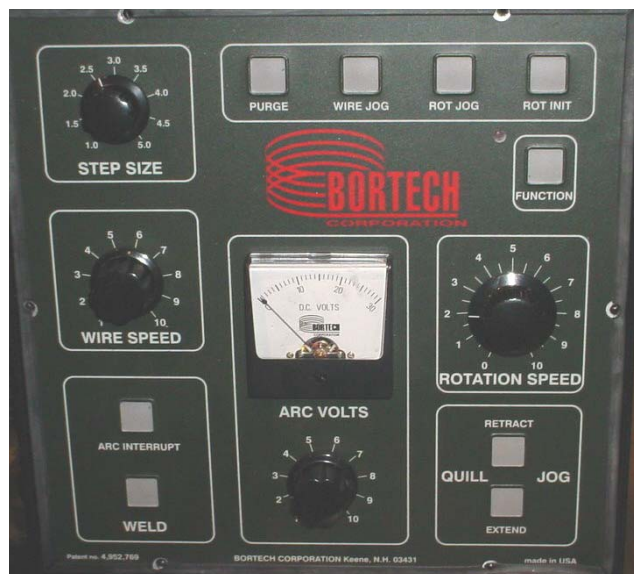
The Bortech system has simple controls for operating constant voltage (CV) power supplies (Figure 32). This includes the ability to set wire feed speed, voltage, step size (for the spiral motion), and rotation speed (i.e., travel speed). The system is very affordable as it uses simple motors for motion. When positioned inside a horizontal pipe, the rotation drive suffered from significant backlash. Conversations with the supplier led to the purchase and installation of a counterbalance weight that was used to balance the weight of the opposing torch.

Figure 32 - Bortech Controller

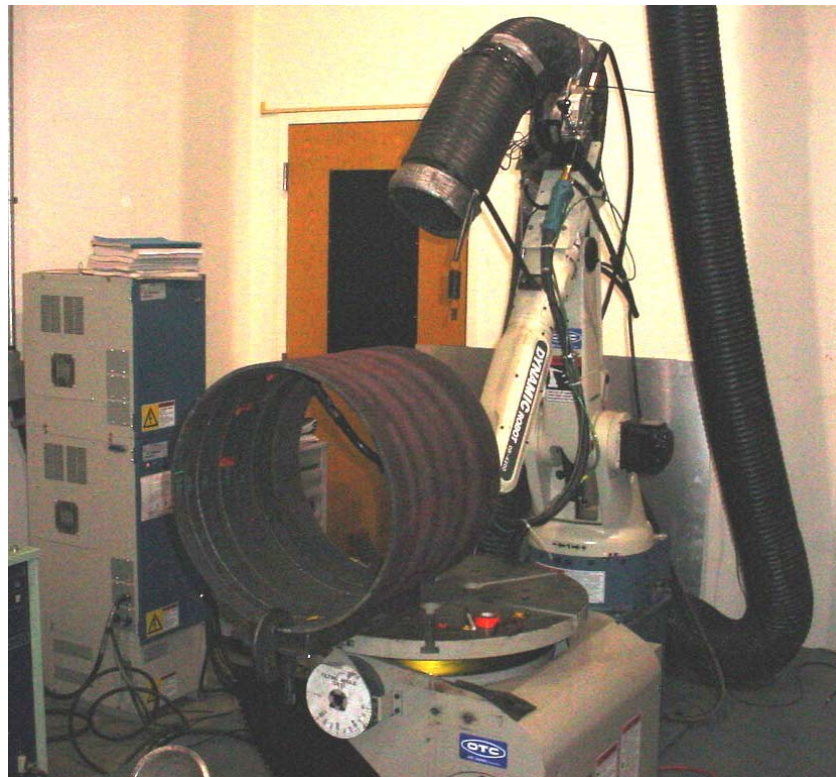
Based on the results experienced with the Bortech system, it was decided to develop preliminary welding procedures using a robotic GMAW system. A 6-axis coordinated motion robot (Figure 33) permitted the application of weave beads for spiral cladding or stringer beads in either direction. An observed limitation was the fact that the system did not have a welding torch current commutator to permit continuous spiral welding.

Figure 33 - OTC Robot Set-Up for Internal Welding

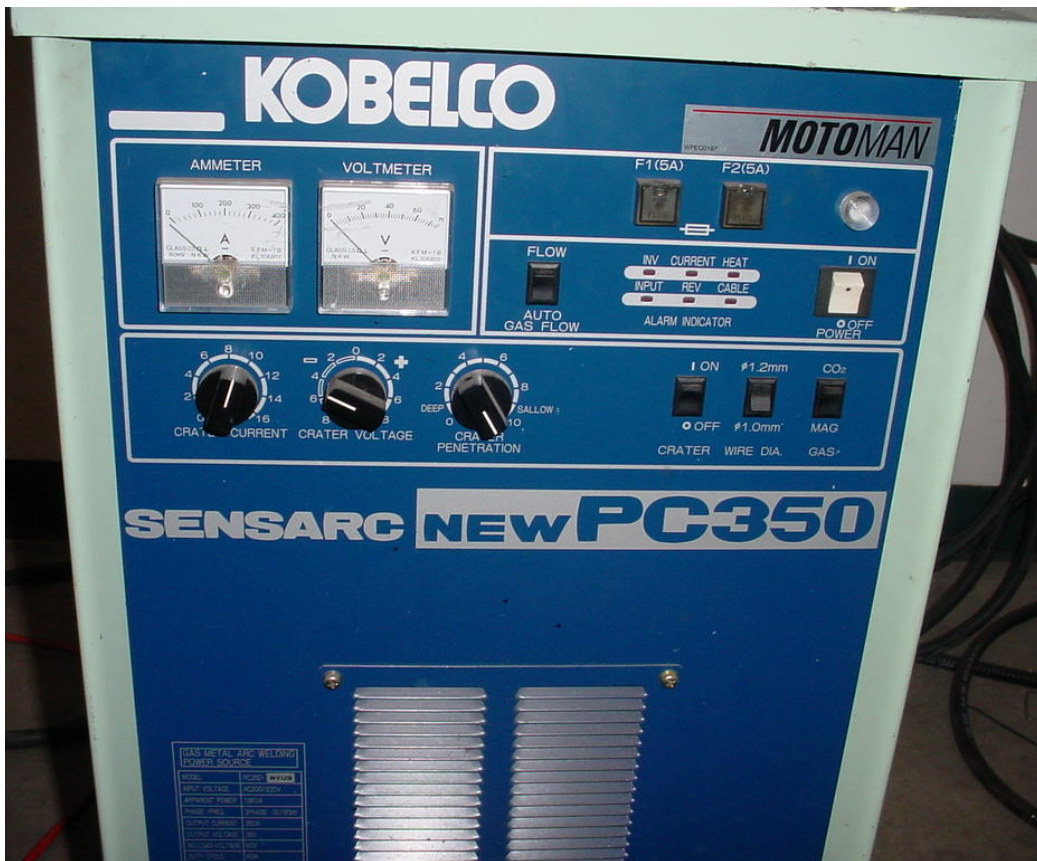
Figure 35 - Kobelco PC-350 Variable Polarity Fuzzy Logic Power Supply

The Kobelco PC-350 power supply (Figure 35) uses fuzzy logic pulse waveforms to minimize spatter during metal transfer and permits the application of variable polarity waveforms. Variable polarity combines the rapid, low heat input, melting of negatively charged electrode with the metal transfer stability of electrode positive. Until 1988, all commercial GMAW systems used positively charged electrodes for constant voltage and pulse power supplies. The PC-350 is more advanced than standard variable polarity power supplies, as it uses a fuzzy logic short-circuit anticipation control. On comparable applications that require low heat input, the PC-350 has shown productivity improvements compared to standard short-circuit. This power supply is equipped with waveform algorithms pre-programmed for steel using either 100% Carbon Dioxide shielding gas or an Argon - Carbon Dioxide shielding gas mixture for both

0.8 mm (0.035 in.) or 1.2 mm (0.045 in) diameter electrodes. The waveform was simply modified by changing the electrode negative ratio on the pendant. Arc length and heat input is changed by an arc length knob on the pendant, which varies the pre-programmed pulse frequency.

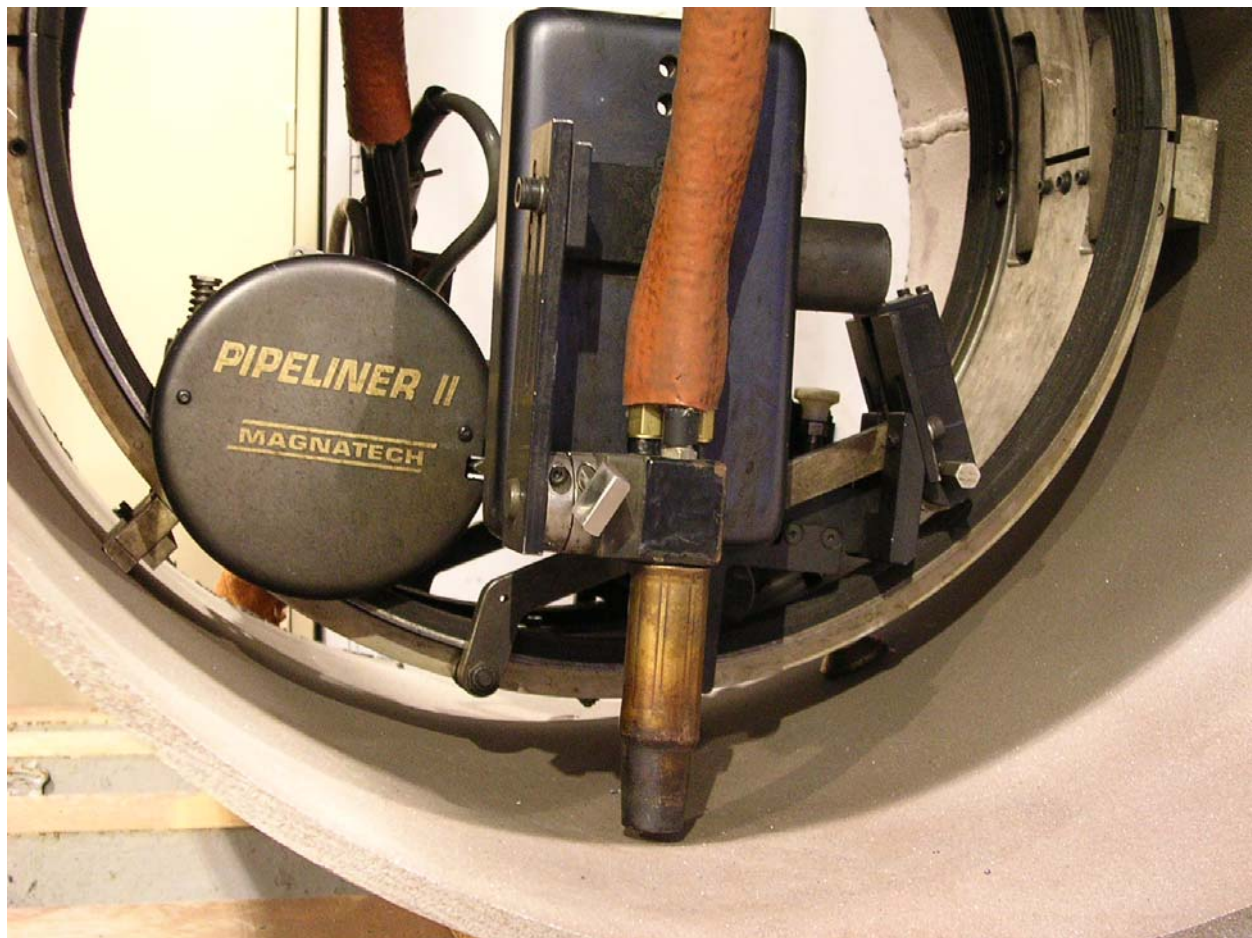
Figure 36 - Magnatech ID Welding Tractor Capable of Spiral & Ring Motion with Oscillation

Several years ago, PG&E purchased a welding tractor (Figure 36) from Magnatech for internal weld repair procedure development. This system was sent to EWI for this project so it could be used for pipeline repair testing and demonstrations, since this equipment is portable where the robot welding system is not portable.

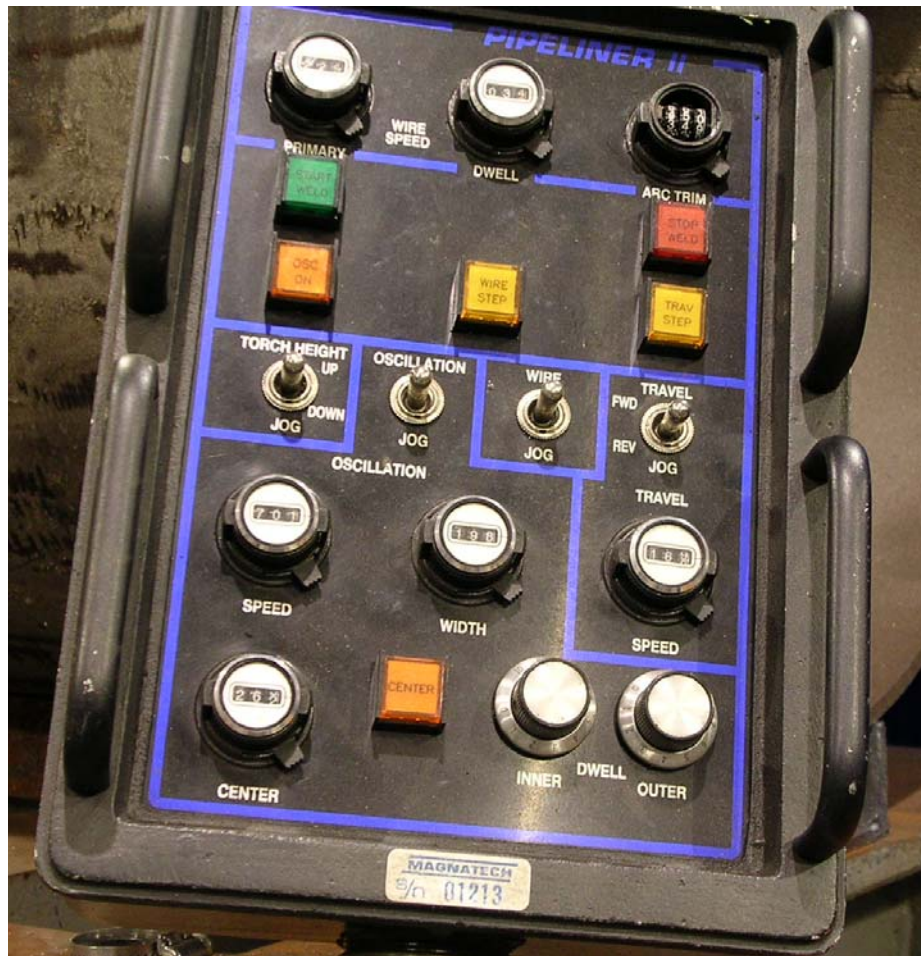
Figure 37 - Magnatech Control Pendant Showing Control Parameters

The Magnatech welding tractor has orbital motion with controls (Figure 37) for torch oscillation. The system is limited to a finite number of revolutions that can be made before cables need to be unwound. The controls are analog and do not have high accuracy, however, they are sufficient for preliminary parameter development and demonstration welding. Programmable controls would be required for an internal repair welding system using a Magnatech tractor. In addition, numerous mechanical changes would be required to accommodate a range of pipeline diameter sizes.

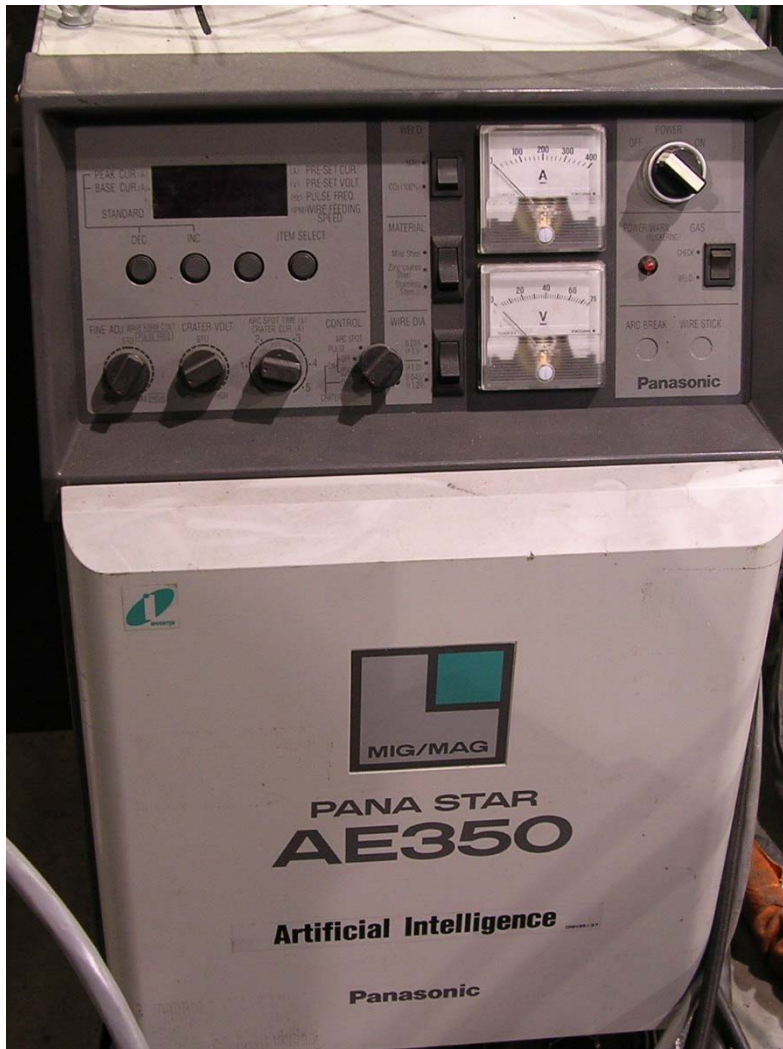
Figure 38 - Panasonic AE 350 Power Supply with Pulse Short-Circuit Metal Transfer Control

The Magnatech tractor was interfaced to a Panasonic AE 350 power supply (Figure 38). This power supply provides pulse waveforms and can be operated in a short-circuit mode where artificial intelligence is used to minimize spatter. The current pulsing and short circuiting helps lower heat input and improve deposition rate in out-of-position welds. Pre-programmed current waveforms are provided by algorithms for steel electrodes, and many other materials.
