EWI Project No. 46211GTH
Electronic File Name: 41633R52.pdf

Internal Repair of Pipelines 24-Month Technical Progress Report

Reporting Period:
March 31, 2004 through September 30, 2004

Submitted By:
Edison Welding Institute
1250 Arthur E. Adams Drive
Columbus, OH 43221

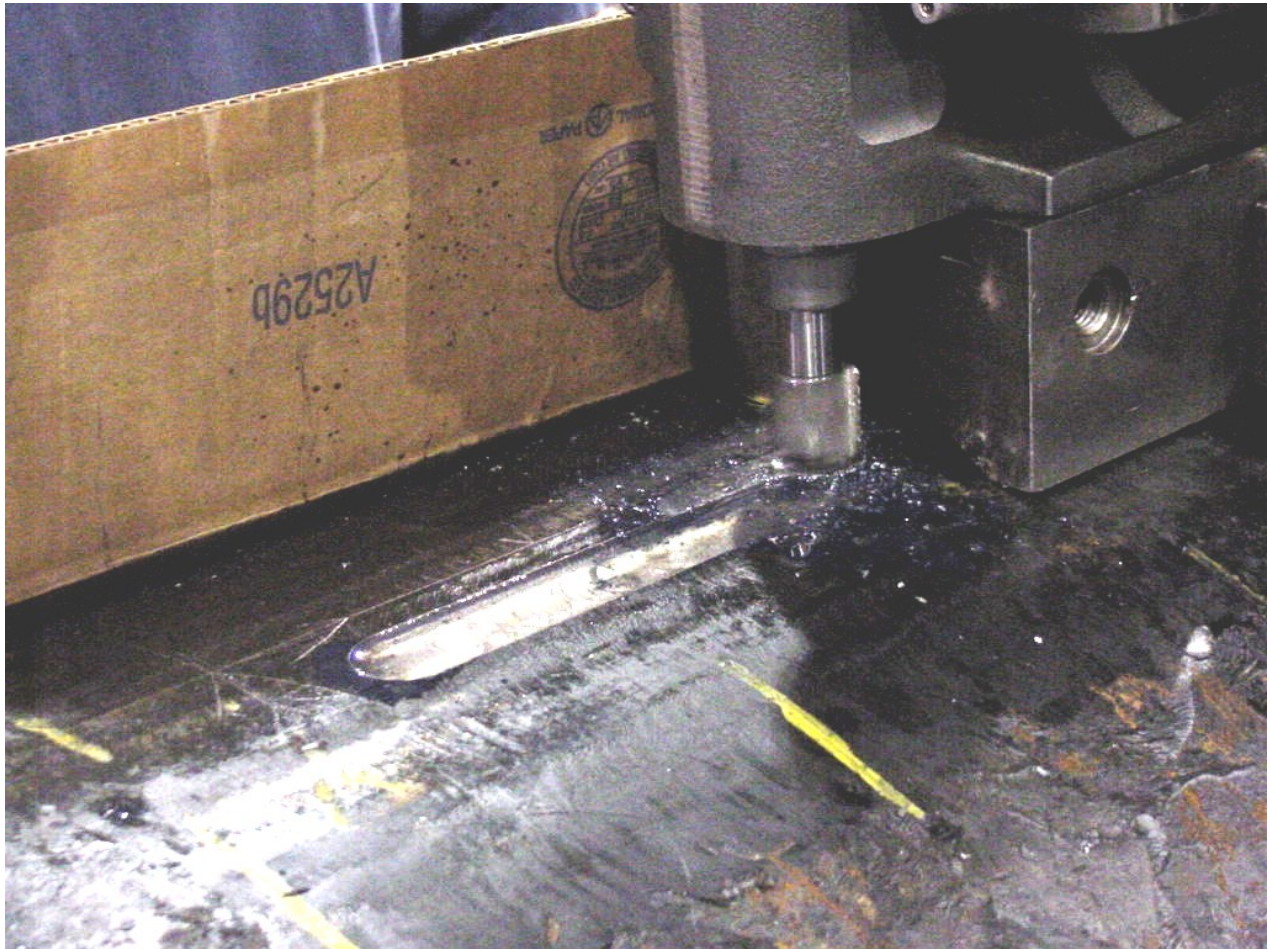
Figure 39 - Milling Machine Set-Up Used to Simulate Corrosion on Pipe Sections

The simulated corrosion in the pipe was introduced by milling a slot into a 559 mm (22 in.) OD pipe with a wall thickness of 7.9 mm (0.312 in.) using the set-up as shown in Figure 39. The dimensions of the corrosion damage are shown in Figure 40; finished simulated damage is found in Figure 41; and a magnified view of the damage is located in Figure 42.

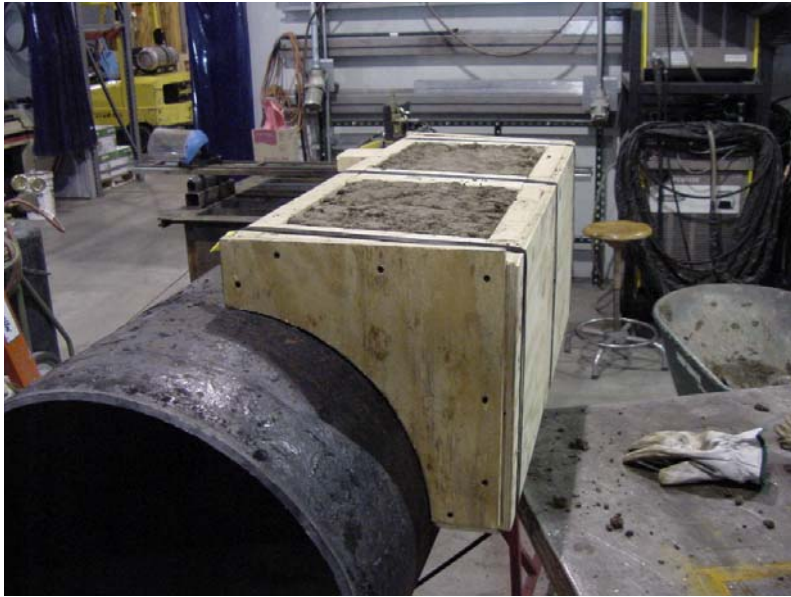
Figure 43 - Dirt Box for Weld Deposition Repair

The dirt box in Figure 43 was used to simulate in-service welding conditions and cooling rates for weld deposition repair evaluation trials.

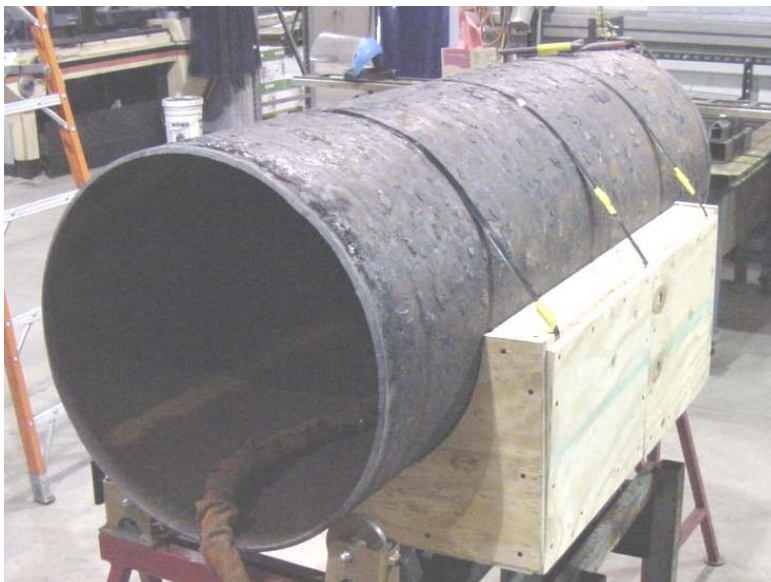
Figure 44 - Orientation of Pipe Section with Dirt Box for Weld Deposition Repair

The pipe section with the dirt box was rotated as shown in Figure 44 to facilitate welding on the inside of the pipe section from the 6:00 position where the weld passes were initiated to the 9:00 position where the weld passes were terminated.

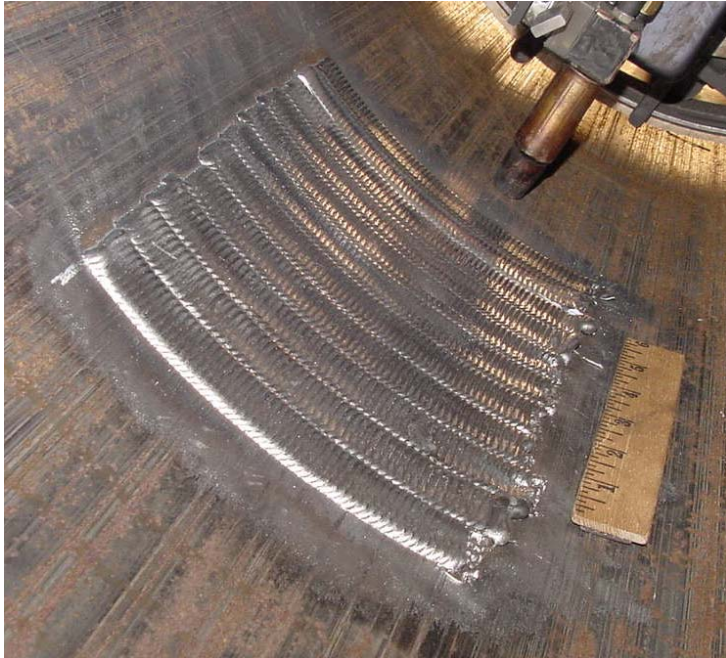
Figure 49 - Finished First Layer of Deposited Weld Metal on Inside Pipe Diameter

The finished first layer of the deposited weld metal repair is shown in Figure 49. The axial length of the deposited layer exceeded the simulated corrosion by more than 25.4 mm (1.0 in.), which is three times the pipe wall thickness (the weld deposit should exceed the corrosion area by at least one wall thickness).

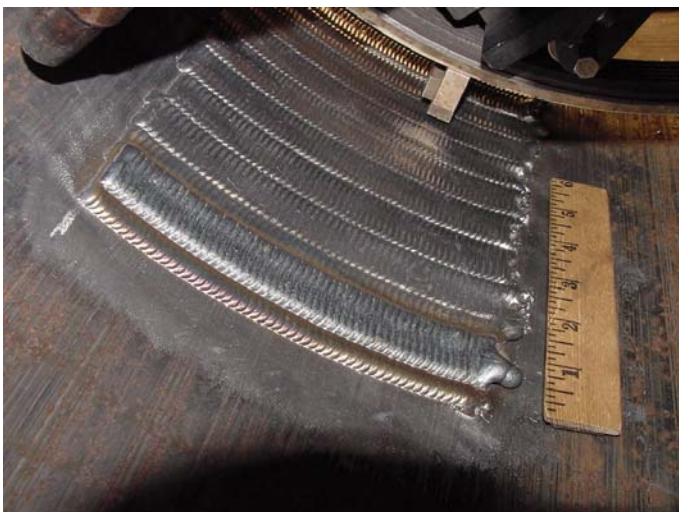
Figure 50 - First Pass of Second Layer of Deposited Weld Metal on Inside Pipe Diameter

First pass of the second layer is shown in Figure 50. The second layer passes were centered over the weld toes of the previous layer.

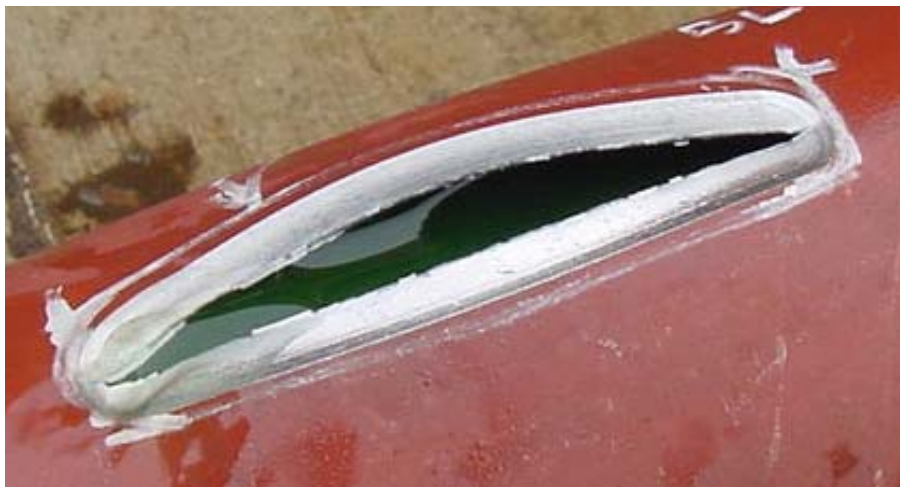
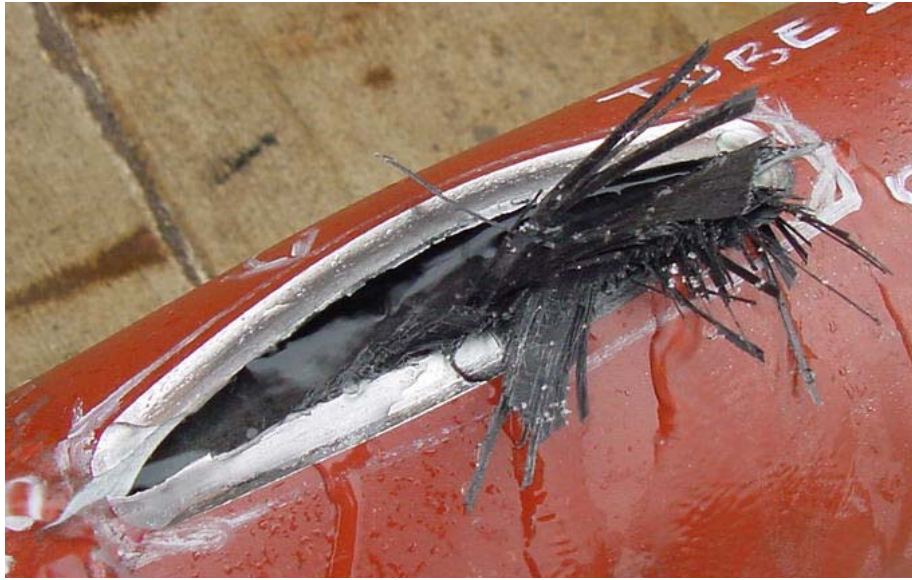
Following the installation of end caps, all four pipe sections were hydrostatically pressurized to failure. All four pipe sections failed in the areas of simulated corrosion damage. The two pipes with long shallow damage representative of general corrosion resulted in ruptures (Figure 74 and Figure 75) and the two pipes with short, deep damage representative of a deep isolated corrosion pit developed leaks (Figure 76 and Figure 77). The hydrostatic testing results are shown in Table 10.

Figure 74 - Pipe Section with Long, Shallow Simulated Corrosion Damage – Without Liner - Following Hydrostatic Pressure Test

Figure 75 - Pipe Section with Long, Shallow Simulated Corrosion Damage – With Liner – Following Hydrostatic Pressure Test

Figure 76 - Pipe Section with Short, Deep Simulated Corrosion Damage – Without Liner – Following Hydrostatic Pressure Test

Figure 77 - Pipe Section with Short, Deep Simulated Corrosion Damage – With Liner – Following Hydrostatic Pressure Test

Simulated Corrosion Damage	Liner	Hydrostatic Failure Pressure MPa (psi)	Failure Mode/Location
Long, Shallow	No	23.6 (3,431)	Rupture in simulated corrosion damage
	Yes	23.9 (3,472)	Rupture in simulated corrosion damage
Short, Deep	No	25.8 (3,750)	Leak in simulated corrosion damage
	Yes	27.7 (4,031)	Leak in simulated corrosion damage

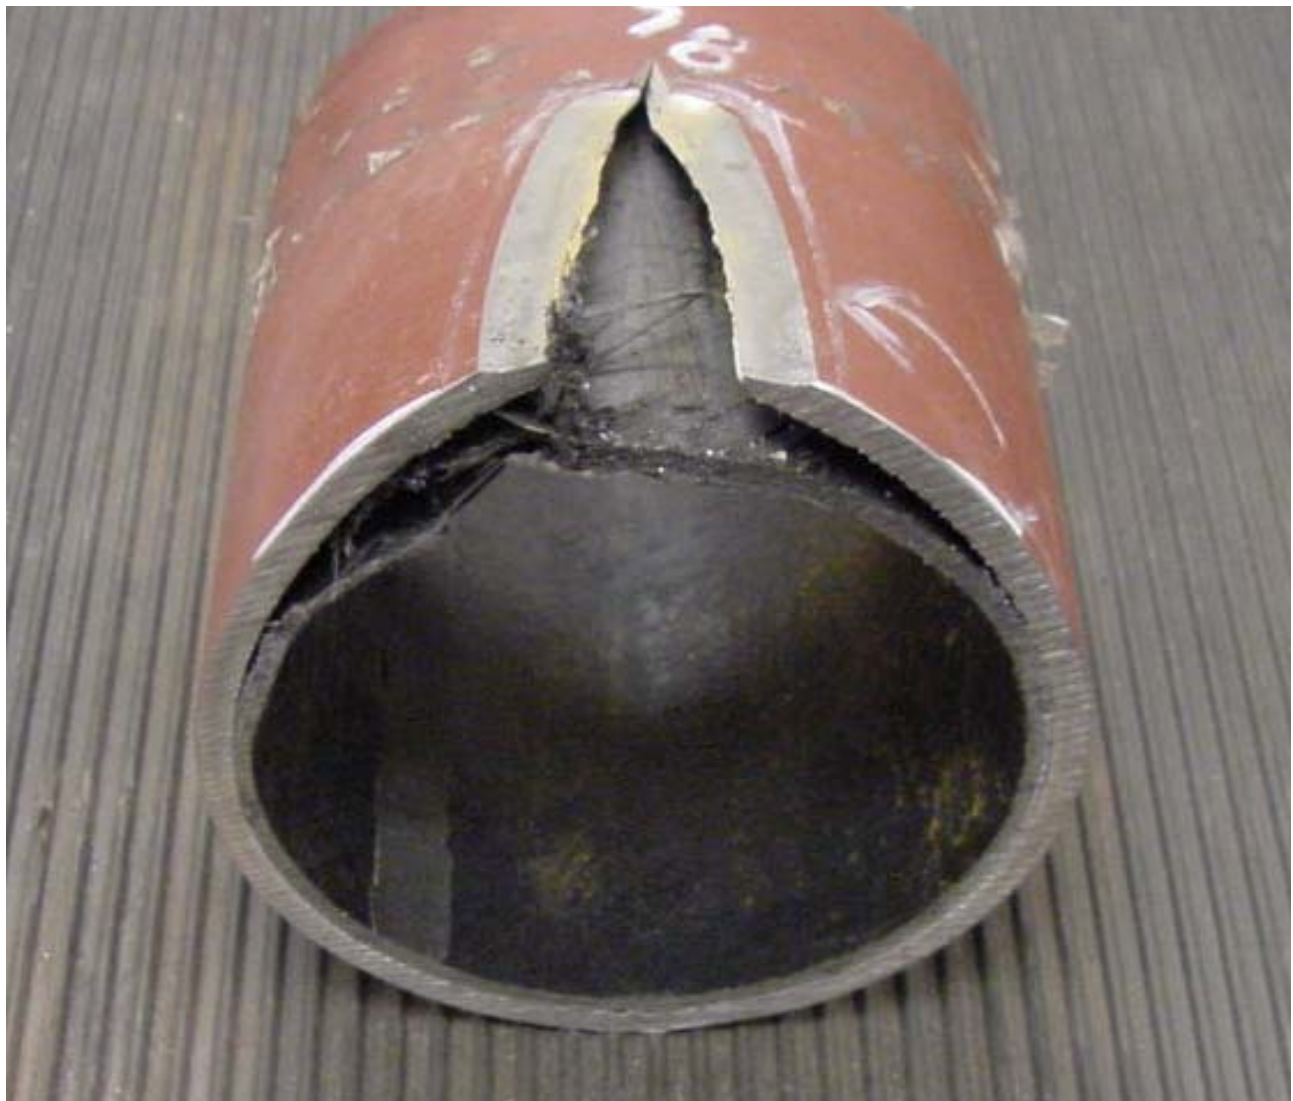
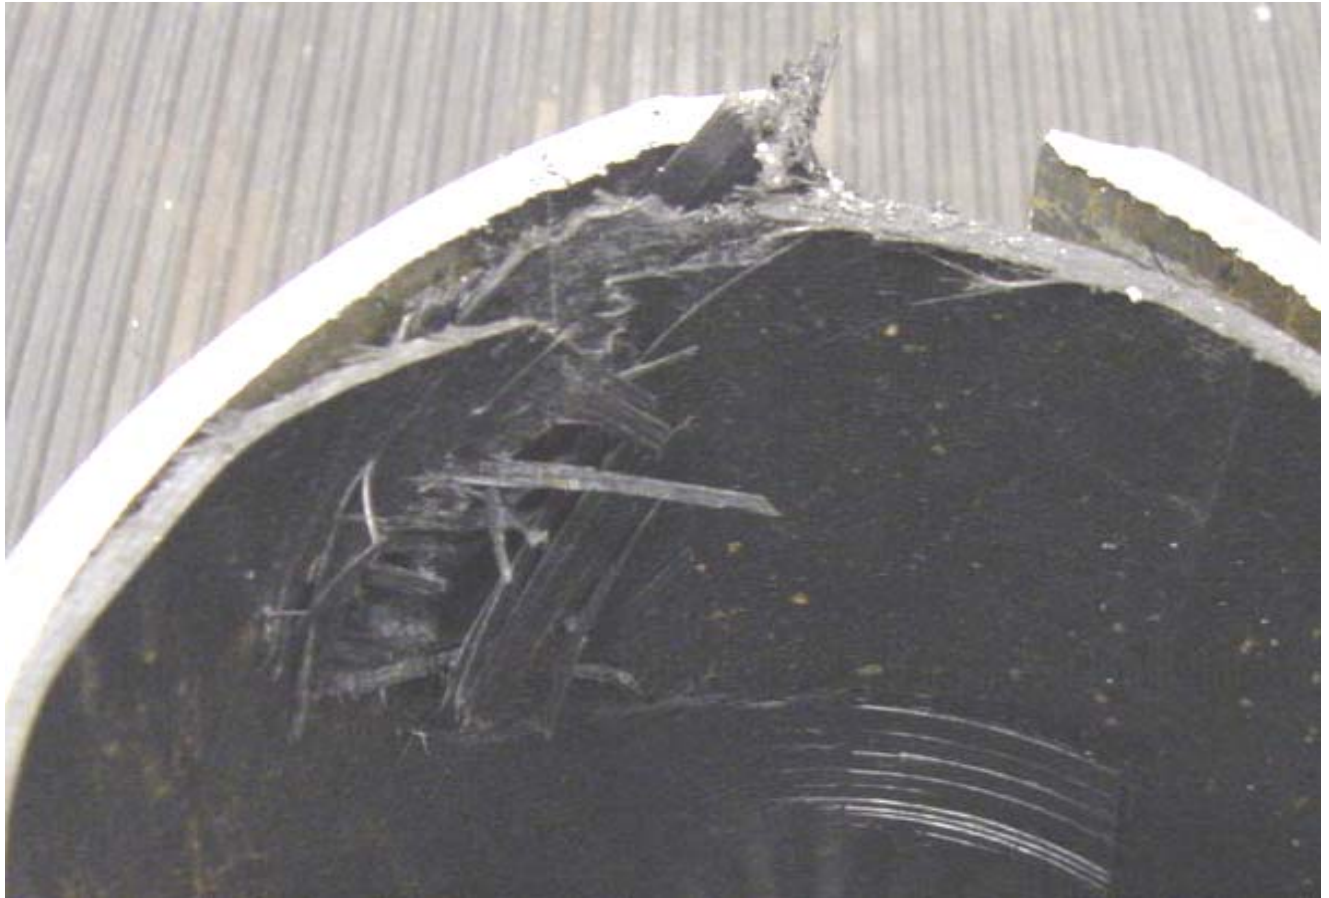
A postmortem analysis of the first four hydrostatic burst tests in pipe sections with simulated corrosion was conducted. So as not to damage the liner, water jet cutting was used to section the pipe sample containing the round-bottom longitudinal slot with the liner installed. The results indicate that the liner did rupture (Figure 78 and Figure 79), thus disbonding was not an issue.

Figure 78 - Water-Jet Cut Section through Pipe Sample Containing Round-Bottom Longitudinal Slot with Liner Installed

Figure 79 - Pipe Sample Containing Round-Bottom Longitudinal Slot Showing Rupture of Liner Material

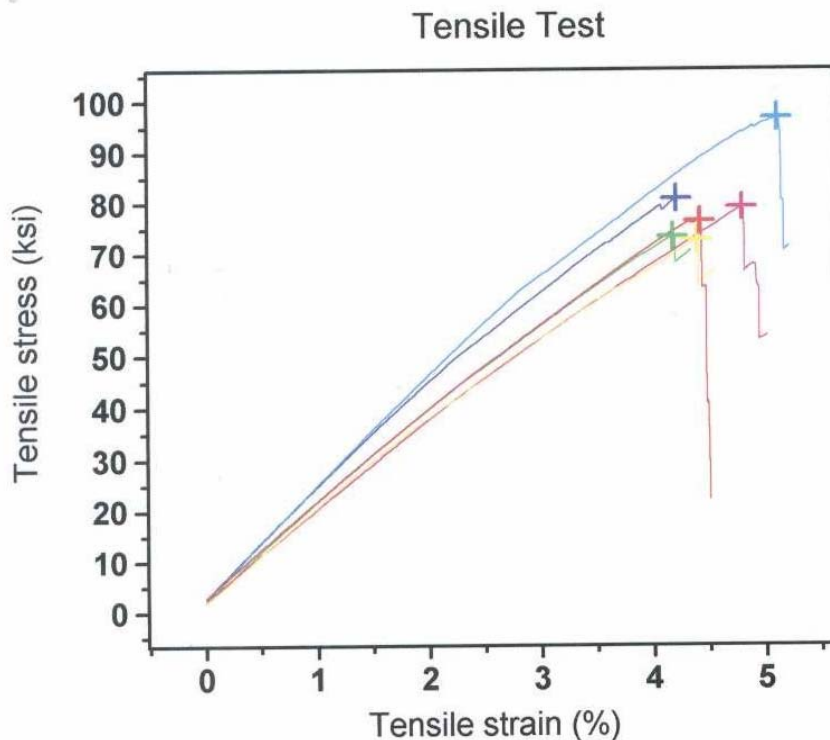
Figure 80 - Tensile Testing Results for Glass/Polypropylene Liner Material

Postmortem test results also indicate that the difference in modulus of elasticity between the steel and the liner material prevents the liner from carrying its share of the load. The modulus of elasticity for steel is approximately 206.8 GPa (30×10^6 psi). Tensile testing was carried out to determine the modulus of elasticity for the glass/polypropylene liner material that was used (Table 11 and Figure 80). The mean value for the modulus of elasticity for the liner material was measured to be approximately 15.2 GPa (2.2×10^6 psi). Because the glass fiber-reinforced liner material has a significantly lower modulus of elasticity than the steel pipe, as pressure in the lined pipe increases, the stiffness of the steel prevents the composite liner material from experiencing enough strain to share any significant portion of the load.

Stress at Break MPa (ksi)	Strain at Break (%)	1% Secant Modulus MPa (ksi)
Trial 1	486.6 (70.58)	4.34	15,123.4 (2,193.394)
Trial 2	557.6 (80.88)	4.21	17,166.7 (2,489.741)
Trial 3	492.0 (71.36)	5.21	17,316.5 (2,511.472)
Trial 4	371.5 (53.89)	5.02	14,103.5 (2,045.482)
Trial 5	460.9 (66.85)	4.56	14,347.9 (2,080.924)
Trial 6	154.7 (22.45)	4.51	15,191.0 (2,203.205)
Mean	420.6 (61.00)	4.64	15,541.5 (2,254.036)
S. D.	143.4 (20.81)	0.39	1,384.3 (200.776)
C. V.	235.1 (34.11)	8.45	61.4 (8.907)
Minimum	154.7 (22.45)	4.21	14,103.5 (2,045.482)
Maximum	557.6 (80.88)	5.21	17,316.5 (2,511.472)
Range	402.8 (58.43)	1.00	3,213.0 (465.990)

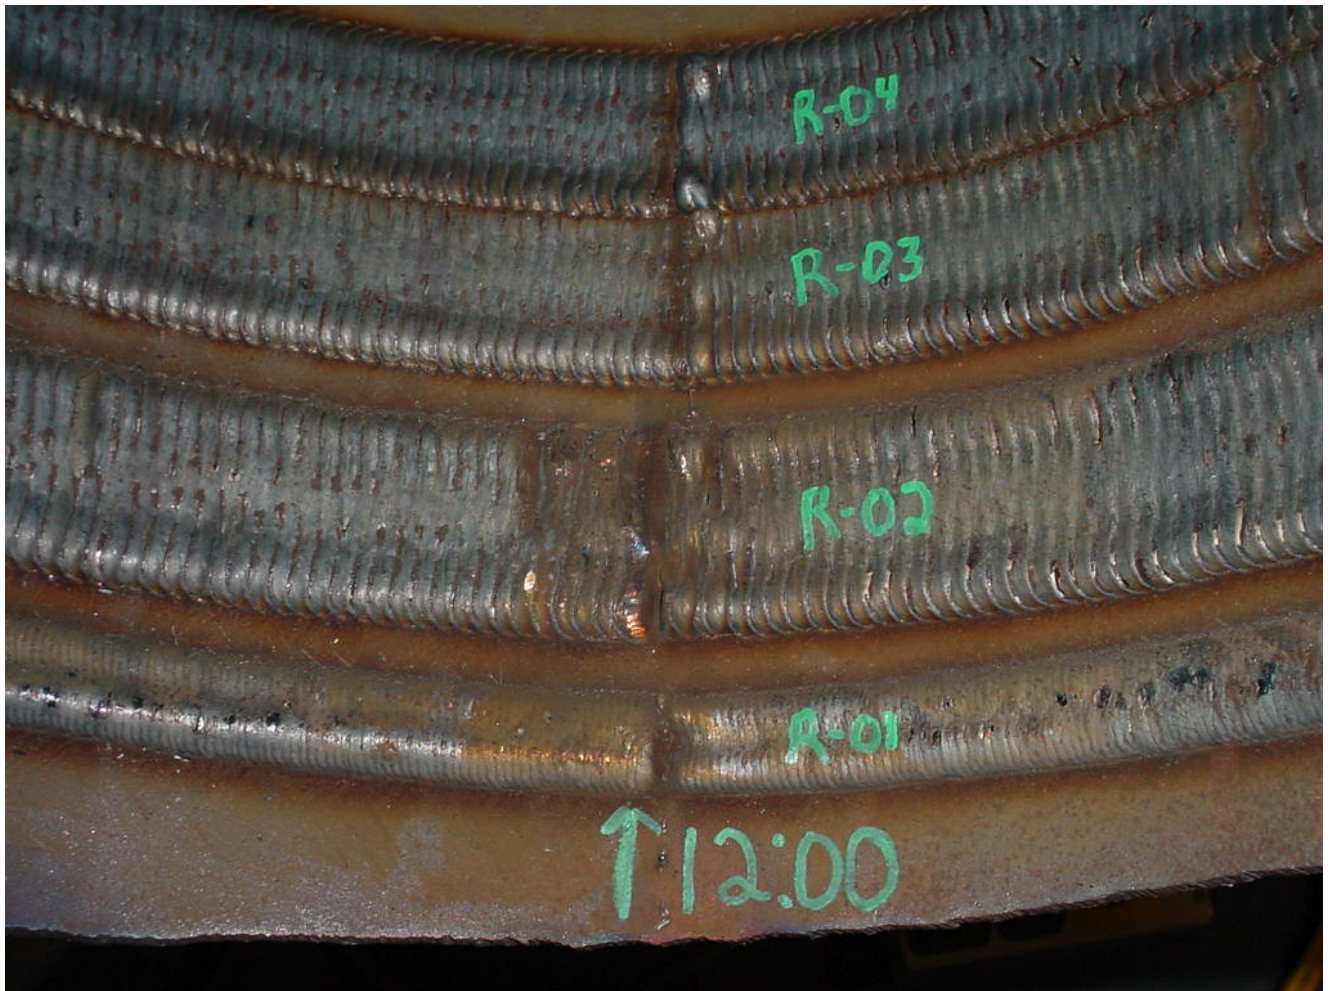
Using the robot welding system, ring welding procedures using weaving were developed for several bead widths (Figure 82). This figure shows the location where the first half of the ring was stopped and the second half was started in the overhead position. This was not an ideal stop-start location but was required with the robot to manage the welding cables. If start-stops were required to complete a repair, it would be preferred to have them positioned at a different location around the circumference, ideally in the flat position. Tie-in parameters will need to be optimized for each possible starting position once preferred bead shape weaving parameters are selected. A true orbital bore welding machine, like the Bortech, would have a current and shielding gas commutation system to provide infinite rotations without cable problems thereby minimizing stop-starts.

Figure 82 - Tests R-01 through R-04 at 12:00 (Note the Poor Tie-Ins for R-01 through R-03)

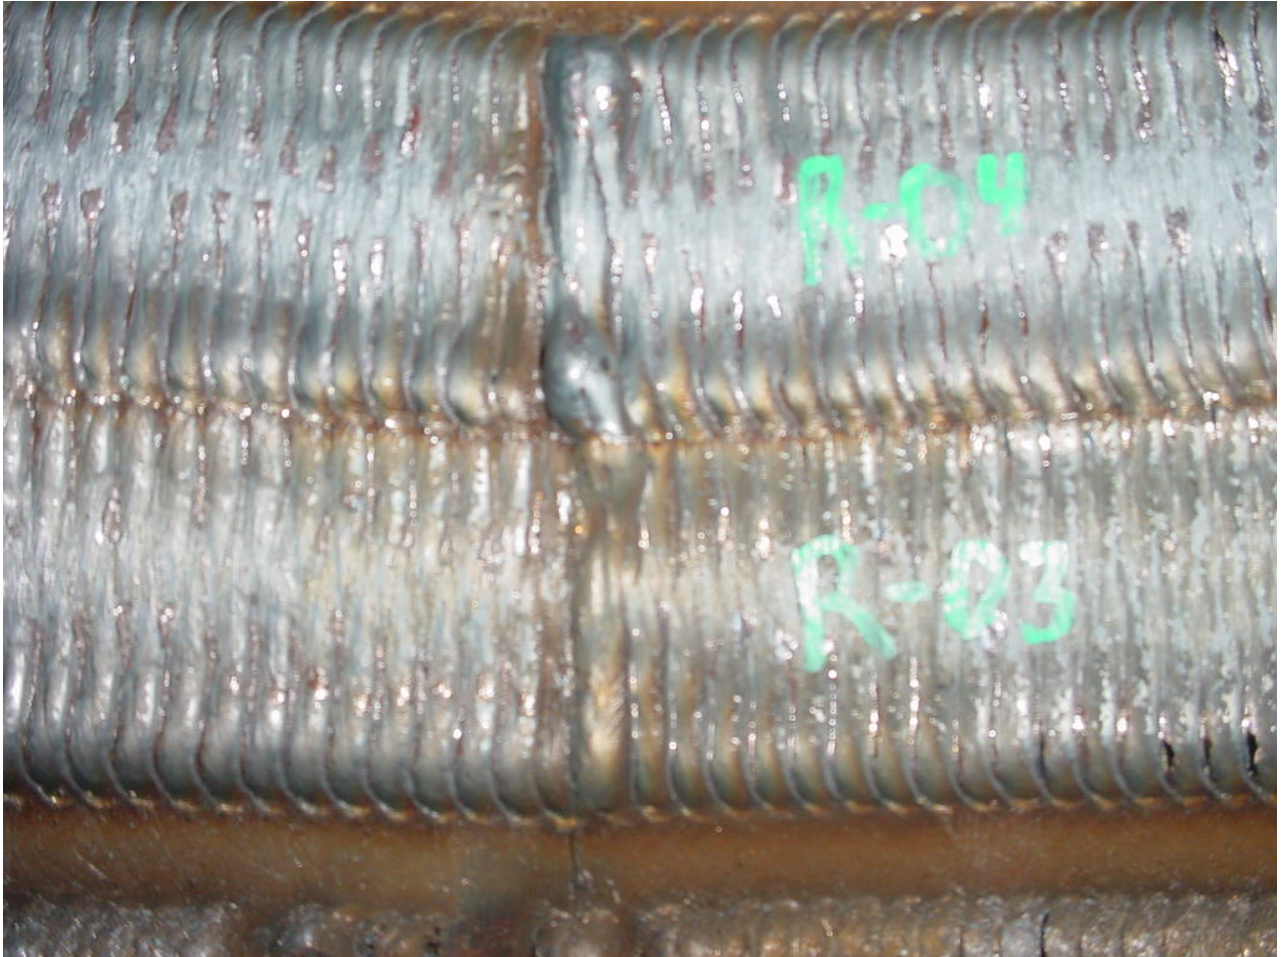
Figure 84 - Tests R-03 and R-04 at 12:00 Showing Better Stop-Start Overlap.

When welding was initiated, the pipe was near room temperature. The weld bead profile at the start (Figure 83 and Figure 84) slowly changed as a steady-state temperatures are built in the material based on the heat input of each welding procedure. In general, most weld starts appeared more convex based on the low starting material temperature. Note that test R-04 was overlapped on test R-03 to provide a larger deposit layer in Figure 84.

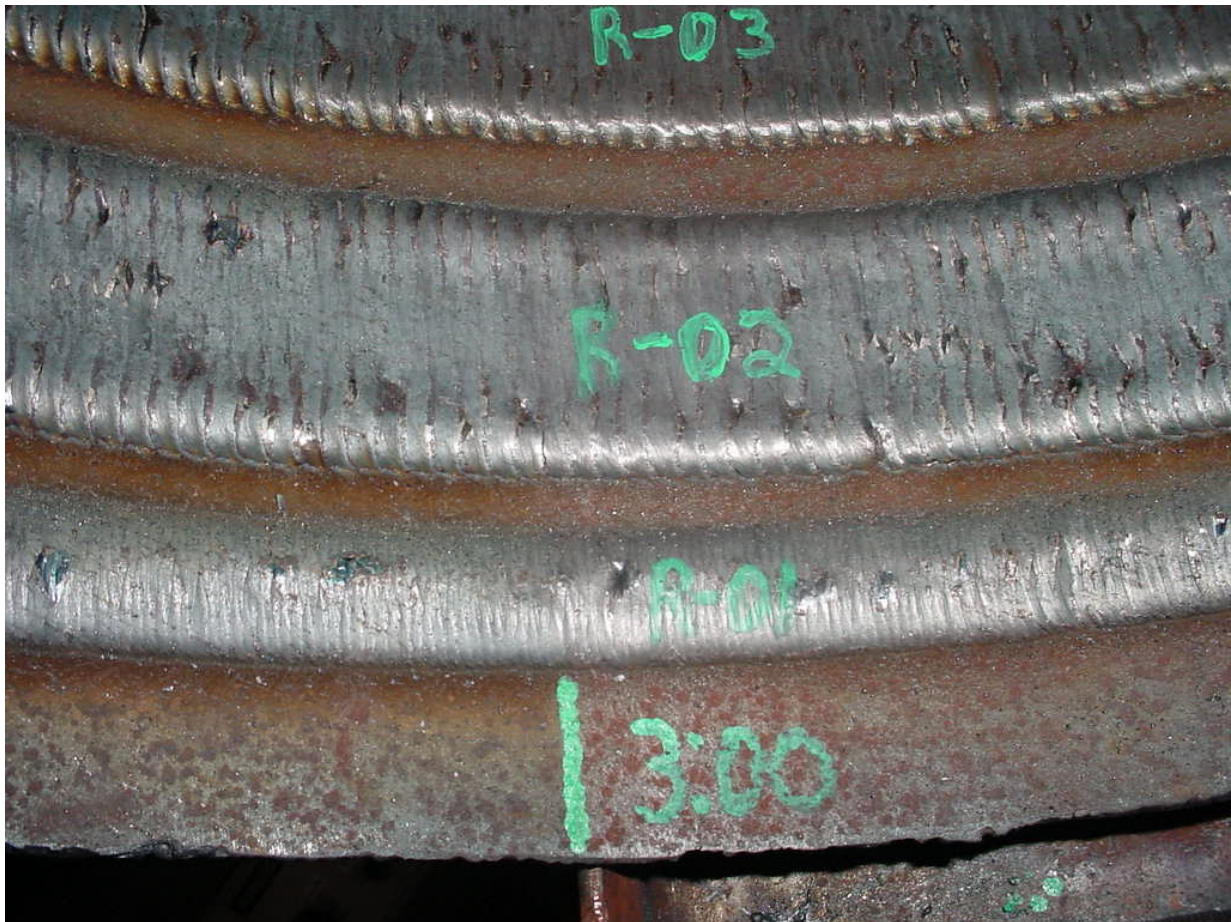
Figure 85 - Tests R-01 and R-02 at 3:00 Showing Steady-State Bead Shape

The preferred welding parameters were based on optimizing the bead shape in the steady state (Figure 85). For internal repair of pipelines, a programmable weld controller could be used to use higher welding heat input at the weld start. This would provide better weld bead start quality. Once welding the start parameters could be ramped in the steady-state parameters to provide uniform bead shape.

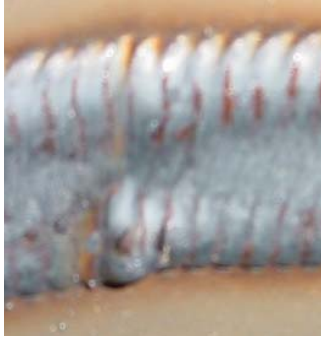
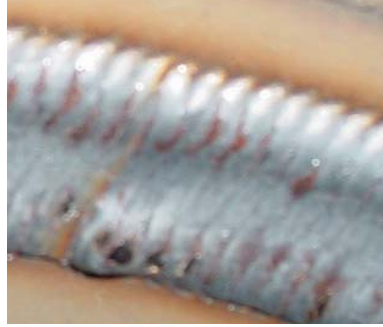
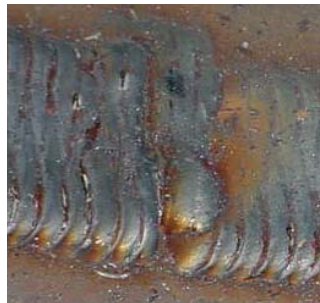
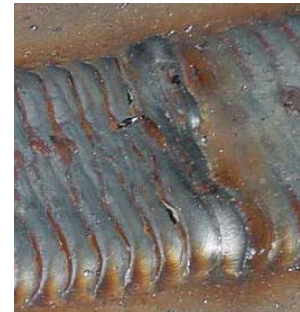
12:00 – Too Much Overlap

1:00 – Too Much Overlap

7:00 – Bad Appearance Due
Robot Program Error

8:00 – Good

Figure 86 - Tie-In Tests Using Parameters R-05 Every 30° Around One Ring Deposit

To further improve starting bead shape, some additional tests were performed using 7.62 mpm (300 ipm) wire feed speed (Figure 86). These tests were used by the technician to study the precise location for starting on a "stop" and to evaluate gravity effects. As shown by these tests, start bead shape can be improved through the use of higher wire feed speeds (which produce higher heat input). No additional procedures were developed with the 6-axis robot.

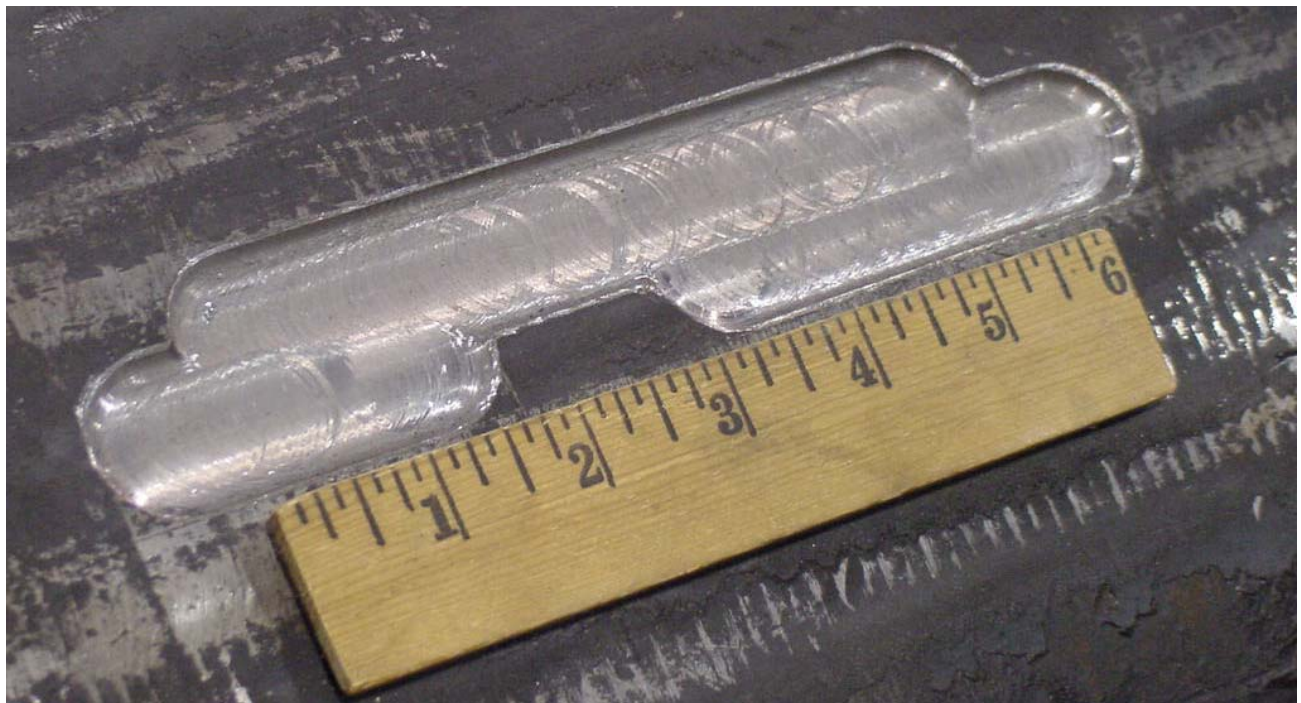
Figure 87 - Selected Configuration of Simulated Damage for 558.80 mm (22 in.) Diameter Pipe Sections

The selected configuration for simulated corrosion damage for 558.80 mm (22 in.) pipe is shown in Figure 87. The dimensions for the 20 in pipe were appropriately scaled down. The selected design for simulated corrosion damage for 508 mm (20 in.) pipe is shown in Figure 88.

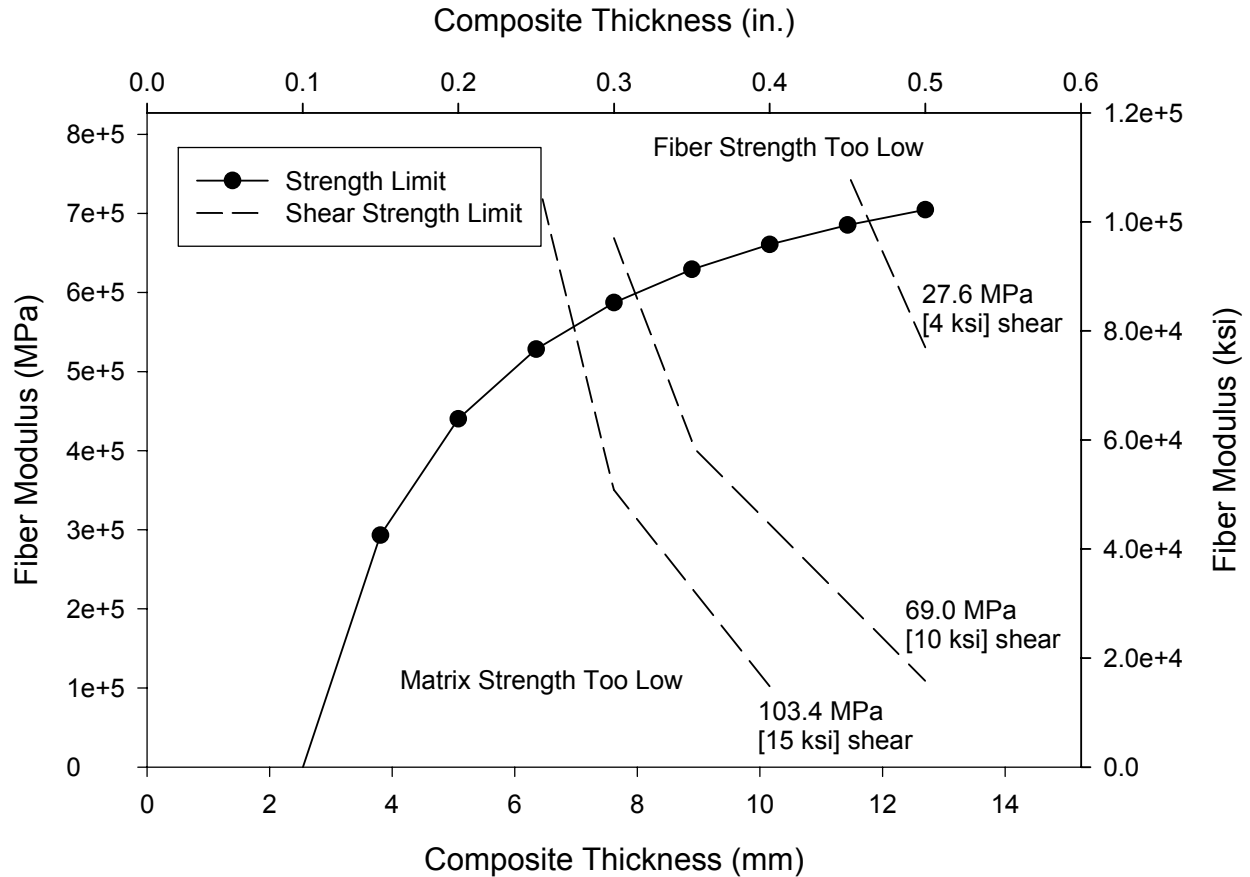
Figure 90 - Design Space for Composite Liner

The fiber modulus can thus be given a maximum value using the linear approximation given above. This function is plotted in Figure 90.

If the fiber modulus is above the line in Figure 90, then the strength of the fibers will be too low to achieve the required strength in the composite.

The shear stress must not exceed the shear resistance of the matrix material in the composite. Some examples of shear resistance have been chosen and included in Figure 90.

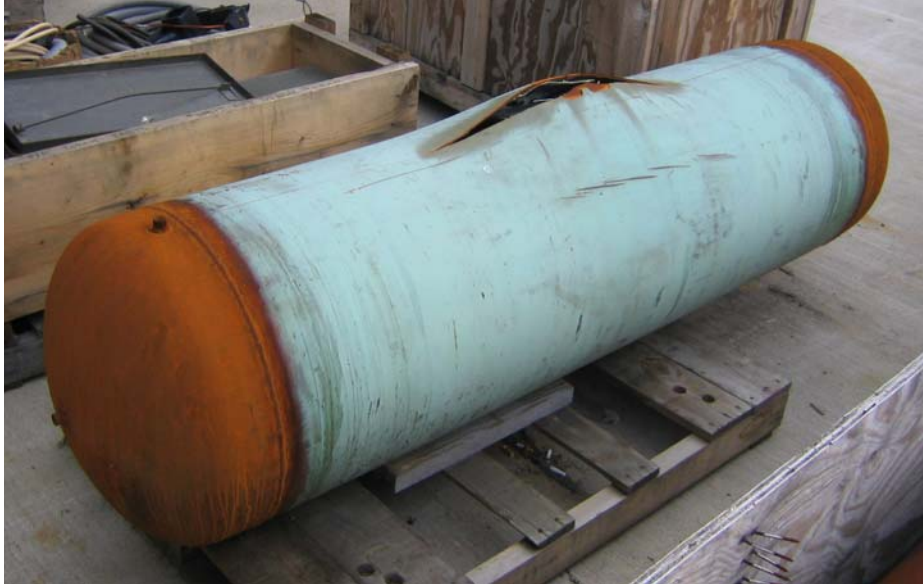
Figure 91 - Pipe With Carbon Fiber-Reinforced Liner Repair After Burst Test

After two weeks of cure time, the pipe section with the EWI fabricated patch was hydrostatically tested until failure (Figure 91). The resultant burst pressure was 15.13 MPa (2,194 psi) which is 122% of pressure corresponding to 100% of specified minimum ultimate tensile strength. Figure 92 is a closer view of the failure initiation site. Figure 93 clearly shows that the failure was caused by interlaminar shear mostly between the anti-corrosion glass layer and the carbon layer (1 → 2 layer interfacial failure is common in composites). There was no evidence of disbonding between the pipe and the composite liner.

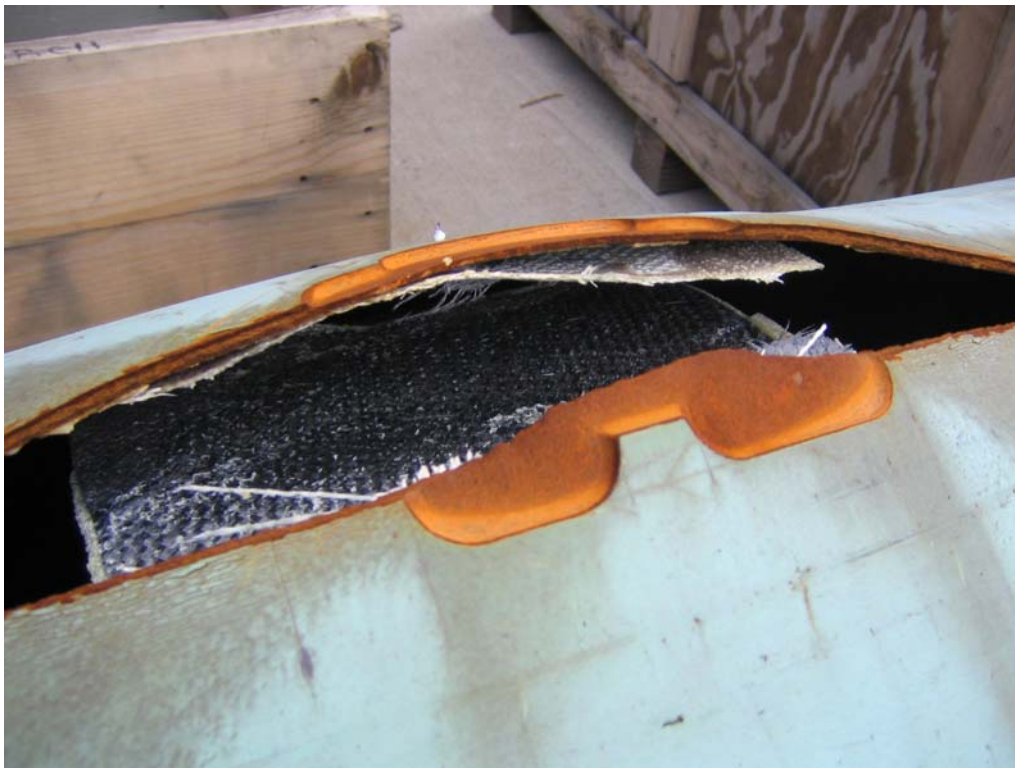
Figure 92 - Failure Initiation Site For Burst Tested Pipe With Carbon Fiber-Reinforced Liner Repair

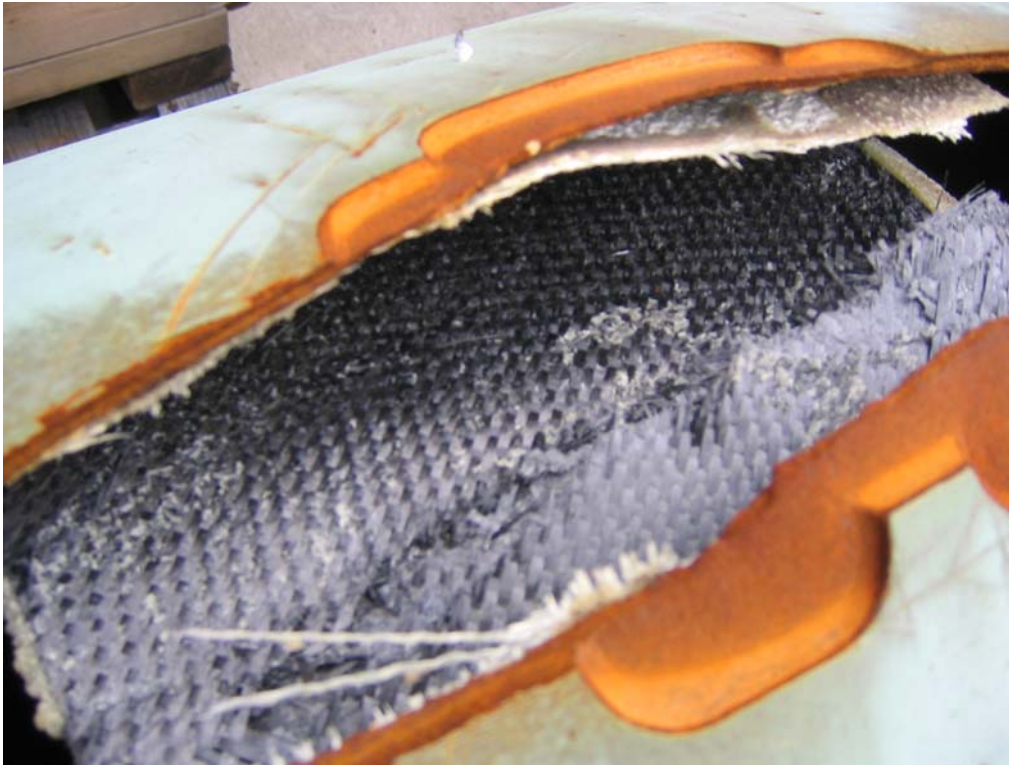
Figure 93 - Magnification of Carbon Fiber-Reinforced Patch After Burst Test

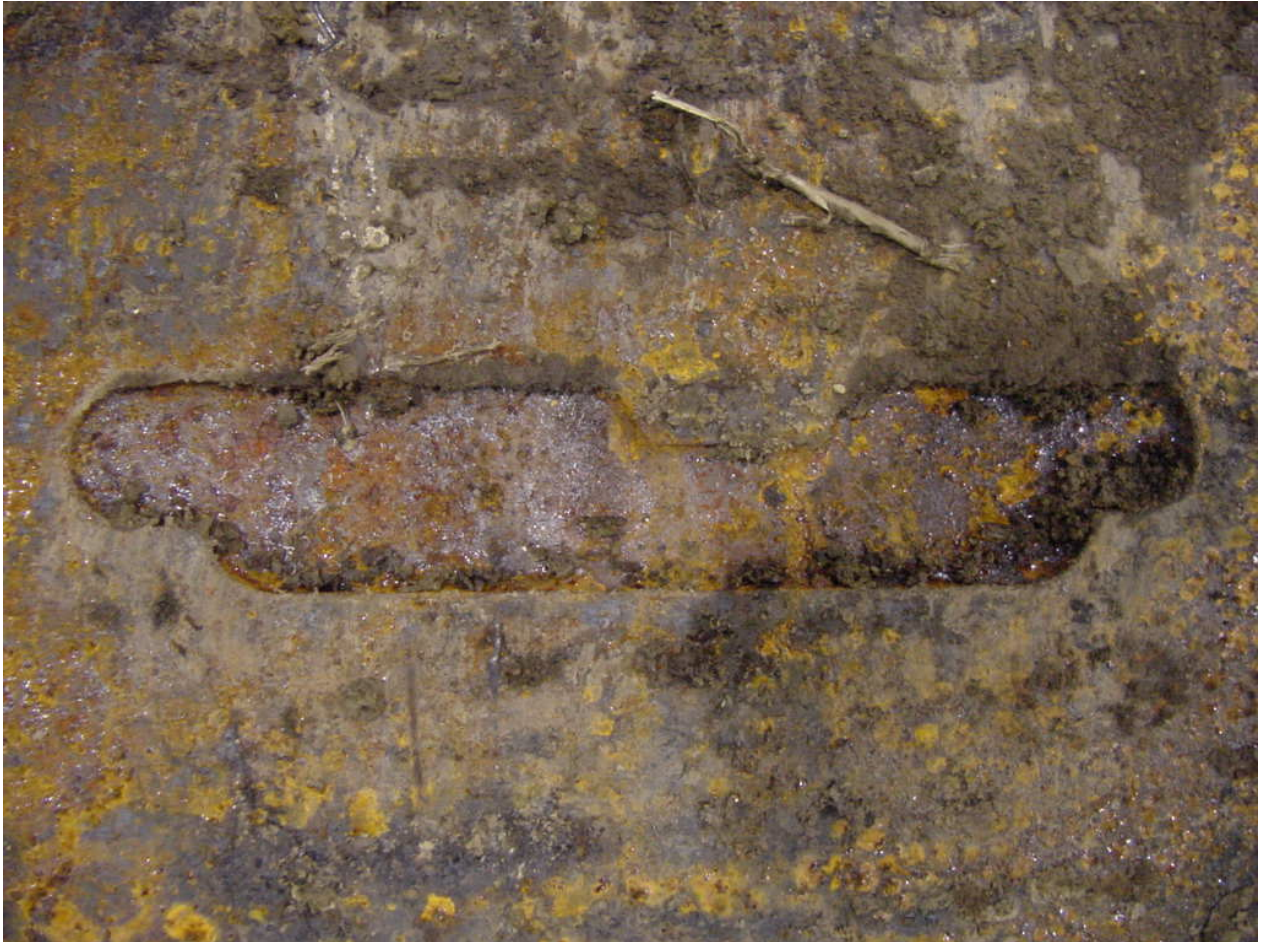
Figure 95 - Simulated Corrosion on Outside of Pipe After Internal Weld Deposition Repair

The area of simulated corrosion on the outside pipe surface is shown in Figure 95 after internal weld deposition repair.

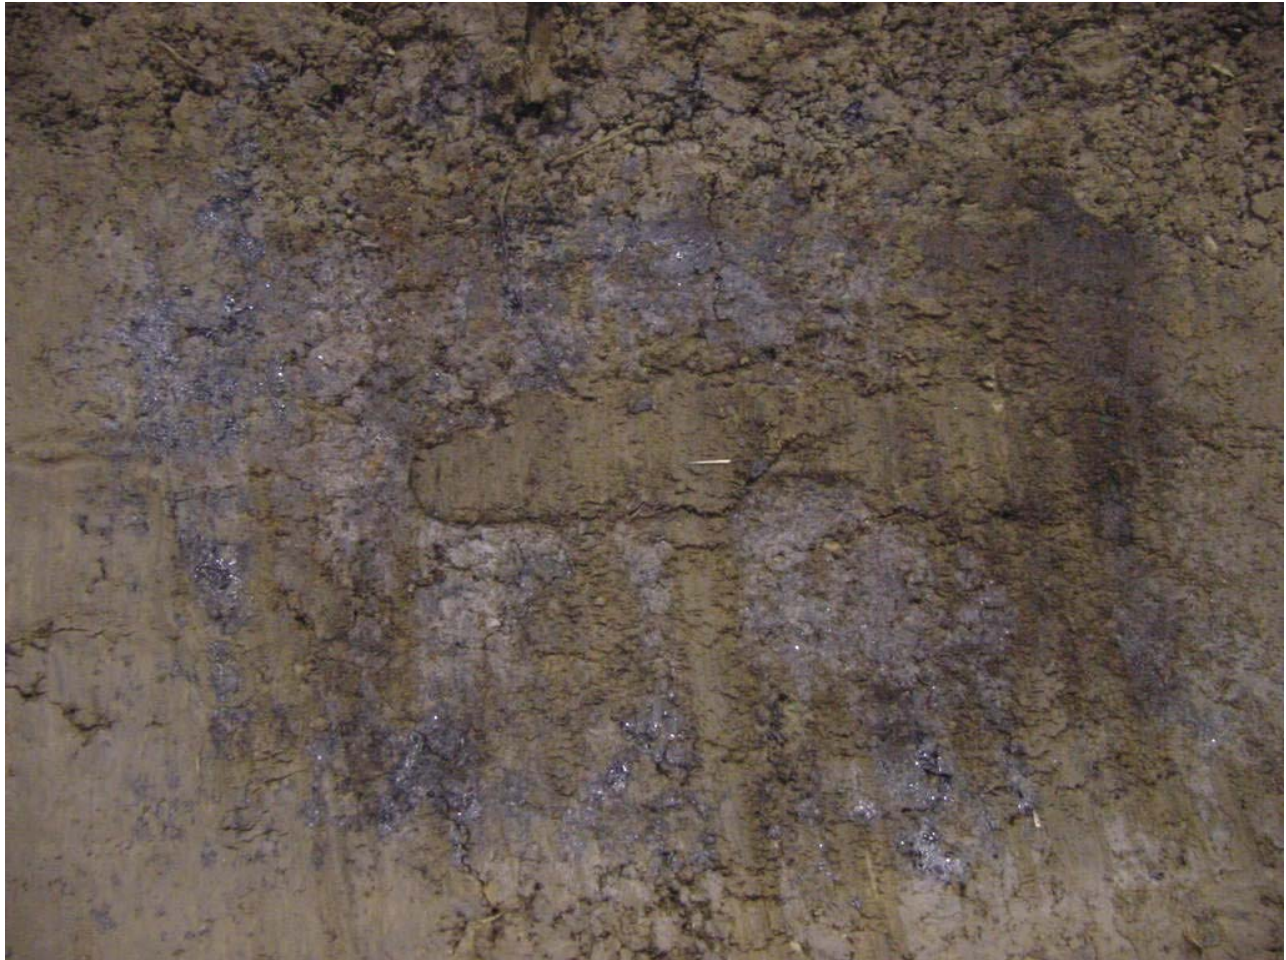
Figure 96 - Dirt That Was In Contact With Pipe During Internal Weld Deposition Repair

After the box with soil was removed from the weld repaired pipe section, an impression of the corrosion damage was left in the soil as shown in Figure 96. The outline of the weld deposition is also clearly visible where the asphalt coating melted and transferred to the surrounding soil during the welding process.

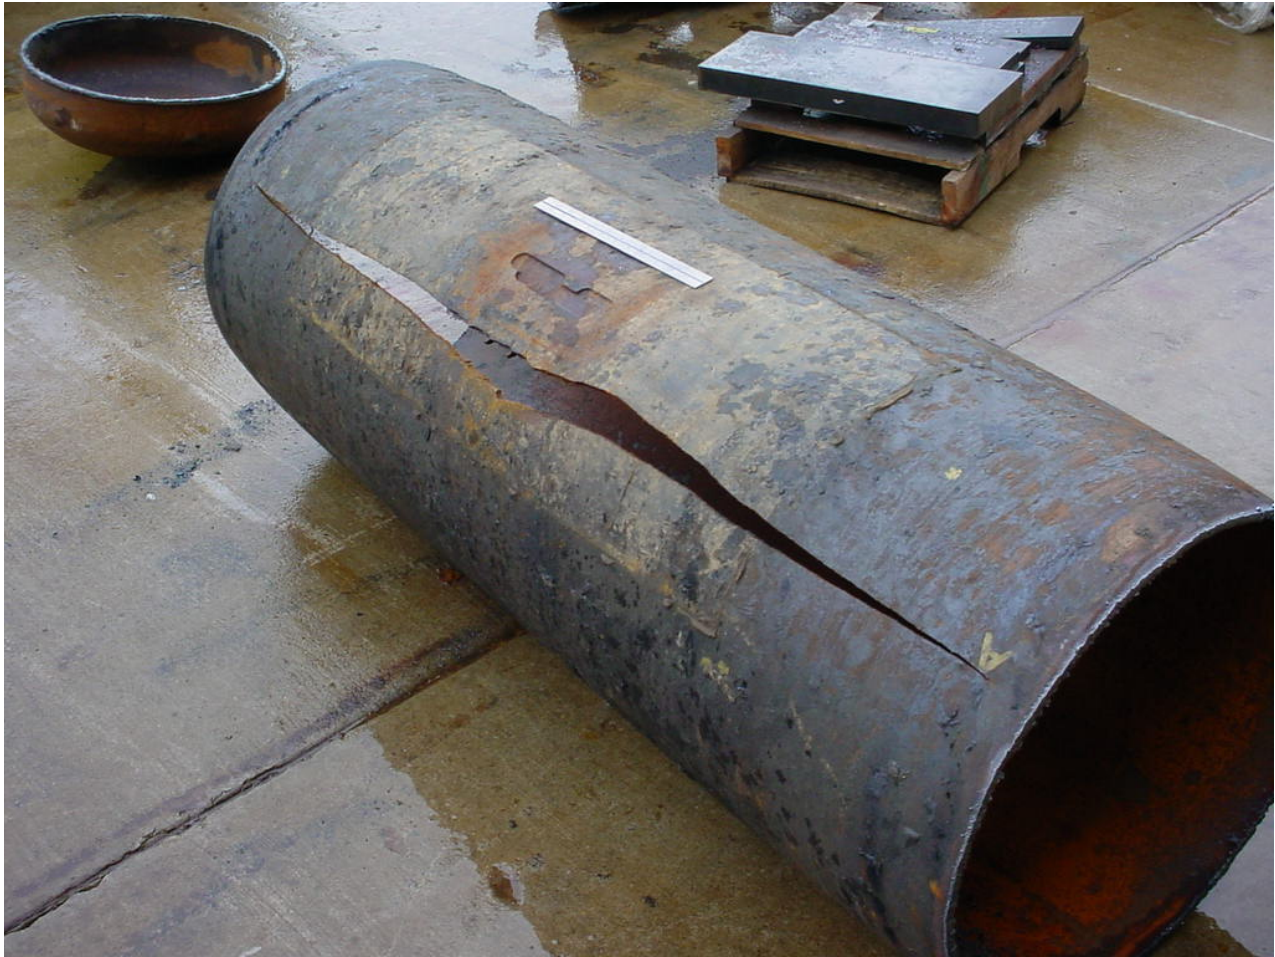
Figure 99 - Pipe Section with Internal Weld Deposition Repair After Hydrostatic Burst Test

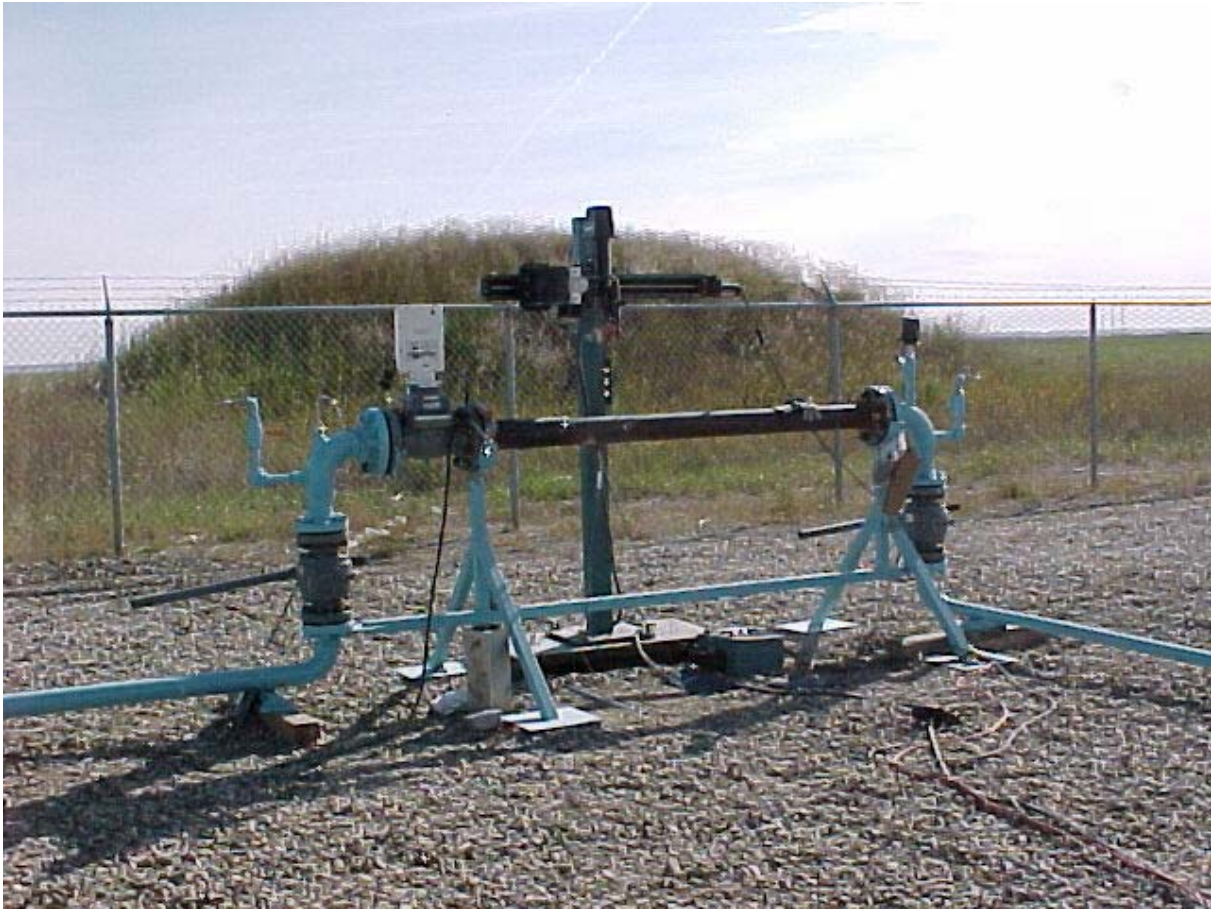
Figure 100 - Experimental Set-Up for Welding onto Thin-Wall Pipe containing Pressurized Methane Gas

methane gas (Figure 100, Figure 101, and Figure 102), carburization and the formation of thin layer of eutectic iron occurred (Figure 103 and Figure 104).
