EWI Project No. 46211GTH
Electronic File Name: 41633R52.pdf

Internal Repair of Pipelines 24-Month Technical Progress Report

Reporting Period:
March 31, 2004 through September 30, 2004

Submitted By:
Edison Welding Institute
1250 Arthur E. Adams Drive
Columbus, OH 43221

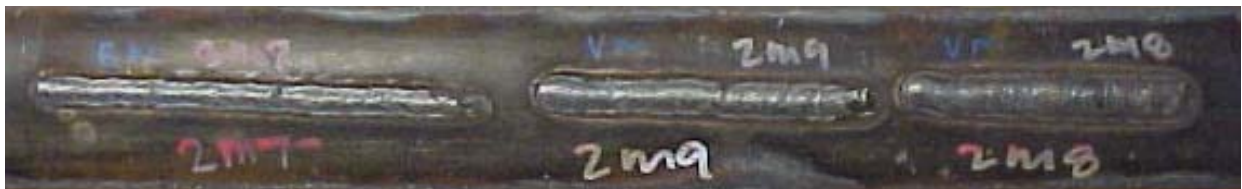
Figure 101 - External Appearance of Welds Made on 3.2 mm (0.125 in.) Thick Pipe with Methane Gas at 4.5 mPa (650 psi) and 6.1 m/sec (19.9 ft/sec) Flow Rate

methane gas (Figure 100, Figure 101, and Figure 102), carburization and the formation of thin layer of eutectic iron occurred (Figure 103 and Figure 104).

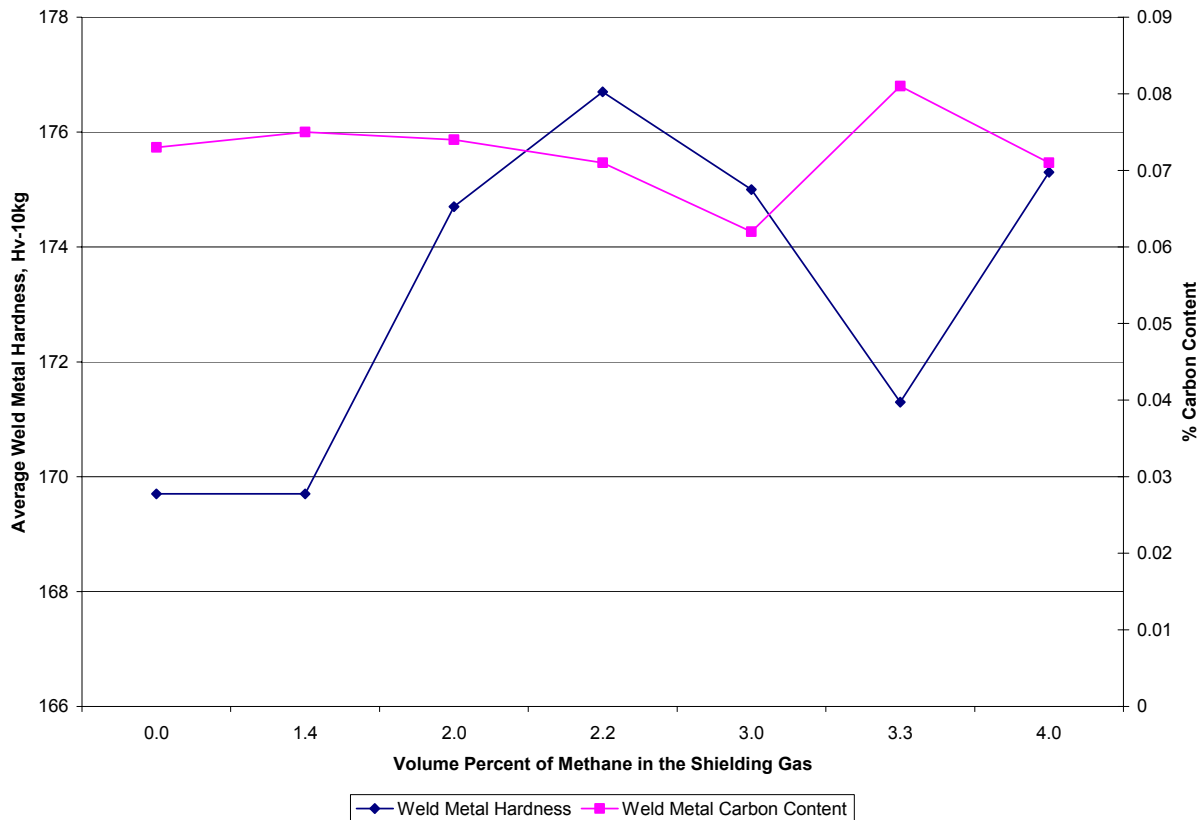
Figure 106 - Graphical Representation of Table 19 Hardness Values and Carbon Content

In Figure 106, the weld metal hardness scale is on the left axis and the percent carbon content of the weld metal is shown on the right axis. Increasing the volume percent of methane did not consistently increase either weld metal hardness or percent carbon content of the weld metal.

The average weld metal hardness values and percent carbon content from Table 19 are graphically depicted in Figure 106.

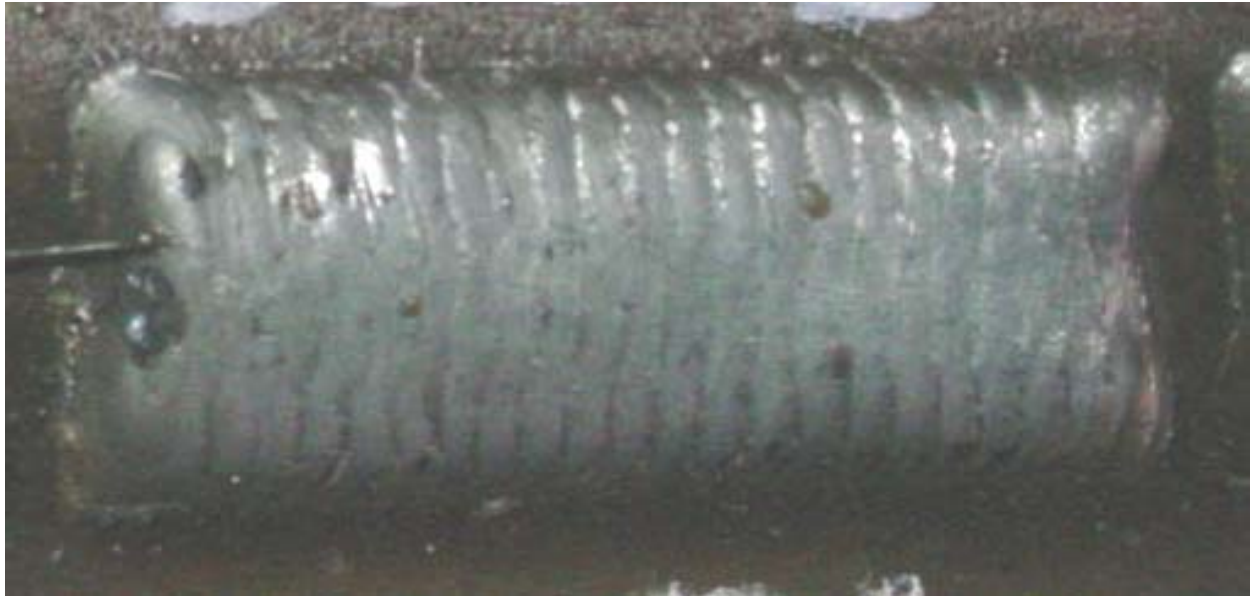
Figure 107 - Weld Specimen 325-2

Each weld deposit specimen (made in methane) was photographed as shown in Figure 107 through Figure 113. A visual examination of the samples revealed that a volume of 3% methane caused porosity in weld specimens 325-4 (Figure 109), 325-5 (Figure 110), and 325-9 (Figure 113).

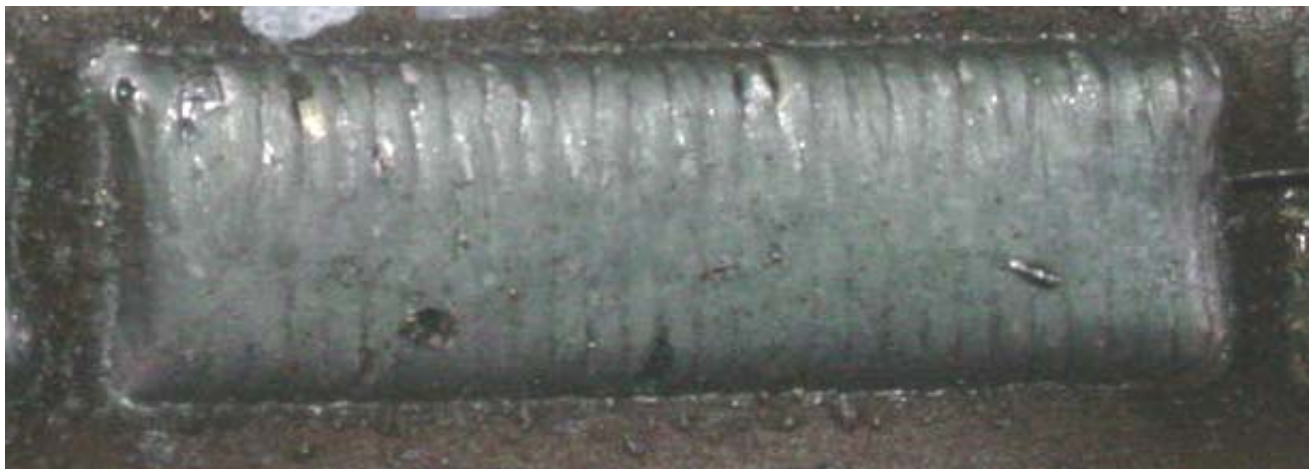
Figure 108 - Weld Specimen 325-3

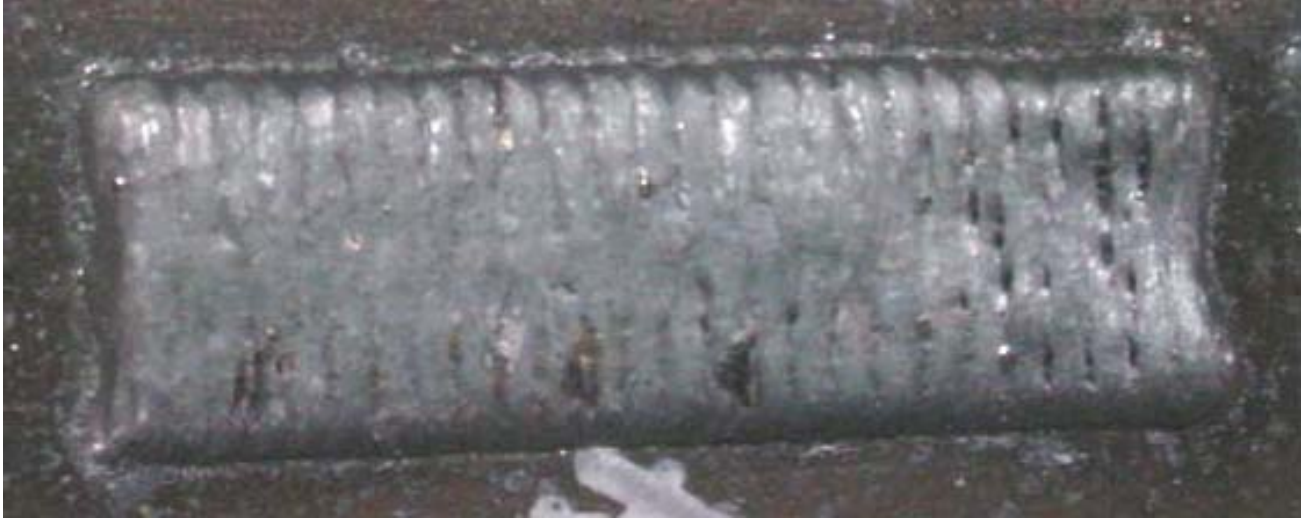
Figure 109 - Weld Specimen 325-4

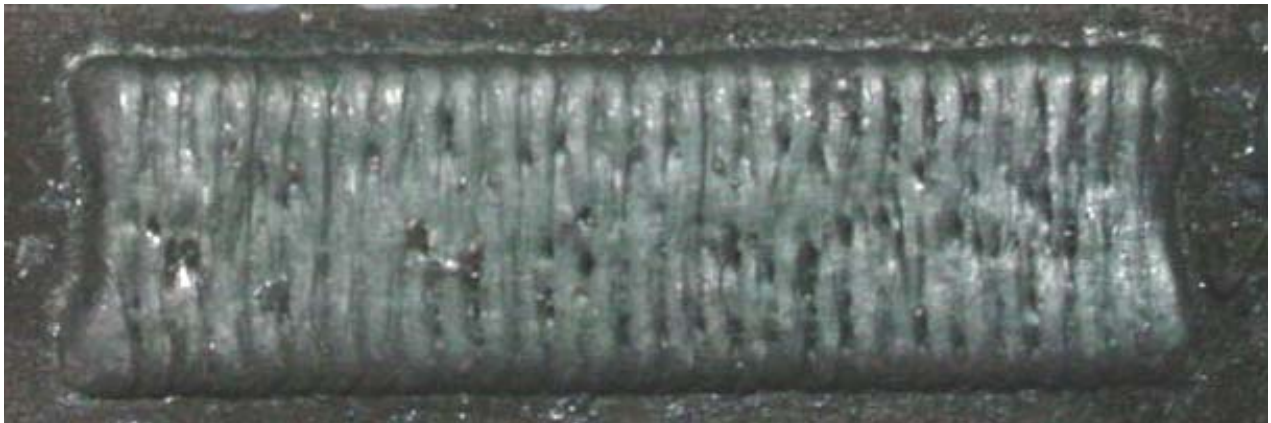
Figure 110 - Weld Specimen 325-5

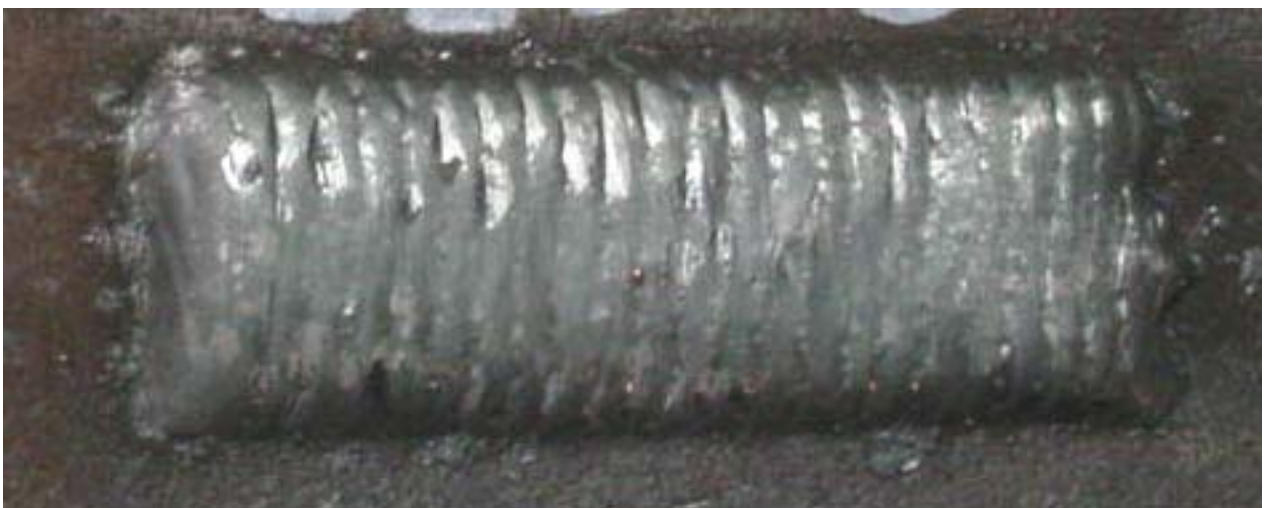
Figure 111 - Weld Specimen 325-6

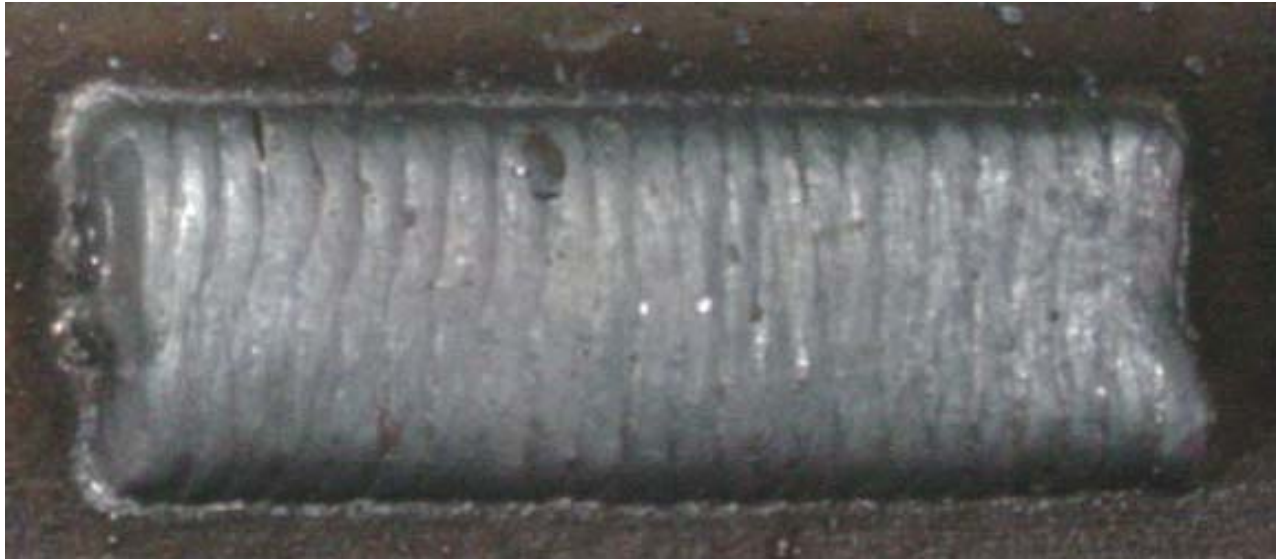
Figure 112 - Weld Specimen 325-8

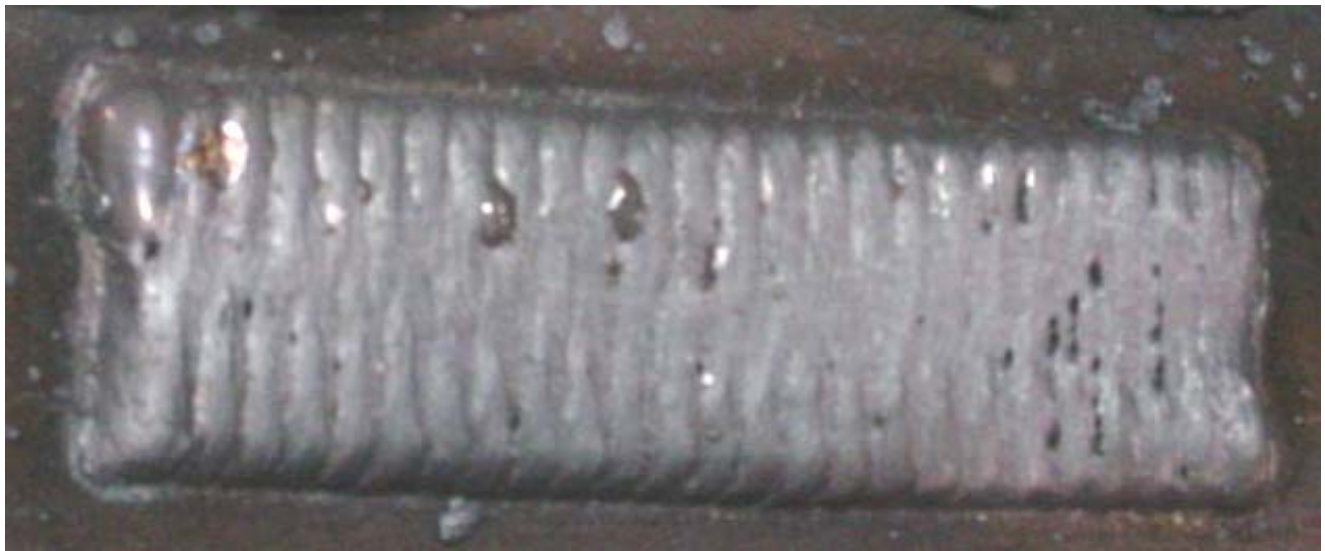
Figure 113 - Weld Specimen 325-9

These results clearly indicate that an increased volume of methane in the weld shielding gas produces welds with porosity defects that decrease weld quality. Adequate shielding gas protection is critical to creating sound, defect free welds. Providing adequate gas shielding protection during welding will be extremely difficult to achieve in a field repair situation.

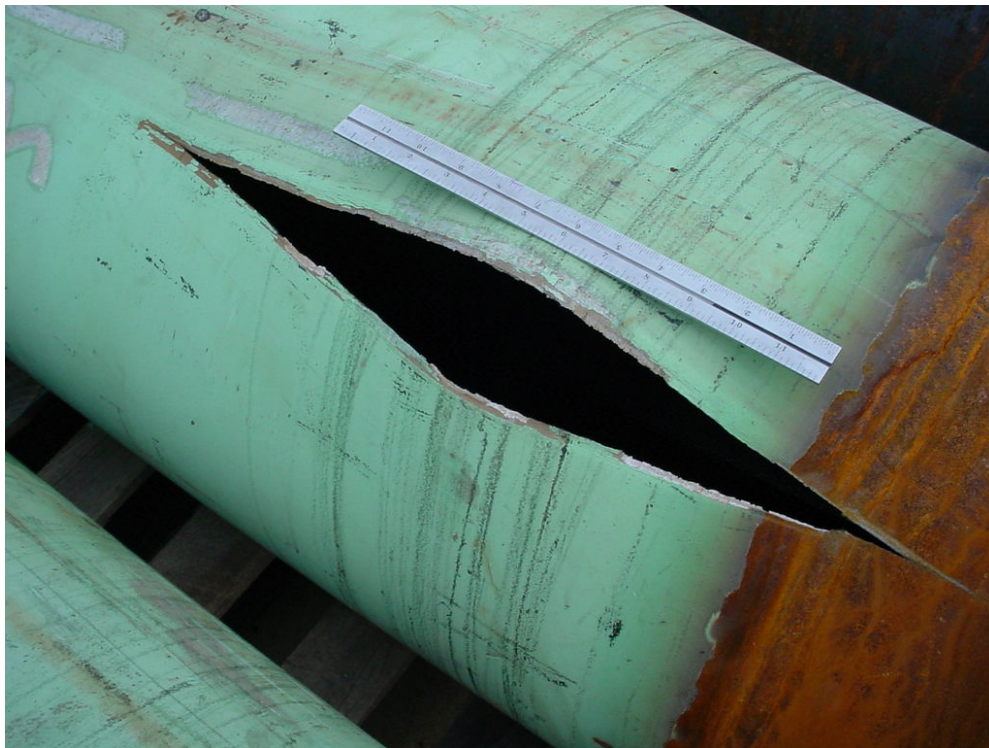
Figure 114 - Hydrostatic Burst Specimen of 508.0 mm (20 in.) in Virgin Pipe

Figure 114 through Figure 117 contain photos of the hydrostatic test specimens without repairs.

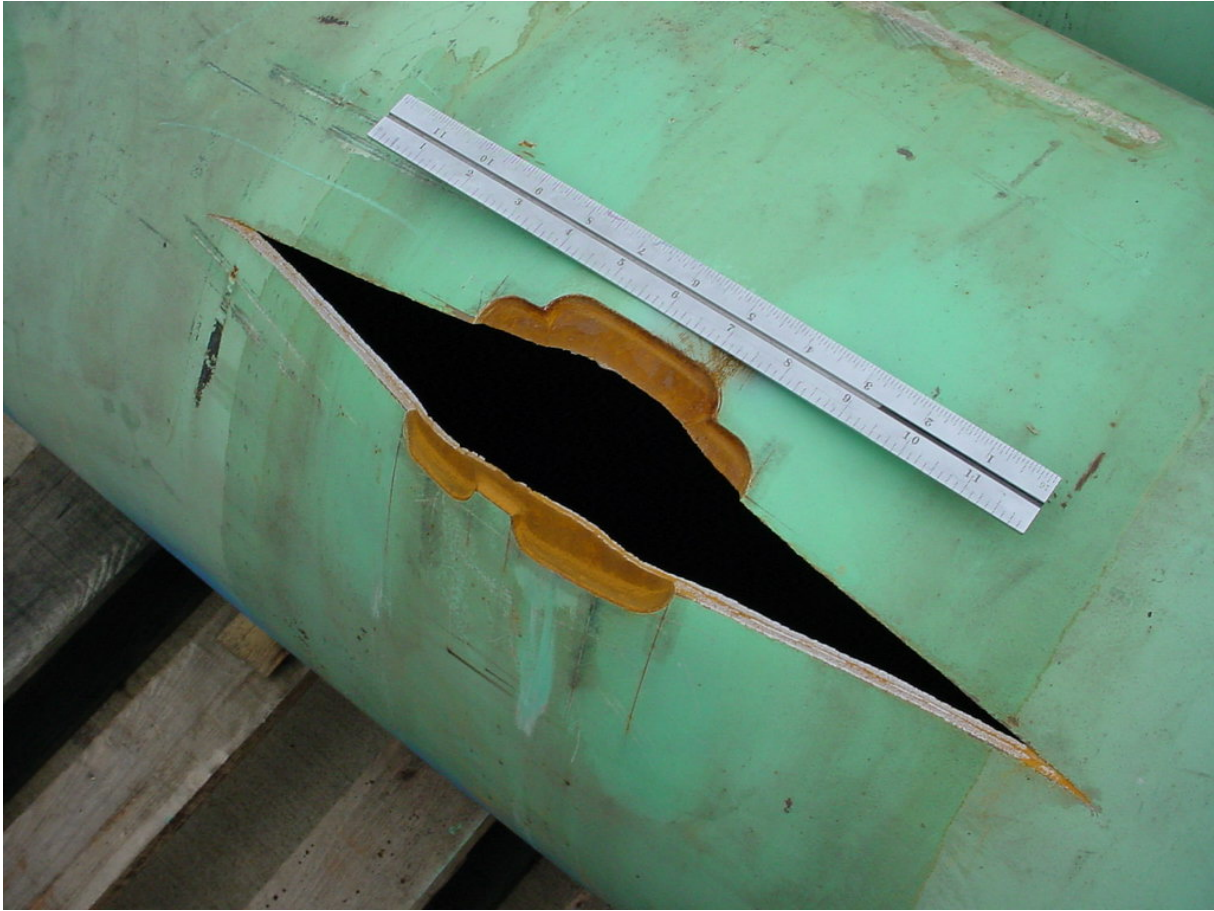
Figure 115 - Hydrostatic Burst Specimen of 508.0 mm (20 in.) with Un-Repaired Damage

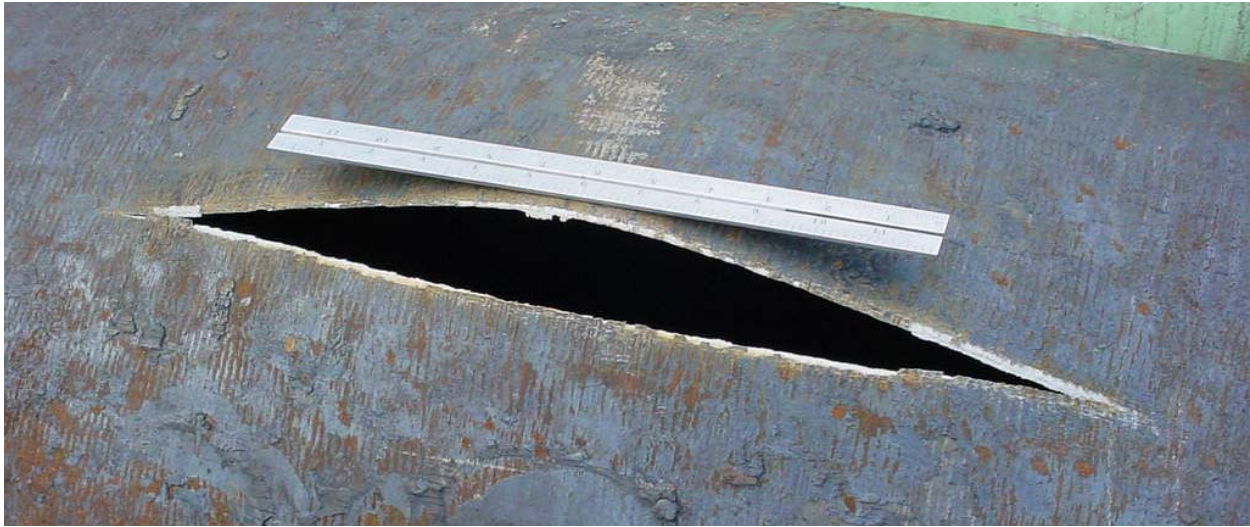
Figure 116 - Hydrostatic Burst Specimen of 558.8 mm (22 in.) Pipe in Virgin Pipe

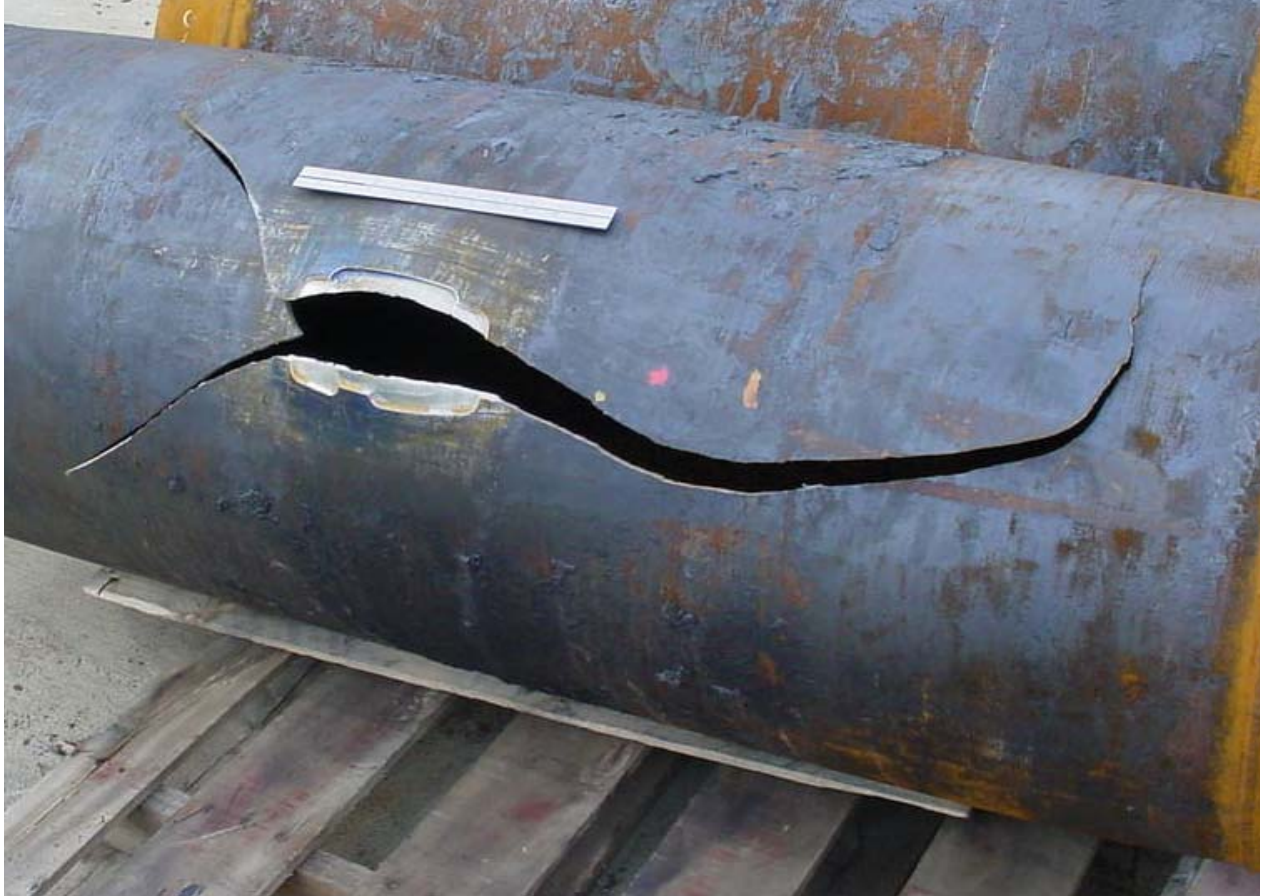
Figure 117 - Hydrostatic Burst Specimen of 558.8 mm (22 in.) With Un-Repaired Damage

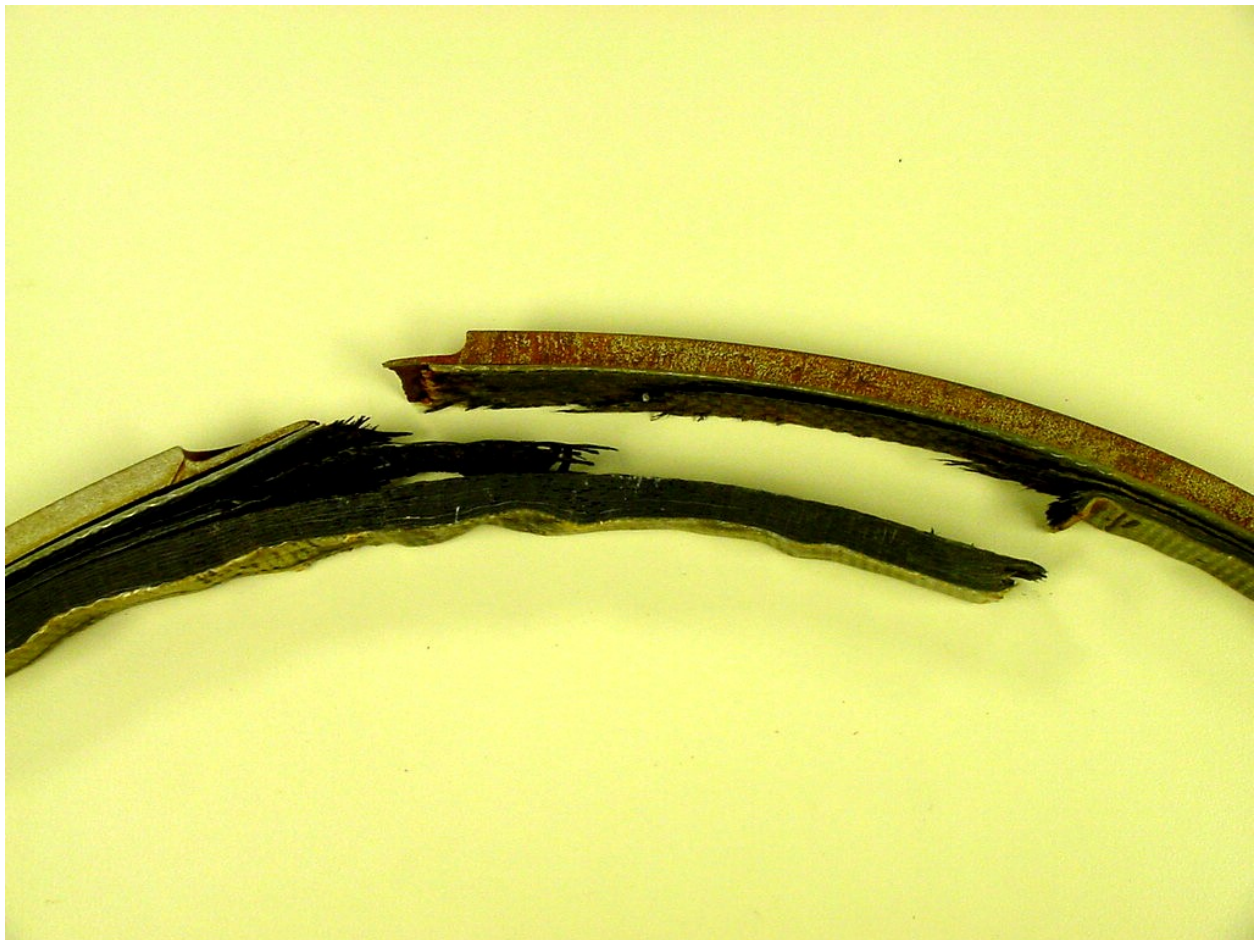
Figure 119 - Failure of Pipe and Composite Repair

The pipe section with the pressure bandage patch was sectioned in the circumferential direction. The pictures in Figure 119 and Figure 120 are of cross sections taken from locations in the area of pipe wall metal loss (i.e., the machined groove on the OD). Figure 119 shows a full failure of the pipe and composite repair. Figure 120 shows a failure of the pipe and the disbondment between the ID of the pipe and the composite repair.
