# **Underwater Coatings For Contamination Control**

#### Waste Management Symposium '05

#### Julia Tripp, Kip Archibald, Ann Marie Phillips, Joseph Campbell Idaho National Laboratory

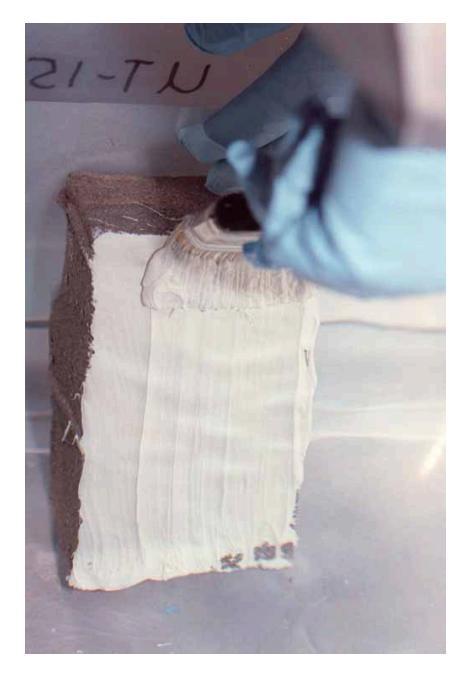
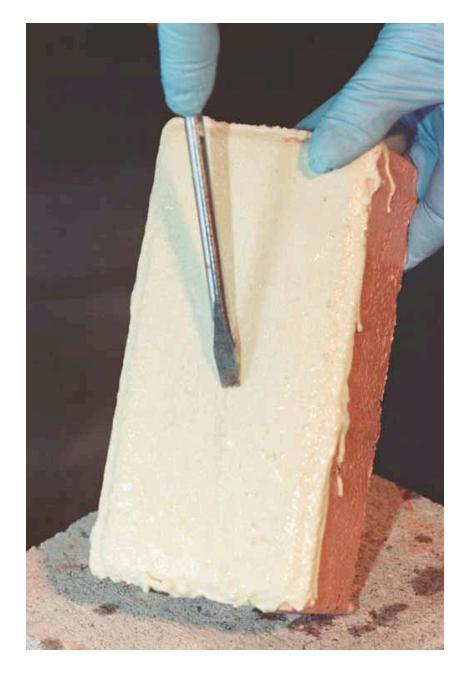
Figure 1. UT-15 adhered well to all surfaces when applying and after drying.

The three coatings that were the easiest to apply and adhered well were the NMP 1710, Corro-Coat FC 2100 Epoxy, and the UT-15 Underwater Epoxy. However, there is some concern on the Corro-Coat FC 2100 since after several weeks it broke off the stainless steel surface. Many of these coatings require a roughened surface to adhere well according to manufacturer's instructions and this may be why this coating came off. The surfaces were not roughened prior to application to more closely simulate field application conditions. In several cases, applied coatings bonded well to the epoxy painted surfaces but caused the bond of the epoxy paint to the surface of the coupon to weaken.

Based on these results, use of the UT-15 (Figure 1) and the NMP 1710 coatings were recommended for use in the actual fuel basins.

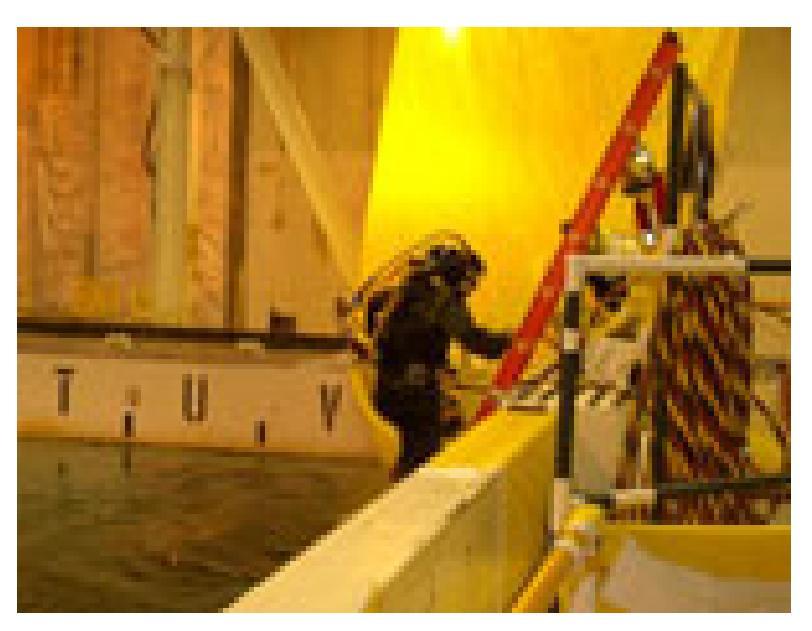
Figure 2. Diver enters basin at Test Area North.

S. G. Pinney commercial divers were chosen to complete this work. Before beginning dive activities, all areas to be worked on were surveyed by the divers themselves. The potential for finding unexpected debris items during cleanup of the basins was anticipated. The dive master was in constant voice and video contact with the divers during dive operations. Divers were instructed not to pick up anything before scanning it. There were no instances in which a diver entered an unsurveyed area or picked up objects that had not been surveyed. They first scrubbed the loose contamination off the basin walls and floors using a ship hull scrubber and vacuumed up the sludge. They then applied the UT-15 coating using a two-hose power roller system, which mixed the epoxy at the roller head, and eliminated the pot life concerns.

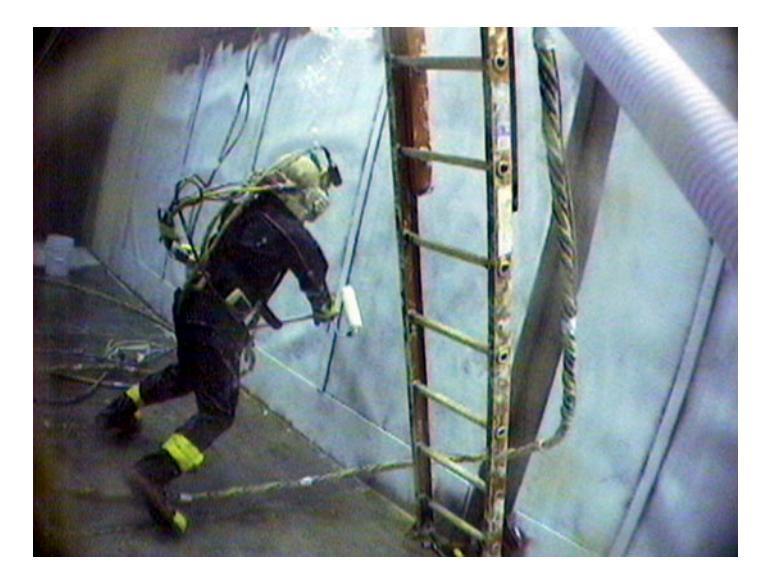
Figure 3. Applying fixative to the wall of the MTR canal.

The epoxy coating is much more difficult to apply under water than house paint in air. It took considerable effort to get a complete coating that passed the dive master's inspection. The divers also had to deal with the bubbled and loose paint layer on the TAN basin walls and the rough, bare concrete surface on the 603 Overflow Pit walls. The condition of the existing surfaces directly affected the time needed to apply the fixative.
