Preliminary Failure Modes and Effects Analysis of the US DCLL Test Blanket Module

Lee C. Cadwallader

June 2010

INL/EXT-07-13115
Rev. 1

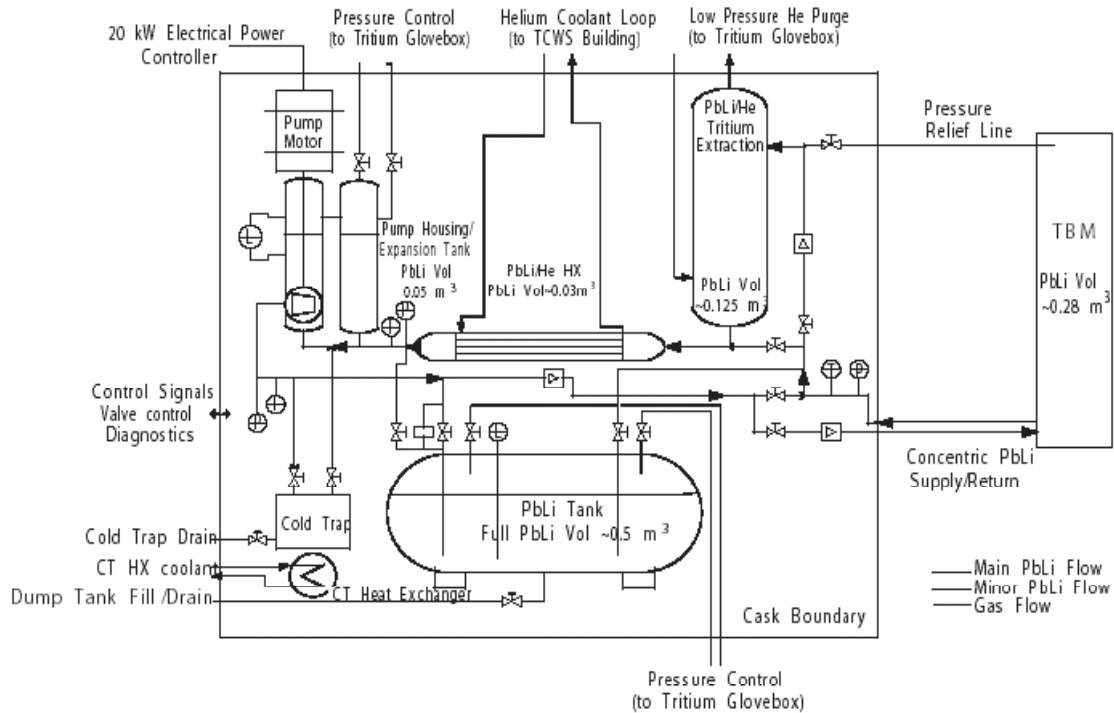
The Pb-17Li centrifugal pump is a modest size unit (20 kW or ≈ 25 horsepower), probably a vertically aligned motor to an overhung shaft with either a magnetic bearing or at least a design provision of no mechanical bearing immersed in the liquid metal. The liquid metal will not touch the pump shaft seal; a cover gas (perhaps helium or argon) will be used to provide a cushion to the shaft seal and pressurize the Pb-17Li. The flow from the pump is $\approx 72 \text{ kg/s}$. At 340°C, the density of Pb-17Li is about 9420 kg/m³, so the flow rate is $7.6\text{E-}03 \text{ m}^3/\text{s}$ (7.6 L/s). An expansion tank is mounted in tandem with the pump casing. The expansion tank serves two purposes: smooth pressure pulsations and supply extra liquid to compensate for liquid level (keep the impeller immersed). In the pump casing expansion tank, the helium cover gas also provides an opportunity to draw off radioactive gases from the Pb-17Li and route them to cleanup via the pressure control system. From the pump exit, the flow passes a cold trap, which is expected to be a tank with baffles and wire screens to promote precipitation of impurities and any oxides that might form in the Pb-17Li. The cold trap lowers the Pb-17Li temperature to approach the freezing

Figure 2-1. The Pb-17Li flow loop of the U.S. DCLL TBM.

point of $\approx 240^{\circ}\text{C}$ but not freeze the alloy. The cooler temperature allows some impurities and oxides to condense out of the liquid alloy. The cold trap can be cooled by forced air, nitrogen, or helium gas; no special coolants or design provisions are needed for this type of cold trap. Only a percentage of the liquid metal flow routes to the cold trap; other designs have used 5% flow diversion to the cold trap (Spencer 2000). From there, the flow proceeds toward the TBM module. Some flow will always divert into the mixing tank, which is included in the design as a provision to allow high temperature (650°C) operation. From the mixing tank, the flow enters a concentric pipe (inner pipe is the outlet flow, the outer pipe annulus is the inlet flow) that connects to the back of the TBM, cools the walls and breeds some tritium, then flows back out to the flow loop. The outlet flow proceeds to a tritium extraction unit, a vacuum permeator. The permeator is designed similar to a heat exchanger. The high temperature Pb-17Li flow enters tubes that allow tritium permeation through the tube walls, and the vacuum pumping equipment connected to the shell draws the gas away for processing. From the permeator, the hot Pb-17Li (470 up to 650°C) enters a heat exchanger. Helium at 8 MPa in the tubes enters at 200°C and leaves 360°C , and the Pb-17Li leaves at 340°C . From the heat exchanger, the Pb-17Li returns to the centrifugal pump. A drain tank is also part of the flow loop. The 0.5-m^3 drain tank is electrically heated by external resistance heaters to keep the Pb-17Li above its freezing point of $\approx 240^{\circ}\text{C}$. External heaters were chosen to enhance reliability and maintainability over that of immersion heaters that would be exposed to the liquid metal. The tank is filled with helium gas at 0.1 MPa to prevent moisture or air intrusion while not in use. A relief valve and a rupture disk will allow flow into the drain tank in the event that overpressure is experienced in the flow loop. The rupture disk is located after the heat exchanger so the Pb-17Li temperature should be relatively constant in that portion of the flow loop. The rupture disk has a rated burst pressure of 3.5 MPa. Rupture disk burst pressures decrease as the temperatures that the disk is exposed to

increase, so keeping a uniform temperature enables proper rupture disk performance. A pressure relief valve on the drain tank lifts at 4 MPa (Wong 2005).

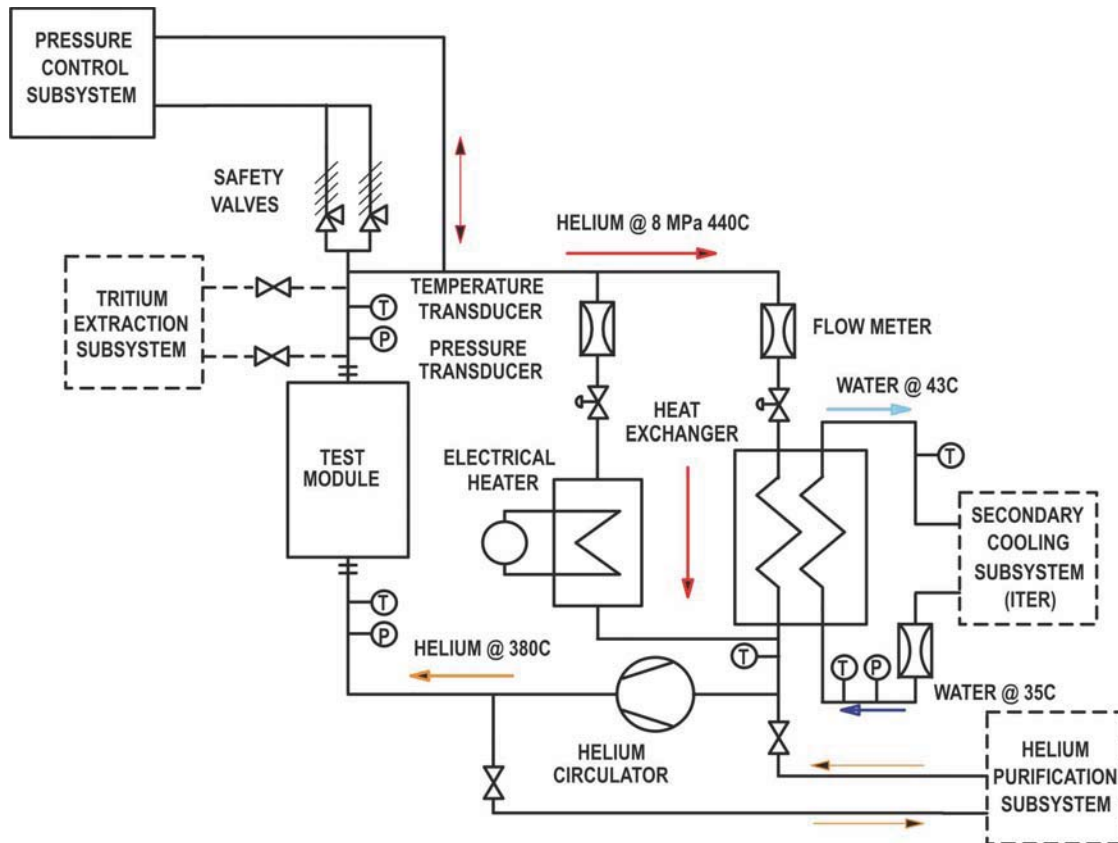
The main components of the TBM first wall helium cooling loop are a heat exchanger, electrical heater, control valves, and pipework. The electrical heater is turned off during normal operations; it is used to raise the helium to the minimum design temperature. The helium purification system (HPS) is small diameter piping with control valves to control flow. The HPS takes a small fraction of the helium coolant as a bypass flow. The helium purification system removes tritium that might diffuse into the helium coolant. There are no filters in the bypass line (e.g., no dust filters like those used in graphite-moderated Magnox and advanced gas-cooled fission reactors) because there are no recognized sources of dust or other contaminants in the TBM flow loop. It is also noted that the Pb-17Li coolant operates at a maximum of 2 MPa, so if a breach between the helium at 8 MPa and the Pb-17Li occurred within the TBM module then helium would pressurize the liquid metal. The module box is built to withstand such a breach without loss of module integrity (Wong 2005). Any 8 MPa helium breaching into the 2 MPa Pb-17Li will transmit pressure throughout the high temperature (highly fluid) Pb-17Li flow loop quickly, and the noble gas is expected to deposit itself in the headspace of the centrifugal pump casing or its expansion tank. The pressure increase in the Pb-17Li loop could actuate the Pb-17Li rupture disk to the drain tank. If the rupture disk opens, the system will depressurize into the drain tank. It is not clear how the helium system would respond to such a breach—the helium will initially depressurize into the drained Pb-17Li piping, but there is makeup helium available from the pressure control system. With the Pb-17Li drained, the Pb-17Li flow loop would de-energize and present a stagnant branch to the helium flow loop. In theory, the helium pressure control system could re-establish helium pressure and continue to cool the TBM module; however, the effects of the transient on the gas circulator (e.g., low pressure/overspeed trip?) and on the TBM box temperature transient during undercooling may require a shutdown. Otherwise, the helium pressure control system is used when evacuating the helium flow loop in preparation for long outages, for supplying makeup helium, and for system overpressure protection.

Figure 3-1. The helium flow loop of the U.S. DCLL TBM.

Note that nine helium storage, four helium dump, and one buffer tank(s) are not shown.

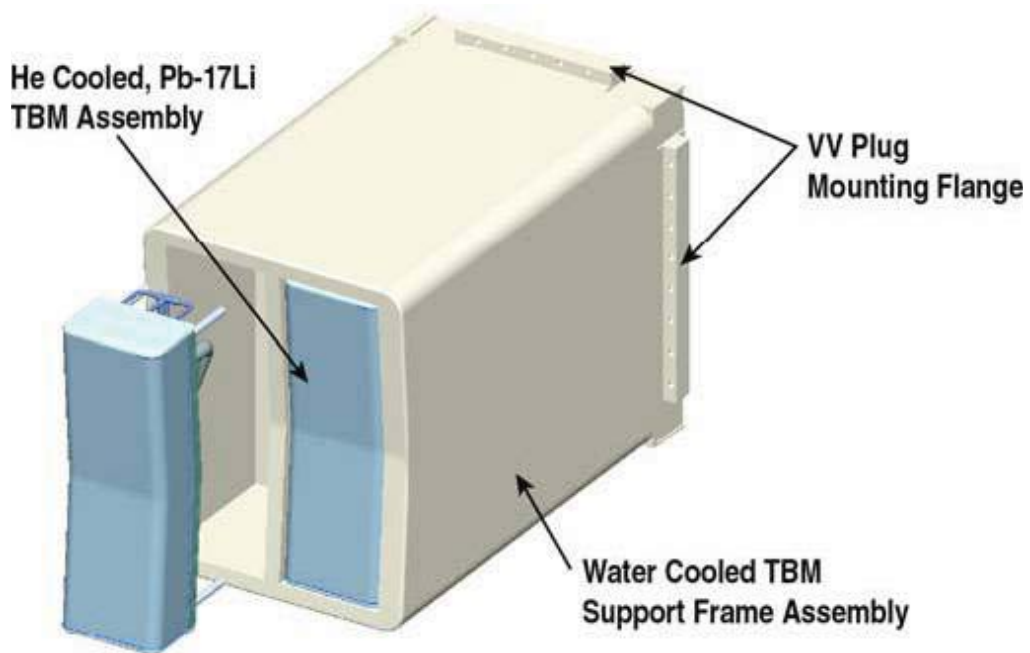
Figure 4-1. U.S. DCLL TBM module front view.

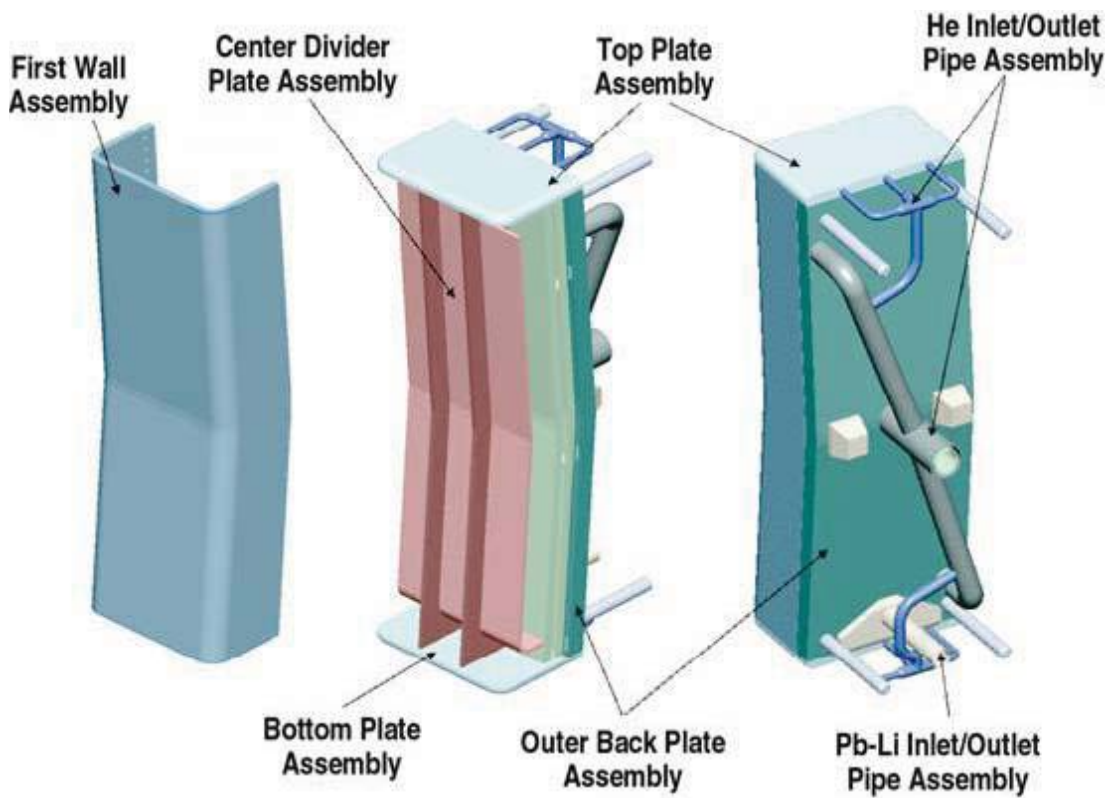
Figure 4-2. U.S. DCLL TBM module box exploded view.

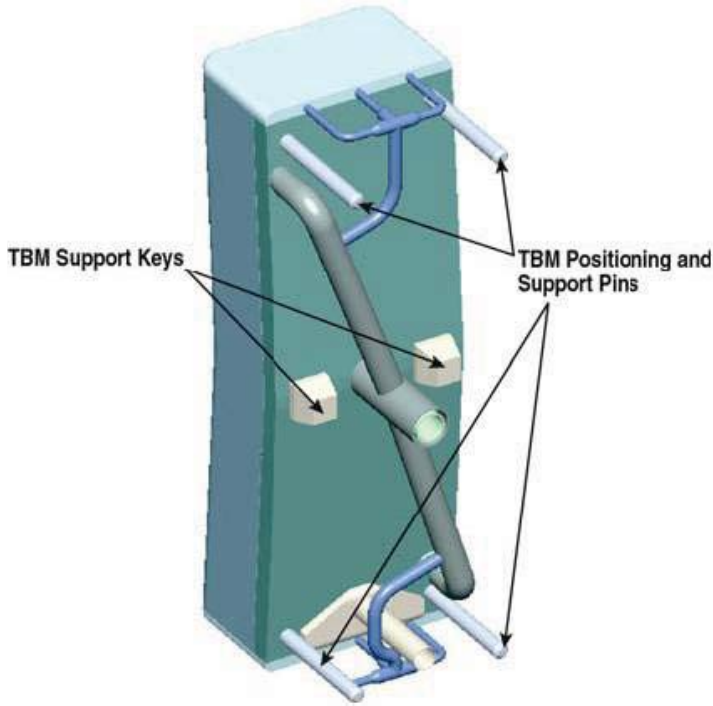
Figure 4-3. U.S. DCLL TBM module box rear view showing support elements.

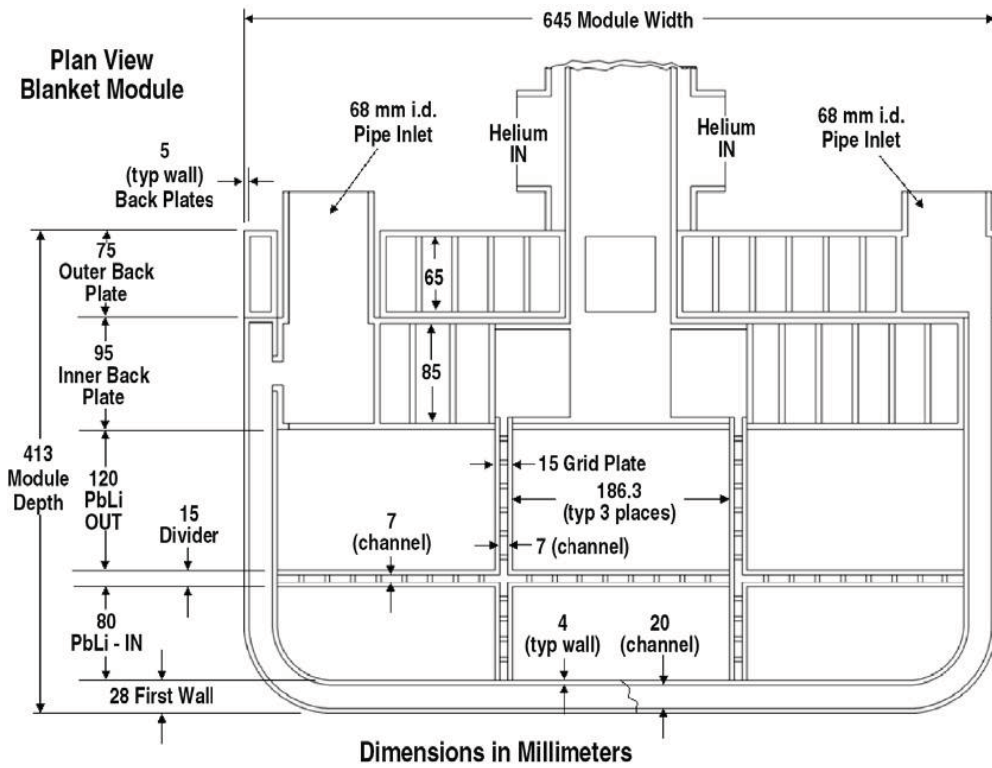
Figure 4-4. U.S. DCLL TBM module box plan view in cutaway.

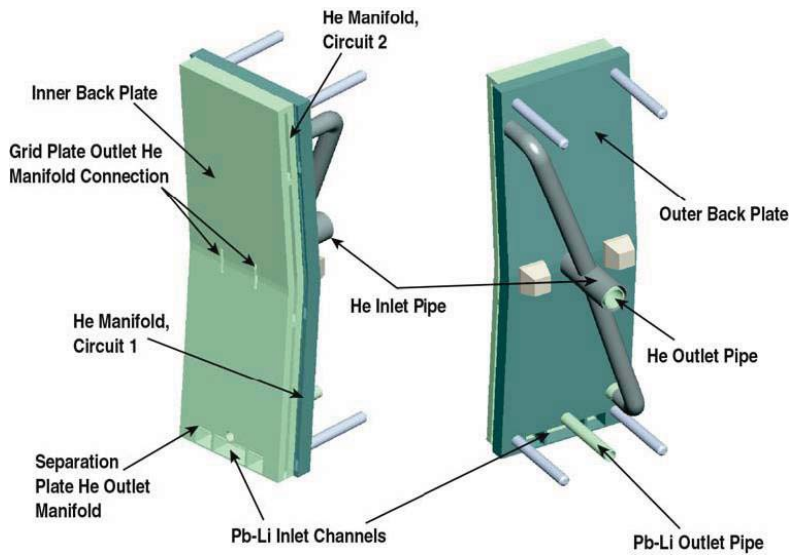
Figure 4-5. U.S. DCLL TBM module backplates and helium gas routing.

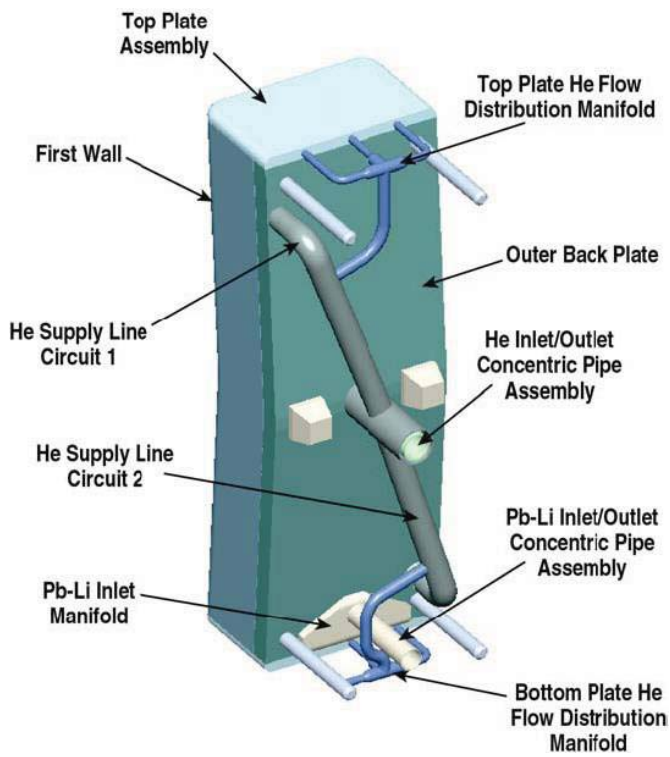
Figure 4-6. U.S. DCLL TBM module box rear view with helium manifolds.

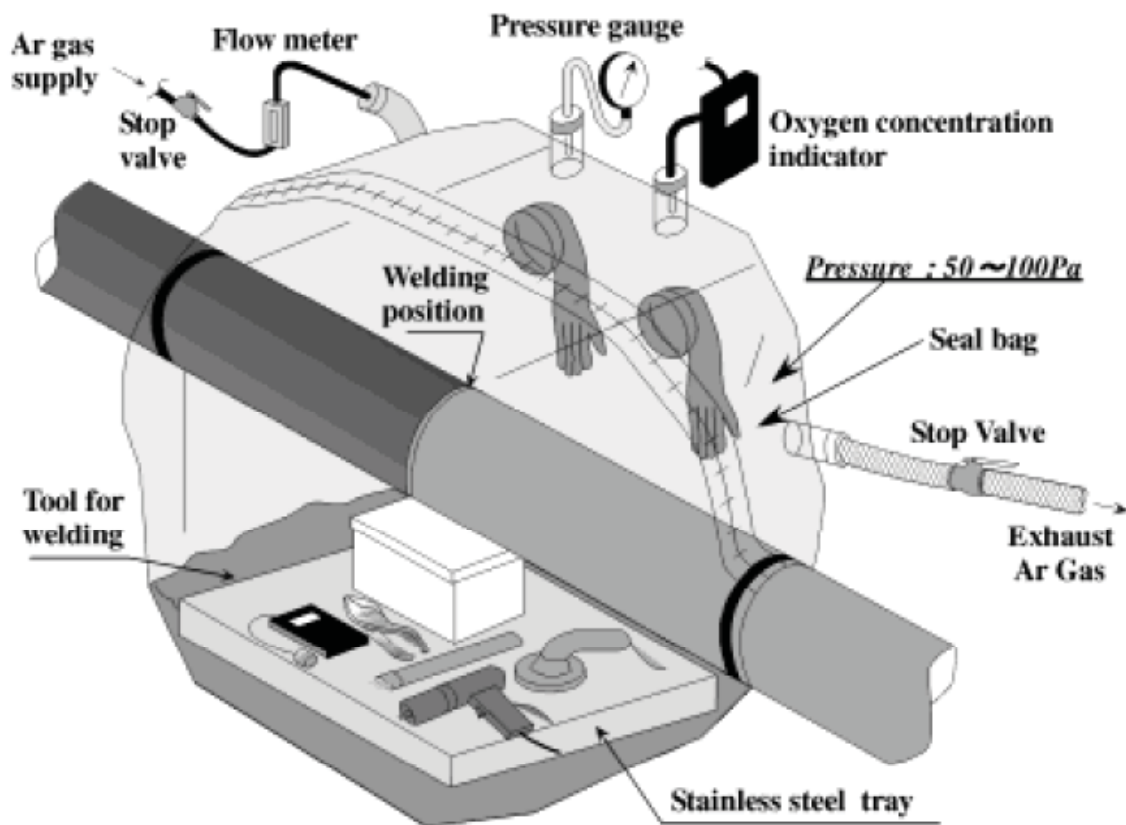
Figure D-1. Depiction of the inert atmosphere seal bag for welding piping. (Isozaki, 2005)

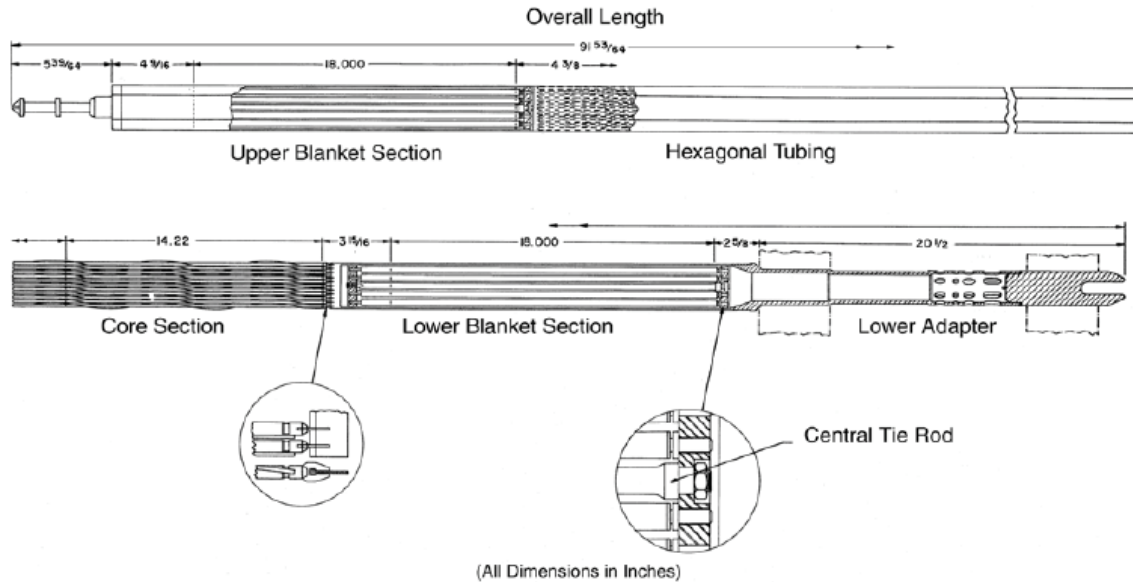
Figure F-1. EBR-II fuel subassembly.
(Note: Figure taken from Koch, 1988).

The Experimental Breeder Reactor-II (EBR-II) at the Idaho National Laboratory (INL), operated from 1961-1994, and was the first US demonstration power plant with a closed nuclear fuel cycle. A large hot cell facility for spent fuel processing was built adjacent to the reactor building. This facility was chosen for two reasons, the high radioactivity handled and the detailed documentation of the operations at that facility. EBR-II spent fuel, called a fuel subassembly, was cooled for at least 15 days after irradiation and then transferred to the hot cell facility for dismantling, melting, and fabrication into new fuel. A spent fuel subassembly entering the hot cell would have about 500,000 Curies of total radioactivity. The fuel subassemblies had unique terminology. A fuel pin was a cast cylinder of metallic uranium fuel. A fuel element was the stainless steel cladding tube that surrounded the fuel pin. There were 91 fuel elements in one fuel subassembly, whose ends were also fabricated from stainless steel (Stevenson, 1987). EBR-II fuel subassemblies were typically irradiated for 135 days in the sodium-cooled reactor core and then allowed to cool down in liquid sodium primary coolant, in the reactor vessel but outside of the reactor core. A spent fuel subassembly was intensely radioactive, giving a hot cell radiation loading that approached $1\text{E}+06$ roentgens/hour, and higher in some areas (Dietrich, 1958). Since penetrating gamma radiation was the principal exposure concern, and the quality factor for gamma rays is 1, the dose rate converts to $1\text{E}+06$ rem per hour or $1\text{E}+04$ Sieverts/hour. Figure F-1 shows an EBR-II fuel subassembly.
