HELIUM/SOLID POWDER O-RING LEAKAGE CORRELATION EXPERIMENTS  
USING A RADIOTRACER\*

R. W. Bild, W. B. Leisher, S. H. Weissman  
Sandia National Laboratories  
Albuquerque, NM 87185 USA

M. Seya  
Power Reactor and Nuclear Fuel Development Corporation  
Tokyo, Japan

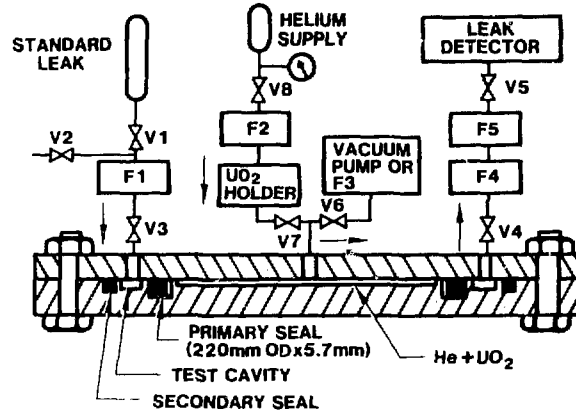
Figure 1. Test Fixture

detection. Figure 1 shows a typical test fixture, further described in Reference 1. The primary O-ring seal (supplied by PNC) is the only barrier between the central chamber and the test cavity. The valves, filters and other plumbing connect with either the central chamber or test cavity and are used for measuring pretest He leak rates, controlling pressure, introduction of tracer to the central chamber and for post-test sampling of the test cavity.

STANDARD LEAK:  $3.31 \times 10^{-8}$  atm cm<sup>3</sup>/sec (HELIUM)  
 V1-V5: BELLOWS SEALED VACUUM VALVES, 1/4 NPT  
 V6-V8: BALL VALVES, 1/8 NPT  
 F1, F4, & F5: FILTER, 0.2 μm SILVER ELEMENT  
 F2 & F3: FILTER, 0.2 μm FIBER GLASS ELEMENT

Each fixture has its He leak rate measured and is then taken to the test temperature. The UO<sub>2</sub> holder, isolated by valves V7 and V8, is removed, filled with tracer and reinstalled. The test is started by opening valve V8 and then V7 to introduce tracer and He (at test pressure) to the previously evacuated central chamber. A vibrator agitates the fixture during the test and thermocouples monitor temperature.

At the completion of a test, all plumbing above valves V3, V8 and V4 is removed. Three washes of approximately 8N HNO<sub>3</sub> are circulated through the test cavity to dissolve any UO<sub>2</sub> tracer present. All washes are combined and gamma ray counted on a Ge(Li) detector to determine the amount of tracer that passed the O-ring seal.
